**National Transportation Safety Board**

**HUMAN PERFORMANCE GROUP FACTUAL REPORT**

**A. ACCIDENT**

**Location:** Near Liberal, Missouri (Barton County, Mo)  
**Carrier:** Kansas City Southern Railroad and BNSF Railroad  
**Trains:** KCS Train QSHKC20  
BNSF Train EMHSEBM088  
**Date:** July 21, 2012  
**Time:** About 3:30 p.m. central daylight time  
**Number:** DCA-12-FR-007

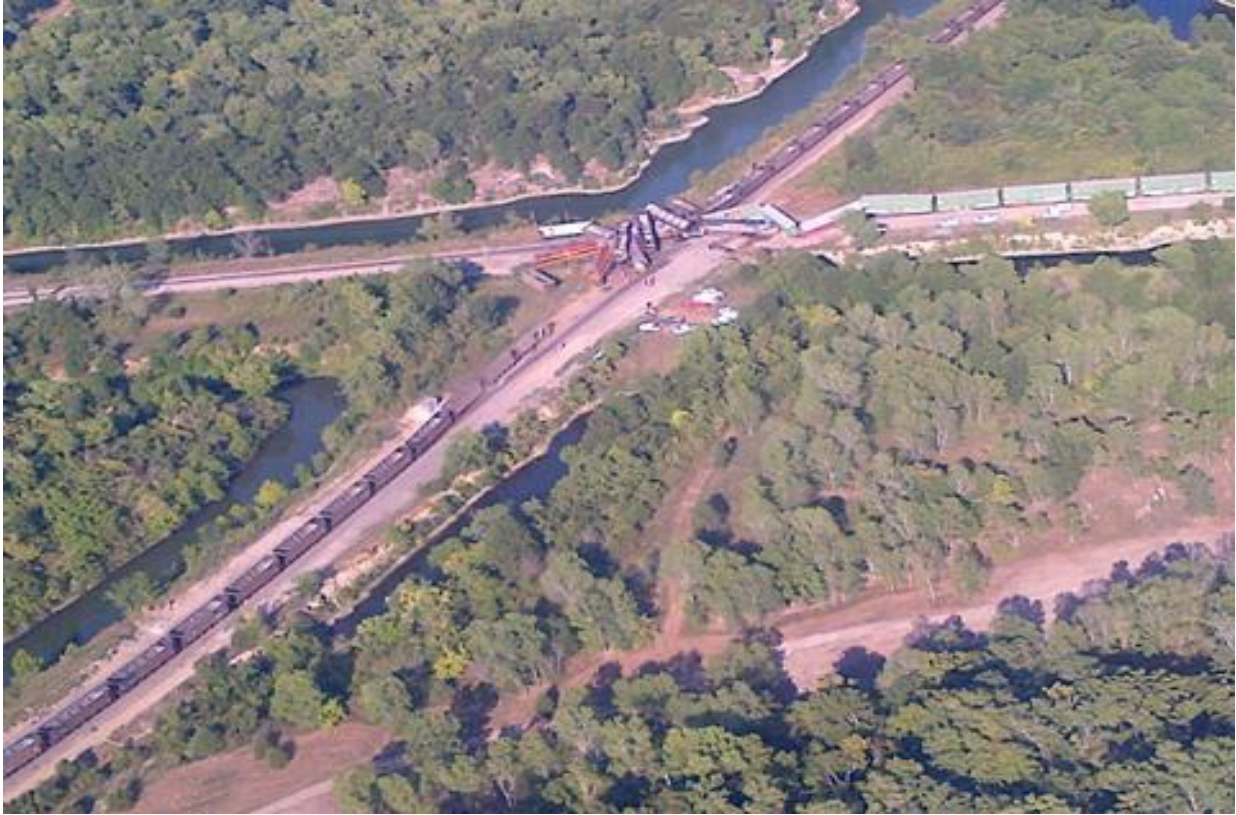
**Figure 1.** Aerial picture shows a northbound Kansas City Southern Railroad mixed freight train (pictured traveling from right to left) that had collided into the side of a westbound BNSF Railway empty unit coal train (pictured traveling from top to bottom) at a joint KCS / BNSF diamond crossing near Liberal (Barton County), Missouri.

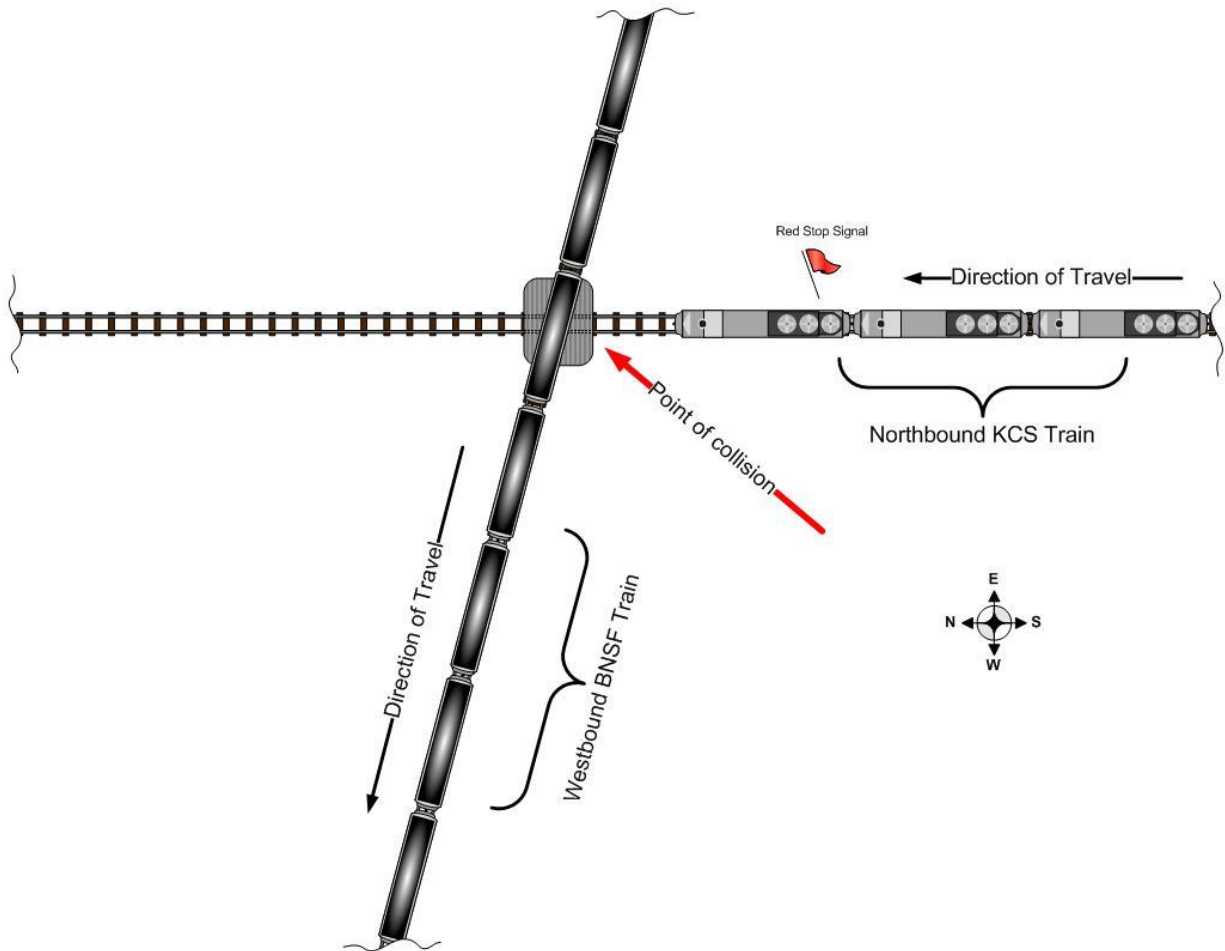
**Figure 2.** This diagram shows a schematic layout of the location where the accident occurred. This diagram has the same orientation as the aerial picture seen in figure 1. Three KCS locomotives are shown traveling north (right to left). The KCS train is pictured just a few feet short of striking the BNSF freight train. Seven cars from the northbound BNSF freight train (traveling from top to bottom on this diagram) are shown covering the entire length of the section of track, which includes the interlocking (the point of collision). The red flag on the KCS track indicates the location of the red signal the KCS crew passed seconds before striking the side of the BNSF train.

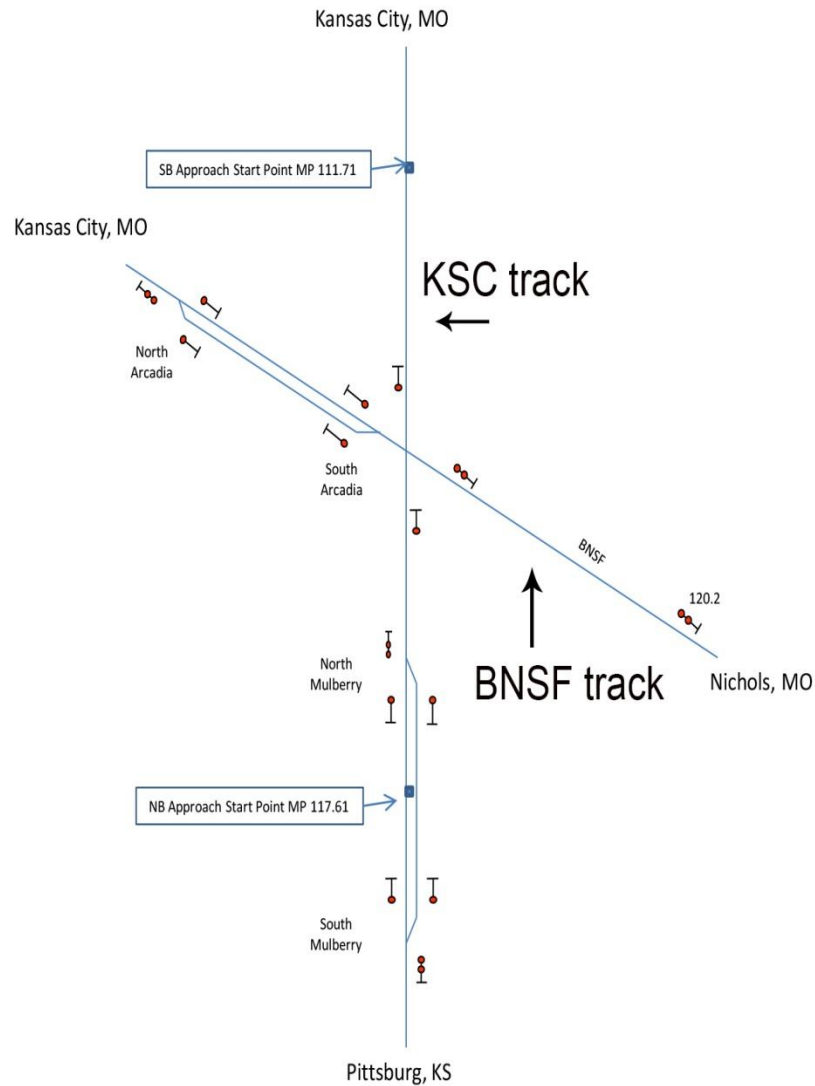
**Figure 3.** This diagram identifies several signals on both the KCS and BNSF tracks leading up to the interlocking. (The diagram was developed by investigators from the Signal Group).

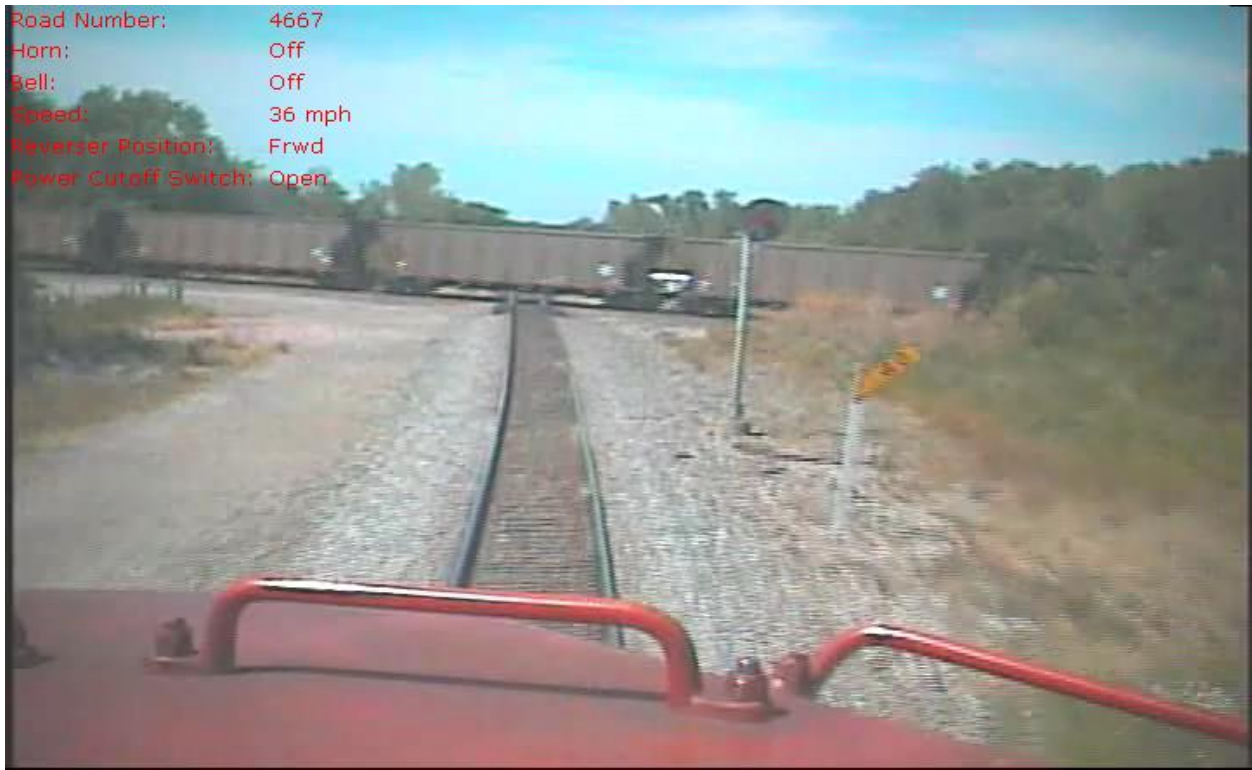
After passing the signal at North Mulberry the train traveled around a curve. According to the crew, at a distance of approximately 25 car-lengths, they observed a red signal at the Home signal at the interlocking.<sup>6</sup> Immediately afterwards the crew saw the BNSF train entering and crossing over the interlocking.<sup>7</sup> The crew told investigators that the engineer immediately applied emergency braking. The engineer did not activate the two-way end-of-train device. (He told investigators, "It did not cross my mind.")

**Figure 4.** This photograph was taken by the KCS freight train's outward facing camera positioned on the lead locomotive. The Home signal can be seen ahead of the train on the right side of the tracks. The KCS train is likely less than 10 seconds before impact with the BNSF train, which is now traversing the interlocking. It is estimated that this was the point where the KCS crew jumped from the lead locomotive.
