**Accident involving AS 350B2 N852HW
Laboratory Investigation Report**

Tests of hydraulic pump HPI and tail rotor load compensator

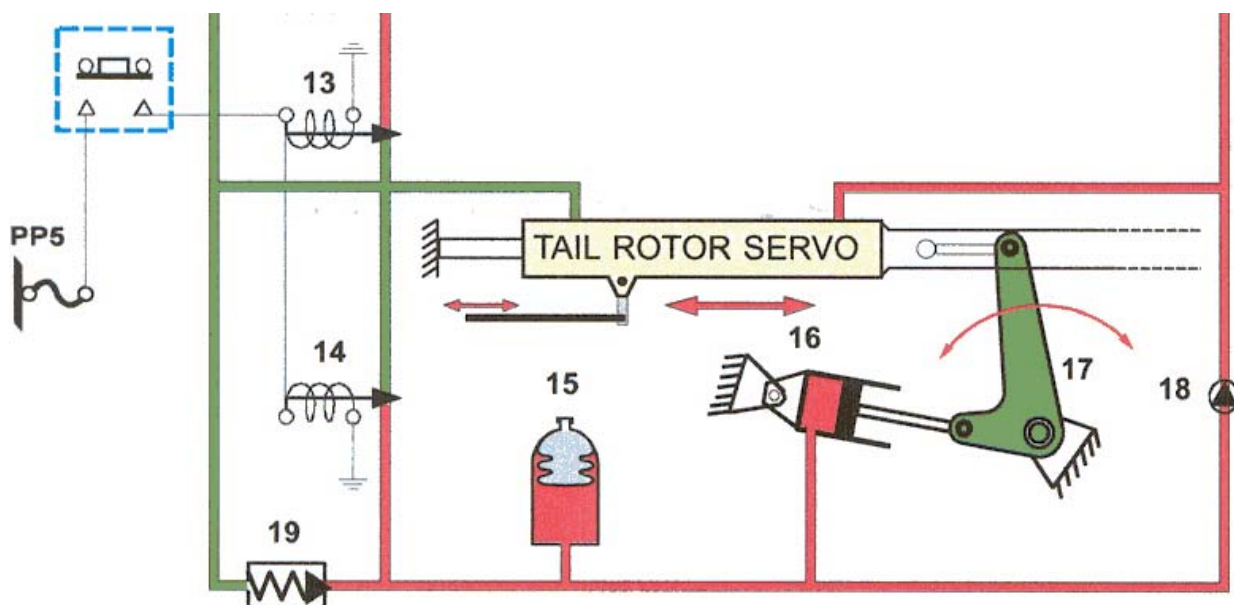
The HPI hydraulic pump test meets the parameters requirements
Compensator actuator accumulator was deflated. Tests have evidenced lack of sealing on the diaphragm between the nitrogen chamber and the oil. But it is important to note that the tail rotor load compensator system itself was able to keep oil pressure. Indeed, there is no leak between the non return valve (18), solenoid valve (14) and pressure relief valve (19)
We remind that, before each flight, the accumulator is tested.
