**ABM 0703-0177-14U
Condition and Valuation
Insurance Survey**

**Christopher's Joy
75 ft Steel F/V**

REPORT OF SURVEY

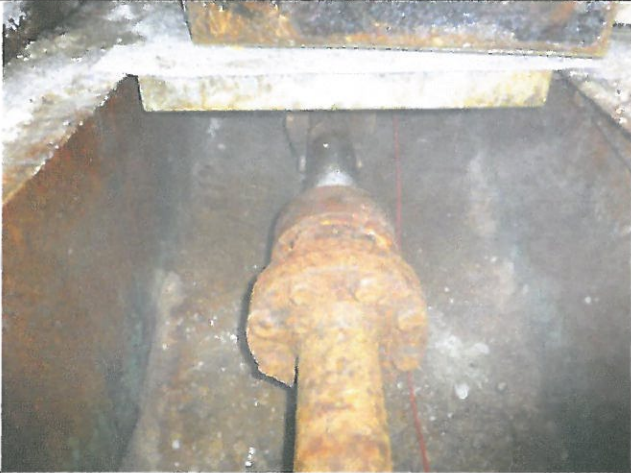
| ITEM | TYPE/MODEL/SN | CONDITION |
|---|--|---|
| Shaft log | | Good / Serviceable |

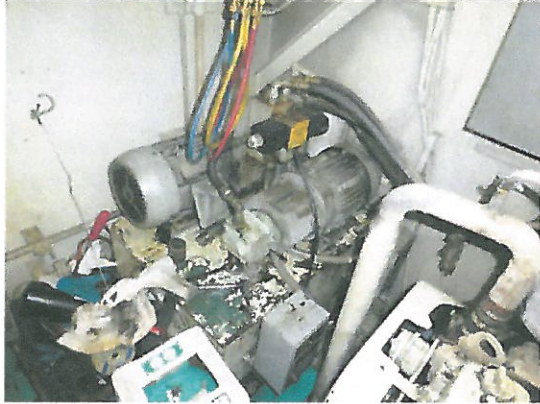
| ITEM | DESCRIPTION | SAT | UNSAT |
|---|---|---|---|
| Hydraulic Steering System | | | |

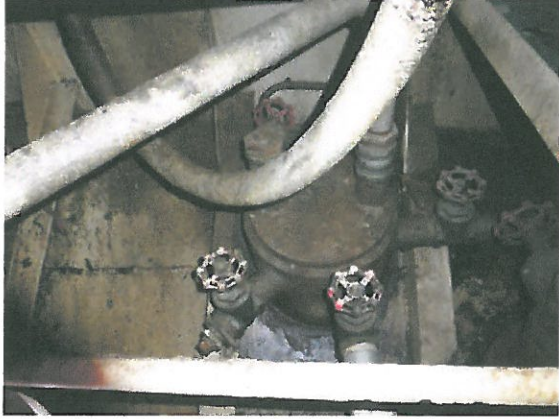
| ITEM | DESCRIPTION | SAT | UNSAT |
|---|--|---|---|
| Sea Chest | 2" pipe manual gate valves picture below. | X | |

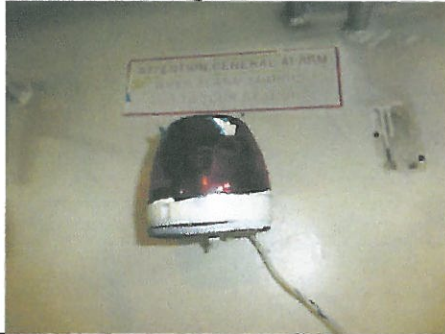
| ITEM | DESCRIPTION | SAT | UNSAT |
|---|--|---|---|
| General | Present tested /Engine room | X | |

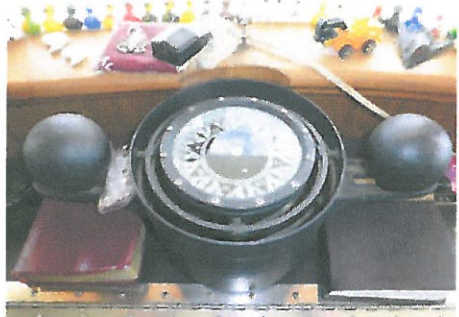
| ITEM | DESCRIPTION | SAT | UNSAT |
|---|---|---|---|
| Compass | Dirigo Gyro Compass with Spheres *Note current calibration card behind left sphere (in good standing) | X | |

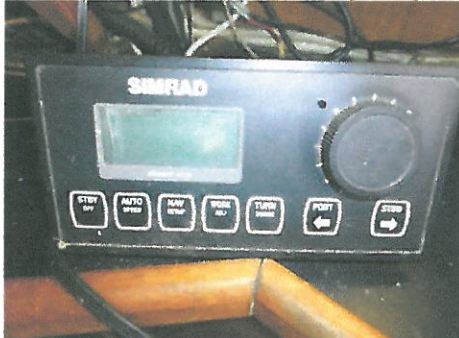
| ITEM | DESCRIPTION | SAT | UNSAT |
|---|---|---|---|
| Autopilot | Simrad AP 35, incorporates computer/plotter | X | |

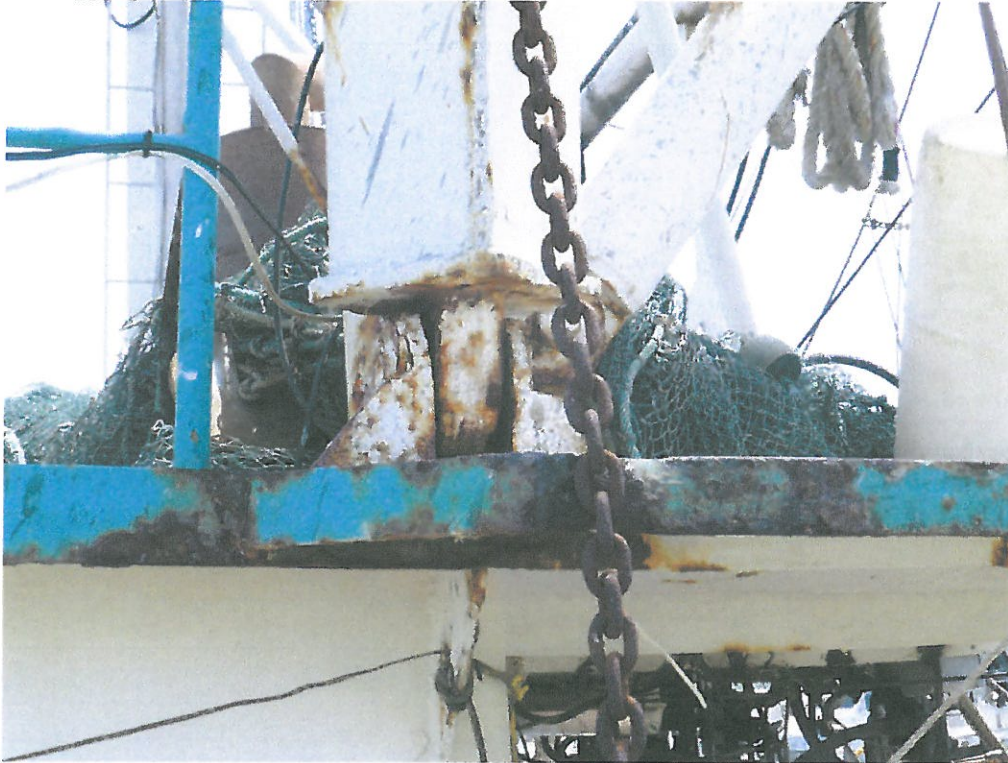
Outrigger pin

| ITEM | DESCRIPTION | SAT | UNSAT |
|---|---|---|---|
| Outrigger pins | Satisfactory condition | X | |

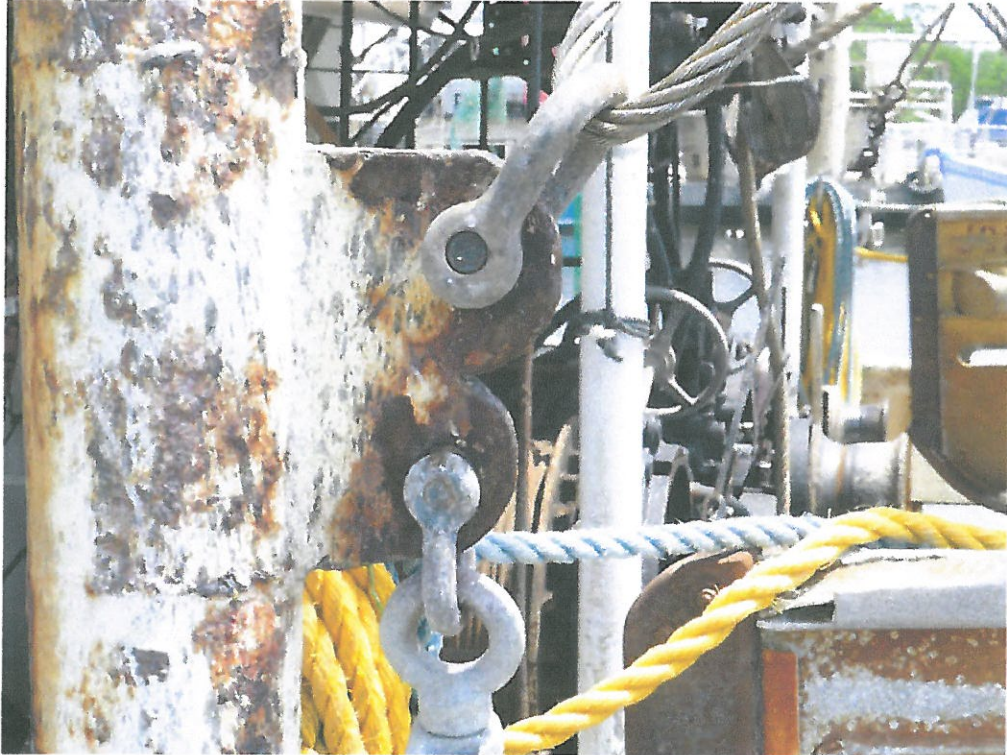
Stbd Outrigger Stay

| ITEM | DESCRIPTION | SAT | UNSAT |
|---|---|---|---|
| Outrigger stays | Good condition | X | |

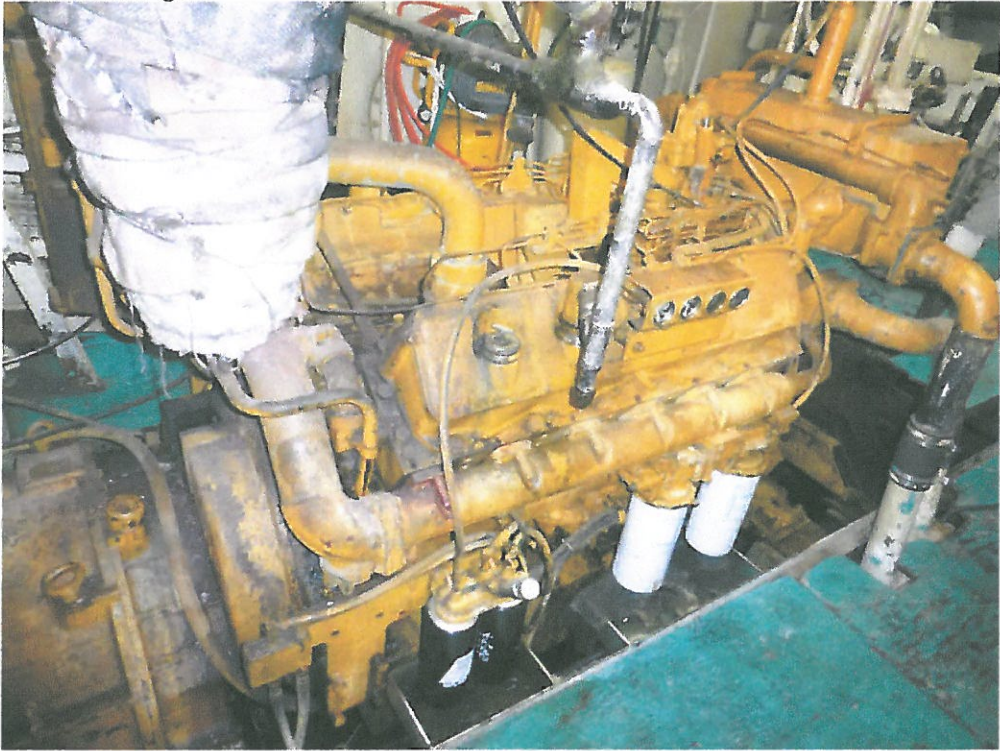
Stbd. Main engine

| ITEM | TYPE/MODEL/SN | CONDITION |
|---|--|---|
| Main Engine | Caterpillar 3412TA, V12, 4 stroke diesel, turbocharged after cooled, Air start | Good / Serviceable |
