**NATIONAL TRANSPORTATION SAFETY BOARD  
OFFICE OF RAILROAD, PIPELINE &  
HAZARDOUS MATERIALS INVESTIGATIONS**

**DCA 11 FR 004**

**REAR END COLLISION OF CSXT Freight Trains  
(TRAIN Q19423 with CSXT TRAIN Q61822)**

**DRAFT FACTUAL REPORT**

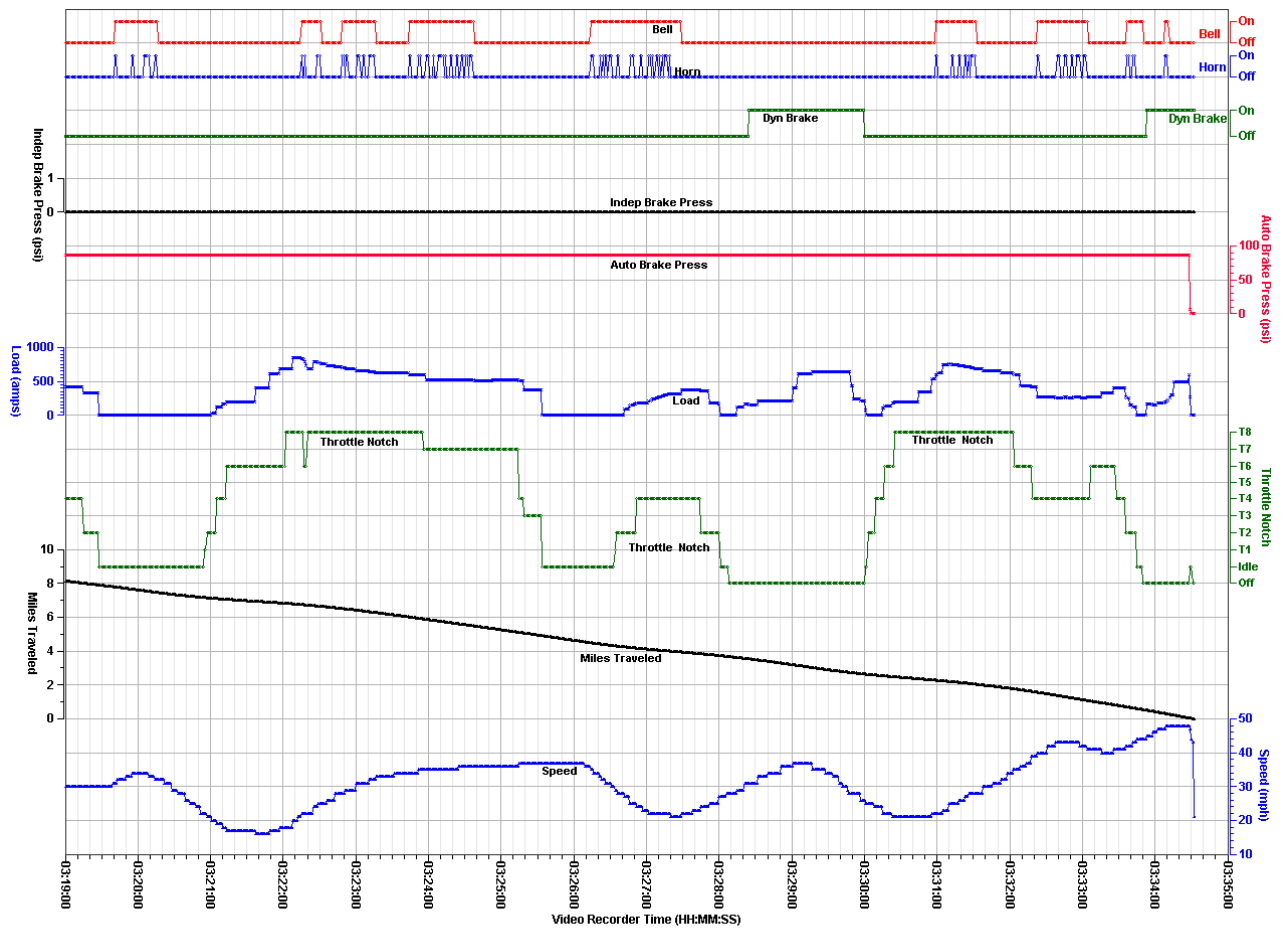
17       Figures 1 and 2 contain CSXT 7783's event recorder parameters listed in table  
18   A-1 during the May 24, 2011 event. Figure 1 covers the last 15 minutes and 32 seconds  
19   of data from 03:19:00 to 3:34:32 (the x-axis ends at 03:35:00). Figure 2 has the same  
20   parameters as figure 1 except miles traveled was replaced by feet traveled. Figure 2

Last 8 Miles of Movement

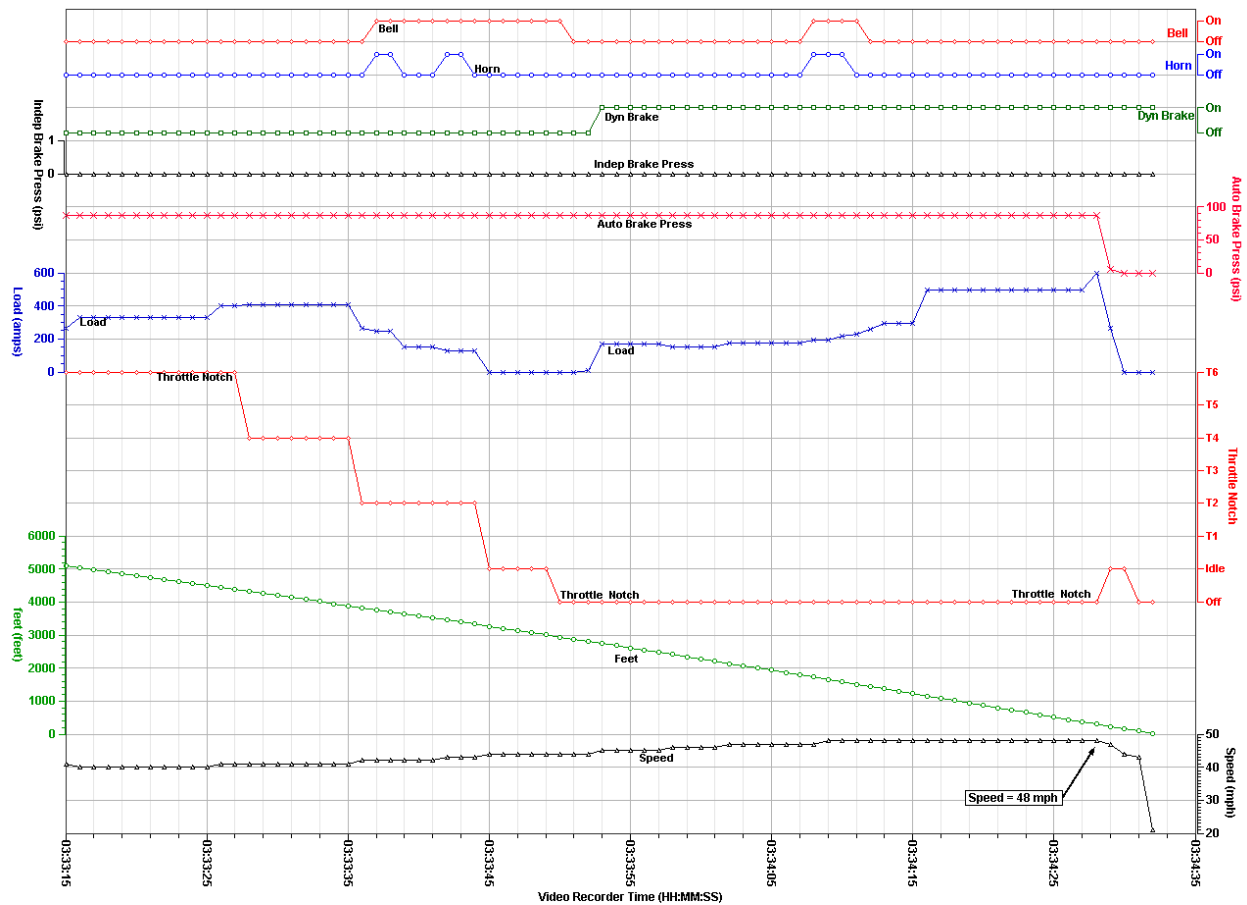
Figure: 2. Last 77 seconds of CSXT 7783 event recorder data.

Last 77 Seconds

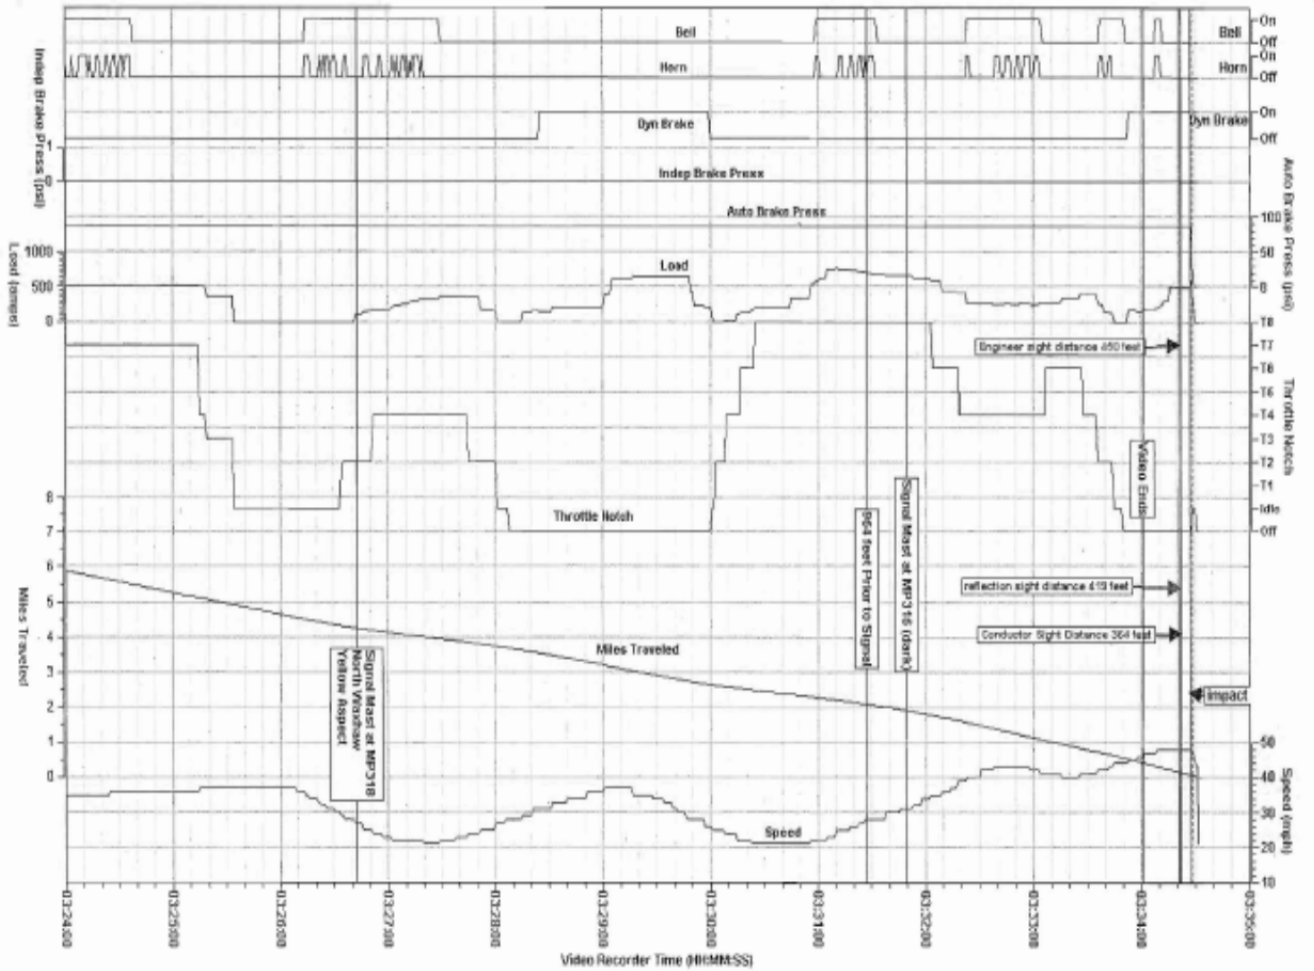
Figure 2 - Event Recorder Data with Overlays - Last 6 Miles

1 video recorder time, as observed in the video recording. This overlay was placed on the  
2 charts in Figures 2 and 3, using that time value.
