National Transportation Safety Board

Factual Report (post tech review with party comments incorporated)

On May 25, 2013 at 2:30 a.m., central daylight time¹, near Chaffee, Missouri, Union Pacific (UP) southbound freight train, 2-ASMAR-25 collided with BNSF southbound² freight train U-KCKHKMO-05T, at Rockview interlocking. The BNSF train was occupying the interlocking when the UP train struck the 12th car behind the locomotives of the BNSF train. As a result of the collision, 13 cars of the BNSF train were derailed. Two locomotives and 11 cars on the UP train were derailed. Spilled diesel fuel from the derailed UP locomotives caught fire. The Missouri State Highway M Bridge was above the Rockview interlocking and collision forces resulted in the collapse of portions of the highway bridge. The engineer and conductor on the UP train were the only crew members that were injured and they were transported to a local hospital. Subsequent to the bridge collapse, two motor vehicles struck damaged highway elements. Five occupants of the motor vehicles were transported to a local hospital. It was clear and 48° F at the time of the accident. Damage was estimated to be in excess of \$11 Milli

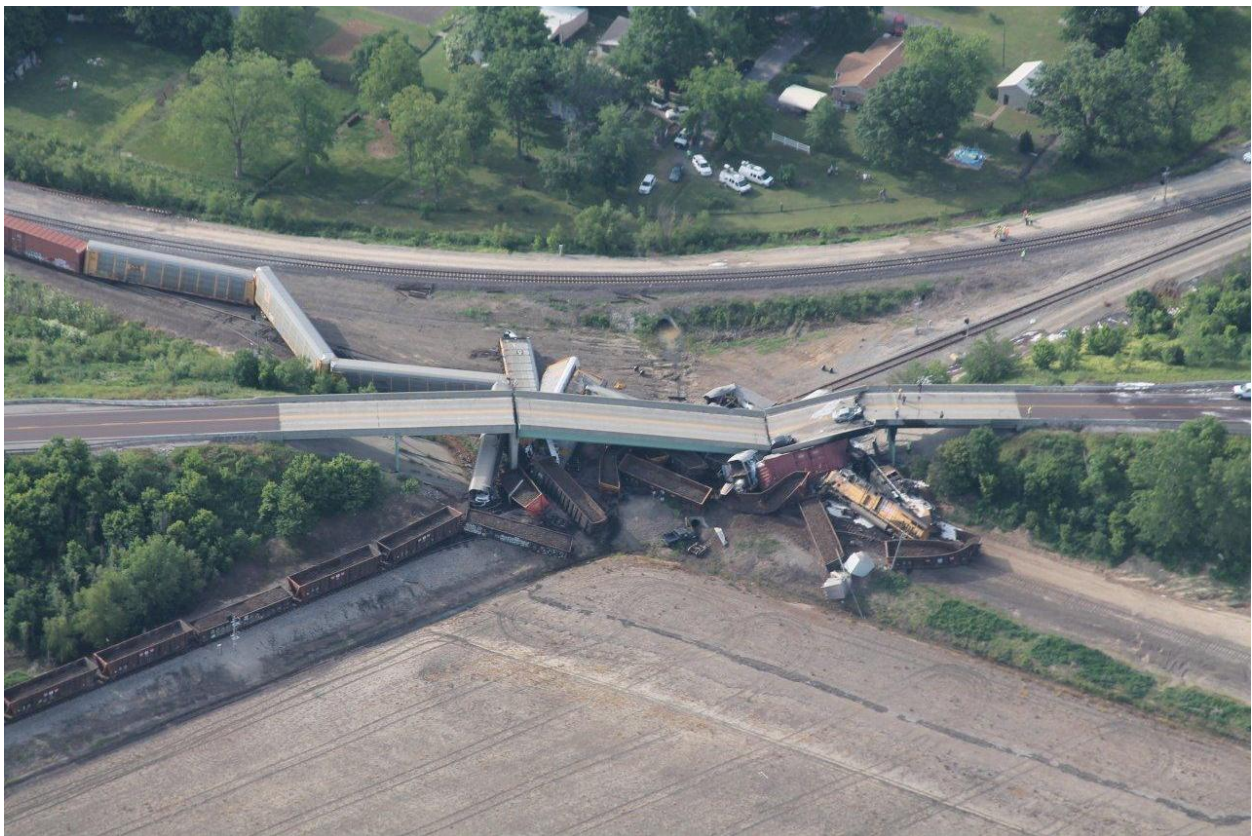
7
8 **Figure 2: Aerial view of accident scene**

3 The UP conductor said that on approaching the restricting signal at MP 131.1, he sensed
4 that the train would not stop short of the stop signal at Rockview and he used the conductor's
5 emergency brake valve to place the train into emergency braking. The UP train struck the
6 passing BNSF train shortly thereafter. Impact speed was 43 mph based on event recorder data.

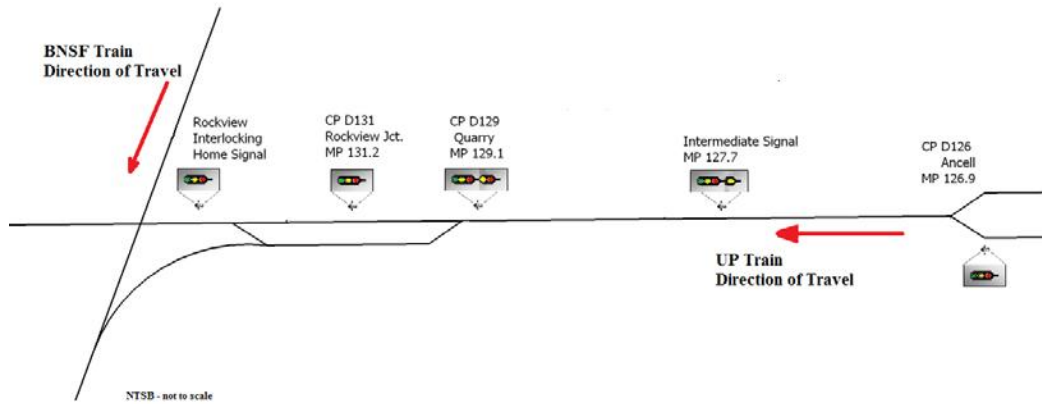
2
 3 **Figure 3: Diagram of UP Signals Approaching Rockview**

18 As the UP 5668 approached Rockview, there were four signals that governed movement
19 and provided information to the engineer in advance of the interlocking. Information on the four
20 signals is provided in the table below.

9 A flashing yellow aspect (advance approach) on the intermediate signal at MP 127.7
 10 required a train to reduce speed to 40 mph and prepared to stop at 2nd signal. A solid yellow
 11 aspect (approach) on the signal at Quarry required a train to not exceed 30 mph and prepare to
 12 stop at the next signal. A flashing red aspect (restricting) on the signal at Rockview Junction
 13 required a train to operate at restricted speed. A solid red aspect (stop) on the Rockview home
 14 signal required a train to stop short of the signal. Event recorder data indicates that the actual
 15 speed of the UP train speed remained between 54 and 48 mph as it passed these four signals.

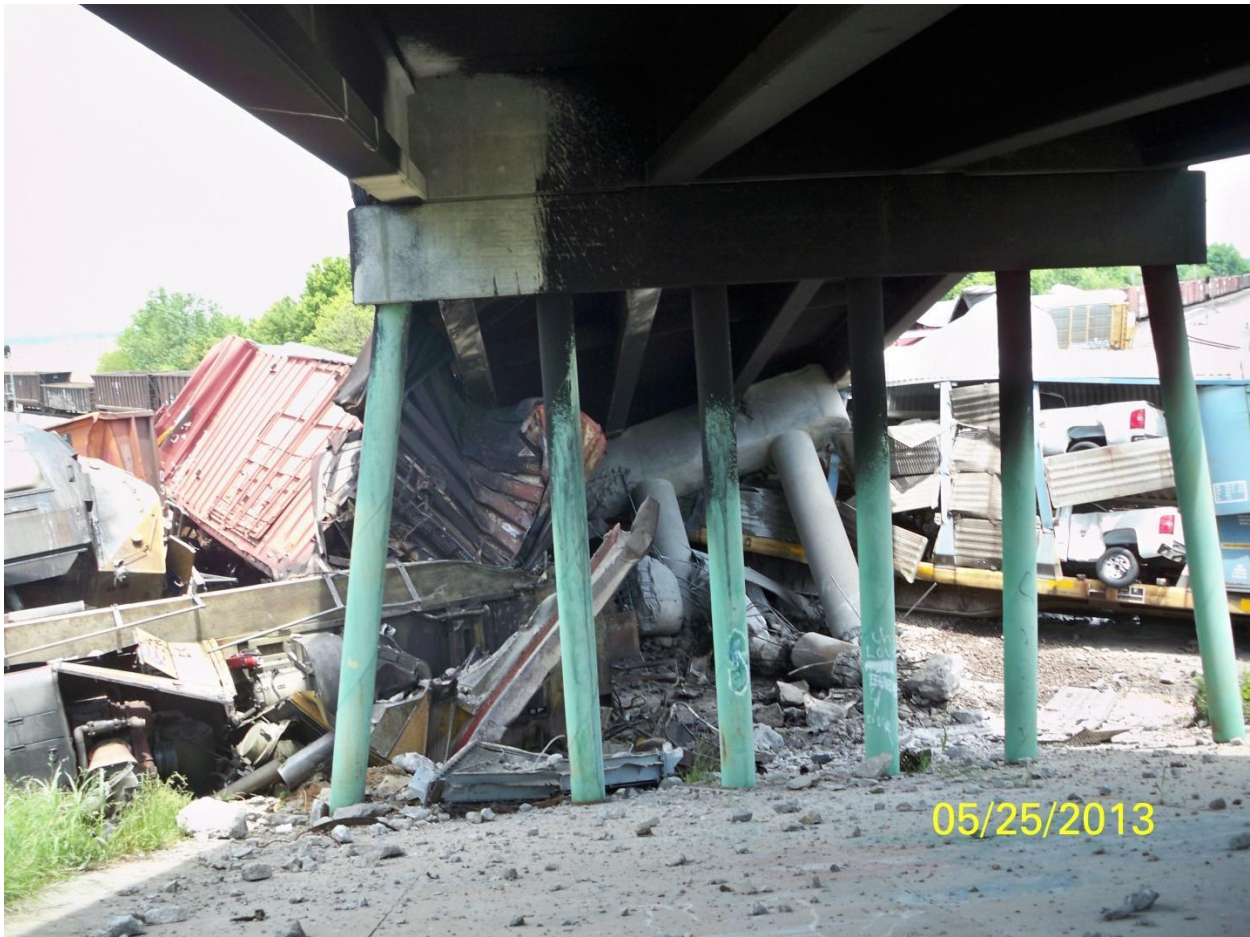
2 **Figure 4: Derailed cars and damaged bridge supports**

3 Bent No. 3 was sheared off at the base of the footing by the train impact after the
4 derailment. This loss of structure allowed spans 2 and 3 to collapse. The downward vertical
5 movement of these spans was stopped by the wreckage of the derailed train cars underneath the
6 structure. Photographs showed there were several UPRR Auto-rack carrier cars that came to rest
7 against the fractured columns of bent No. 3. Also, oval shaped impact damage was found on BN
8 Car No. 30230 that was 42-inches wide and 39 inches deep. The shape of the damage was
9 consistent with impact into one of the bent columns. This car number was car 22 in the BNSF
10 train consist, 10 cars behind the impact area, which occurred at 12 cars behind the rearmost
11 locomotive. The vertical clearance between the track elevation and the bottom of the girders was
12 approximately 24.5 feet. The horizontal clearance from the center of the rails to bent No. 3 was

1 21 feet 9 ¼ inches. There was not a crash protection wall shielding the bents from impact with
2 railroad equipment.
