1 **NATIONAL TRANSPORTATION SAFETY BOARD**

8
9
10
11 **IIC FACTUAL REPORT**

12
13
14
15
16
17 **DCA-13-FR-008**

18
19
20
21
22 **Collision of Union Pacific Railroad Freight Train MSIDV 15 with Standing**
23 **Railroad Cars in Hays, Kansas**

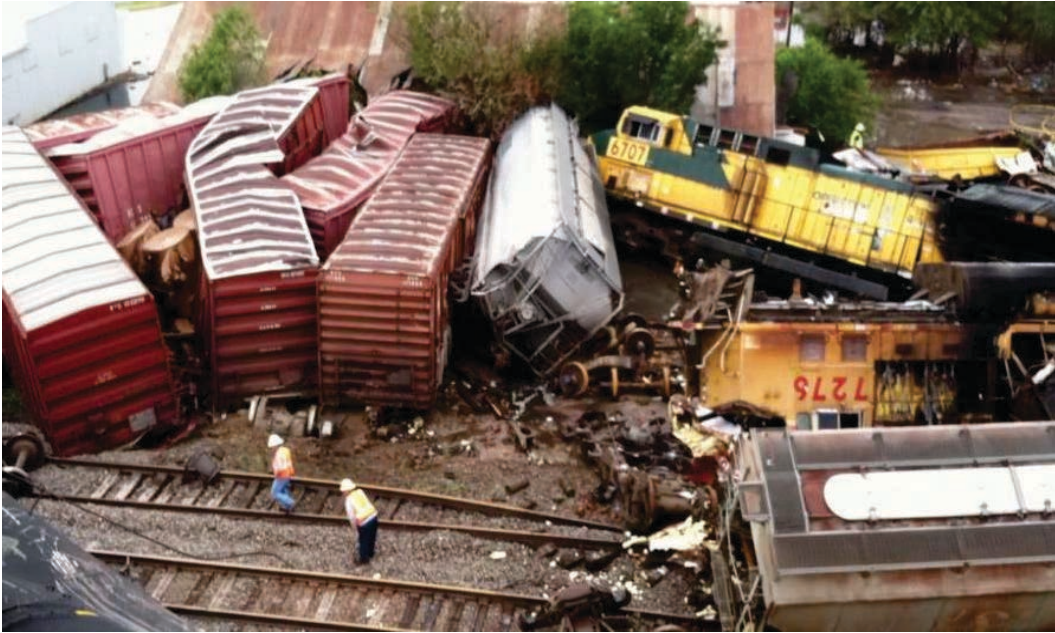
22
23
24 **Figure 1. Photograph showing the wreckage resulting from the collision and derailment. (Photo by**
25 **Union Pacific) 508 Text: Lead locomotive of train MSIDV 15, number UP 7276 is seen in the center**
26 **of the photograph, derailed, upside down, and rotated 180 degrees amongst debris from**
27 **derailment.**

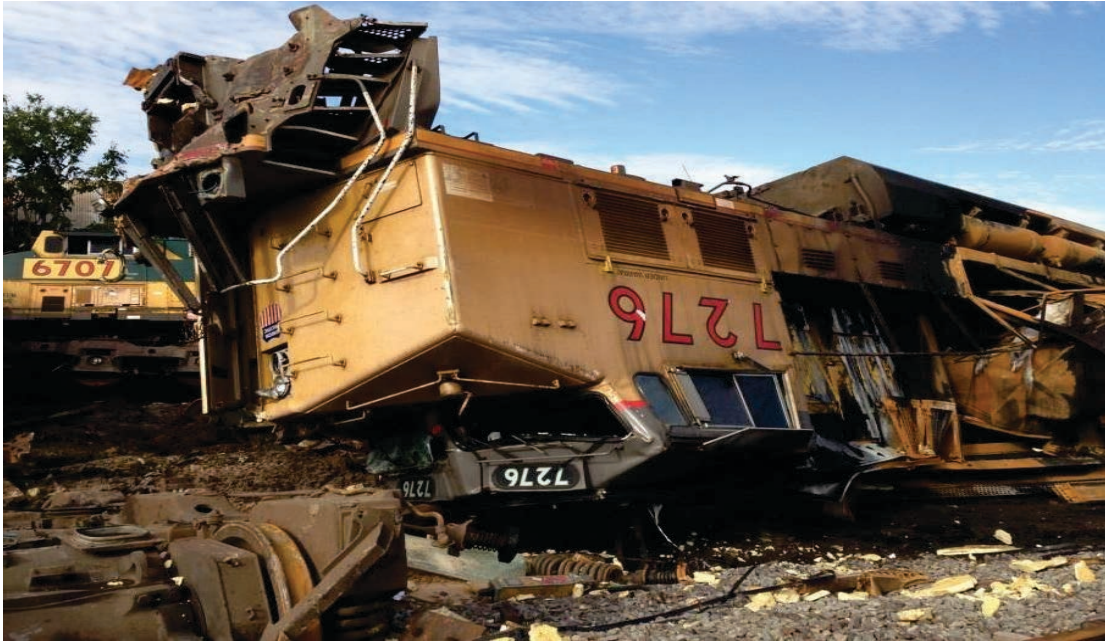
Figure 2. Photograph of the lead locomotive of Train MSIDV 15. The locomotive 7276 is upside down and has rotated 180°. (Photo by Union Pacific)

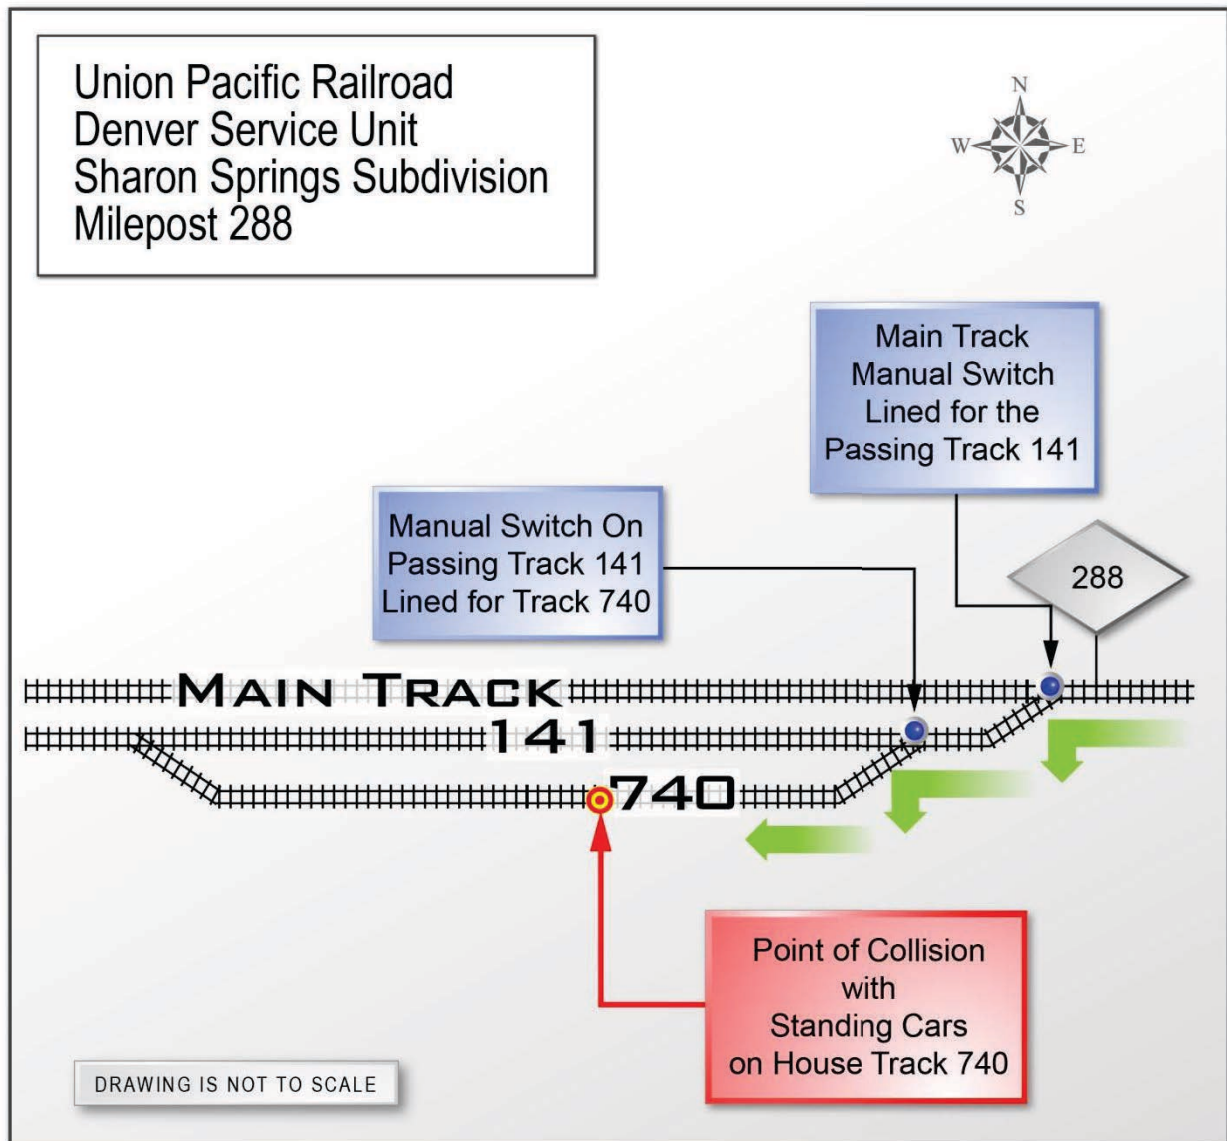
According to railroad supervisors, when they first responded to the scene, the main track switch was lined for movement towards yard tracks 141 and 740. The yard switch controlling movement into track 141 and 740 was lined for movement into track 740 (see Figure 3).

1
2 **Figure 3. A drawing showing the layout of the tracks and switches at milepost 288 on the UP Sharon**
3 **Springs Subdivision in Hays, KS.**
