National Transportation Safety Board

IIC Factual Report

Accident No.: DCA-12-FR-007
Location: Barton County, Missouri
Date: July 21, 2012
Time: 3:30 PM, Central Daylight Time (CDT)
Railroads: Kansas City Southern Railway & BNSF Railway
Fatalities: None
Injuries: 2
Type of Accident: Side Collision

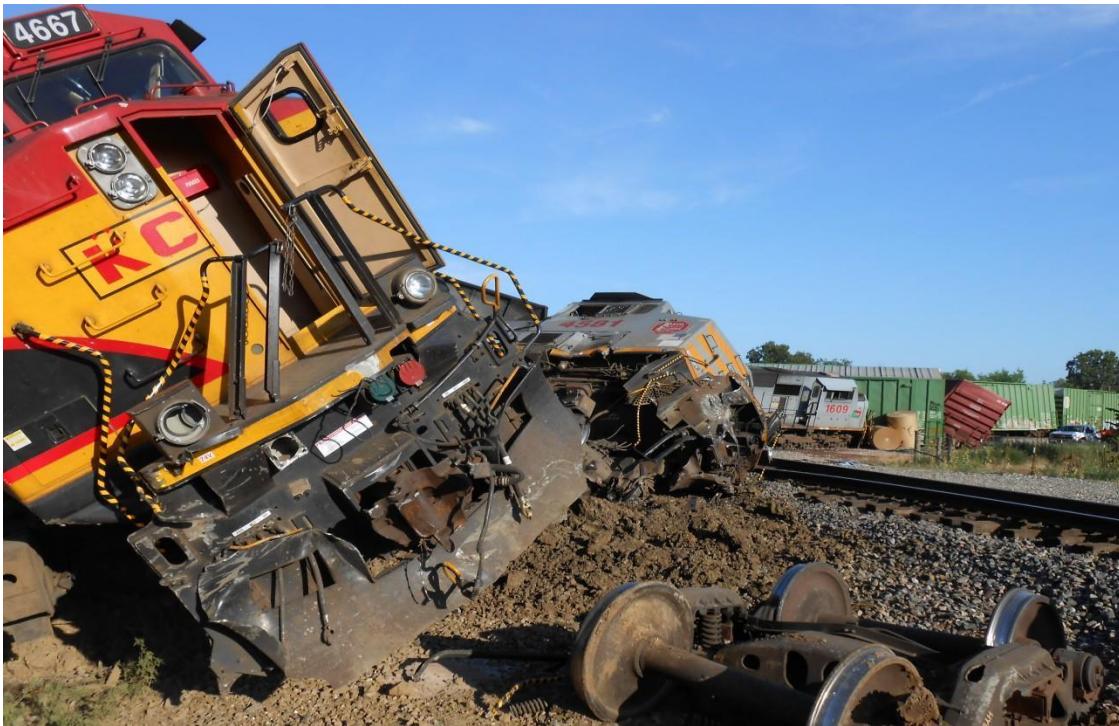
Figure No. 1 – Kansas City Southern locomotive No. 4667 derailed as a result of side collision with BNSF train near Arcadia, KS.

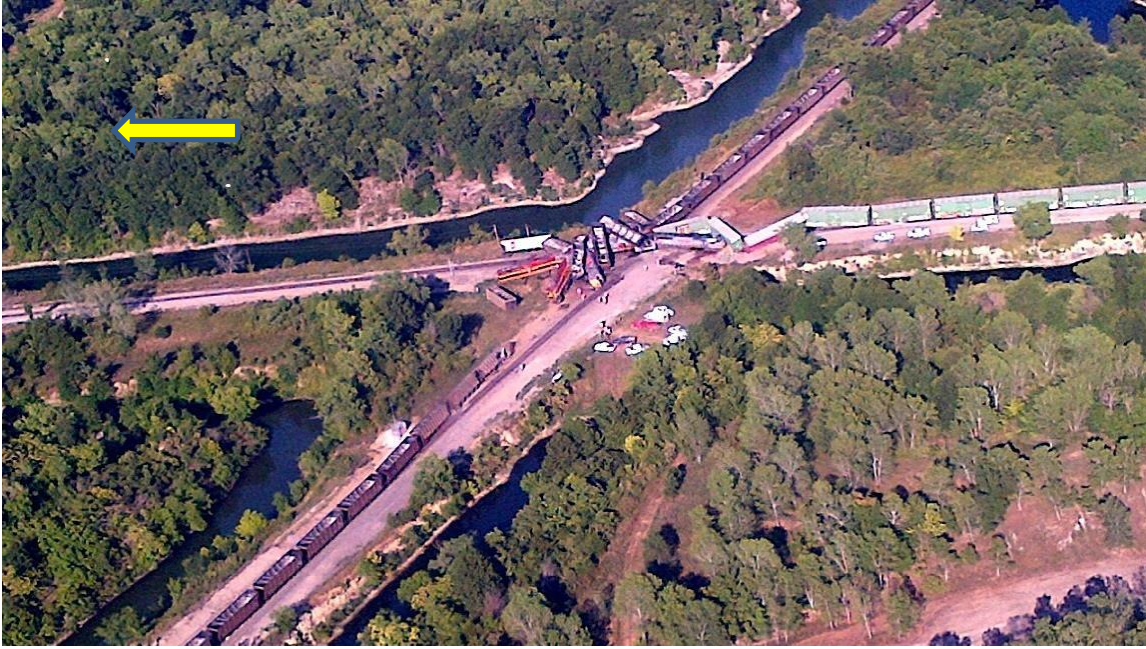
Figure No 2. – Overview of accident site. KCS train operating right to left. BNSF train operating from upper right to bottom left (arrow indicates north).

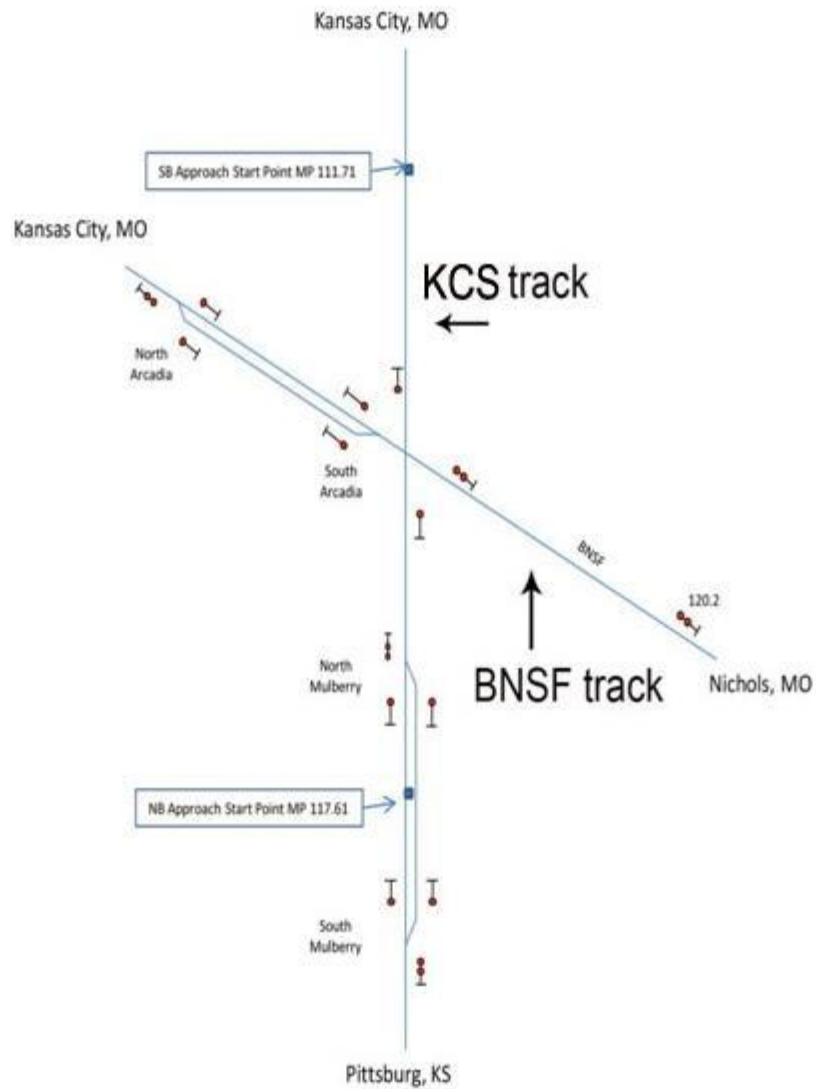
Figure No 3. This diagram identifies several signals on both the KCS and BNSF tracks leading up to the interlocking. (The diagram was developed by investigators from the Signal Group).

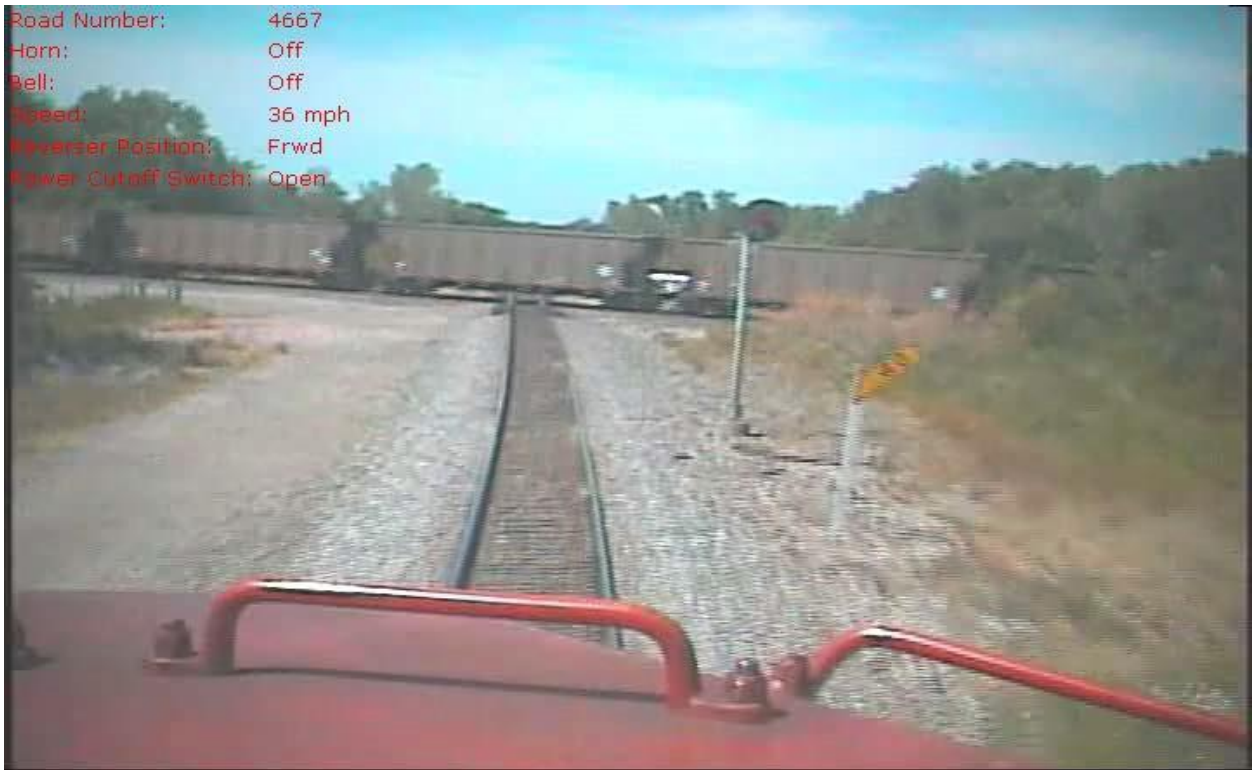
Figure 4. This photograph was taken by the KCS freight train's outward facing camera positioned on the lead locomotive. The railroad crossing Home signal can be seen ahead of the train on the right side of the tracks. The KCS train is likely less than 10 seconds before impact with the BNSF train, which is now traversing the railroad crossing. It is estimated that this was the point where the KCS crew jumped from the lead locomotive.

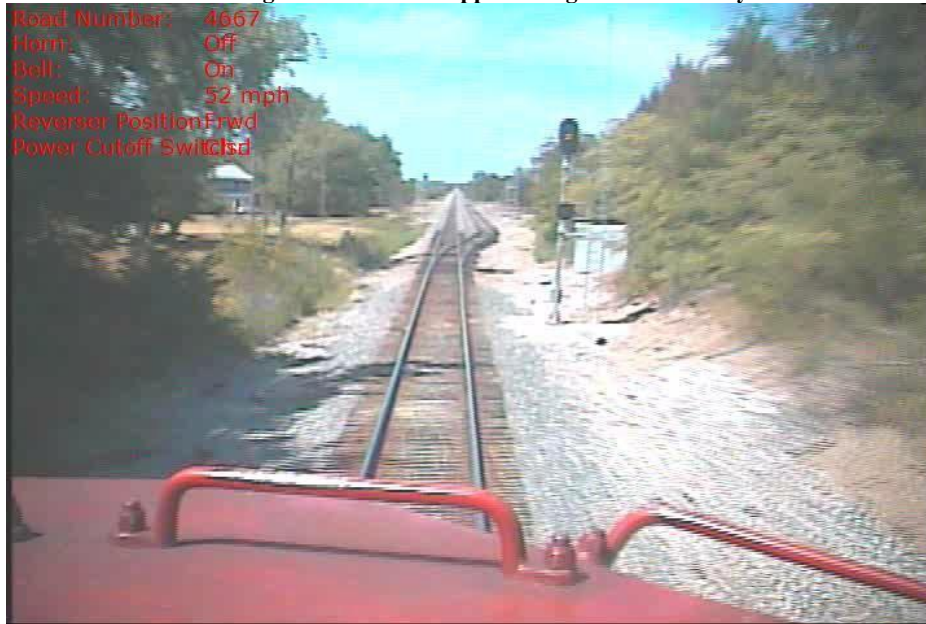
Figure 5. KCS 4667 approaching South Mulberry.

At 15:25:17 CDT, the locomotive approached the start of the double track at South Mulberry, receiving a flashing yellow signal, as shown in figure 5.

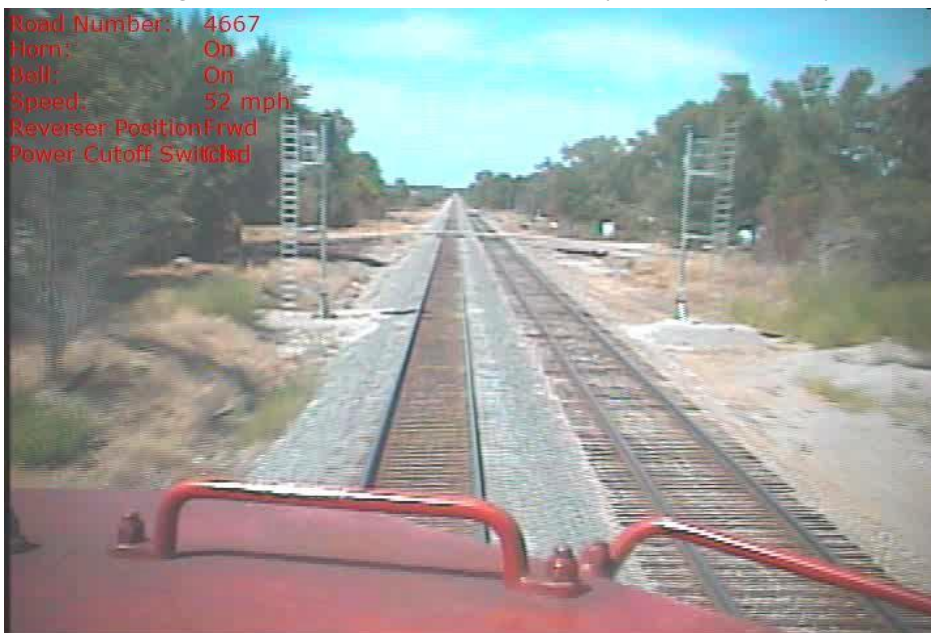
Figure 6. KCS 4667 between South Mulberry and North Mulberry.

At 15:25:24 CDT, the locomotive was on the west track of the double track between South Mulberry and North Mulberry, as shown in figure 6.

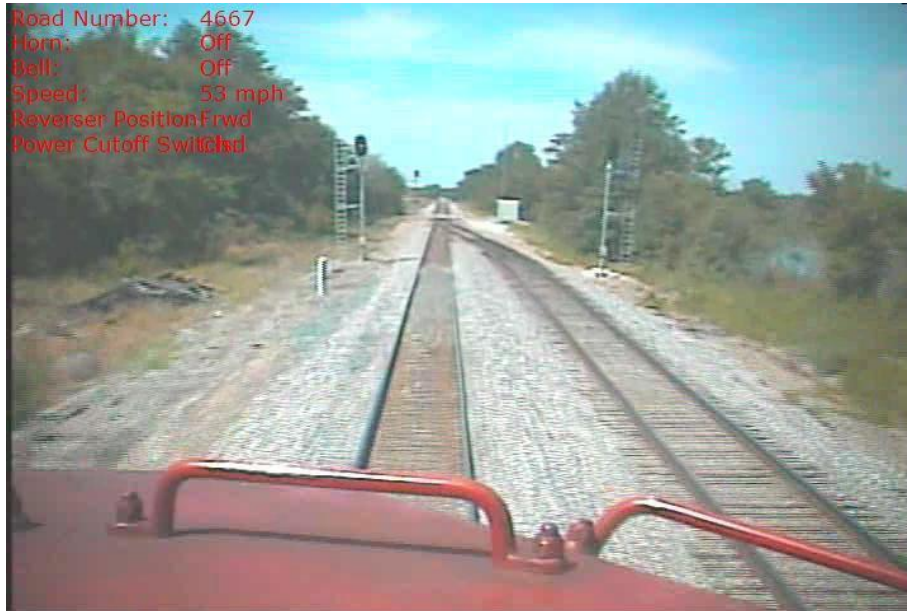
Figure 7. KCS 4667 near North Mulberry.

At 15:28:00 CDT, the locomotive approached the end of the double track near North Mulberry, receiving a steady yellow signal, as shown in figure 7.

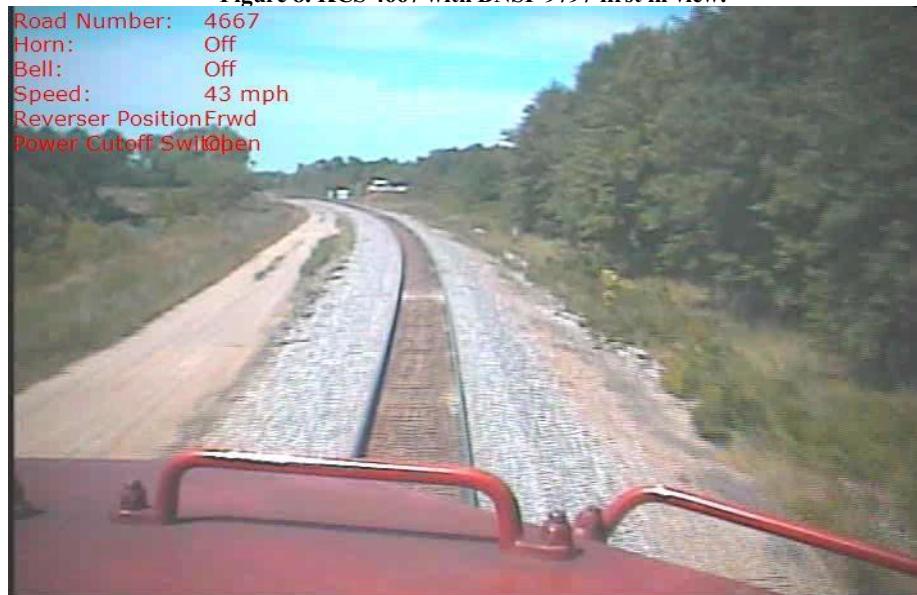
Figure 8. KCS 4667 with BNSF 9797 first in view.

At 15:29:32 CDT, the BNSF train first came into view of the locomotive, as shown in figure 8.

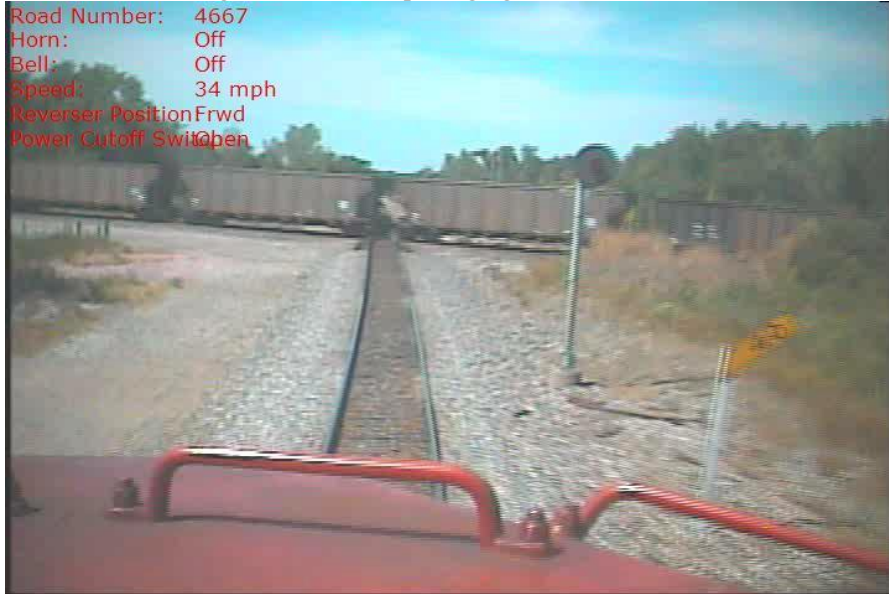
Figure 9. KCS 4667 passing signal before collision.

At 15:29:44 CDT, the locomotive passed the signal just prior to the collision.

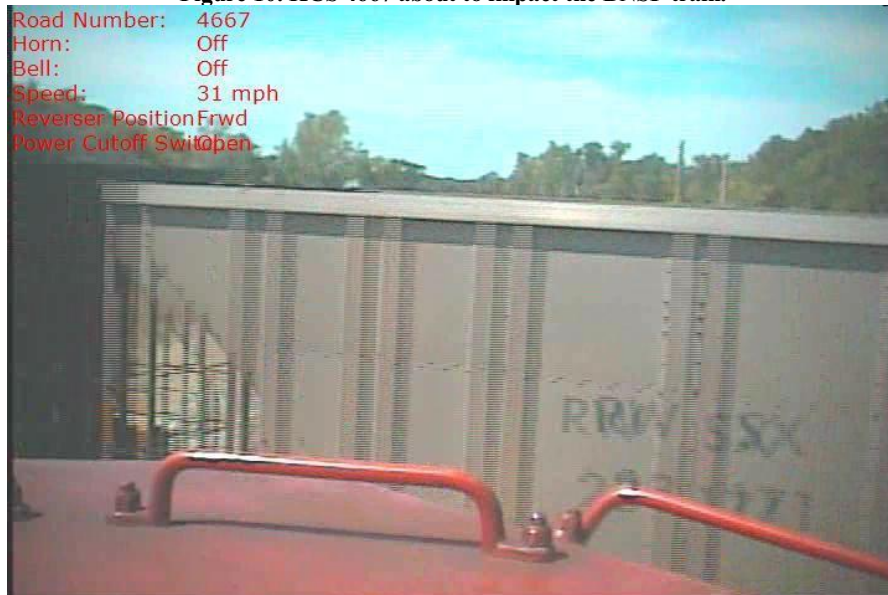
Figure 10. KCS 4667 about to impact the BNSF train.

At 15:29:48 CDT, the locomotive was just about to strike the BNSF train. The car passing in front of the locomotive was labeled “RW SX 23 171,” as shown in figure 10.

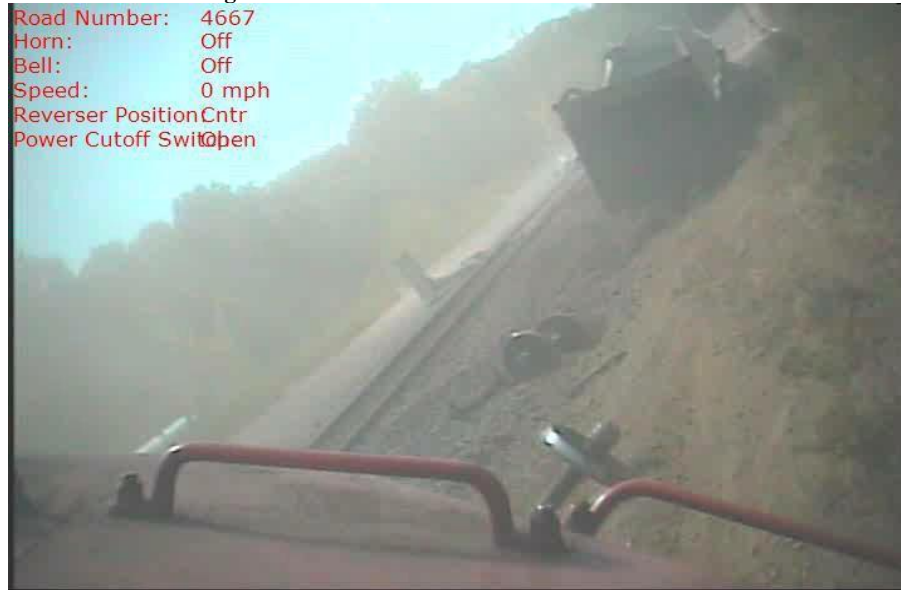
Figure 11. View from KCS 4667 recorder after collision.

After the collision, at 15:31:36 CDT, the dust had cleared enough to regain forward visibility. The stationary train image is shown in figure 11.
