NATIONAL TRANSPORTATION SAFETY BOARD

FACTUAL ACCIDENT REPORT

Accident No.: DCA-12-FR-003
Location: Amarillo, Texas
Date: January 09, 2012
Time: 11:09 a.m., Central Standard Time
Railroad: BNSF Railway
Property Damage: \$150.00
Injuries: 0
Fatalities: 1
Type of Accident: Employee Fatality

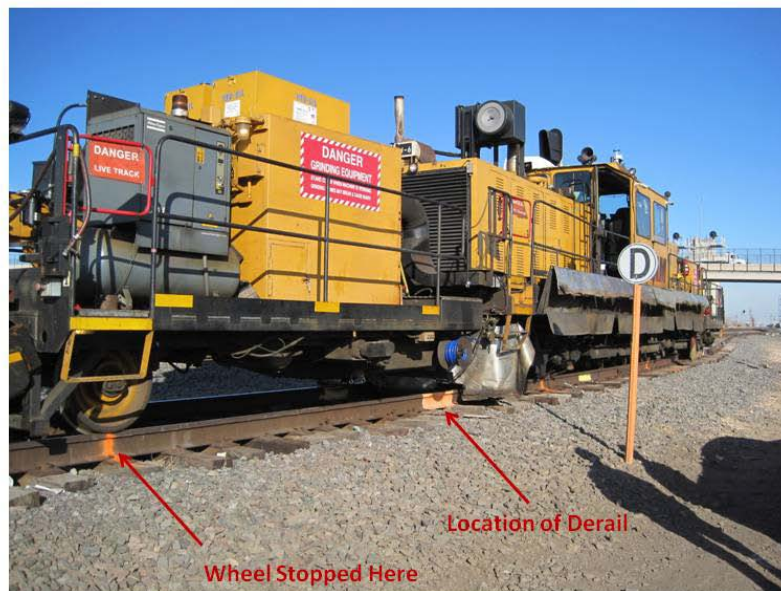
Figure 1
Side View of the Loram J6 Rail Grinder

Once the general laborer realized the rail grinder may not be able to be stopped short of the welding foreman, he started to yell for him to get out of the way. As best as he could tell, the welding foreman never heard him. He assumed that due to the noise of the rail grinder's engine and the hearing protection that the welding foreman was wearing, plus the welding foreman had his back to the grinder as the grinder was approaching and there was no body movement to indicate that the attempt to alert was ever heard. He stated that welding foreman, while in the middle of the rails, proceeded to unlock and attempted to remove the derail when he was struck by the rail grinder and was fatally injured.⁸ See Figure 1 for a side view of the Loram J6 rail grinder.

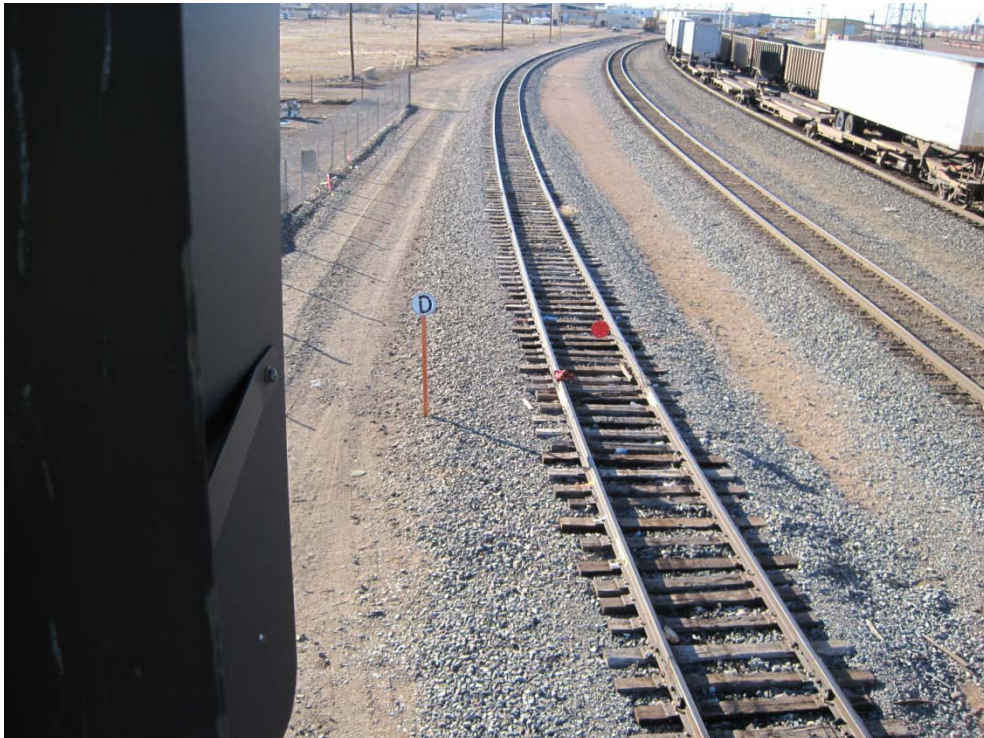
Figure 2
Overhead Westward View of Track #1805, and the Derail

The employee fatality occurred in Amarillo, Texas on the BNSF Red River Valley Subdivision of the Texas Division at milepost 334.7, on track #1805. For the direction of the reverse westward movement the track curved to the right. The curve was a compound curve that changes from a 5°19' to a 3°00' back to a 5°30' to a 3°30' to a 5° to a 3°45' to a 1°30' to a 5°08' to a 3°54'. The track grade was 0.12 percent. A gravel road was adjacently located to the south. See Figure 2, for an overhead view of the accident area at the derail.

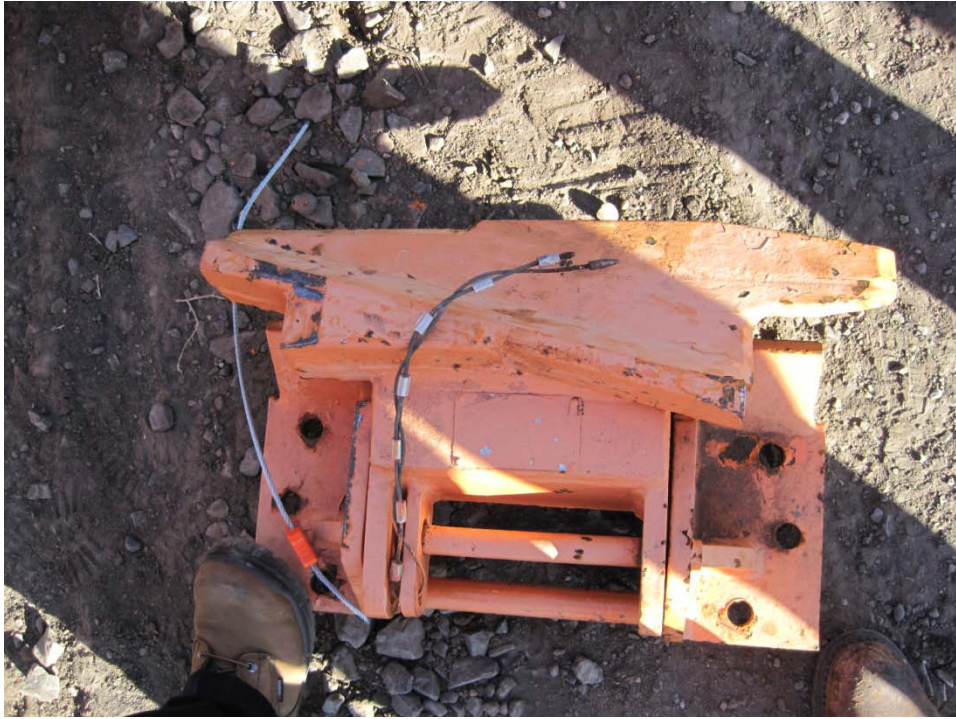
Figure 3
Photograph of the Hinged Derail Involved in the Accident

The derail⁹ involved in the accident was called right hand hinged derail. The derail functions by lifting the flange of the wheel up and deflecting it laterally to drop the wheel clear of the rail head, on the field side of the track. Movement of the rolling equipment is halted by the wheels becoming imbedded in the track ballast. The hinged derail was fastened to the ties with six inch cut spikes. The derail block is lifted by hand in a vertical semi-circle on and off the rail head. See Figure 3, for the hinged derail involved in this accident, and the diagram below to see the off and on positions.
