NATIONAL TRANSPORTATION SAFETY BOARD

IIC Factual Report

DCA-12-MR-009

**CSXT Transportation Derailment with
Non-Railroad Fatalities**

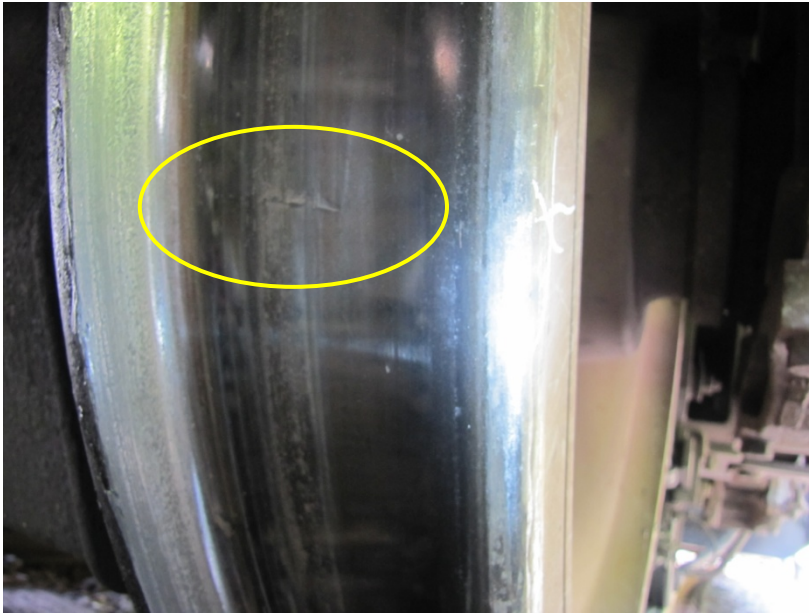
On August 21, 2011, the two locomotives were given a Class 1 mechanical inspection at their point of rest by the Mechanical Group. The brakes on both units were applied and released as designed. The group observed very light witness marks on the wheels of the second locomotive that traveled over the north rail. The marks were located on the tread of the wheels perpendicular to the running surface.

3 Figure 2 - Photograph of Witness Mark on CSXT 4579, Wheel R1

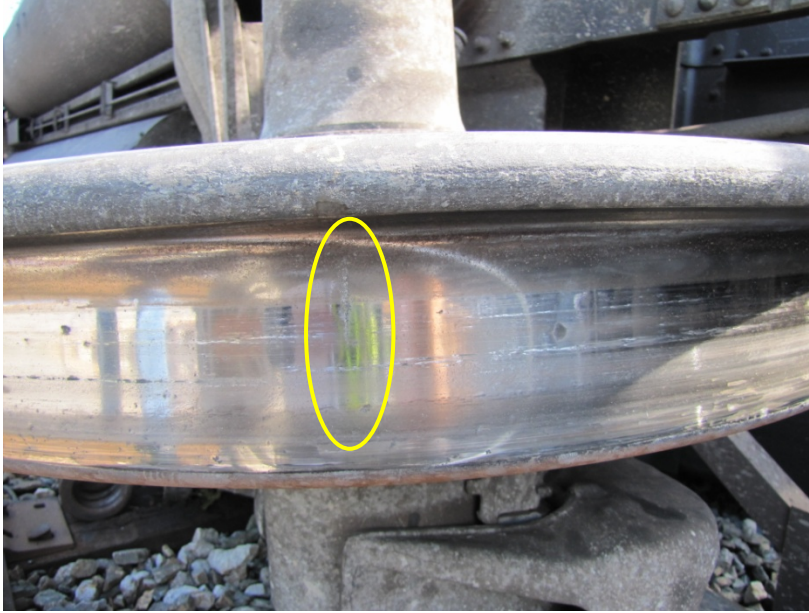
11 Wheels from these cars that traveled over the north rail were observed to have witness marks
12 in their tread, perpendicular to the running surface. Beginning at car numbers one through car
13 ten, the witness marks became increasingly apparent in both size and depth.

2 Figure 3 - Photograph of Witness Mark on CSXT 398511, Wheel R4

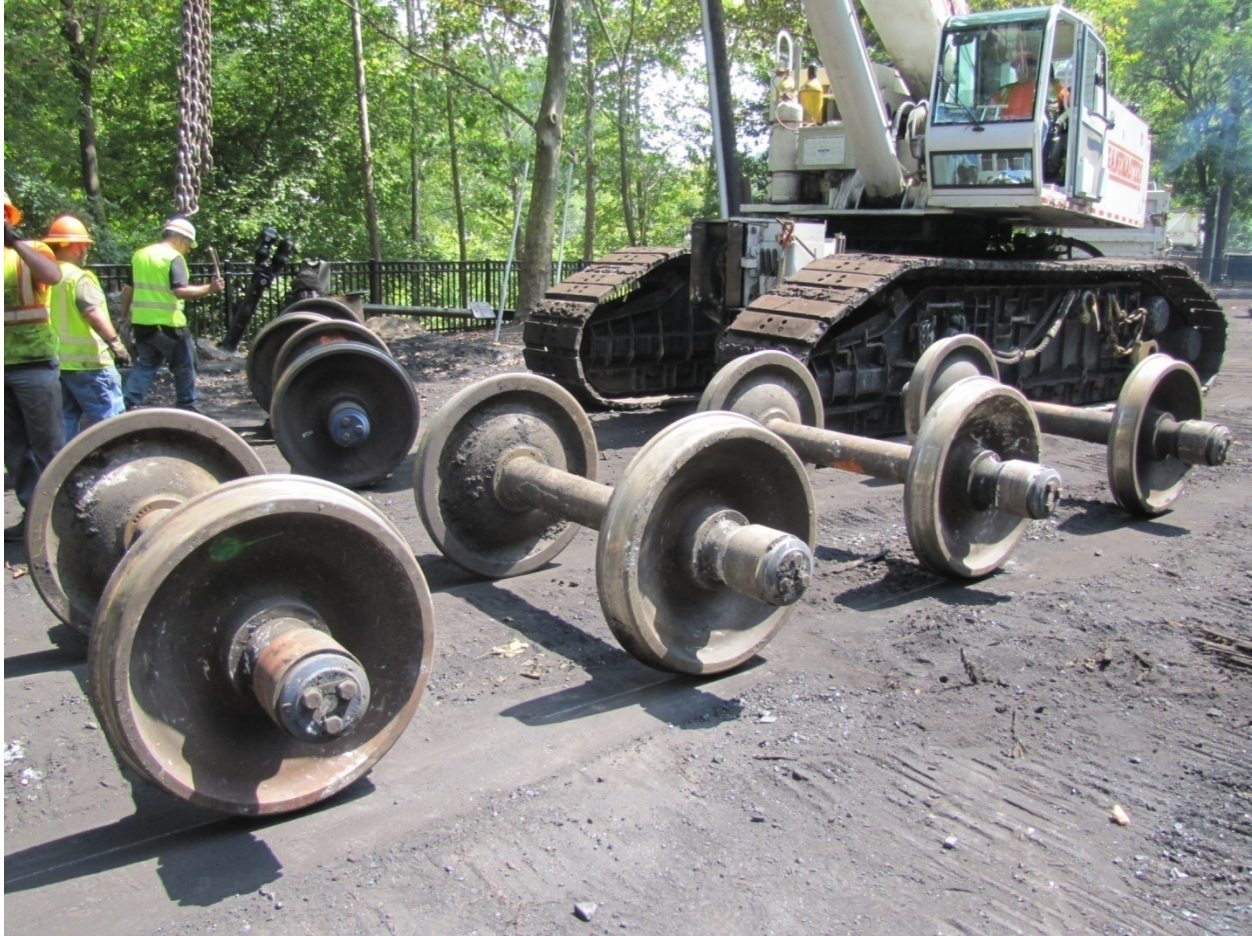
9 The group noted the presence of witness marks on many wheels examined, similar in
10 appearance to those previously mentioned. The group located wheels from the twelfth car, CSXT
11 302724, and placed them in position oriented as they would have been when moving through the
12 derailment area.

2 Figure 4 - Photograph of Wheel Sets from CSXT 302724

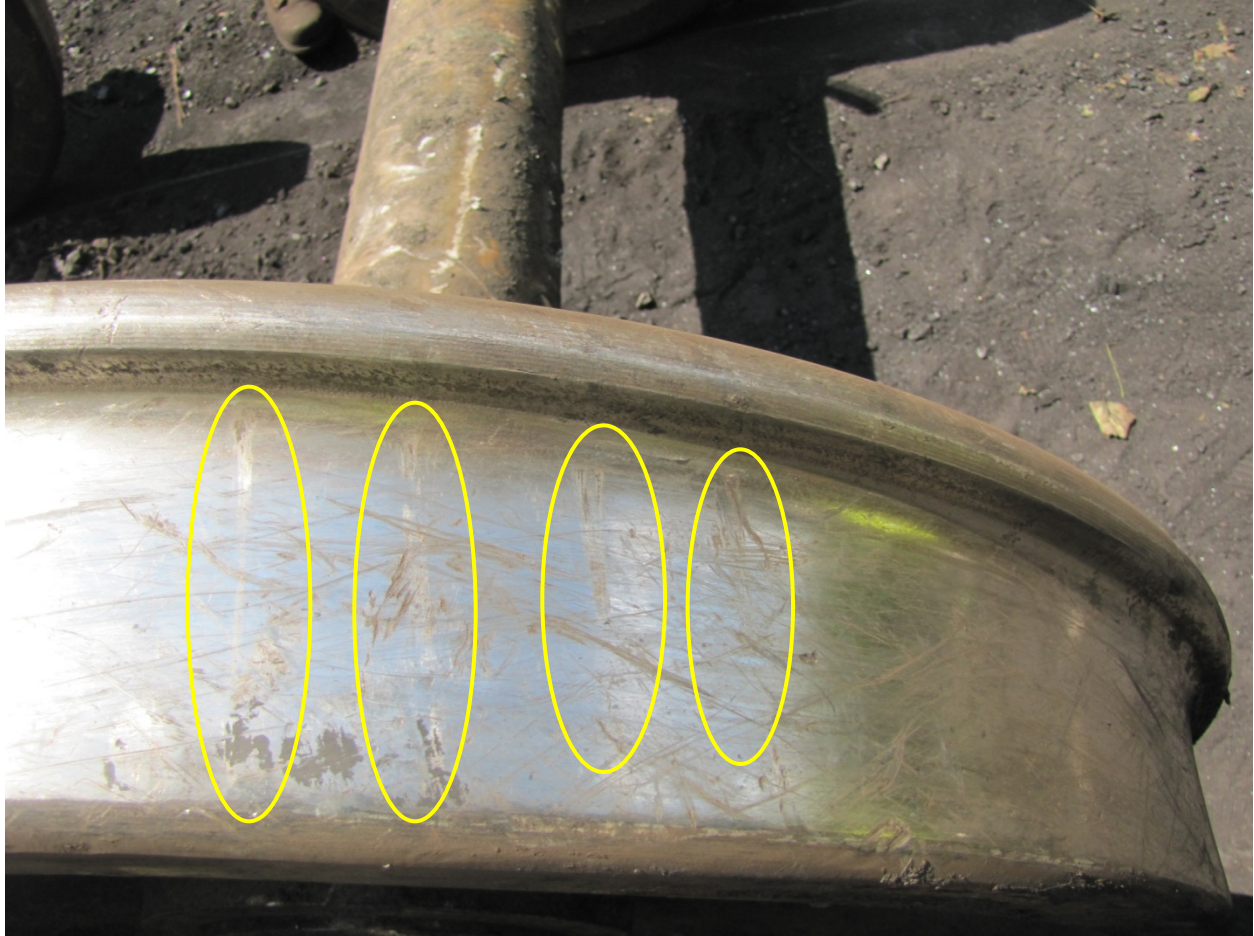
4 Upon close examination, the group observed several lateral strike marks in the wheel tread of
5 the third set of wheels, specifically the wheel that moved over the north rail (R3). These series of
6 marks were the first marks observed to have a pattern of successive impacts spaced
7 approximately three-inches apart becoming more apparent in size and depth. These series of
8 marks did not appear on the wheels on axles one and two.

2 Figure 5 2- Photograph of Witness Marks on Wheel R3 from CSXTT 302724

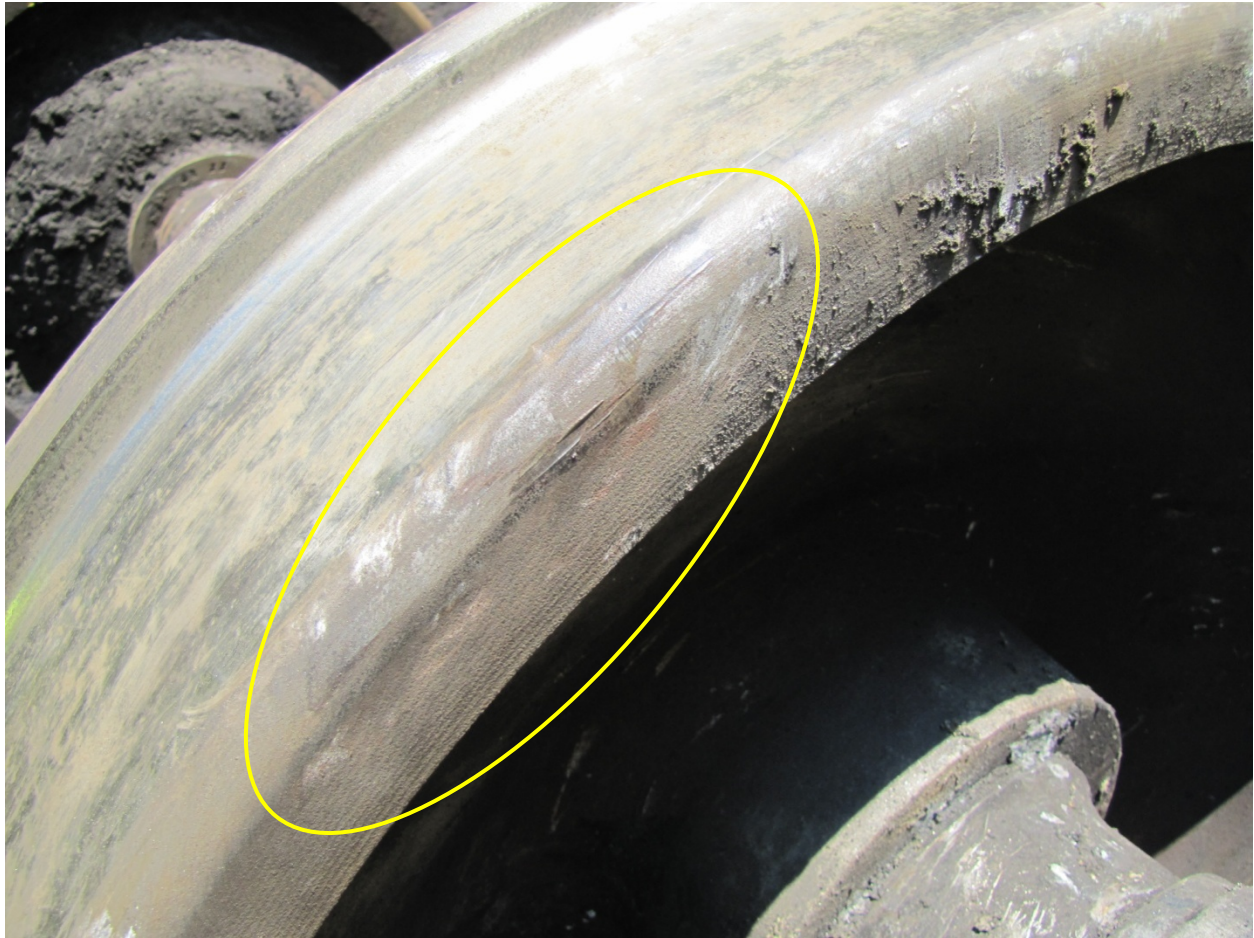
10 Additionally, a corresponding mark, or a mark on the adjacent wheel in the same horizontal
11 plane of reference, was observed on the on the L3 wheel, located on the outside rim of the wheel.

2 Figure 6 - Photograph of Corresponding Witness Mark on Wheel L3 from CSXT 302724

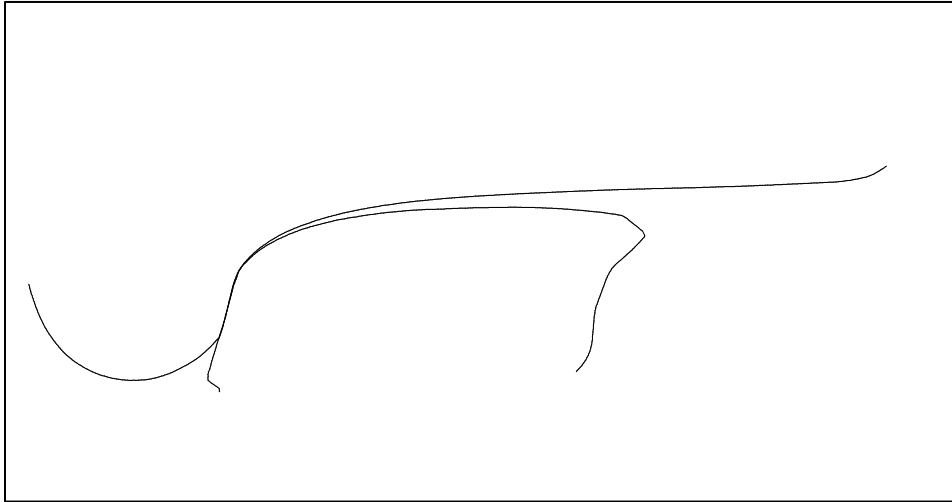
6
7 Figure 7 - CSXT 302724, Wheel R3 Profile Aligned with High Rail Profile at POD

8
9 The alignment represented reflects the wheel and rail interface expected during curving
10 conditions when CSXT 302724 moved through milepost 12.9 on the Old Main Line in Ellicott
11 City, MD.

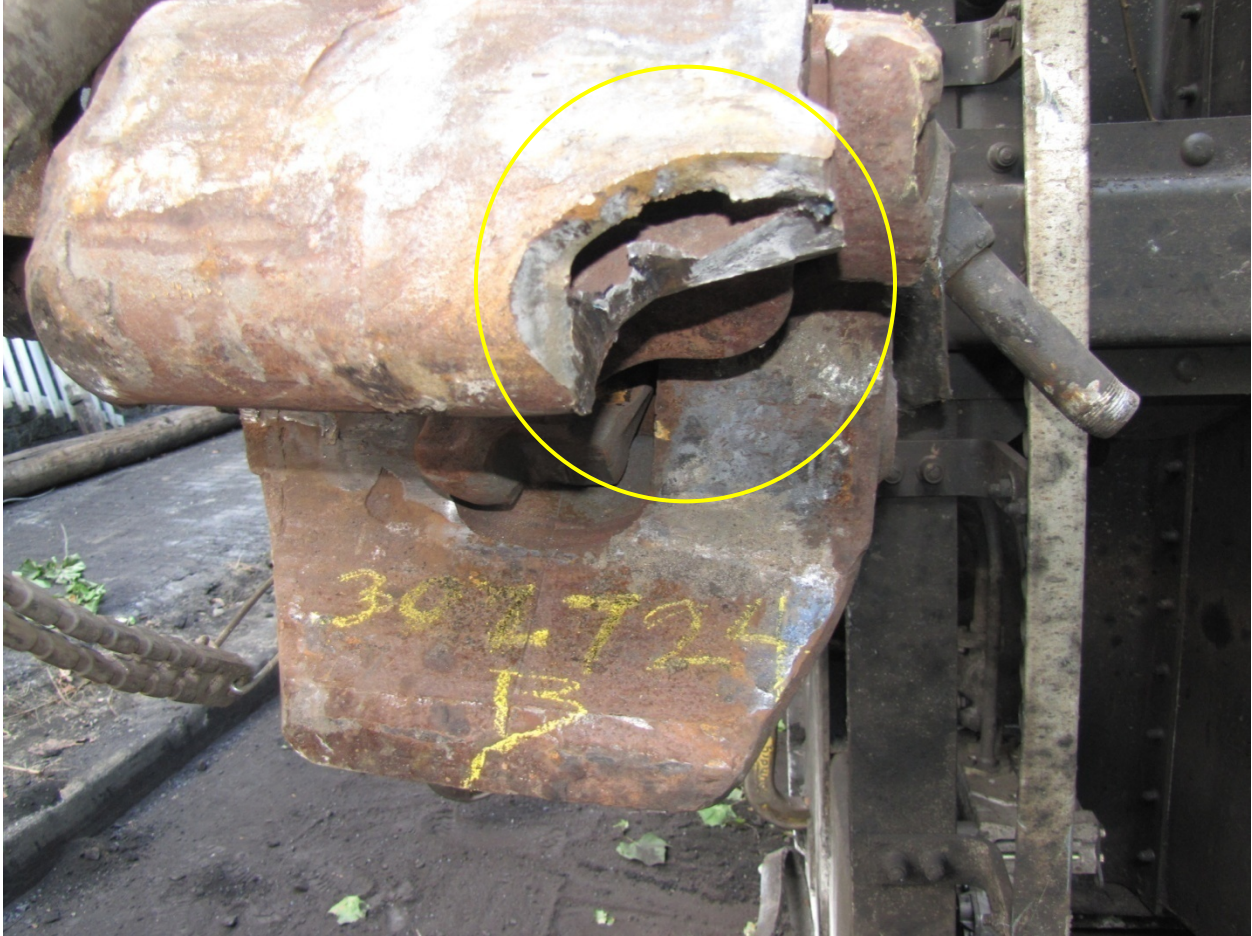
12
13 The mechanical coupler assemblies were examined on cars ten through twelve. The
14 mechanical coupler knuckle on the B-end of the twelfth car, CSXT 302724, was observed to
15 have been severely loaded and fractured in the upper portion of the face. The fracture surfaces
16 were sharp and showed indications that the knuckle was twisted.

2 Figure 8 3- Photograph of CSXT 302724 B-End Fractured Knuckle Assembly

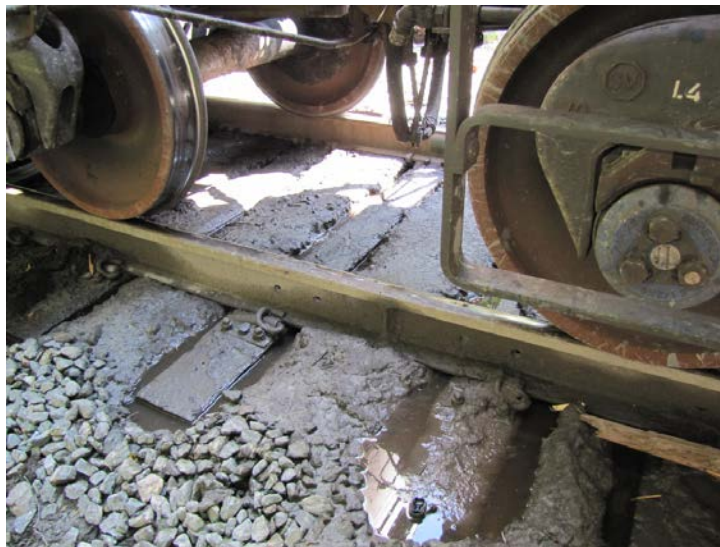
14
15
16 Figure No. 7. View of water and mud condition under derailed car.

Investigators noted that several locations prior to and at the point of derailment exhibited fouled ballast conditions or saturation of the subgrade. Investigators observed that the south ditch line was wet and there was evidence of water flow along the ditch line

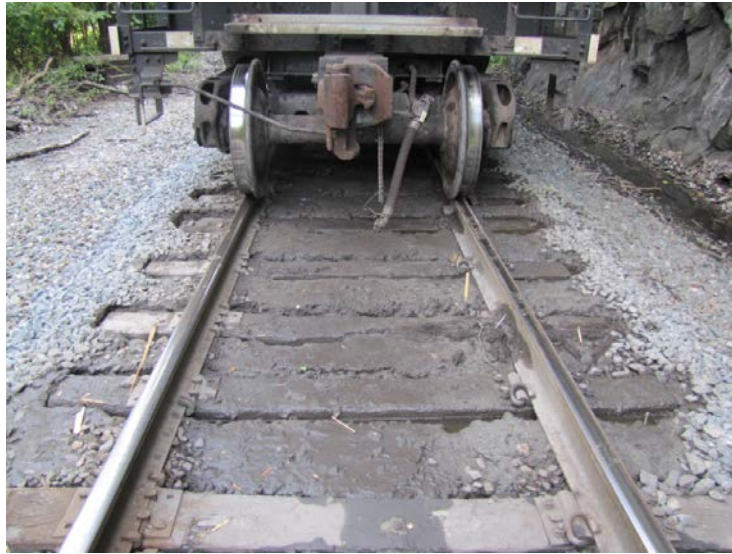
Figure No. 8. View of a fouled ballast condition

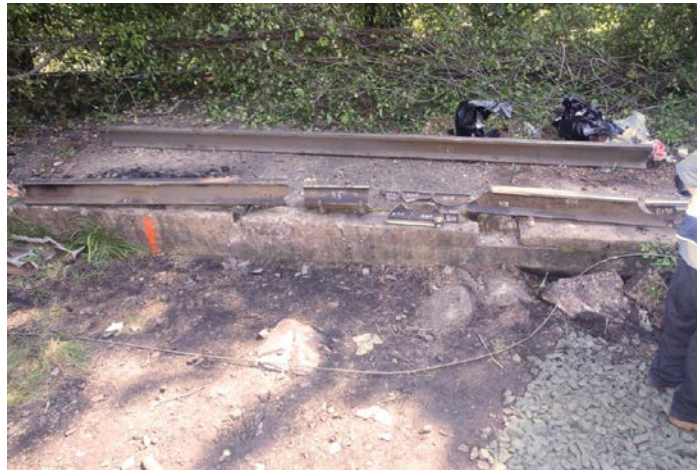
1 with marking indicating a loss of normal wheel/rail relationship that was directly opposite of the
2 north rail re-build location. This section of the south rail was under the last car derailed (the 21st
3 head car). A set of joint bars on the north rail under the same car and directly opposite the south
4 rail was cut from that joint location to serve as a coordinated set of reference points for the rail
5 re-build. Investigators examined, recovered and achieved total continuity of the south rail. In
6 reconstructing the west portion of the north rail, investigators pieced together all of it, save for
7 about 5 inches of rail missing from the west portion of a 17' 1" section of rail. (See rail inventory
8 photos and details in this report or NTSB's Materials Laboratory Factual Report. Note: During
9 the laboratory examination, investigators confirmed the 5 inch figure for the missing piece of
10 rail).

Figure No. 5. View of rail re-build.

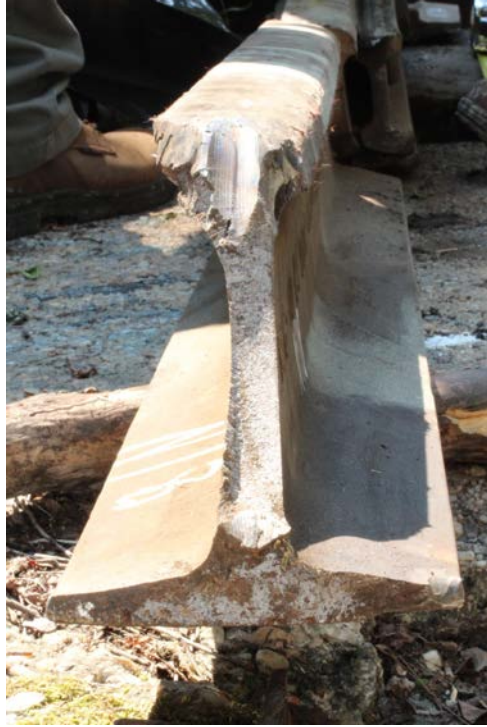
1
2 Figure No. 6. A view of a severe wheel
3 flange strike mark on piece No. "N 18".
4

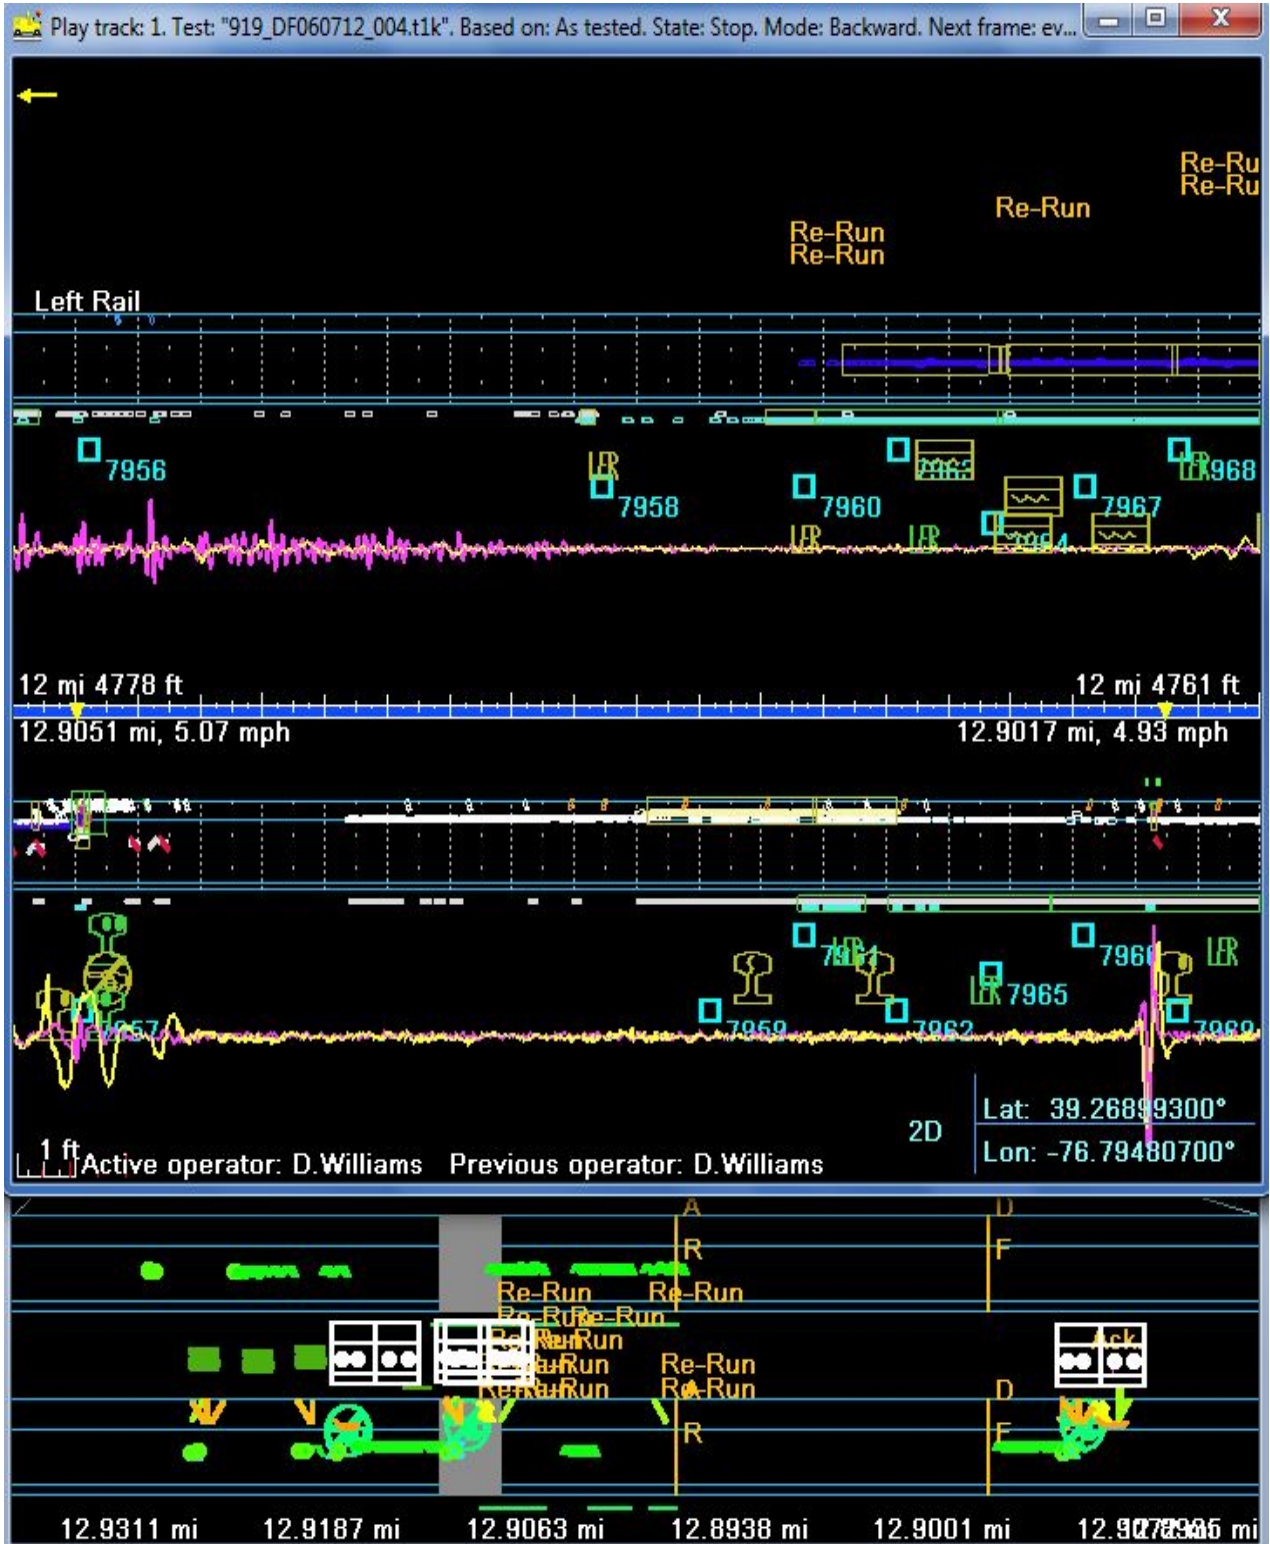
1 Figure No. 11. Sperry Rail Flaw Test July 6, 2012, Screen Shot of milepost 12.9311 to 12.9001.

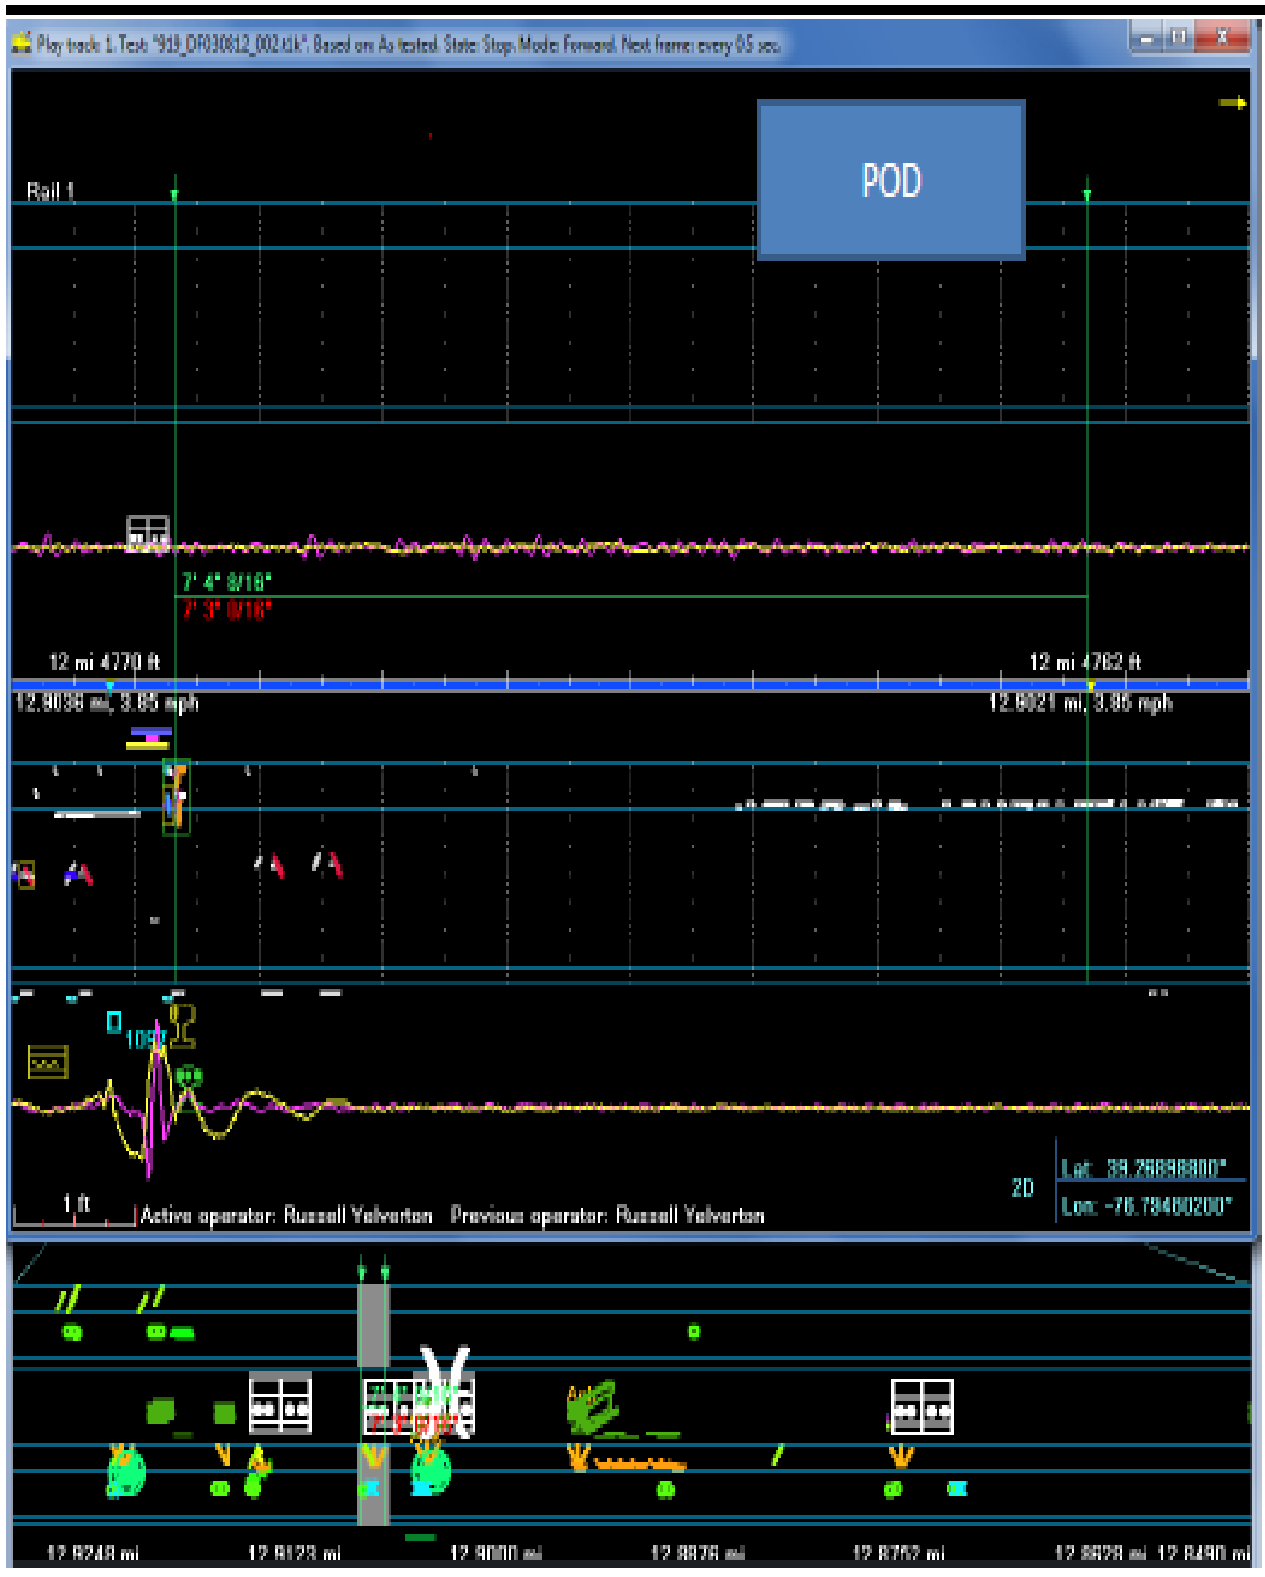
Figure 13. August 3, 2012, Sperry Screen Shot.
