NATIONAL TRANSPORTATION SAFETY BOARD

FACTUAL REPORT

DCA-15-FR-011

**BNSF Train No. DMIDNTW125 Collision with Track Panels
Resulting in an Engineering Employee Fatality**

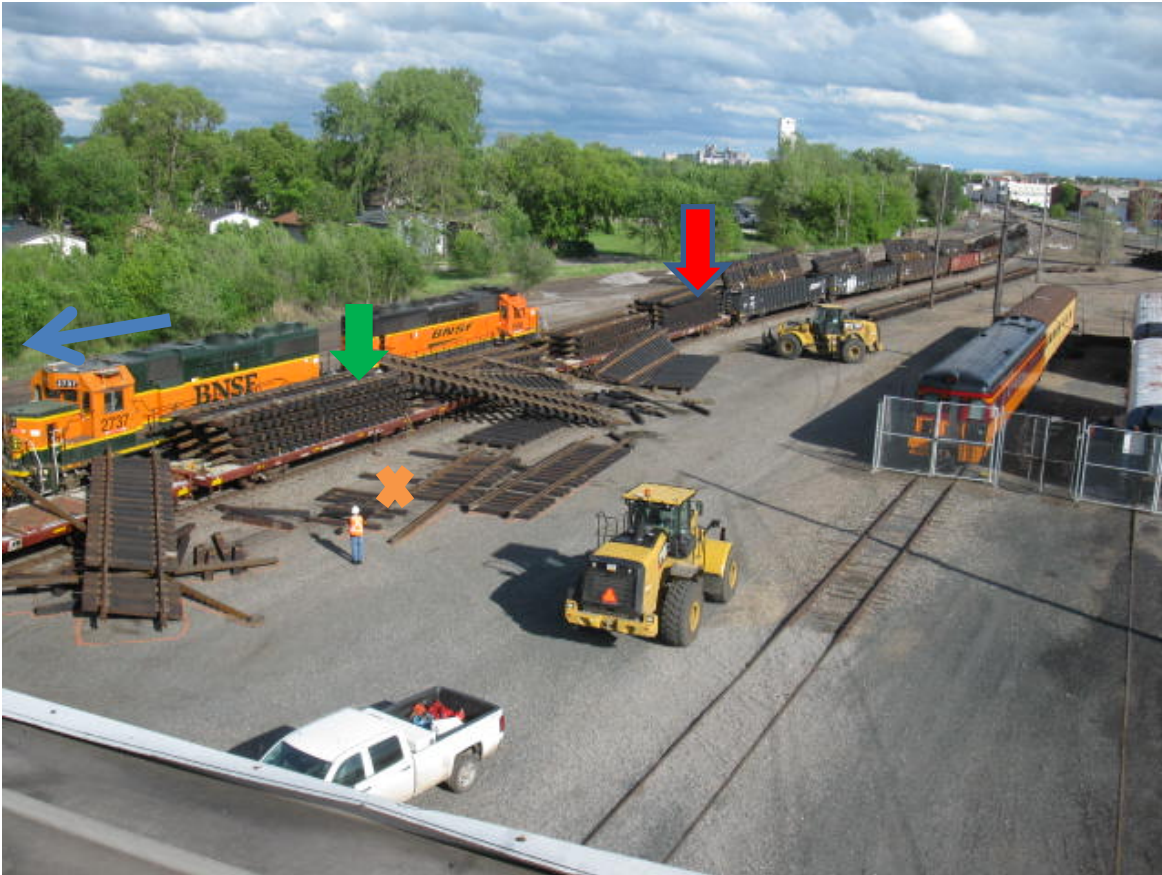
Figure 1. This is a view looking southeast at accident scene where loader in the background had attempted to lift two track panels (see red arrow). There are two loaded flat cars with two stacks of track panels per car, seven track panels to a stack. Blue arrow indicates direction of travel of locomotives. Green arrow points to likely position of foreman atop a stack of track panels as indicated by train crew. Orange “x” is approximate location of deceased.

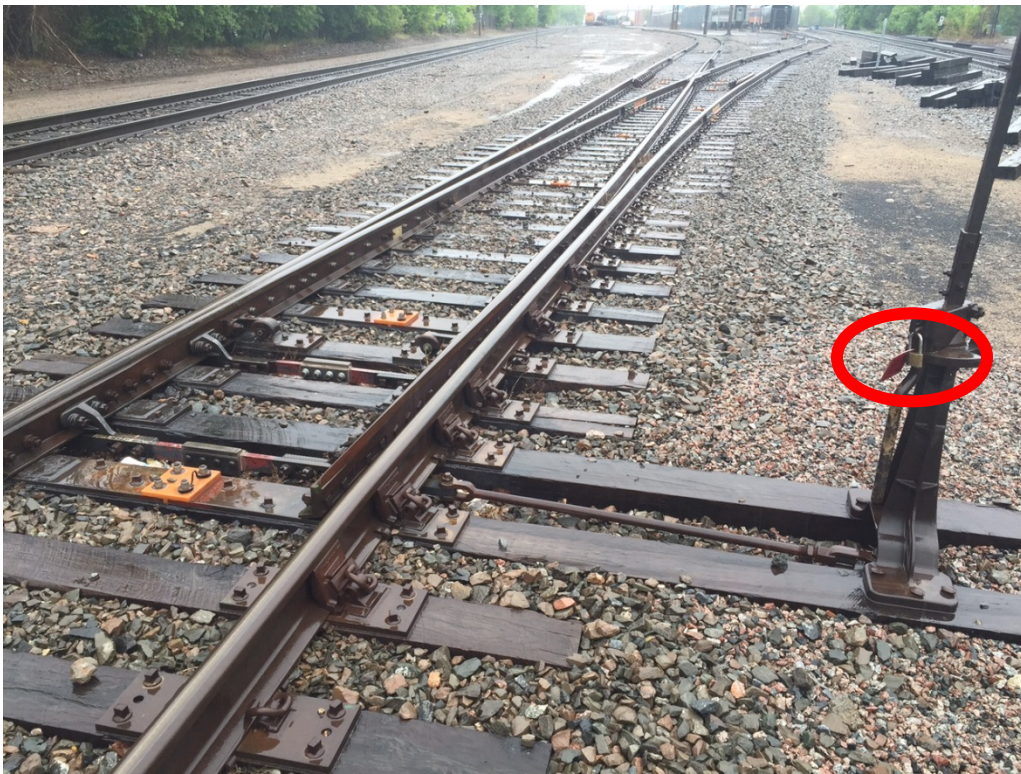
Figure 2. A view of the west switch leading into the Old Main 2 Pocket track lined toward another track. The red circle shows where a maintenance of way lock had been applied.

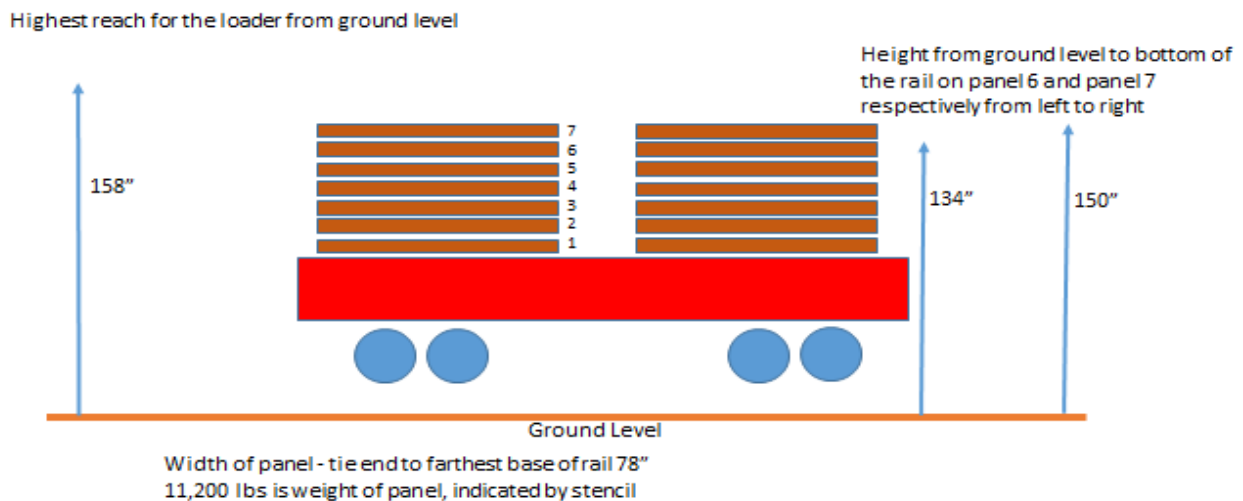
Figure 3. Diagram of east flat car loaded with two stacks of track panels. Diagram shows highest lift capability for front end loader and the measured lift height for the forks to grab two panels.

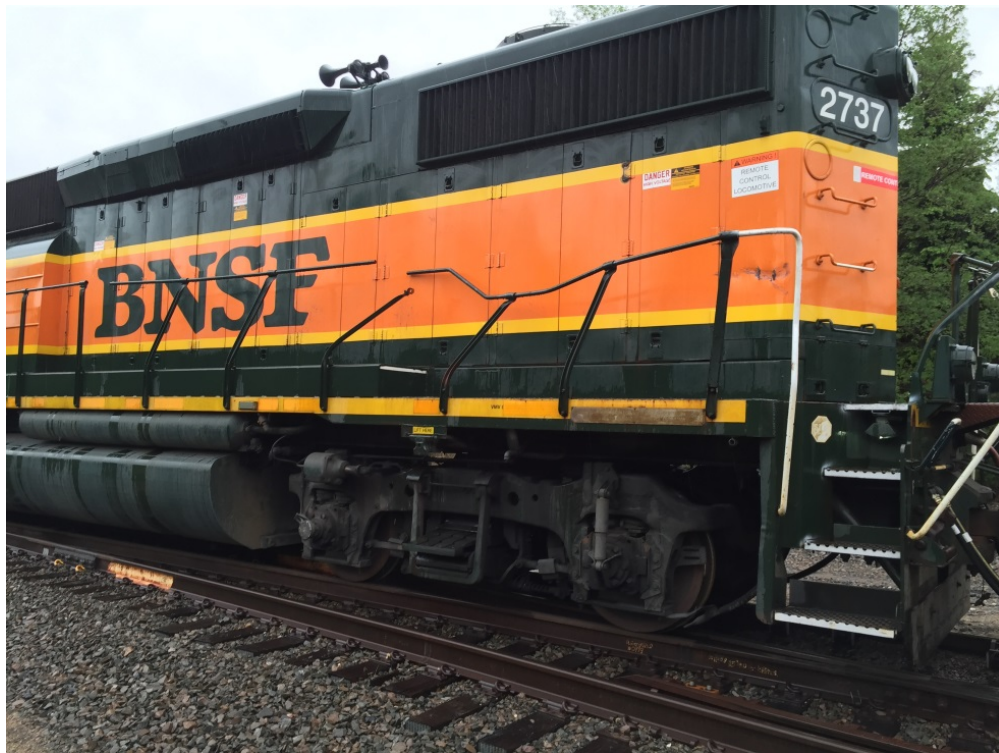
Figure 4. View of the south side of locomotive BNSF 2737 showing damaged hand rails.

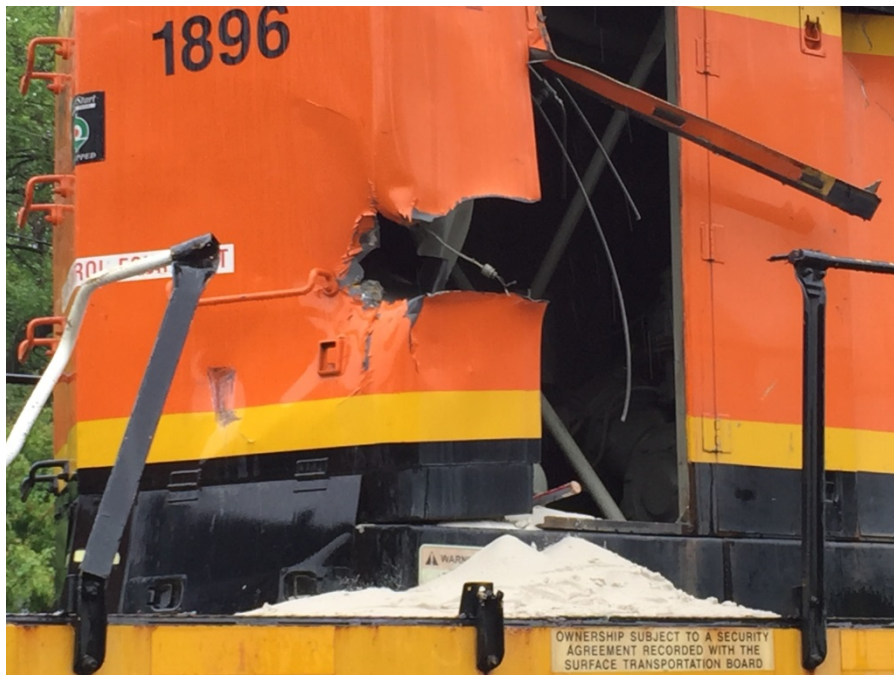
Figure 5. A view of damage to the front end nose area of the lower hood of the BNSF 1896, the trailing locomotive.

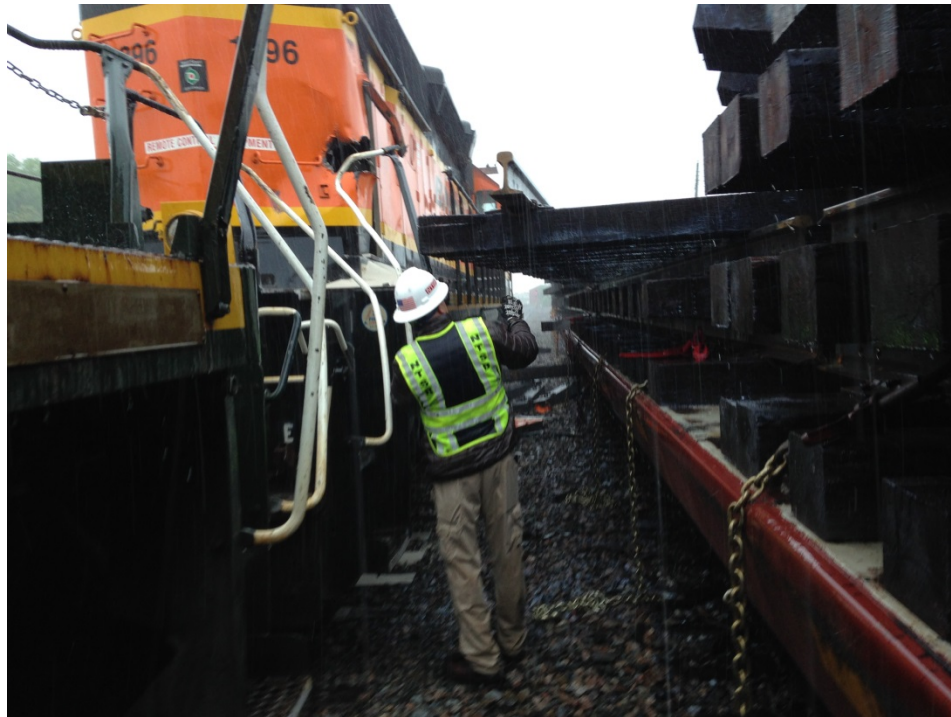
Figure 6. This is a view of dislodged track panel and damage to front end of trailing locomotive BNSF 1896.

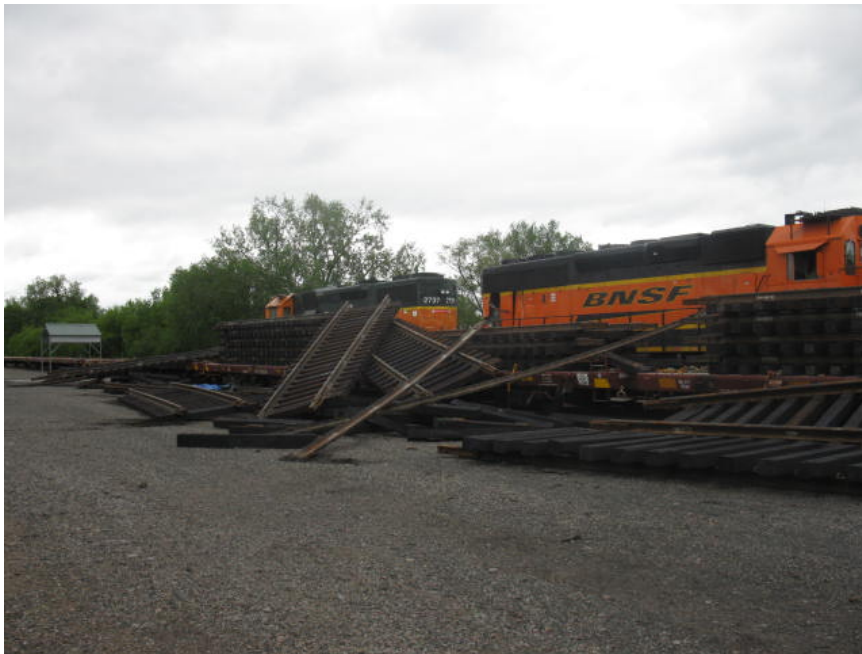
Figure 7. This is a view of dislodged track panels.

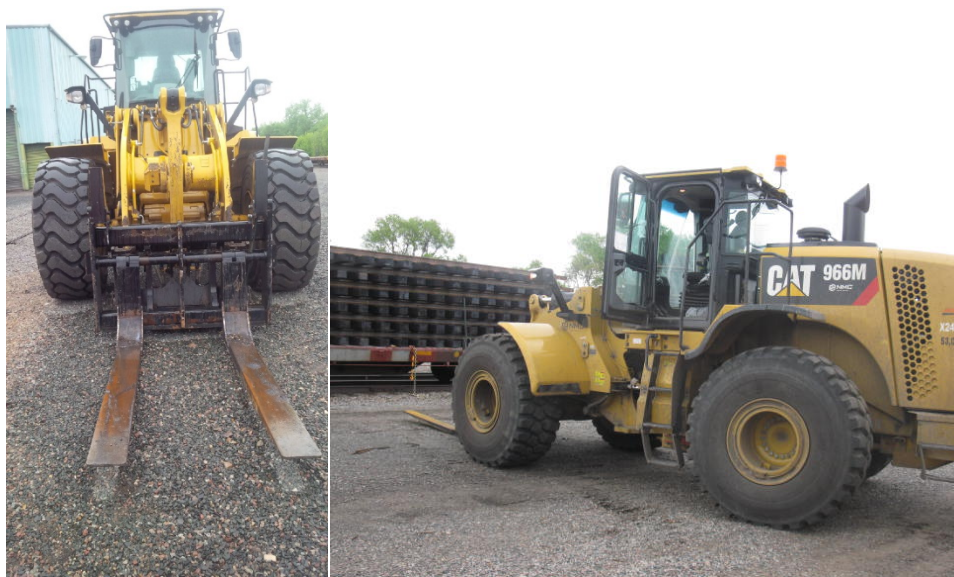
The two front end loaders and fork attachments were visually inspected, operation control panel tested for functionality, and various measurements and notes were recorded. Measurements were also recorded of the flat cars loaded with track panels. (See diagrams and pictures below). Both of the front end loaders are model Caterpillar 966M. Specifications for the loaders were provided by BNSF. Inspections of the front end loaders included radio inspection and testing. Both radio units were Kenwood mobile radios mounted in the loader cabs. Both radios were found to be in working order. Programming software was current and within specifications. Radio tests between loaders and between loaders and dispatcher were successful. A review of adjacent radio relay tower for radio transmission, which is located 28 miles away, did not reveal any radio transmissions for channel 55, the channel commonly used by MOW.

Figure 8. This is a front and side view of the front end loader equipment used to off load the track panels.
