Attachment IV
(Figures 4-7)

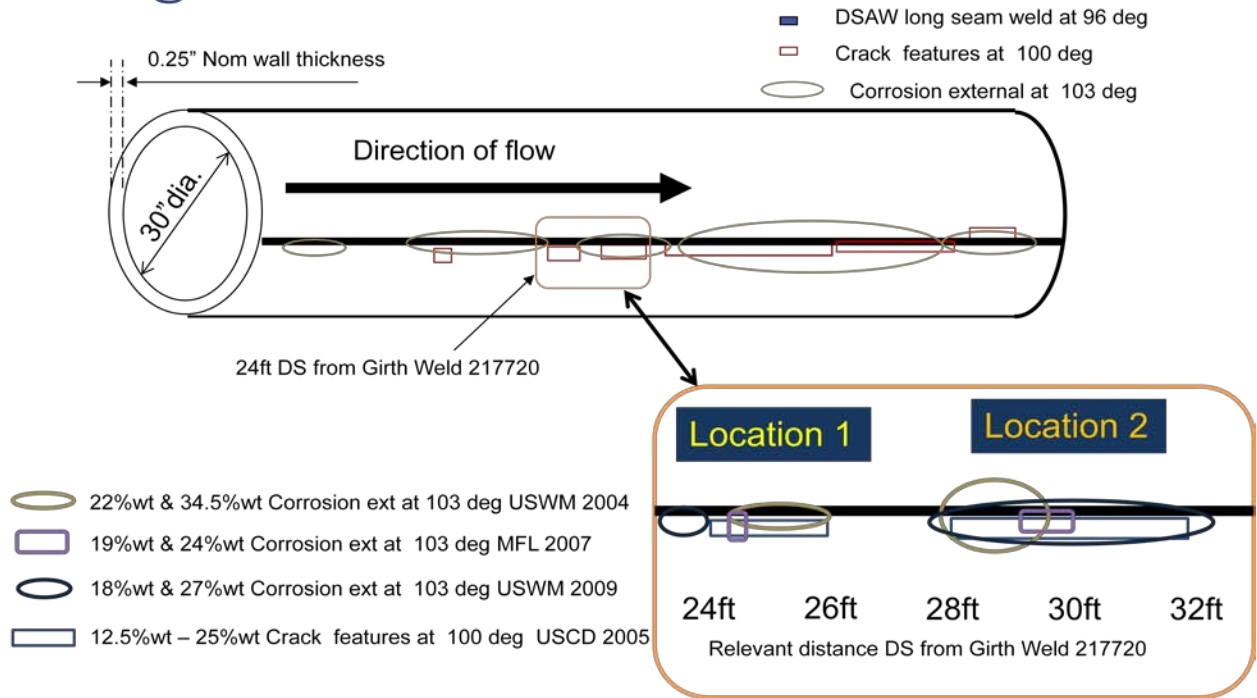
Diagram of feature locations

Figure 4: Summary of ILI data for the ruptured pipe joint provided by PII

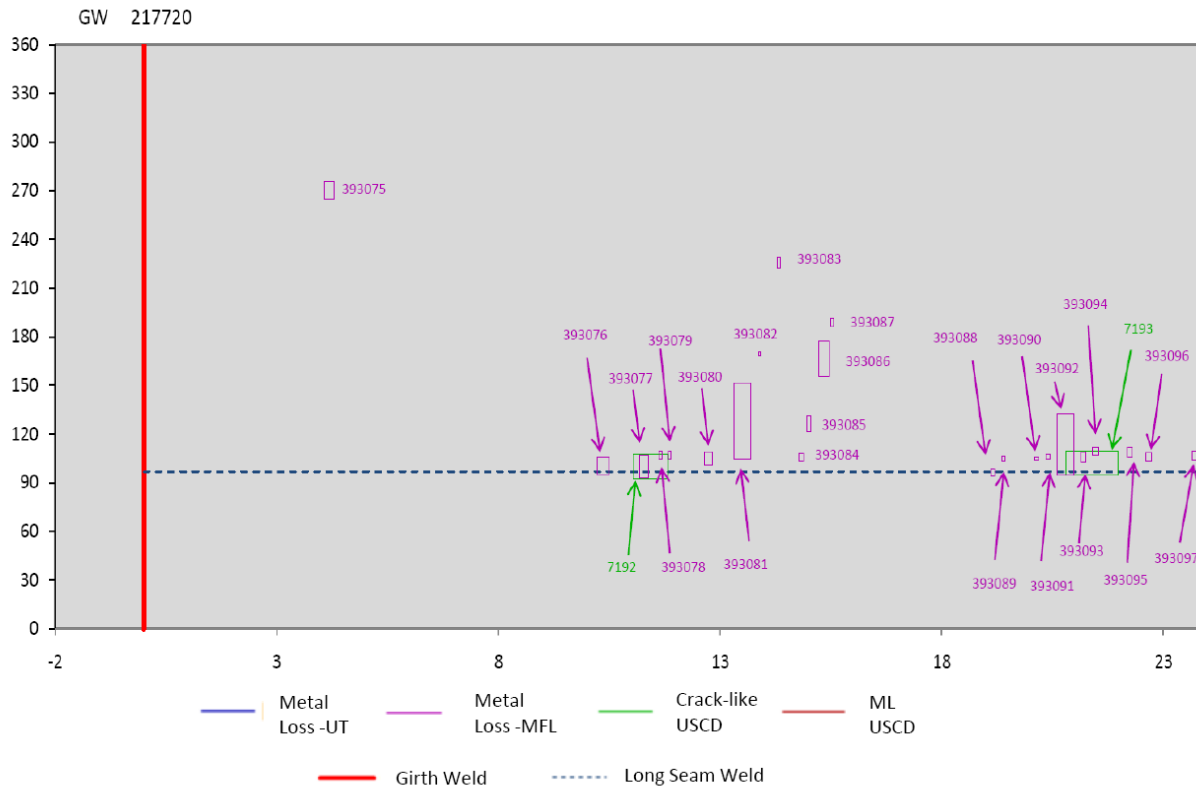
Figure 5: Summary of MFL and USCD ILI data for the ruptured pipe joint (part 1/2) provided by Enbridge.

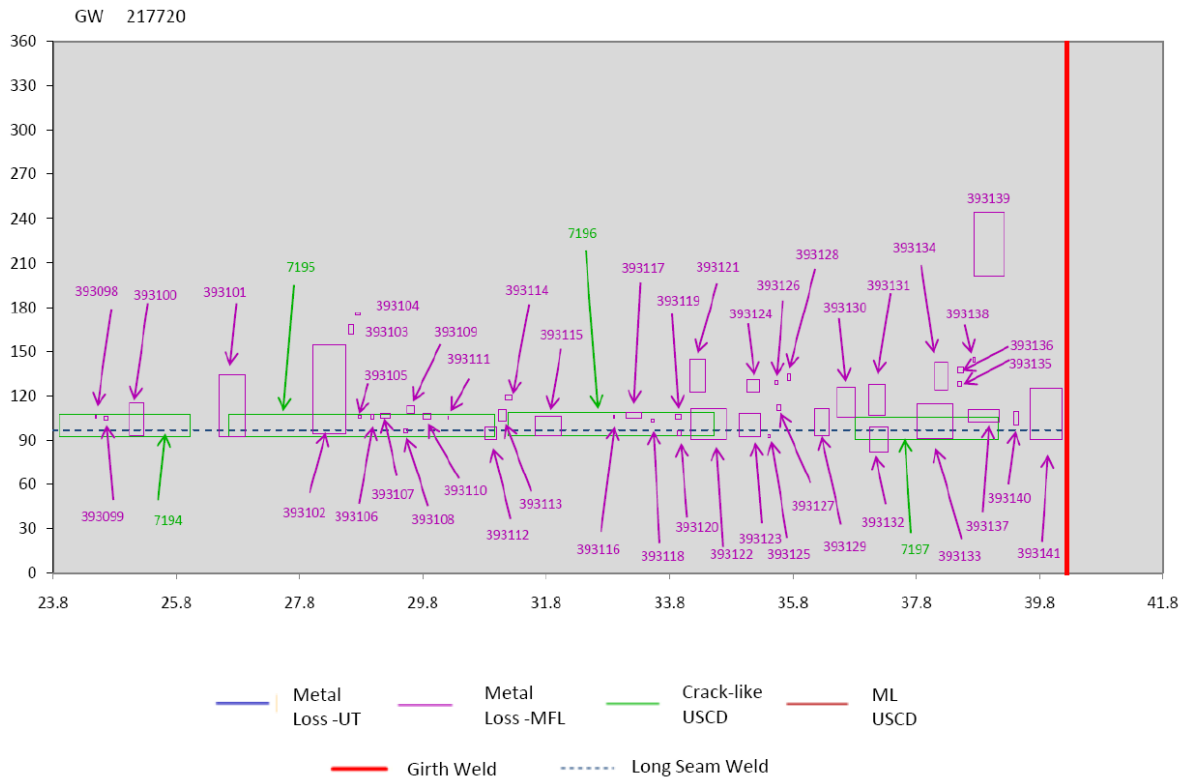
Figure 6: Summary of MFL and USCD ILI data for the ruptured pipe joint (part 2/2) provided by Enbridge.

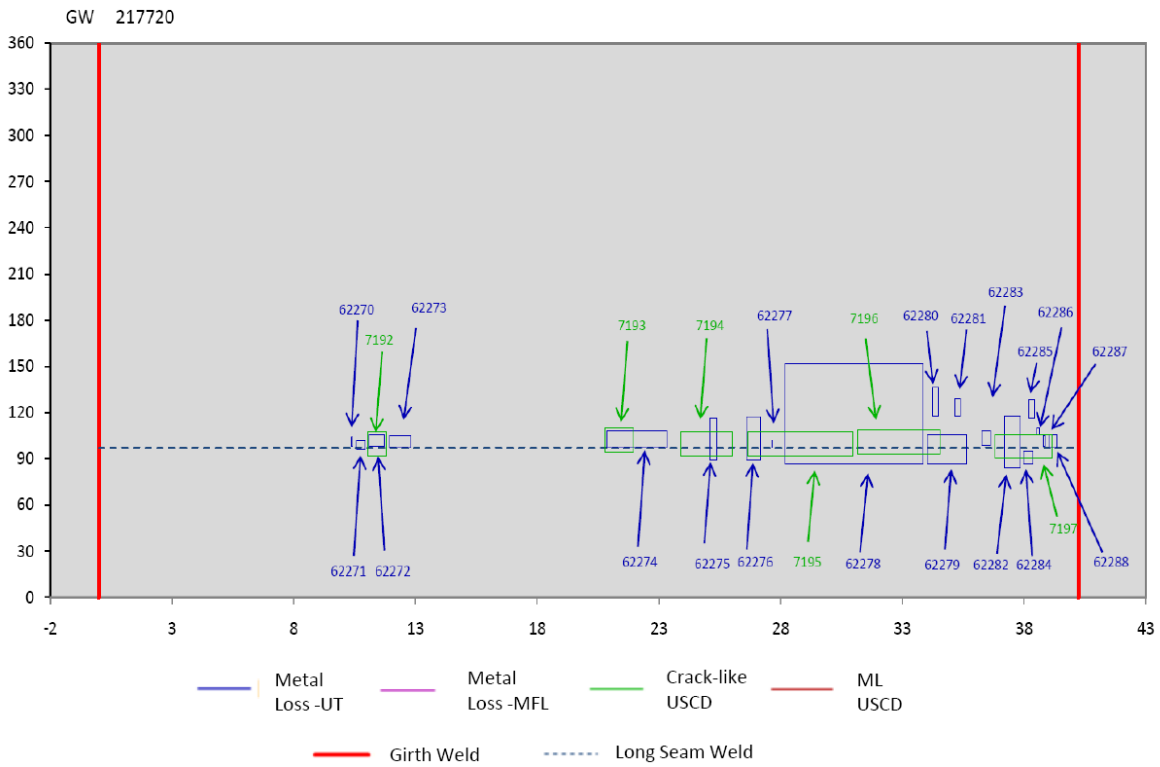
Figure 7: Summary of UT and USCD ILI data for the ruptured pipe joint provided by Enbridge.
