SUBJECT: Marshal Area Close Interval Survey

RE: Cathodic Protection Results – Marshall Leak Site

SUBJECT: Line 6-B exposed coating inspection
DATE: August 10, 2010

INTERNAL / EXTERNAL PIPE INSPECTION FORM

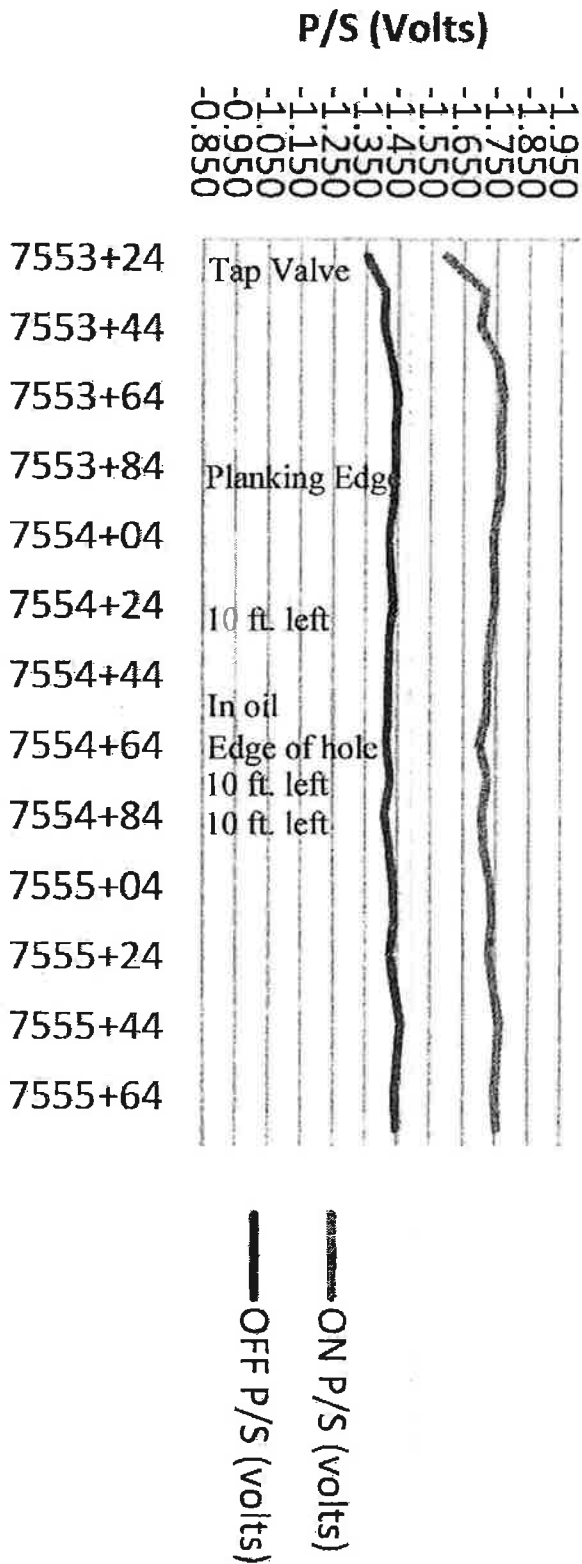
Enbridge Energy Line 6B - Marshall Leak Site Survey

The following Enbridge Energy rectifiers were interrupted with synchronized GPS interrupters on an 8 second cycle ON and 3 second cycle OFF. Readings were obtained on approximately 10 foot intervals, starting at the temporary valve at Station 7553+24. Survey direction was down stream towards the leak site and beyond approximately 100 feet. Attached is a graph of the potentials obtained during this test.

Cathodic protection levels appear adequate with minimal deviation along the length of pipeline surveyed.

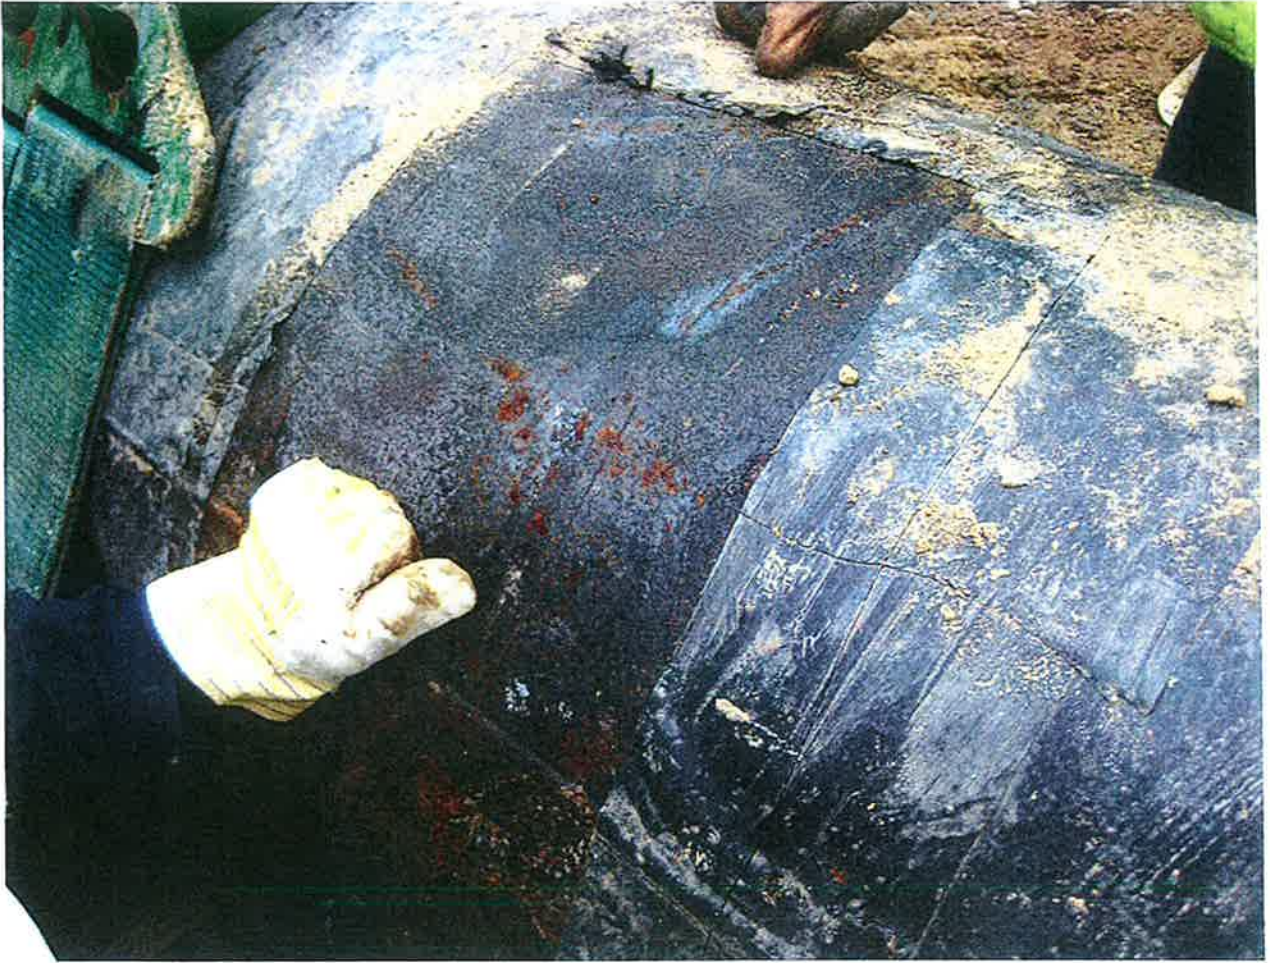
<u>See attached photos below</u>					
If pipe was cut for any reason an internal inspection must be done.					
Describe internal condition.

The coating in contact with oil was observed to be in generally poor condition exhibiting looseness, softening, and wrinkles. Coated surfaces not in contact with the oil residue were in fair to good condition with only slight evidence of wrinkling.

There were a few areas where the coating was damaged and the pipeline was exposed to the soil, calcareous deposits were observed and are believed to be a direct result of minerals transported to the structure surface with the passage of cathodic protection current. This is an additional indication that the cathodic protection system is functional.

There were no signs of corrosion observed during this inspection.

COMPANY NAME	Enbridge Inc.		DATE	8/12/1010	
PIPELINE SEGMENT NAME	Line 6-B from station 7552+46 to 7554+99				
Is person conducting task qualified in accordance with the Enbridge Operator Qualification Program? If no, do not proceed with inspection.				YES	NO
				<input checked="" type="checkbox"/>	<input type="checkbox"/>
Does the pipeline have cathodic protection?				YES	NO
				<input checked="" type="checkbox"/>	<input type="checkbox"/>
If so, what is the pipe/soil reading?		-1.645 millivolts			
Is pipe bare or coated?		coated			
Type of coating?	Poleyken tape	Condition of Coating?	Fair to poor		
Describe external condition of pipeline?		<p>The pipe coating in most areas is in fair shape, with visible slight damage and wrinkles from station 7552+46 to 7553+95 from this point to 7994+55 the coating was removed and abrasive blasted or is coated with fusion bond epoxy, from 7554+55 to 7554+99 the Polyken tape coating is oil damaged and should be replaced.</p> <p>The PLM crew is planning to remove all exposed tape coat and replacing it with SPC epoxy.</p>
