MP 608 – Marshall, Michigan Incident NTSB/PHMSA Information Request No. 24

SUBJECT: Marshal Area Close Interval Survey

RE: Cathodic Protection Results - Marshall Leak Site

SUBJECT: Line 6-B exposed coating inspection DATE: August 10, 2010

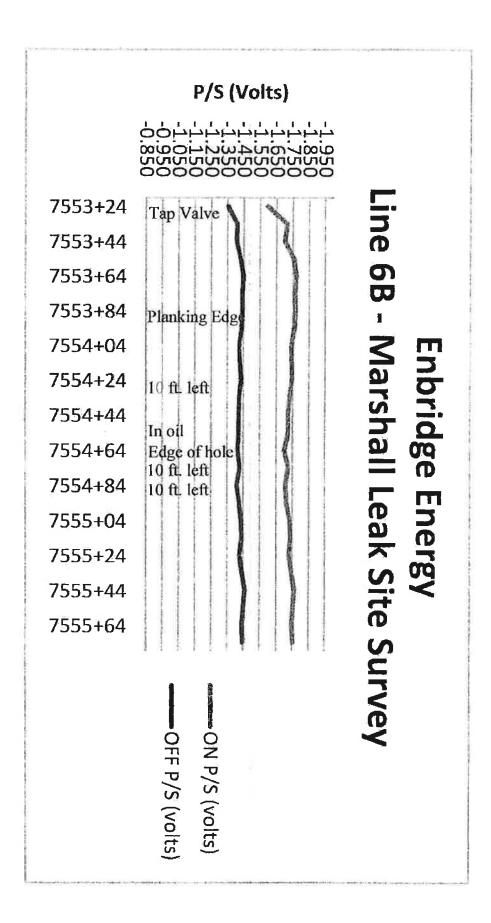
National Pipeline Services, LLC (NPS) obtained cathodic protection structure-to-soil potentials at the Marshall, MI leak site on July 31, 2010 between 6:30 and 7:00 pm. These readings were obtained by Keith Boswell and Cliff Metcalf with National Pipeline Services. These reading were obtained prior to the pipeline being exposed for inspection.

The following Enbridge Energy rectifiers were interrupted with synchronized GPS interrupters on an 8 second cycle ON and 3 second cycle OFF. Readings were obtained on approximately 10 foot intervals, starting at the temporary valve at Station 7553+24. Survey direction was down stream towards the leak site and beyond approximately 100 feet. Attached is a graph of the potentials obtained during this test.

Cathodic protection levels appear adequate with minimal deviation along the length of pipeline surveyed.

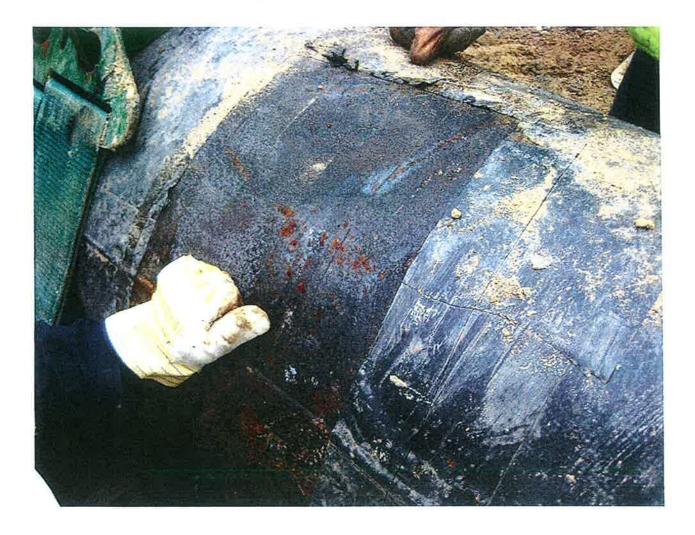
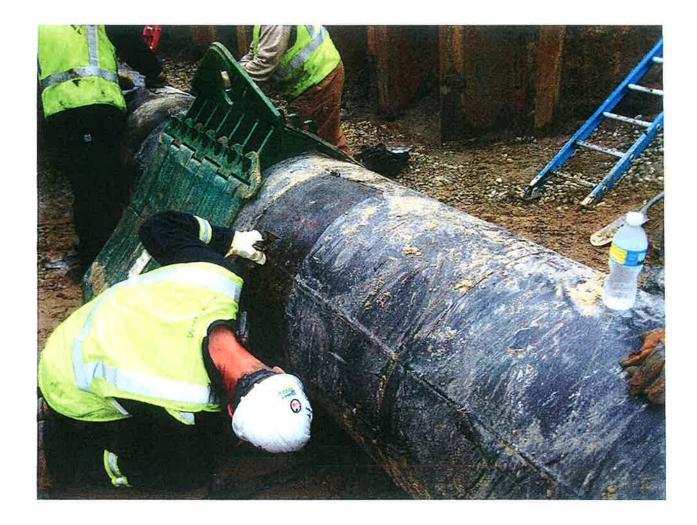
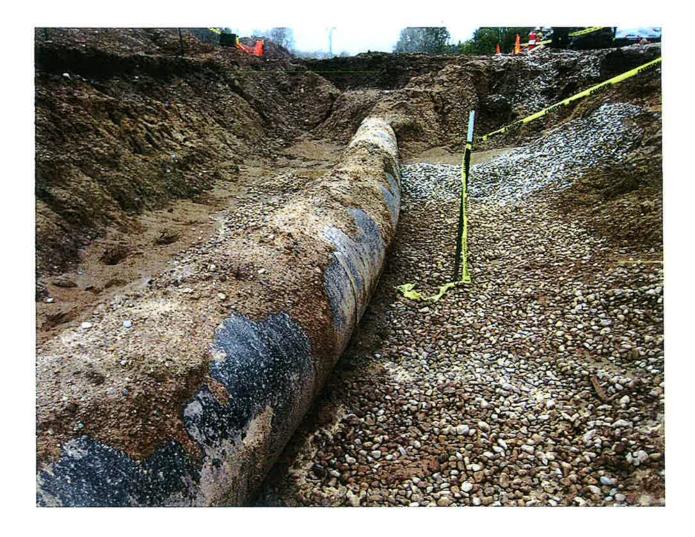
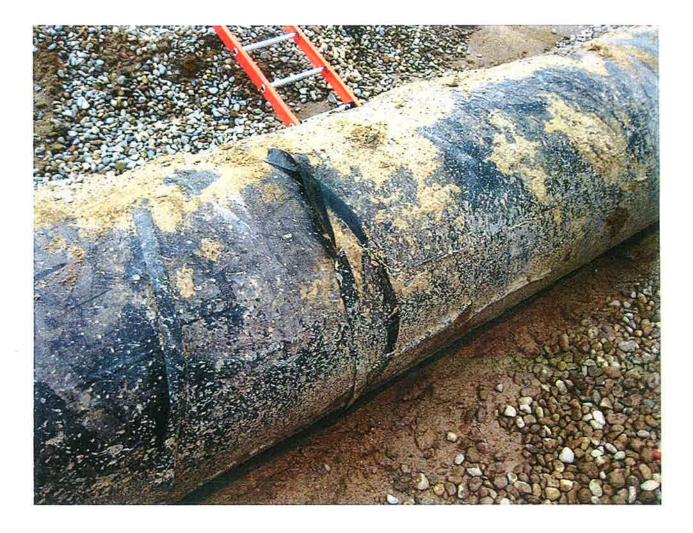
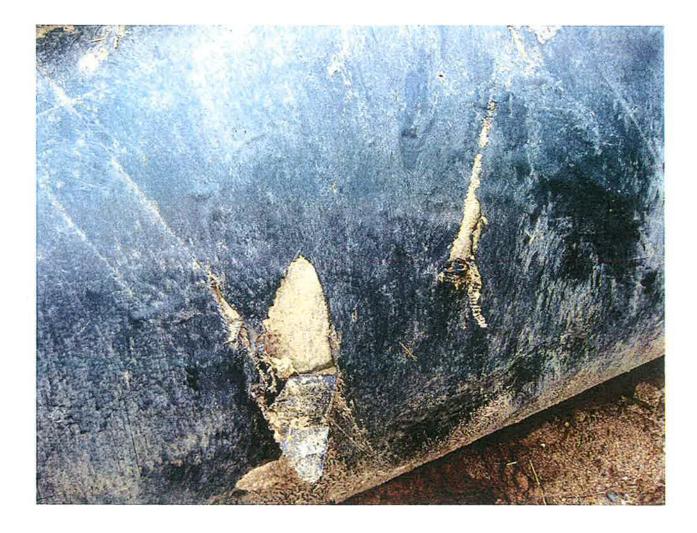
The coating in contact with oil was observed to be in generally poor condition exhibiting looseness, softening, and wrinkles. Coated surfaces not in contact with the oil residue were in fair to good condition with only slight evidence of wrinkling.

There were a few areas where the coating was damaged and the pipeline was exposed to the soil, calcareous deposits were observed and are believed to be a direct result of minerals transported to the structure surface with the passage of cathodic protection current. This is an additional indication that the cathodic protection system is functional.

There were no signs of corrosion observed during this inspection.

COMPANY NAME	Enbridge Inc.				DATE	8/12/1010			
PIPELINE SEGMENT NAME	Line 6-B from station 7552+46 to 7554+99								
Is person conducting task qualified in accordance with the Enbridge Operator Qualification Program? If no, do not proceed with inspection.						YES X	NO		
Does the pipeline have cathodic protection?						YES X	NO		
If so, what is	s the p	ipe/soil rea	ading?	-1.045	millivolts				
Is pipe bare	or coa	ated?		coated					
Type of coa	ting?	Poleyken	tape	Conditi	on of Coat	ing?	Fair	to poor	
with visible slight damage and wrinkles from station 7552+46 to 7553+95 from this point to 7994+55 the coating was removed and abrasive blasted or is coated with fusion bond epoxy, from 7554+55 to 7554+99 the Polyken tape coating is oil damaged and should be replaced. The PLM crew is planning to remove all exposed tape coat and replacing it with SPC epoxy. See attached photos below									
If pipe was cut for any reason an internal inspection must be done.

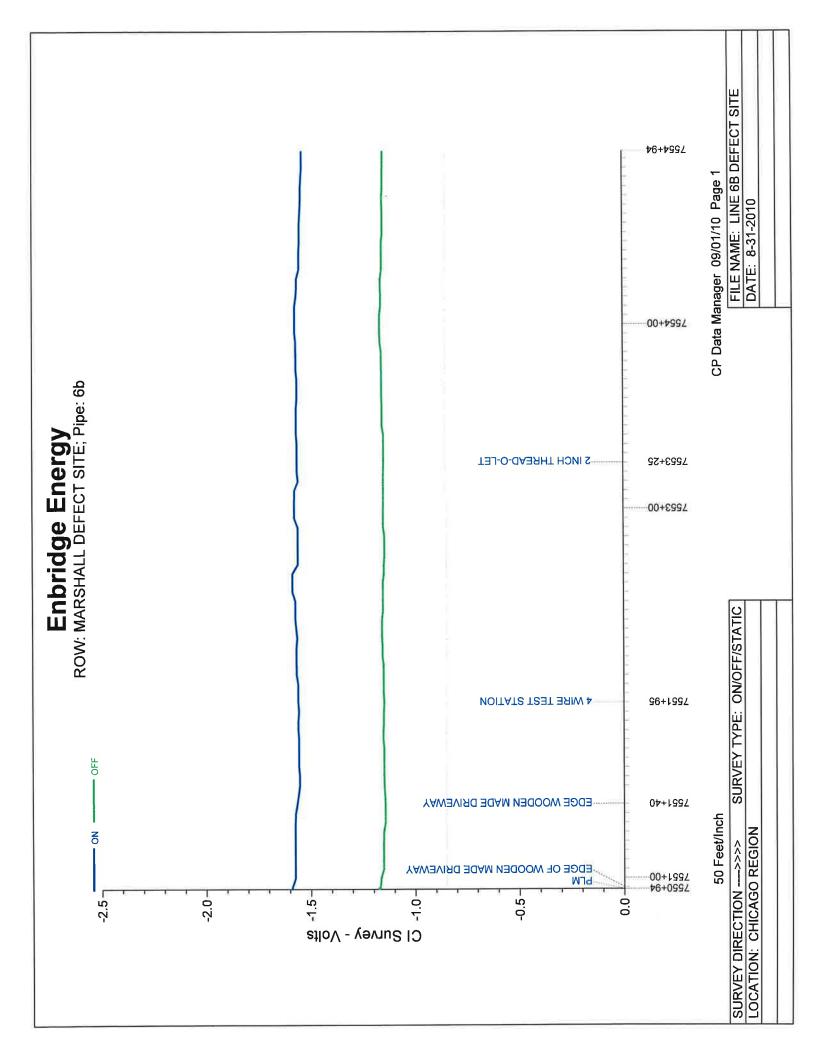
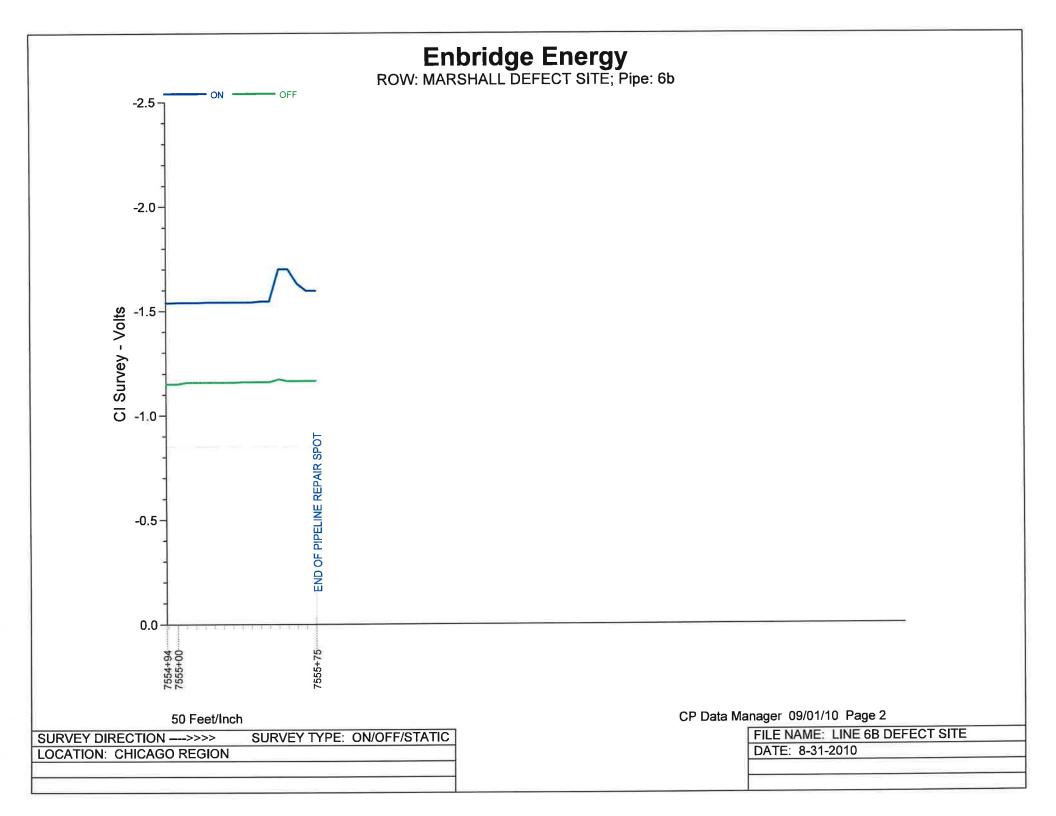
Marshall – 8/31/10 Survey (Pipeline Segment Replaced)

Attached is the graph of the potentials obtained after the pipeline segment was replaced. Cathodic protection levels show adequate potentials with Instant OFF potentials of -1.150 volts. Also included is a copy of the initial survey that was performed on July 31 and August 1, 2010.

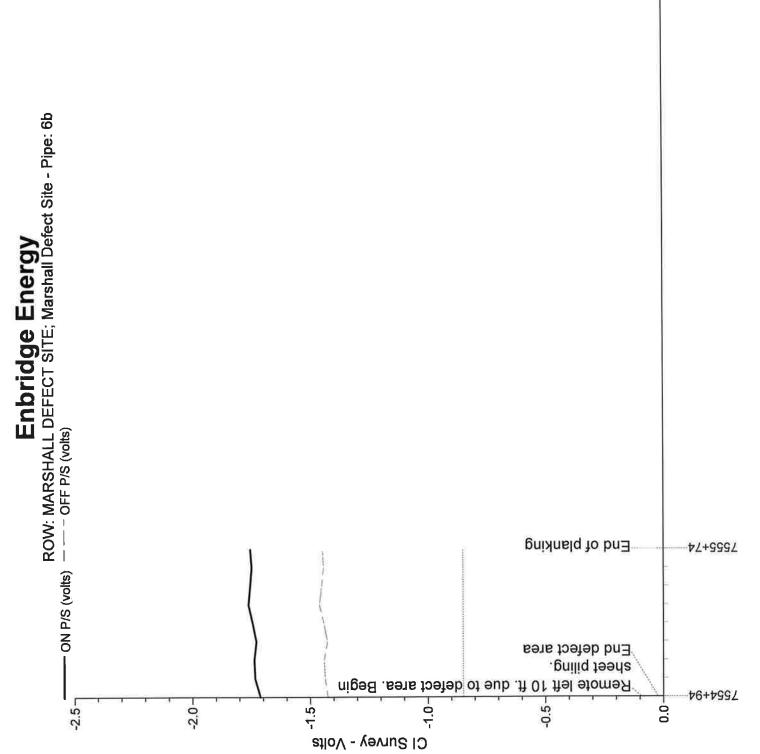
Marshall – 7/31/10 Survey (Defect Exposed)

CI Survey - Volts								
	0.0	-1.0	- <u>1</u> .5	-2.0	-2.5				
50 7550+94 7551+04 7551+14 7551+24 7551+34 7551+34 7551+54 7551+64 7551+74	PLM at portable toilets Read on top of tempor Edge of temporary roa 3 ft. after stake - 41" co remote left 10 ft due to 5 ft. after planking at co 5 ft. before stake - 40" 5 FT. after stake - 40" At stake - 49" cover	ary road d over planking ommand post cover			ON P/S (volts)				
7551+94 7552+14 7552+24 7552+54	5 ft. before stake - 42" At stake - 42" cover 2 ft. before stake - 47" At stake - 49" cover				Enbrid ROW: MARSHALL DEFECT & 				
7552+84 7553+04 7553+14 7553+24 7553+34	In between cracks in p Edge of planking Top of bank to tempor 2" vent piping Top of bank to tempor	ary valve			'idge Energy DT SITE; Marshall Defect Site -				
CP Data Manager 08/01/10 Page 1 7554+54 7554+54 7554+54 7554+64 7554+74 7554+94	Edge of planking In between cracks in p Remote left 10 ft. due Start readings in oil Begin defect area Remote left 10 ft. due Center of defect area Remote left 10 ft. due sheet piling. End defect area	to planking to leak site hole	gin		Site - Pipe: 6b
