**MP 608 – Marshall, Michigan Incident
NTSB/PHMSA Information Request No. 24**

Request: Provide a list of all leaks discovered on the pipeline including when they were detected, their severity and when they were repaired.

Response: Repair/Leak Records: MP 671.96.pdf, MP 722.81, MP 716.32.pdf, MP 749.93.pdf, MP 751.07.pdf, MP 512.27.pdf, MP 714.93.pdf, MP 475.30.pdf, MP 682.77.pdf, MP 468a.pdf, MP 468b.pdf

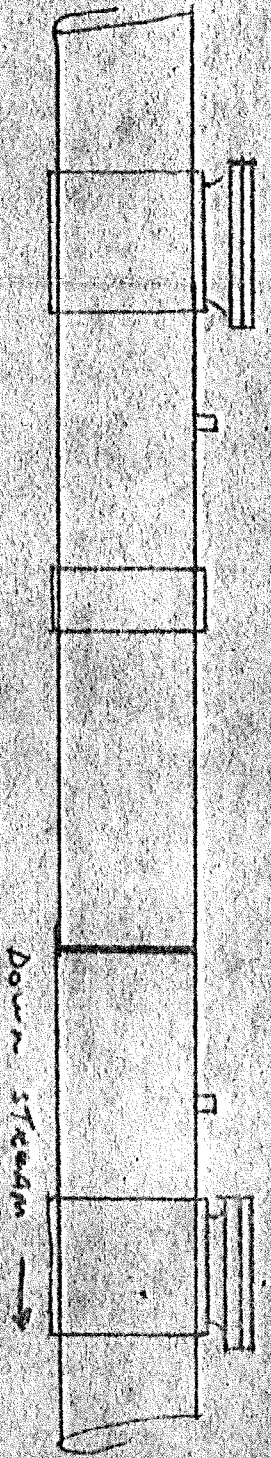
Leak AT MP 448-1 50 30" Line

Describe Specific Nature and Cause of Break or Leak Pin point leak in seam, 40" from downstream end of joint. Permanent repair at a later date will consist of sleeving the entire joint.			
Oil Out of Line - Barrels 3	Oil Recovered - Barrels 0	Net Loss - Barrels 3	Crude Type
Batch Number			
Disposition of Lost Oil Oil soaked soil removed and buried			
Name and Address of Person Reporting Leak Buckeye Pipe Line Co. Partol Pilot			Was a Report Fee Paid? No

NATURE AND CAUSE OF BREAK OR LEAK
Pin point leak in seam, 40" from downstream end of joint.

NATURE OF REPAIR
Temporary repair by 14" Plidco clamp, not welded.

REMARKS
Permanent repair at a later date will consist of sleeving the entire joint.
