Analysis Completion Date: February 14, 2003

Initial Submission Date: September 17, 2002

**Subject : Analysis of pressure switches 1103P26-1 (2 each) and 1103P26-19 (2 each)**

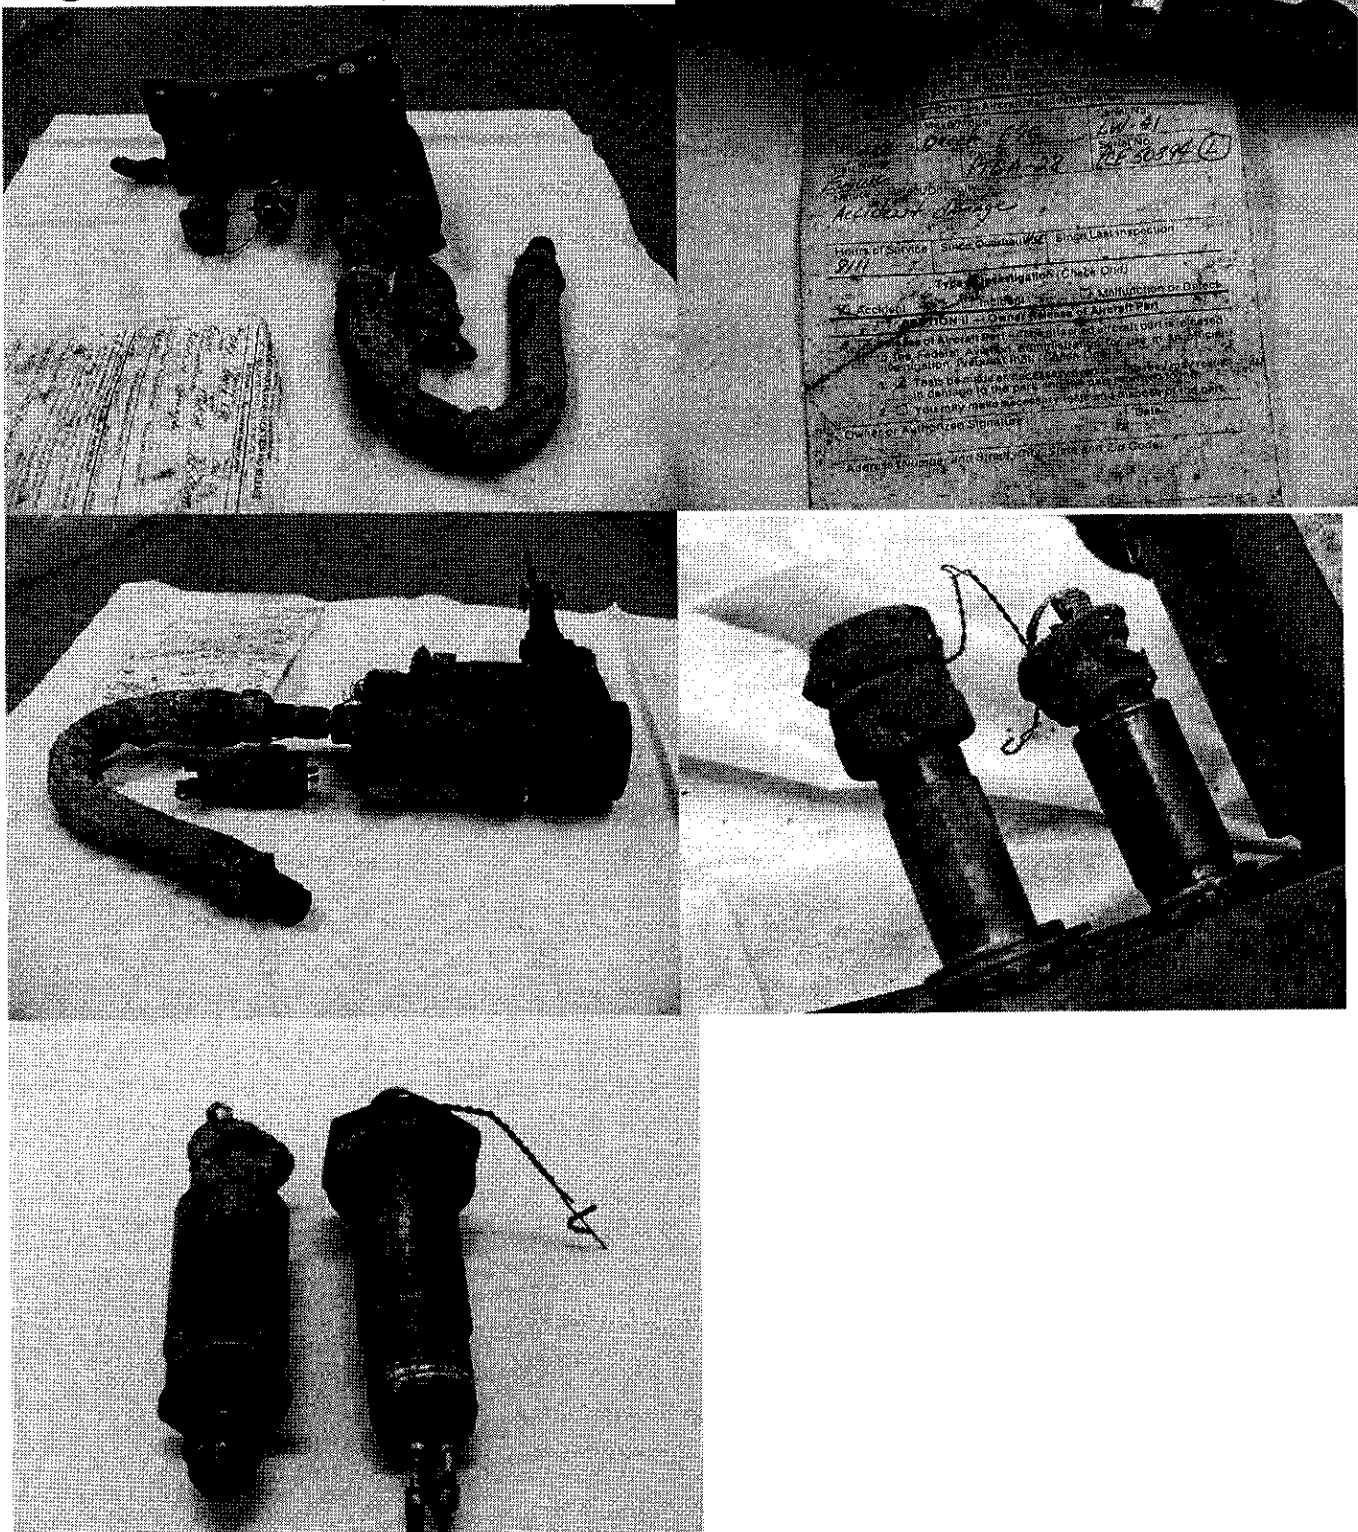
## Right Assembly

Results: An understanding of the accident scenario was established. Two assemblies were examined labeled "Right" and "Left". Each assembly contained both a 1103P26-1 and 1103P26-19 switch. The assembly labeled, "Right", was badly burned as evidenced in the following photos. Both banks of switches were exposed to high temperature and the shock from the accident. The switch identification and as assembled locations are as follows:

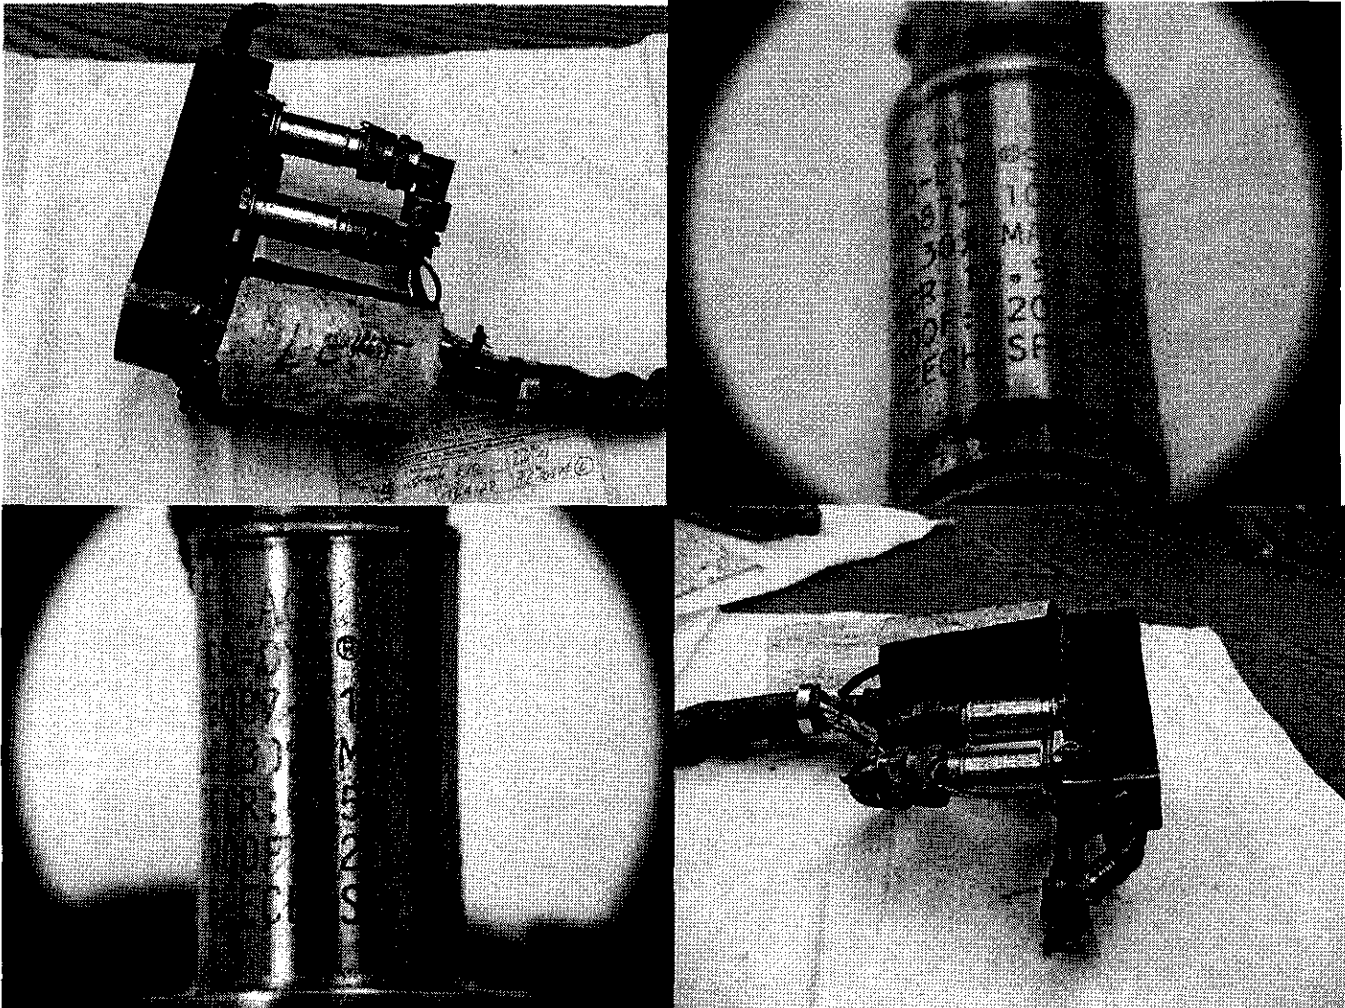
## Left Assembly

As observed from Table 2, the decreasing pressure setpoints from both switches on the, "Left", assembly were below specification. Also as indicated in Table 2, the deadband reading of serial number 3987 exceeded specification and the deadband reading of serial number 10743 was within specification. The switches from the, "Right", assembly were pressurized and the technician listened for an audible sound that might indicate the mechanical portion of the switch was functioning. An audible noise was detected while pressurizing both switches between 16 and 22 psig. All switches were also determined not to leak.

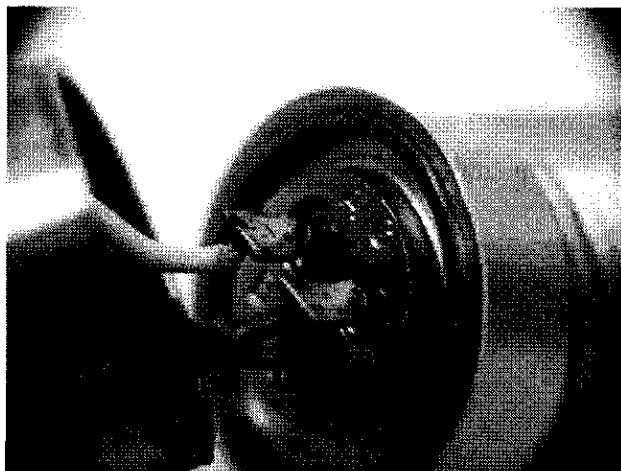
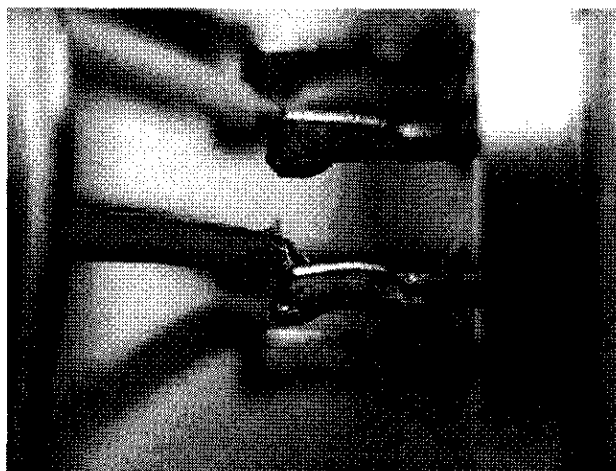
Figure 4 Soldered Connector Terminals Indicating Excessive Heat Exposure

On February 14, 2003 the switches were hand carried to ITT by Mr. Doug Orchard for further teardown and visual examination of the internal components. The connectors were removed from the switches from the left assembly and the soldered connector terminals were examined. The connections appeared to have been exposed to excessive heat as evidenced by the condition of the soldered terminals, see figure 4. Although it appeared that the terminal connections were slightly reflowed all nodes were intact and functional.

Close-up of solder connection  
shows area of solder re-flow.

Different photo angle  
showing solder re-flow

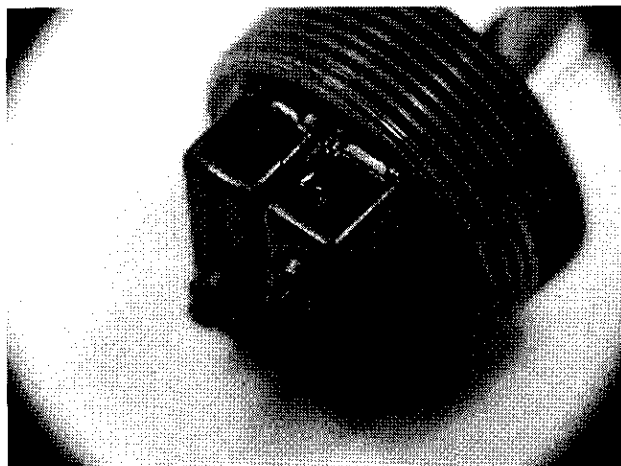
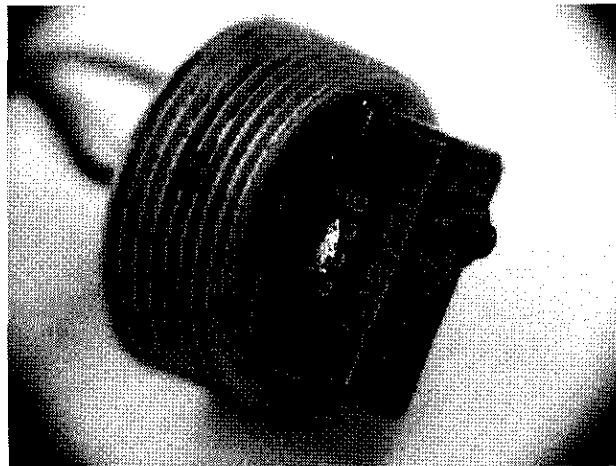
Figure 5 Microswitches

The mechanical switch components were manually actuated and were functional except for the setpoint shifts previously identified. The microswitches were removed from the switch bodies and visually examined and functionally tested. No damage was observed and the microswitches functioned normally, see figure 5.

Dual Micro Switch.

Single Micro

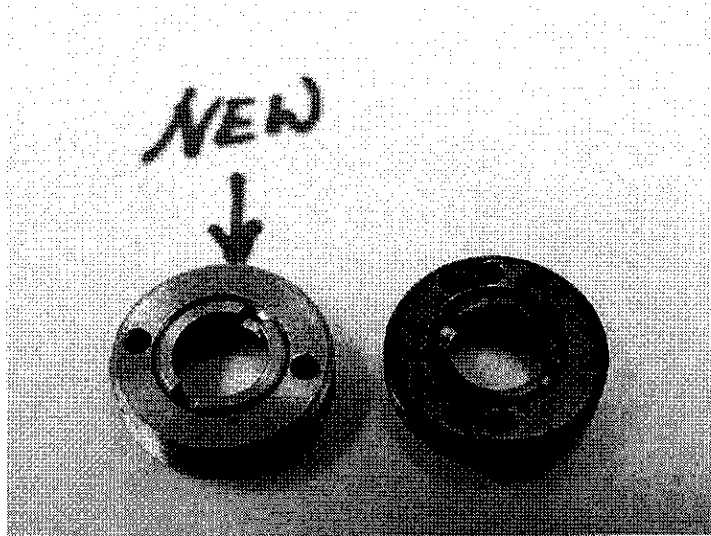
After removing the microswitches the brass retainers were removed from the switch bodies and examined. Both retainers appeared slightly tarnished as compared with a new retainer indicating exposure to excessive heat, see figure 6.

Figure 6: Retainer indicating excessive heat exposure Side by comparison

The unit on the left is a new part. The unit on the right is from the switch under analysis. The diaphragms, belleville springs, stops, actuation shoes were then removed and examined for signs of damage. No damage was observed and were functional, see figure 7.

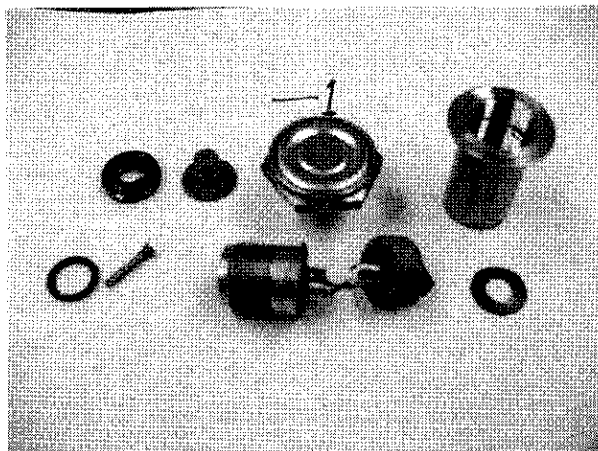
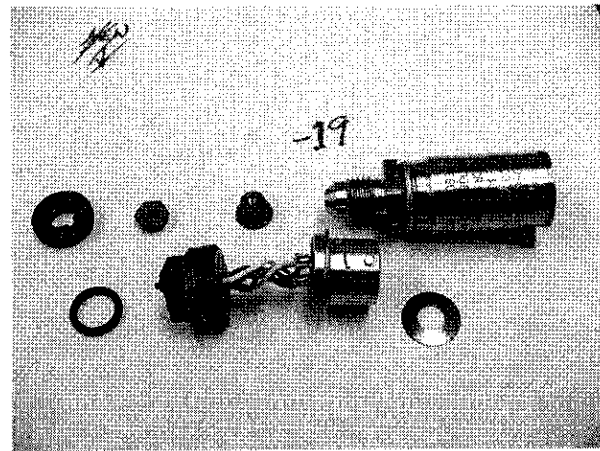
Figure 7 Disassembled switches

Switch ITT P/N 1103P26-1

Switch ITT P/N 1103P26-19
