**Illinois State Police
Accident Scene Photos**

**Naperville, IL
HWY14FH002**

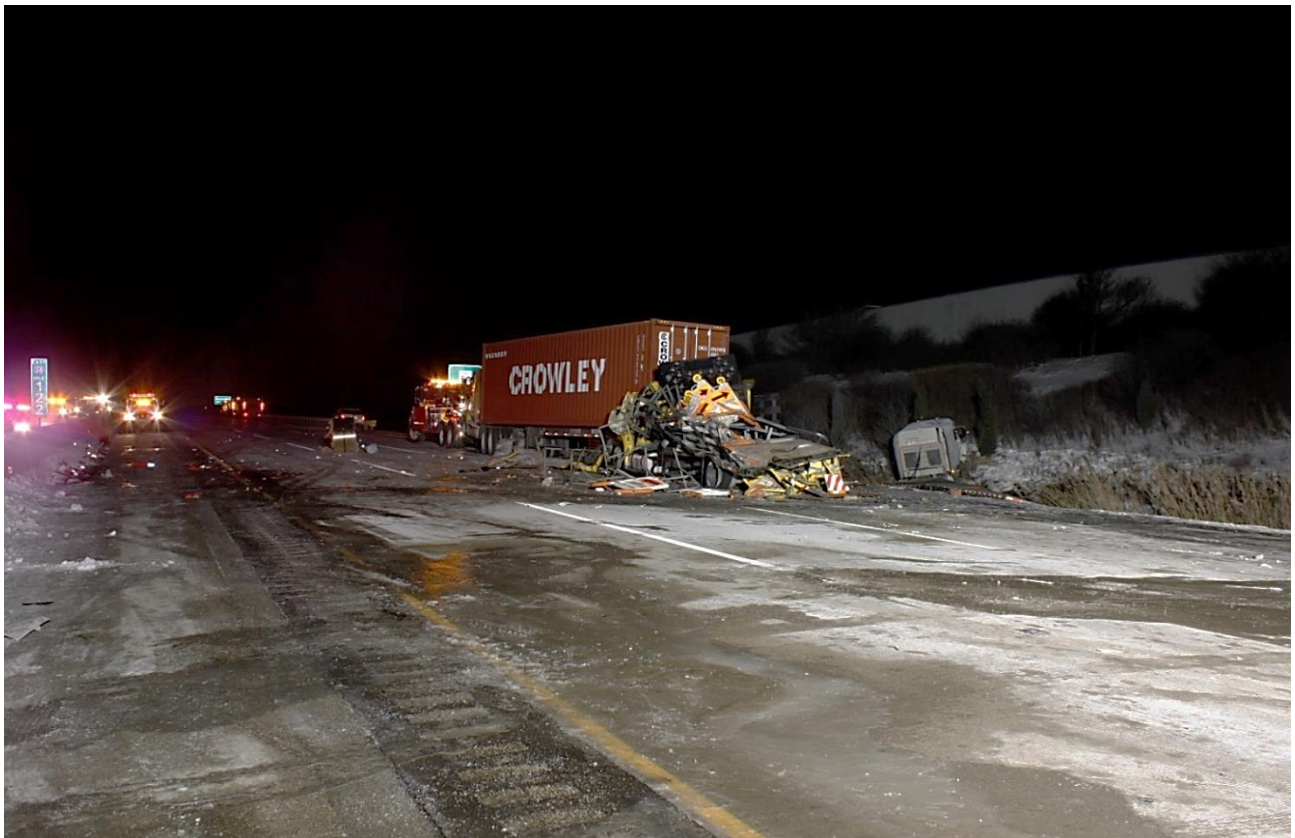
Photo 1 – Accident scene view looking east. The heavy duty tow truck, disabled intermodal combination unit, and the Illinois State Toll Highway Authority help truck are shown at final rest in the right lane of eastbound Interstate 88. The 2004 Freightliner tractor and flatbed trailer combination unit can be seen off in the ditch to the south, and one of the steel coils from its flatbed trailer can be seen at rest in the center lane of the interstate.

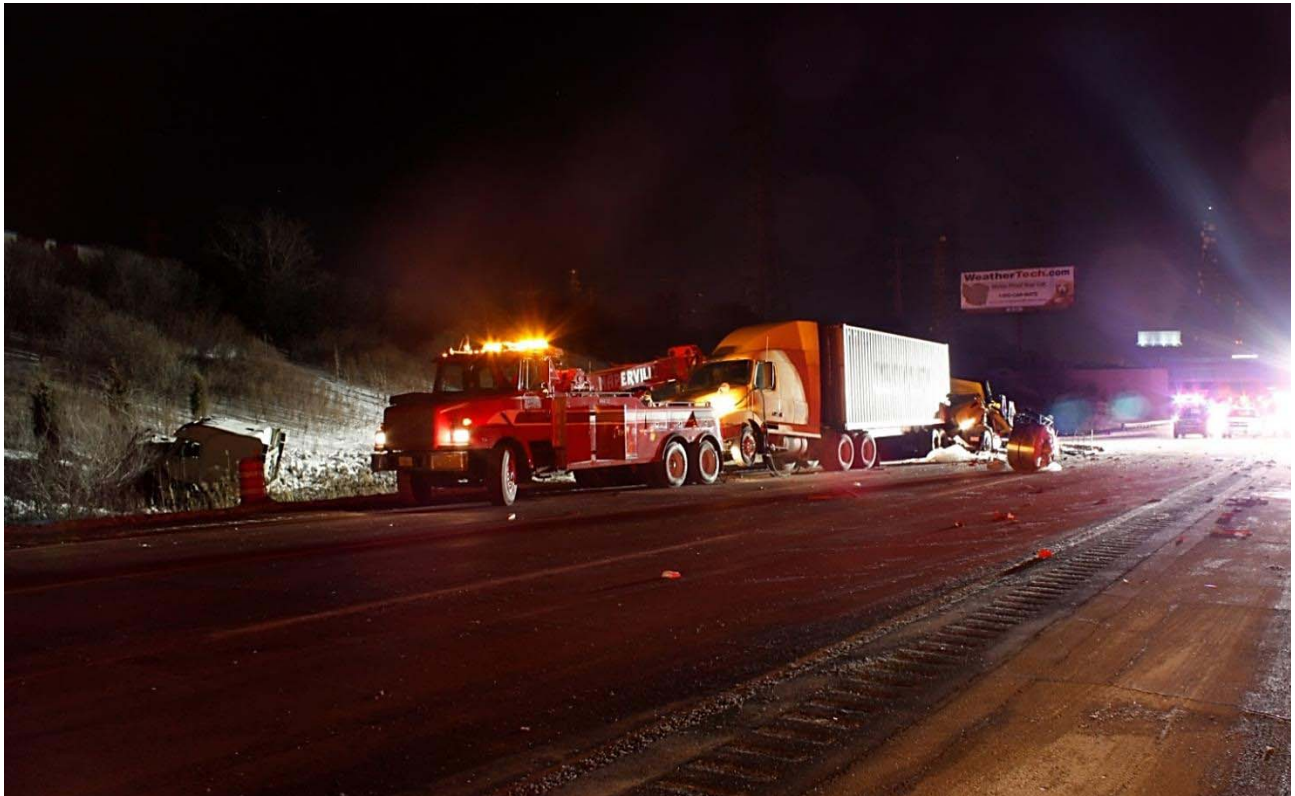
Photo 2 – Accident scene view looking west. The heavy duty tow truck, disabled intermodal combination unit, and the Illinois State Toll Highway Authority help truck are shown at final rest in the right lane of eastbound Interstate 88. The 2004 Freightliner tractor can be seen in the ditch to the south, and one of the steel coils from its flatbed trailer can be seen at rest in the center lane of the interstate.

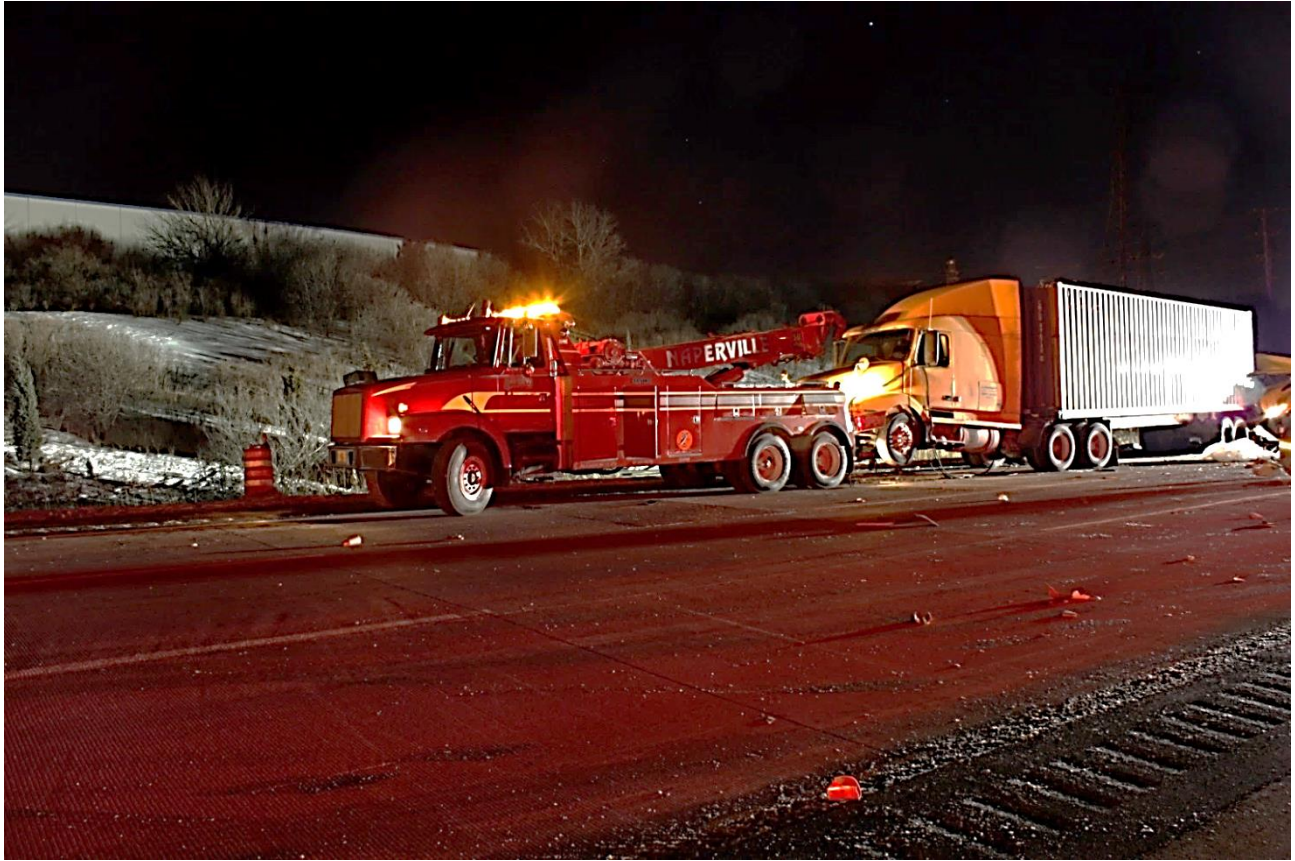
Photo 3 – Accident scene view looking south, showing a side view of the heavy duty tow truck hooked up to the disabled intermodal combination unit

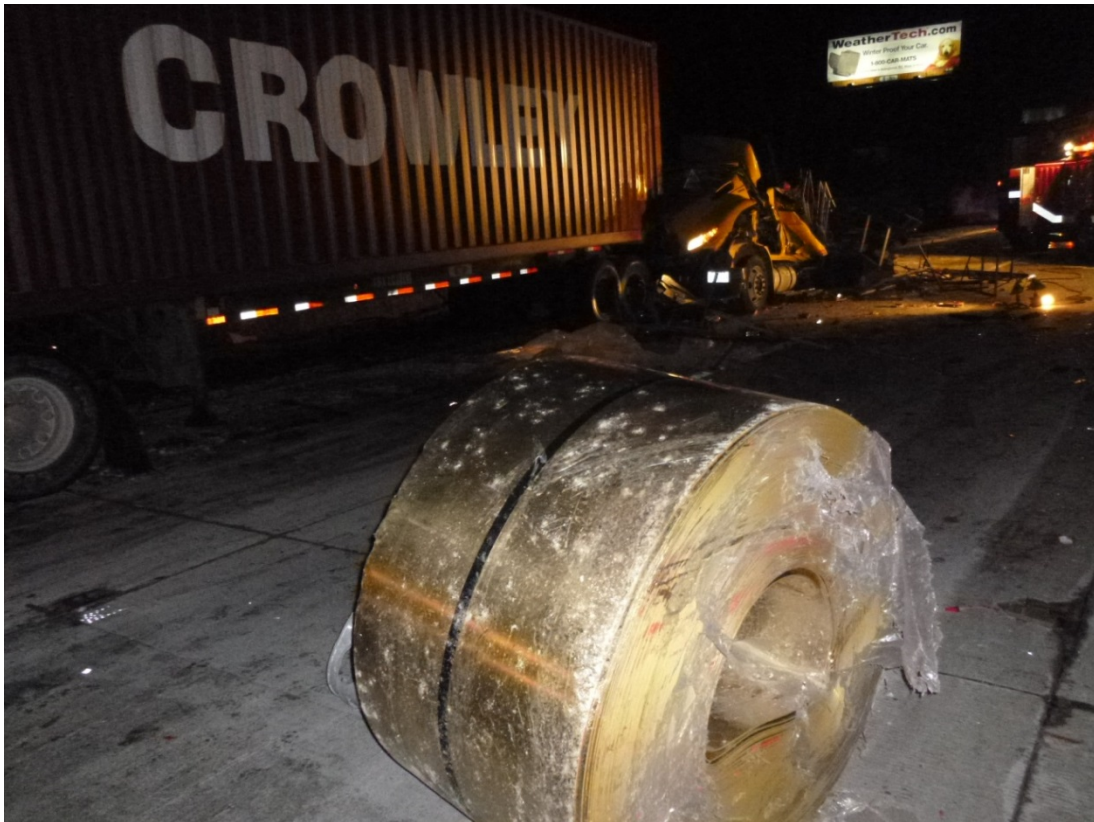
Photo 4 – Accident scene photo showing a closer view of the steel coil at rest in the center lane of the interstate.

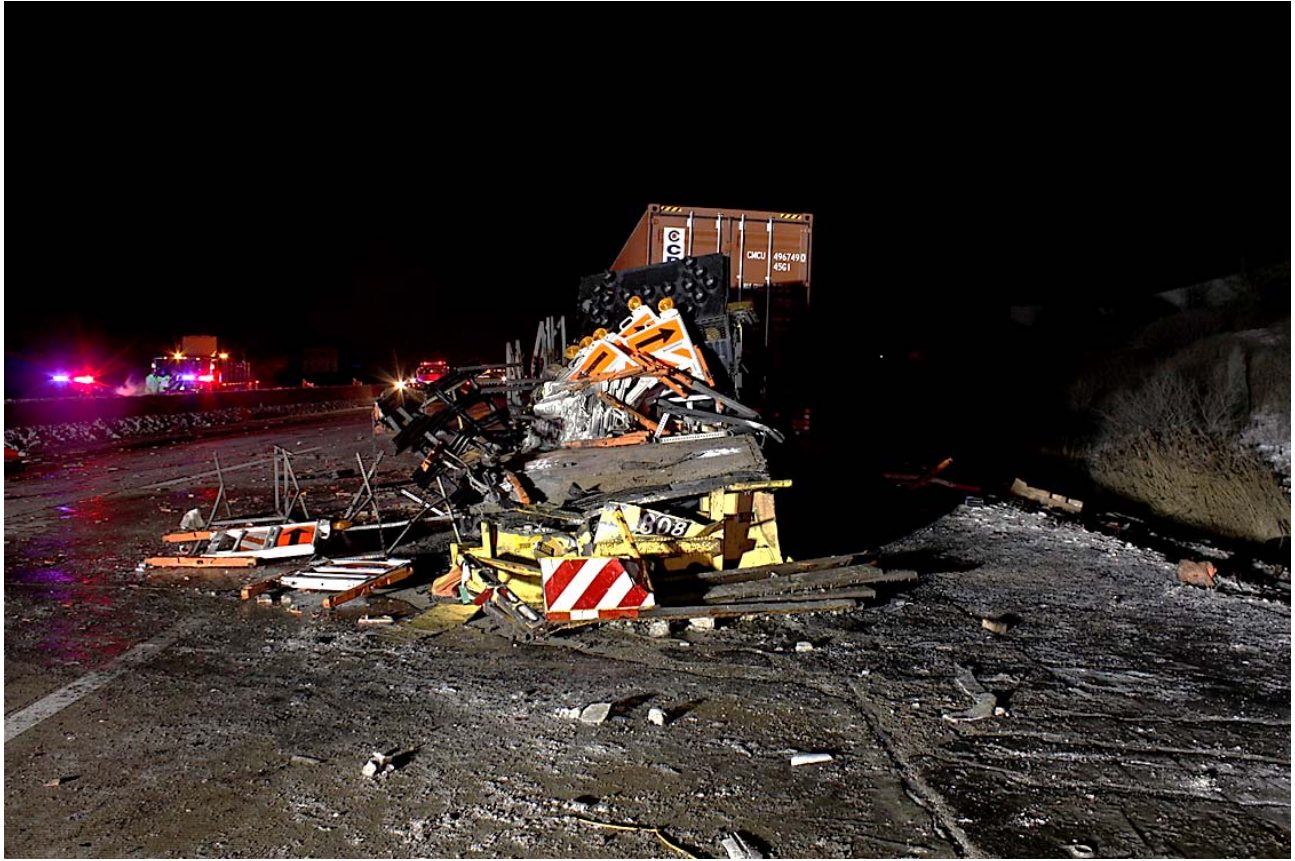
Photo 5 – Accident scene photo showing a rear view of the damage to the Illinois State Toll Highway Authority help truck.

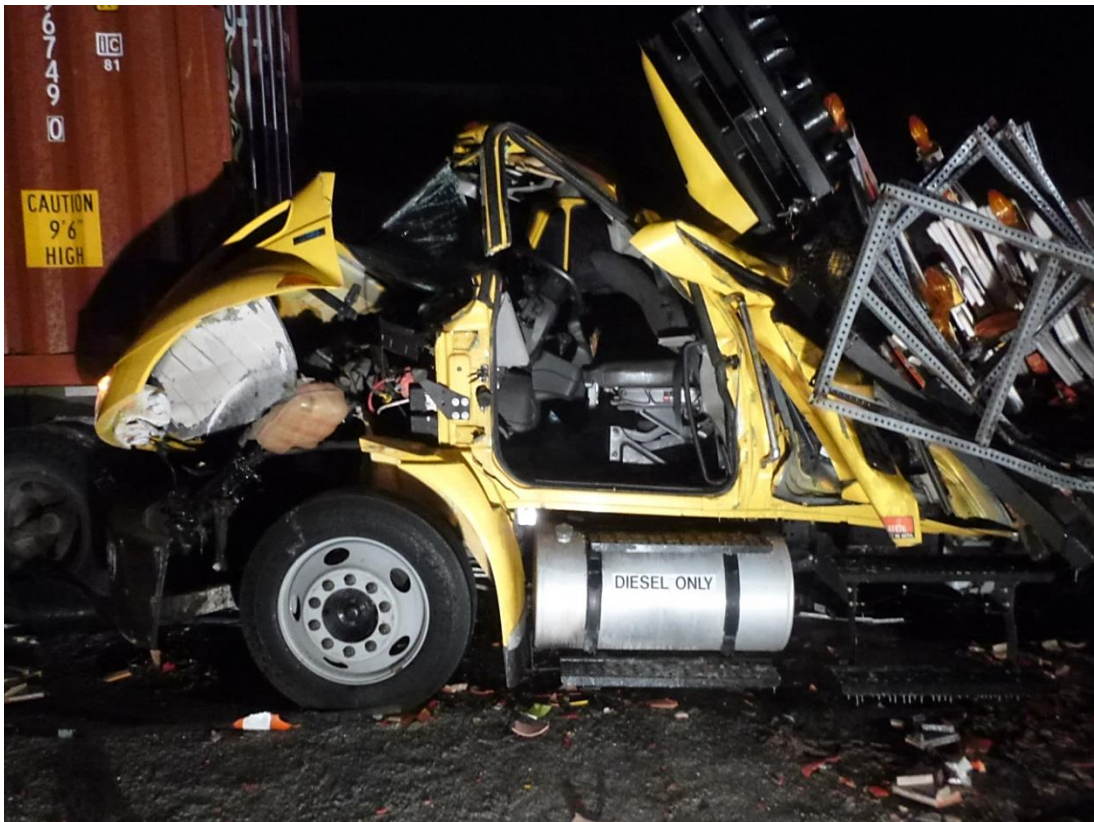
Photo 6 – Accident scene photo showing a side view of the damage to the cab and driver seat area of the Illinois State Toll Highway Authority help truck.

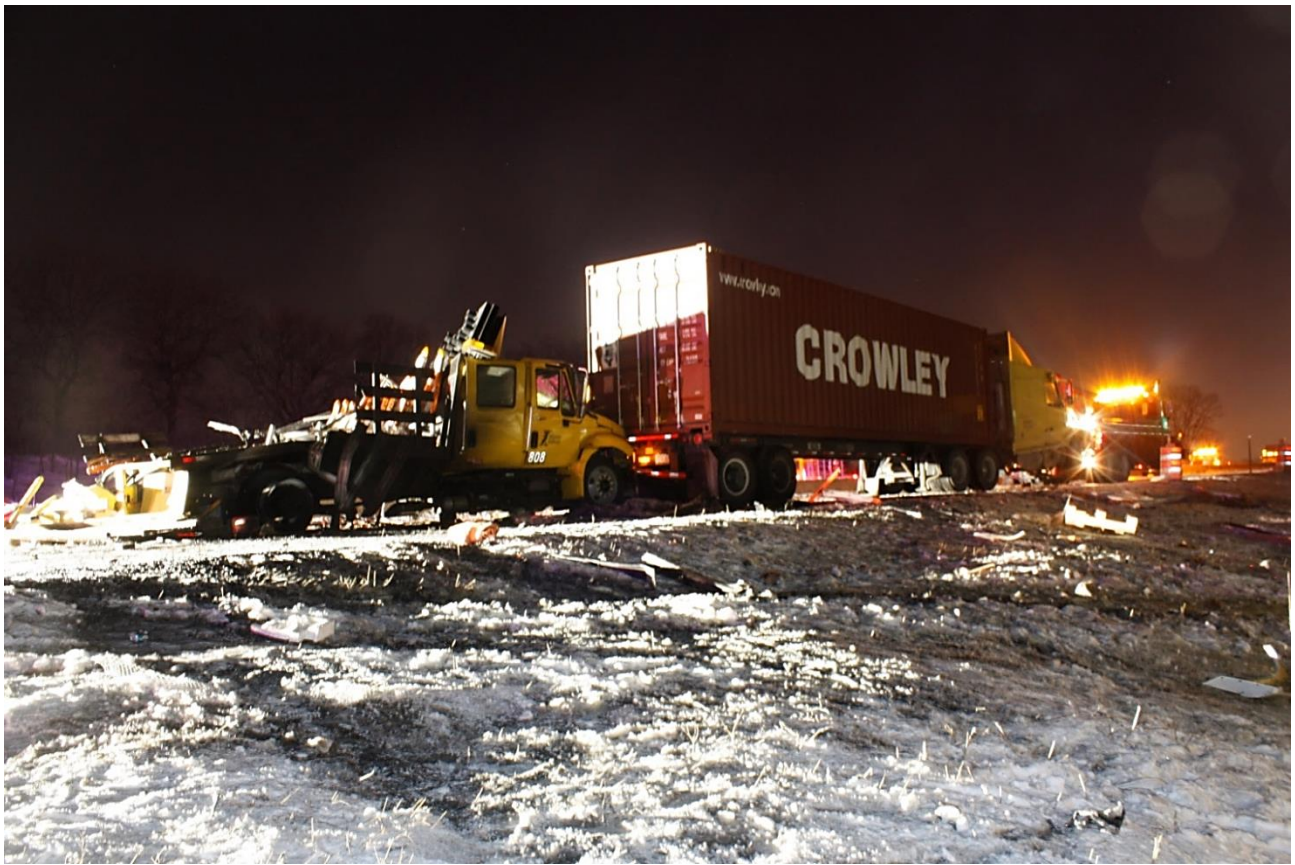
Photo 7 – Accident scene view looking north, up from the ditch. The heavy duty tow truck, disabled intermodal combination unit, and the Illinois State Toll Highway Authority help truck are shown at final rest in the right lane of eastbound Interstate 88.

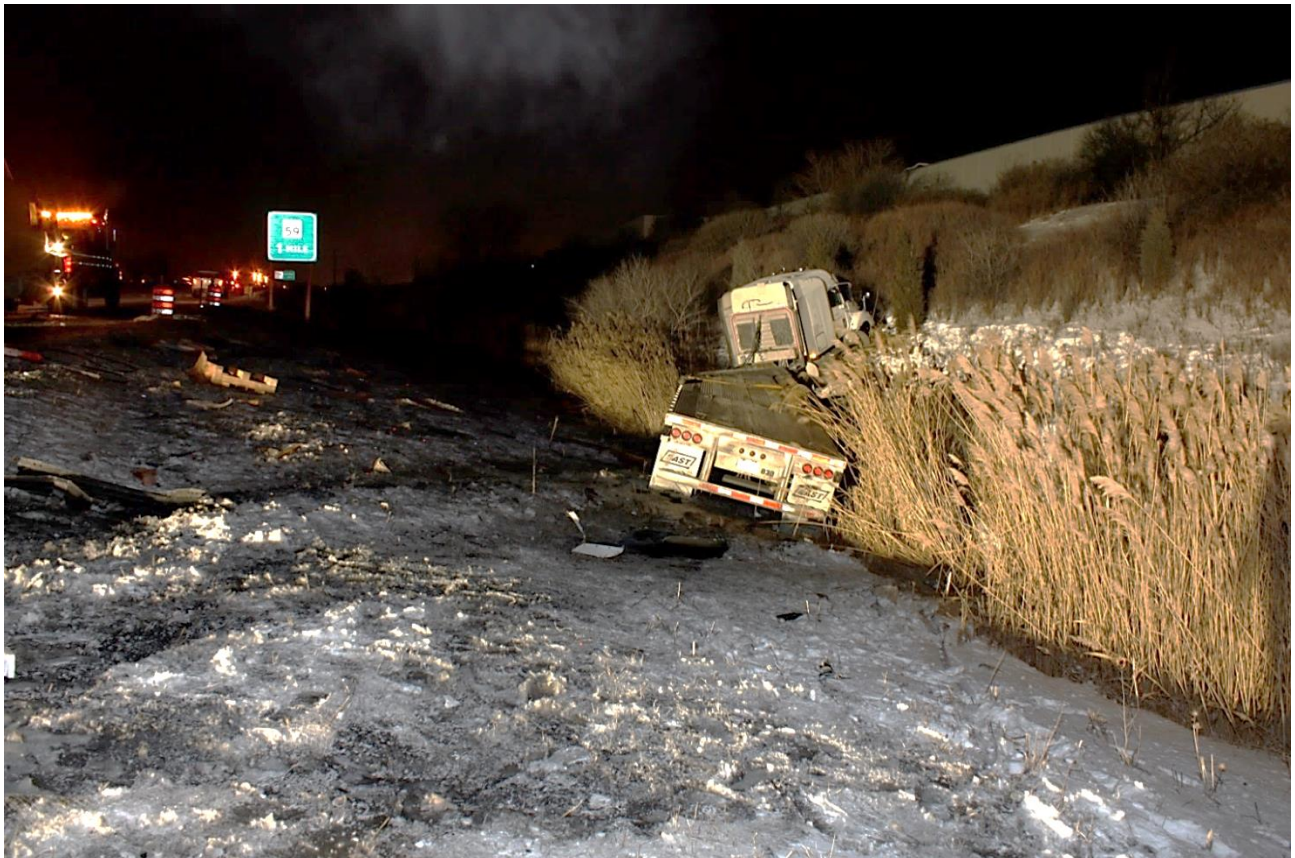
Photo 8 – Accident scene photo looking into the ditch to the south of eastbound Interstate 88, showing a closer view of the 2004 Freightliner tractor and flatbed trailer combination unit at final rest.

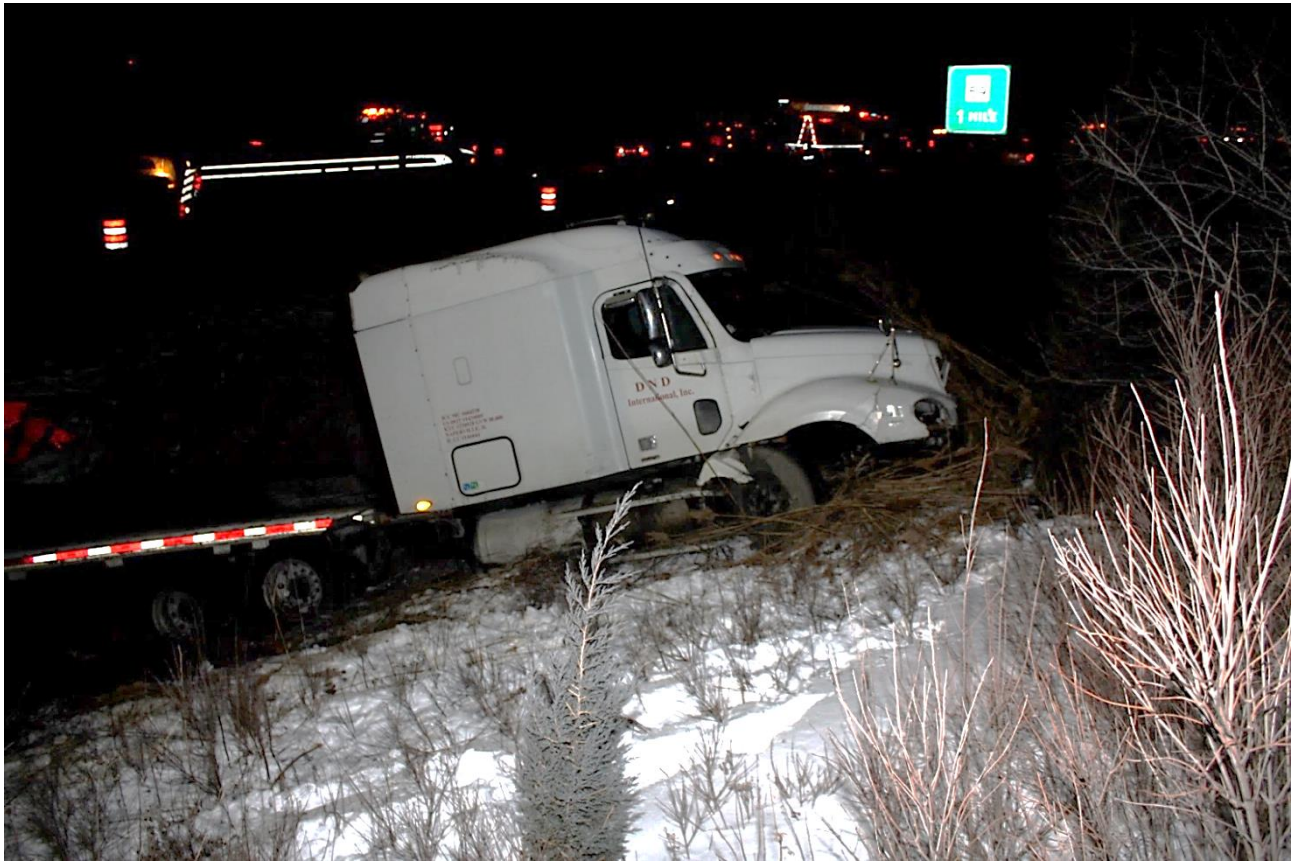
Photo 9 – Accident scene photo showing a closer view of the 2004 Freightliner tractor at final rest.

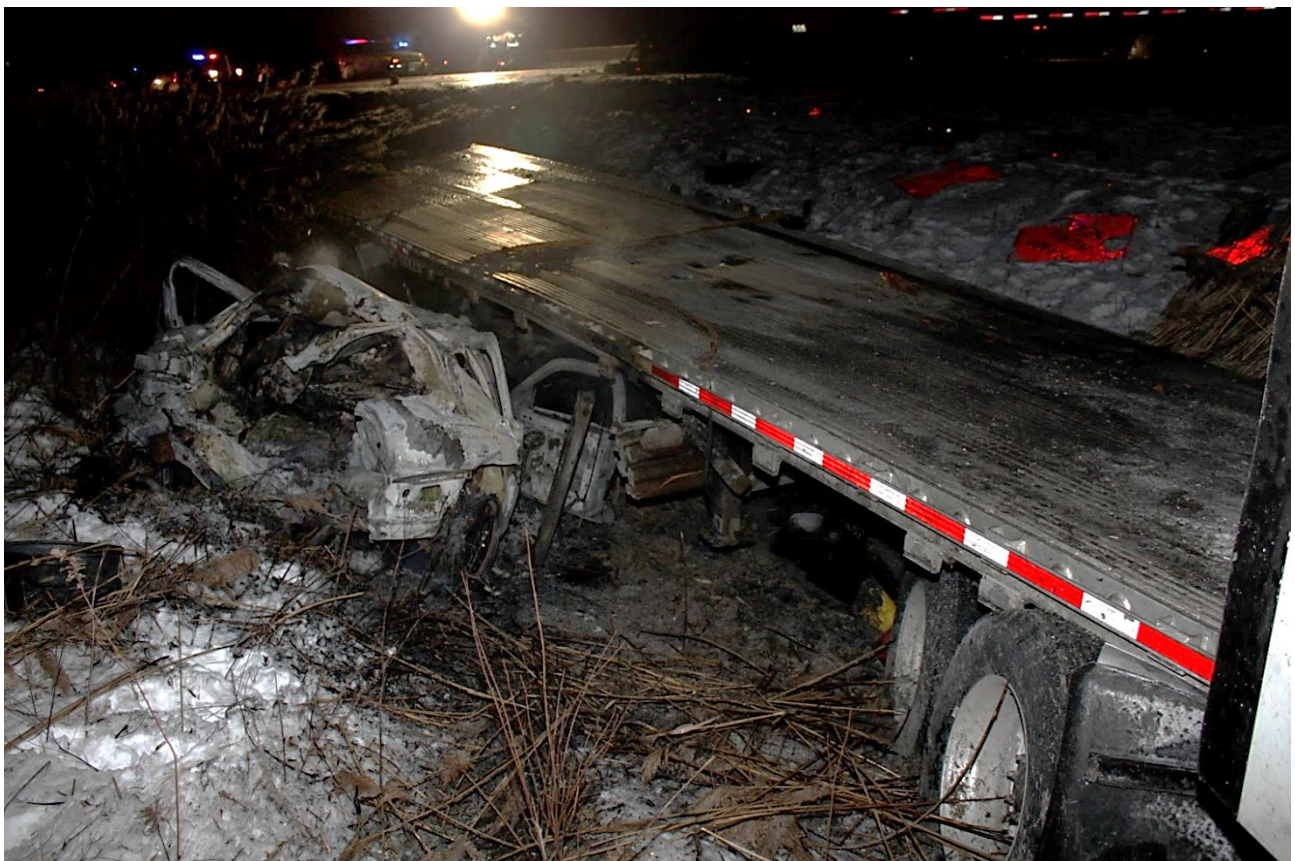
Photo 10 – Accident scene photo showing the location where the Illinois State Police patrol car came to rest, against the right side of the flatbed trailer of the 2004 Freightliner tractor, in the ditch to the south of the interstate.

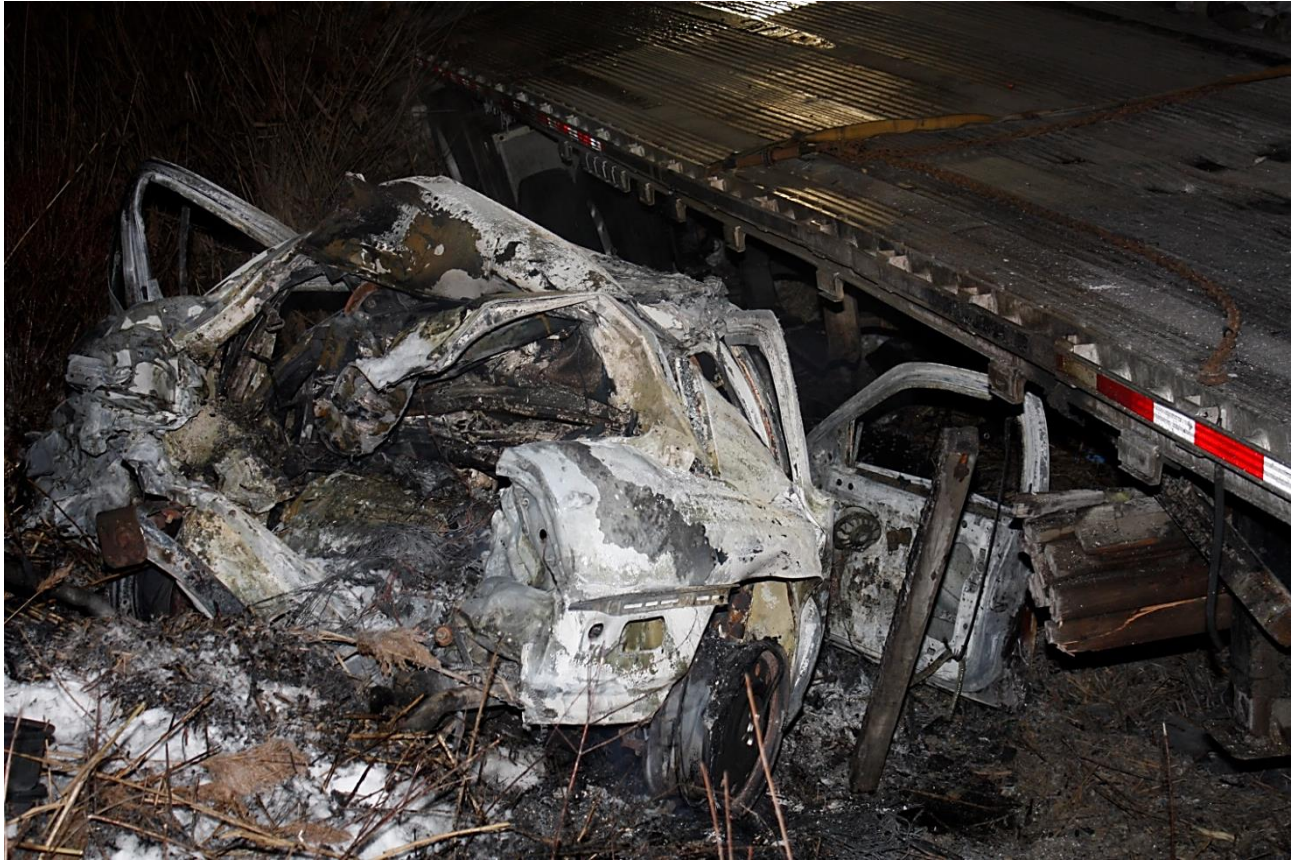
Photo 11 – Accident scene photo showing a rear view of the damage and fire consumption to the Illinois State Police patrol car.

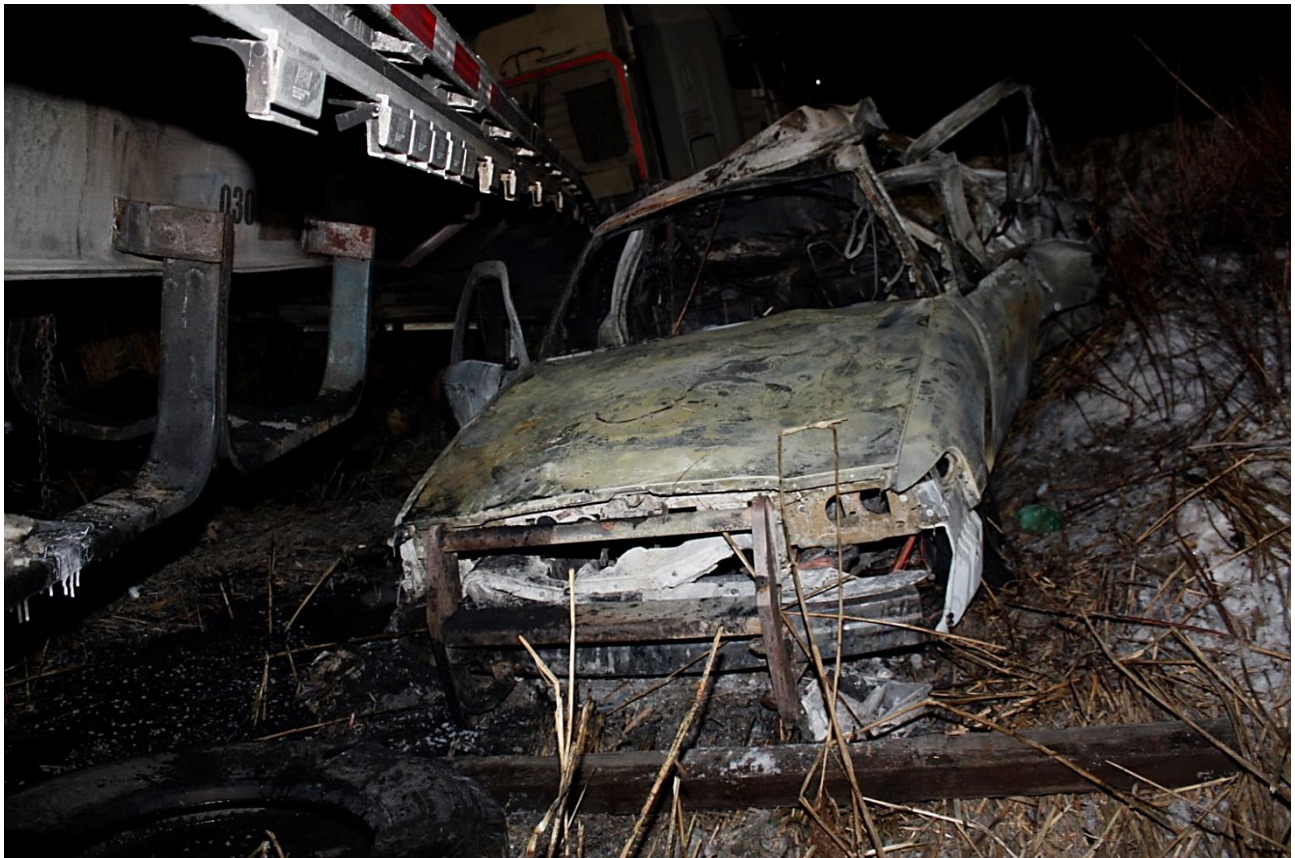
Photo 12 – Accident scene photo showing a front view of the damage and fire consumption to the Illinois State Police patrol car.
