ANC06FA018

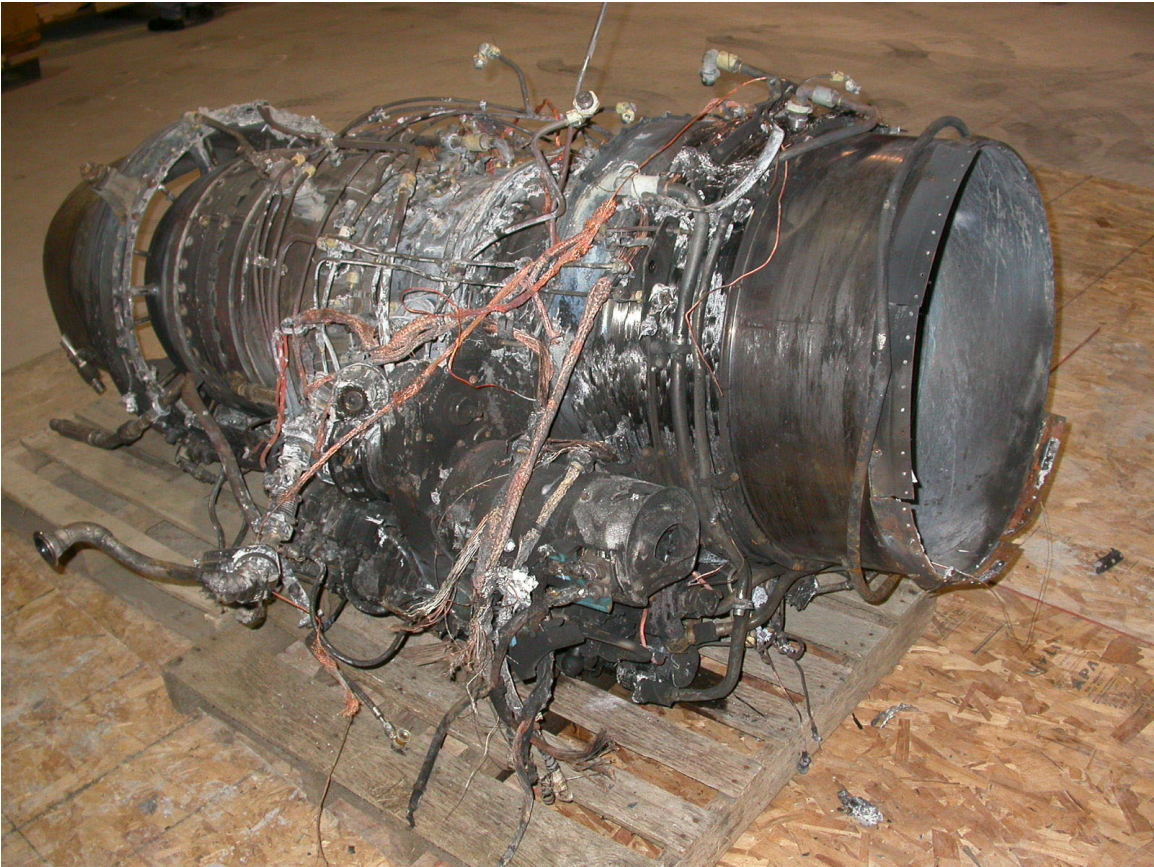
Photo 12

View of fire damaged right side of engine after removal from the airframe
