ANC06FA018

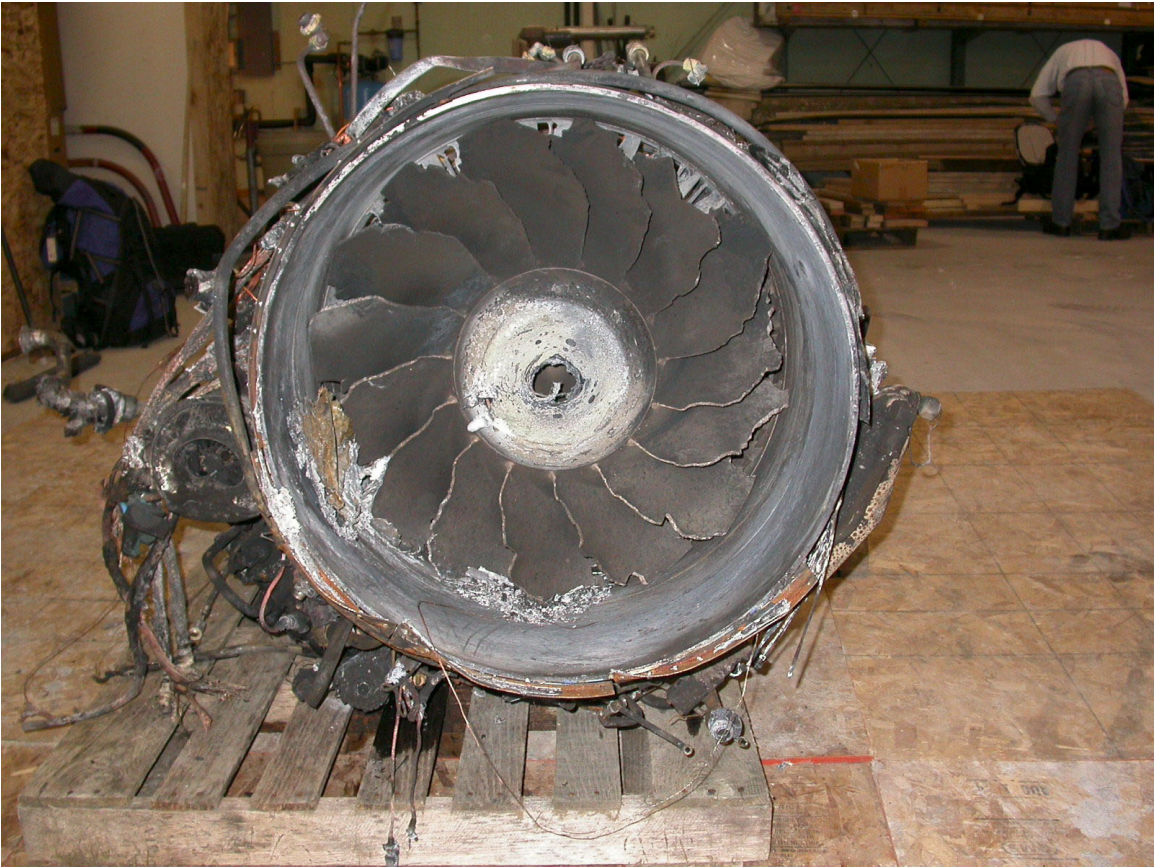
Photo 13

View of inlet fan. Note damage to leading edges.
