ANC06FA018

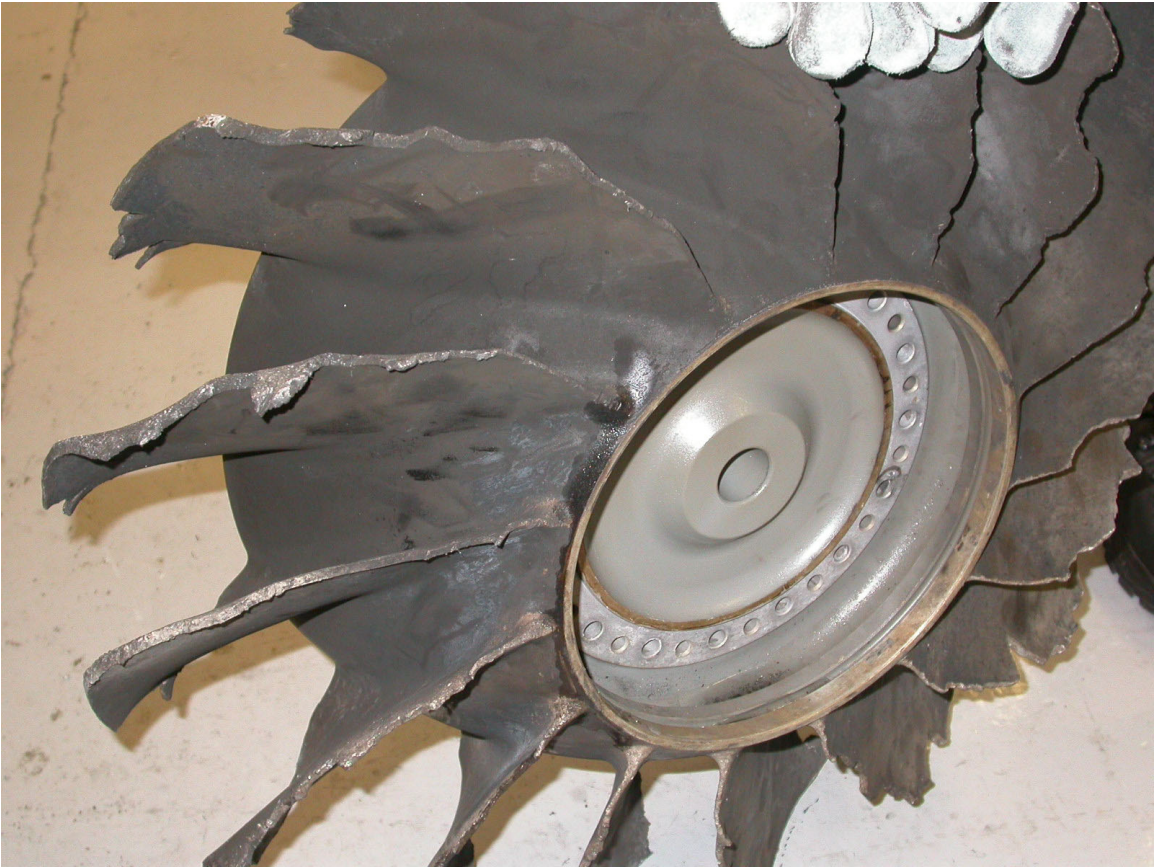
Photo 14

Closer view of damaged inlet fan.
