ANC06FA018

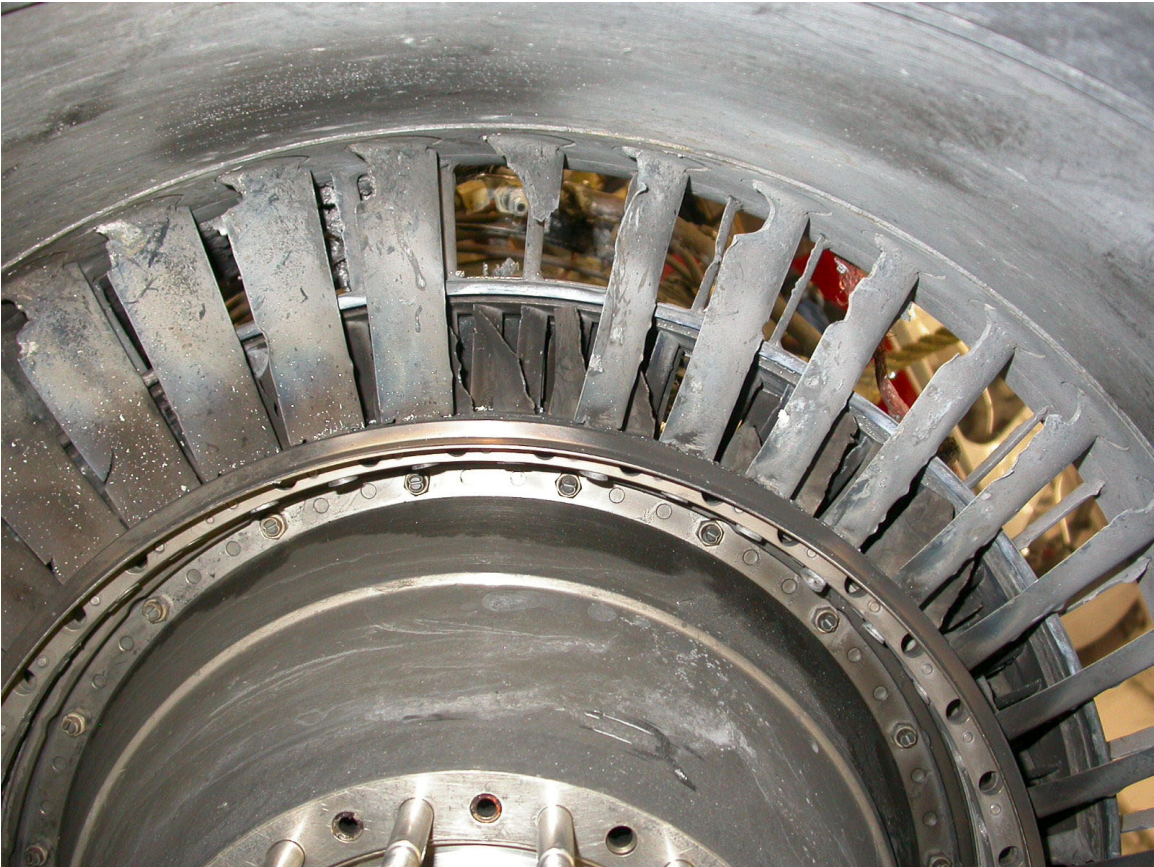
Photo 15

View of fractured and damaged stator vanes.
