NATIONAL TRANSPORTATION SAFETY BOARD

Image Study

Specialist's Study Report By Christopher Babcock

Location: Reno, Nevada
Date: 09/16/2011
Aircraft: P-51D
Registration: N79111
Operator: Aero-Trans Corporation
NTSB Number: WPR11MA454

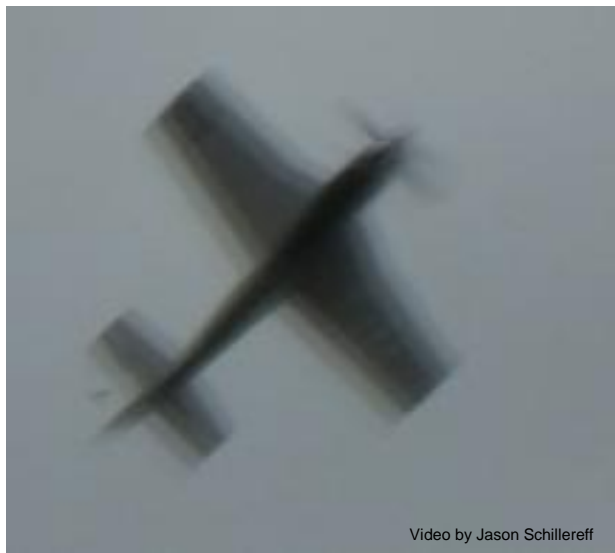
Figure 1. Trim tab departs in video.

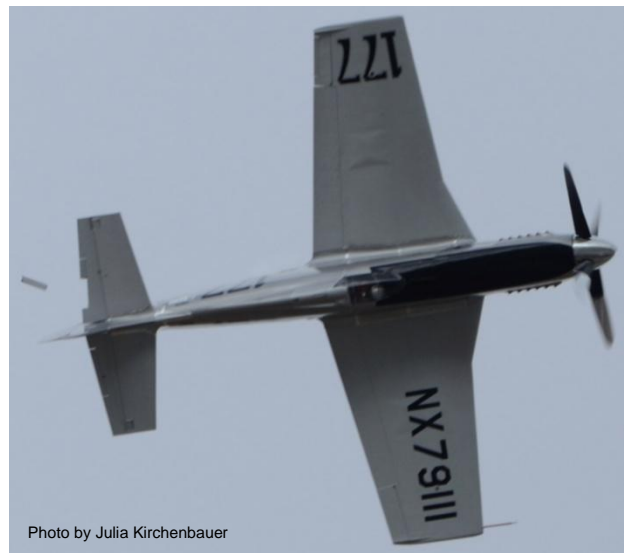
Figure 2. Trim tab departs in photograph.

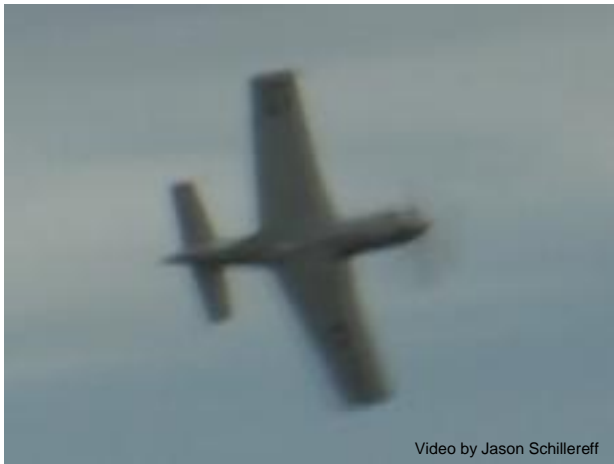
According to the video the tail wheel extended at 16:24:30.20 PDT ± 0.10 second due to some blurred frames (Figure 3). Figure 4 shows the wheel just beginning to extend at 17:23:25.94 according to the Exif data from the Apfelbaum camera. Exif times attached to images from the Apfelbaum camera times should be decremented by 58:55.74 (mm:ss) to adjust to local PDT time.

Figure 3. Video frame showing tail wheel extending.

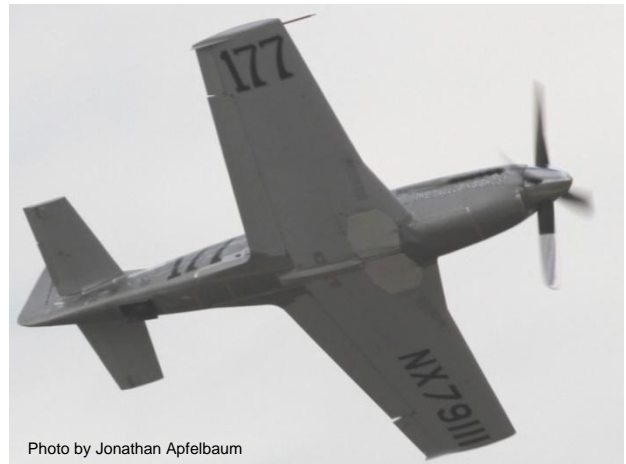
Figure 4. Photo showing tail wheel extending.

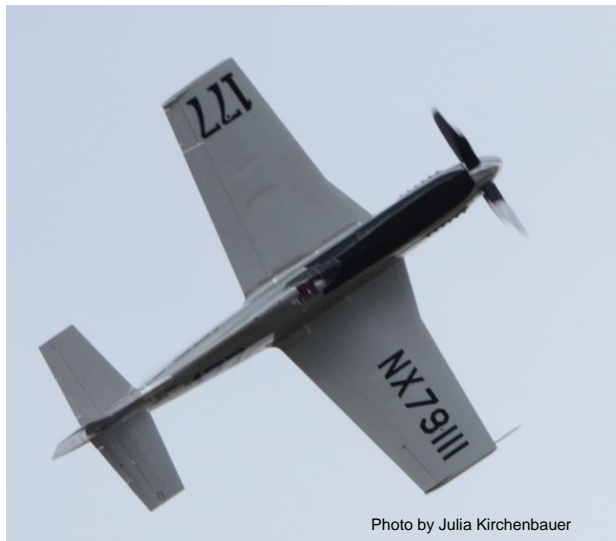
Figure 5. Just prior to tab separation at 16:24:32.3 PDT.

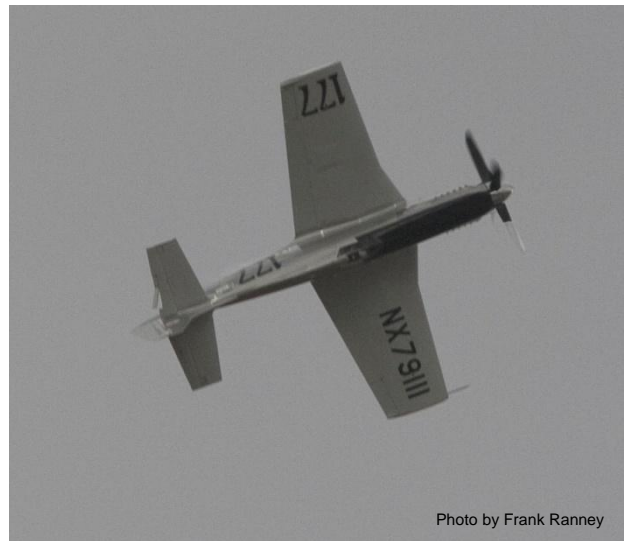
Figure 6. Trim tab begins to separate.

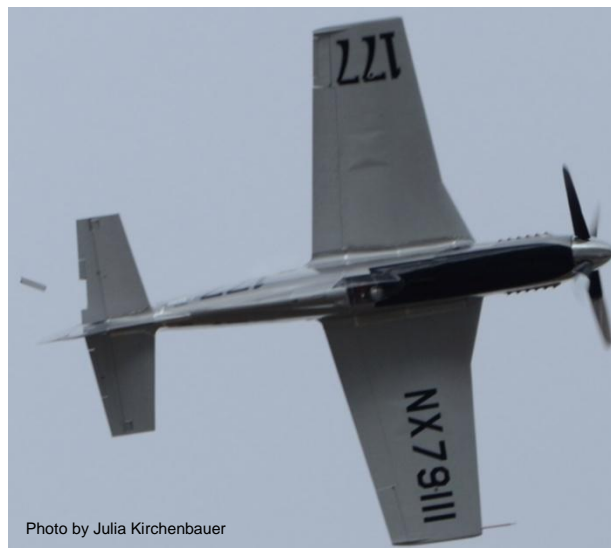
Figure 9. Trim tab separates at 16:24:33.5 PDT

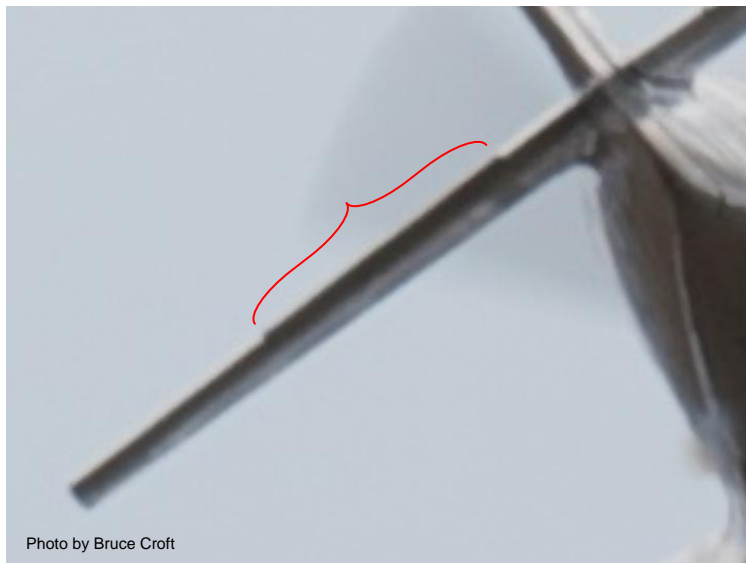
Figure 10 shows a cropped image of the rear of the aircraft in the “Valley of Speed” portion of the race course between pylons 6 and 7 during the aircraft’s second flight on September 13, 2011. It is zoomed in on the left tab deflected trailing edge up. Although it is not possible to determine on which lap this image was taken, telemetry data recorded indicate

Figure 10. Cropped photo showing trim tab deflected upward.

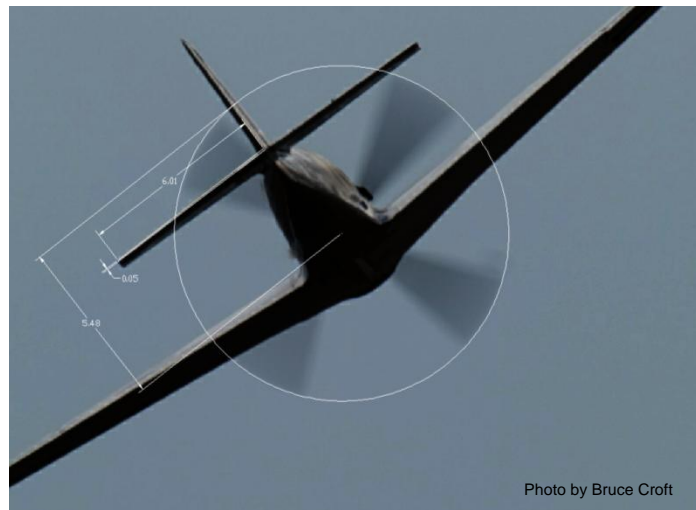
Figure 12. Dimensioned photograph of trim tab deflection (dimensions in feet).

Using the equation in Figure 6 and the known prop diameter of 11 feet 2 inches the pitch angle relative to the camera is 10.0° nose down. After adjusting for the horizontal stabilizer incidence angle, the plane of the trim tab displacement was at a 9° incline to the image plane. Also using the general form of the equation from Figure 11, the trailing edge tab displacement can be found, 0.6 inches. Along with the chord of the tab, 4.32 inches, the tab deflection angle in this photograph is approximately 8° trailing edge up.

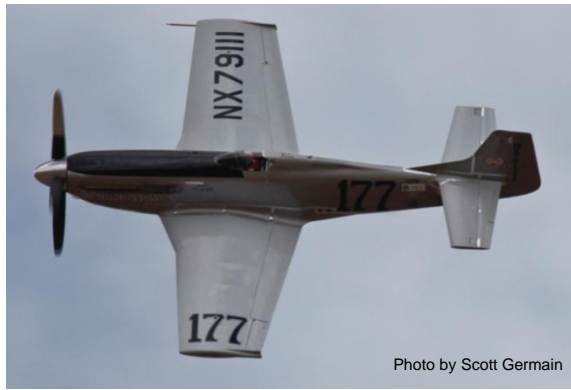
A second measurement was taken by directly measuring the trim tab deflection in Figure 13 and correcting for roll angle of the aircraft relative to the camera. The image in Figures 13-14 was captured as the aircraft rounded pylon 2 on the accident flight. It was scaled using the known length of the aircraft. The perceived length in the Figure 13 does not need correction as the yaw angle of the aircraft with respect to the camera is small.

Figure 13. Cropped photo of aircraft.

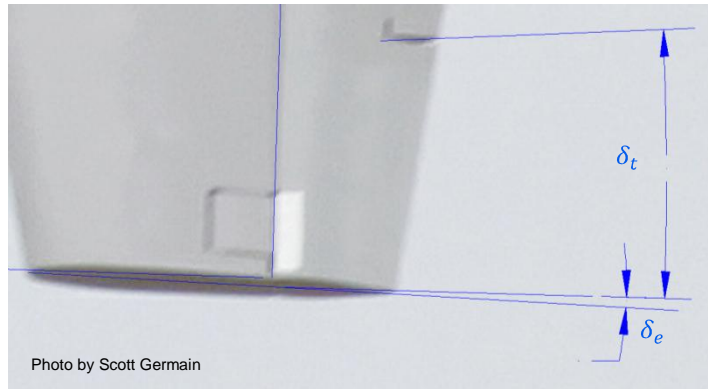
The roll angle with respect to the camera was determined using the known and perceived length of the horizontal stabilizer and rudder hinge using an equation similar to Figure 11 and was found to be 48° left wing down. The perceived elevator deflection, δ_e , and trim tab deflection, δ_t , in Figure 14 were measured and corrected for the roll angle and found to be 2° and 6° trailing edge up respectively.

Both tab and elevator measurement is very sensitive to where the chord line of the horizontal stabilizer, trim tab, and elevator are placed which limits the precision to $\pm 2^\circ$ on trim tab angle and $\pm 1^\circ$ on the elevator angle.

Figure 14. Perceived tab and elevator deflection.

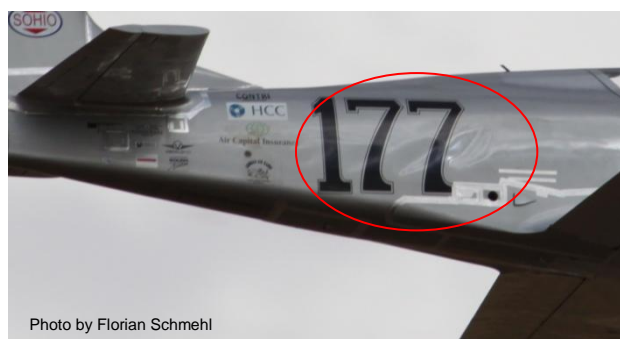
Photographs from various times of the accident flight were examined to determine the extent of fuselage deformation was present. Figure 17 shows a cropped image of the right side of the aircraft in the Valley of Speed during the second lap. "Oil canning," or structural deformation in thin walled structure, can be seen on the right side of the empennage. This deformation is not present on the ground. Figure 18 shows similar deformation on the left side of the aircraft as it rounds pylon 2 on the final lap.

Figure 17. Oil canning on right side during accident flight.

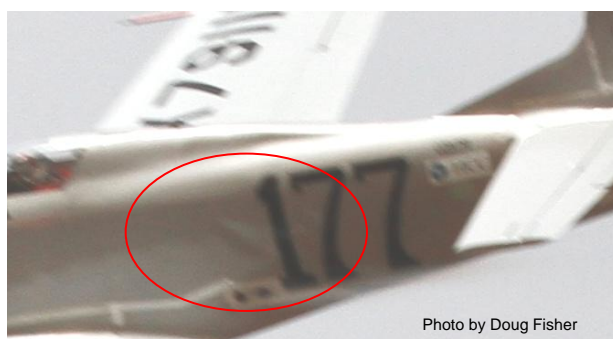
Figure 18. Oil canning on left side during accident flight.

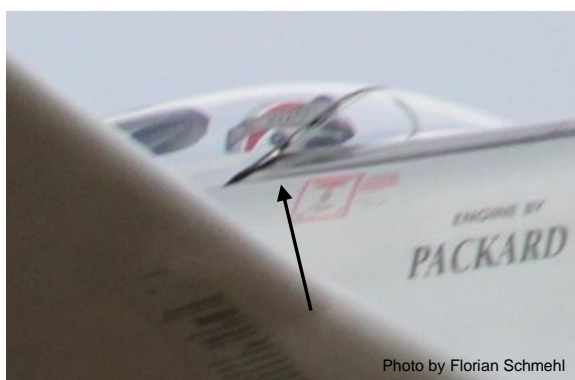
Additionally, Figure 19 shows deformation along the canopy rail and canopy on the first lap of the accident flight in the Valley of Speed. The canopy is not flush with the fuselage as it is in Figure 20 when the aircraft is on the ground.

Figure 19. Canopy out of alignment with fuselage in flight.

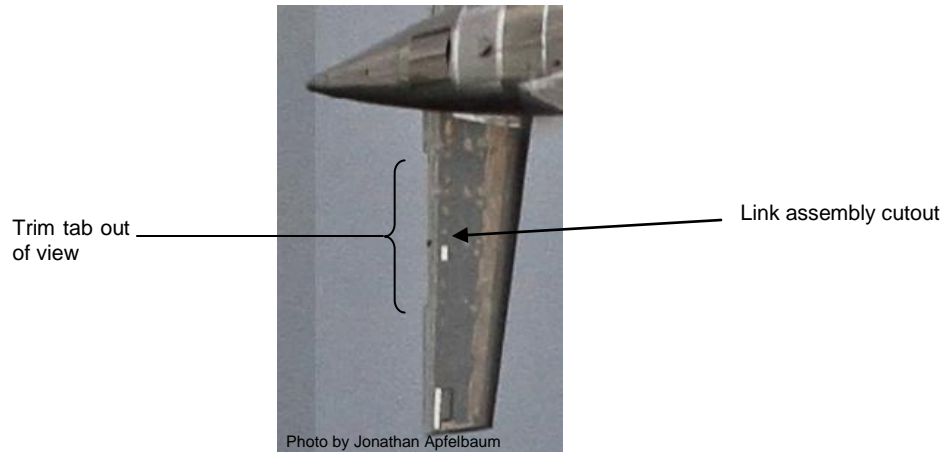
Figure 21. Trim tab not visible.

No part of the trim tab is visible to the camera. The trim tab must be deflected upward at some minimum angle to be out of camera view, obscured by the elevator. According to the video study, the aircraft is banked nearly 88° left wing down at this time, presenting a near flat lateral view of the aircraft to the camera. This allows the wing span of the aircraft, 346 inches, to be used as a true distance against which to scale the photograph. The angle between the longitudinal axis of the aircraft and the image plane, Φ , can be calculated by comparing the known length of a portion of the fuselage, in this case the distance between the spinner and the tail wheel door (343 inches), to its scaled length as measured in the photo. The deflection of the tab with respect to the elevator necessary to obscure the tab from view was calculated according to the Figure 22.

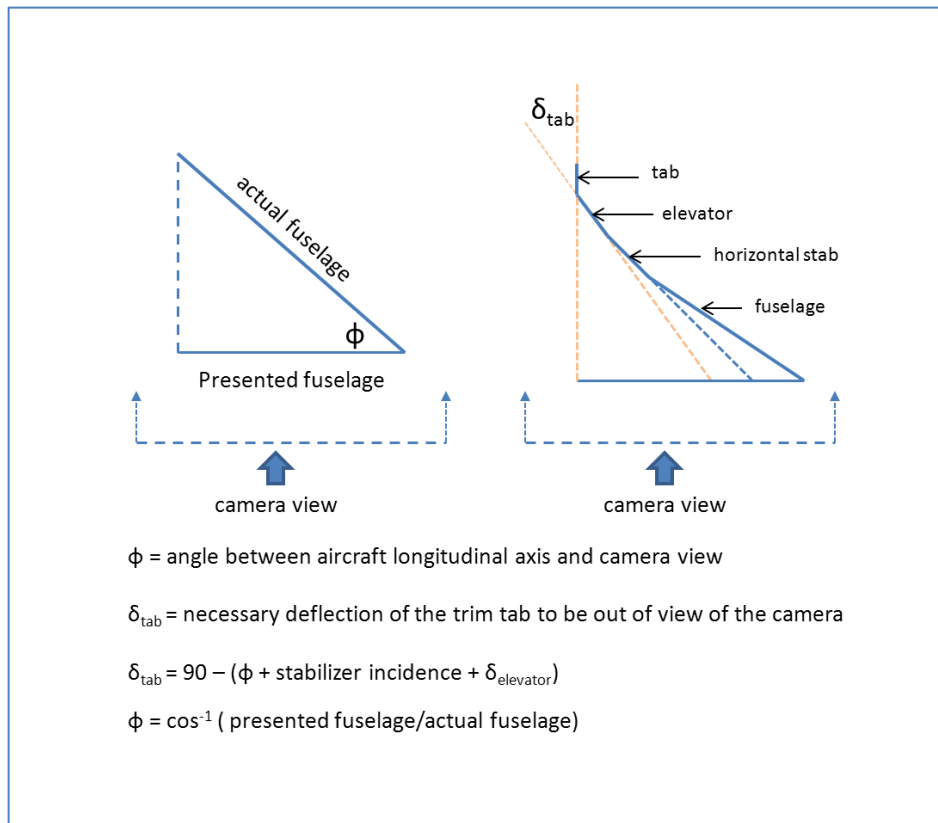
Figure 22. Schematic of trim tab obscuration.

The angle, Φ , between the fuselage and image plane was 65° . With the horizontal stabilizer incidence angle of approximately 1° and zero elevator deflection, the tab must be deflected a minimum or 25° trailing edge up to be out of view of the camera. Table 1 shows the minimum tab deflection for a range of possible elevator angles.

The trim tab system was designed to have at most 13° of trailing edge up travel.⁵ A tab deflection greater than 13° indicates that the control rod is broken. The 25° calculation allows up to 12° of uncertainty to the angle of the aircraft, the elevator, and stabilizer. This puts the failure of the left tab link assembly as late as 16:24:29.46 PDT in the accident sequence.

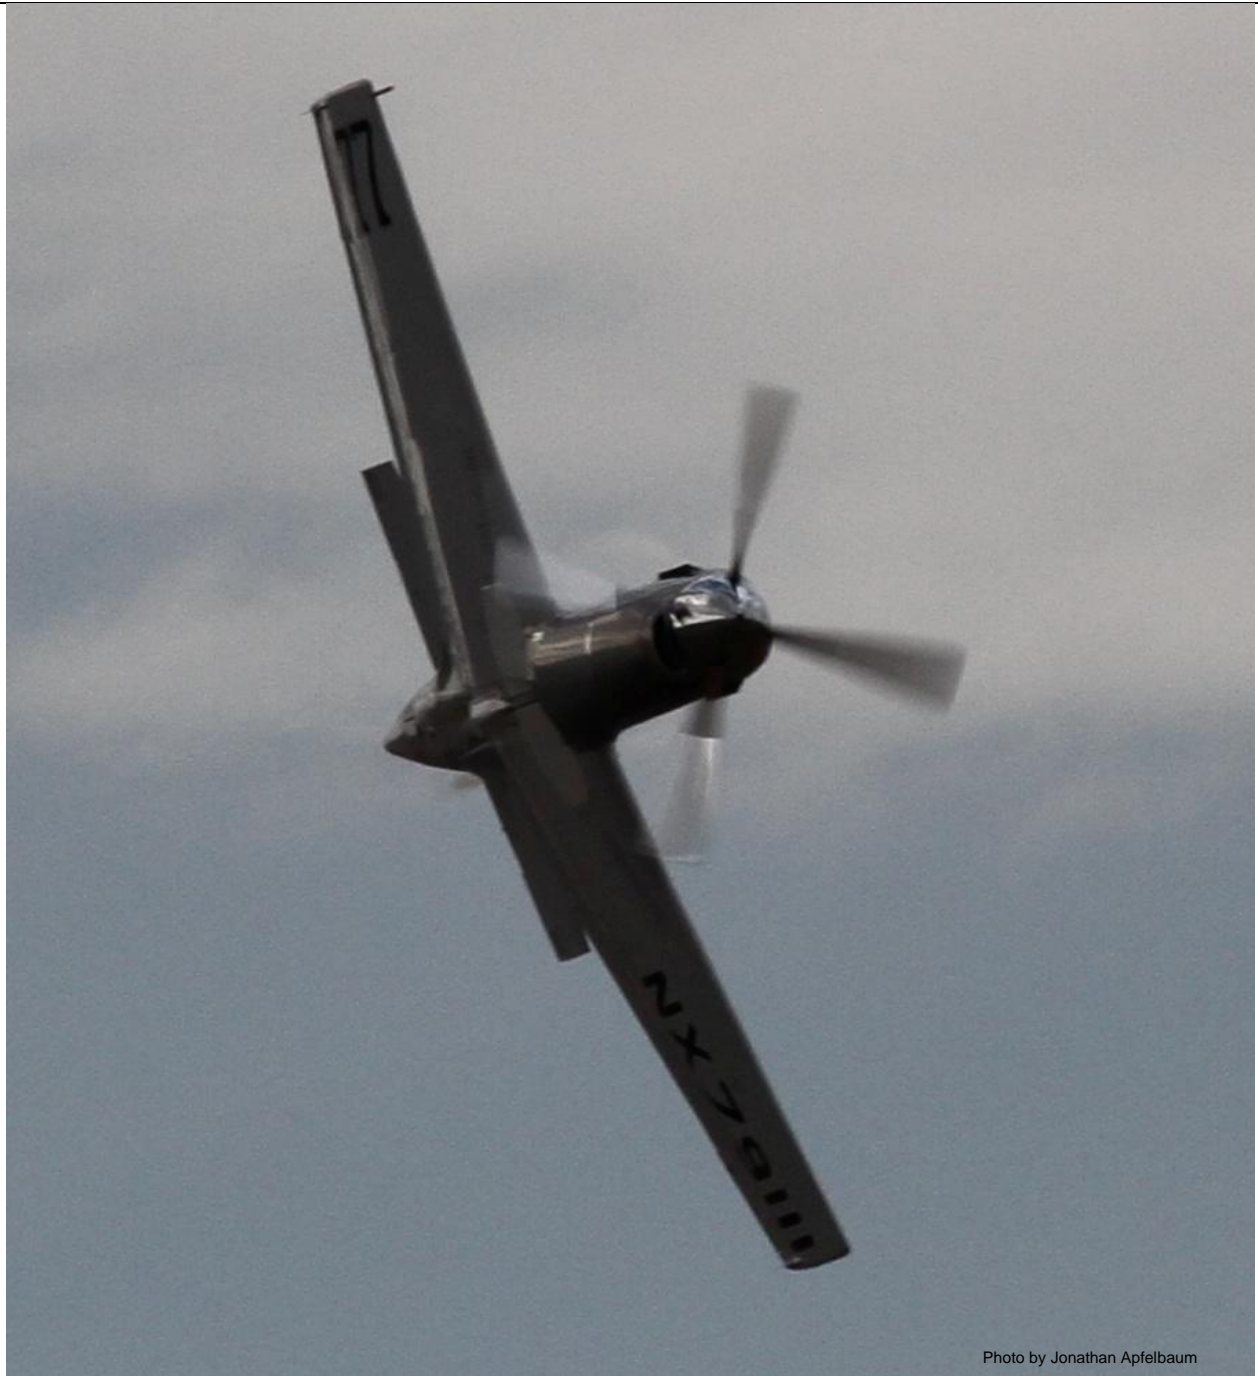
Figure 23 shows the aircraft rounding pylon 8. The positions of the elevator trim tabs are consistent with the observed position during previous laps. Figure 24 shows the aircraft continuing its turn just prior to the roll upset. According to the Video Study, at approximately 16:24:28.8, the aircraft experienced a roll upset to the left. The Airplane Performance Study showed that the roll moment leading to the left roll upset appeared at approximately 16:24:28.2. Figure 25, just prior to the visible roll, shows the aircraft with an increasing right wing down aileron deflection. Figure 26 shows the aircraft approximately 0.5 seconds after the roll upset began. Figure 27 shows the left trim tab trailing edge up

Figure 23. Aircraft rounding pylon 8 on final lap.

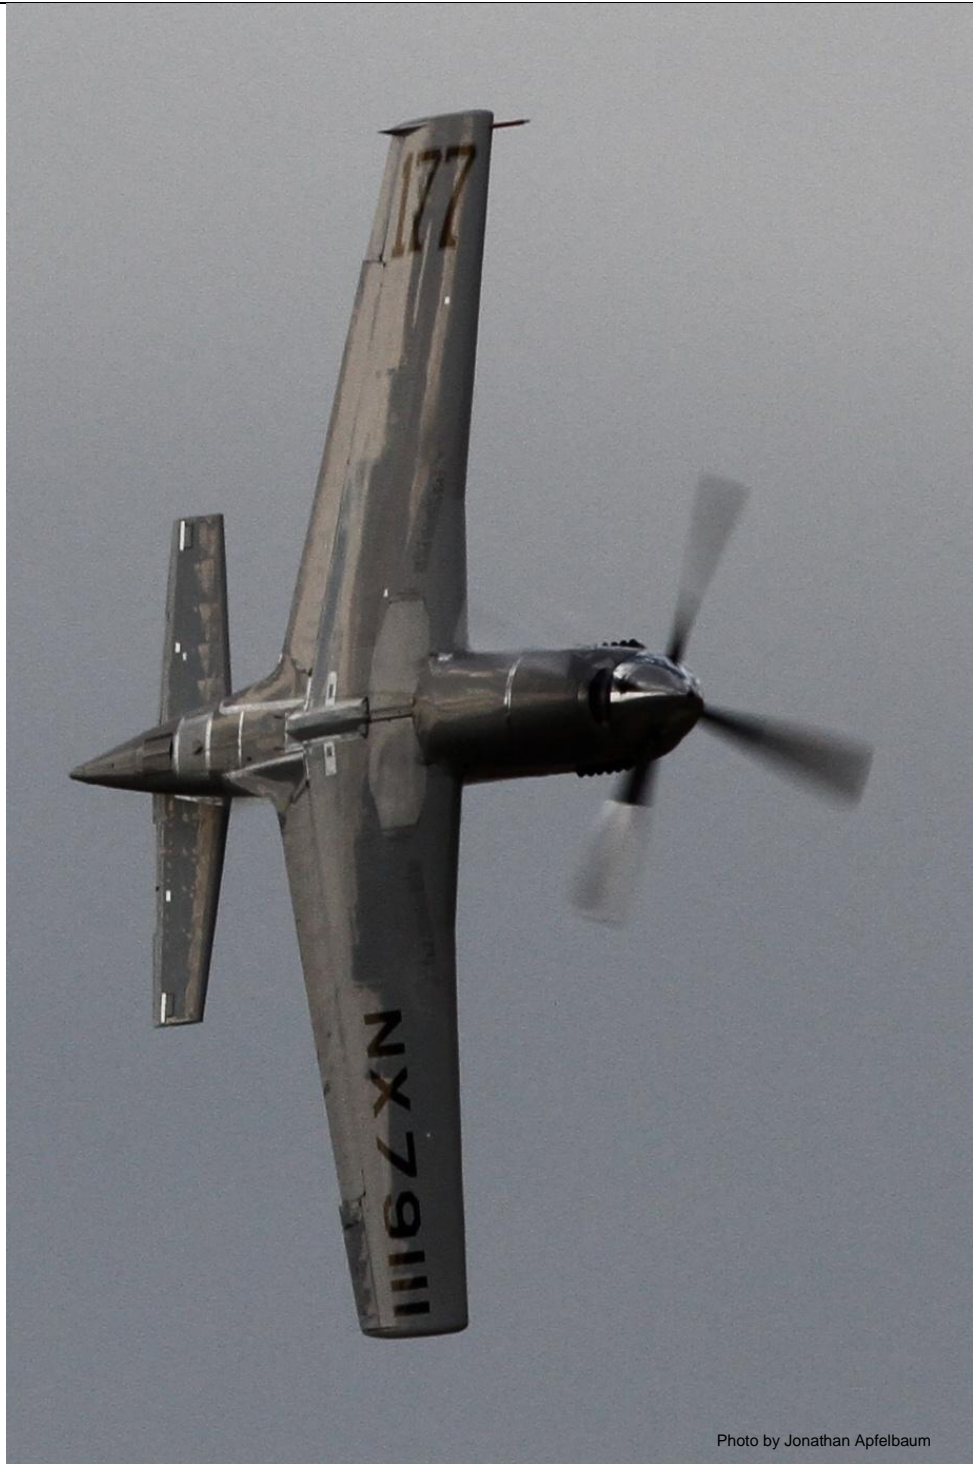
and the top of the control rod is seen extending to the edge of or beyond the structure of the airplane (see Figure 21 for zoomed version).

Figure 27. Aircraft in roll upset.

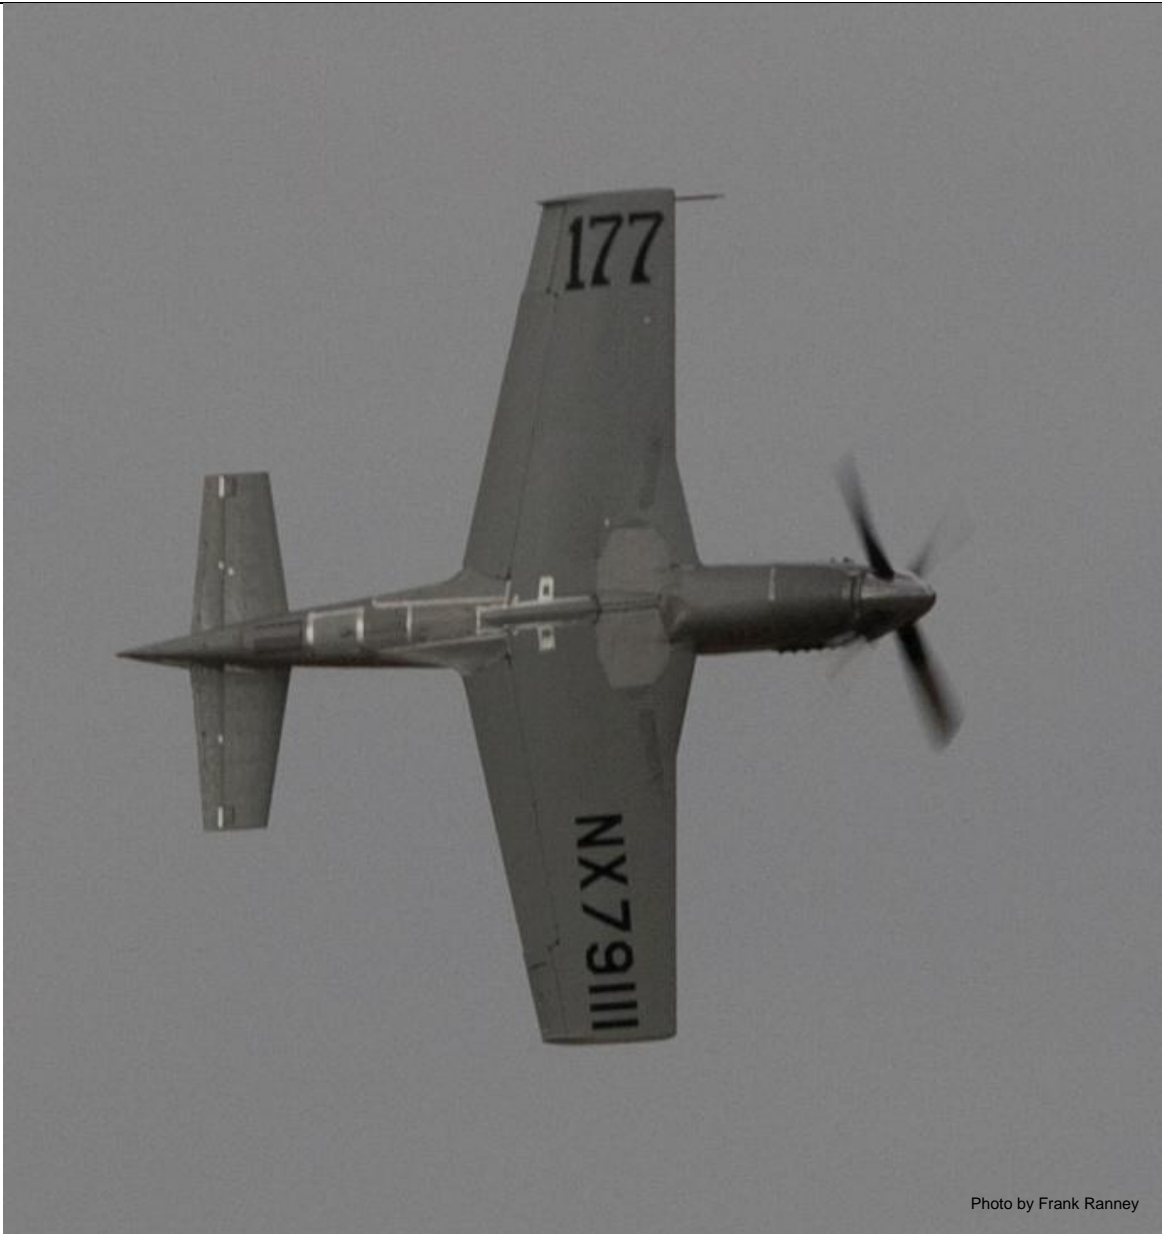
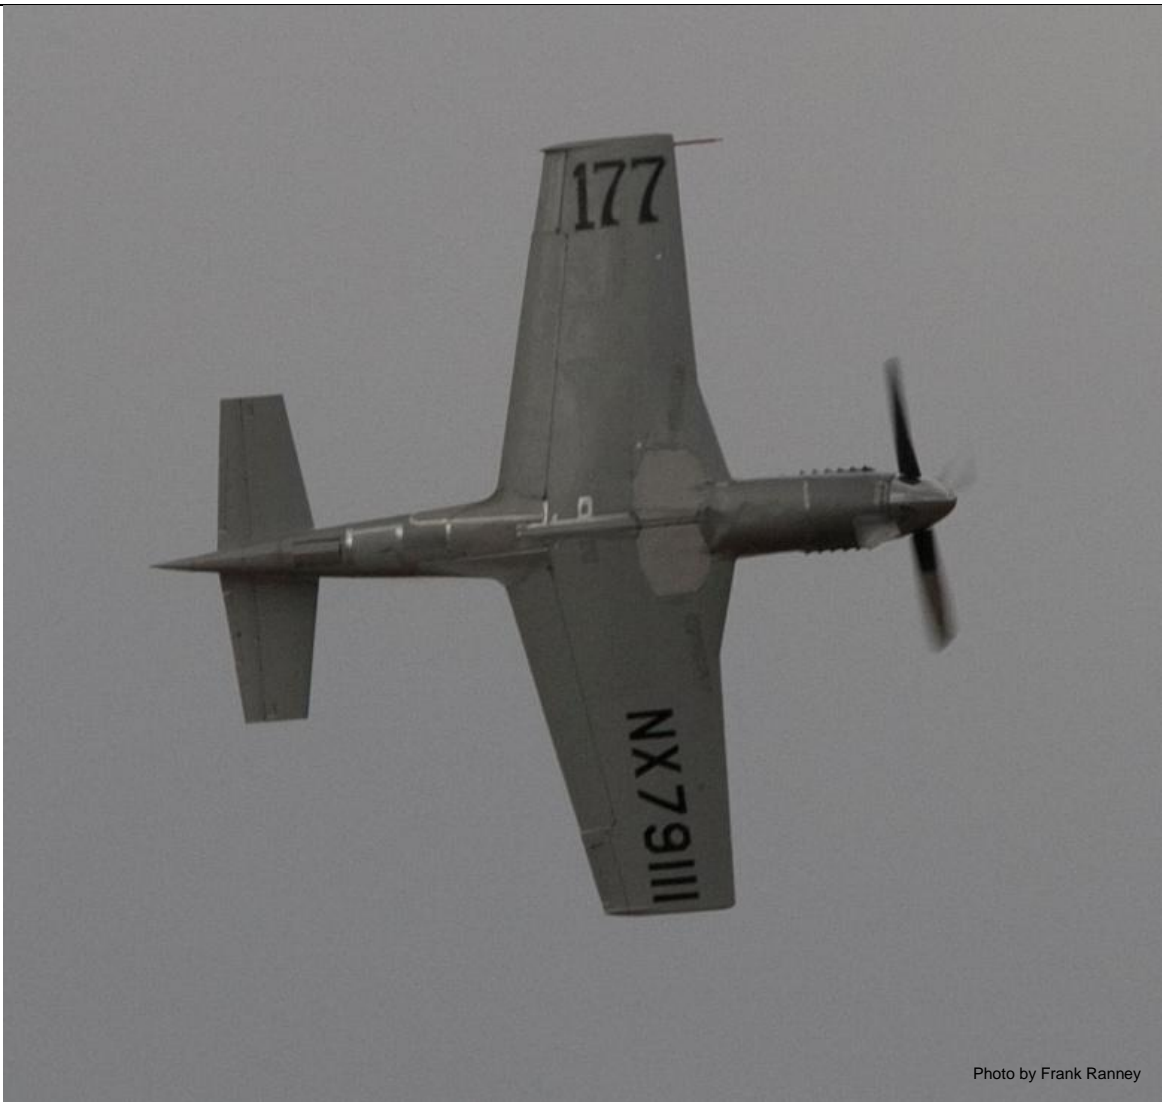
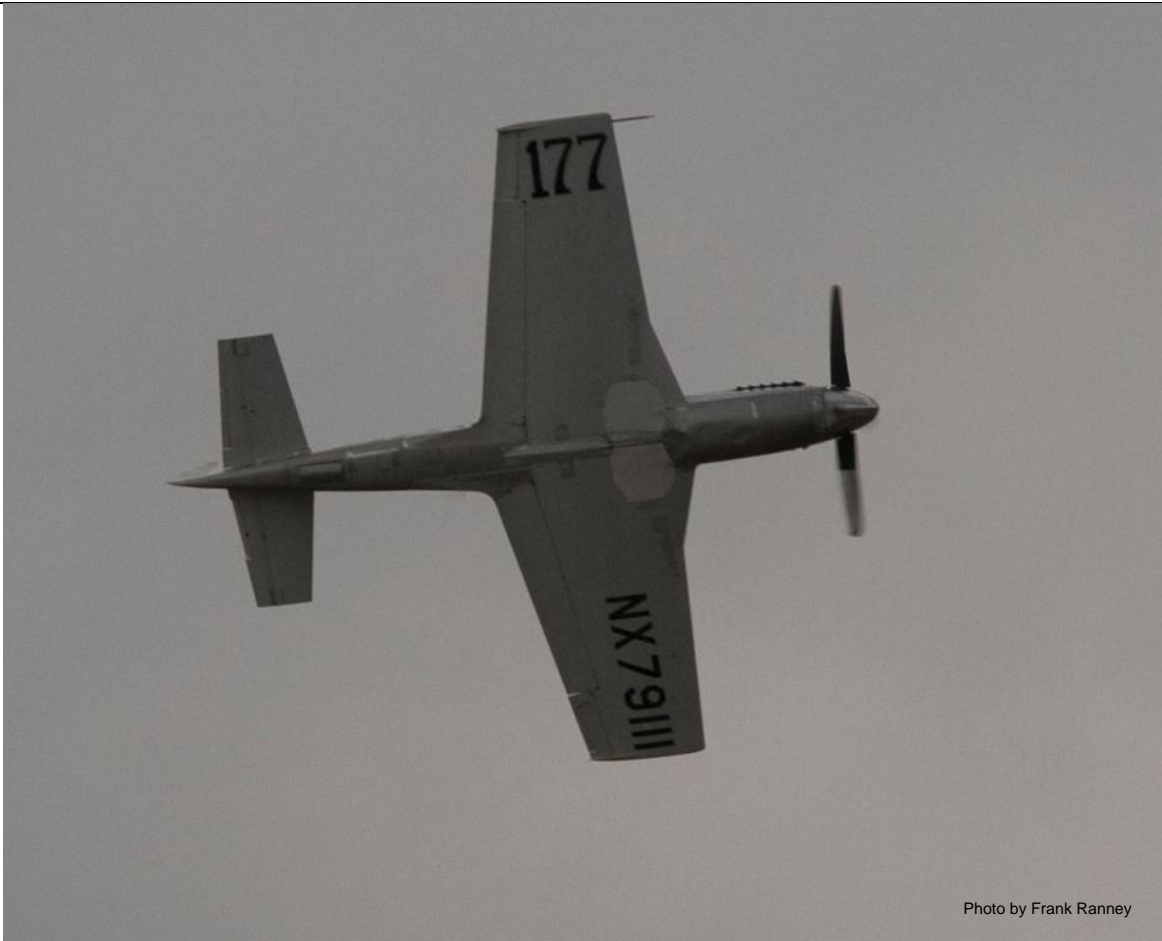
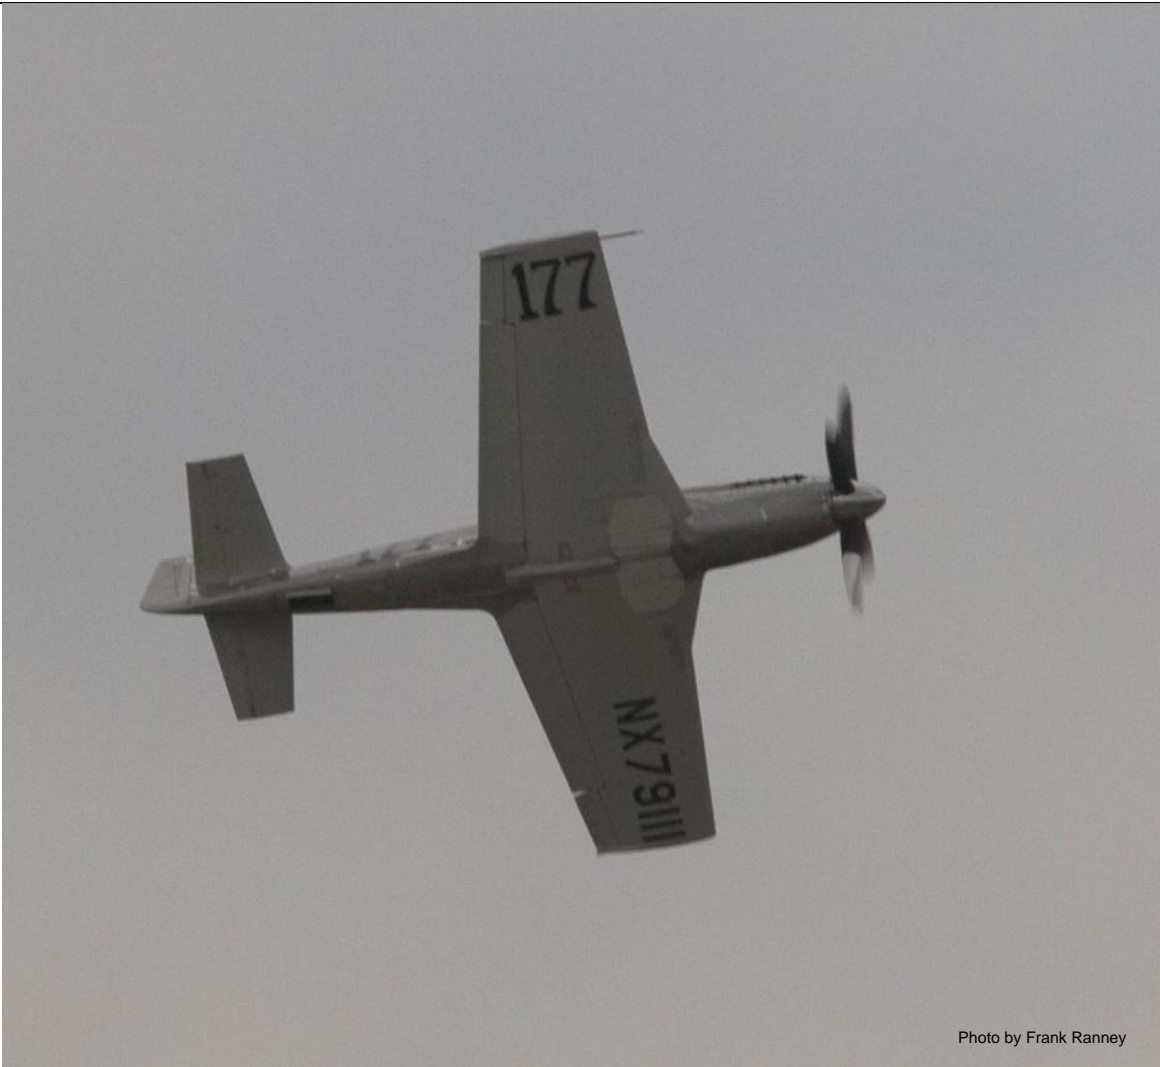
Figures 29-32, taken from a different camera, were all taken between 16:24:29.60 PDT and 16:24:30.20 PDT, although the exact time cannot be determined as the Exif timestamp precision was only to the nearest second. The camera used to capture these images, the Canon EOS 1D Mark II, is capable of shooting in two continuous burst modes: a lower speed burst mode with a maximum capture rate of 3 images per second, and a higher speed mode with a maximum capture rate of 8.5 images per second. Four images were captured in 0.60 seconds between 16:24:29.60 and 16:24:30.20. At the maximum image capture rate these images can be no closer than 0.12 seconds apart from one image to the next. Time between image capture can be affected by the selected image compression, speed of image storage medium, and state of the camera’s internal memory buffer, so the longer the continuous burst mode is used, the further apart subsequent images will be captured. Figures 29-31 show the aircraft as it rolled to the right after the initial upset. Figure 31 and Figure 32 show the left trim tab deflected trailing edge up and faired with the elevator, respectively.

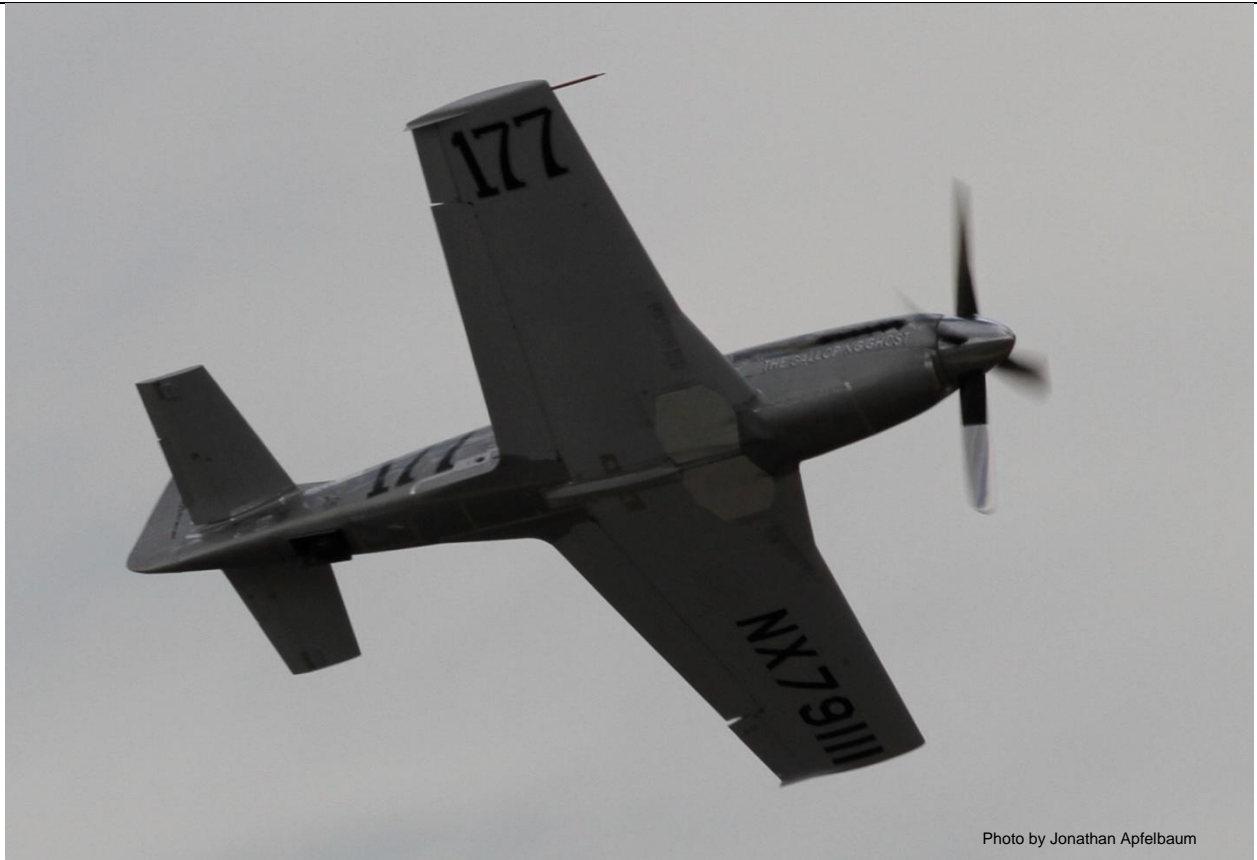
In Figure 33, the aircraft has rolled to the right and beginning to pitch up. The right elevator trim tab is now trailing edge down and the left tab appears to be faired with the elevator. The tailwheel begins to extend from its housing. In Figure 34, captured 0.14 seconds after Figure 33, the right elevator trim tab is now trailing edge up and the left tab is trailing edge down. Nearly full right wing down aileron is also observed. Figure 35 shows the pilot leaning forward as the aircraft was near the apex of the climb. As the aircraft reached the apex of the climb the left elevator trim tab is visibly detached from its inboard hinge at 16:24:33 PDT (Figure 36). Approximately 1.5 seconds later it separated from the airplane (Figure 37). At 16:24:38 PDT the aircraft impacted the spectator viewing area.

Figure 33. Aircraft at point of maximum vertical load factor.

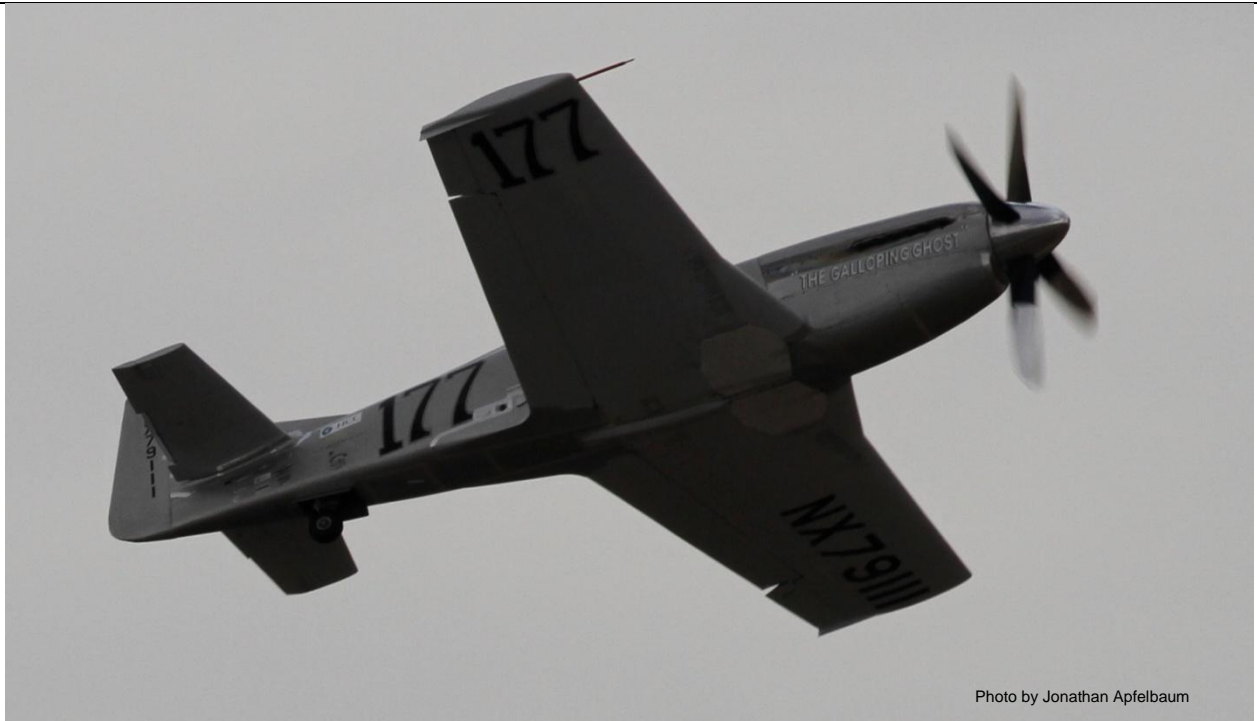
Figure 34. Aircraft pitching up with near full right wing down aileron deflection.

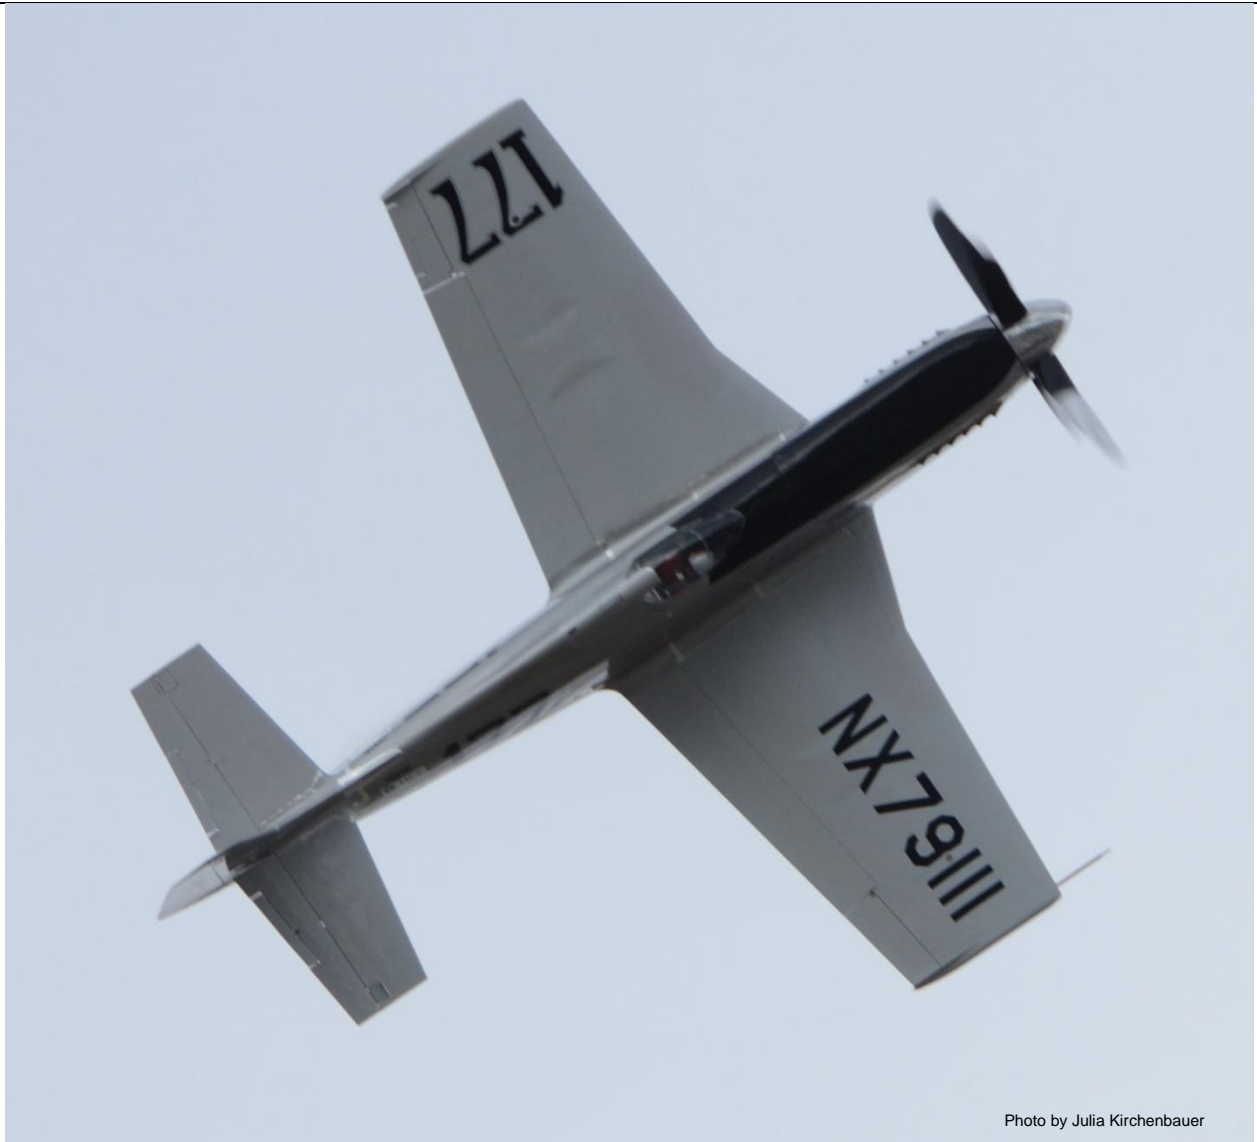
Figure 35. Aircraft near apex of helical maneuver, pilot slumped forward and to the right.

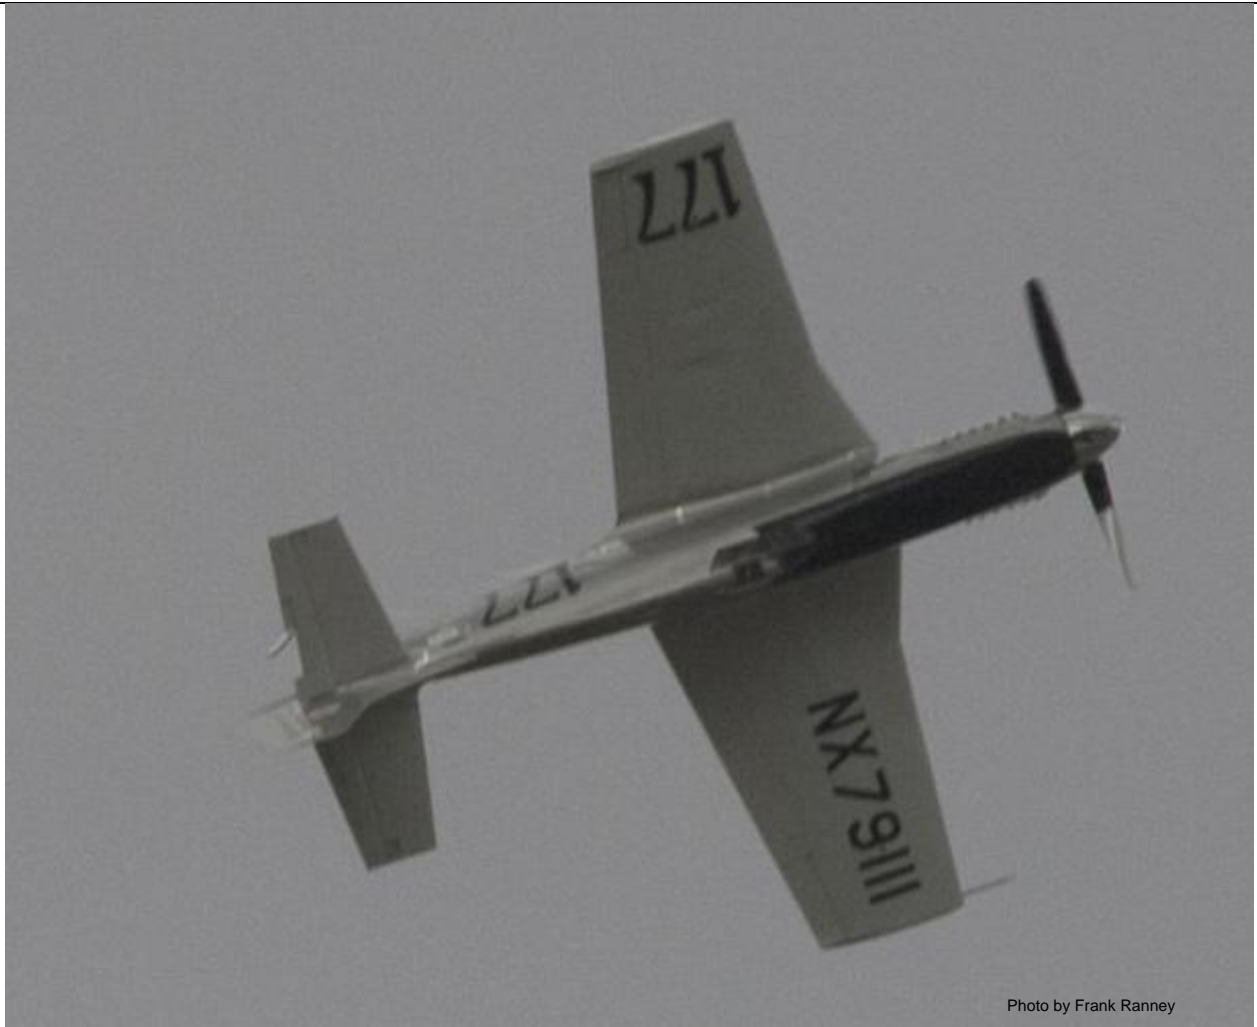
Figure 36. Left elevator Trim tab detaches at inboard attach point.

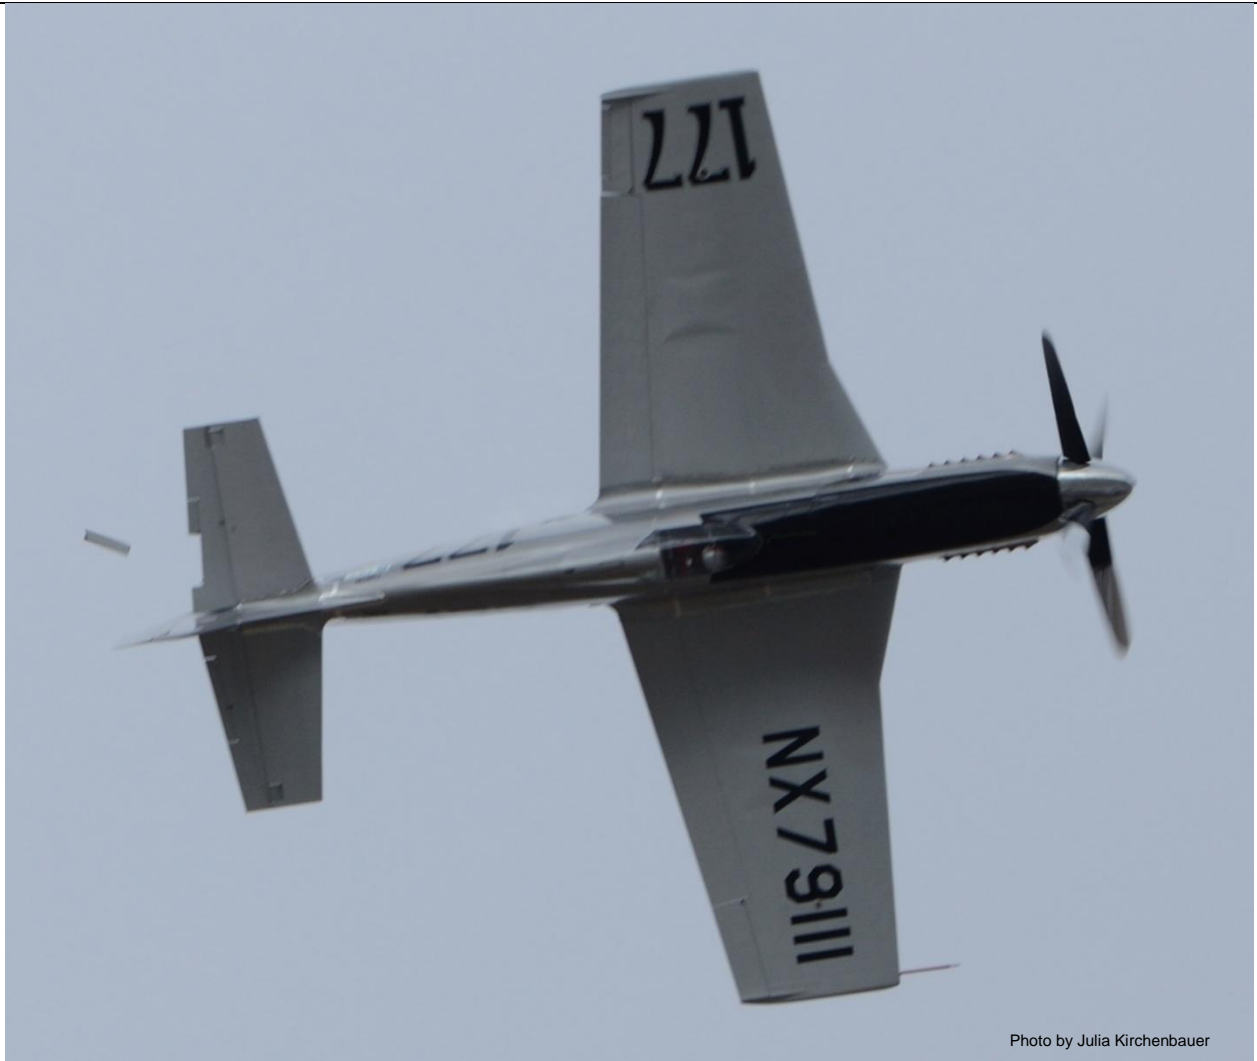
Figure 37. Trim tab separates from aircraft 5.3 seconds after left roll upset.
