NATIONAL TRANSPORTATION SAFETY BOARD

IMPACT STUDY AND ALTITUDE ALERTER OPERATION

ANC10MA068

Location: Aleknagik, Alaska
Date: August 9, 2010
Time: 1442 Alaska Daylight Time (ADT)
Aircraft: de Havilland Canada DHC-3T, N455A

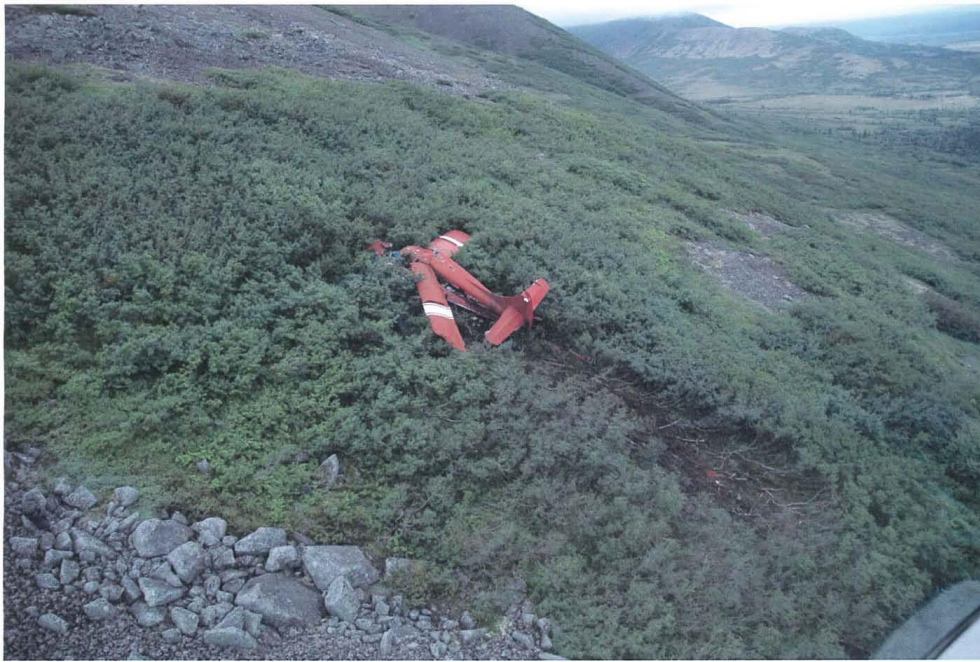
Photograph 1 depicts the overall crash scene.

Photo 1 - Overall crash scene

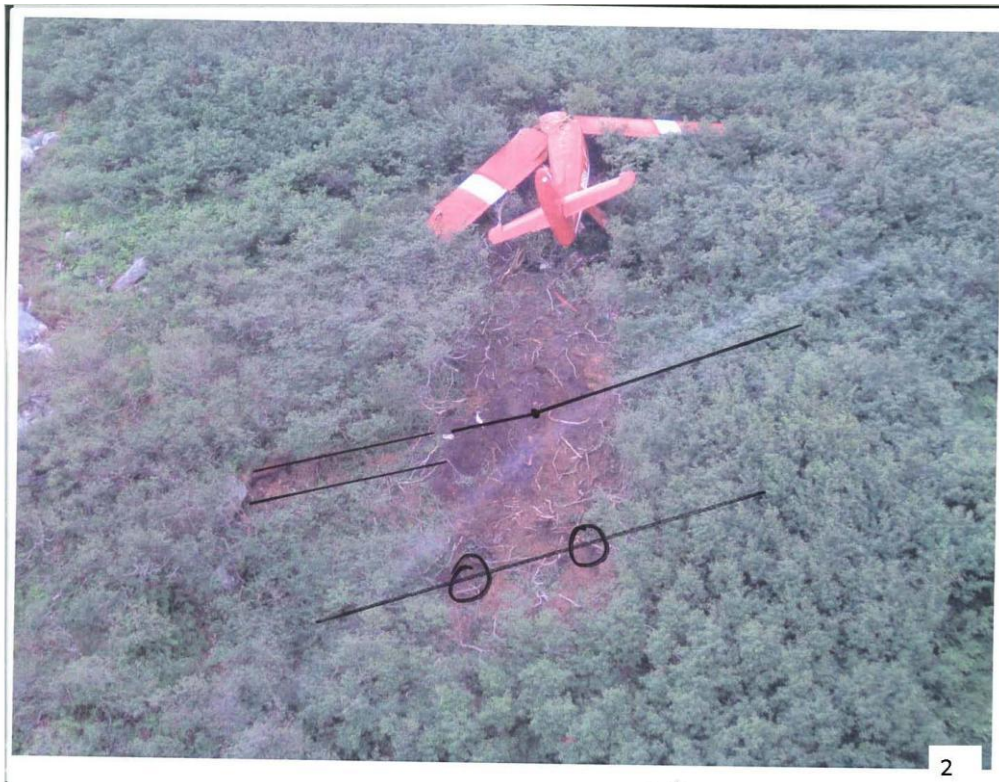
Photograph 2 depicts the relative roll angle of the float impacts and of the wing impacts. The Airworthiness Group chairman determined that the impact angle of the floats was about 30 degrees, left wing down (LWD). The ground scar left by the left wing depicted a 21 degree angle. That equates directly to a 24 degree roll angle LWD (the dihedral is 3 degrees). It is possible that the difference between the impact angles of the floats and wing is a result of changing angles during crash sequence. However the elapsed time of the impact sequence is relatively short, about 0.17 seconds (discussed later). The left wing was folding back and that could also account for an apparent roll angle that is slightly less than the actual bank angle.

Photo 2- Roll Angle at Impact. The float and left wing ground scars are highlighted.

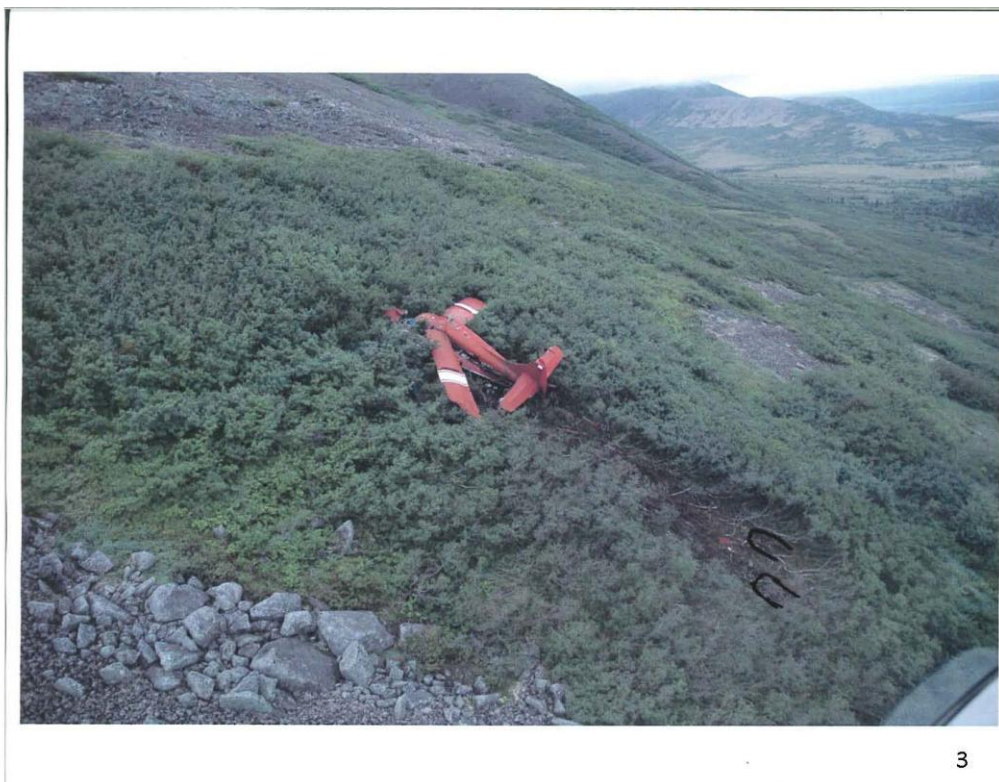
Photo 3 - The float impact marks are highlighted.

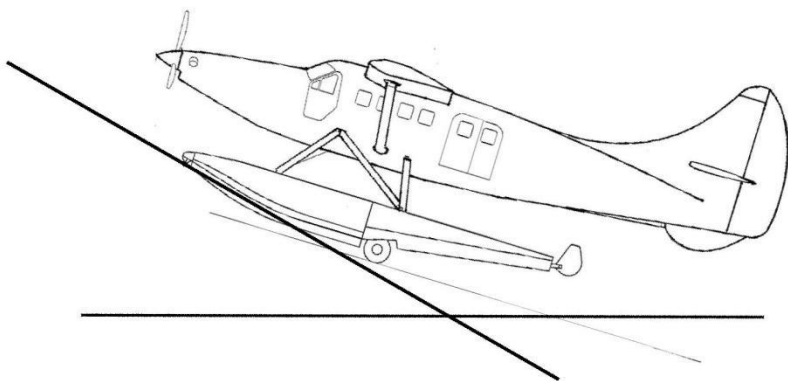
Photograph 4 depicts the airplane rotated up 17 degrees so that the 13 degree crush on the left float matches the 30-degree upslope of the terrain. Photographs 5 and 6 depict the relative height at a point defined by the leading edge of the wing and centerline of the fuselage (LE/CL). That point on the fuselage is used to define the motion of the airplane during the impact sequence. The two positions are transferred to Photograph 7 and labeled point B and point C. The center of a line between points B and C are a reasonable representation of the reference point LE/CL. Another line represents the centerline along the ground. That line is centered between the ground scars created by the floats and features that are common to Photographs 1 and 2. A vertical height of the LE/CL point on the crashed fuselage is defined as point A. That vertical height is transposed to the ground scar area to the right.

Figure 1 - Airplane rotated 17 degrees nose up so that the 13 degree crush matches the 30 degree terrain

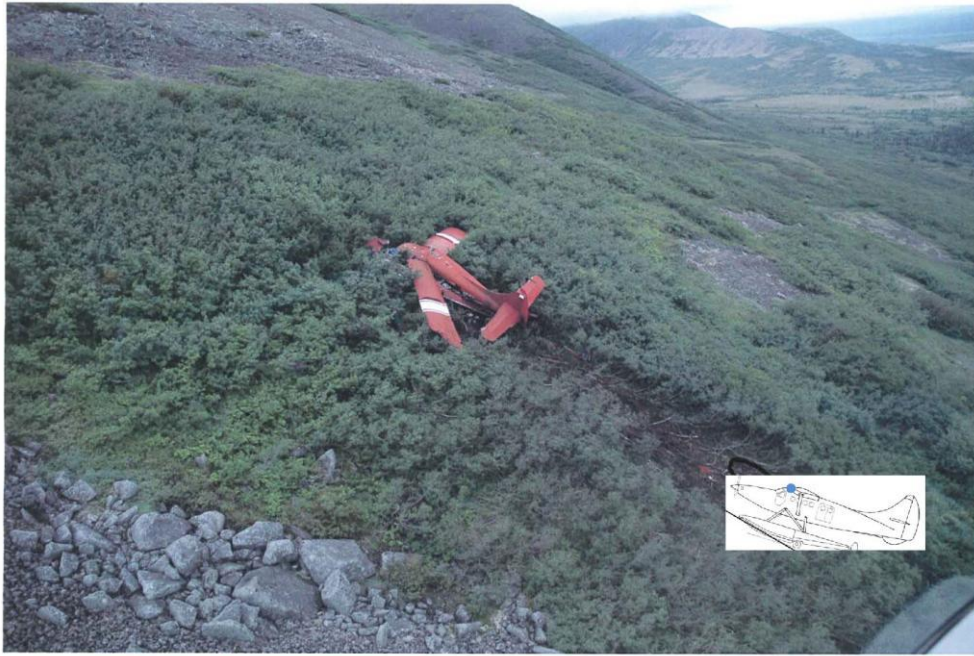
Photo 4 - A two-dimensional photograph of a DCH-3 on floats is rotated 17 degrees up to derive the height of the point at the leading edge of the wing at the centerline (LE/CL) – left float.

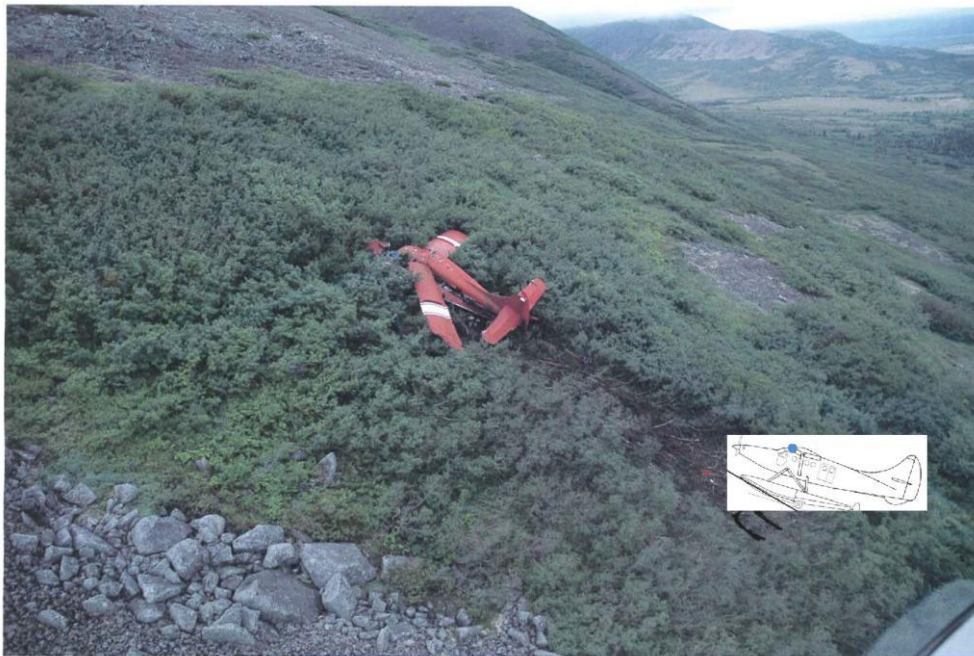
Photo 5 - A two-dimensional photograph of a DHC-3 on floats is rotated 17 degrees up to derive the height of the point at the leading edge of the wing at the centerline (LE/CL) – right float.

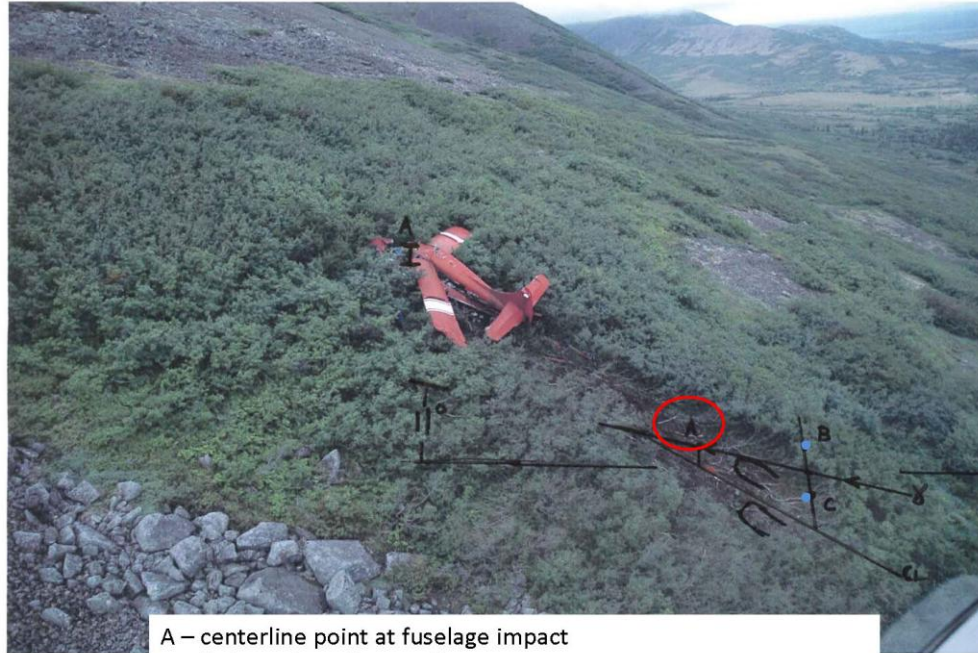
A line that is midpoint between points B and C and transects point A defines the motion of the reference point LE/CL. The upslope of that line is consistent with a flight path (γ) of 11 degrees climb. The derived angle should not be considered an absolute, but does show that the climb angle was significant and not near zero (as if the airplane had cruised into the hillside).

A – centerline point at fuselage impact
 γ – flight path angle = 11 degrees up

Photo 6 – Reconstructed flightpath angle of 11 degrees.

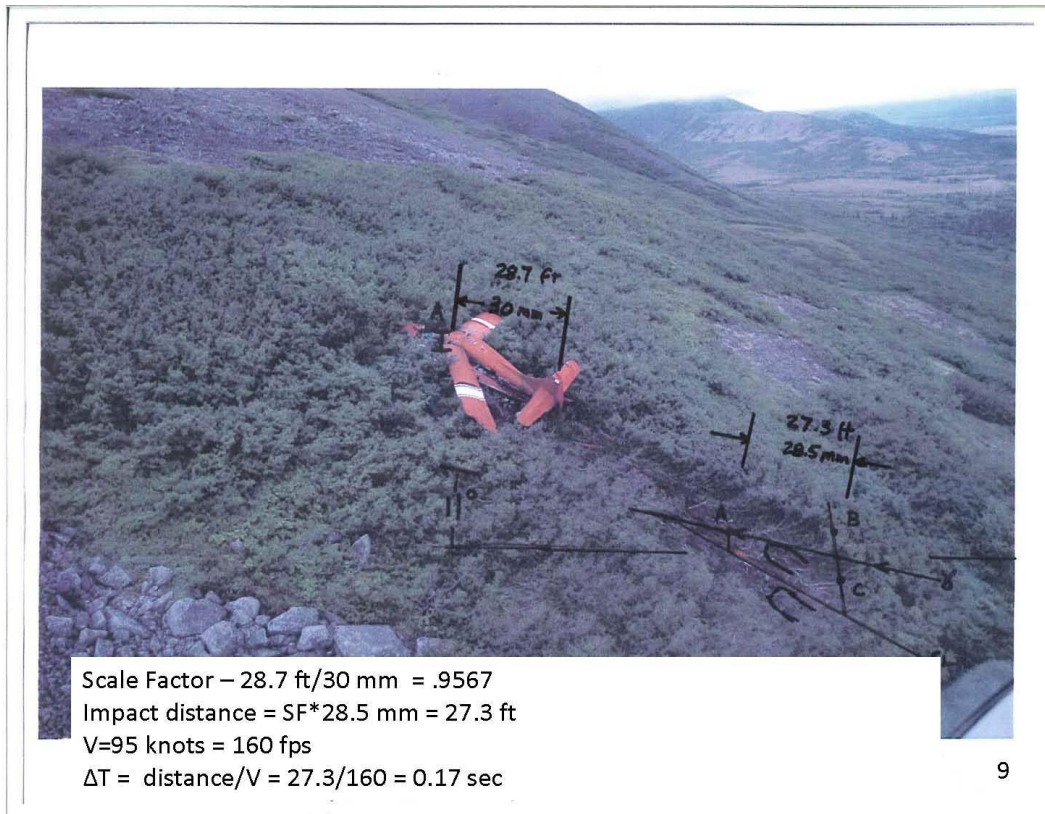
The distance traveled by the fuselage between the points of contact of the floats and left wing root was about 27 feet. Although the impact speed is unknown, a representative ground speed of 95 knots would yield an elapsed time from float impact to wing tip impact of about 0.17 seconds.

Photo 7 - Time and Distance Calculations. The distance travelled from float impact to wing impact was about 27 feet. At 95 knots, the time to travel that distance is about 0.17 seconds.

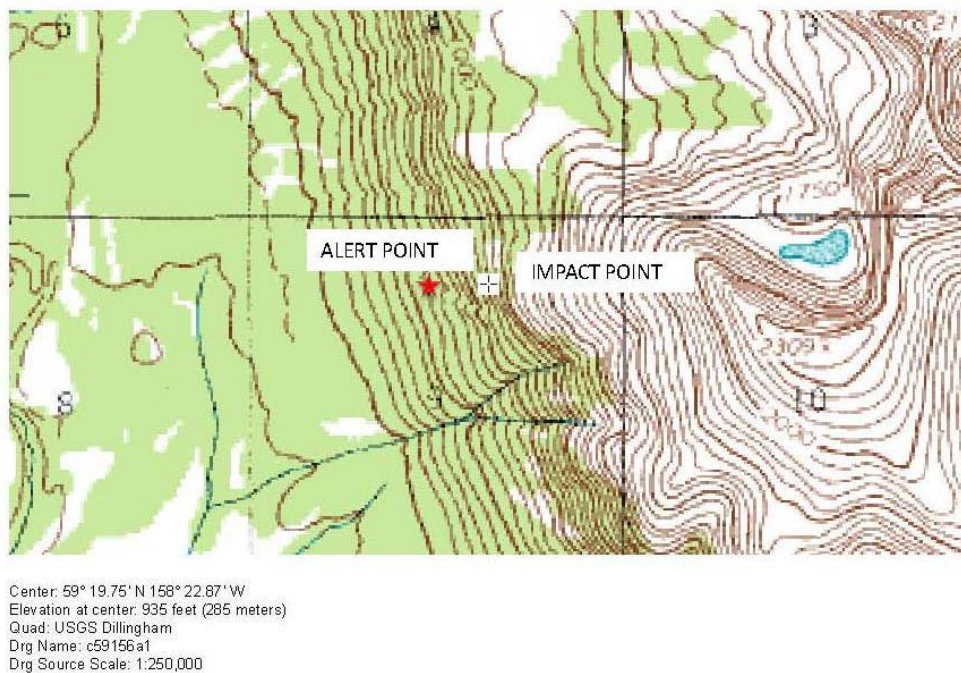
is about 1.7 seconds. The heading would change about 14 degrees to the left during the 1.7 second period and the airplane would climb about 30 feet. The altitude alerter was set at 275 feet for a total of about 305 feet elevation change from the point of altitude alert to impact. Several samples from Google Earth (one is presented in Figure 2) show that an elevation change of 305 feet could occur in about 700 feet. That distance would be traveled in about 4 seconds at a 100 knot ground speed.

Figure 3 - Estimated position of altitude alert.
