NATIONAL TRANSPORTATION SAFETY BOARD

INITIAL and ON-SCENE INFORMATION

**NTSB Accident: WPR13FA294
Accident Date: June 27, 2013**

Location: Birdseye, Utah
Date: June 27, 2013
Aircraft: Cessna 172M, N4459R, Serial # 17263201
NTSB IIC: Michael Huhn

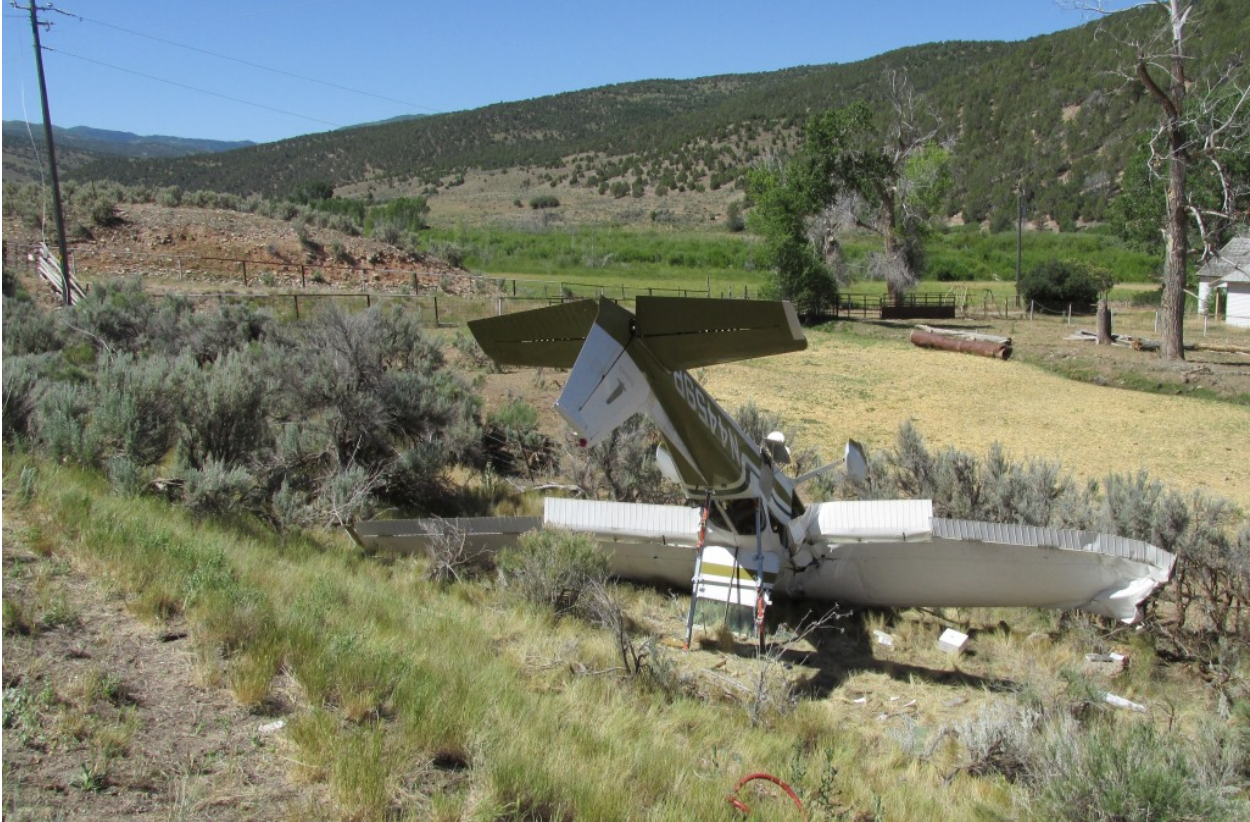
The airplane came to rest about 270 feet south of the transverse cable strike location. The airplane came to rest inverted, with the fuselage oriented about 45 degrees from horizontal. The approximate at-rest heading was 220 degrees magnetic. A north-south ground scar that measured about 15 feet long, and that was consistent with being made by the left wingtip, was situated about 60 feet prior to the wreckage. Aside from multiple plastic and window fragments, no components had separated from the airplane.

Figure 1 - Airplane After Impact (view southwest)

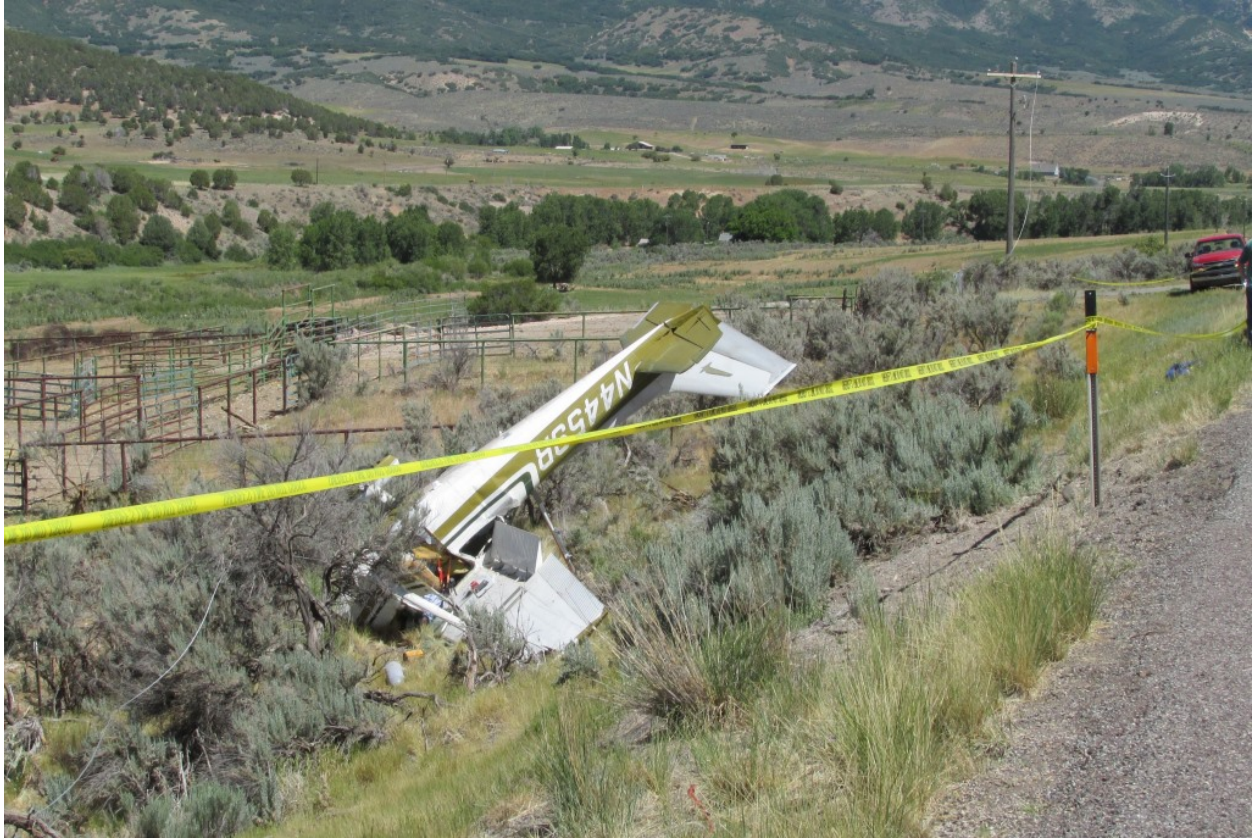
Figure 2 - View North-Northwest (note downed wires)

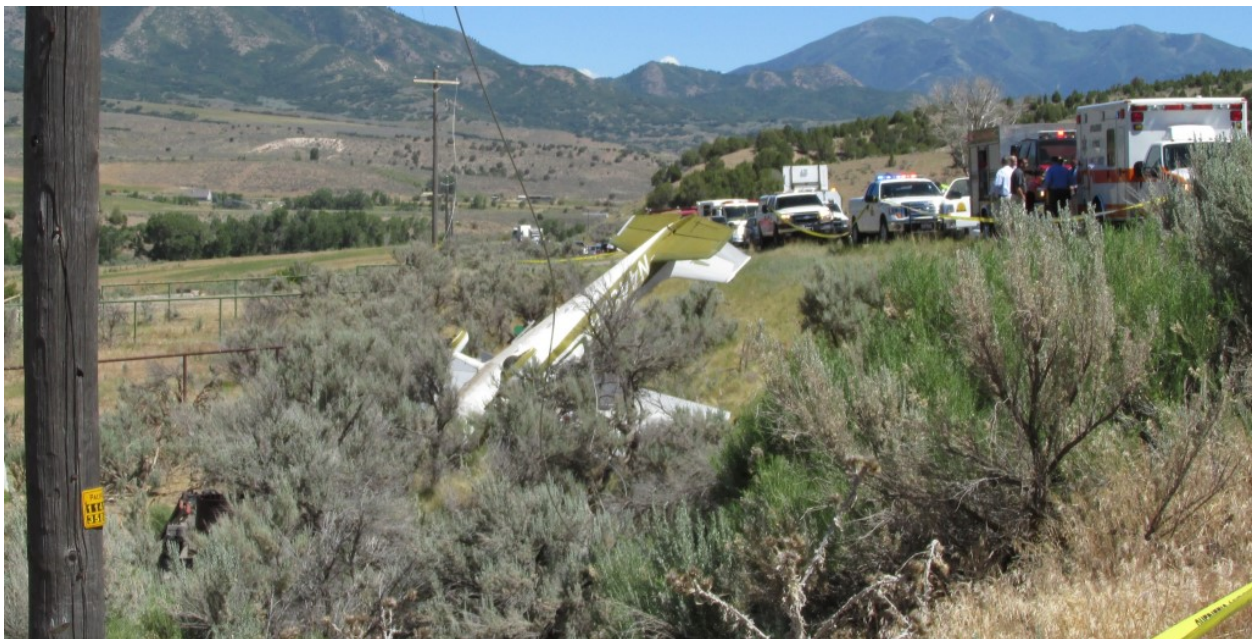
Figure 3 - View North (note downed wires)

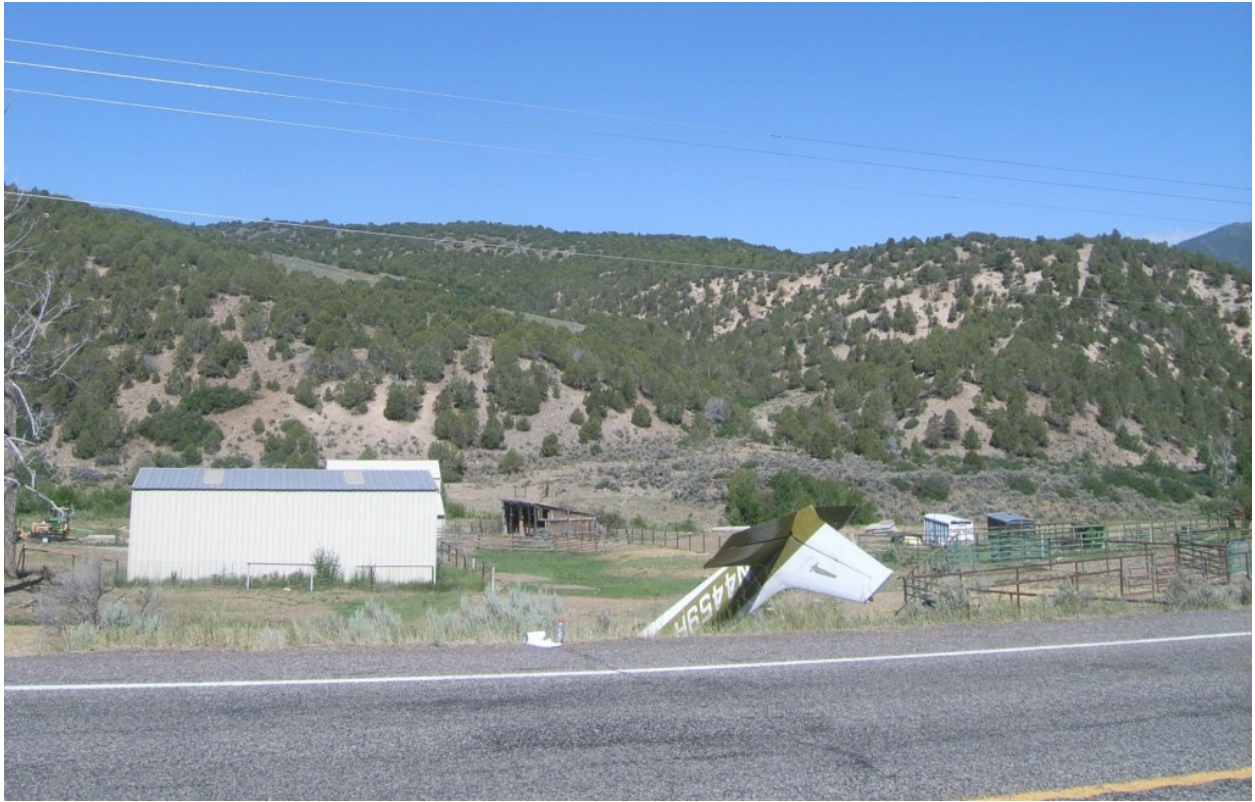
The airplane then struck at least two separate cables that were in the four-line set that paralleled the roadway on its west side. The uppermost cable was situated about 35 feet above the road. The cable was significantly damaged but not completely fractured; all but one strand of that cable were "bunched" at the south end of an approximately 18 foot section, consistent with them

Figure 7 - Airplane, Road, and Parallel Wires (view west)

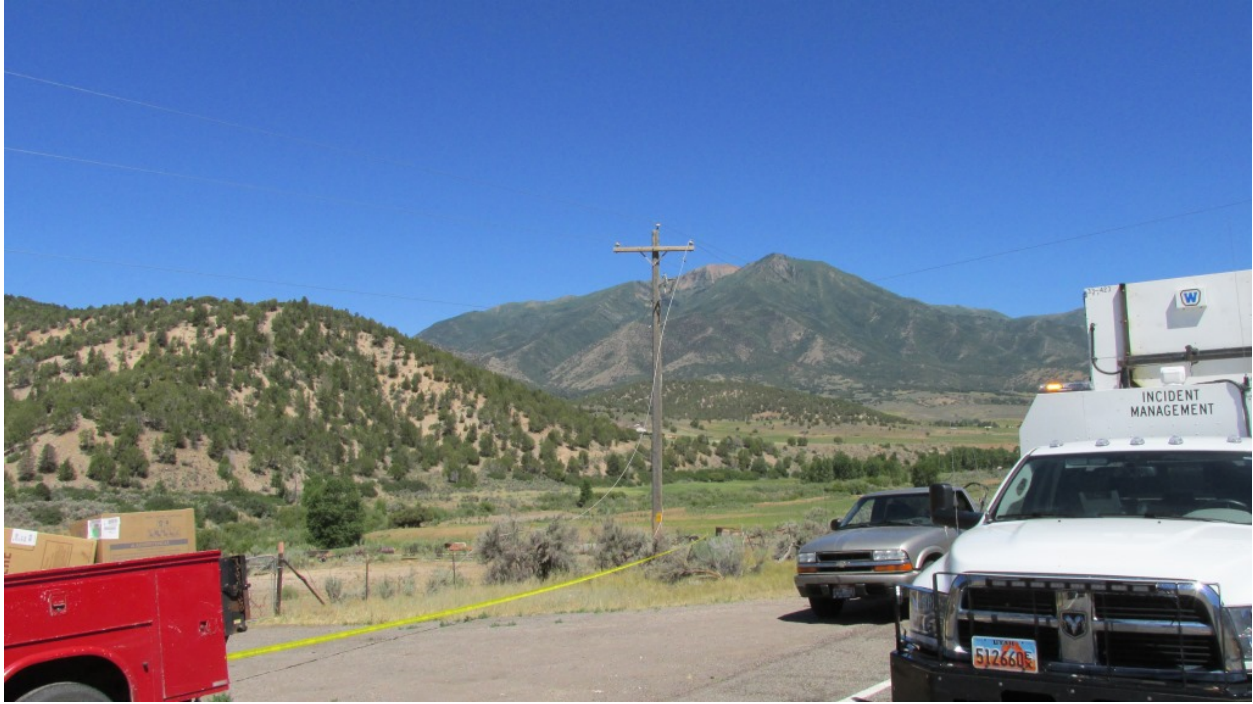
A second cable, situated about 4 feet closer to the road than, and 3 feet below, the top cable, was completely fractured. Two other cables in that group were not fractured but displayed electrical arcing burns in the vicinity of the bunching. All three of these cables were also 1/0 ACSR.

Figure 8 - Downed Parallel Wire and Road

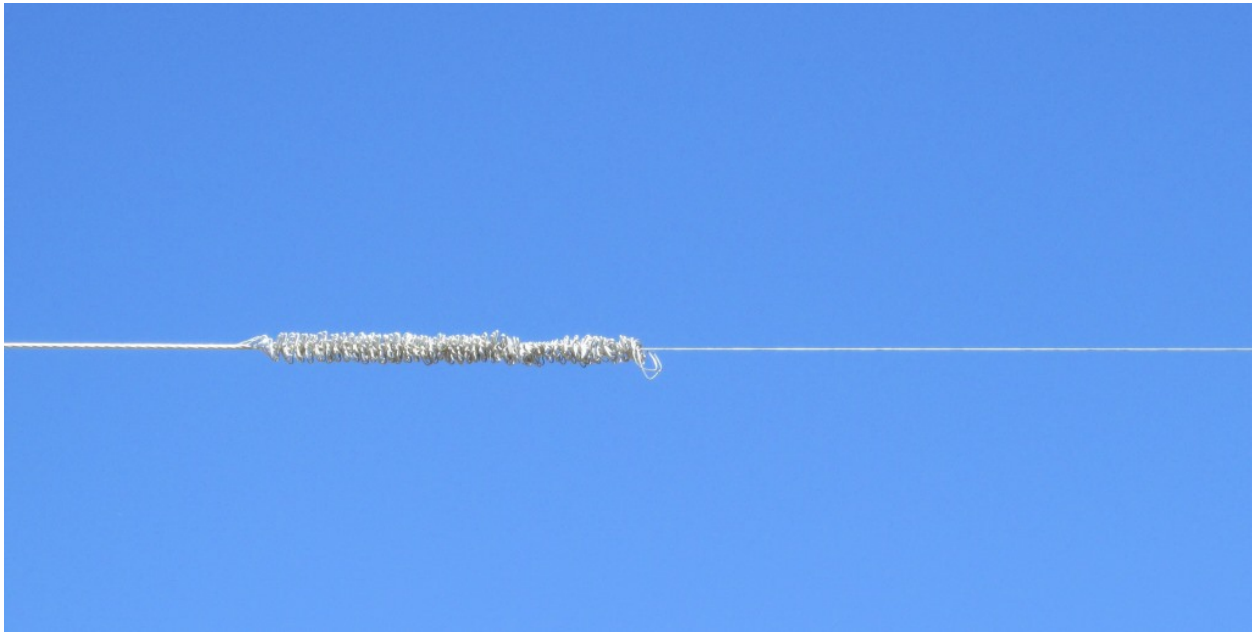
being fractured and then compressed along the single intact strand by the airplane. This cable was designated as a "1/0 ACSR," which was a bare (uninsulated) cable with an aluminum core conductor, and 6 steel reinforcing wrapped strands. The nominal overall cable diameter was 0.398 inches, and the diameters of the central aluminum conductor and each steel reinforcing strand diameter were 0.1327 inches. The nominal rated strength of the cable was 4,380 pounds.

Figure 9 - Bunched Wires on Parallel Powerline

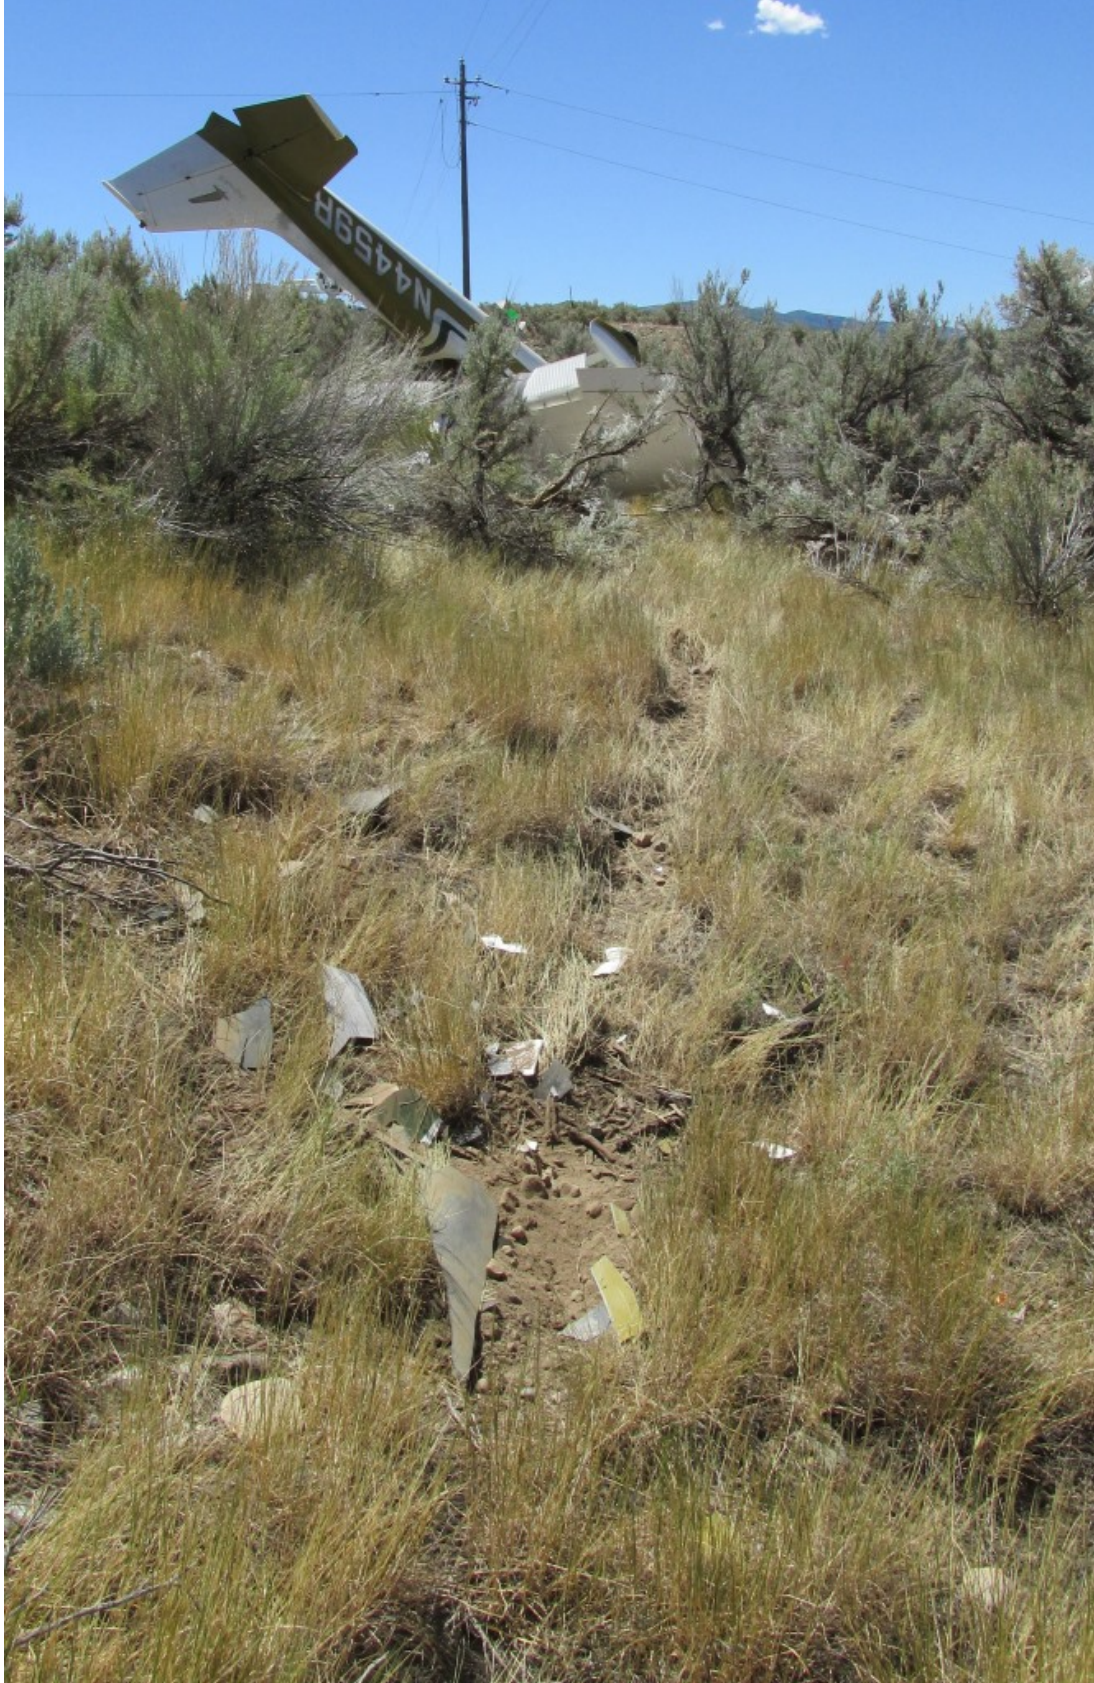
Figure 14 - Left Wing Ground Scar

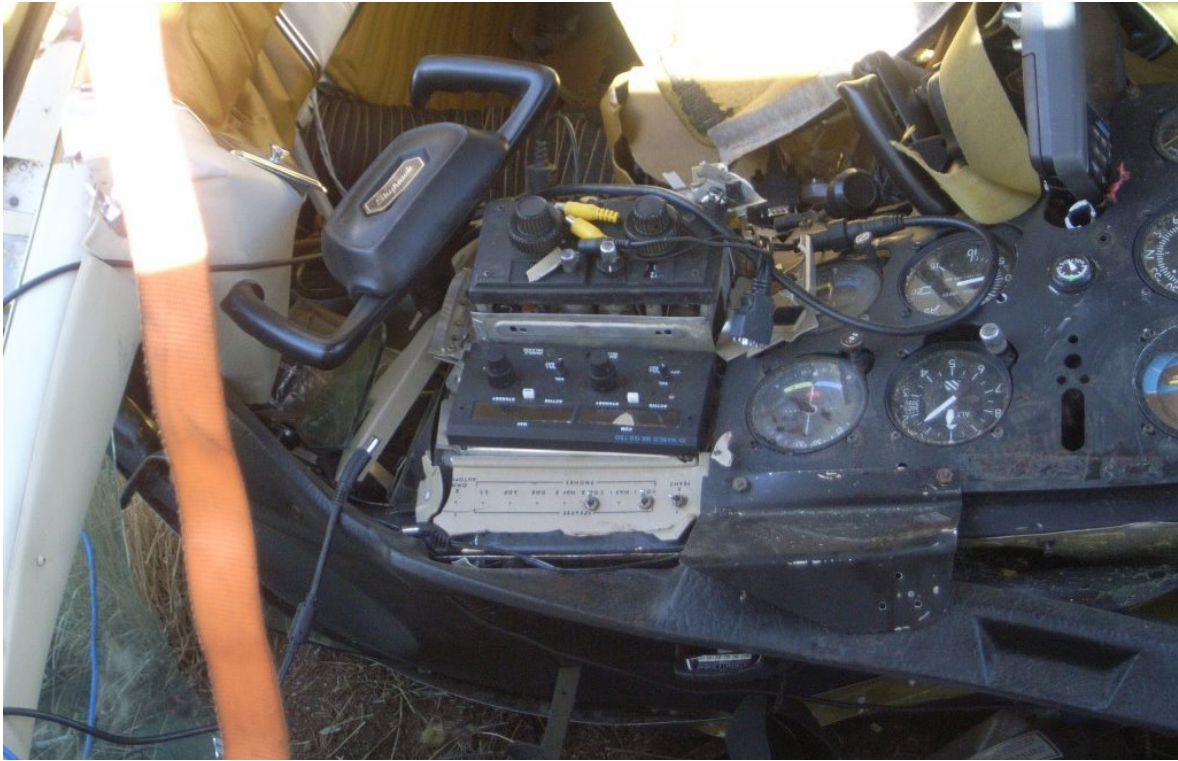
Figure 17 - Instrument Panel

Although not explicitly documented by the first responders, the evidence was consistent with the test engineer's (right) seat possibly separating from its seat tracks during the impact sequence. The instrument panel and two control wheels sustained moderate crush damage, consistent with ground and occupant impact.

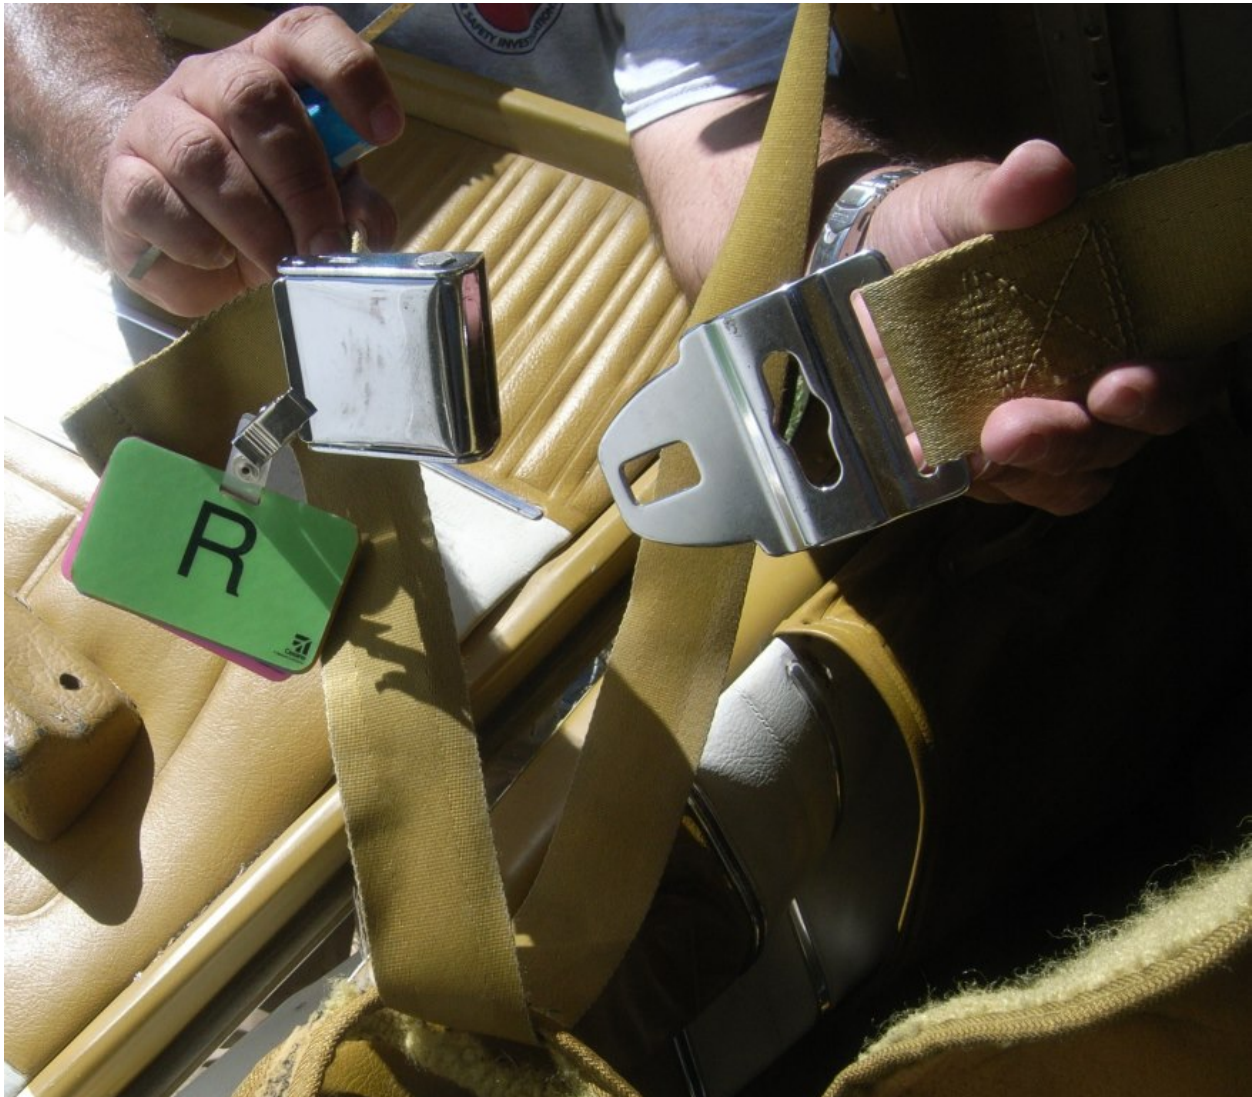
The right seat lap belt buckles were not latched, and the shoulder harness was not attached to the main buckle. The use of the seat restraint by the test engineer was not able to be determined.

Figure 23 - Right Seat Restraint System

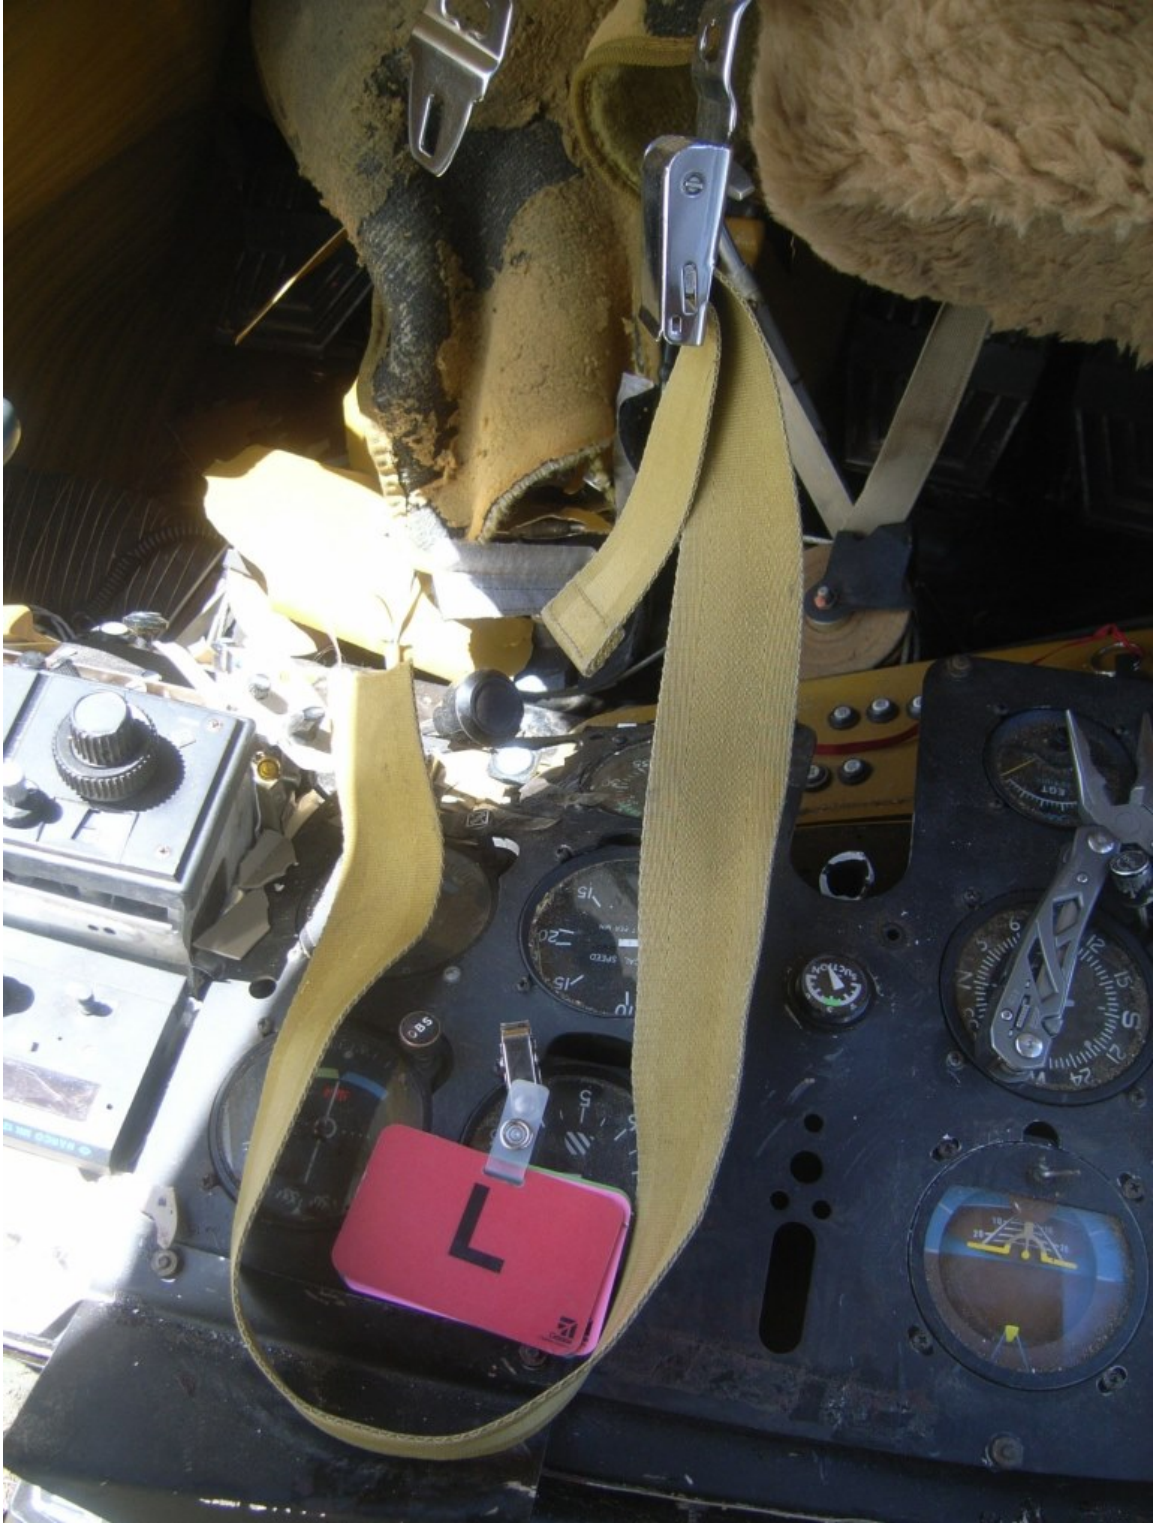
The left seat lap belt was observed with the buckles latched and the lap belt cut. The shoulder harness was not attached to the main buckle.

Figure 24 - Left Seat Restraint System

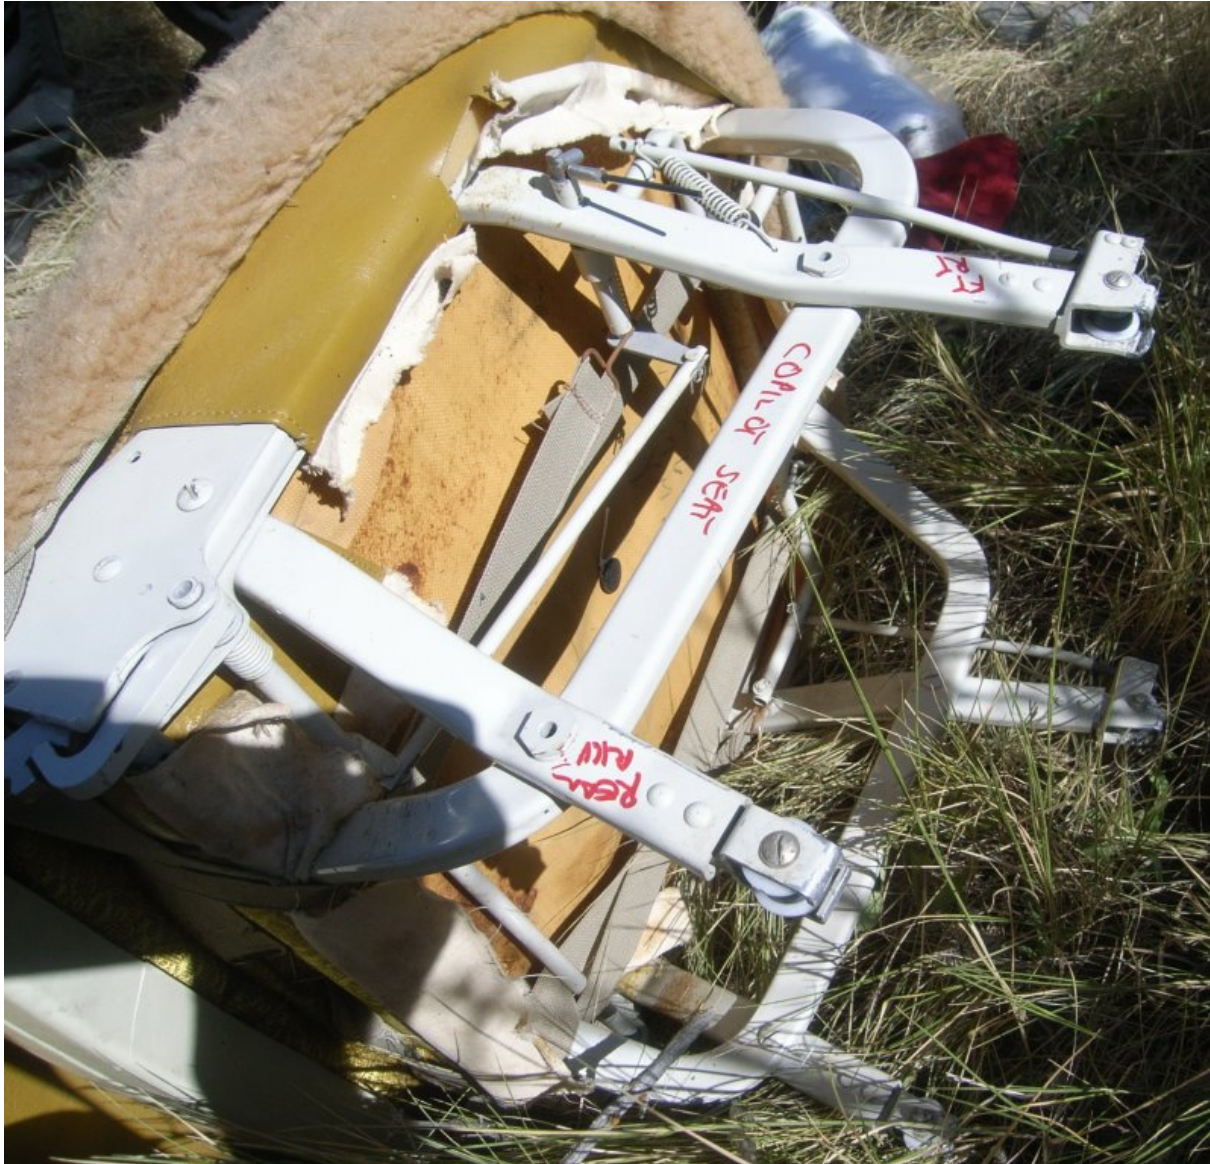
Except for the right rear foot, the feet of the right seat displayed deformation consistent with loading the seat in the up direction (airplane axis system)

Figure 25 - Right Seat Feet

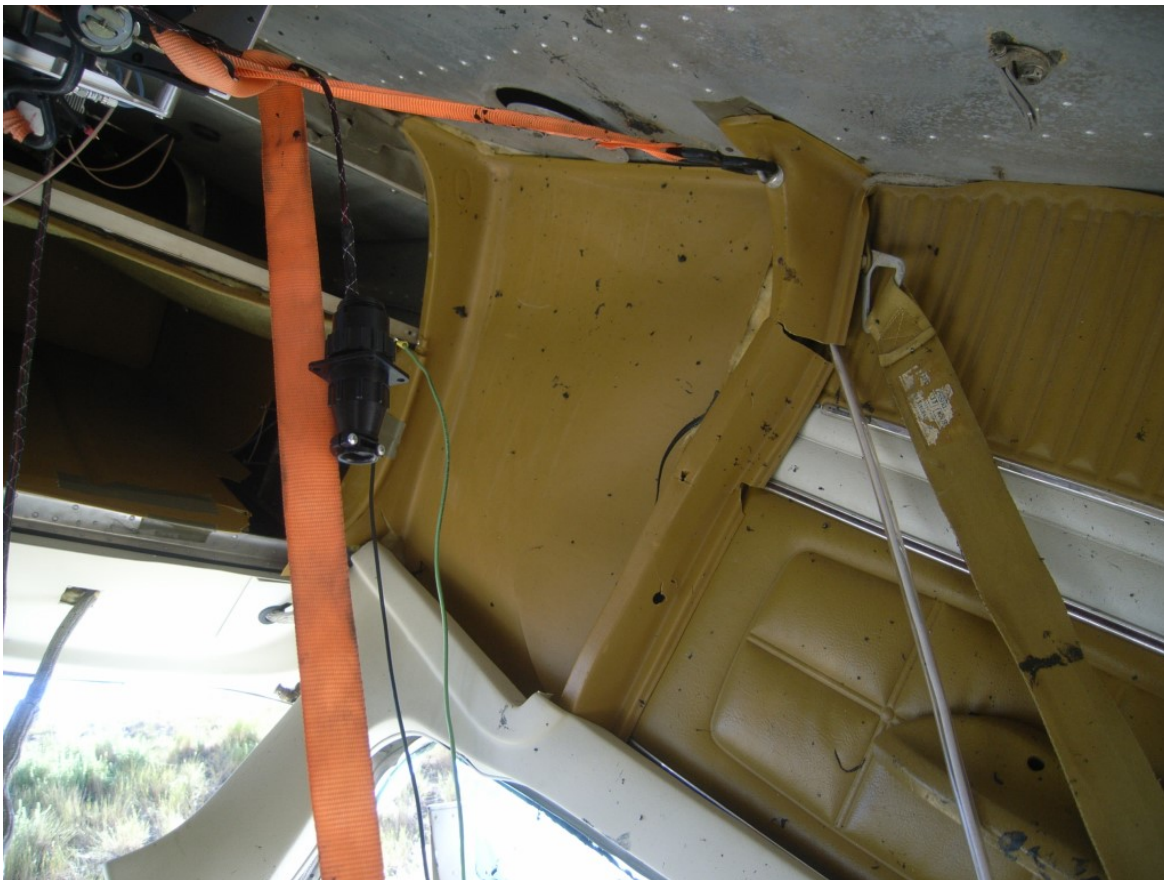
Some of the cabin sidewalls had significant evidence of burned or melted plastic remnants deposited on and/or fused to them. The cabin ceiling was covered with a layer of black sooty particulate matter that was consistent with uncontained, smoky combustion. The aft cabin carpet was partially burned; the burned areas and patterns were congruent with burned portions of the supplemental power (described below).

Figure 32 - Cabin Sidewall with Melted Deposits

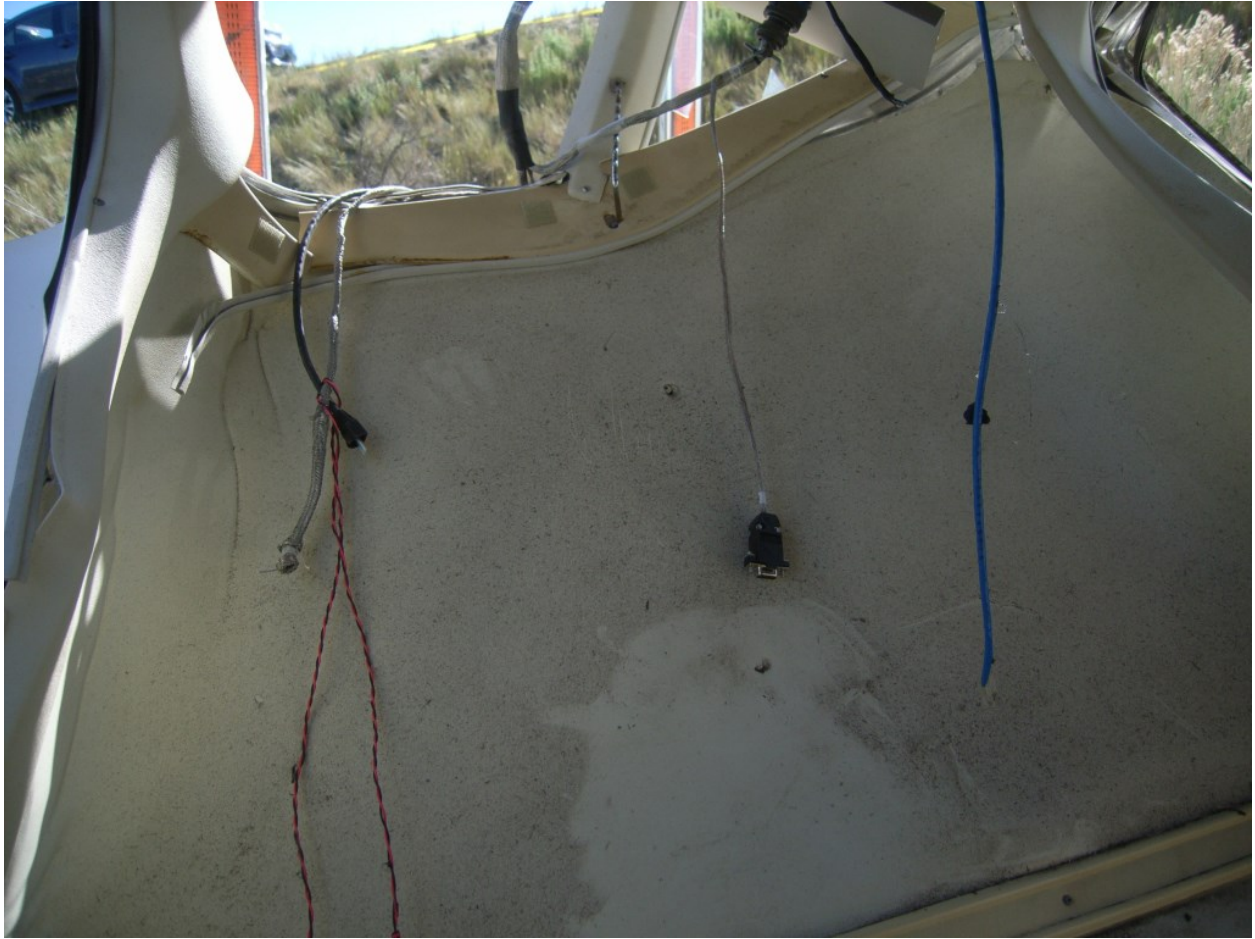
Figure 33 - Cabin Ceiling with Soot Layer

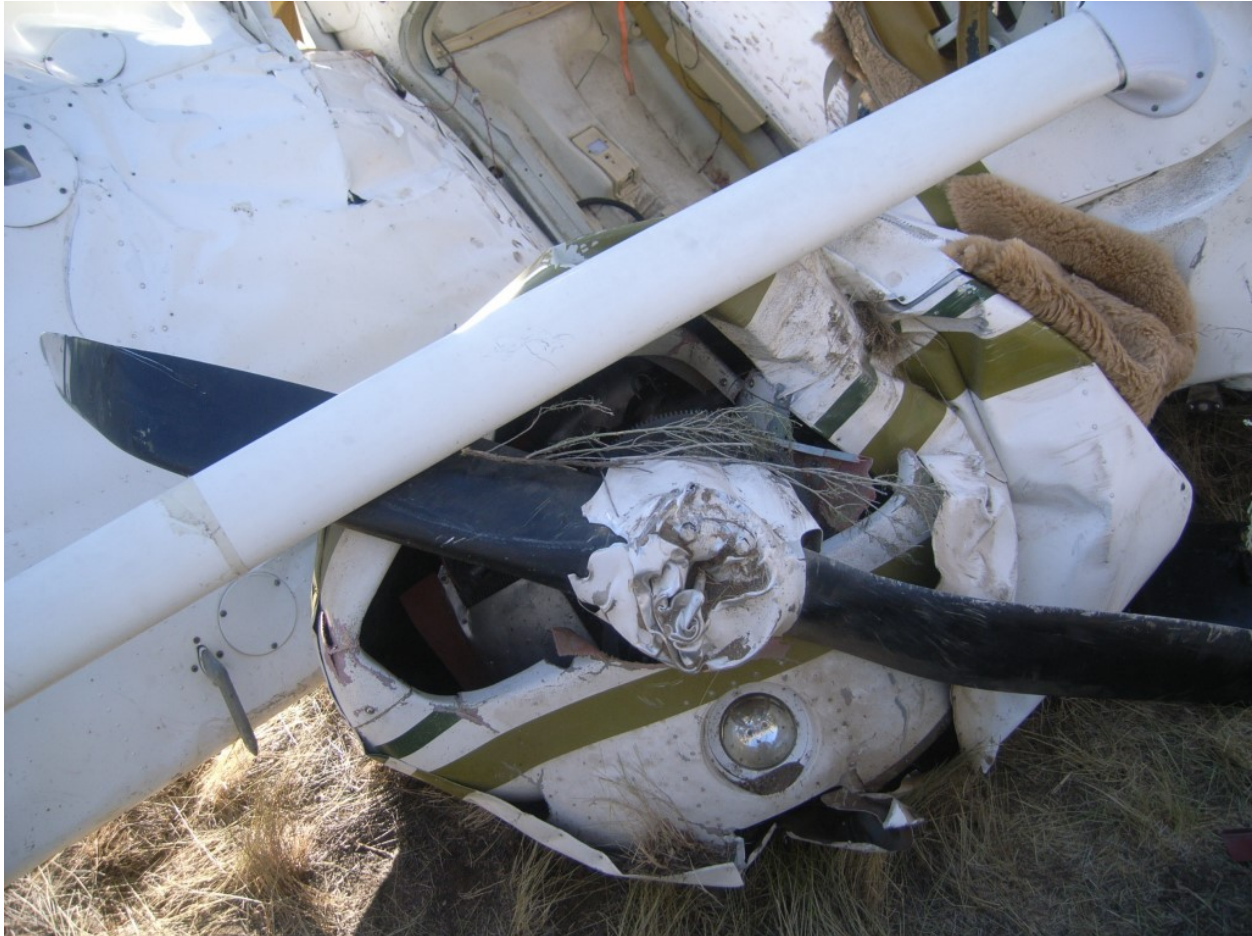
The propeller remained attached to the engine. Both blades showed S-bending, leading edge nicks, and chordwise scratches, consistent with power at impact.

Figure 34 - Spinner, Propeller, and Cowling

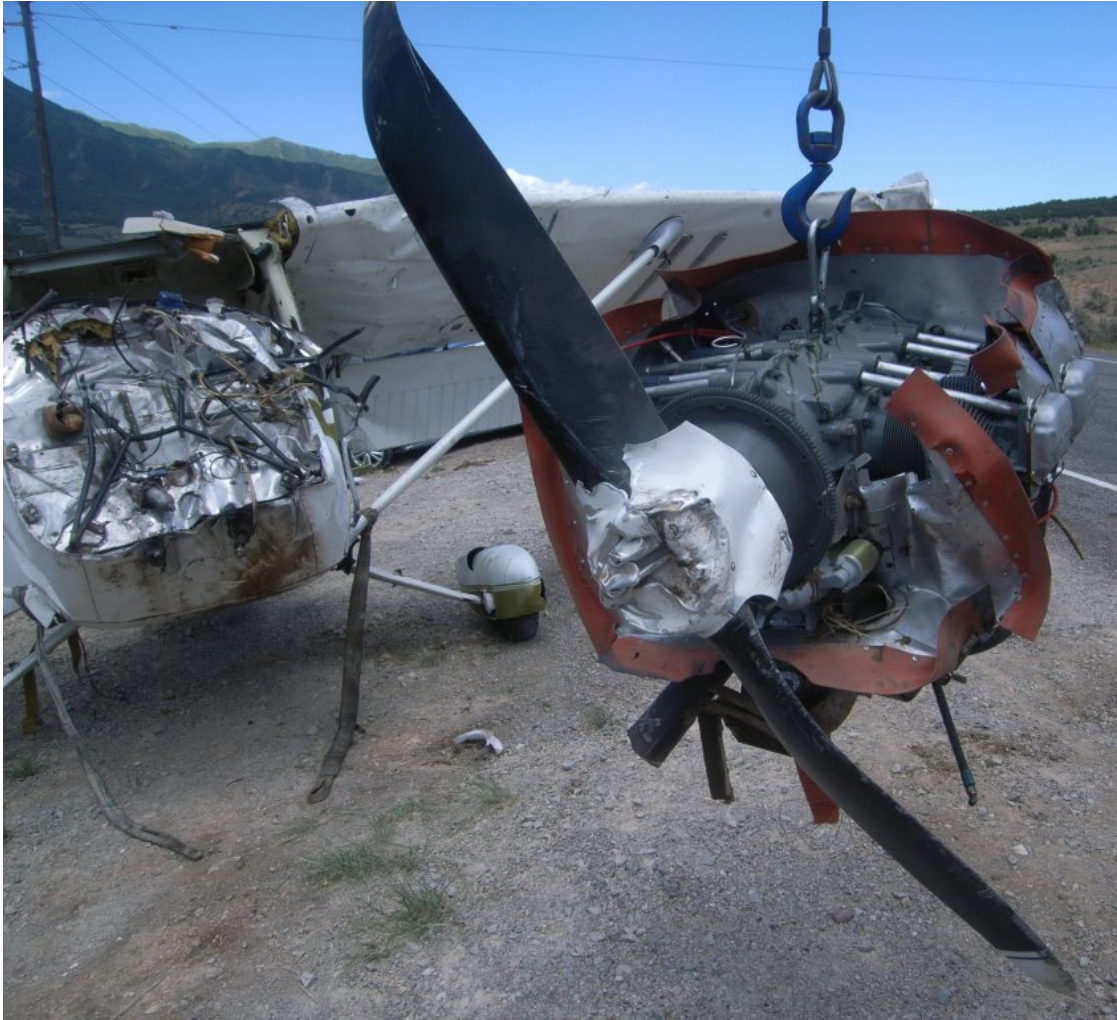
The engine was displaced to the left of the fuselage, separated from its mounts, but still attached to the firewall by cables and hoses.

Figure 35 - Engine and Propeller

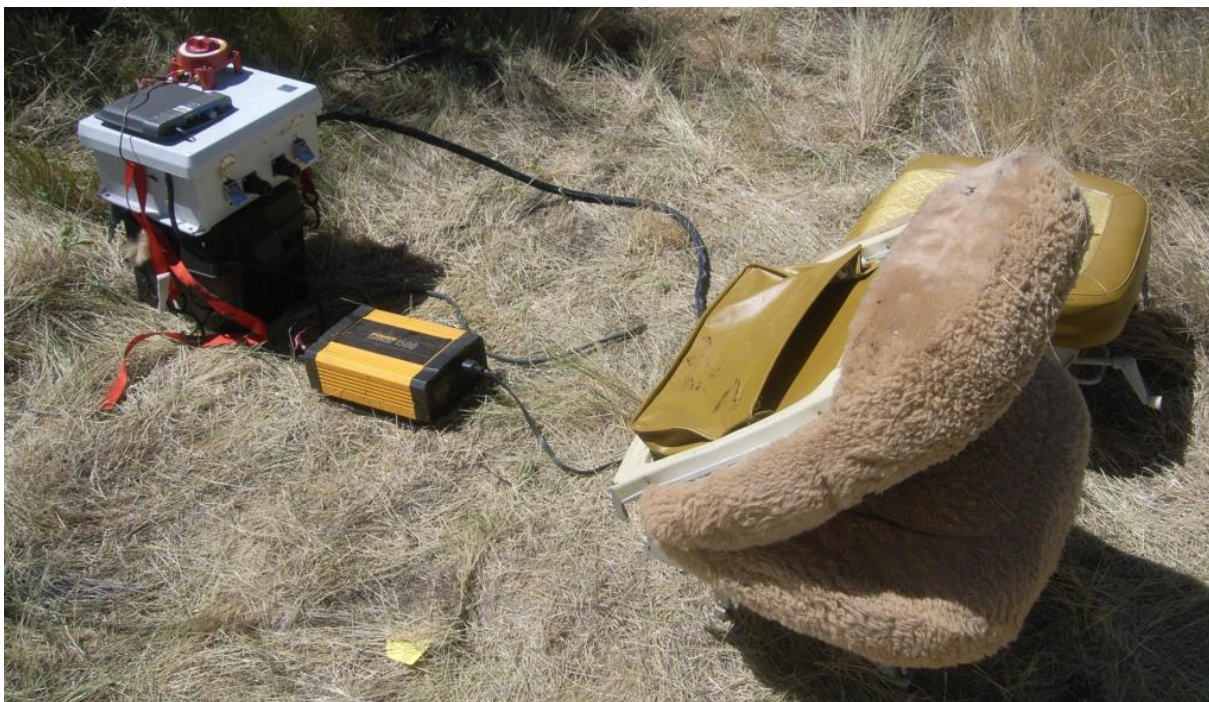
Most components had separated from the airplane or one another during the impact sequence. The components were removed from the airplane and laid out in their relative positions and documented. The plastic battery box, the distribution box, some of the wires from the battery, and the carpet sustained the bulk of the fire damage. The components were hand-carried to IMSAR the following day and examined in more detail with knowledgeable IMSAR personnel.

Figure 36 - Layout of Power Supply Components

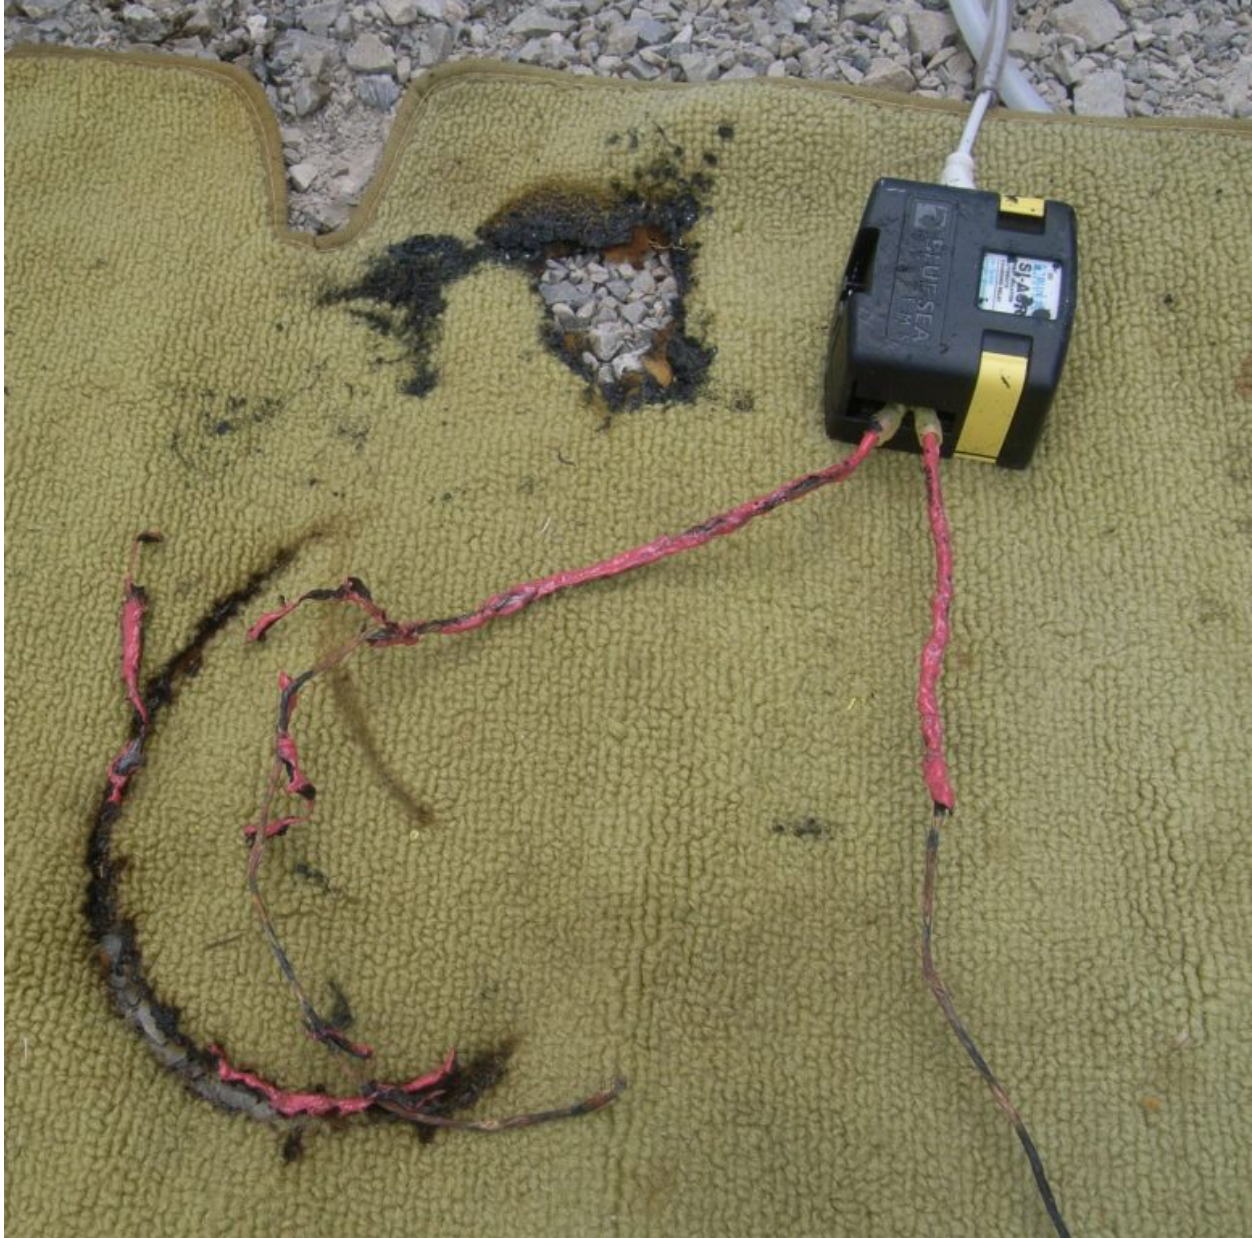
Figure 47 - Burned Isolator, Wires, and Carpet
