NATIONAL TRANSPORTATION SAFETY BOARD

INTERIM TECHNICAL REVIEW FACTUAL REPORT¹

DCA-15-FR-003

**Amtrak Train No. 280 Collision with an Engineering Employee
at Milepost 100.9 on Amtrak's Hudson Line**

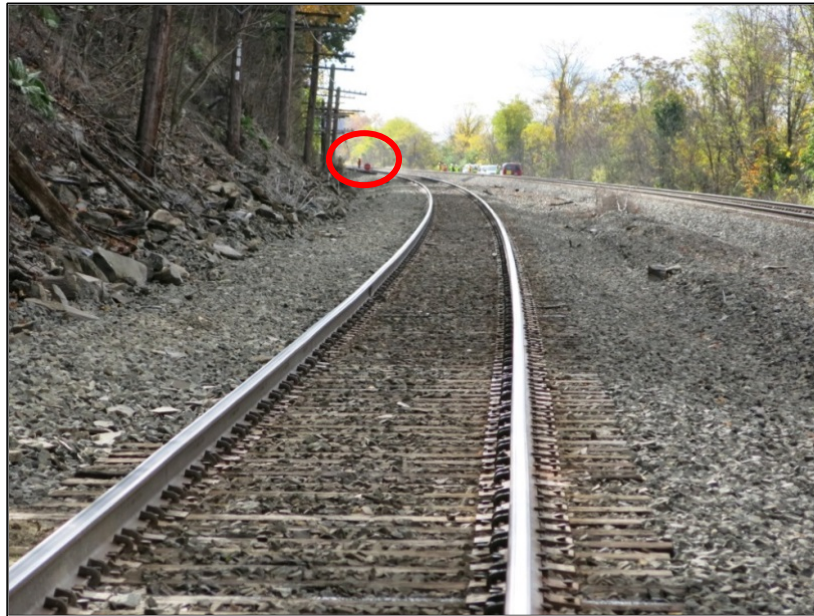
Figure 1. A ground level view looking south at main track 1 at the curve north of accident site. The red circle indicates location of employees at 100.9².

² This photo graph was taken by investigators who were determining the likely sight distance and visibility of a person standing on or near the track where the concrete box was located.
