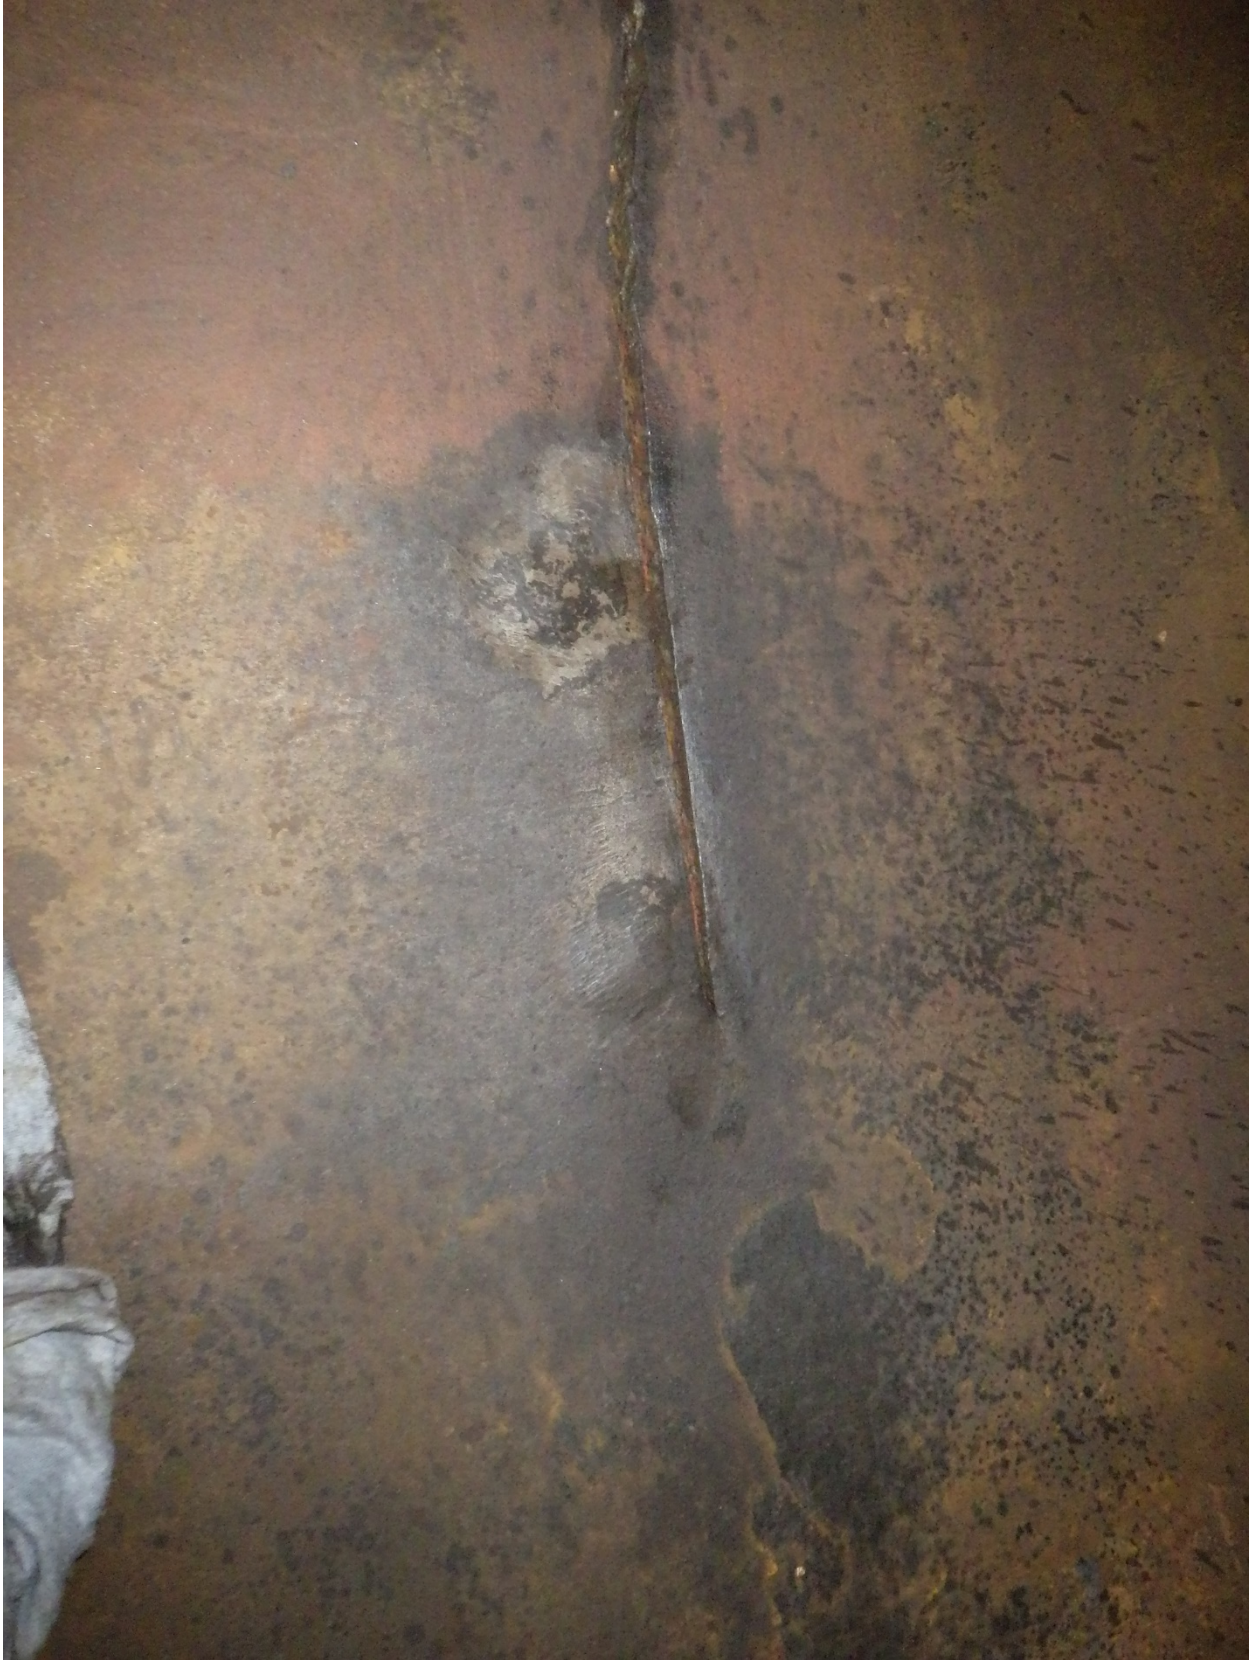
Interior corrosion repair spots inboard of cradle pad termination adjacent to shell crack, August 31, 2016.
