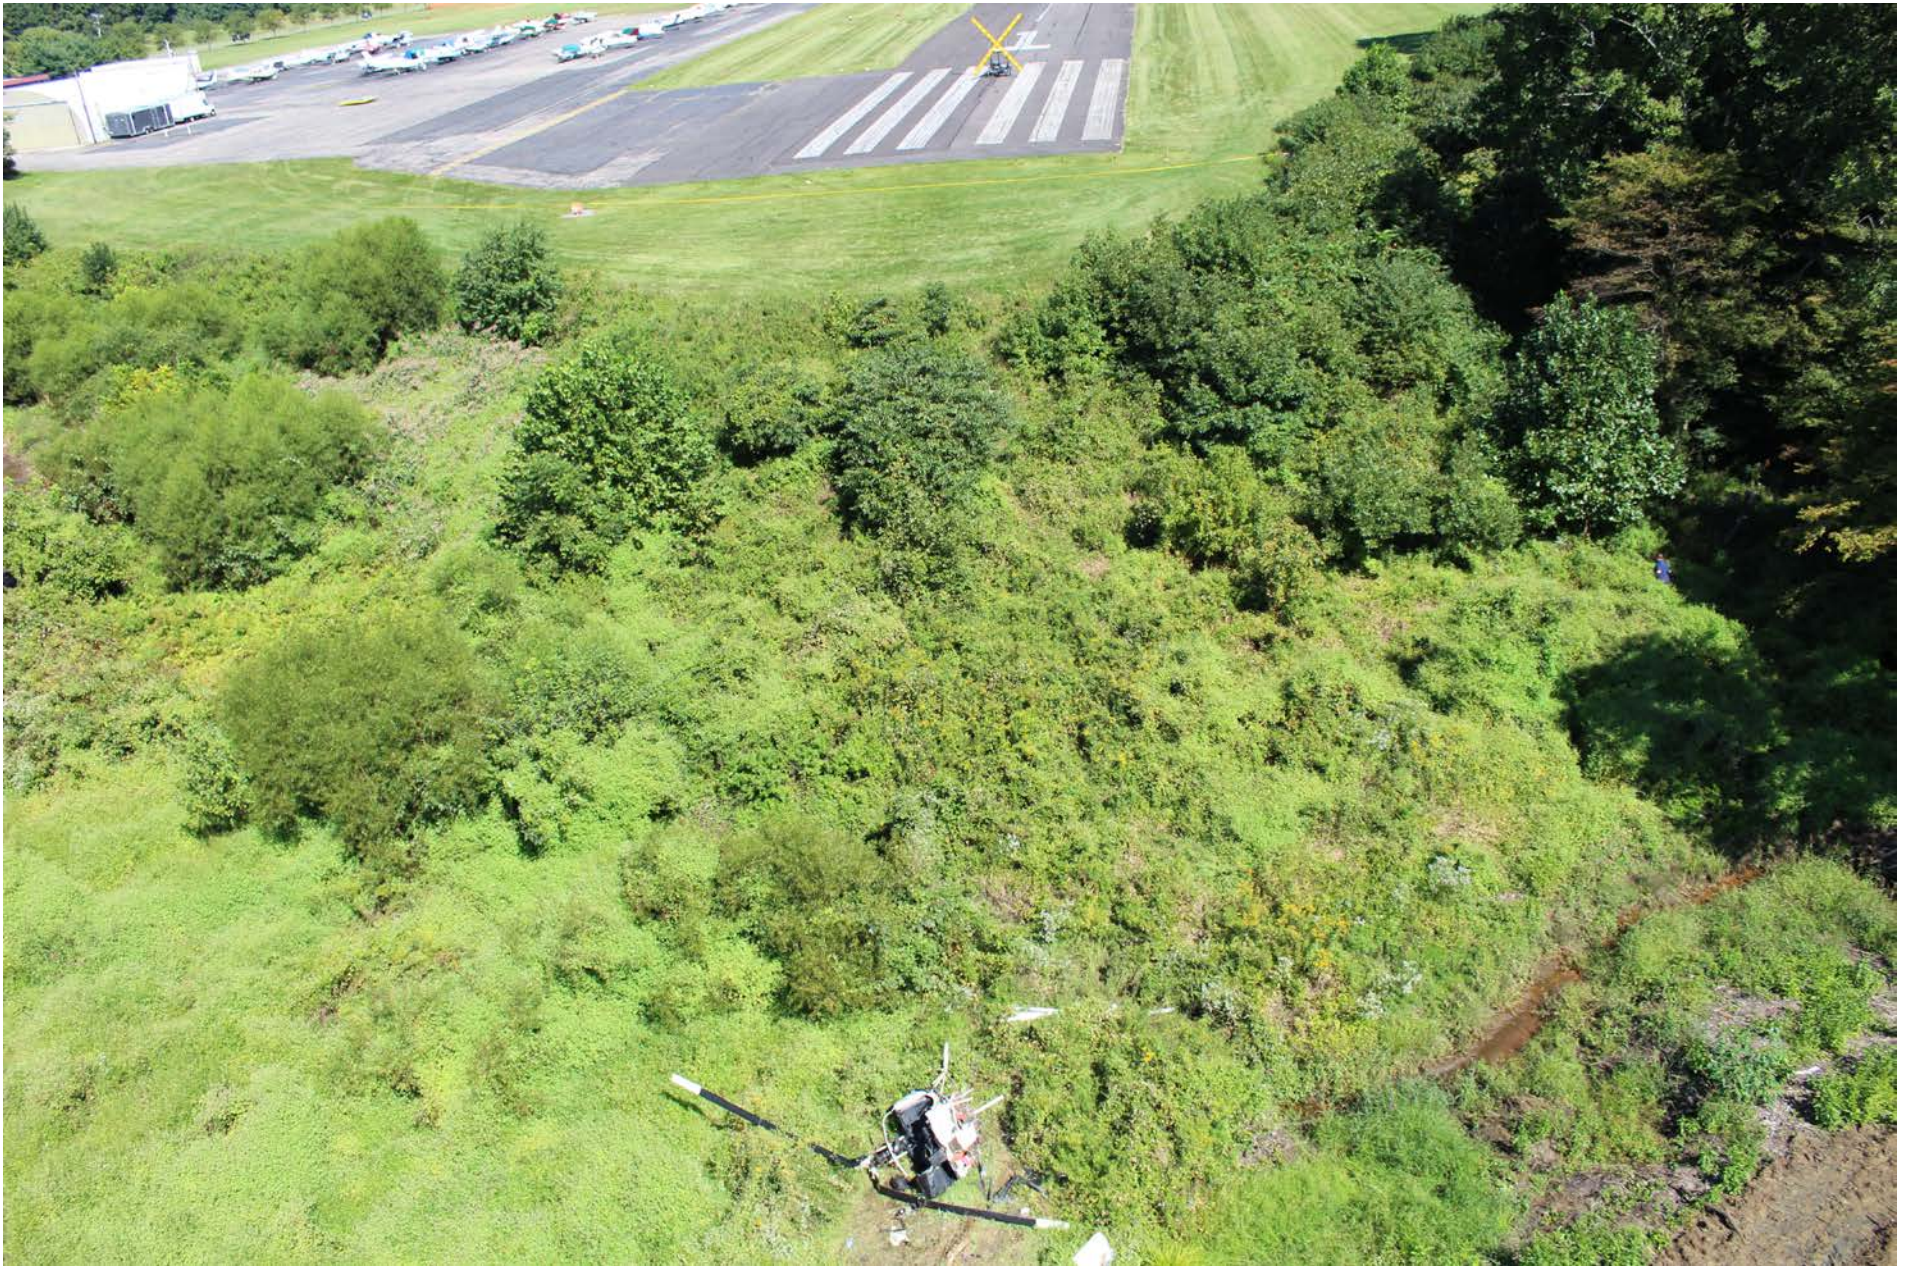
Photo 1 – View of Helicopter as Found Relative to Landing Runway (Medford FD)

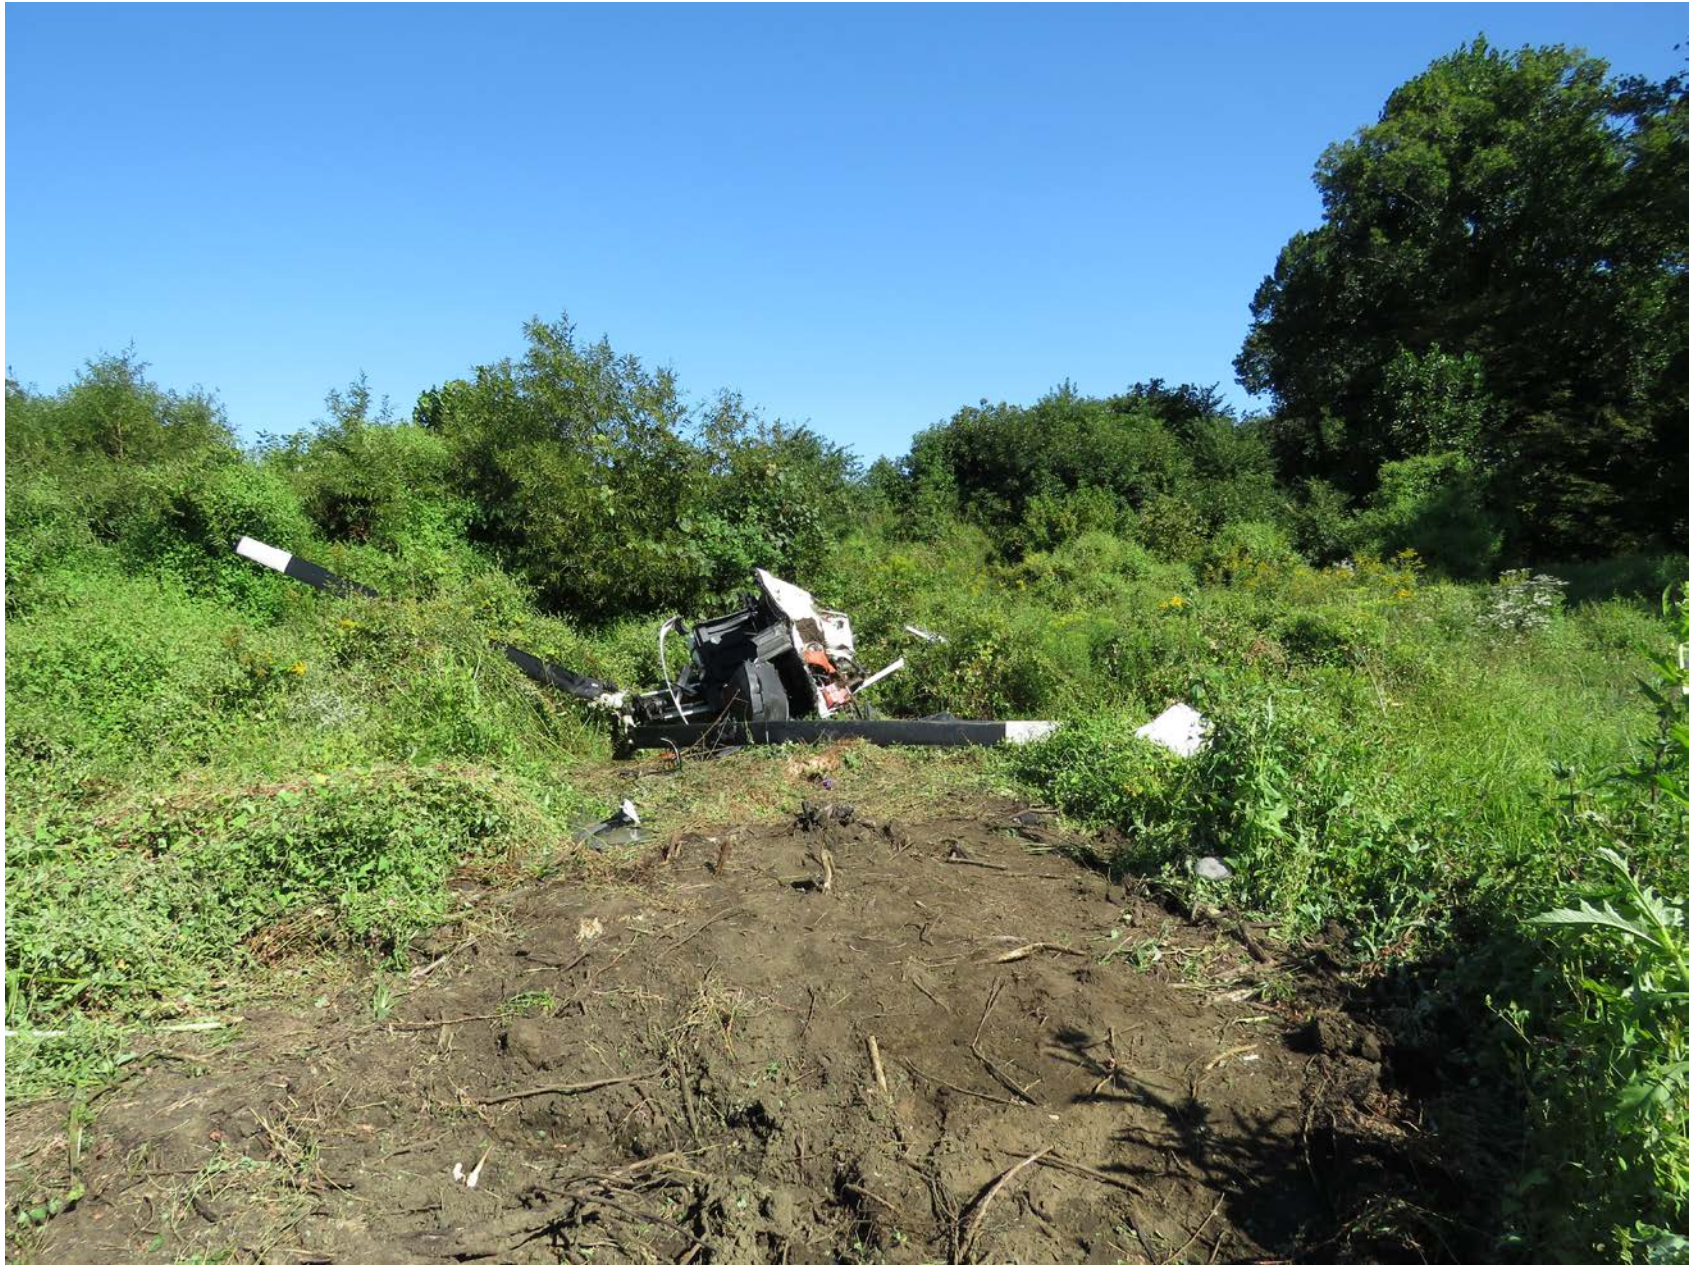
Photo 2 – View of Main Wreckage as Found (Lycoming Engines)

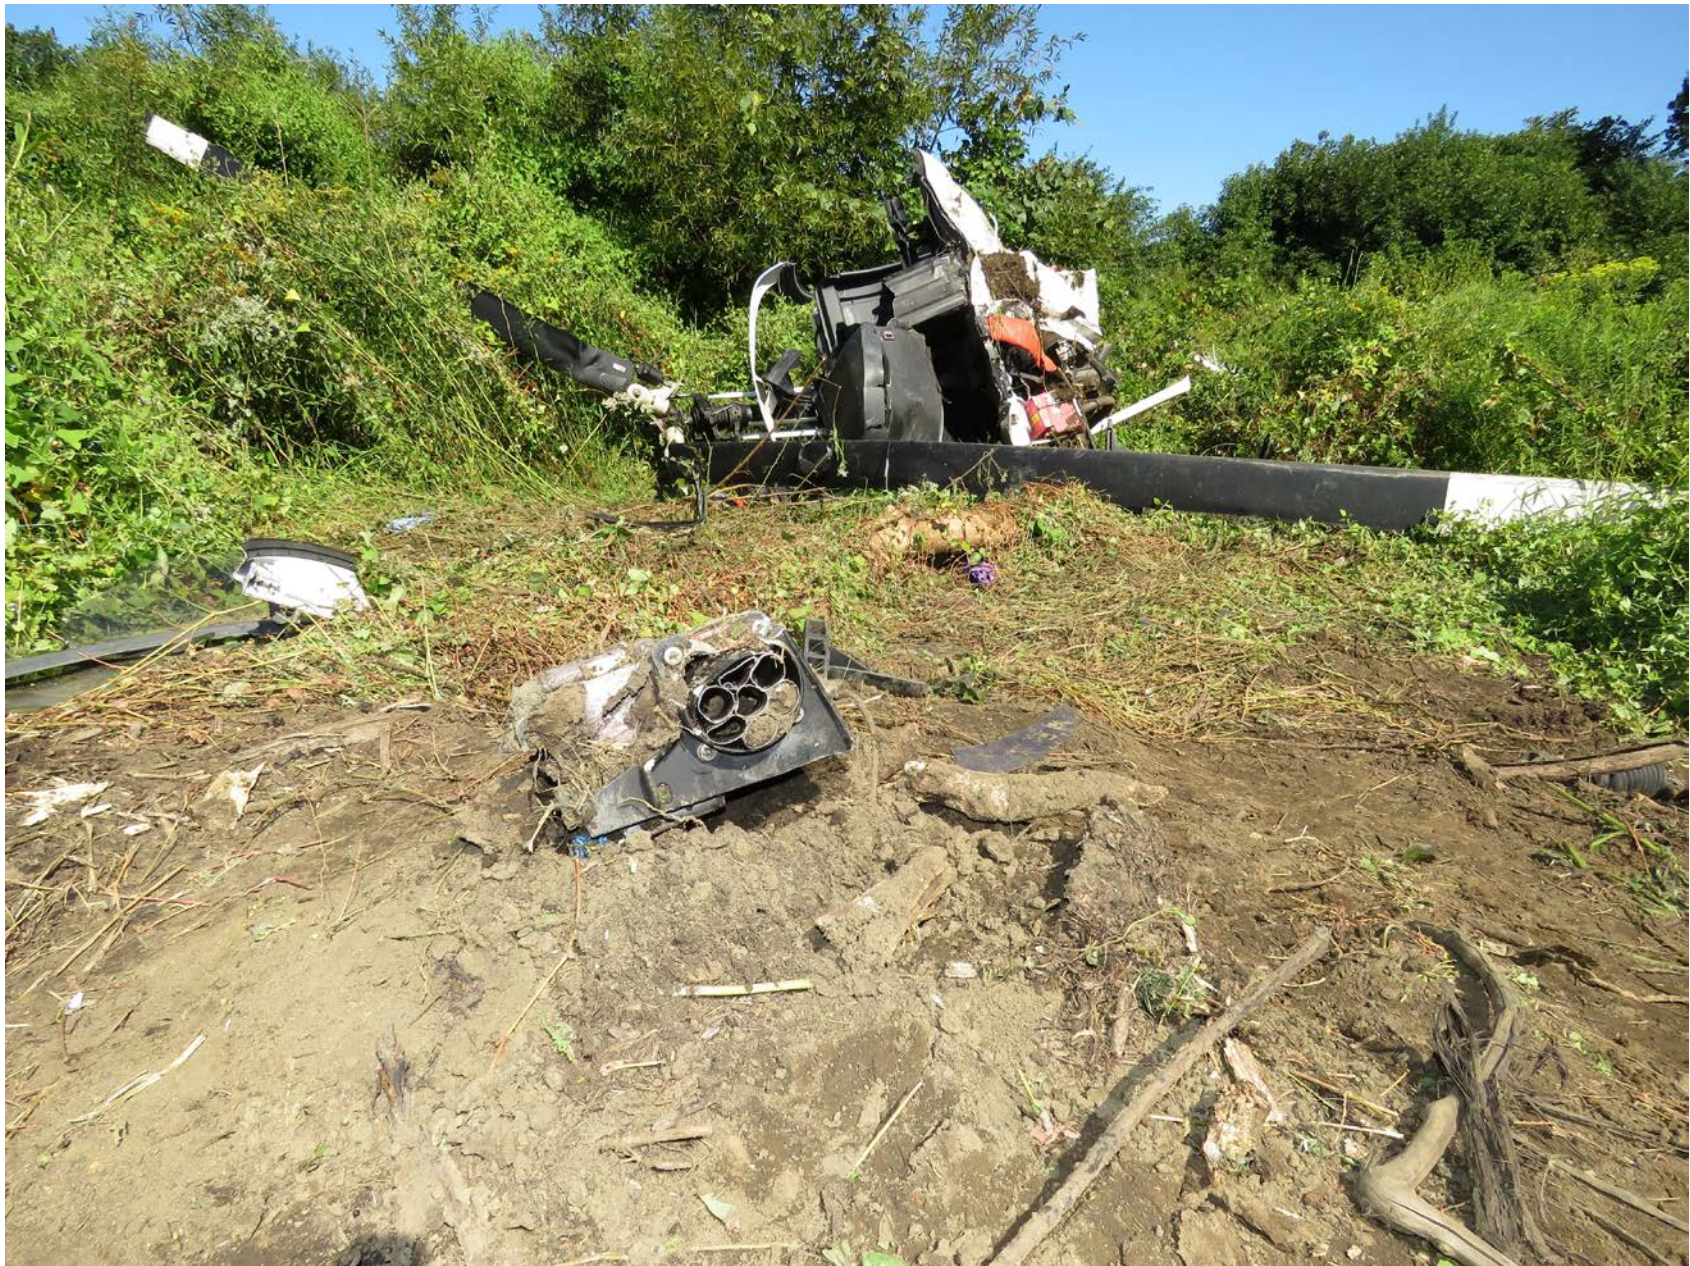
Photo 3 – View of Main Wreckage with Carburetor in Foreground (Lycoming Engines)

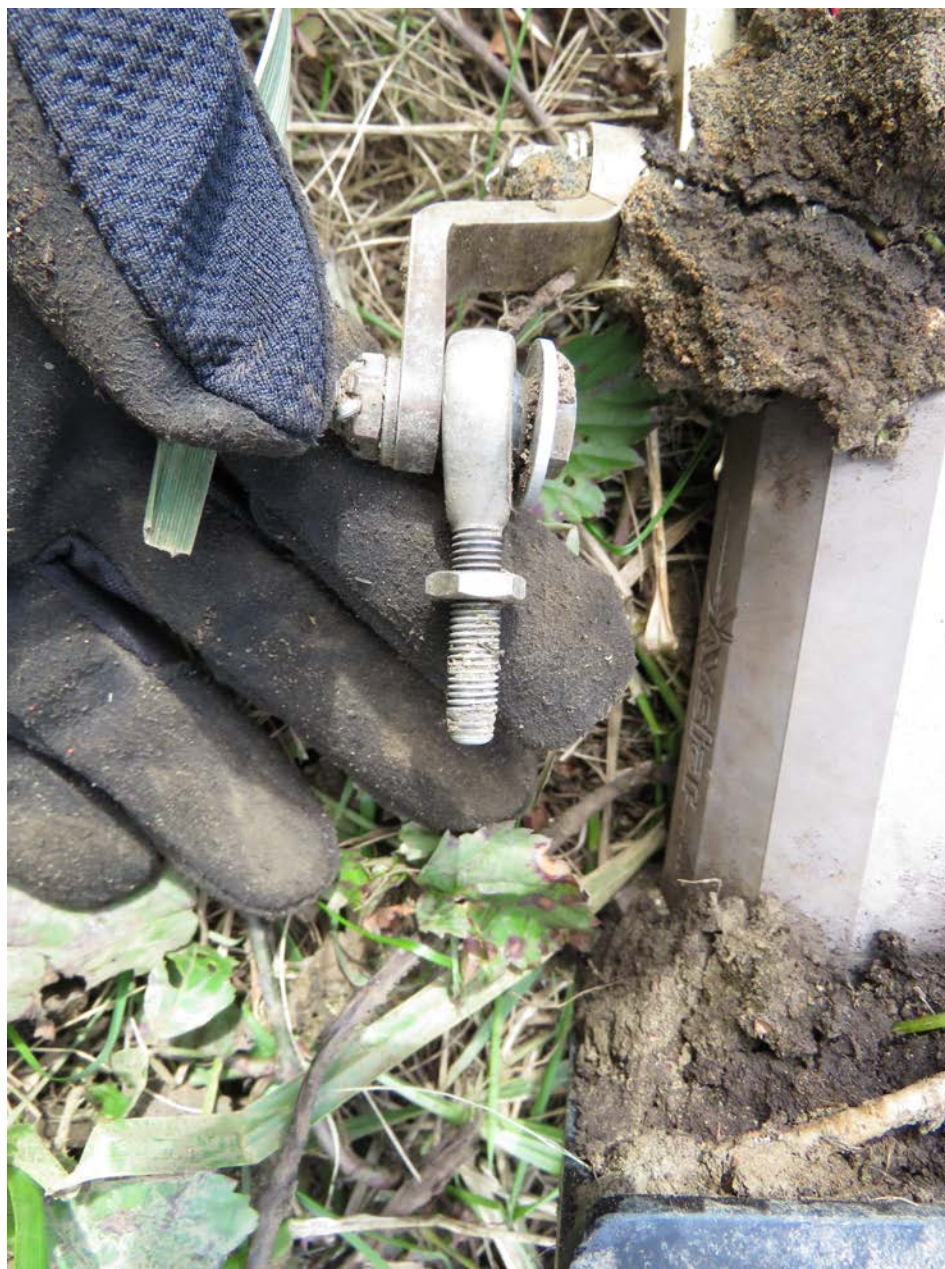
Photo 4 – View of Throttle Control Arm of Carburetor with externally-threaded portion of the two-piece throttle control tie rod still attached to the throttle arm. (Lycoming Engines)

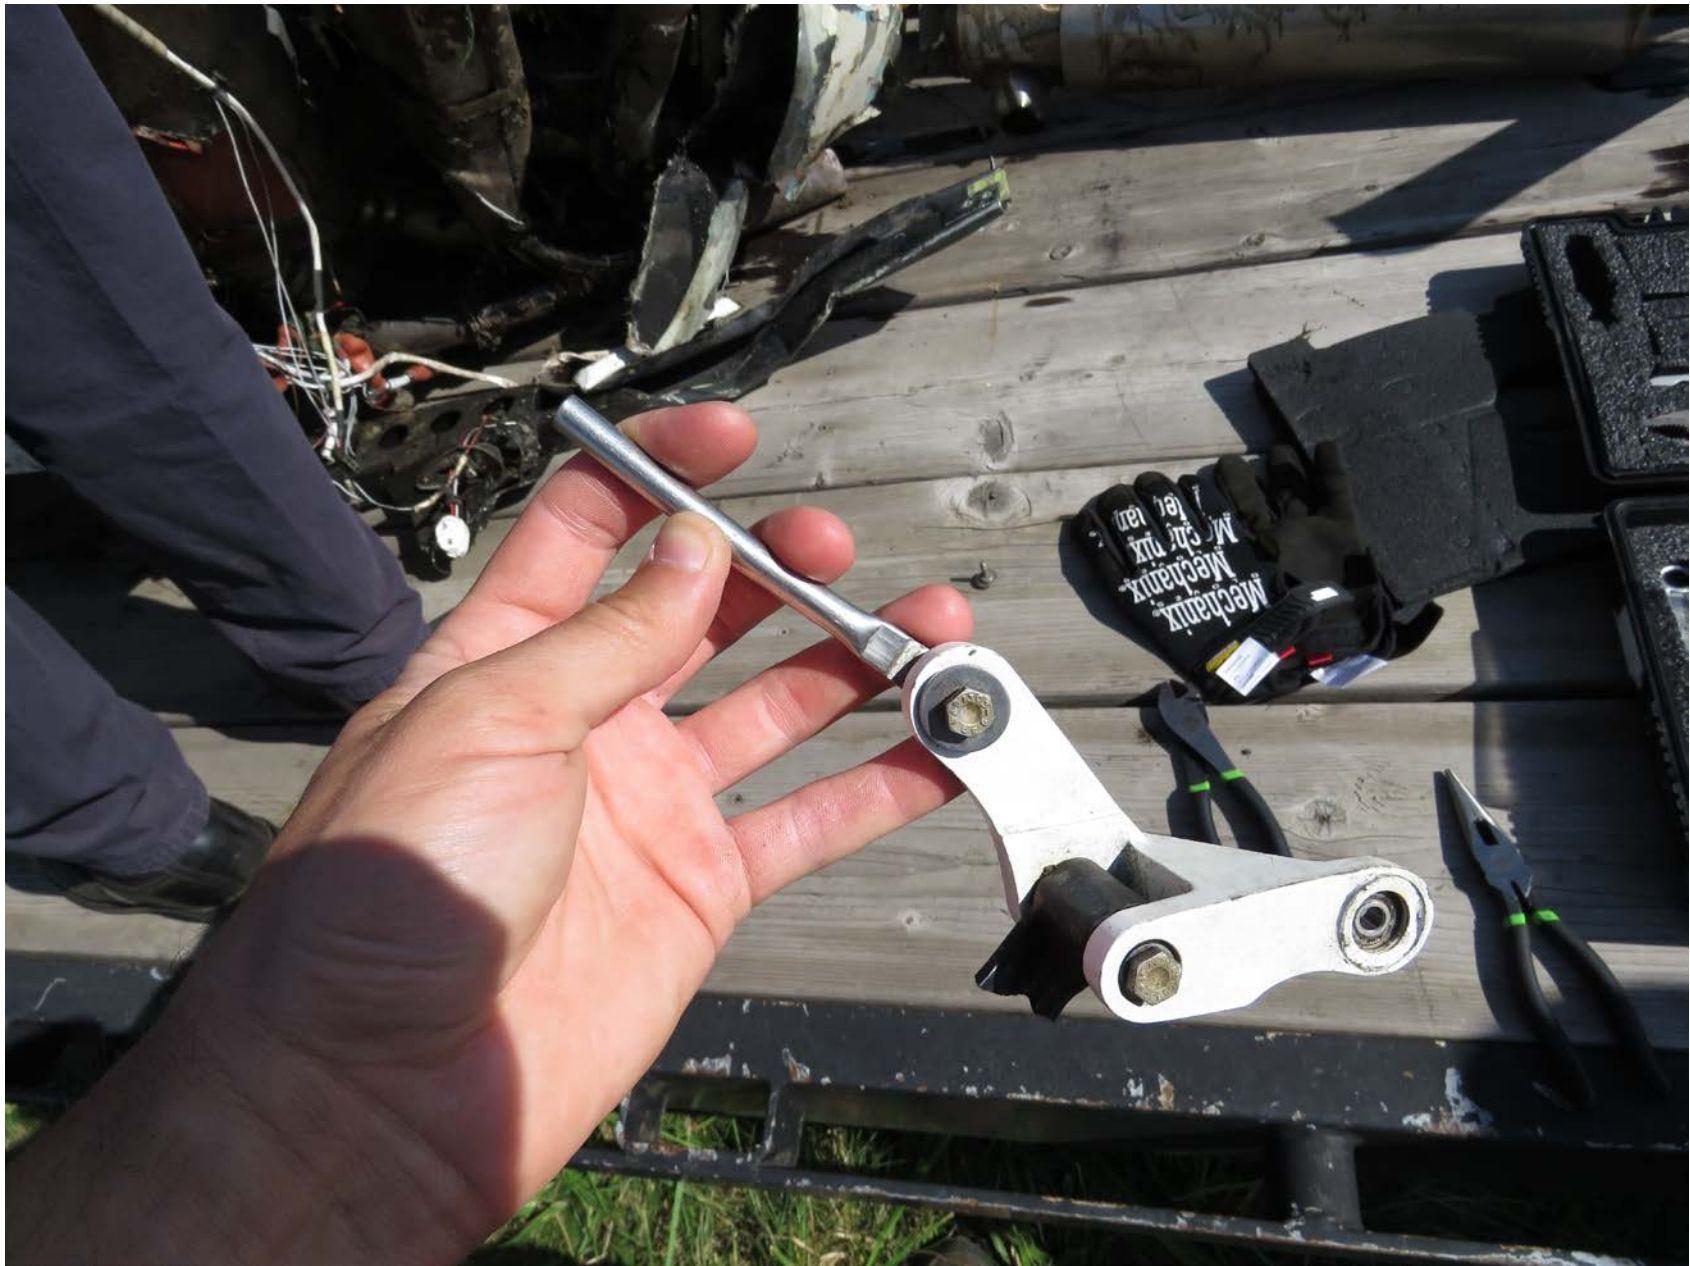
Photo 5 - View of internally-threaded portion of the two-piece throttle control tie rod still attached to the throttle control bellcrank. (Lycoming Engines)

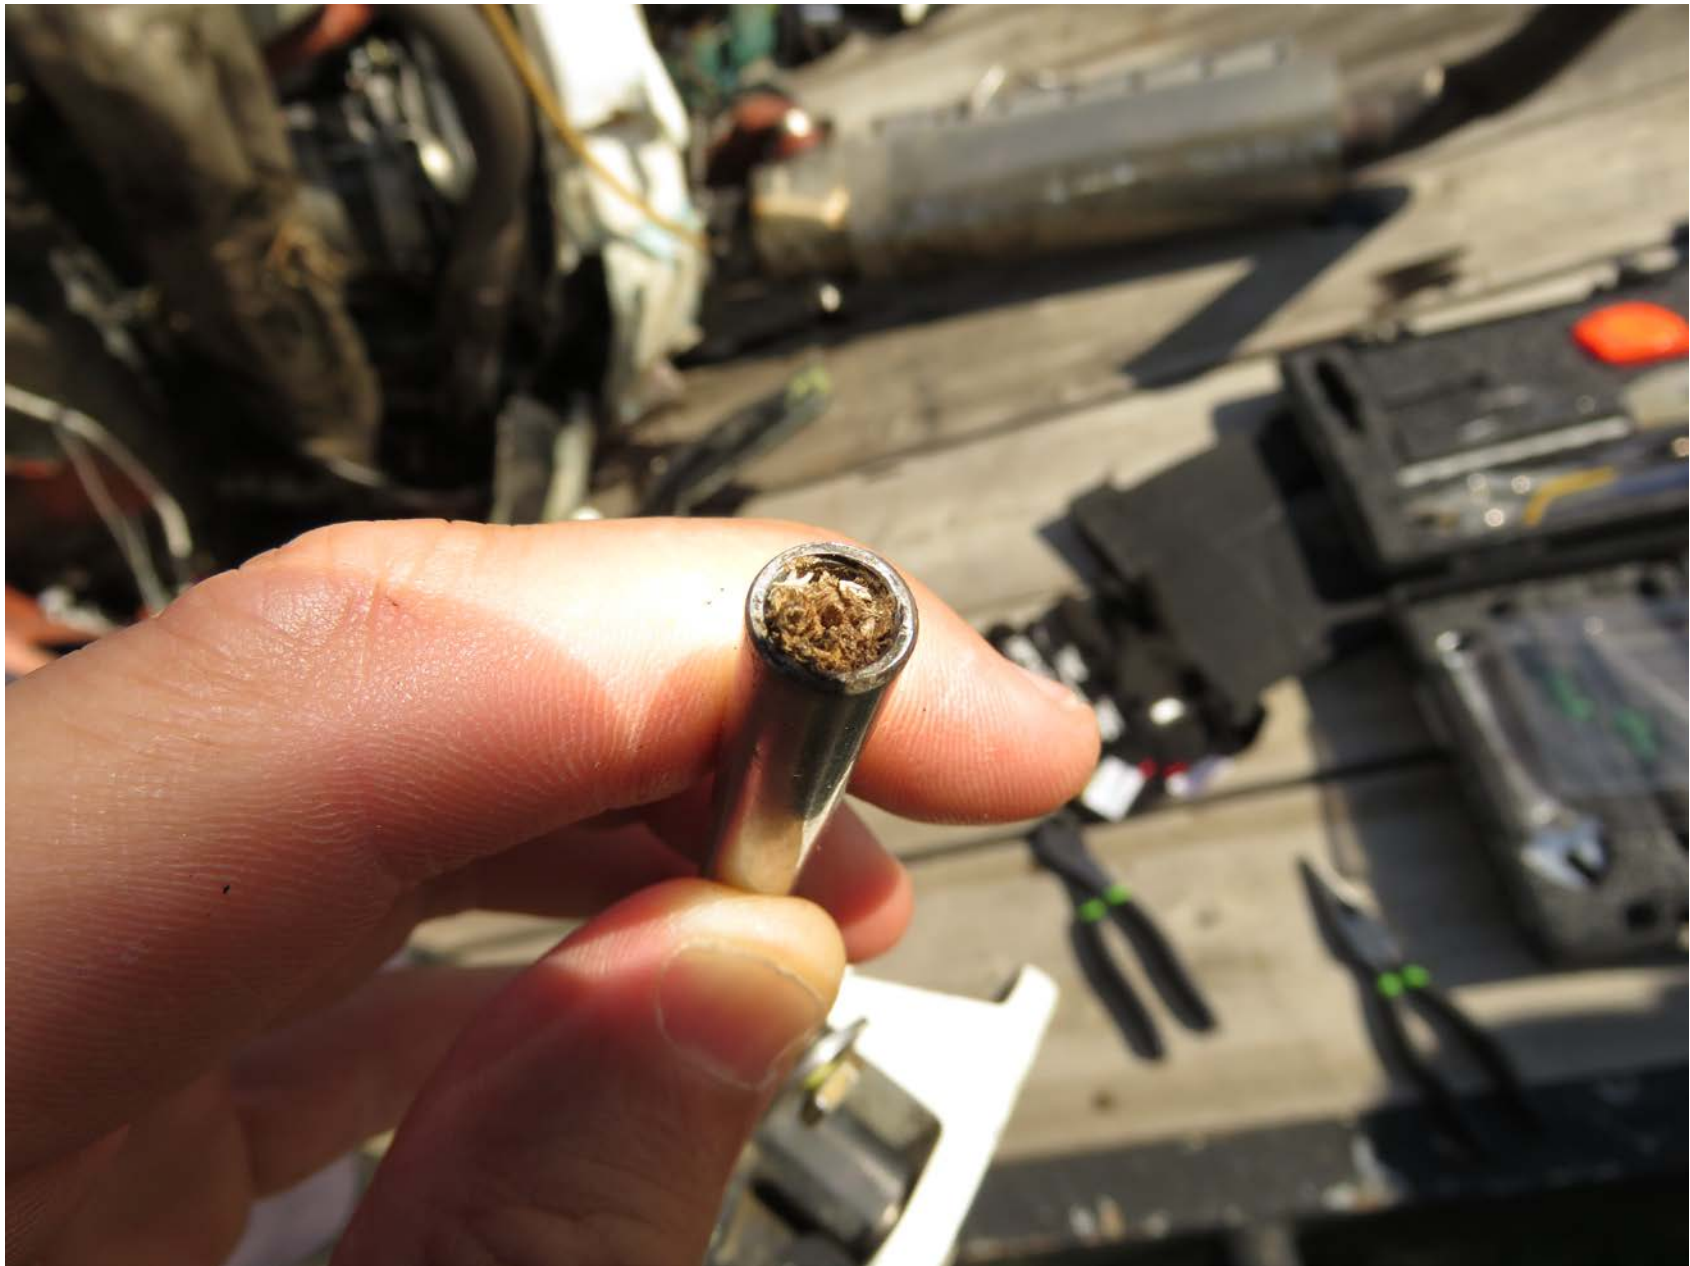
Photo 6 - Photo 5 - View of cellulose material (wood) imbedded in internally-threaded portion of the two-piece throttle control tie rod still attached to the throttle control bellcrank. (Lycoming Engines)

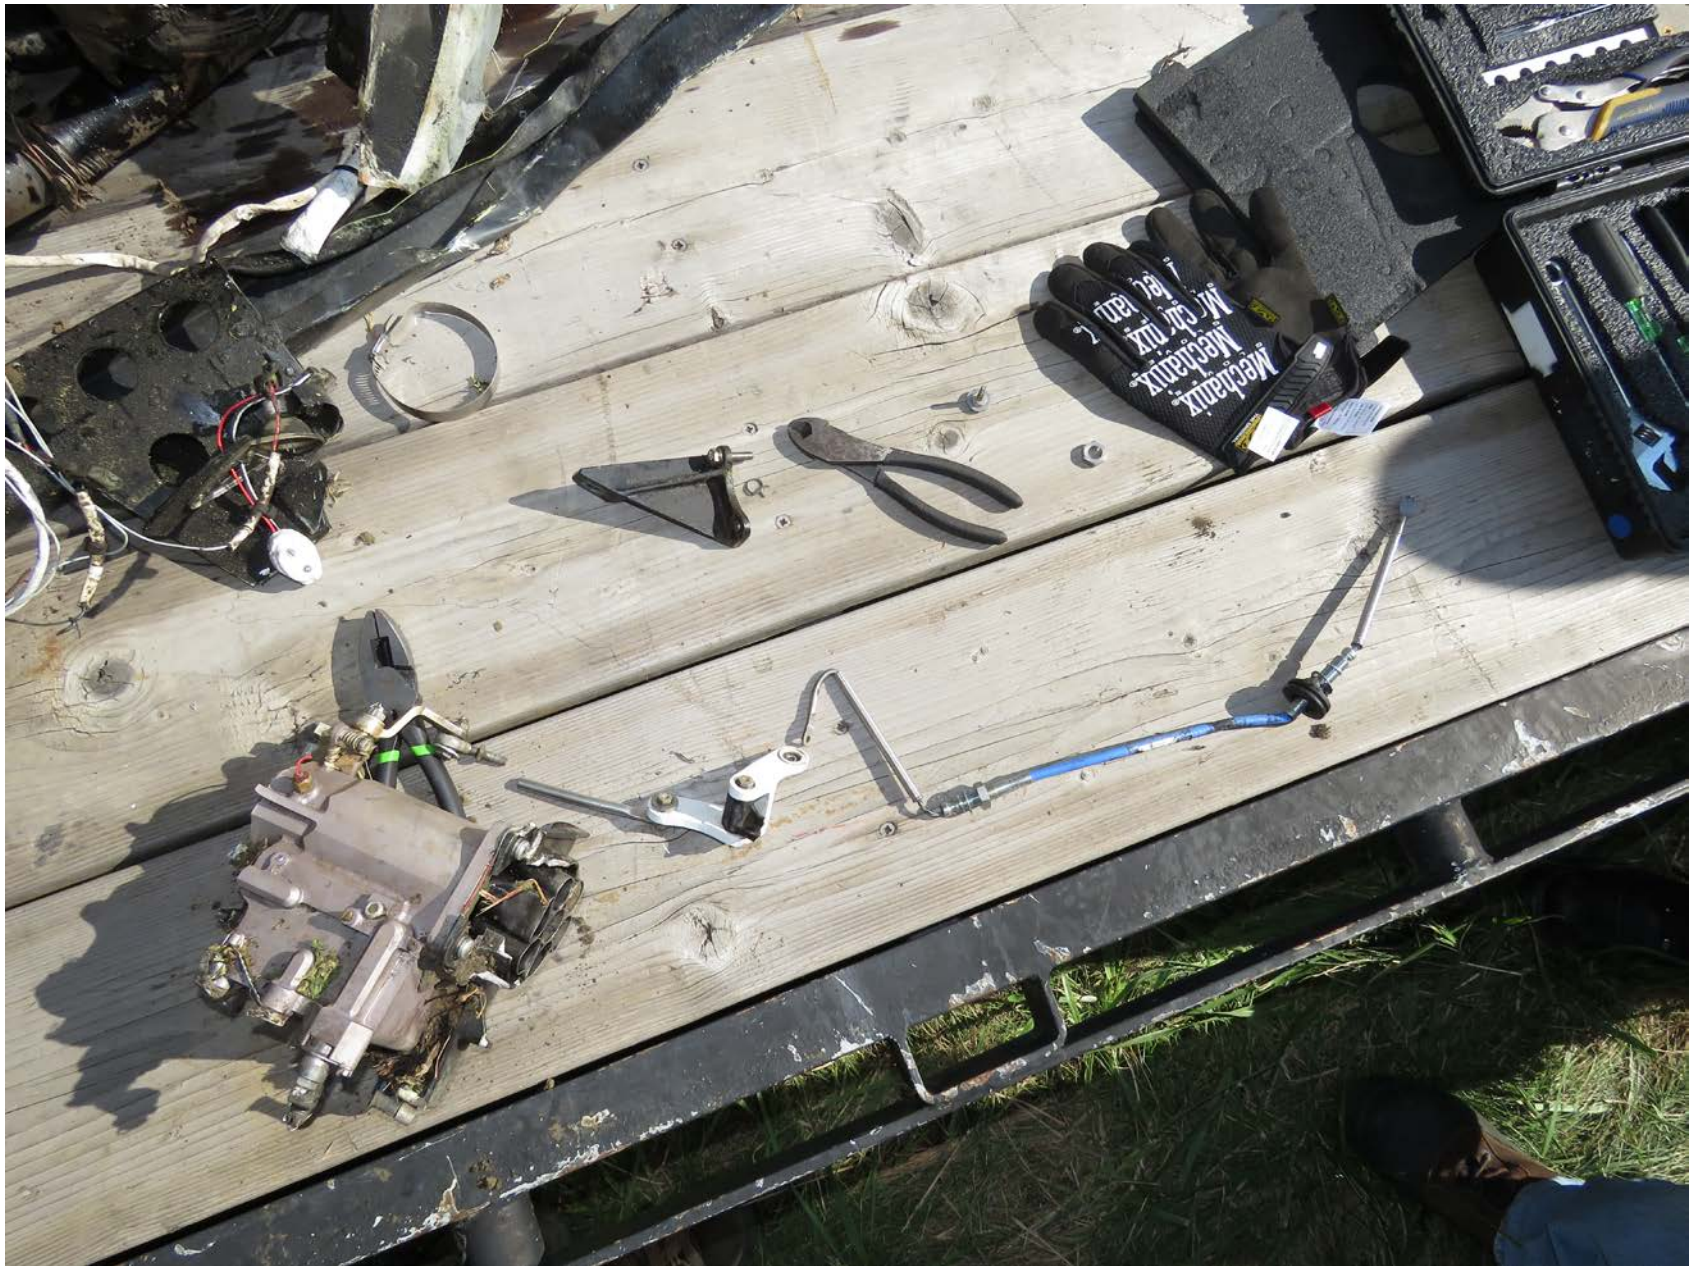
Photo 7 – View of throttle control system after recovery from crash site and wreckage. (Lycoming Engines)

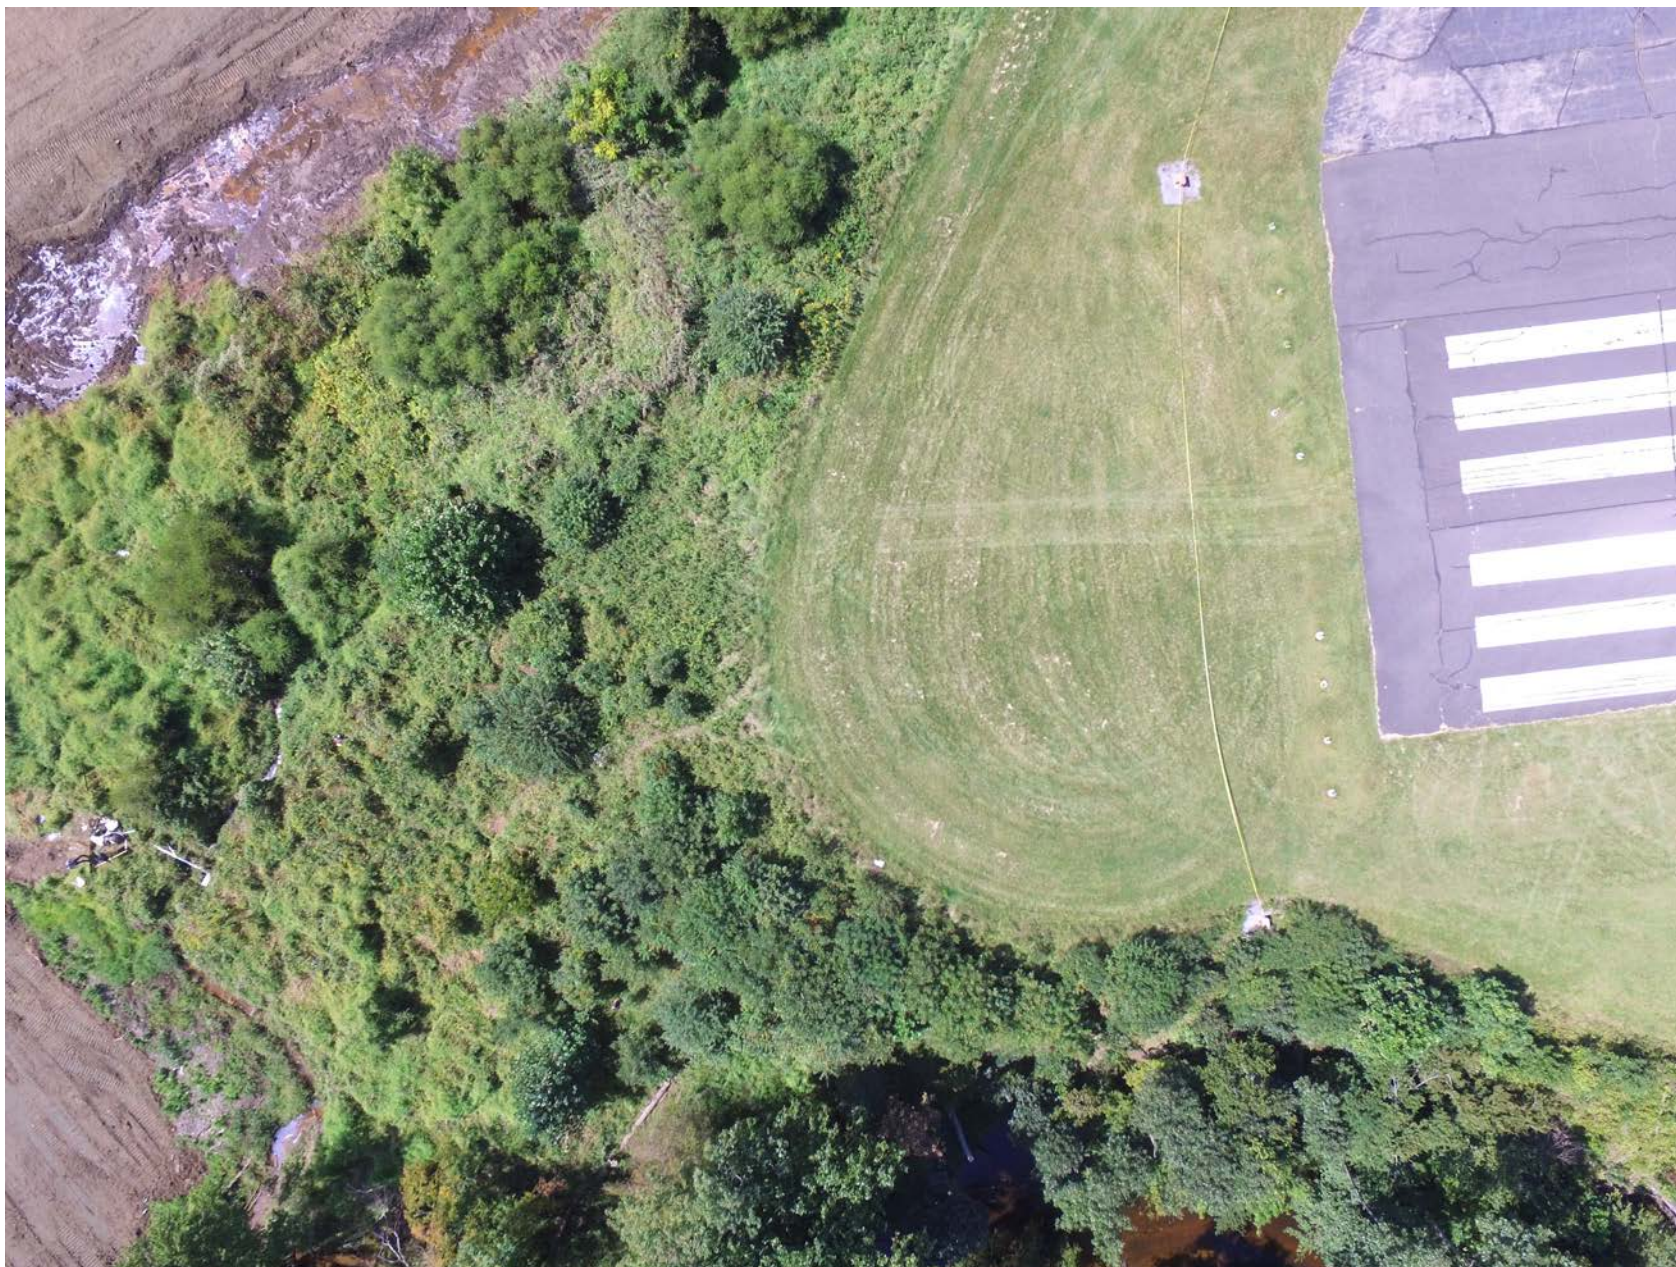
Photo 8 – Overhead view of wreckage in proximity to approach end of Runway 01. (Medford FD)
