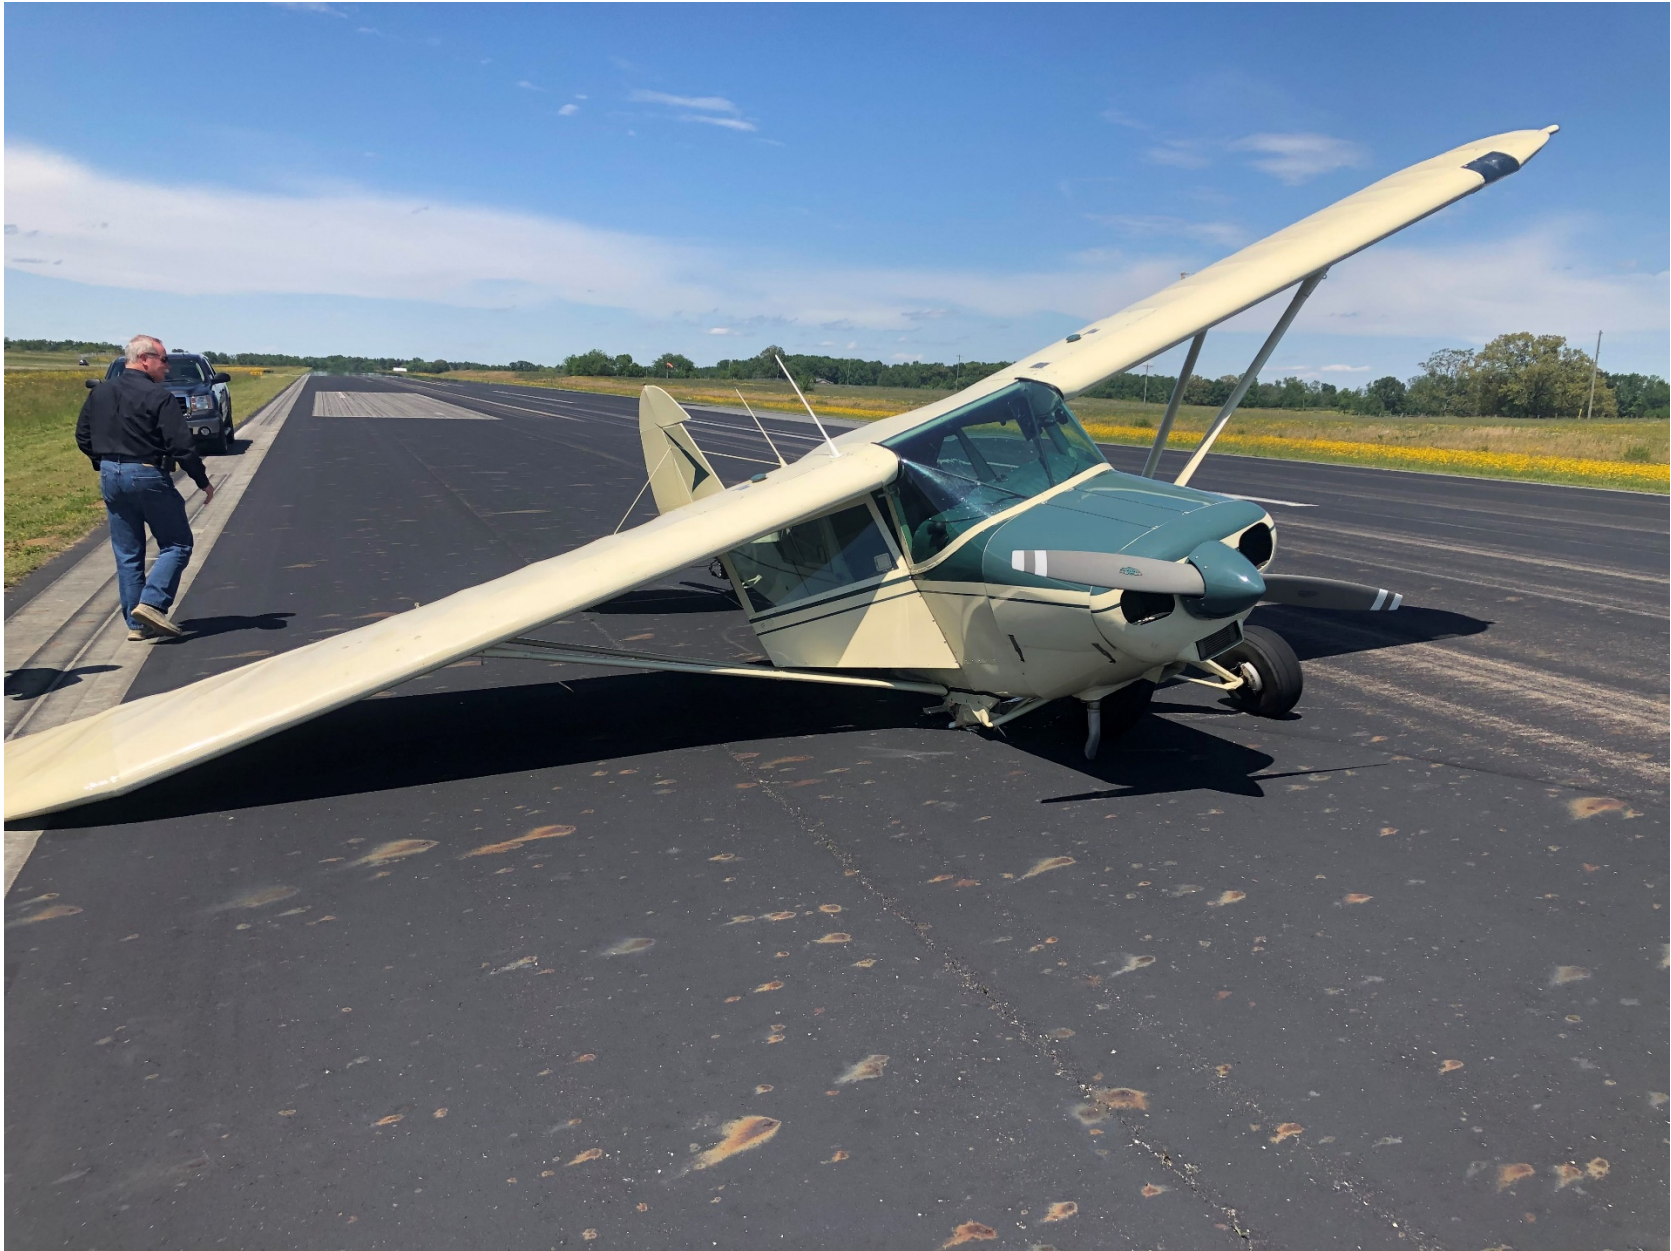
Photo 1 – Main wreckage, front view

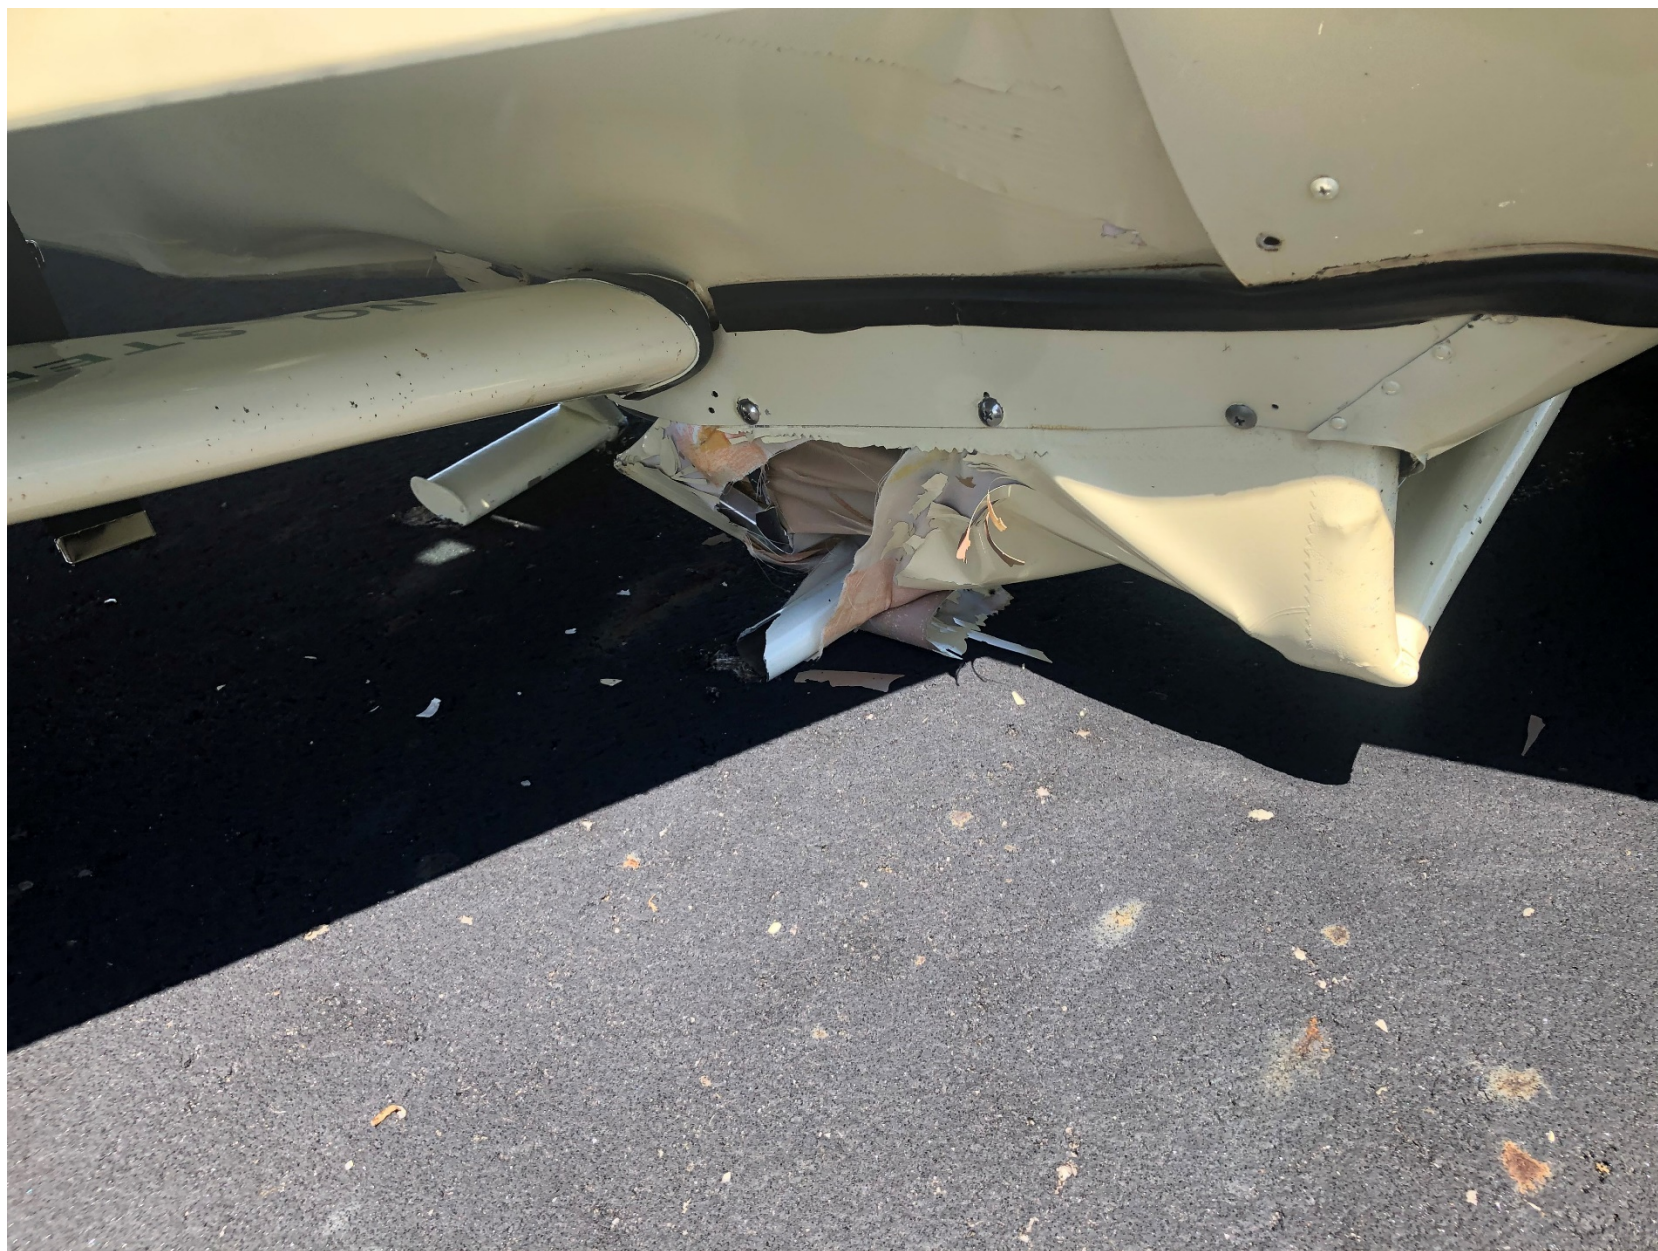
Photo 2 – Right main gear collapse

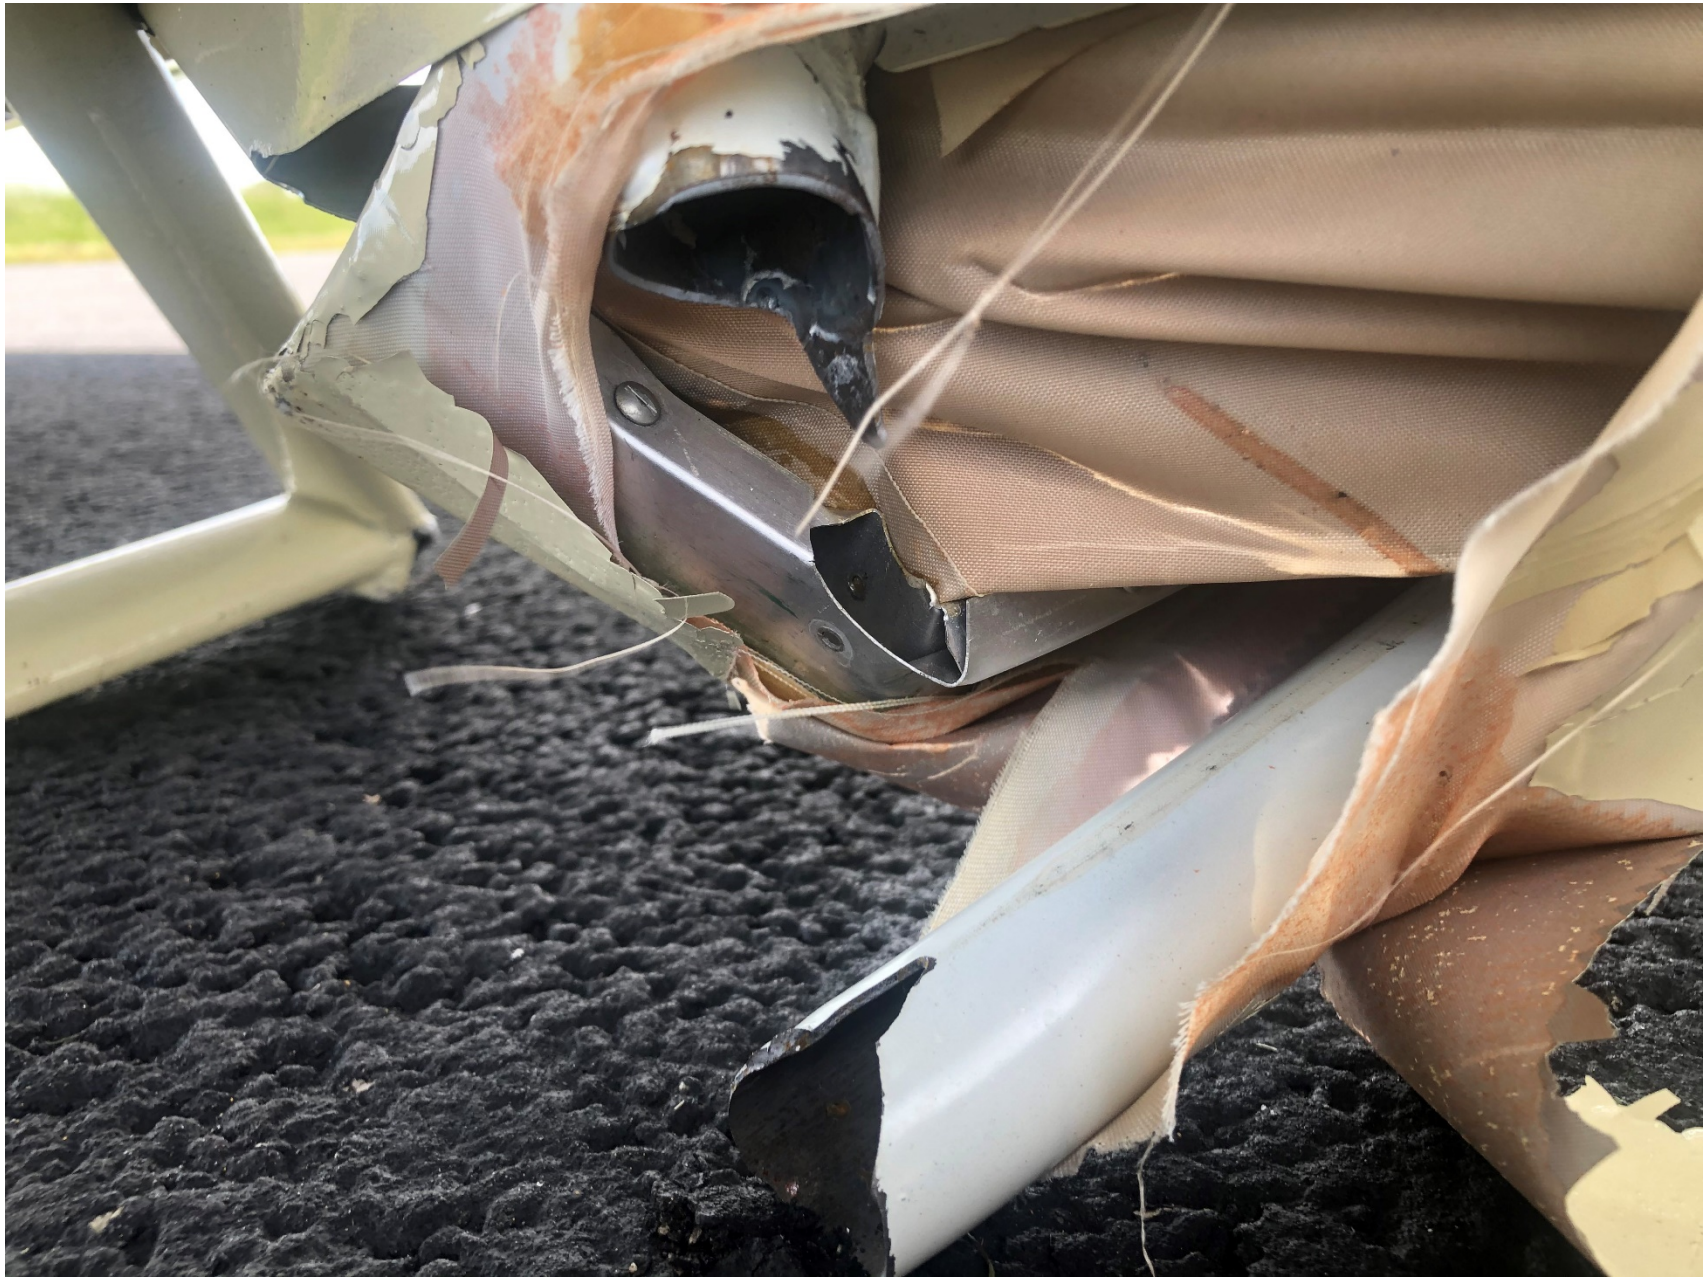
Photo 3 – Fractured landing gear
