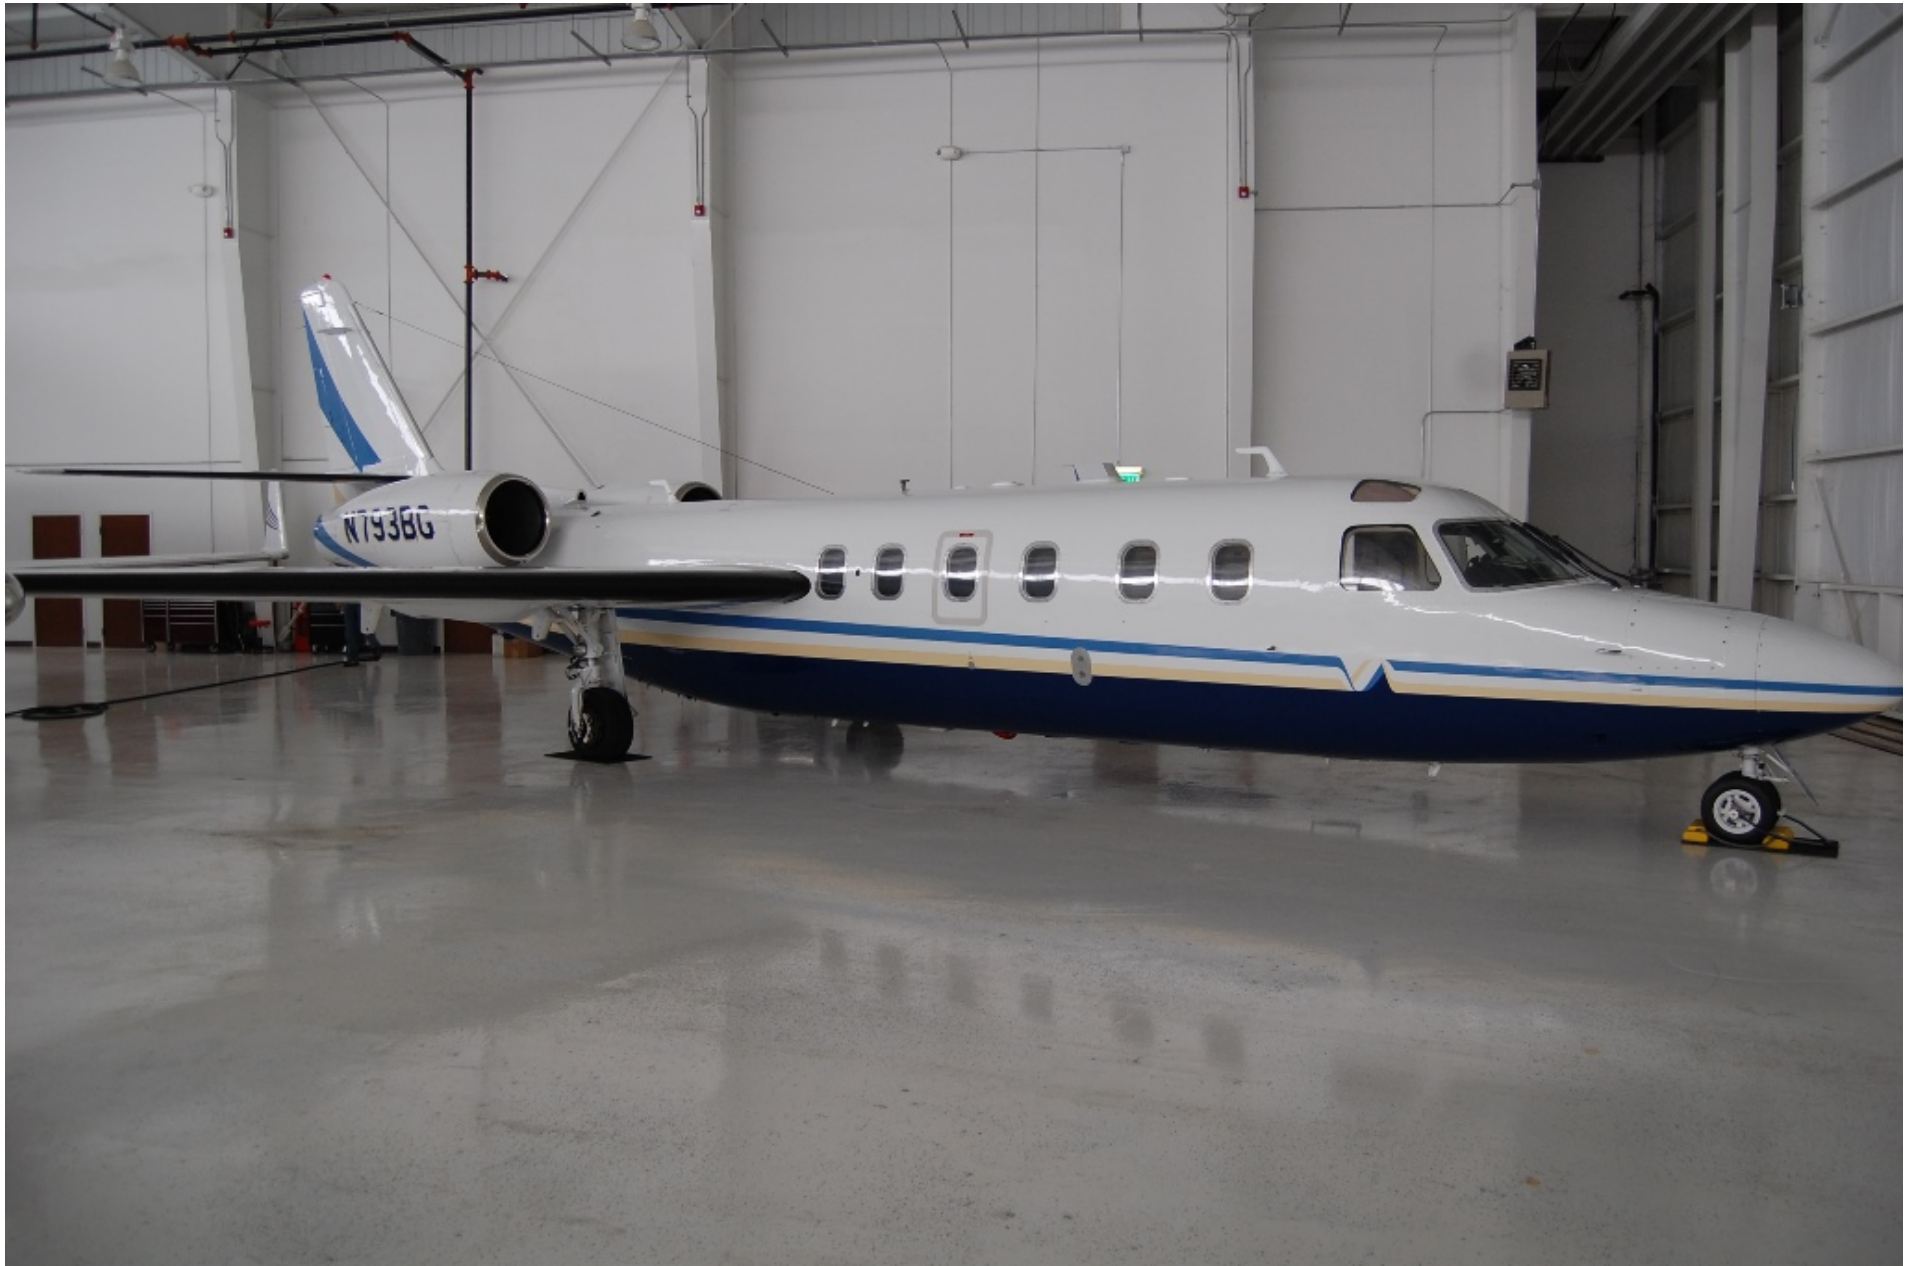
**Photo 1 - Digital Photograph Provided by Operator. Right side view of the Accident Airplane.**

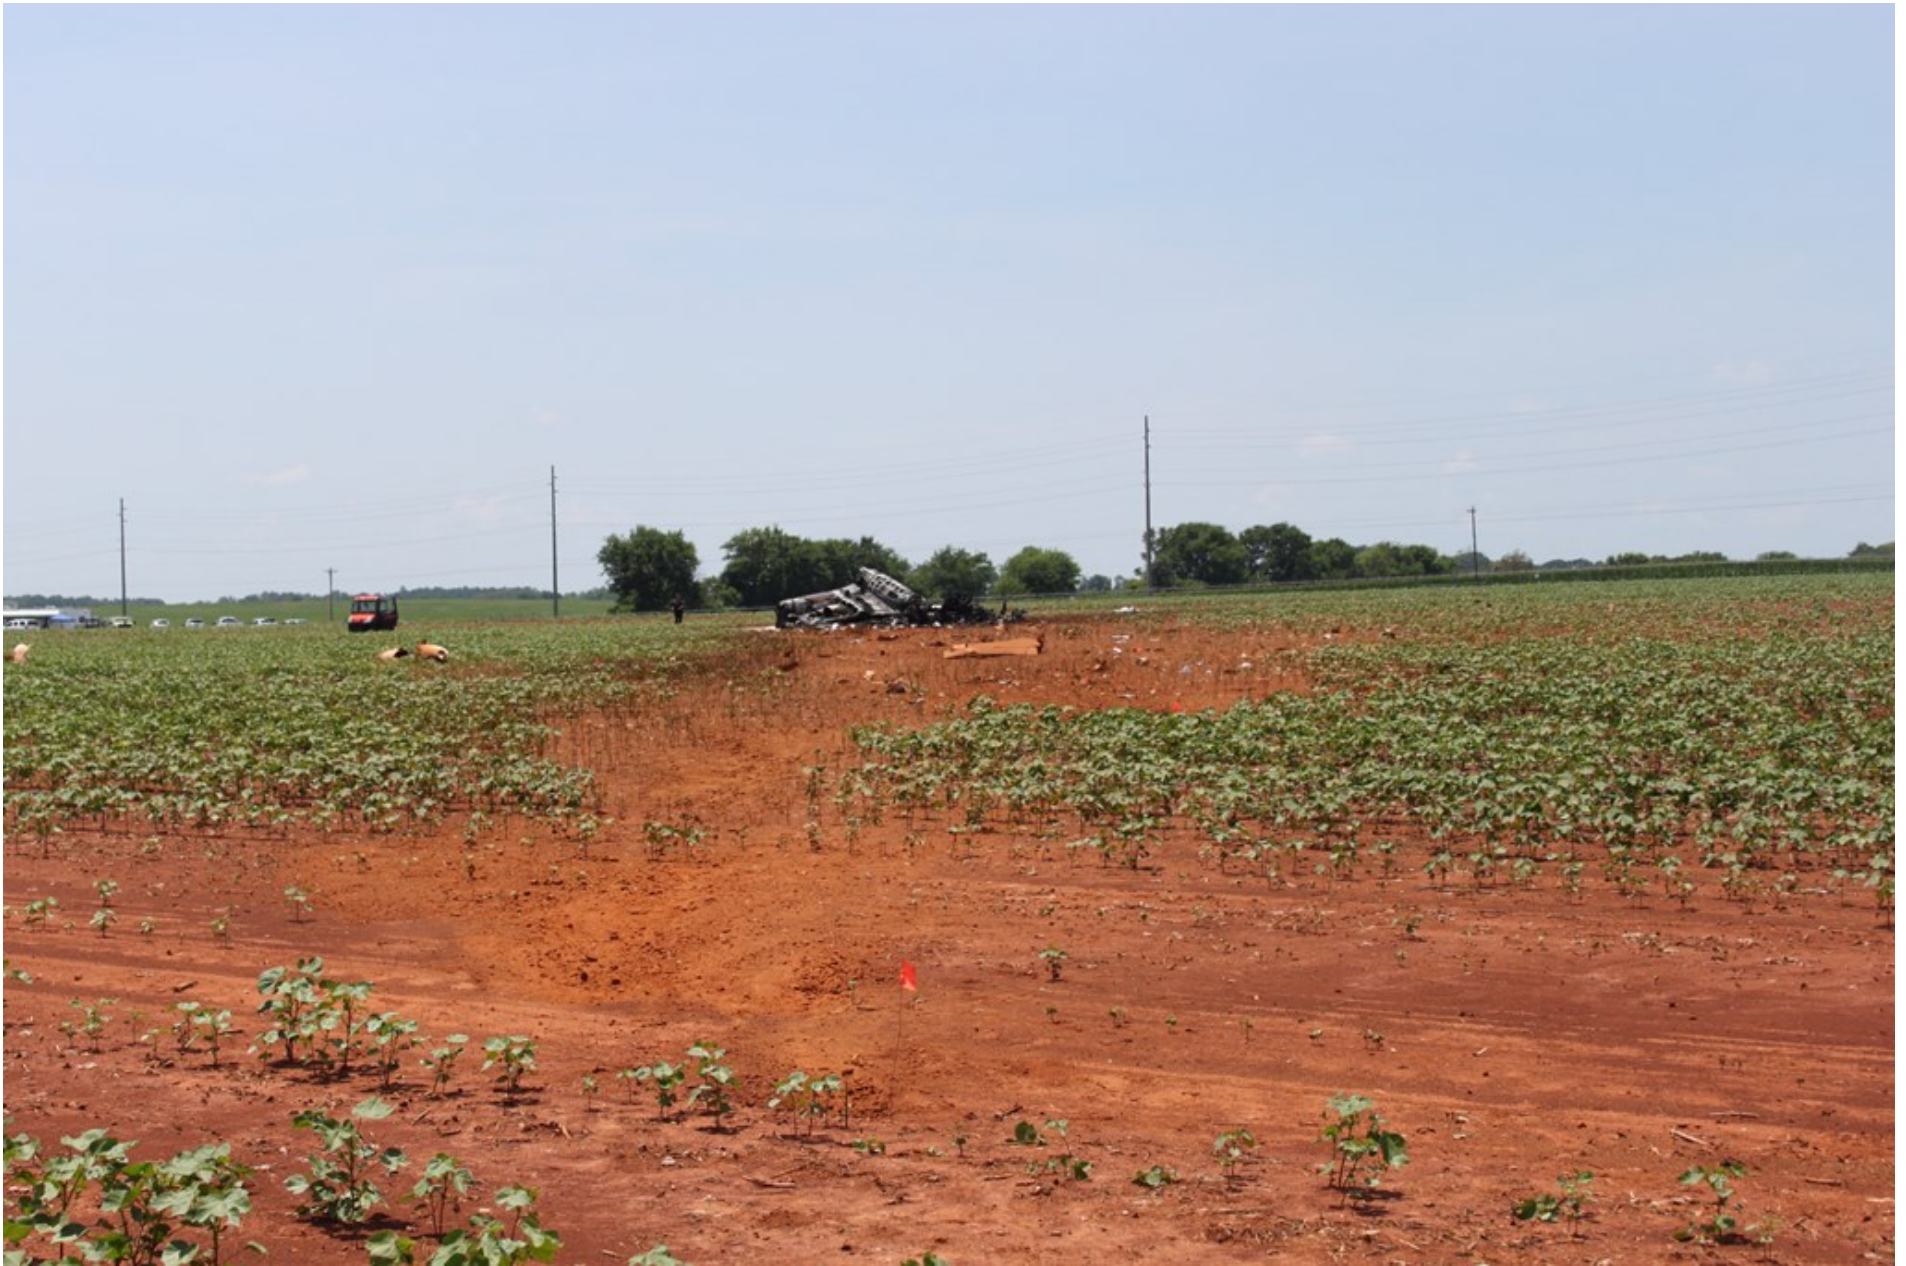
**Photo 2 - NTSB Digital Photograph. View depicting the first impact crater and the energy path of the airplane with the wreckage in the background.**

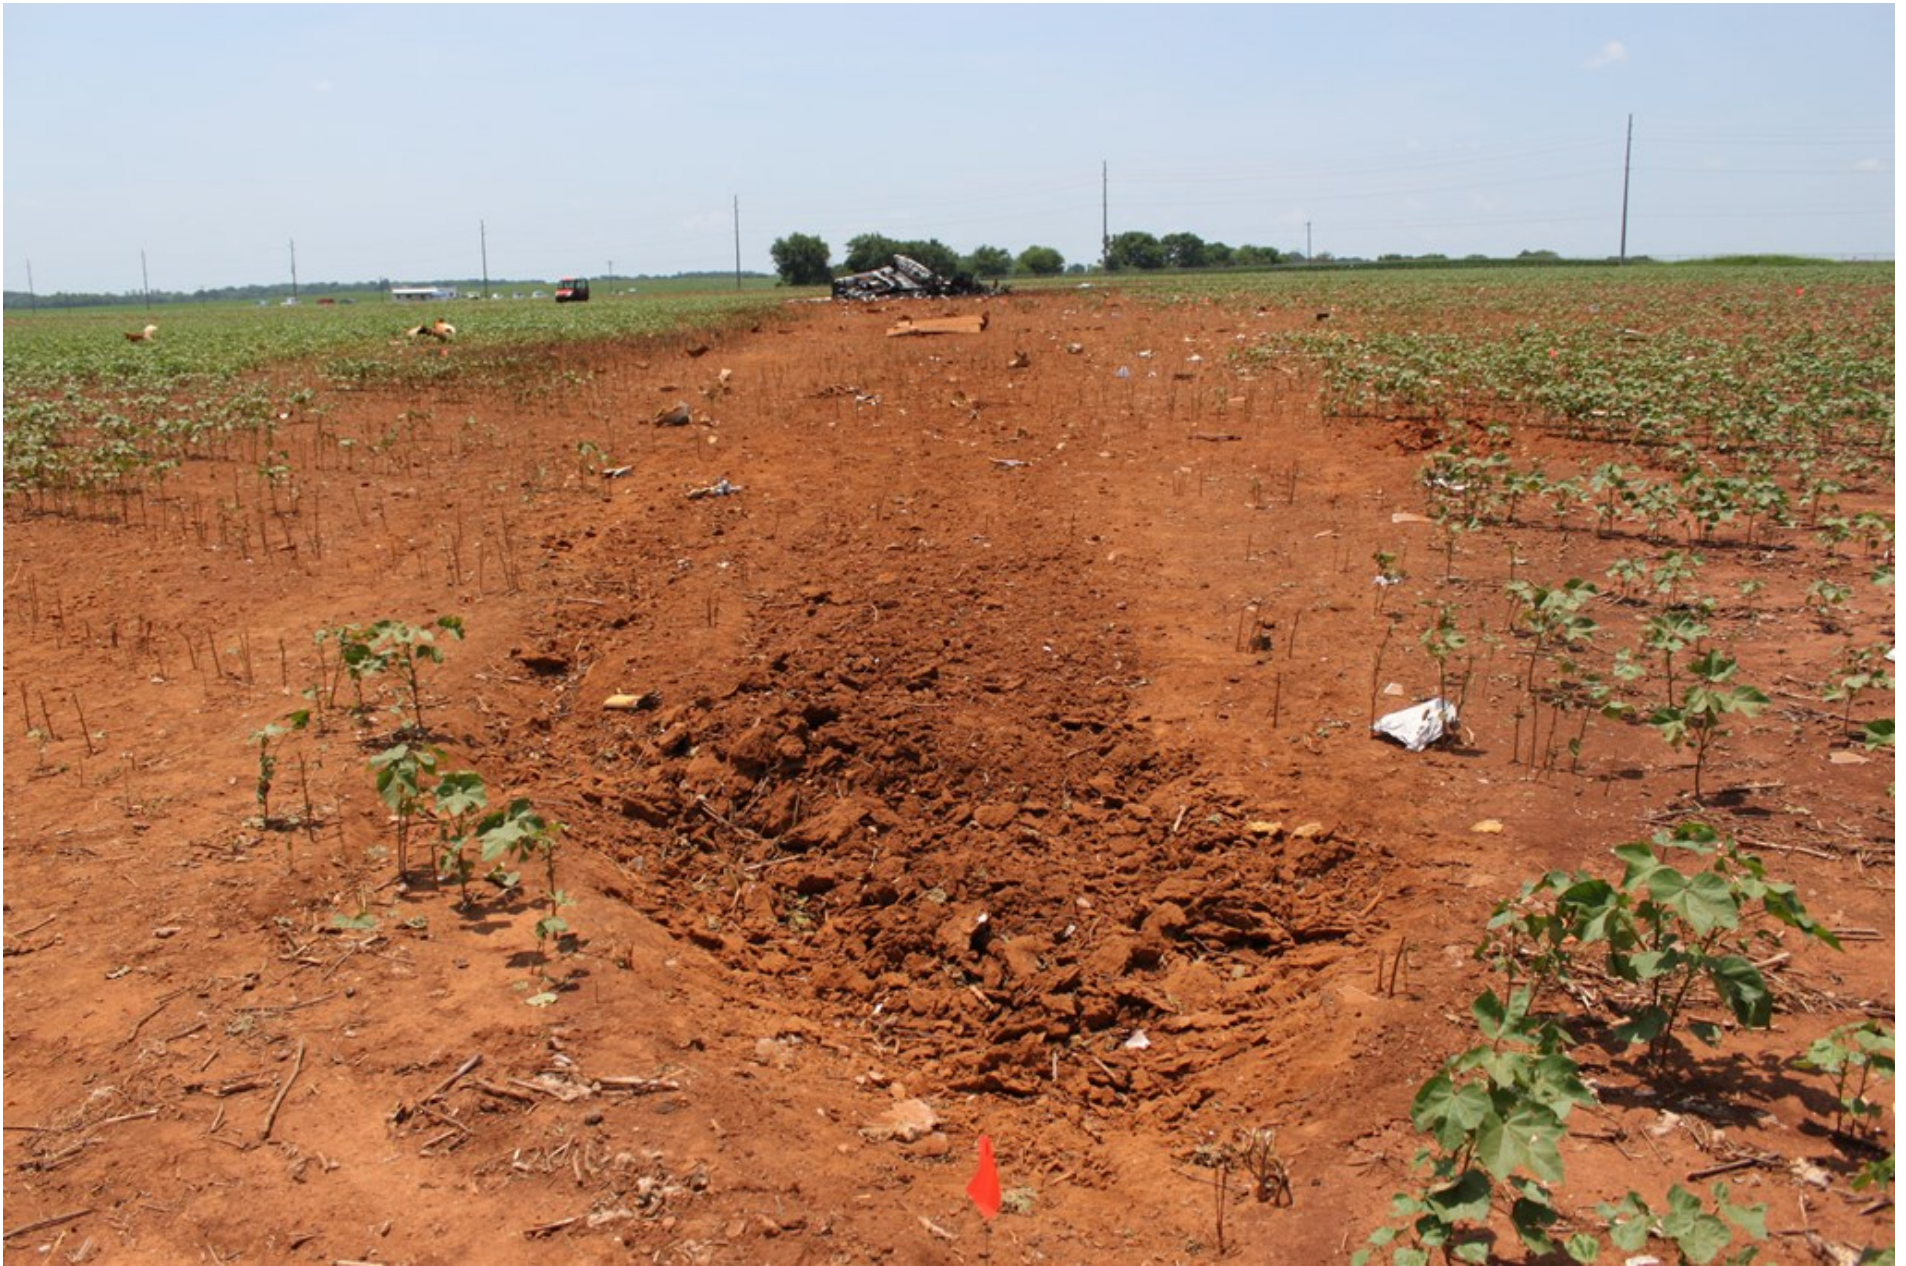
**Photo 3 - NTSB Digital Photograph. View of the energy path taken from the impact crater containing glass fragments.**

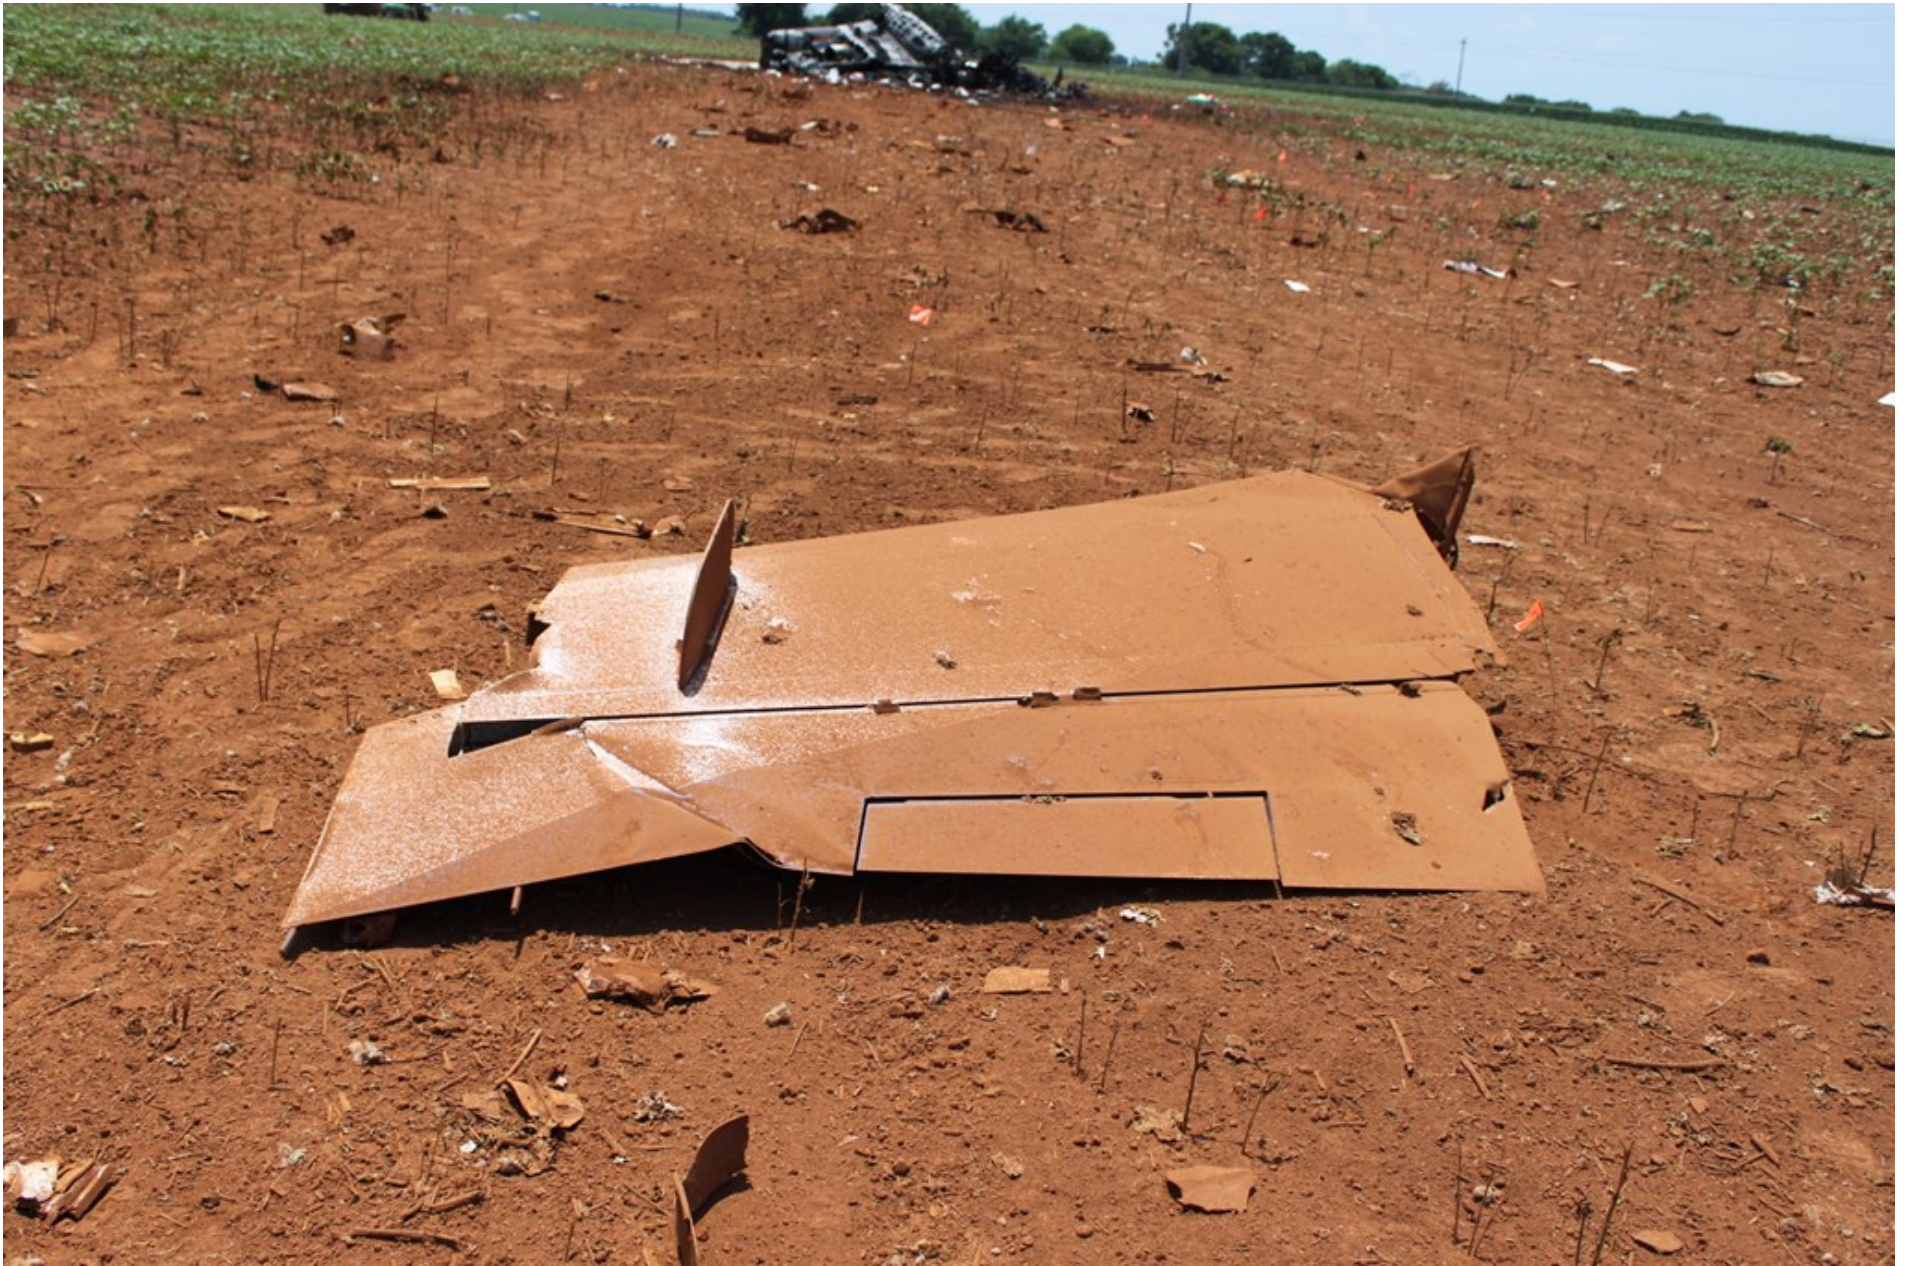
**Photo 4 - NTSB Digital Photograph. View depicting the separated vertical stabilizer, rudder, and attached rudder trim tab, with wreckage in the background.**

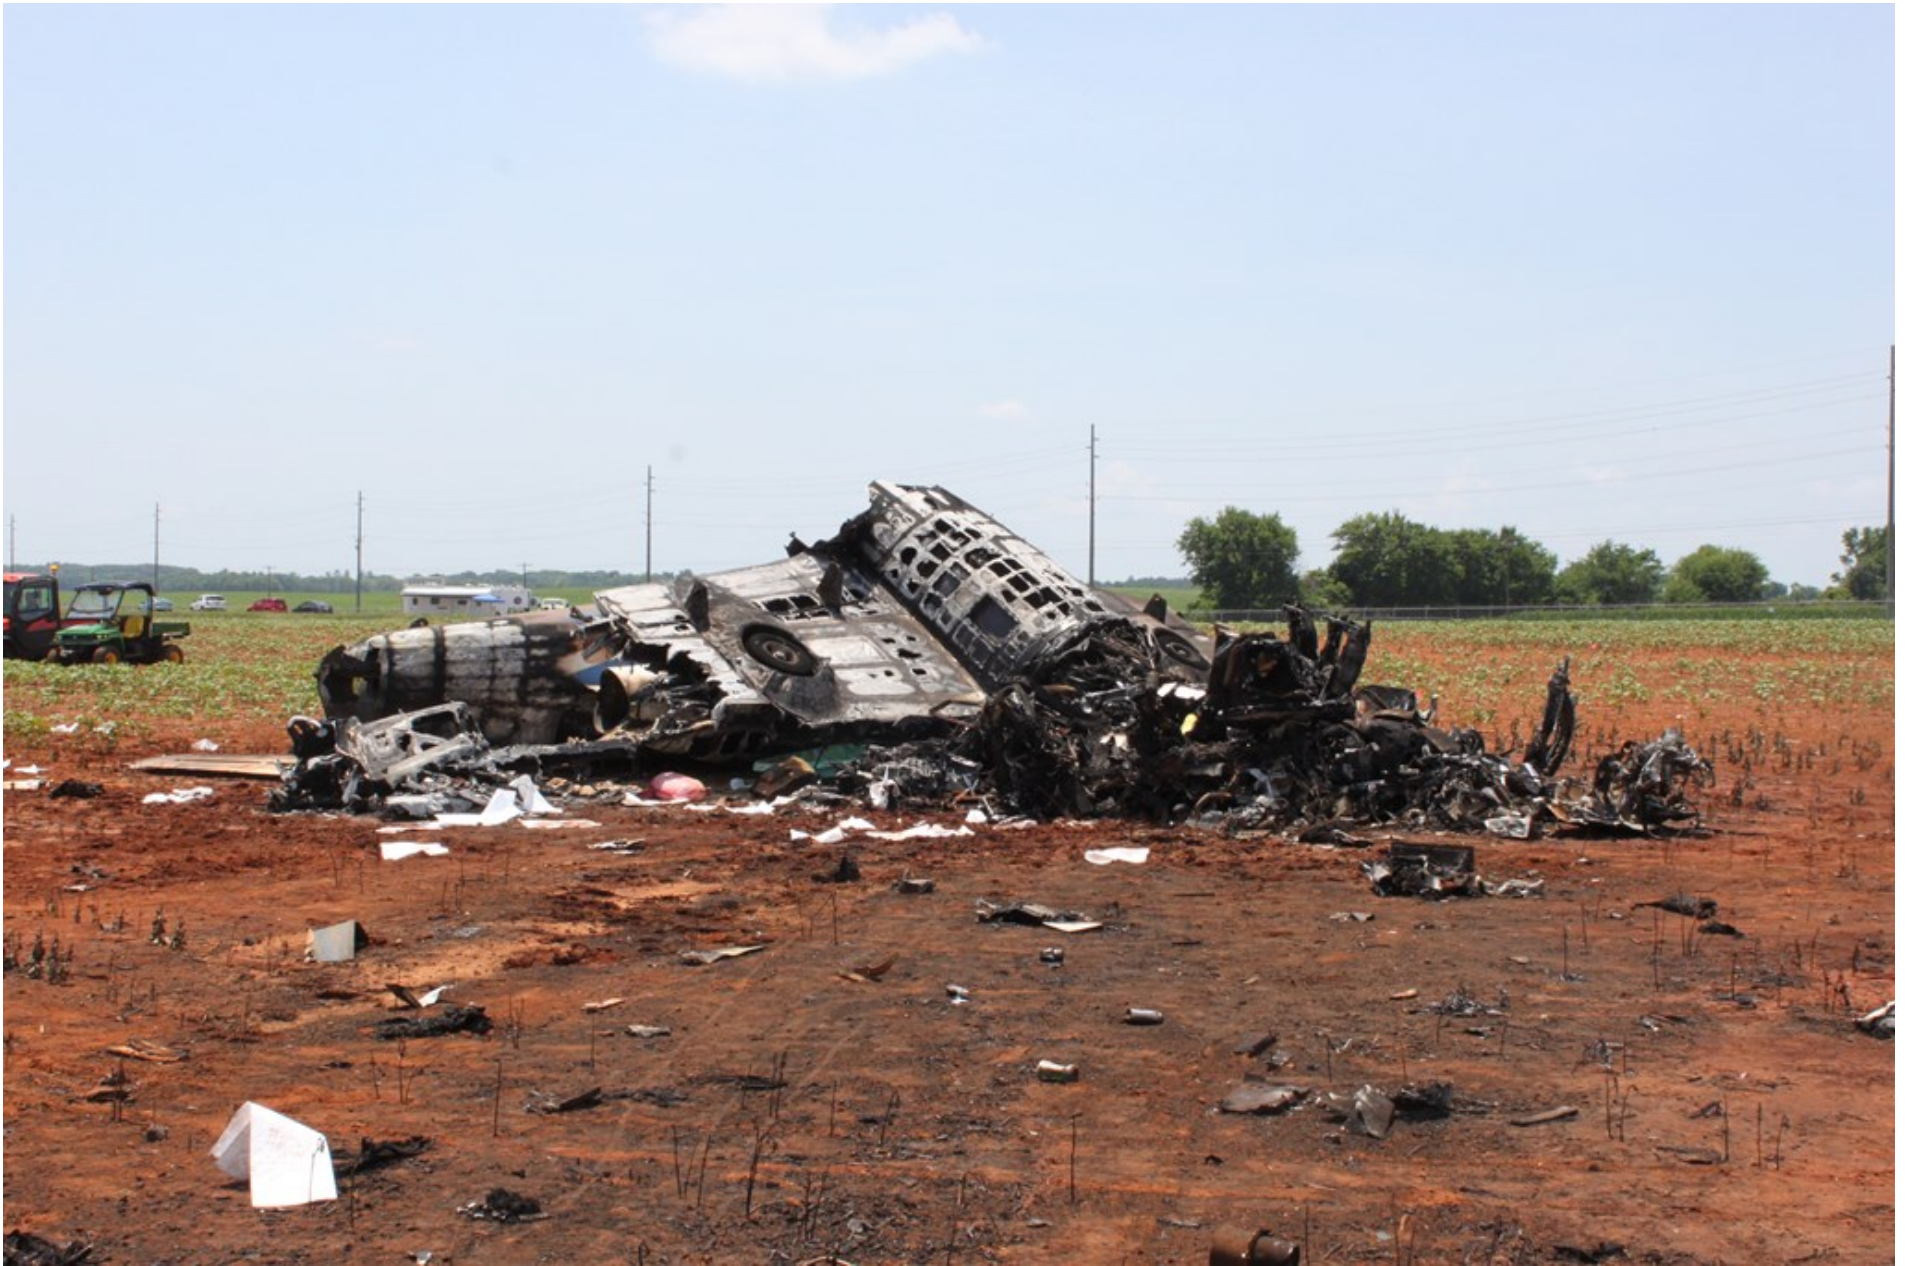
**Photo 5 - NTSB Digital Photograph. View depicting the resting position of the inverted wing and fuselage section of the main wreckage.**

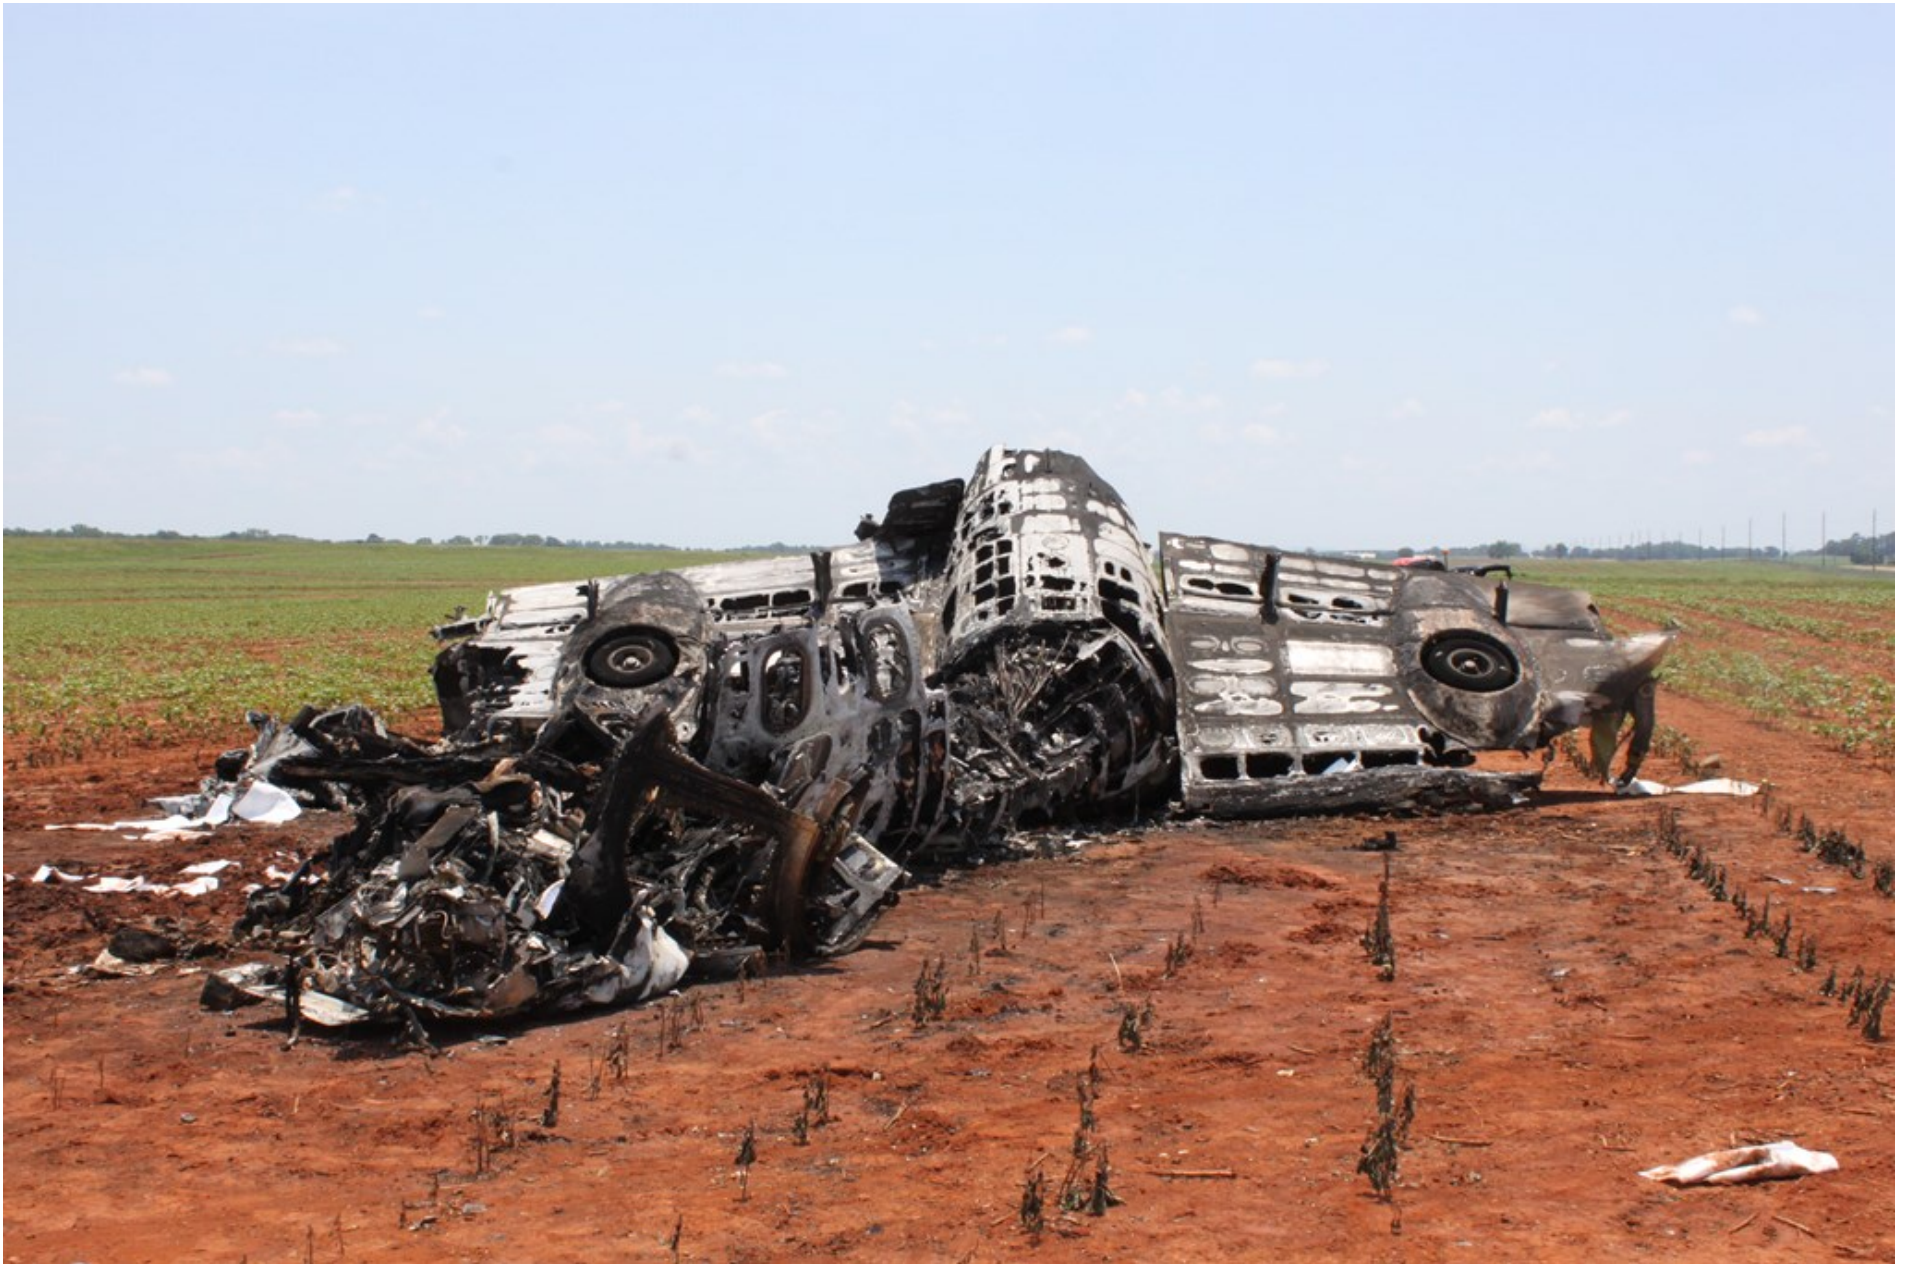
**Photo 6 - NTSB Digital Photograph. Another view depicting the resting position of the inverted wing and fuselage section of the wreckage.**

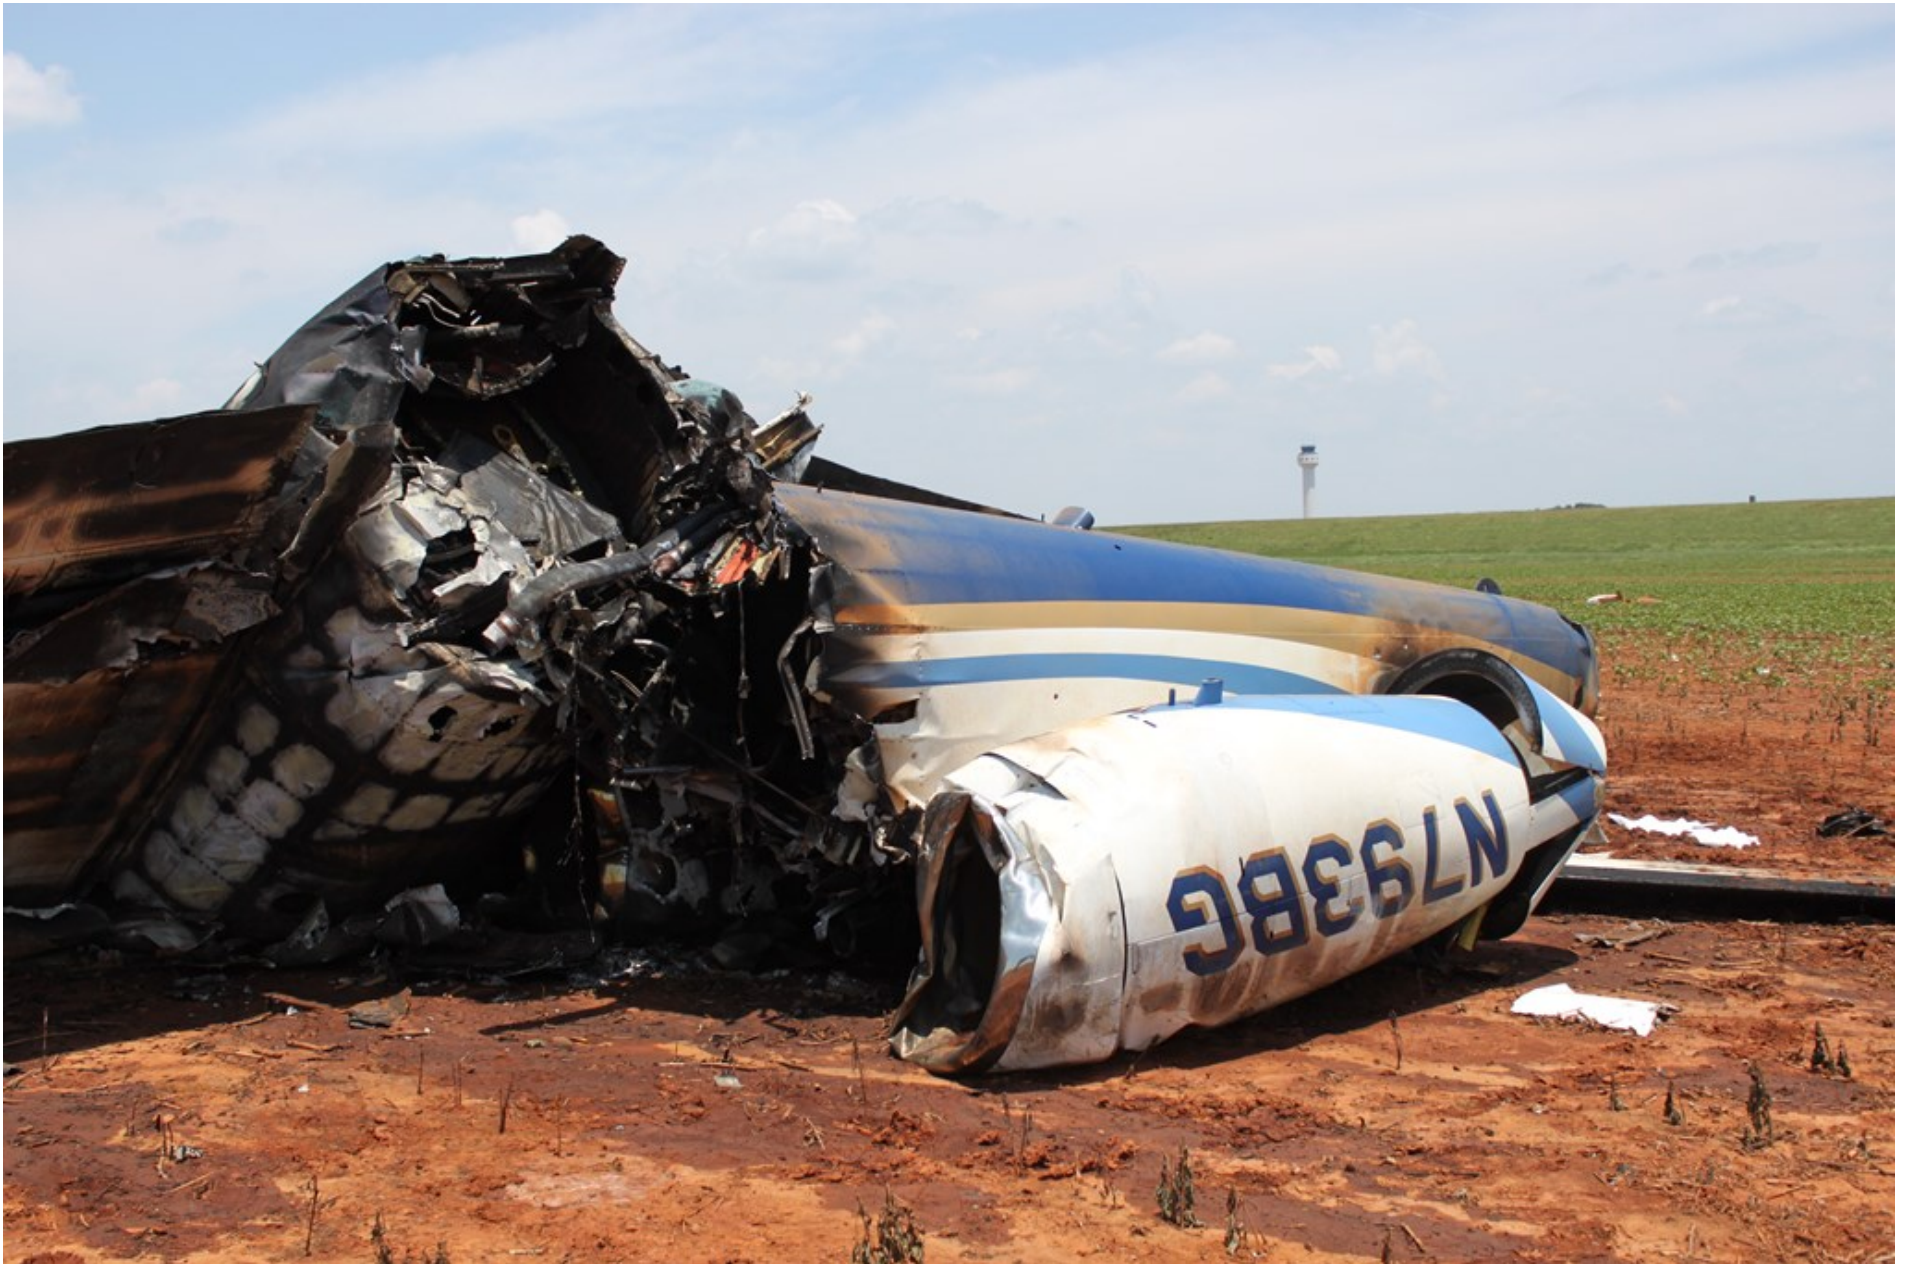
**Photo 7 - NTSB Digital Photograph. View depicting the inverted wing and fuselage. Note the attached right engine and partially deployed upper and lower right thrust reverser clamshell doors.**

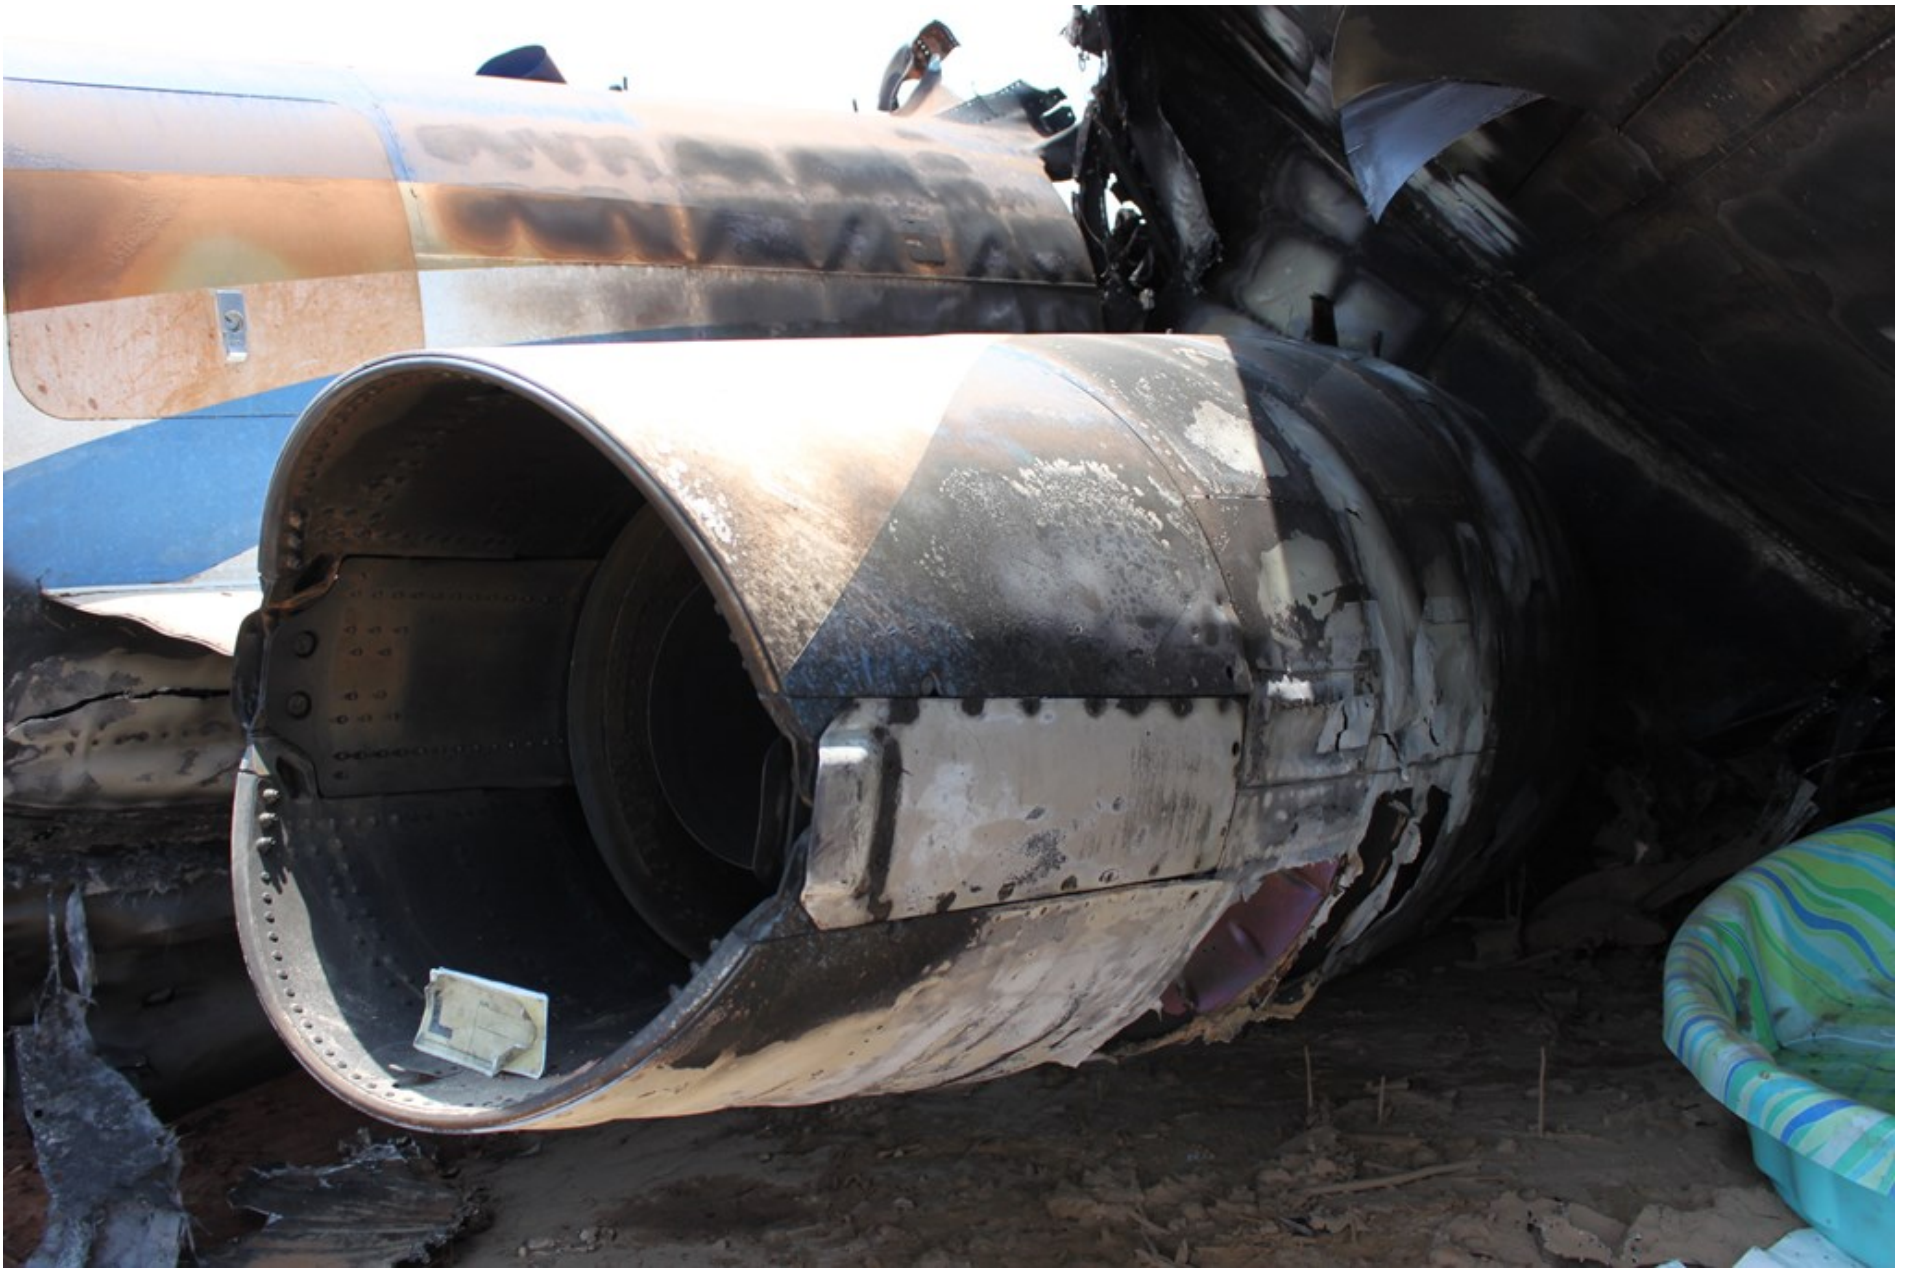
**Photo 8 - NTSB Digital Photograph. View depicting the left engine upper and lower thrust reverser clamshell doors.**

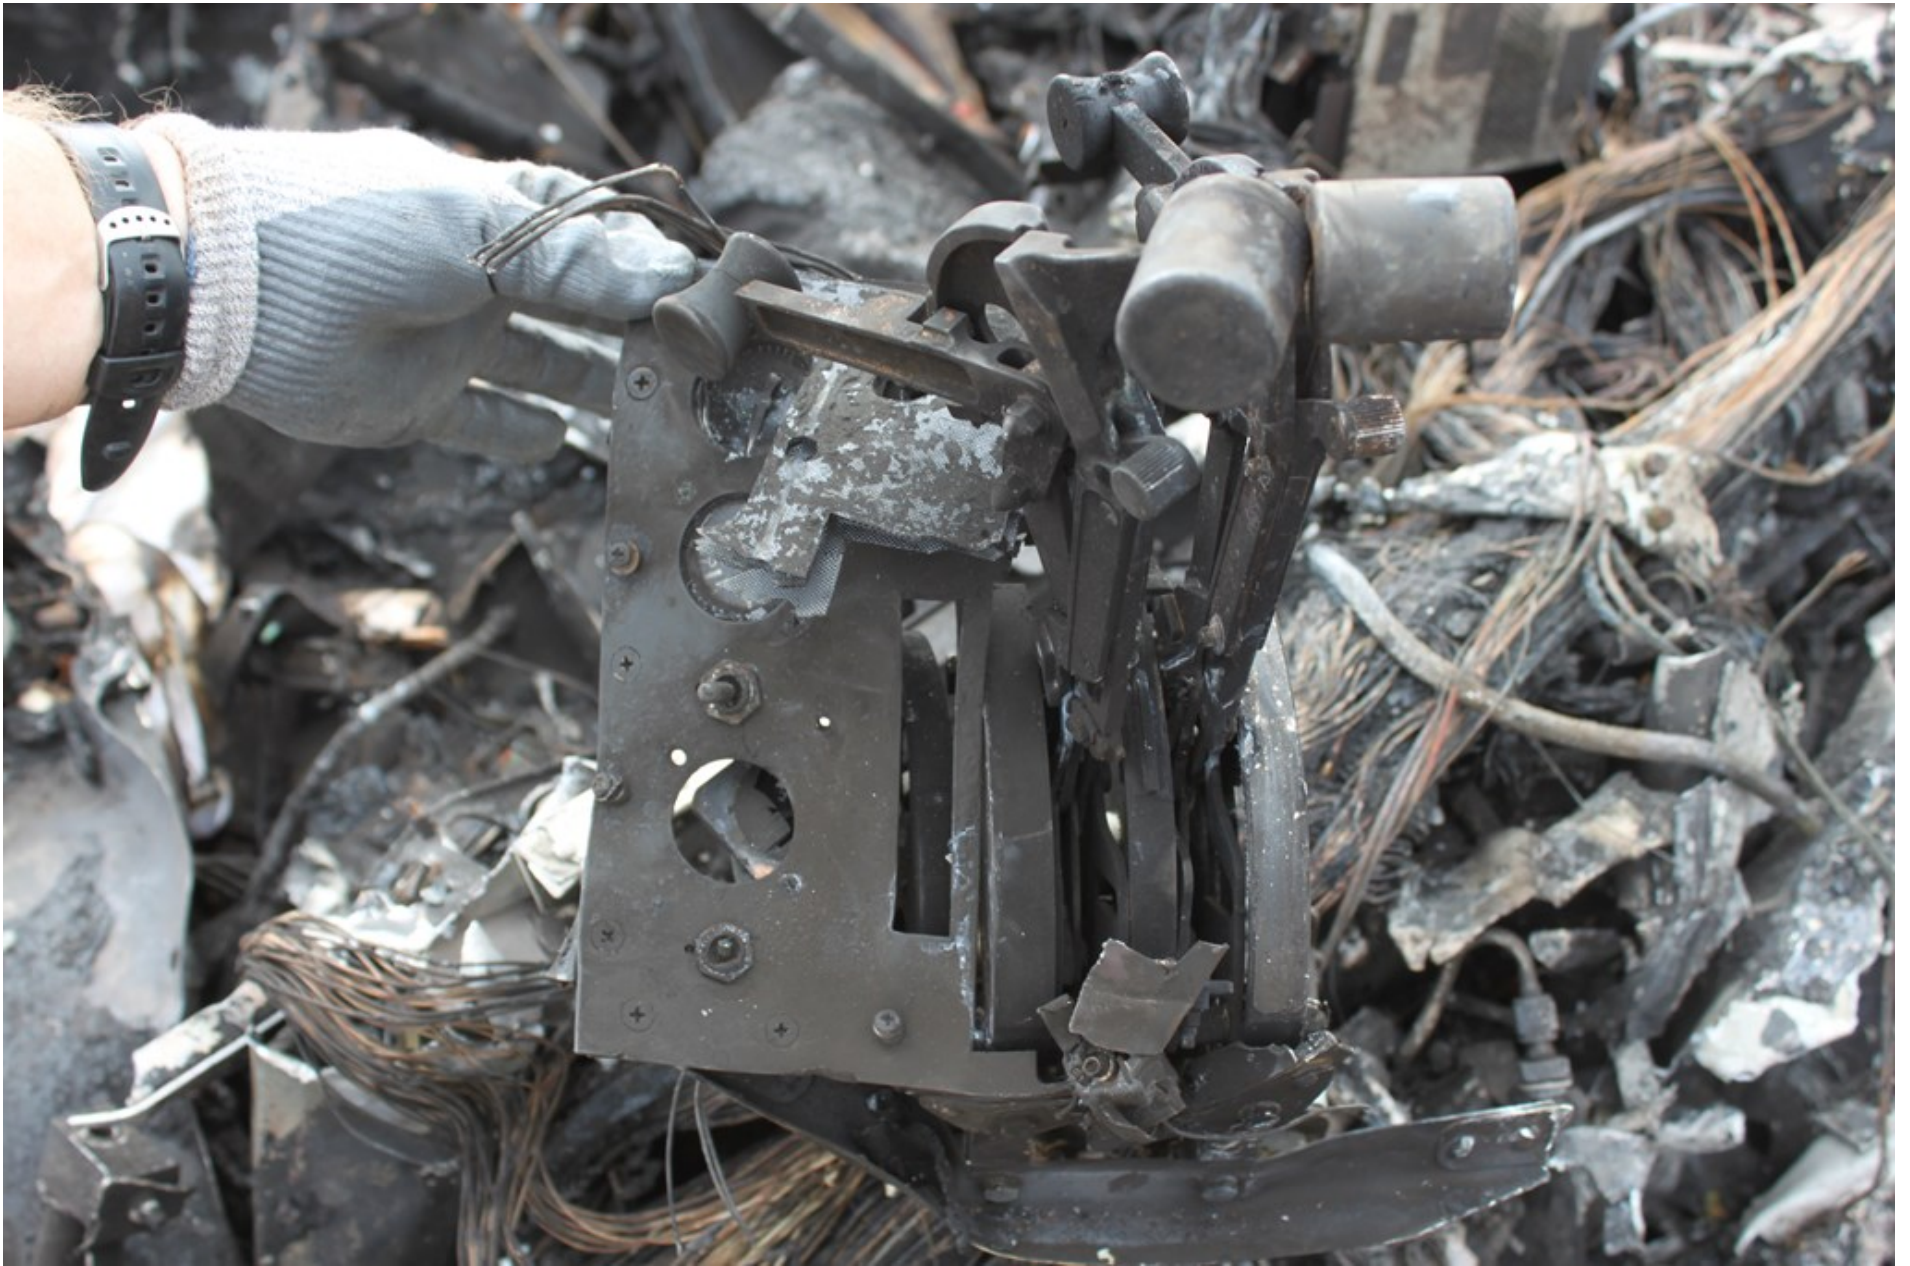
**Photo 9 - NTSB Digital Photograph. View of the throttle quadrant.**
