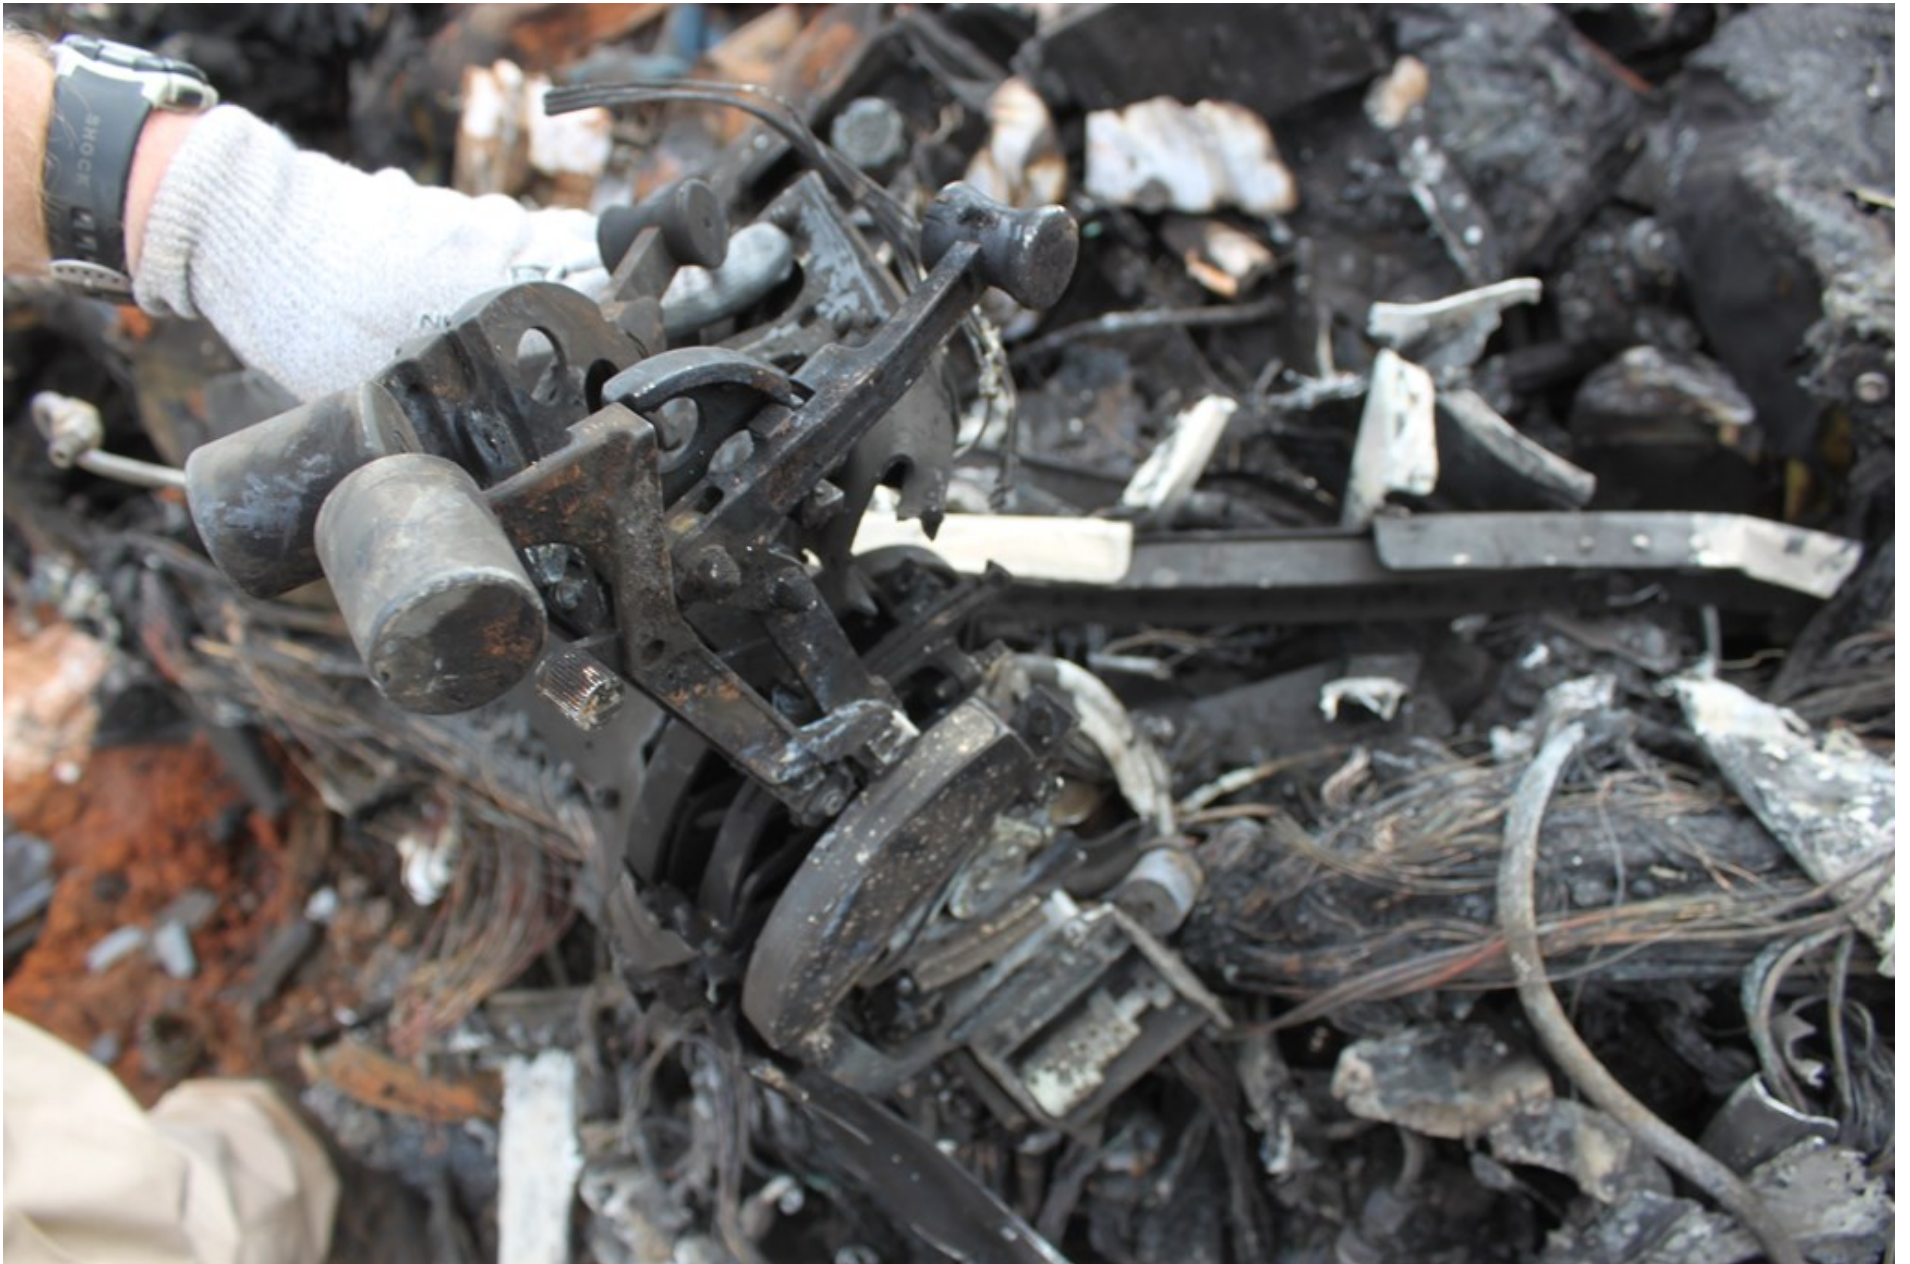
**Photo 10 - NTSB Digital Photograph. View of the right side of the throttle quadrant.**

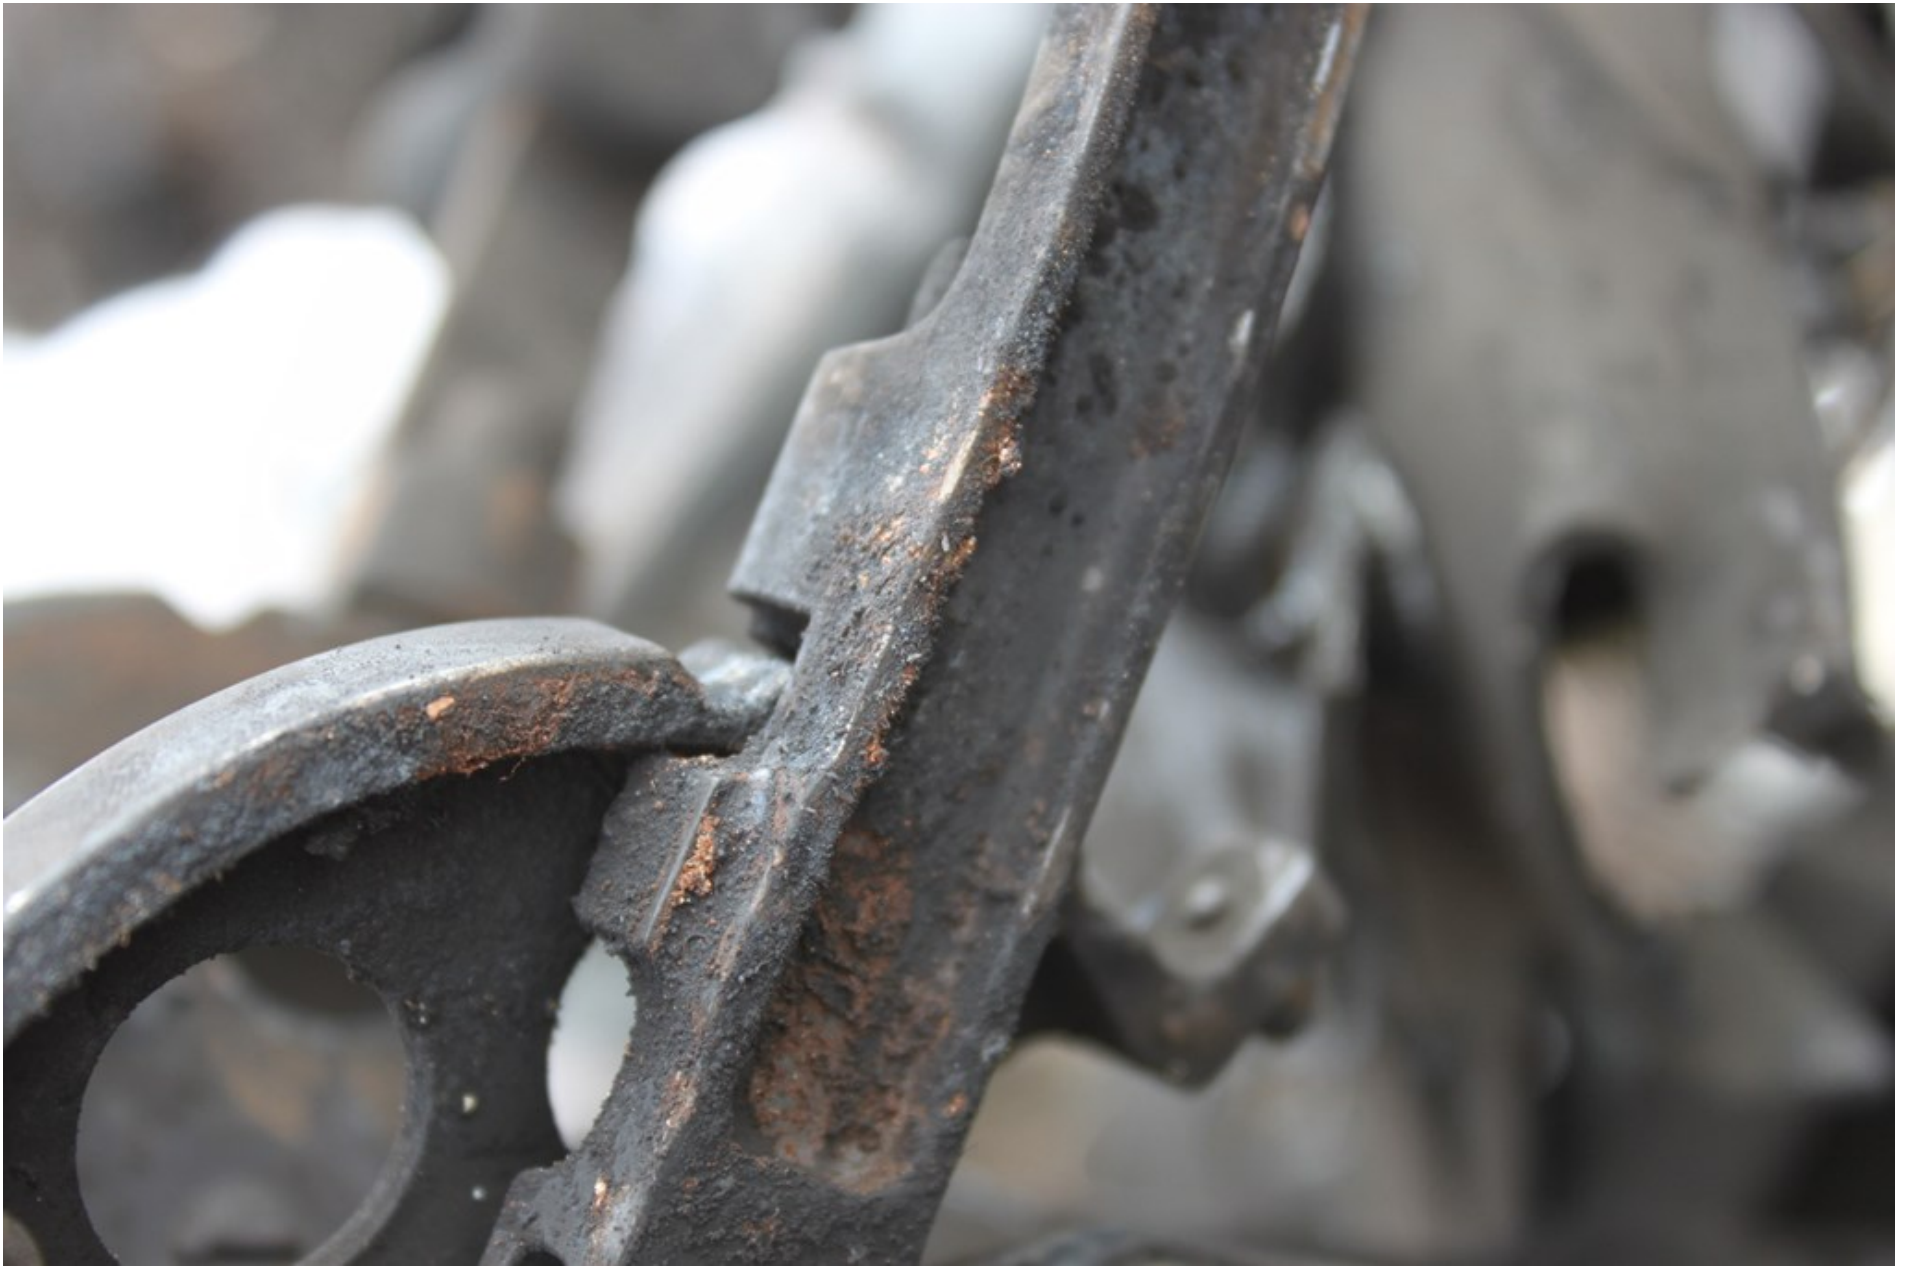
**Photo 11 - NTSB Digital Photograph. Close-up View of the Right Engine Thrust Reverser Piggy Back Lever and Adjacent Portion of Throttle Quadrant. Note the impact signature aft of the deploy detent.**
