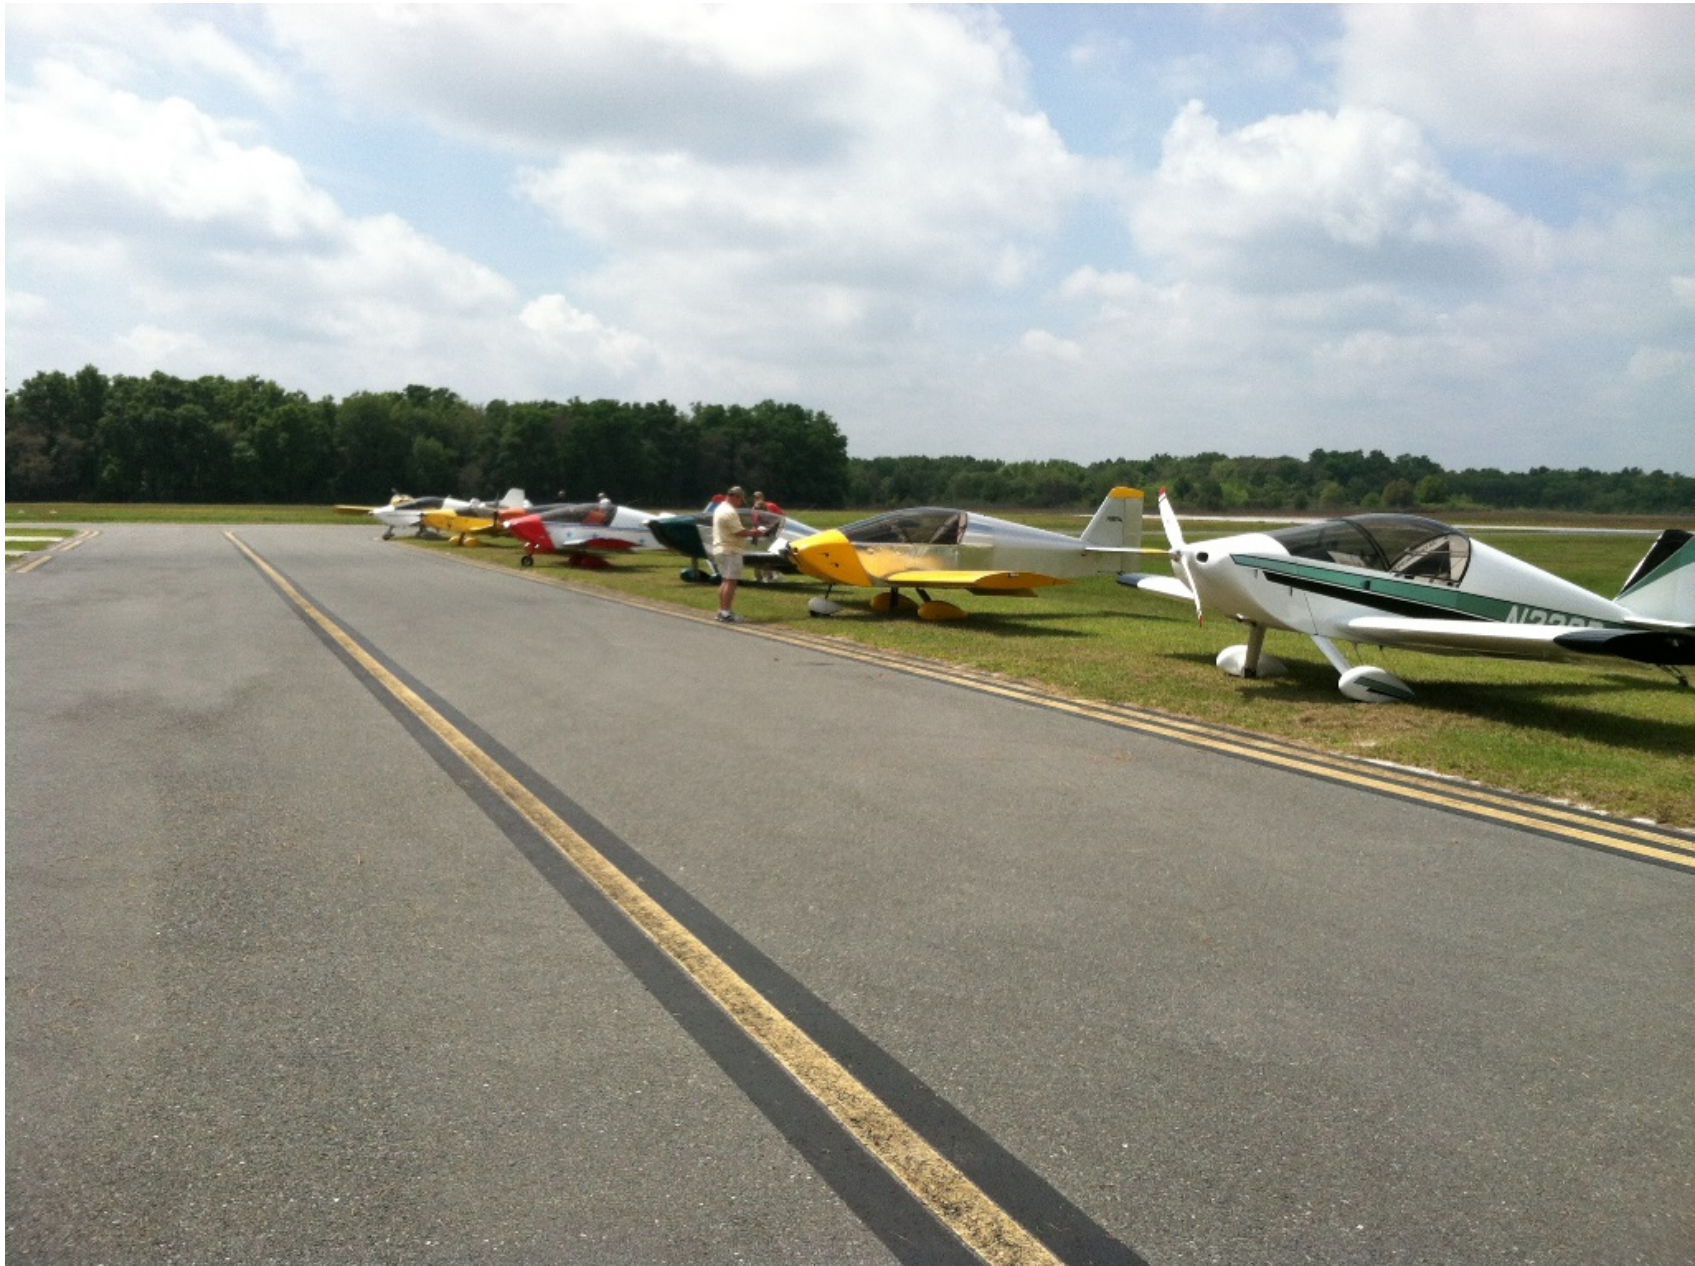
**Photo 1 – Digital Photograph Provided by X35 Airport Manager. Picture taken 4/5/2014 at 1221:24. View of the airplane at X35.**

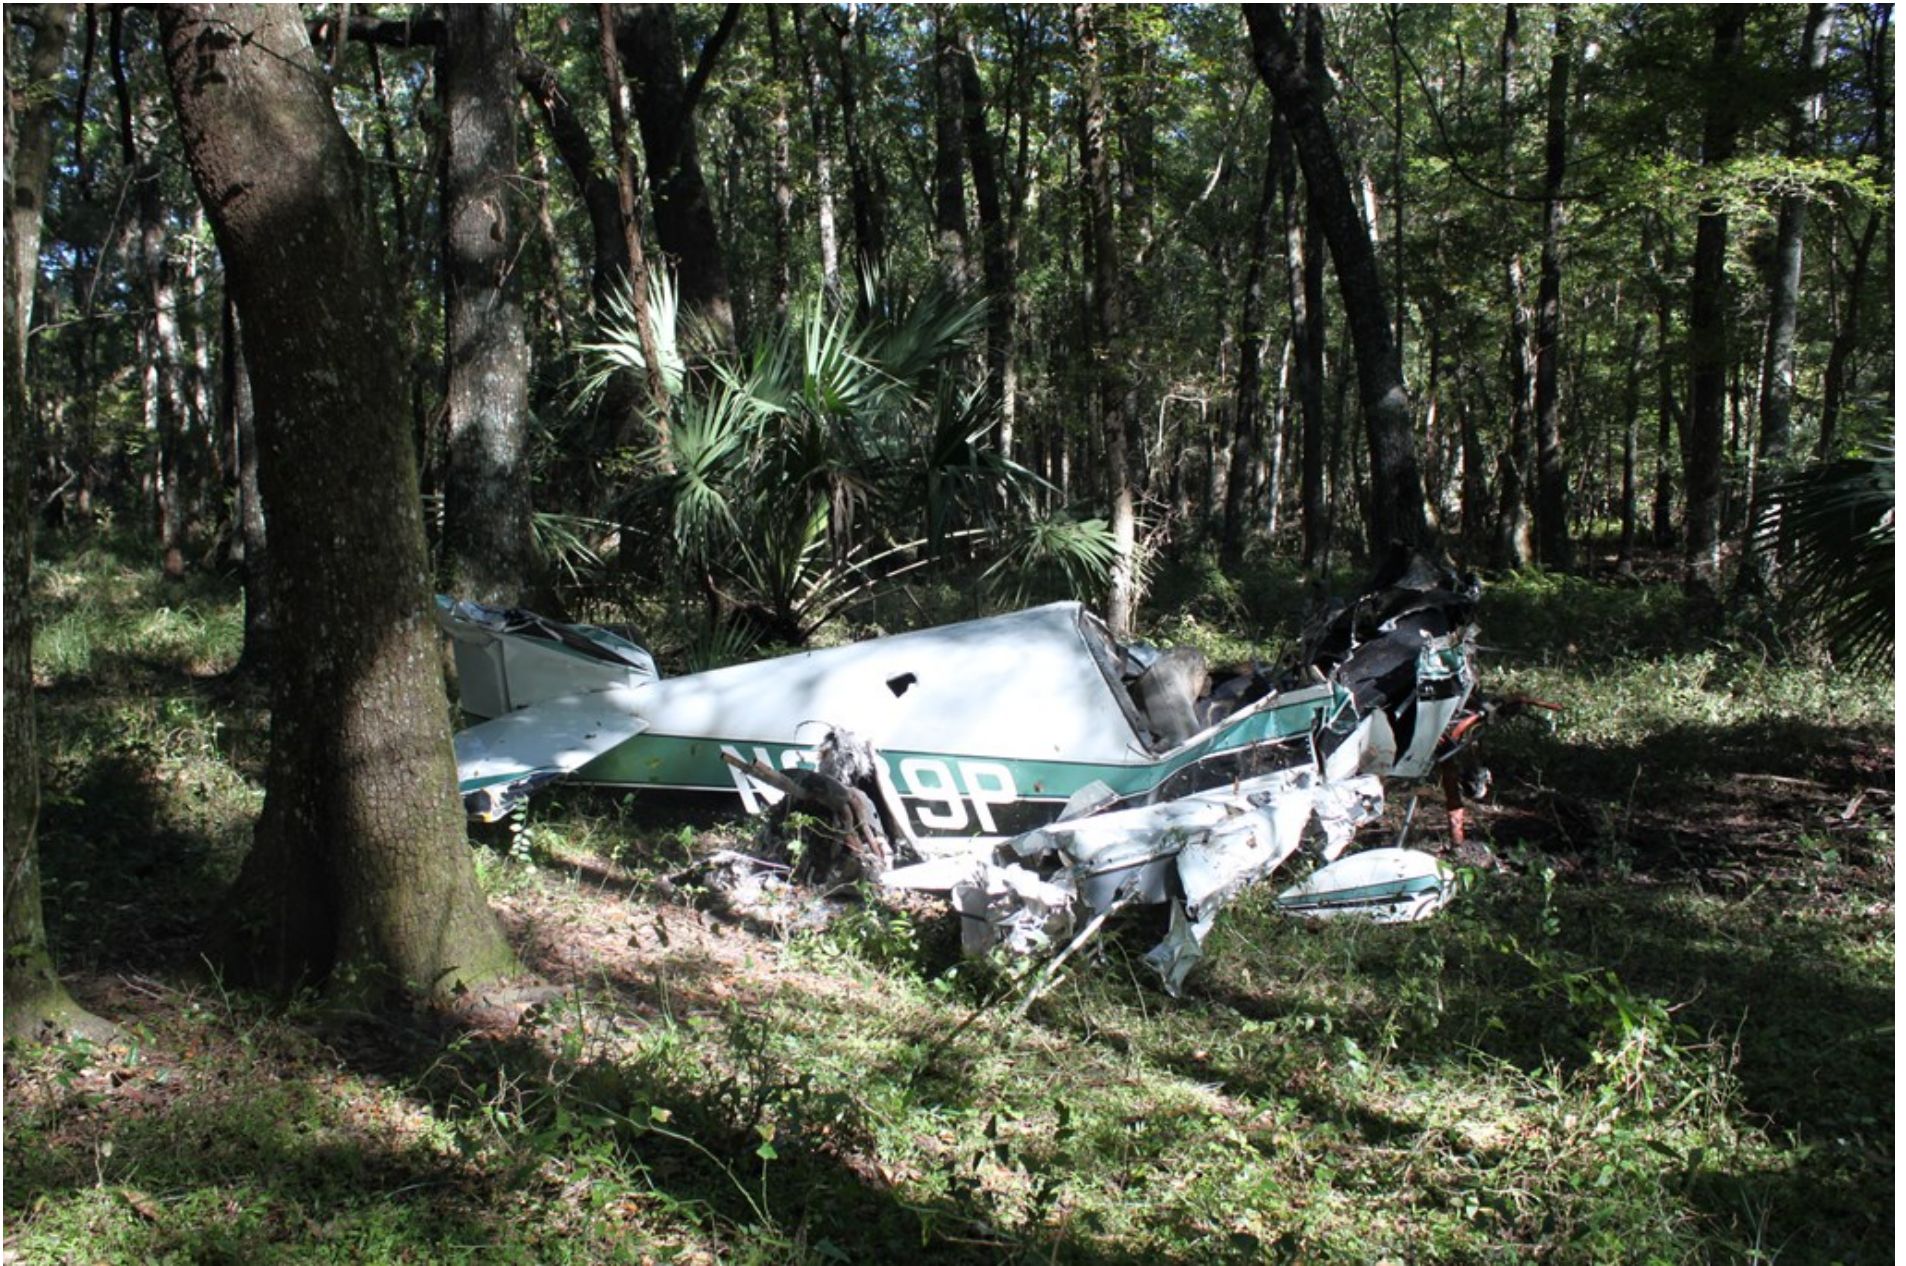
**Photo 2 – NTSB Digital Photograph. Right Side View of the Wreckage at the Accident Site and Being Uprighted.**

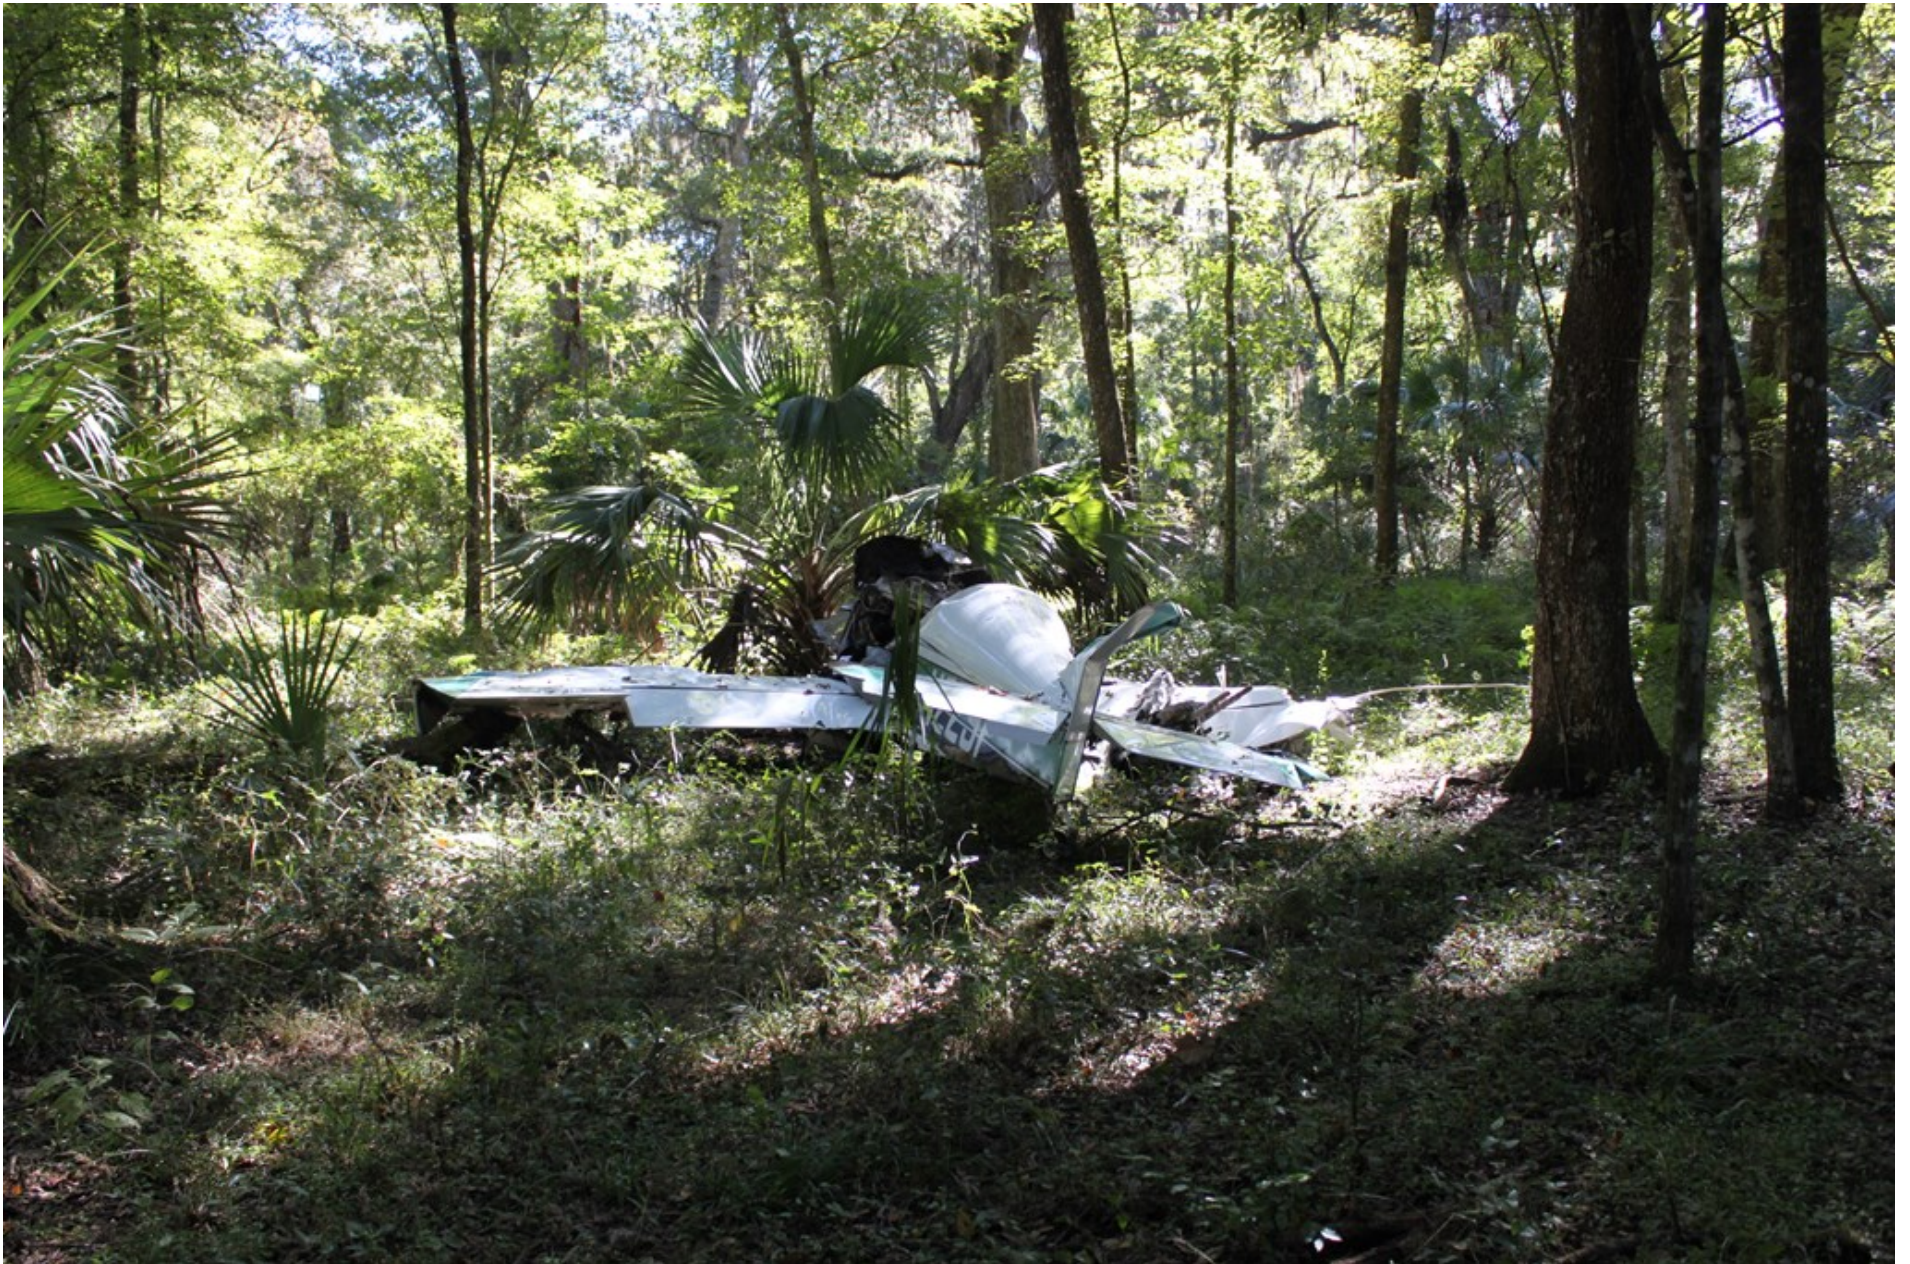
**Photo 3 – NTSB Digital Photograph. Rear View of the Wreckage at the Accident Site.**

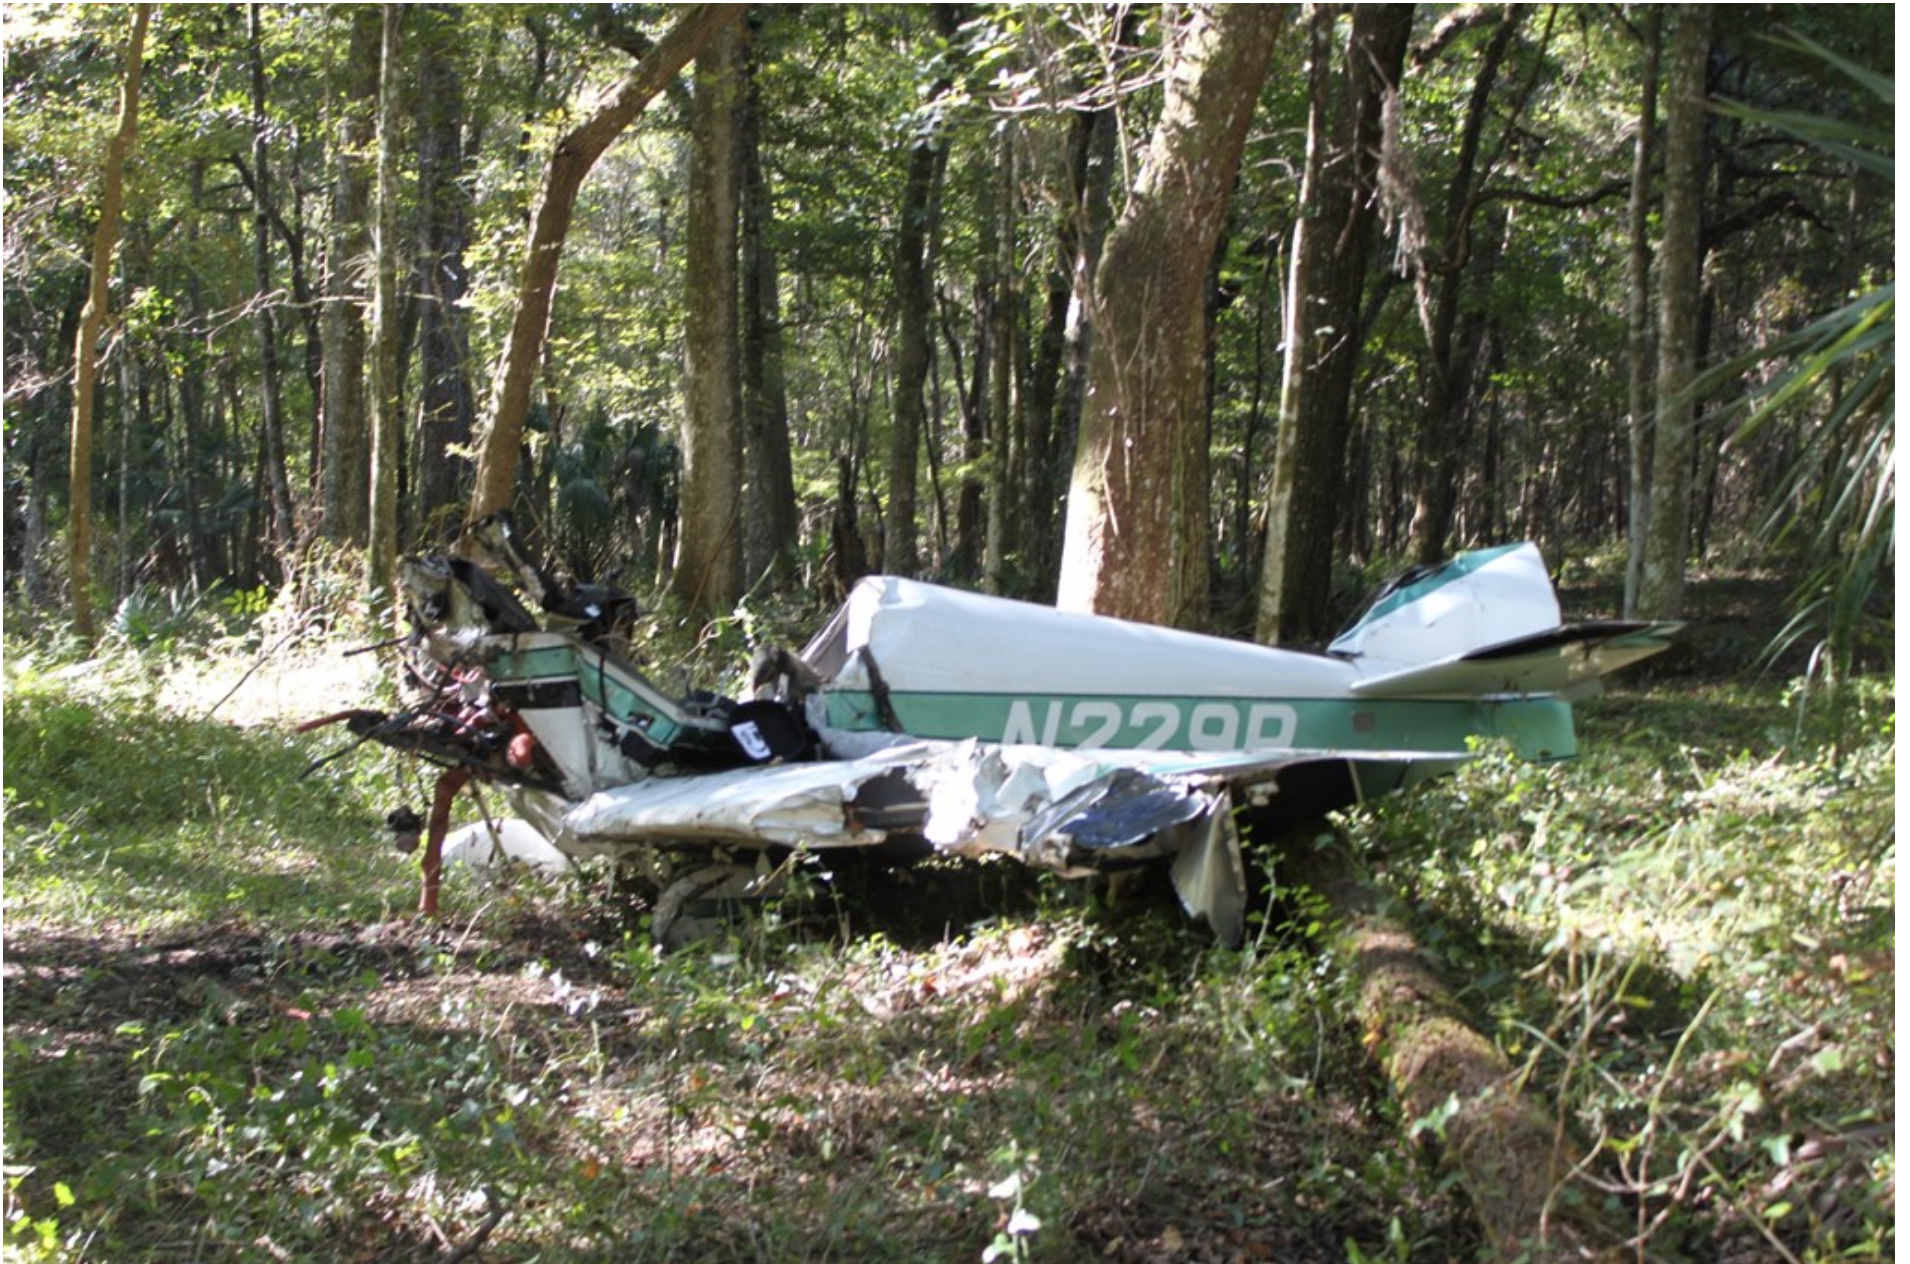
**Photo 4 – NTSB Digital Photograph. Left Side View of the Wreckage at the Accident Site.**

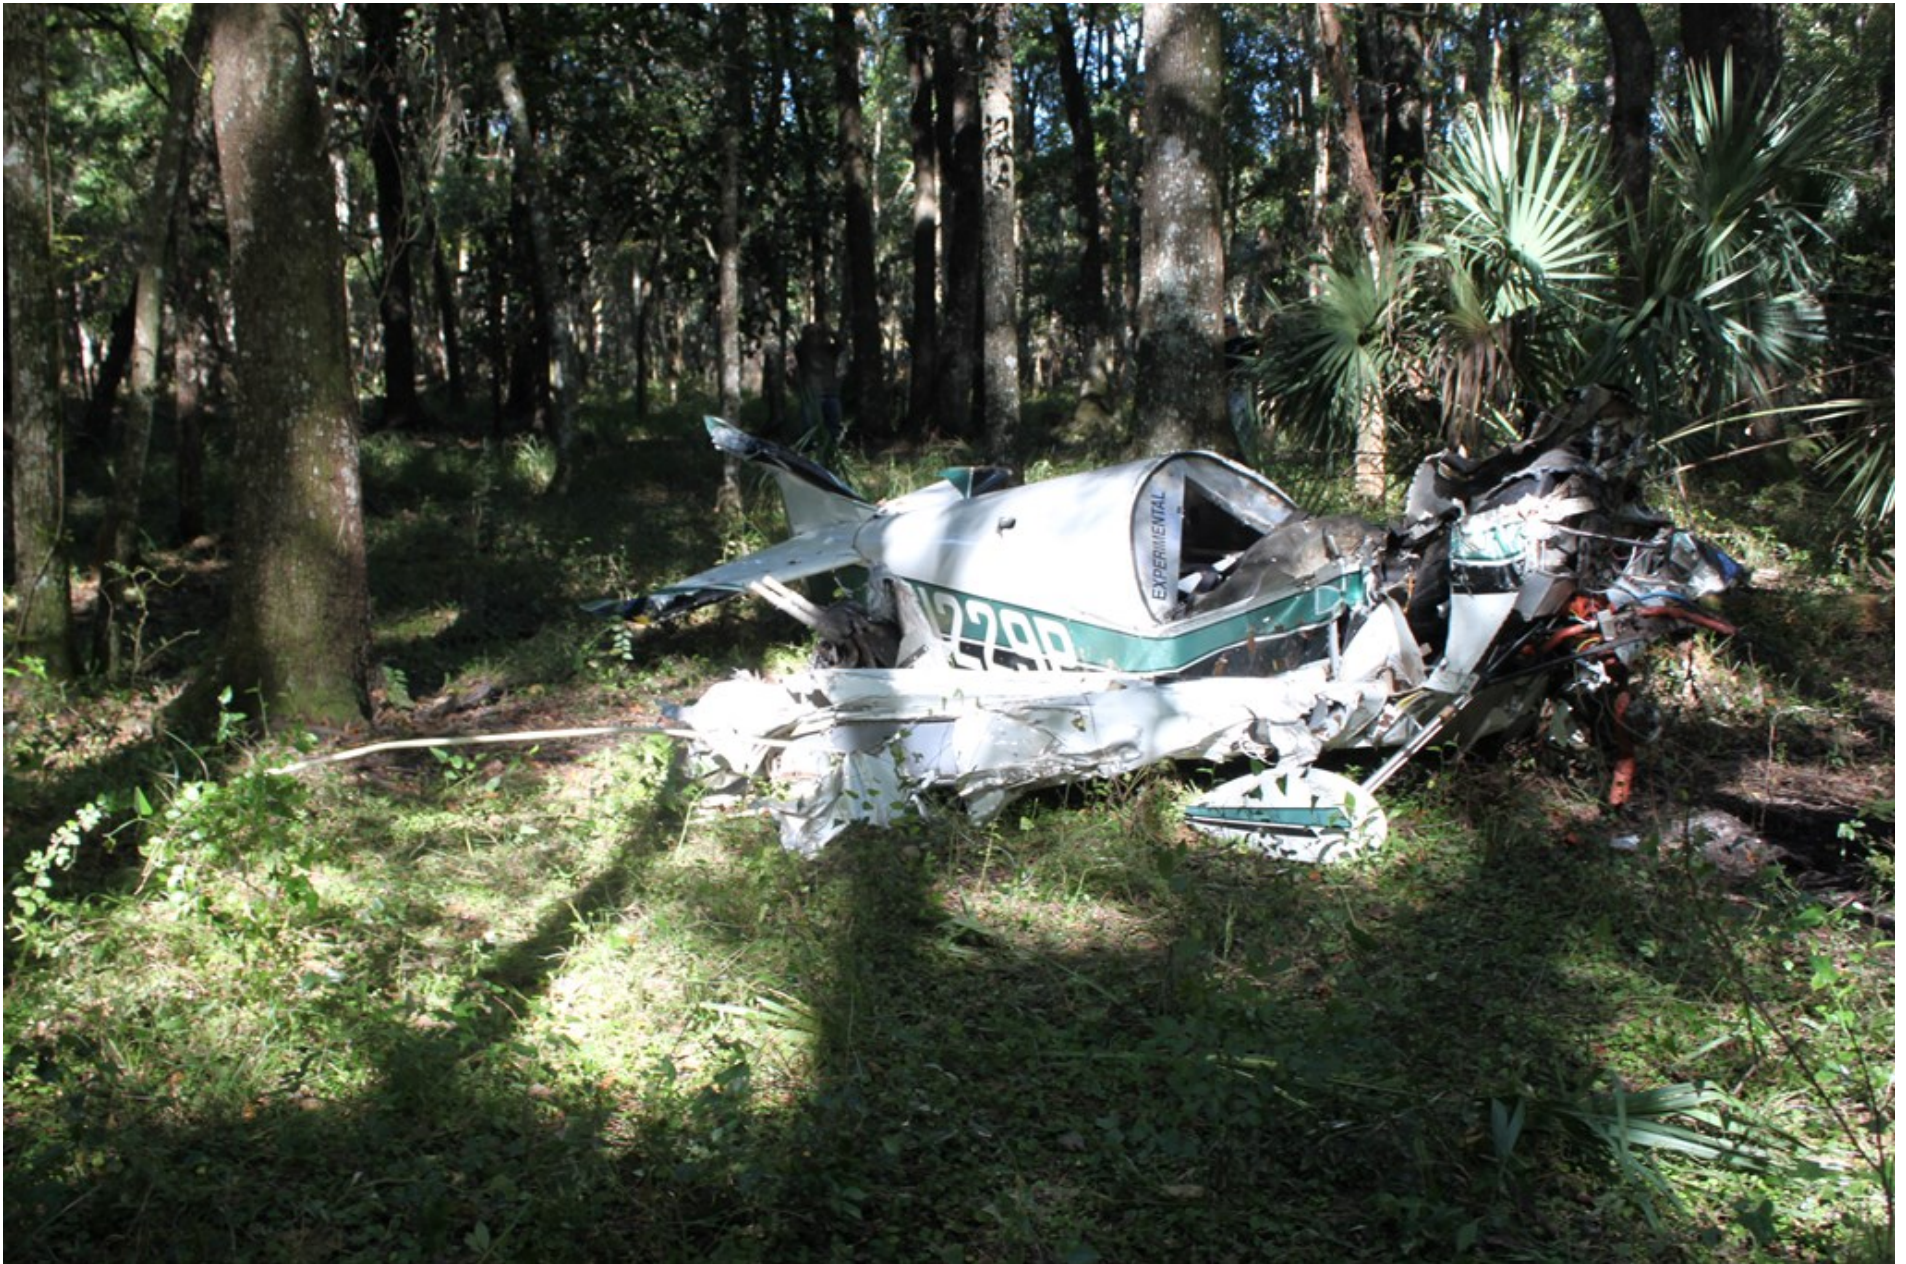
**Photo 5 – NTSB Digital Photograph. Right Forward Quartering View of the Wreckage.**

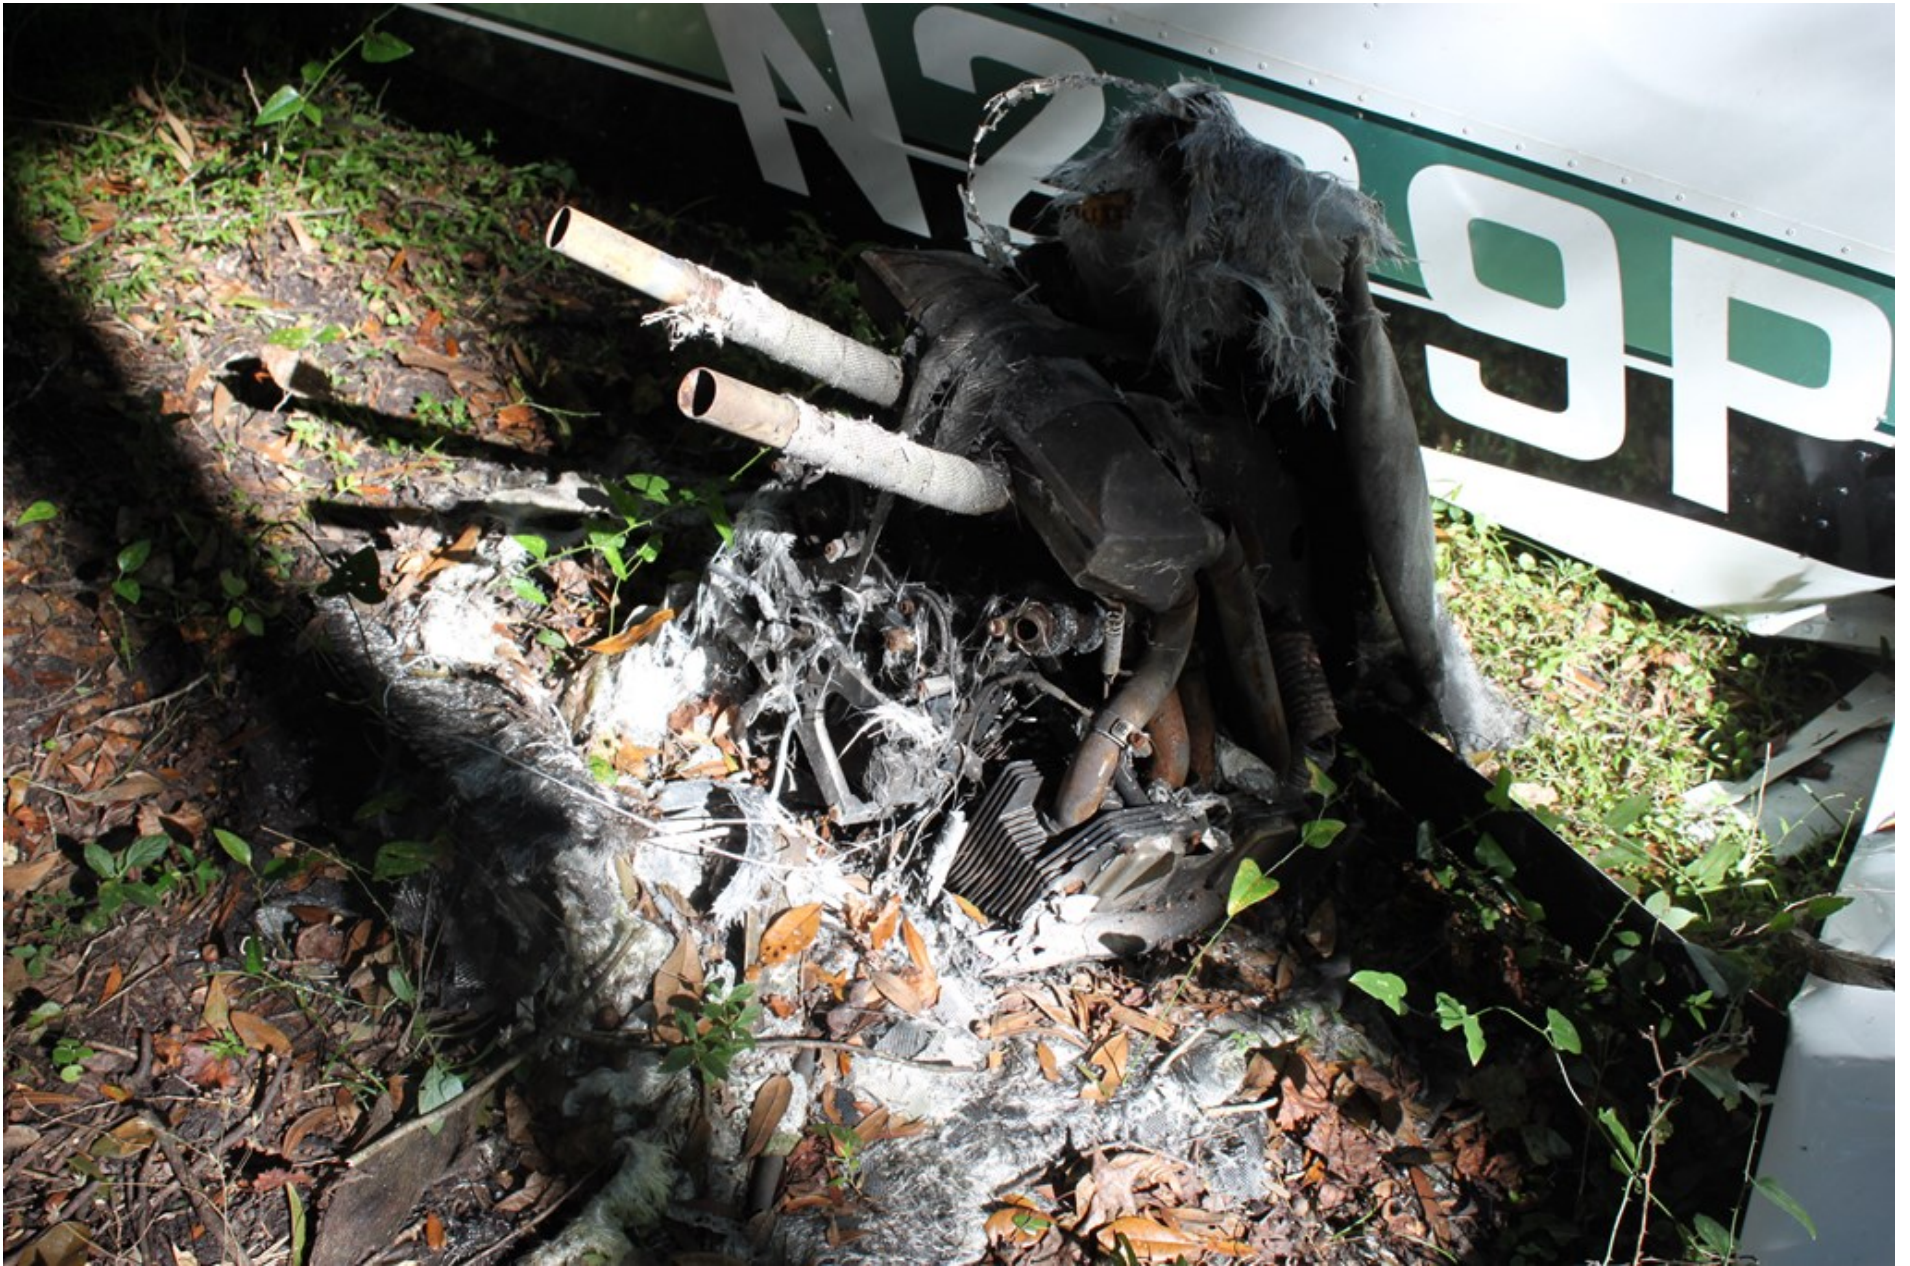
**Photo 6 – NTSB Digital Photograph. View of the Separated Engine Assembly.**

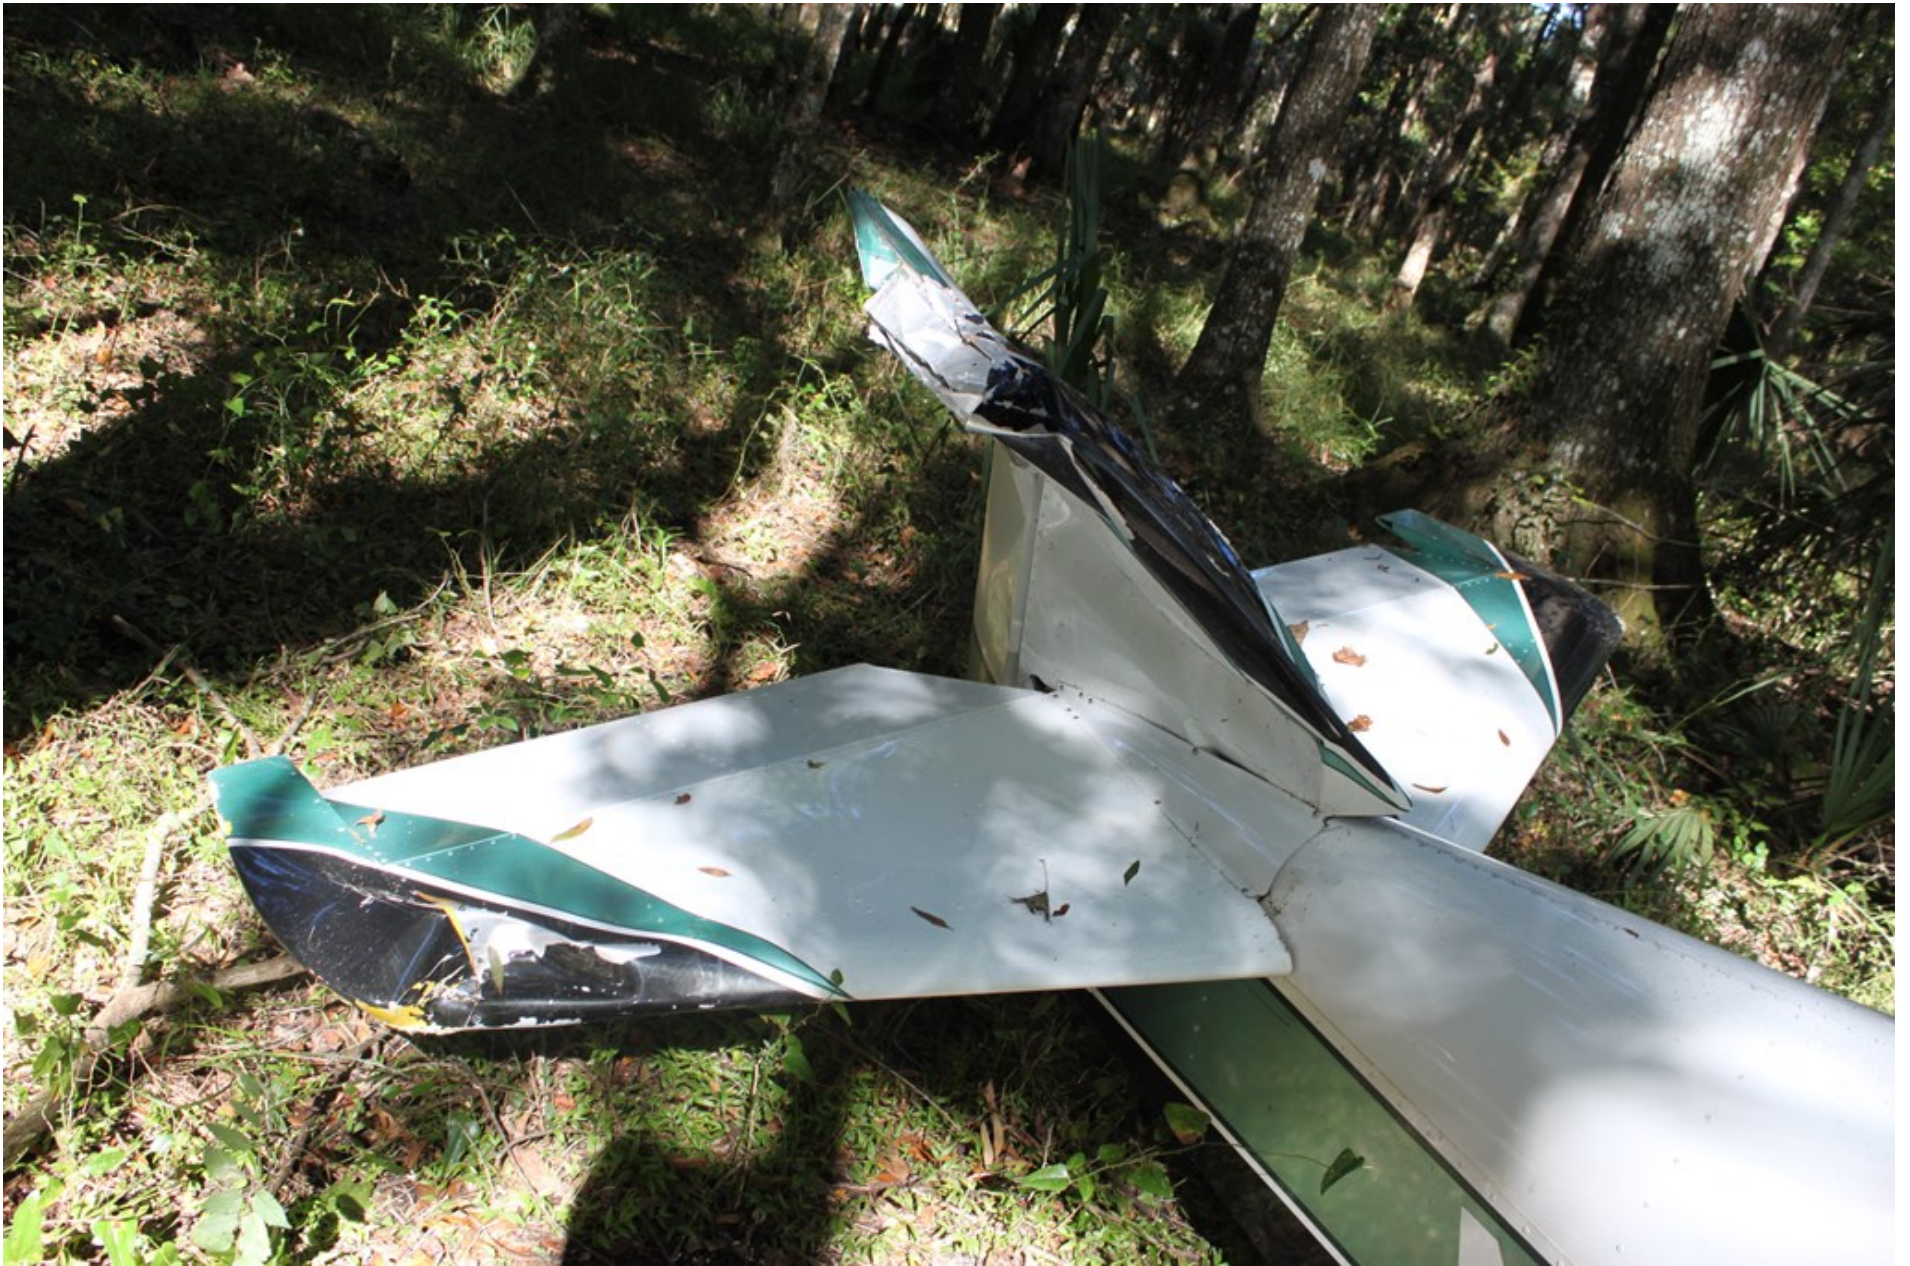
**Photo 7 – NTSB Digital Photograph. View of the Aft Empennage.**

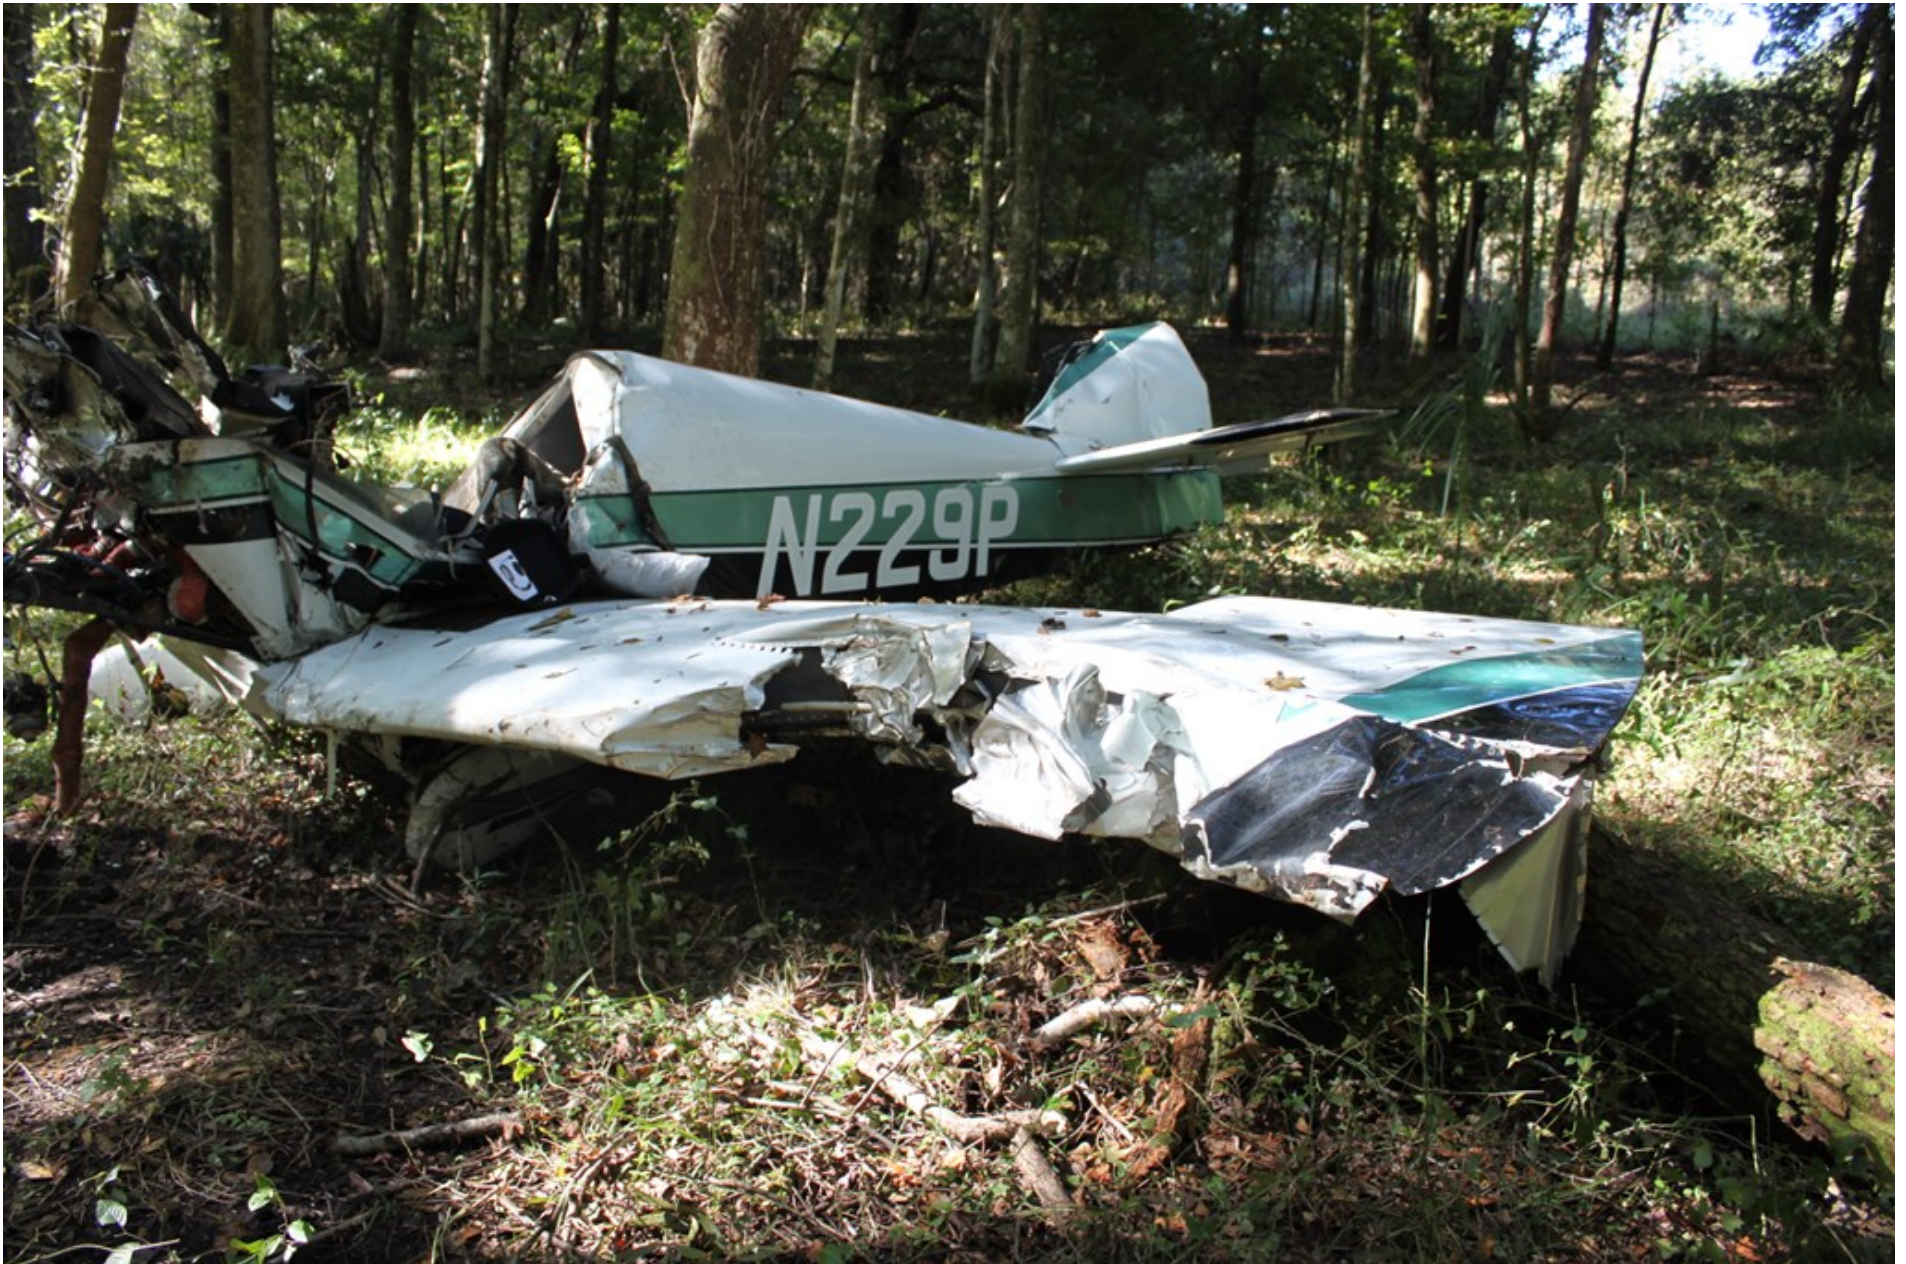
**Photo 8 – NTSB Digital Photograph. View of the Left Wing. Note the Leading Edge Tree Contact Damage**

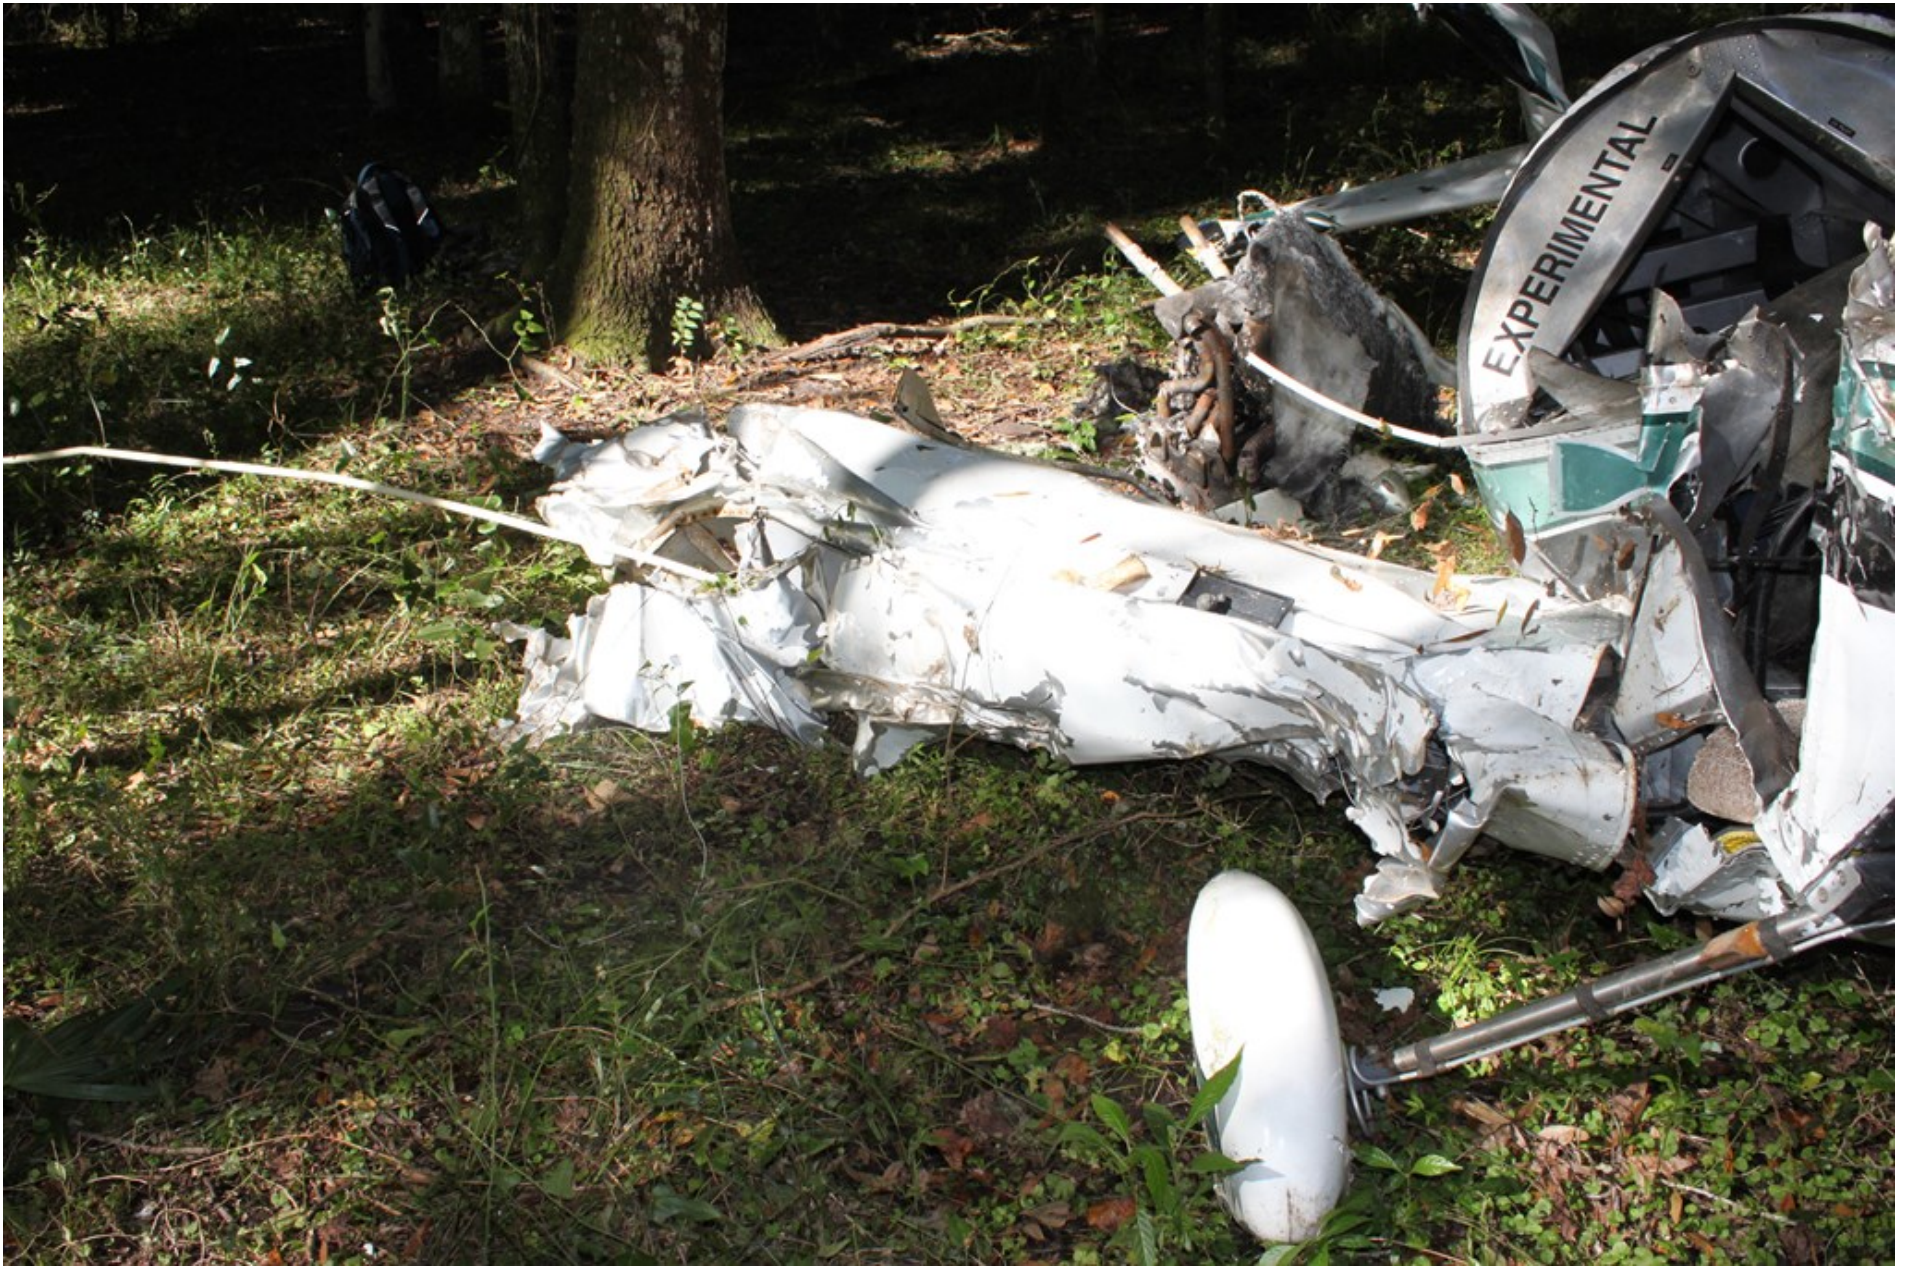
**Photo 9 – NTSB Digital Photograph. View of the Right Wing**
