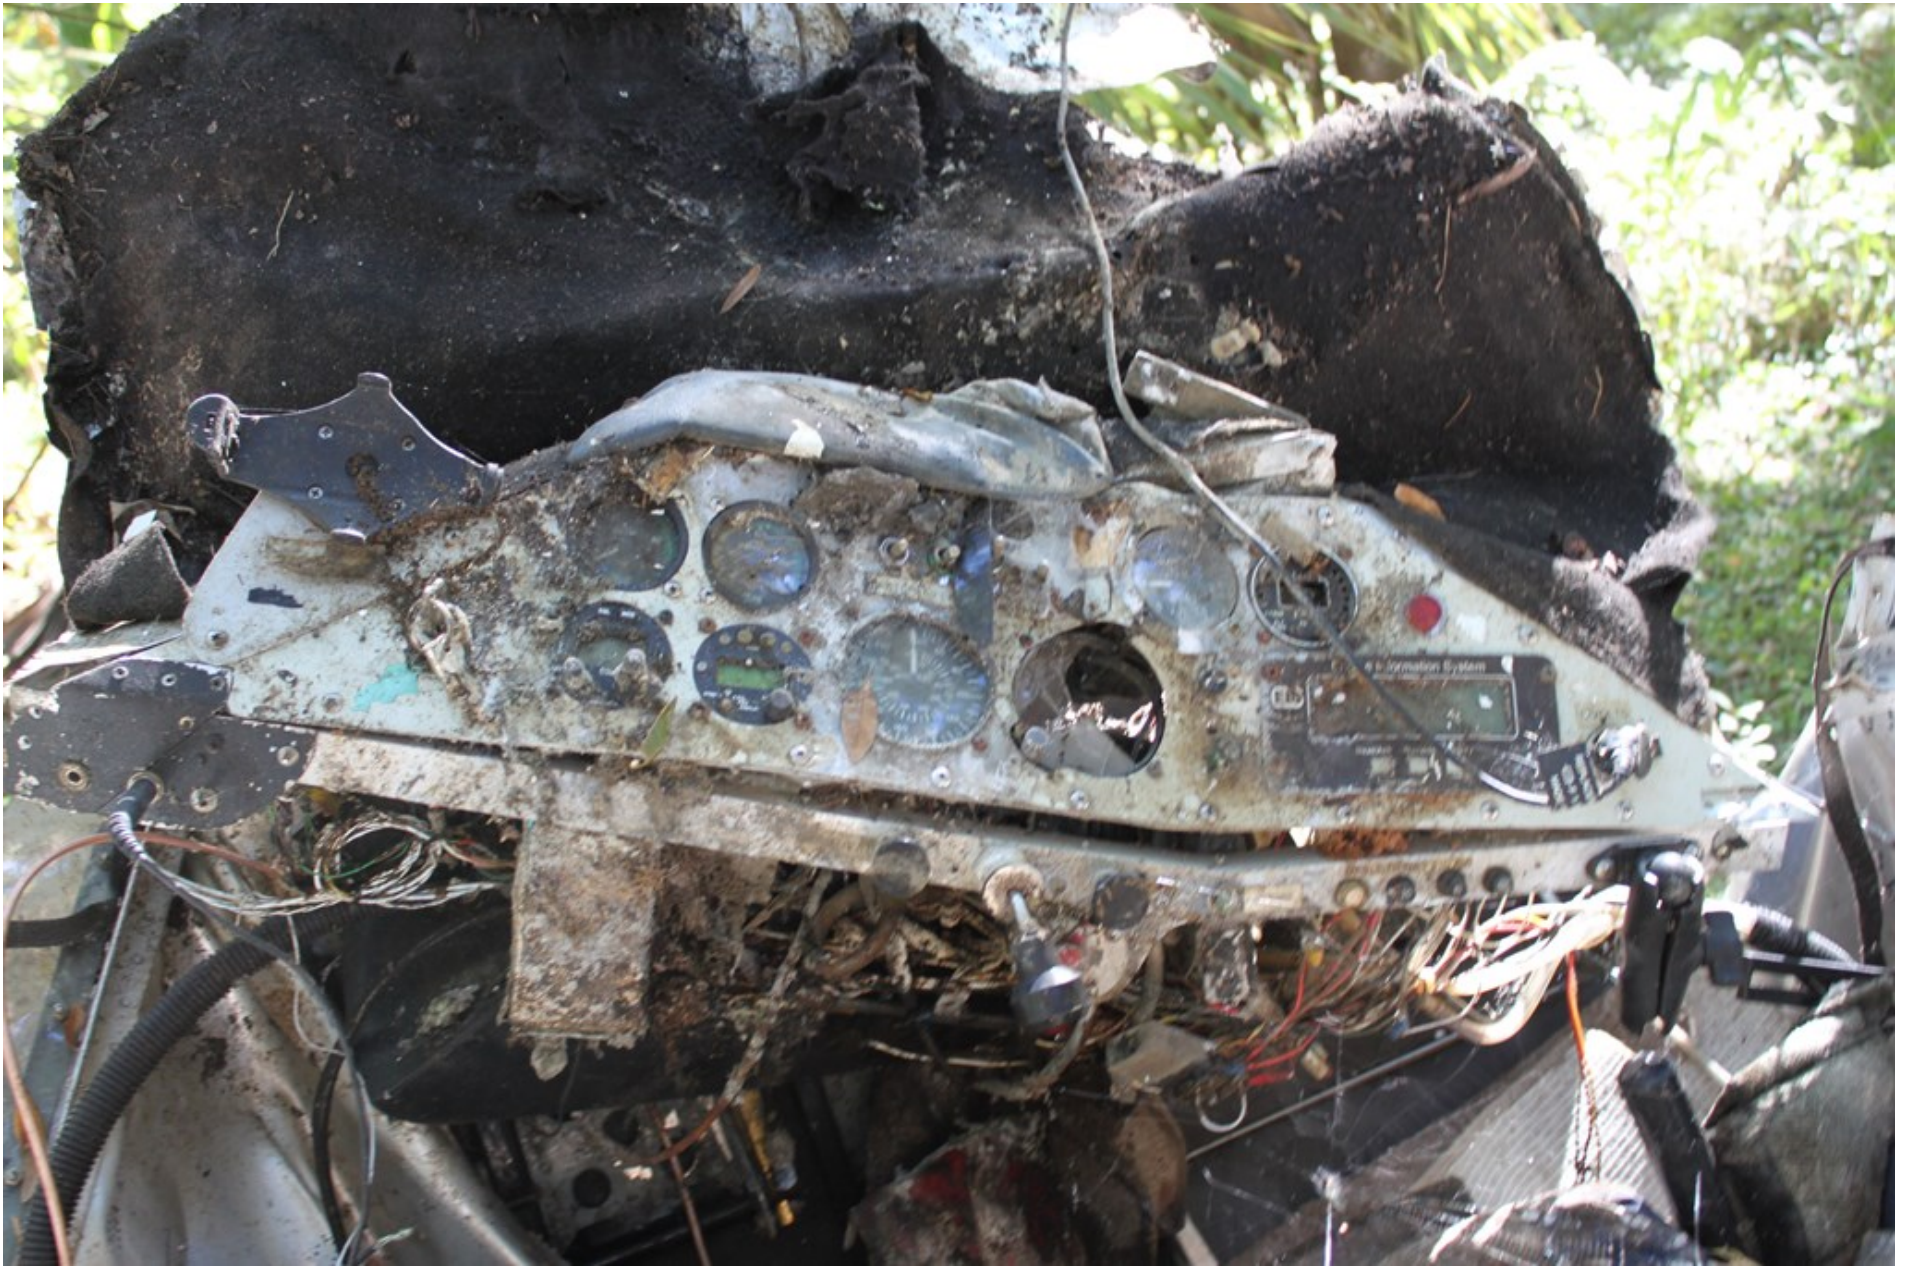
**Photo 10 – NTSB Digital Photograph. View of the Instrument Panel**

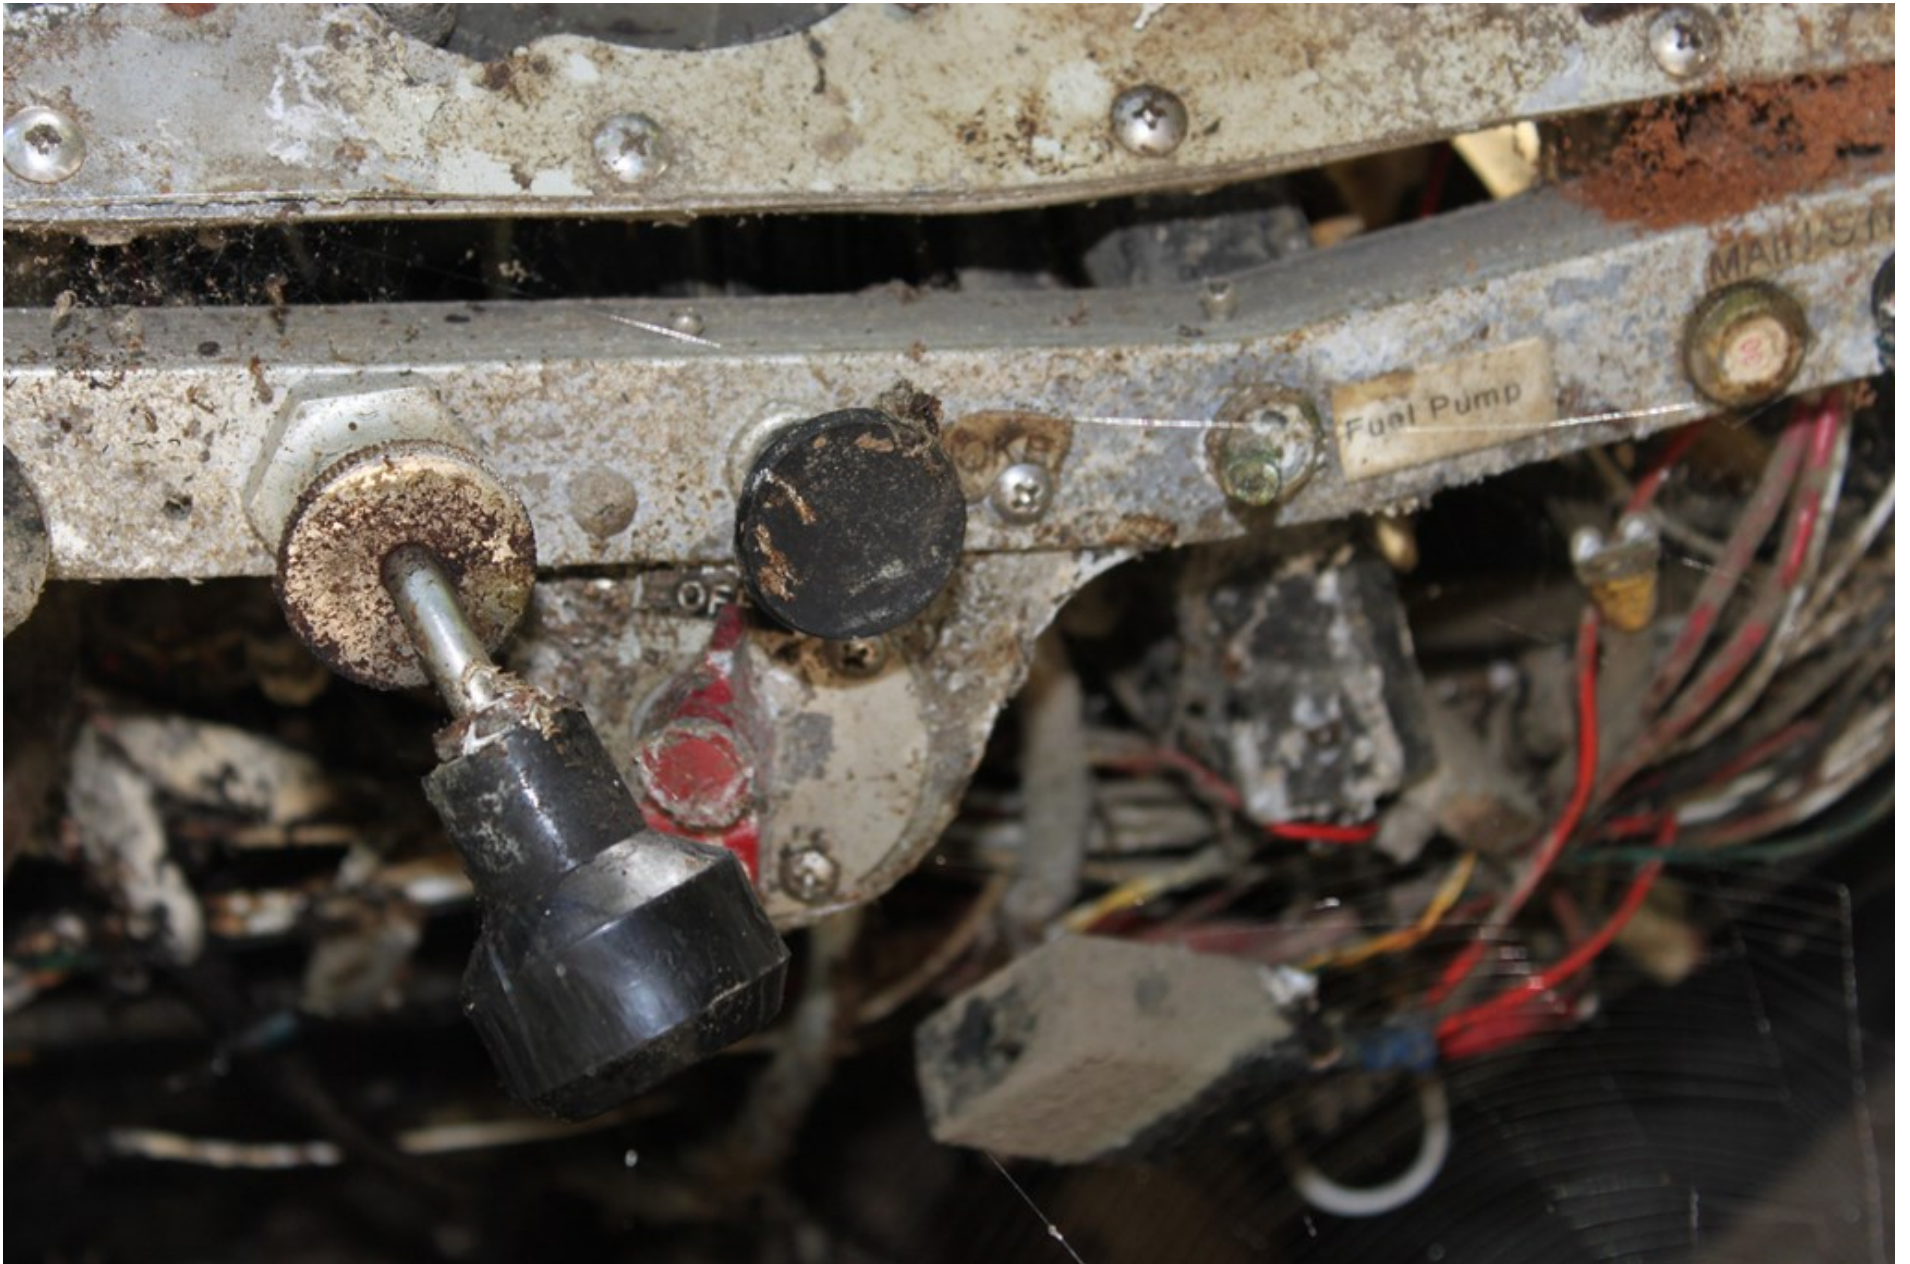
**Photo 11 – NTSB Digital Photograph. View of the Fuel Shutoff Valve Position.**

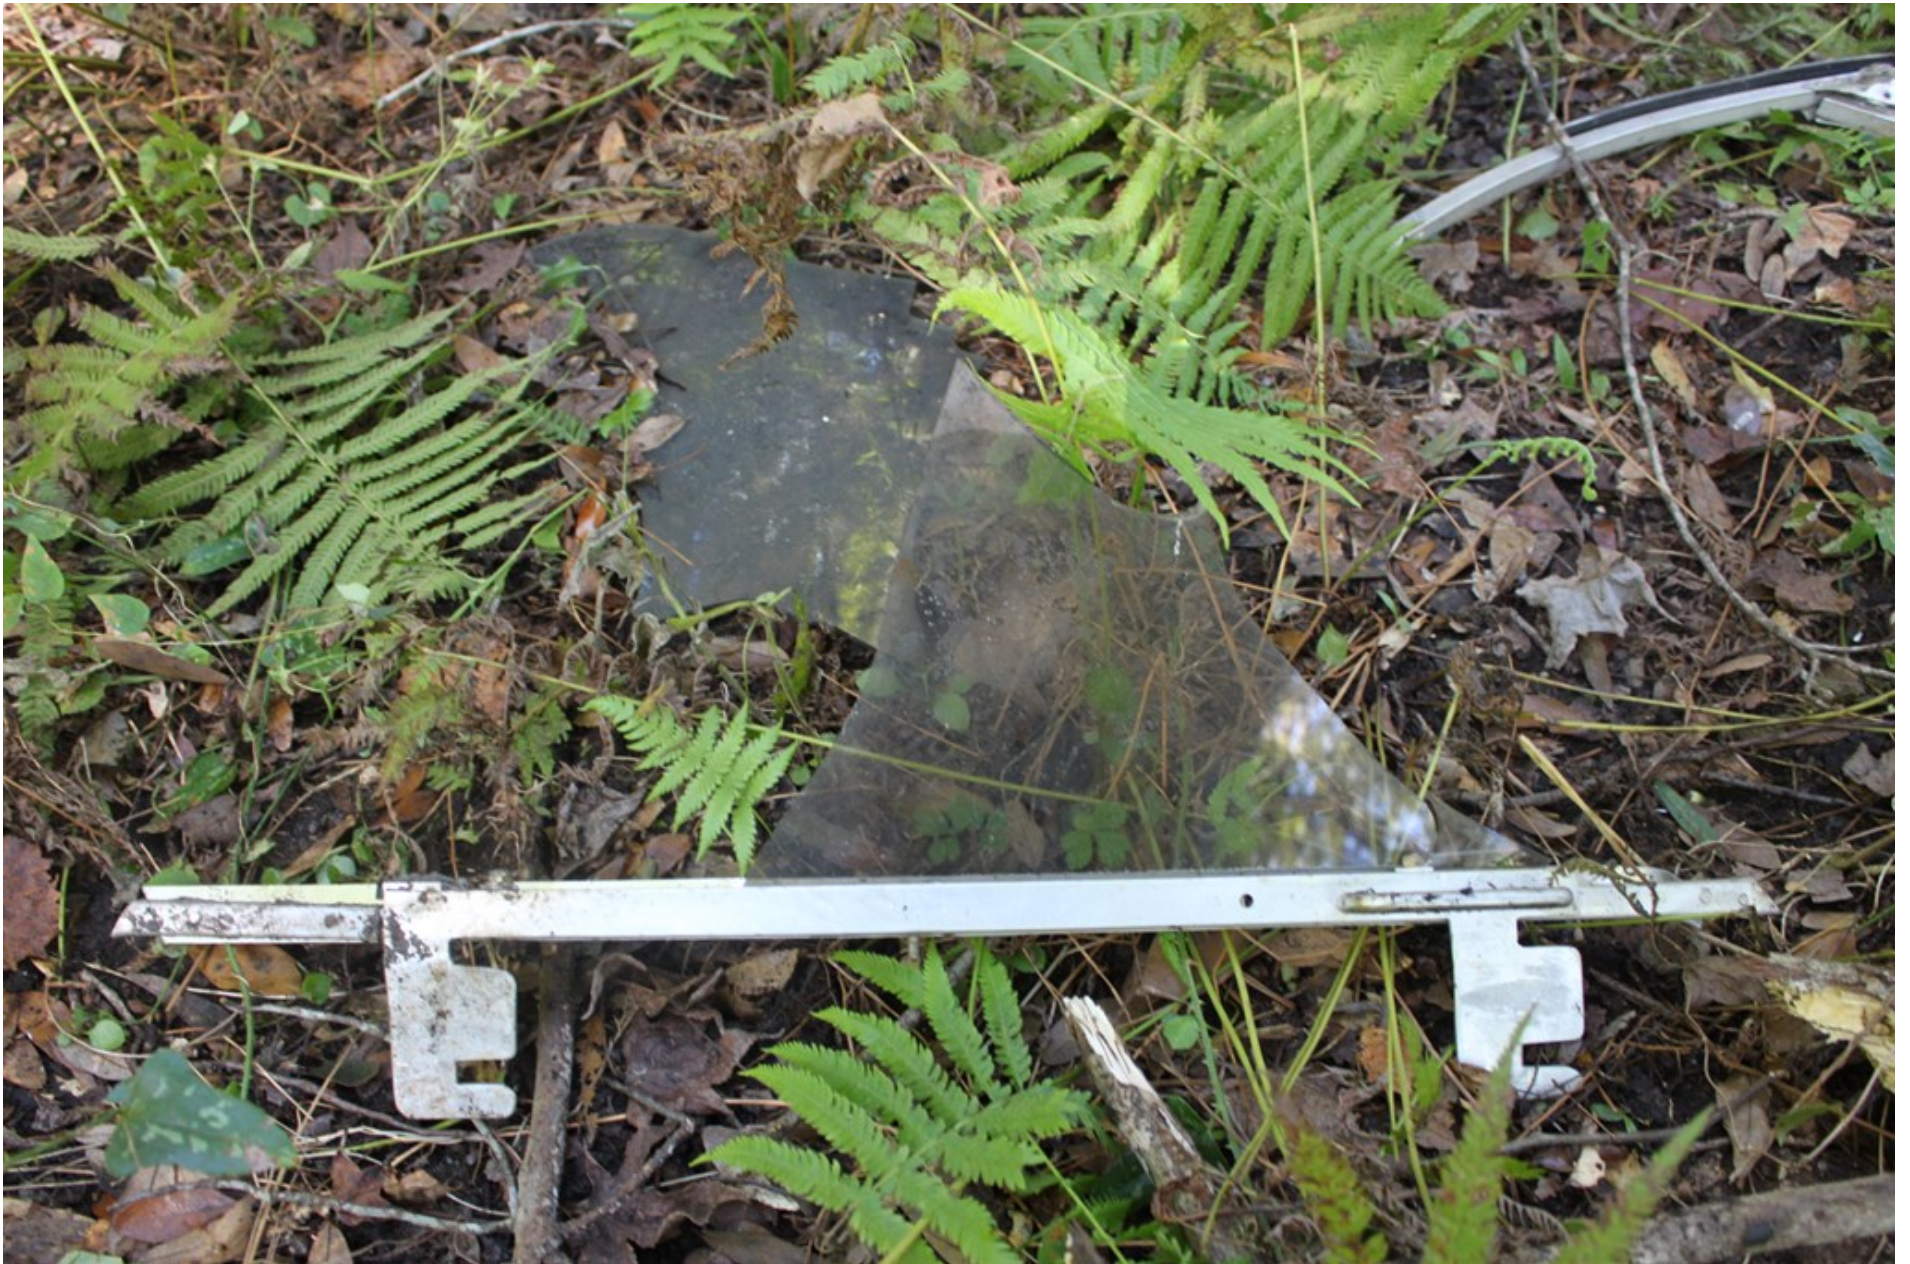
**Photo 12 – NTSB Digital Photograph. View depicting the locking portion of the canopy. Note the undamaged latches for taxi (lower) and takeoff (upper) positions**

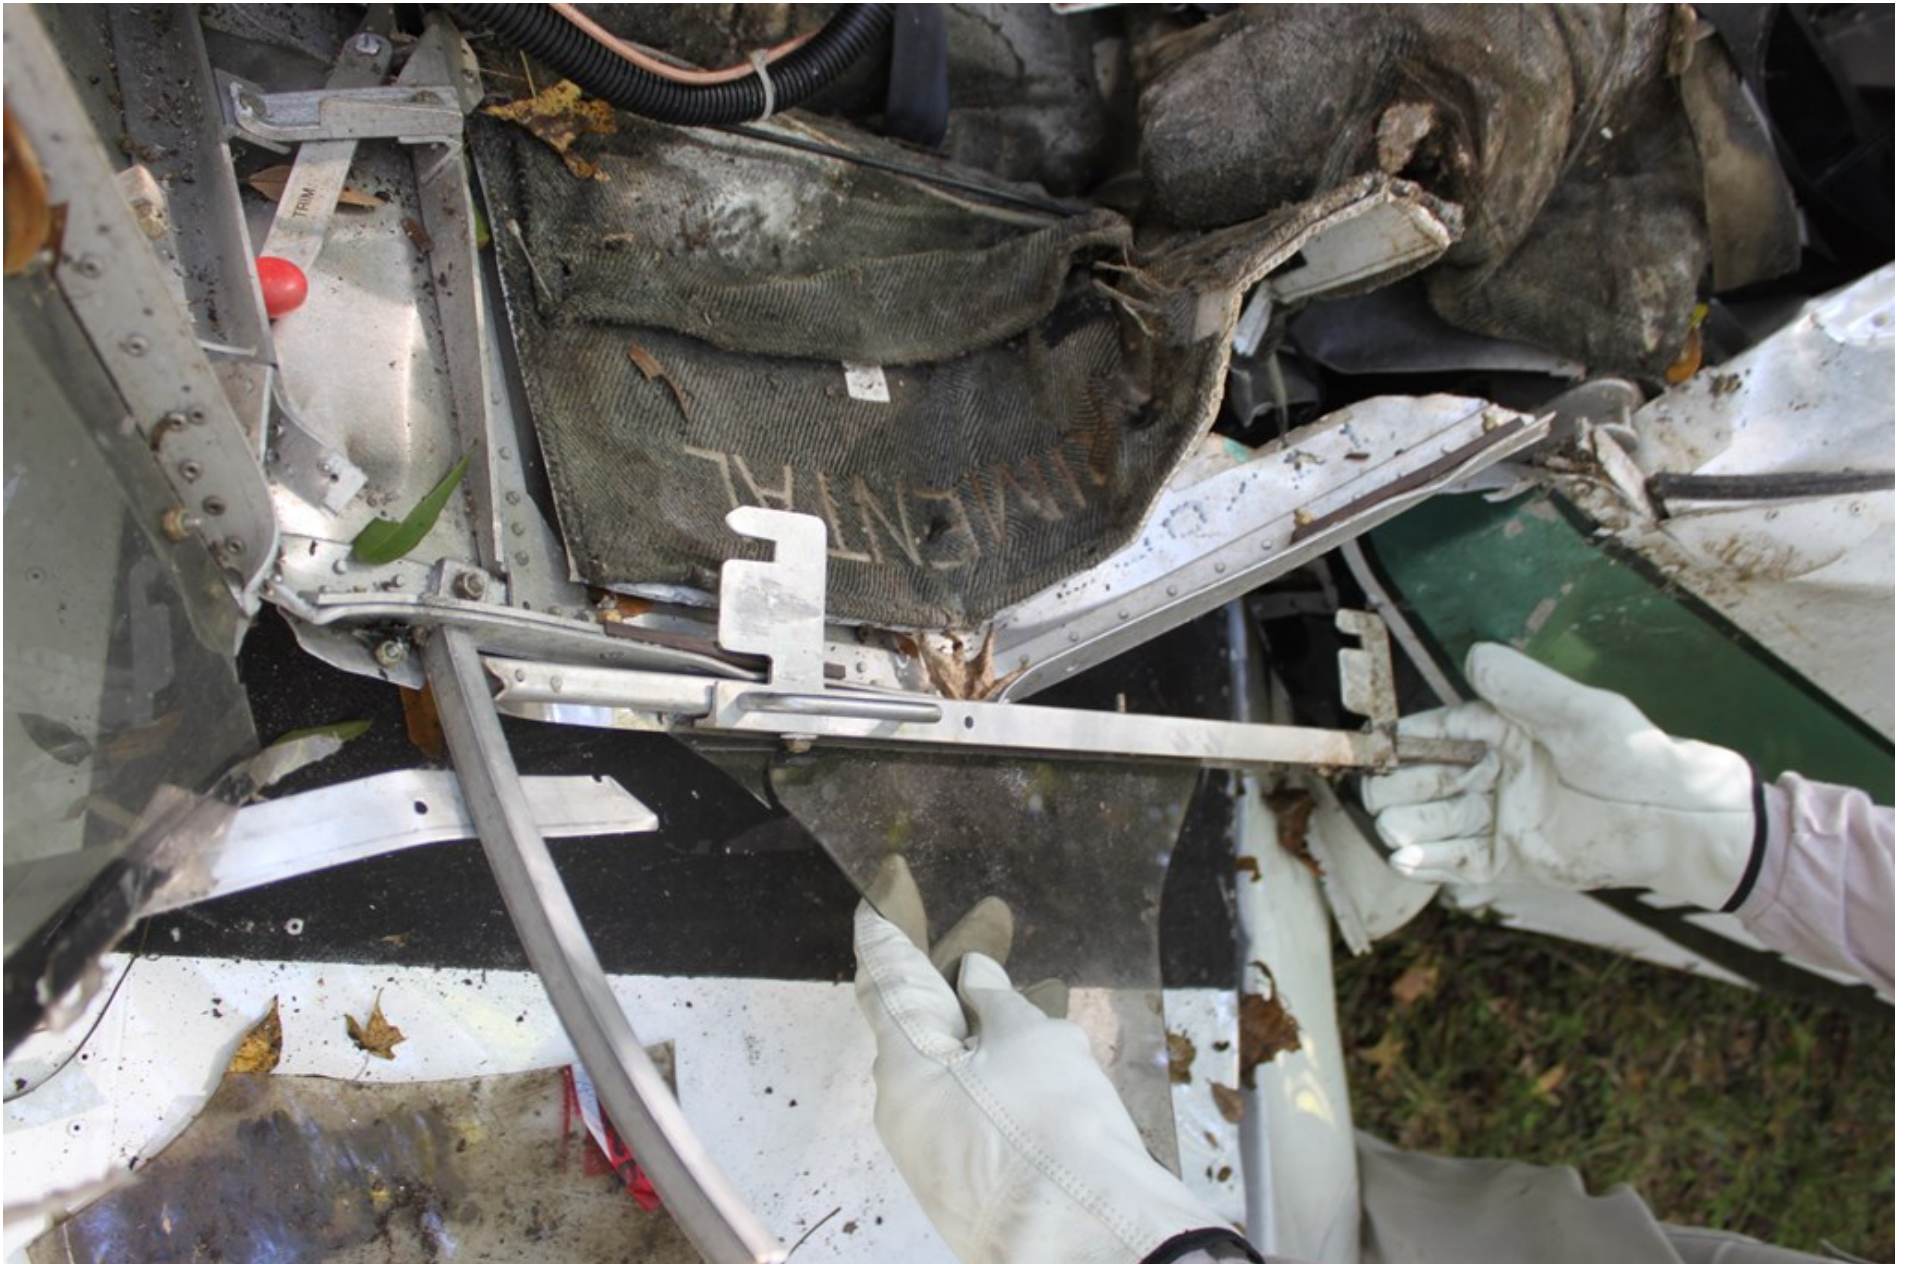
**Photo 13 – NTSB Digital Photograph. View Depicting the Damage to the Longeron adjacent to the Locking Portion of the Canopy Frame, and the Locking Portion of the Canopy Frame**

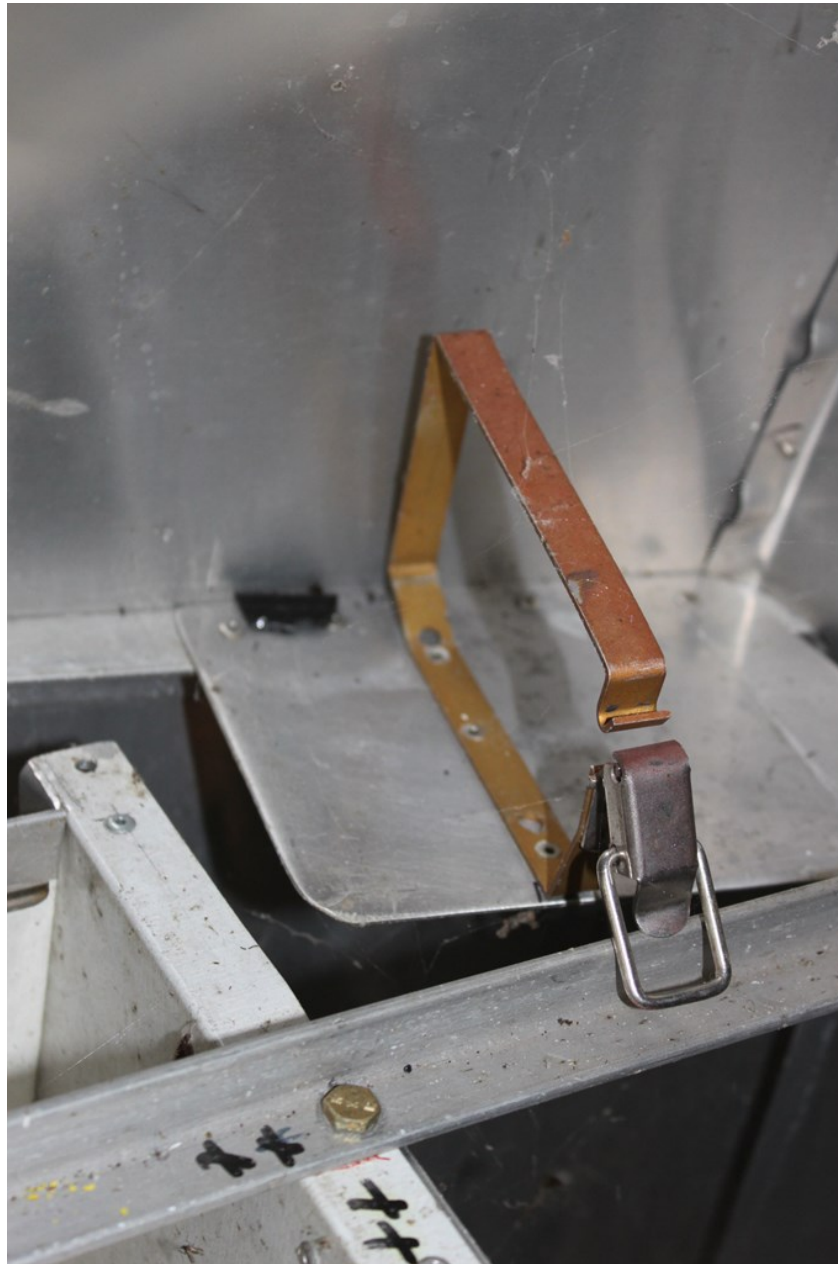
**Photo 14 – NTSB Digital Photograph. View Depicting the ELT Bracket and Lower Mount Tray**

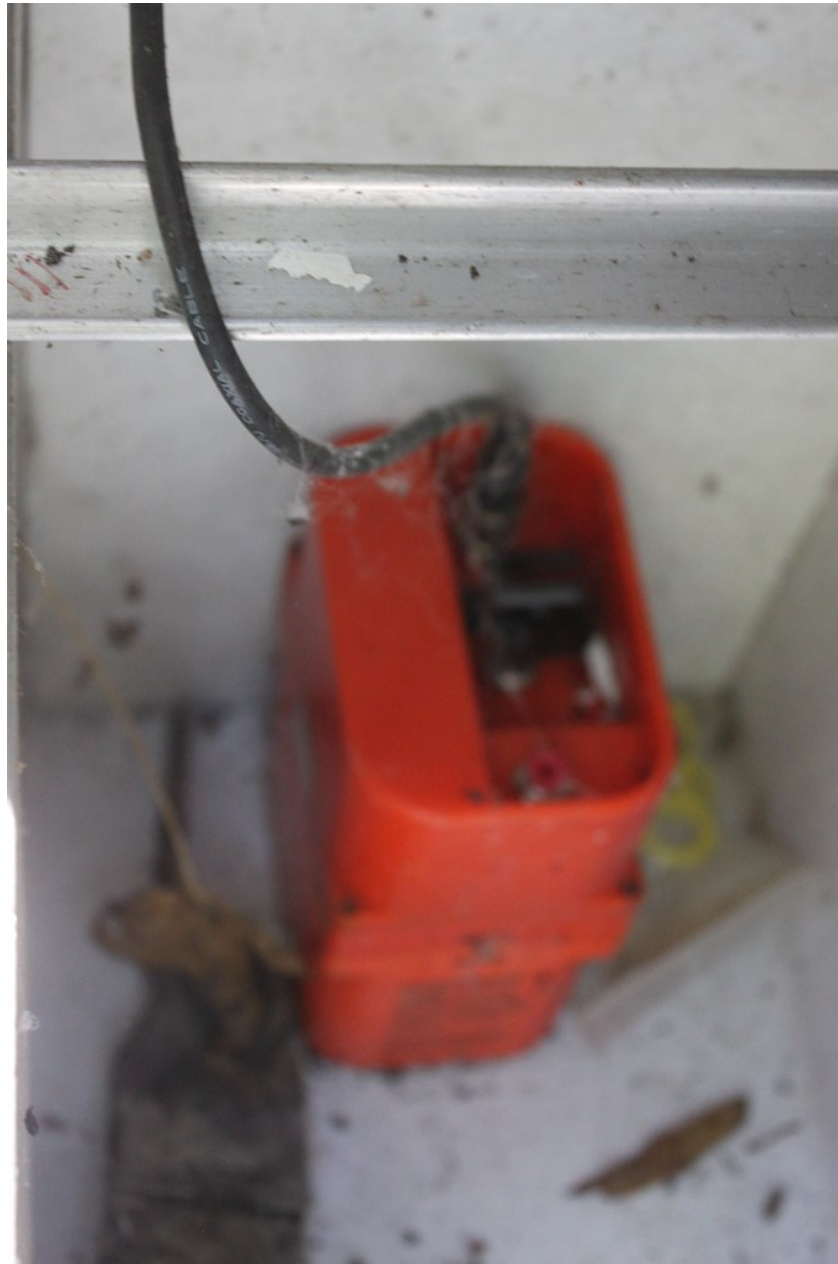
**Photo 15 – NTSB Digital Photograph. View of the As-Found Position of the ELT.**
