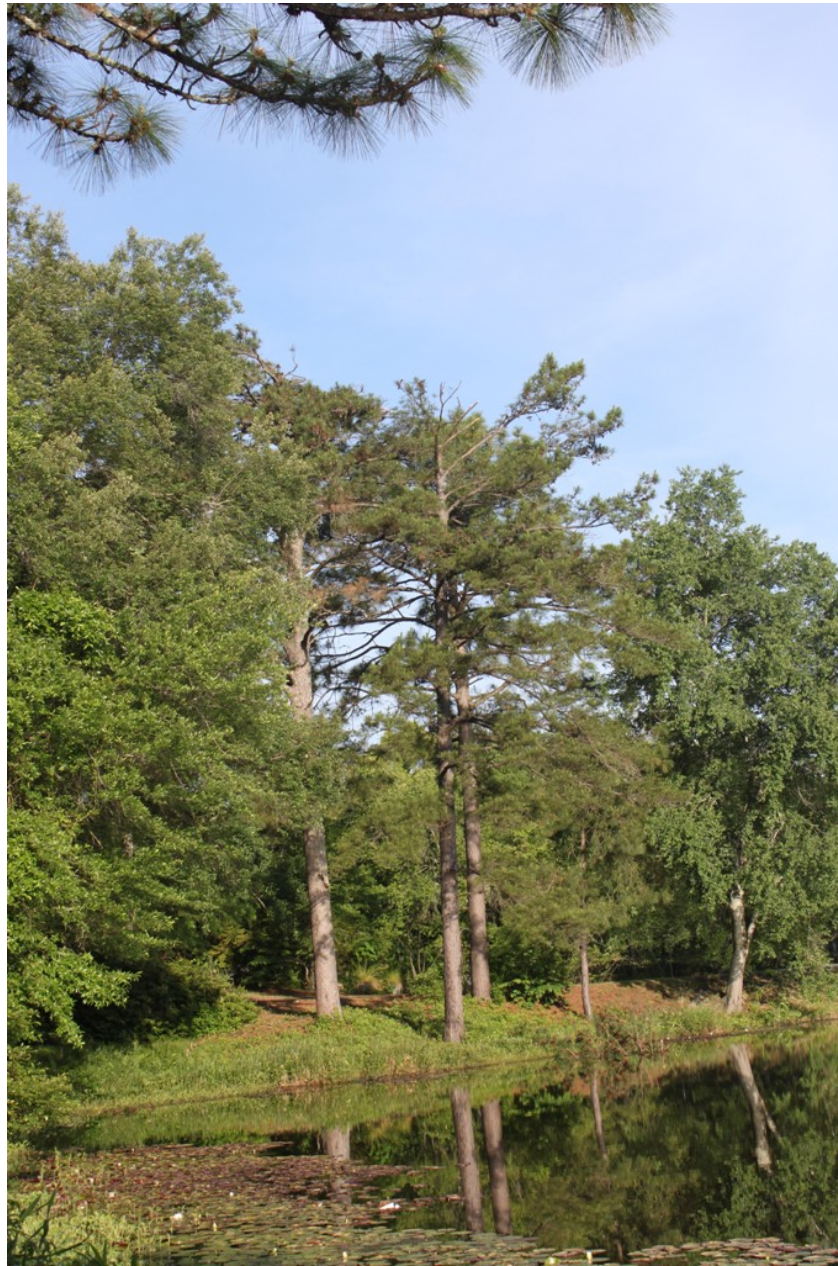
Photo 1 – NTSB Digital Photograph. View Depicting the Contacted Tree.

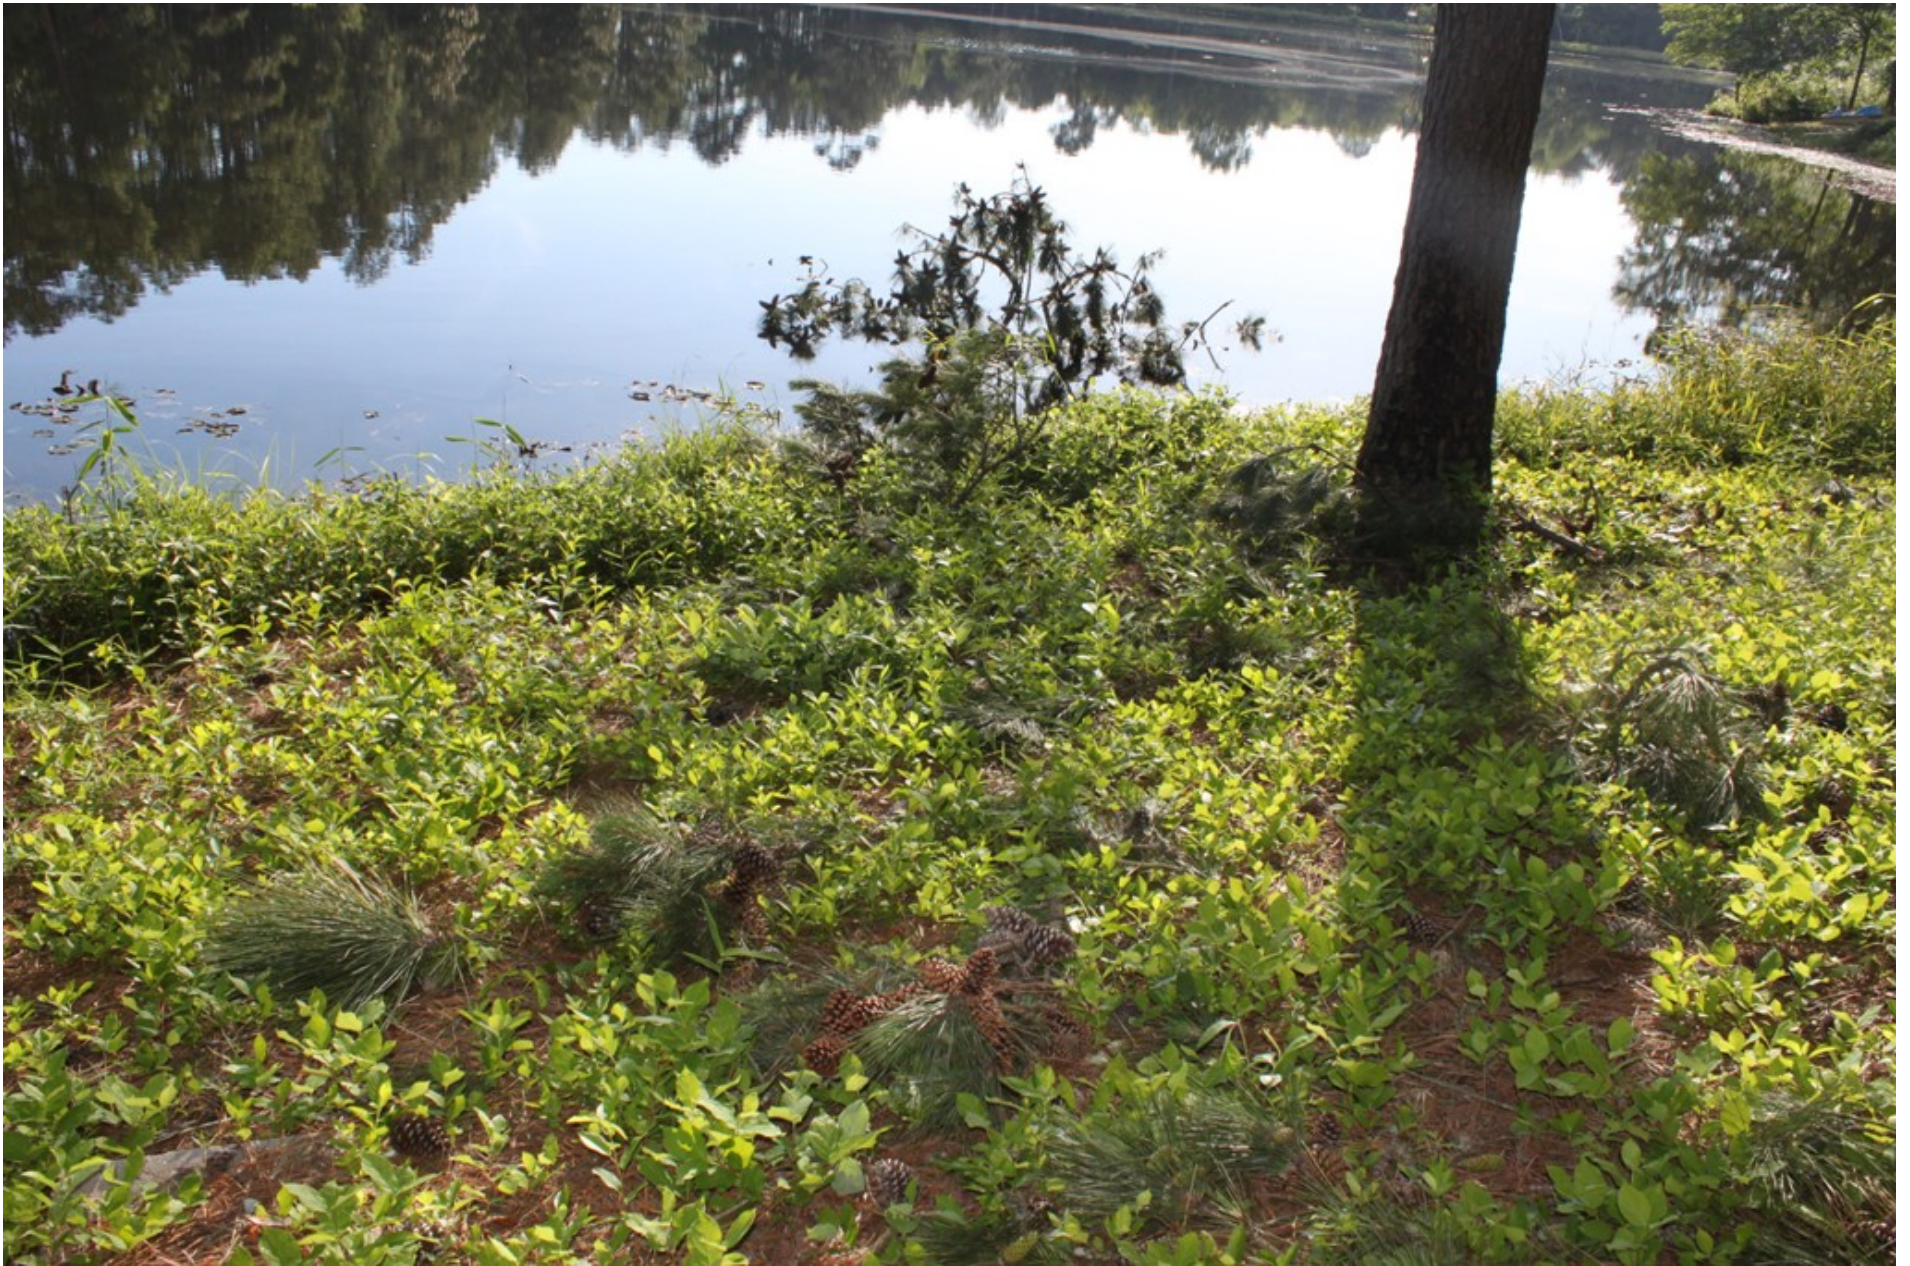
Photo 2 – NTSB Digital Photograph. View Depicting Broken Tree Branch at Base of Impacted Tree.

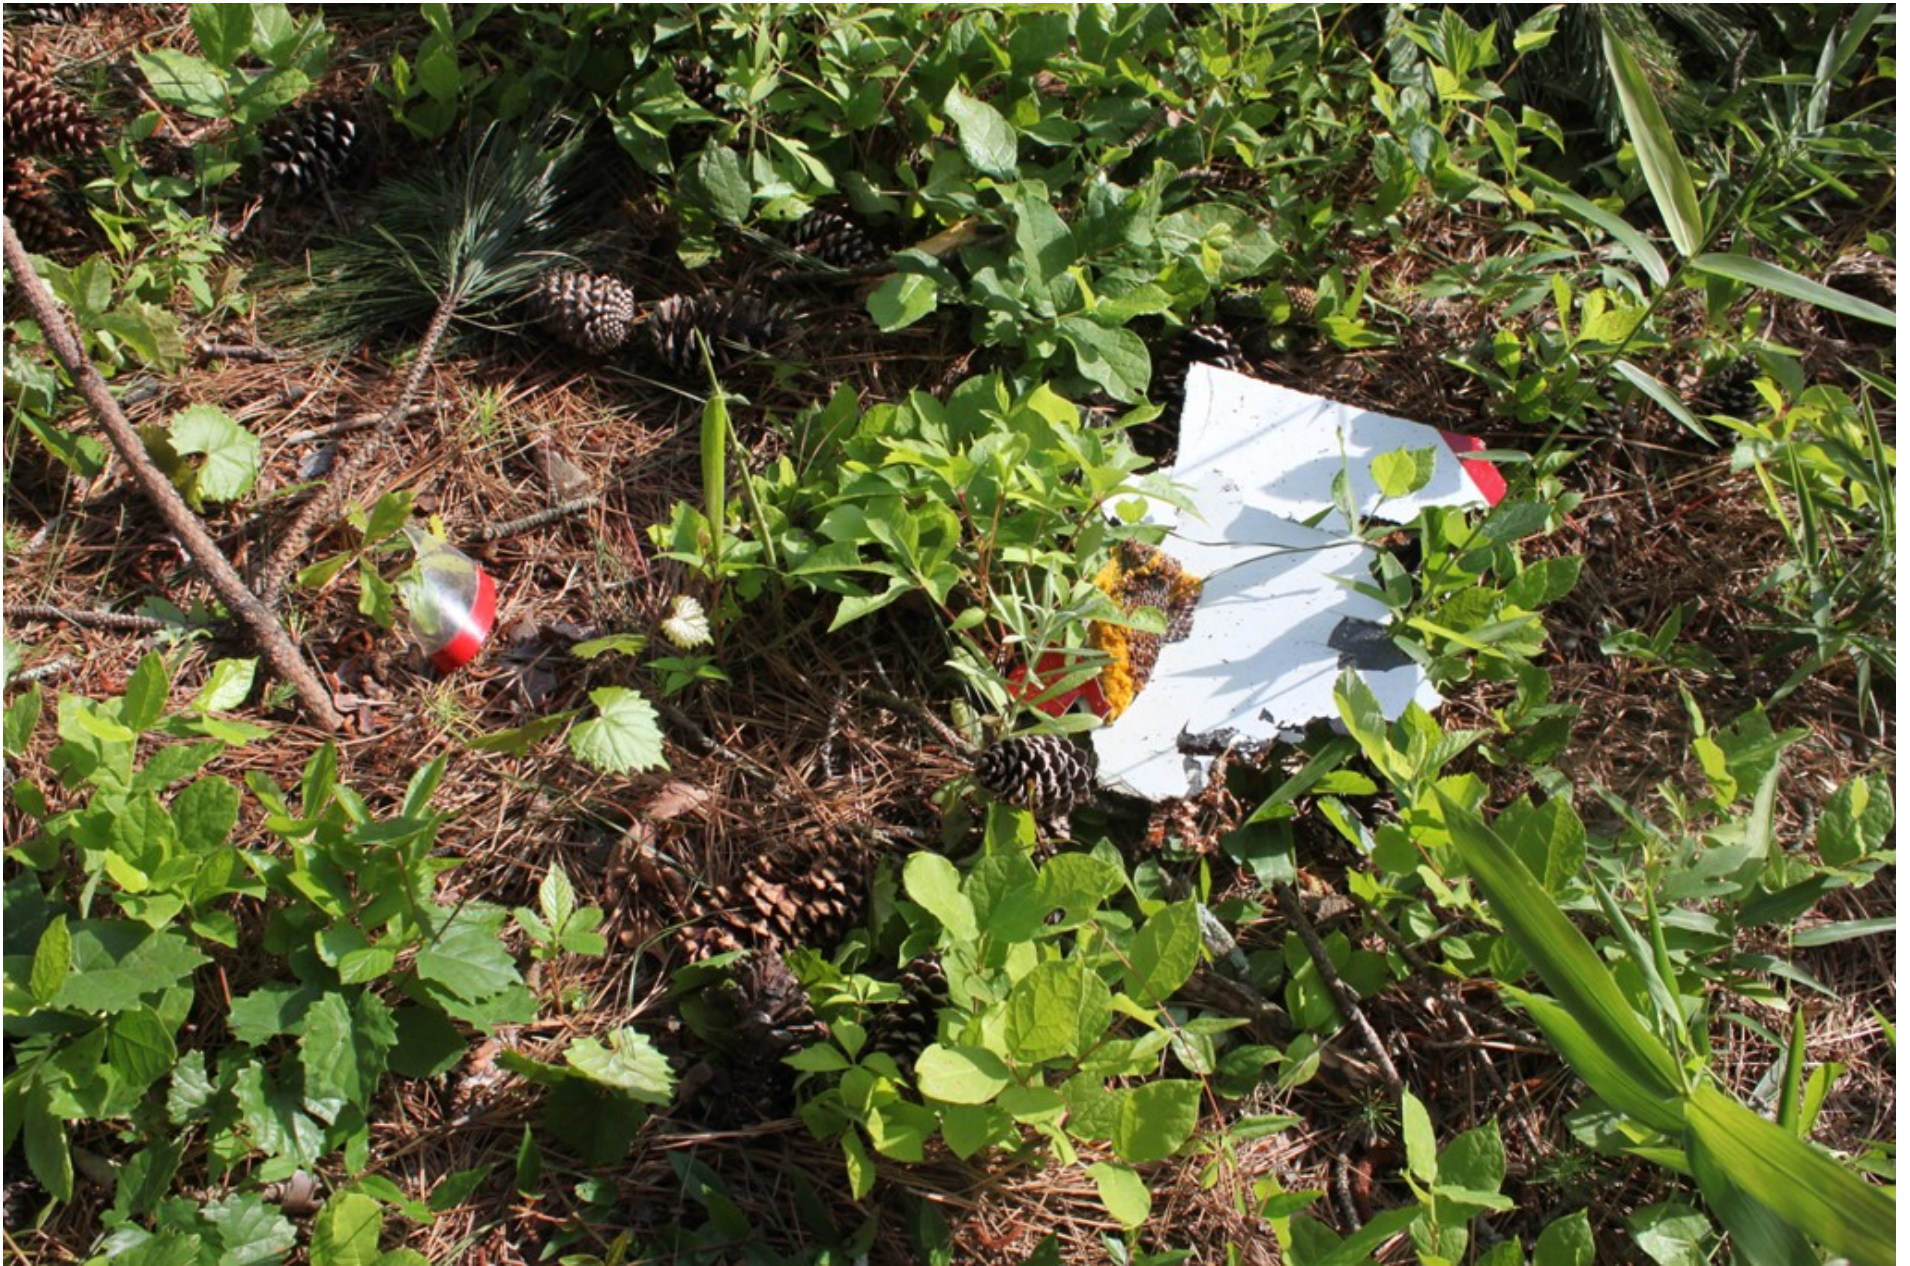
Photo 3 – NTSB Digital Photograph. View Depicting Airplane Debris at Base of Impacted Tree.

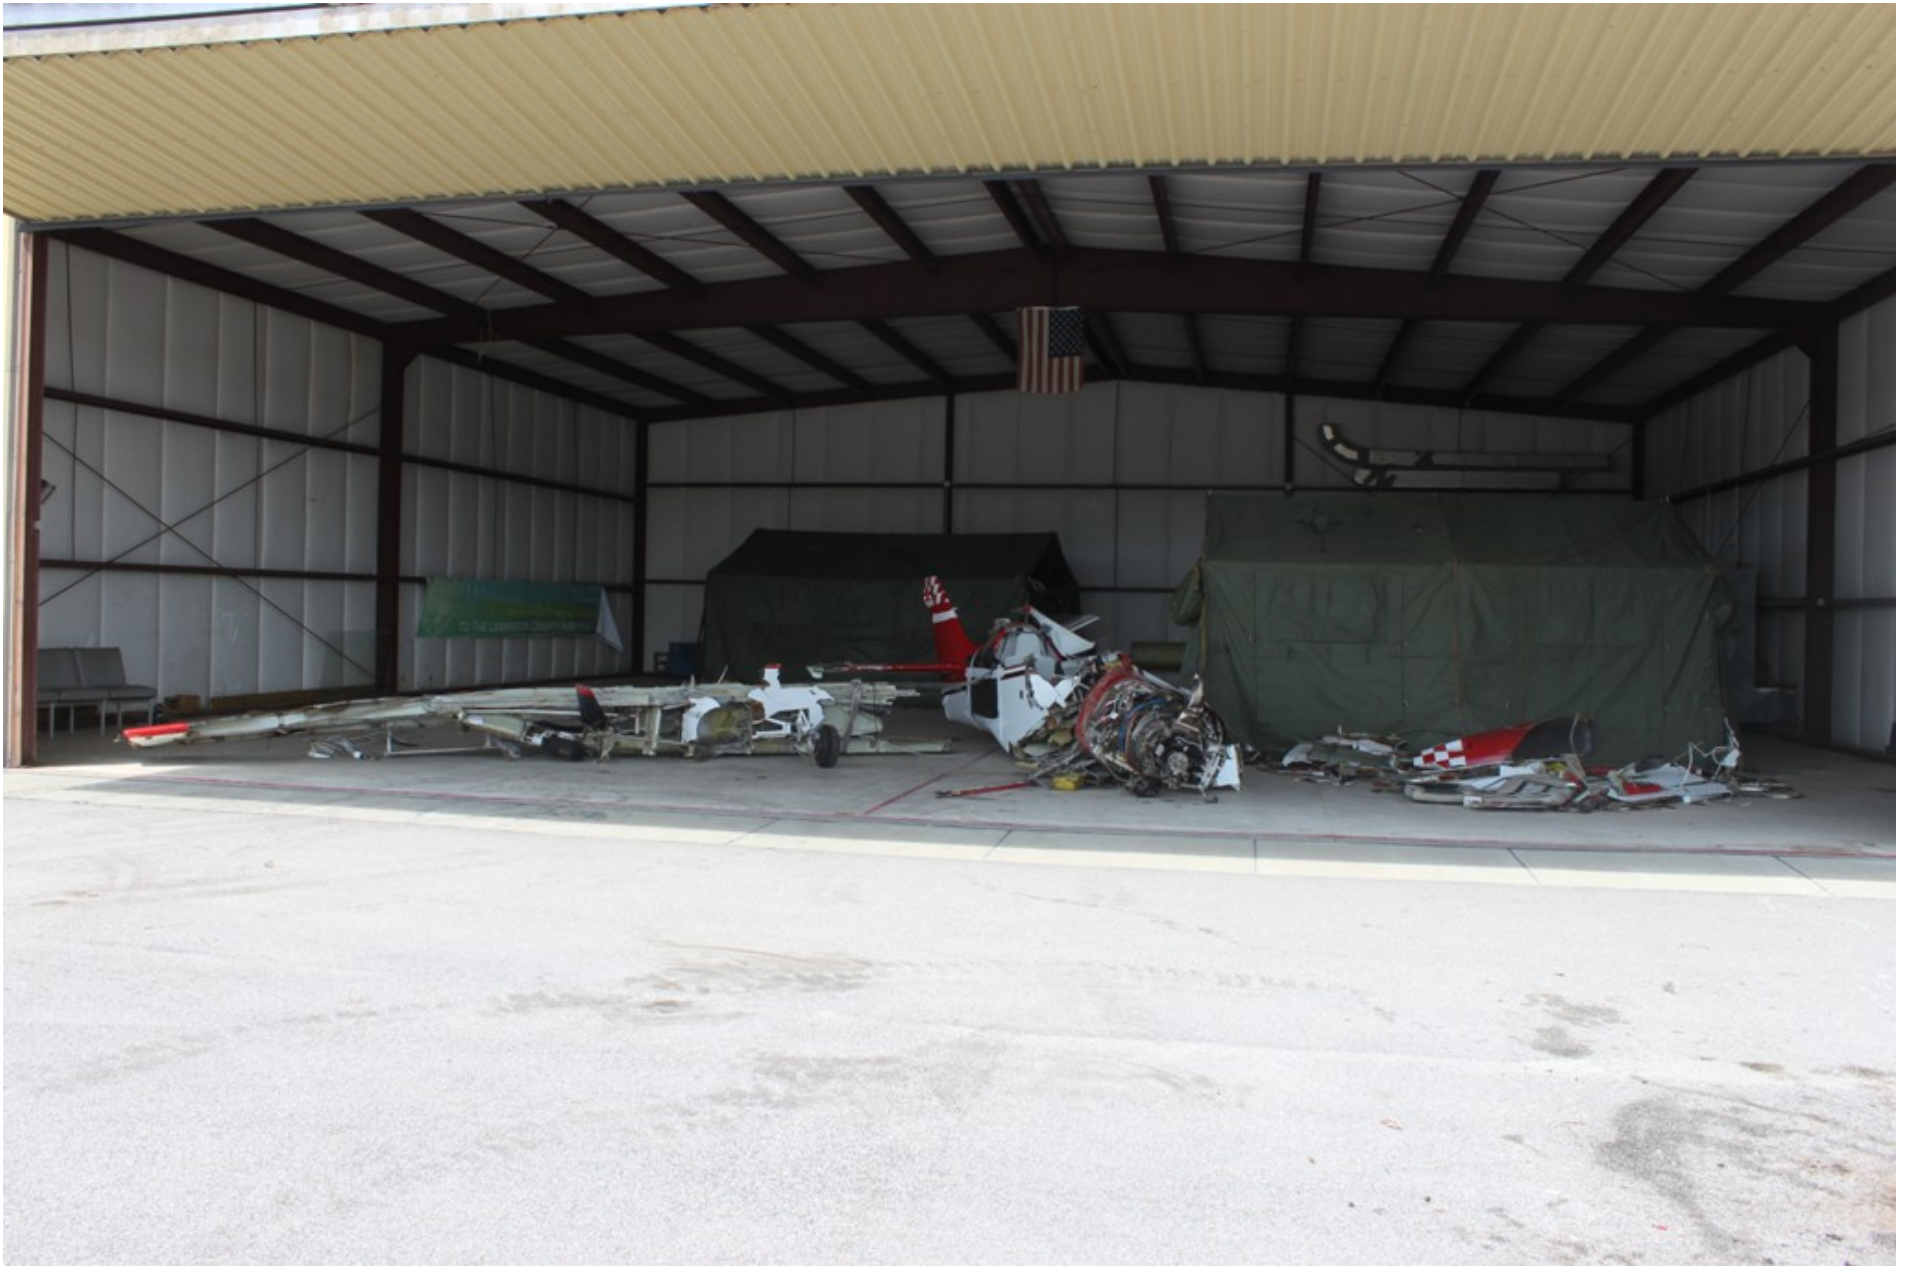
Photo 4 – NTSB Digital Photograph. View Depicting Recovered Wreckage as First Viewed by NTSB.

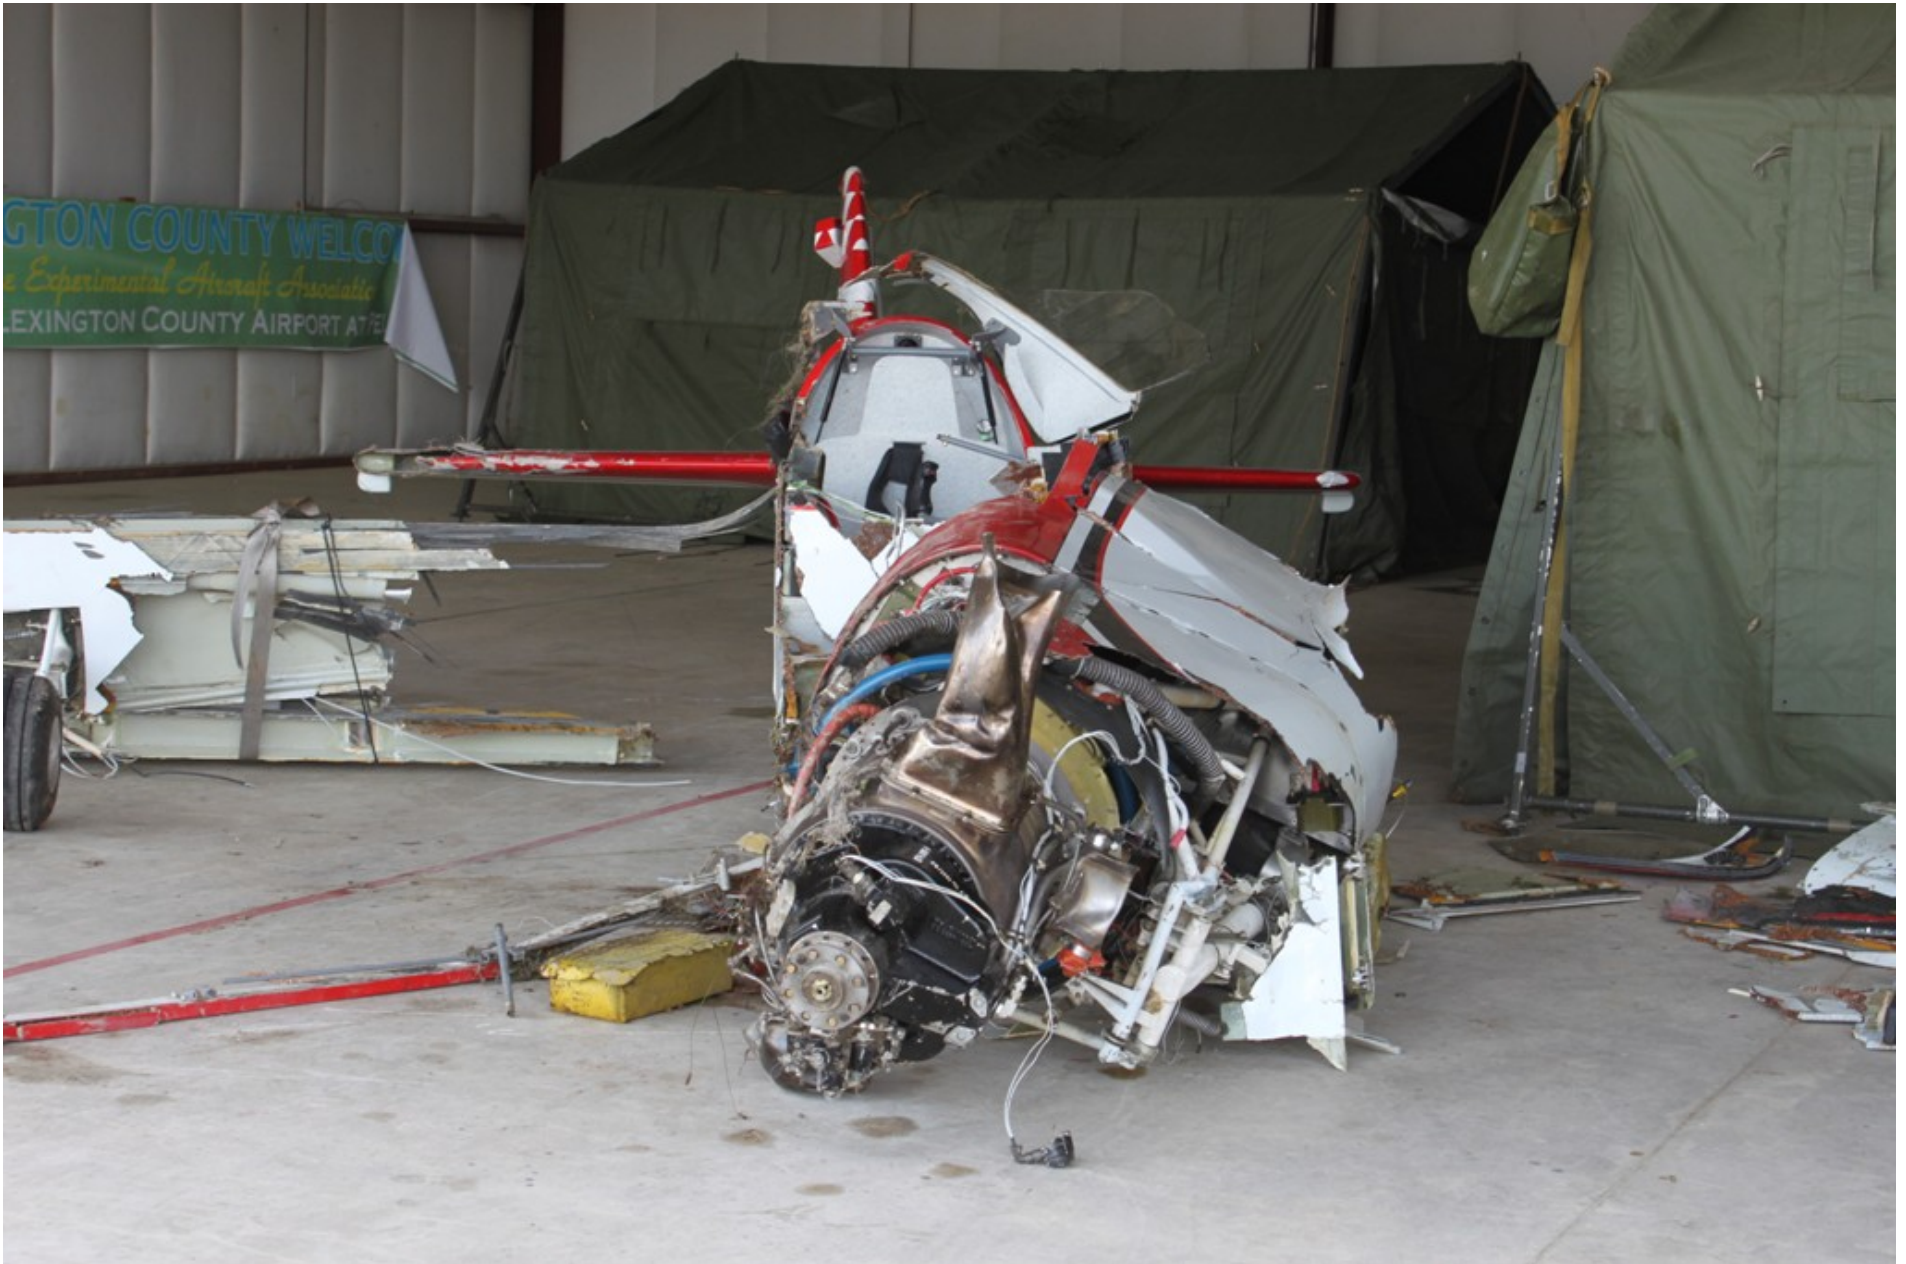
Photo 5 - NTSB Digital Photograph. Front View Depicting Installed Engine, and Fuselage, with Portion of Right Wing Visible.

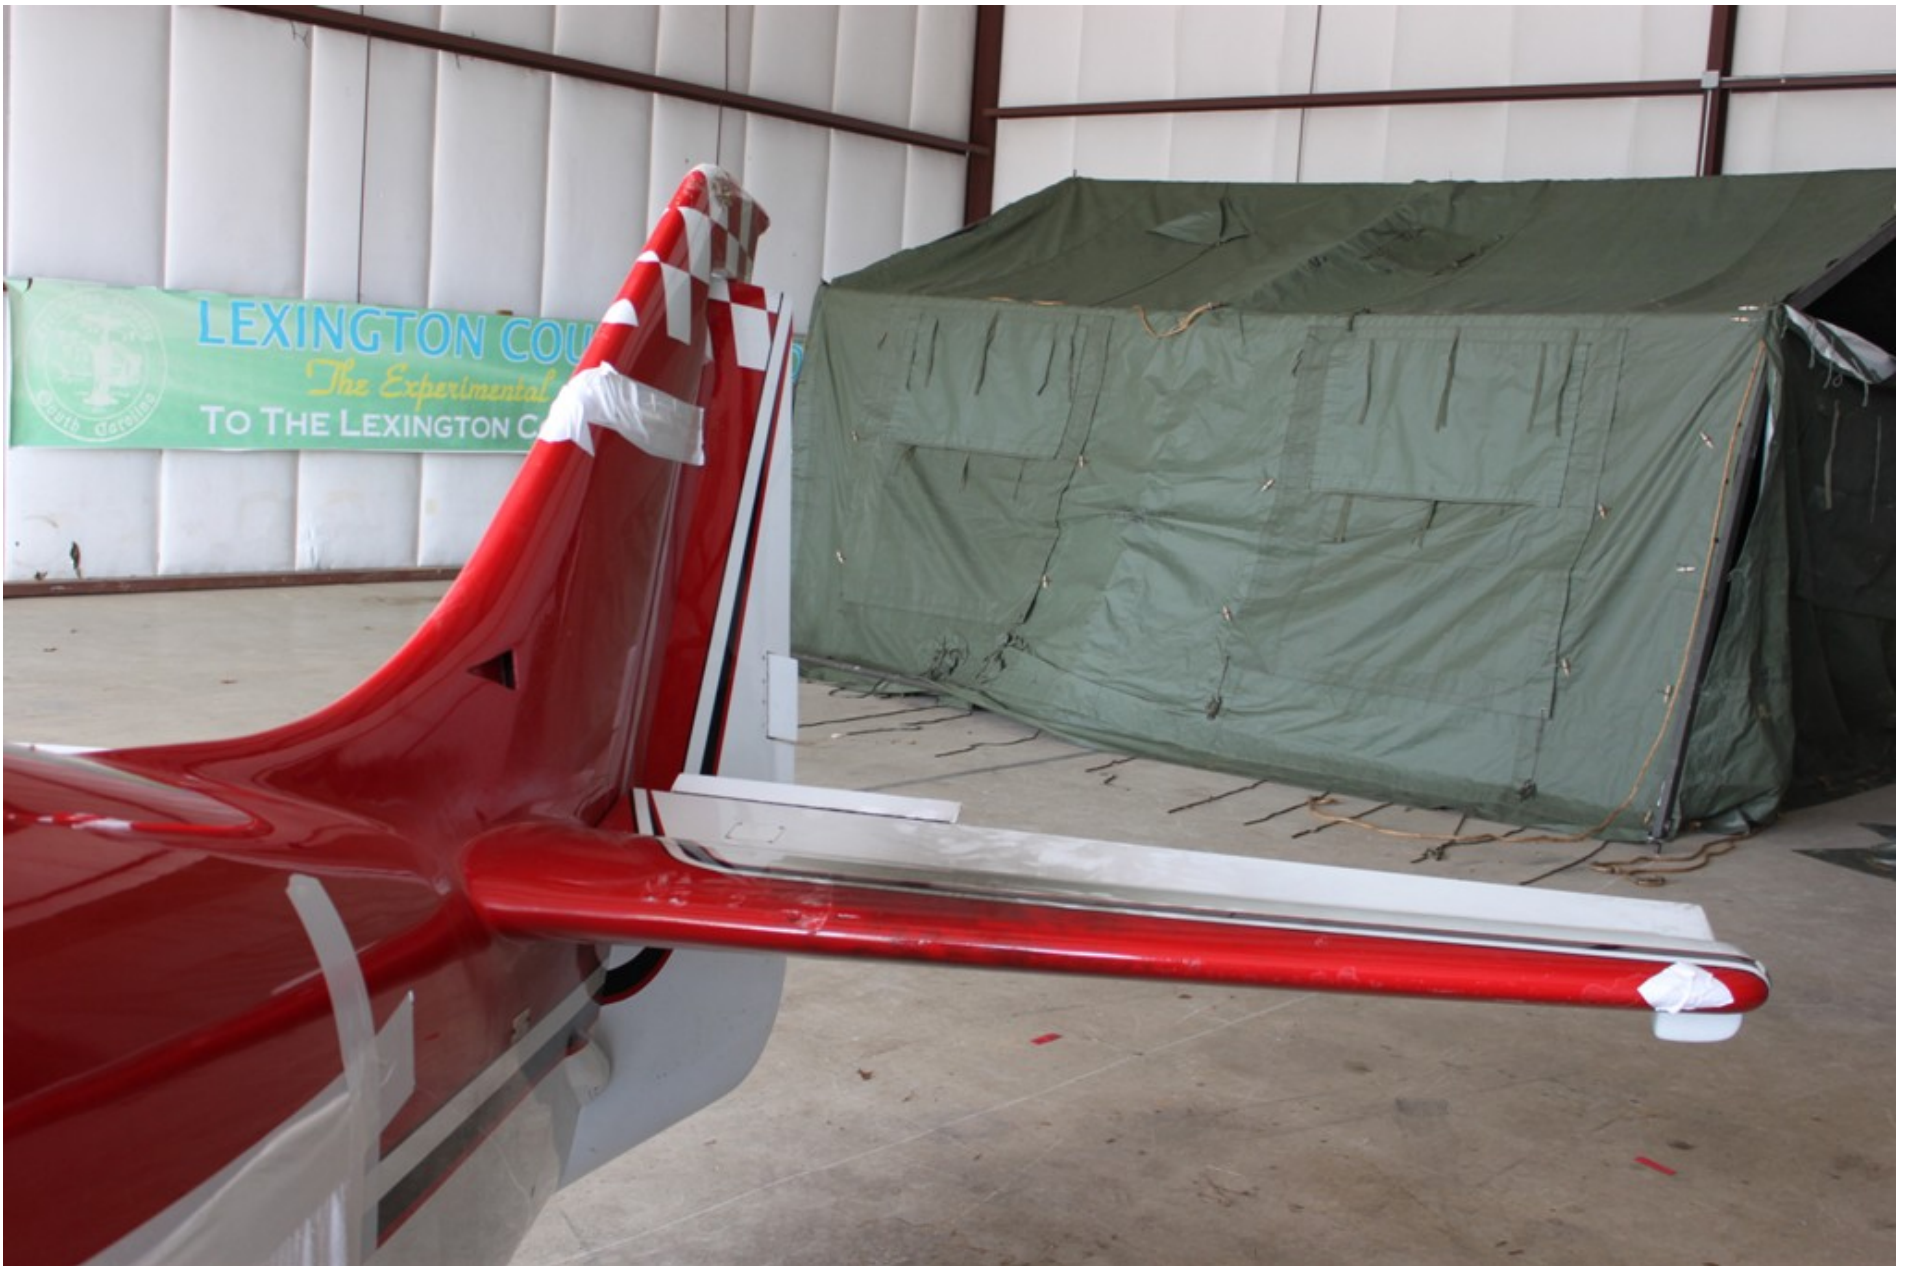
Photo 6 - NTSB Digital Photograph. Left Side of Aft Empennage with Left Horizontal Stabilizer, Elevator, Vertical Stabilizer and Rudder.

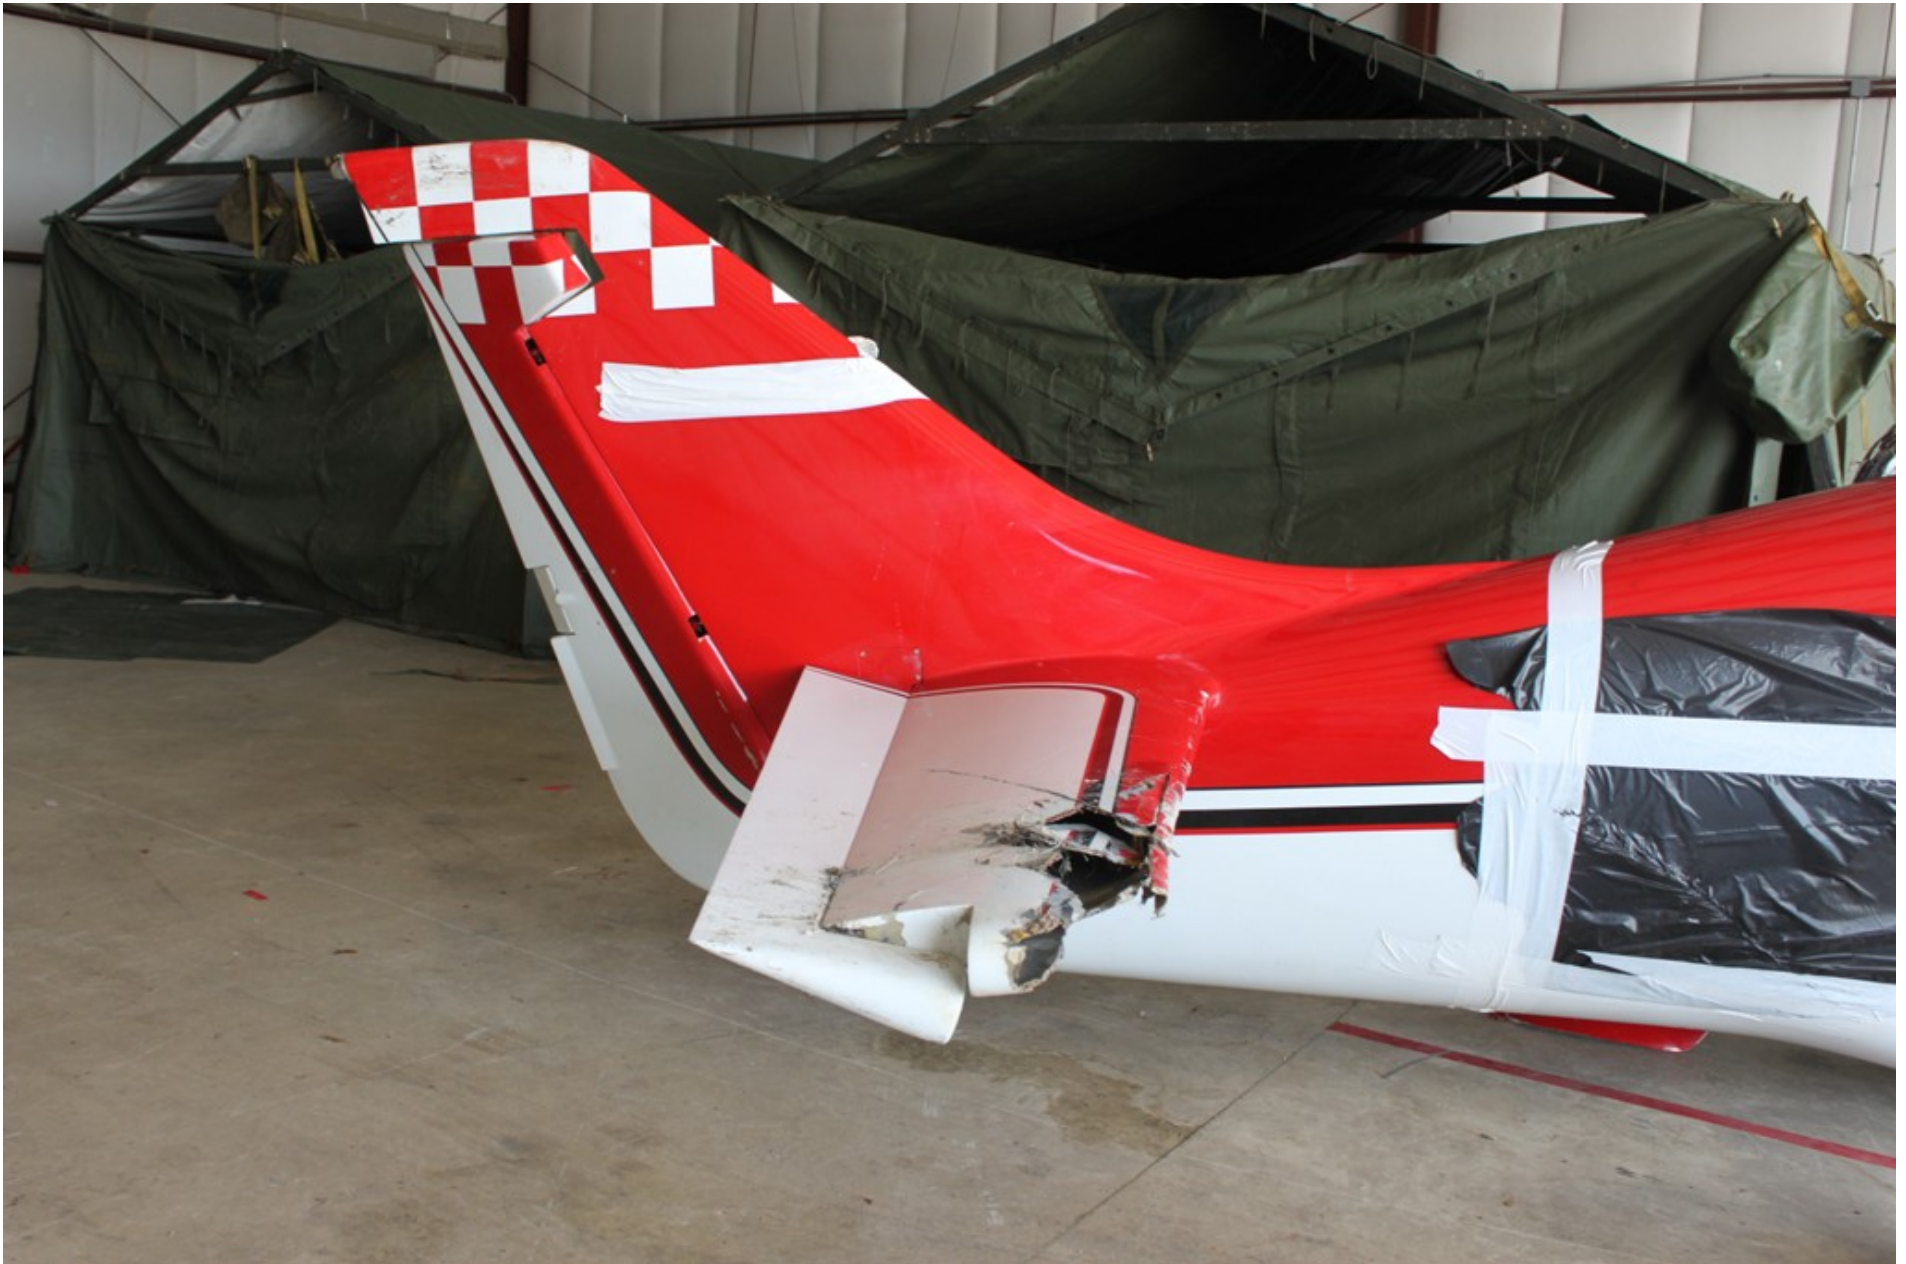
Photo 7 - NTSB Digital Photograph. Right Side of Aft Empennage with Damaged Right Horizontal Stabilizer, Elevator, Vertical Stabilizer and Rudder.

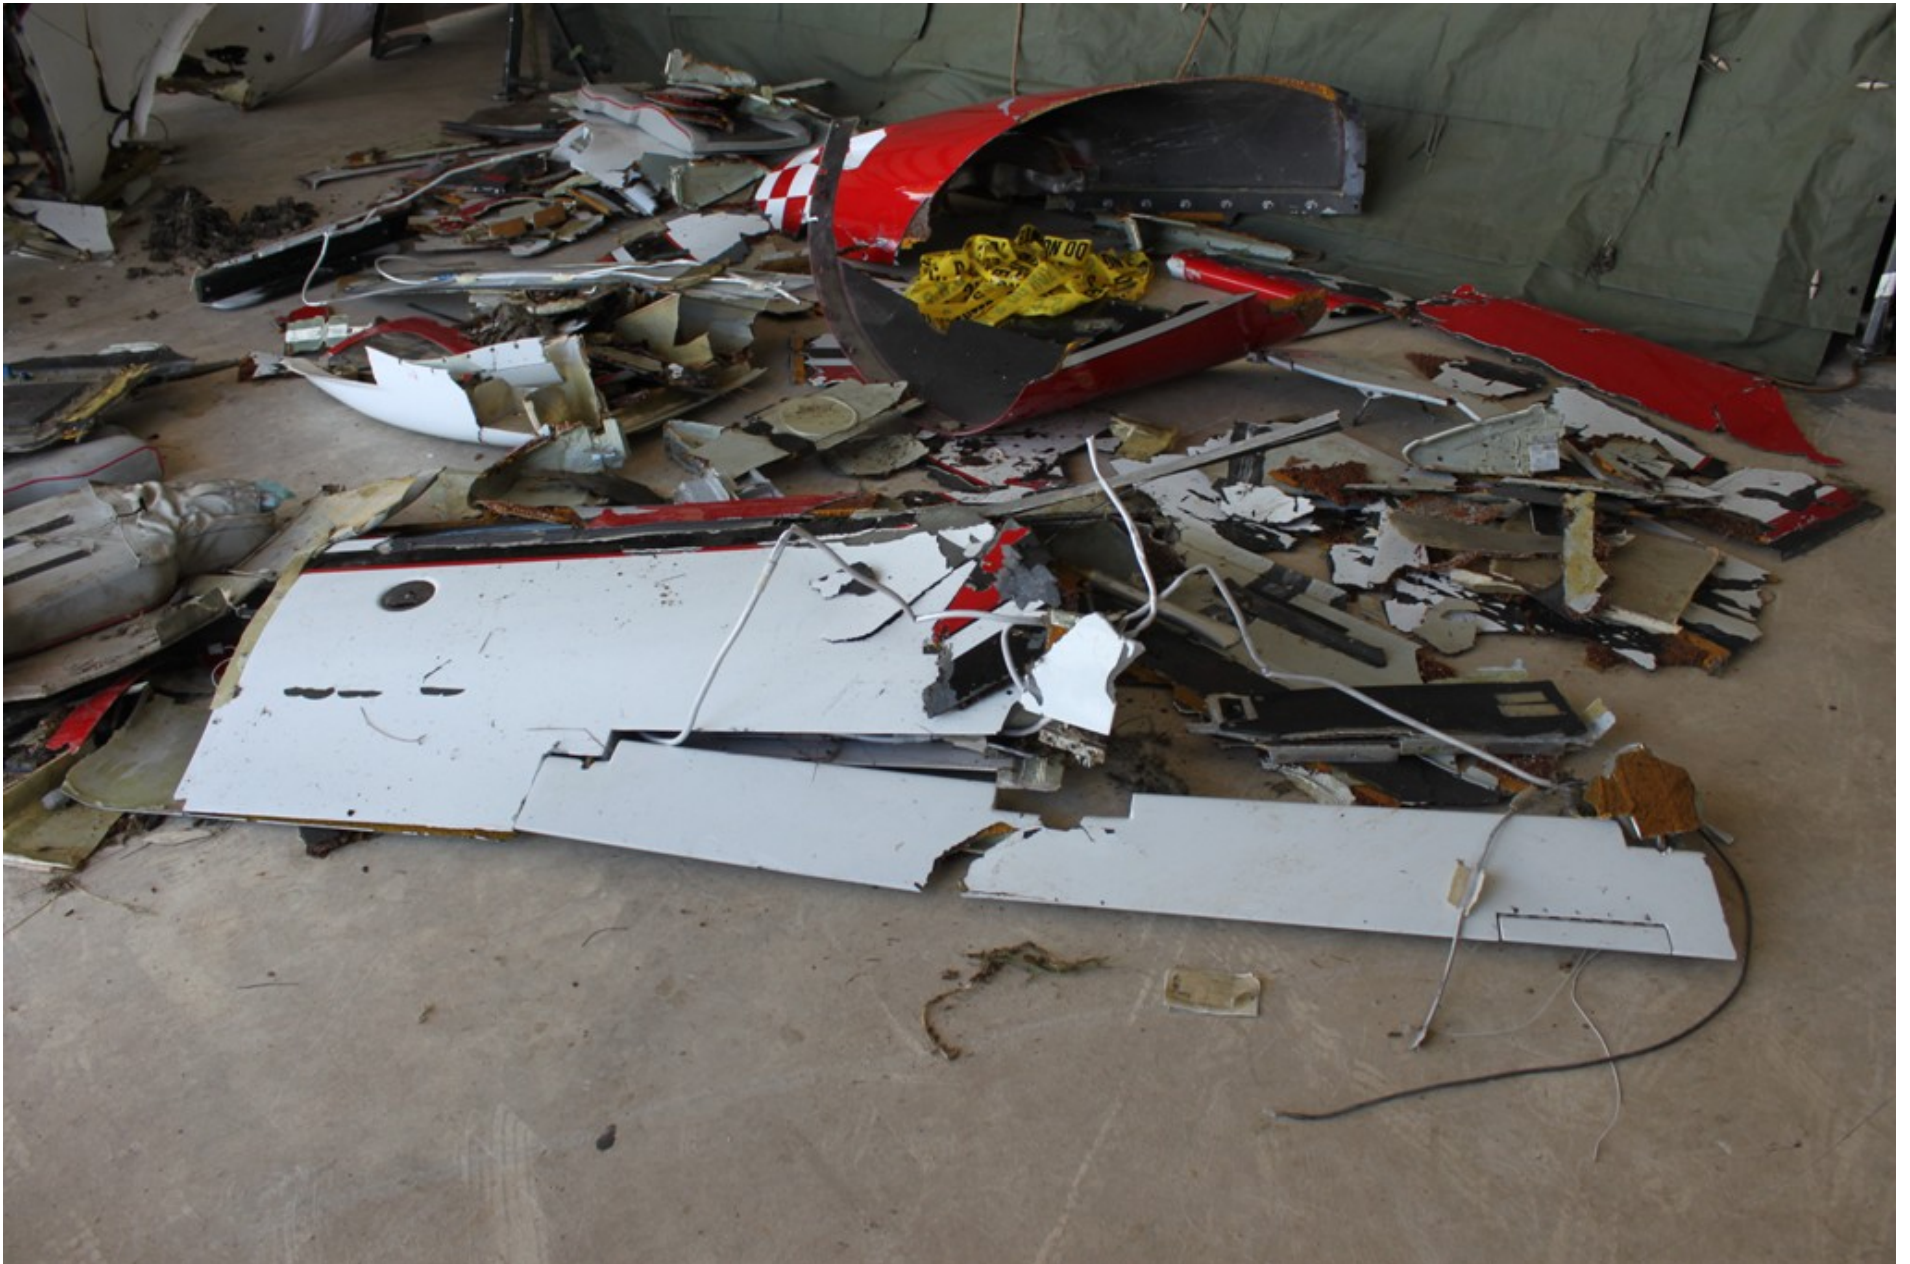
Photo 8 - NTSB Digital Photograph. View of Portion of Left Wing, Left Aileron, and Recovered Debris in Background.

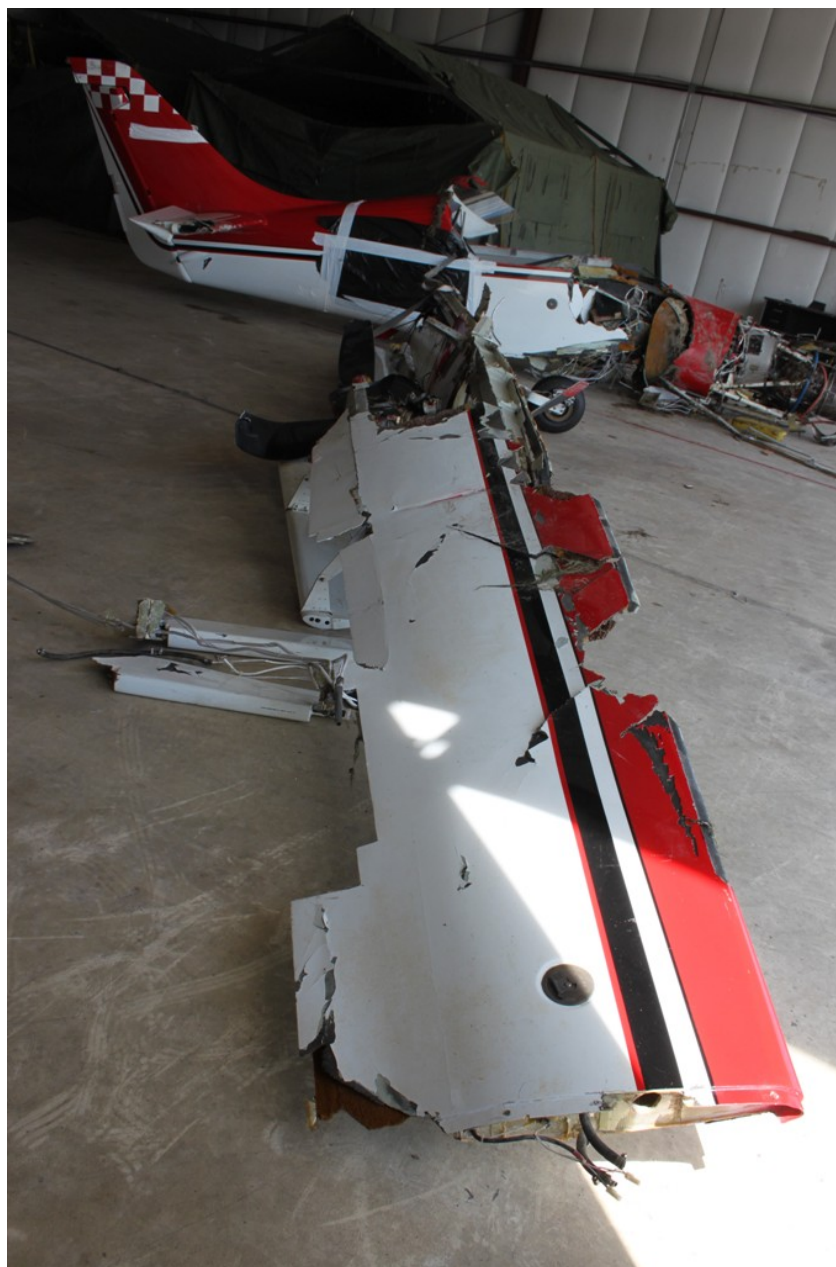
Photo 9 - NTSB Digital Photograph. View of Right Wing, Right Aileron, and Right Side of Fuselage in Background.

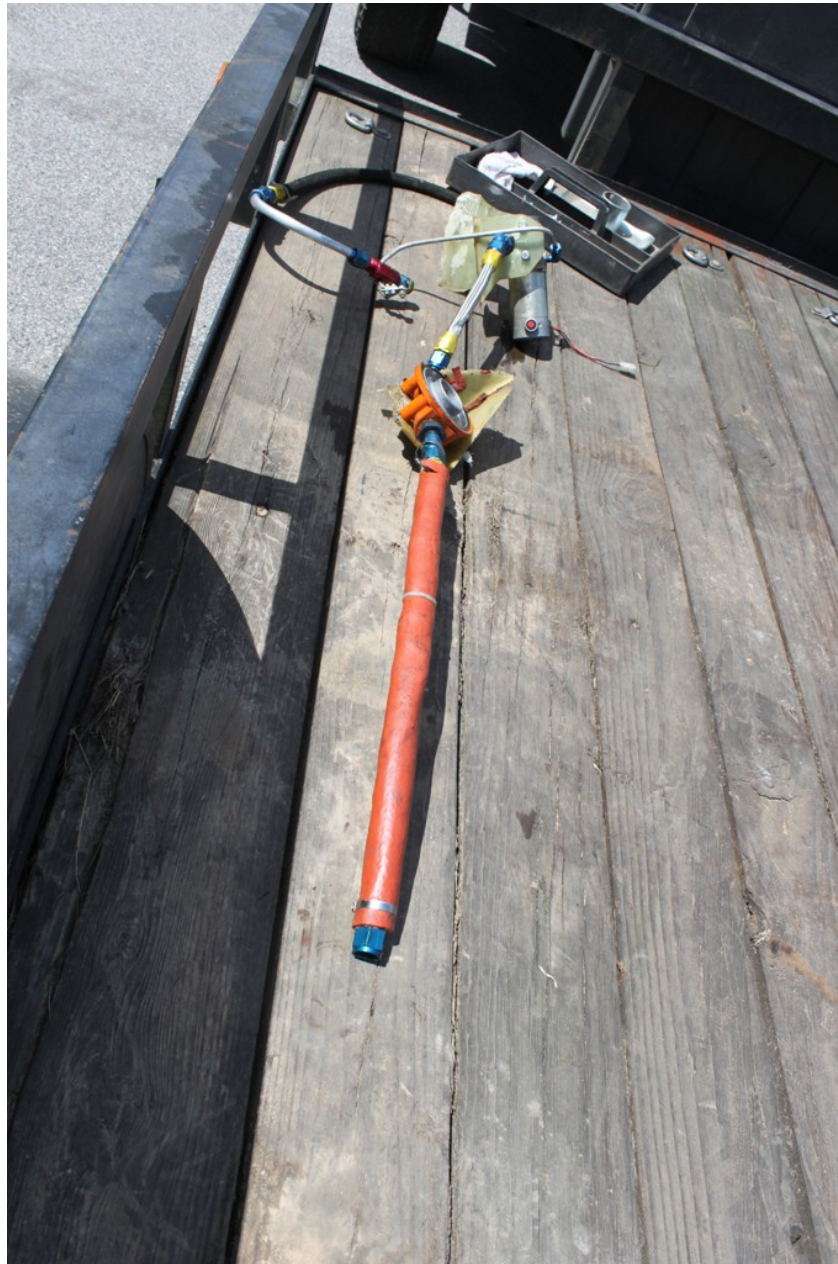
Photo 10 - NTSB Digital Photograph. View of the Fuel Supply System Including Lines from the Fractured Fuel Tank Outlet Fitting, Shutoff Valve, Auxiliary Fuel Pump, Fuel Filter, and Fuel Line to Engine-Driven Fuel Pump.

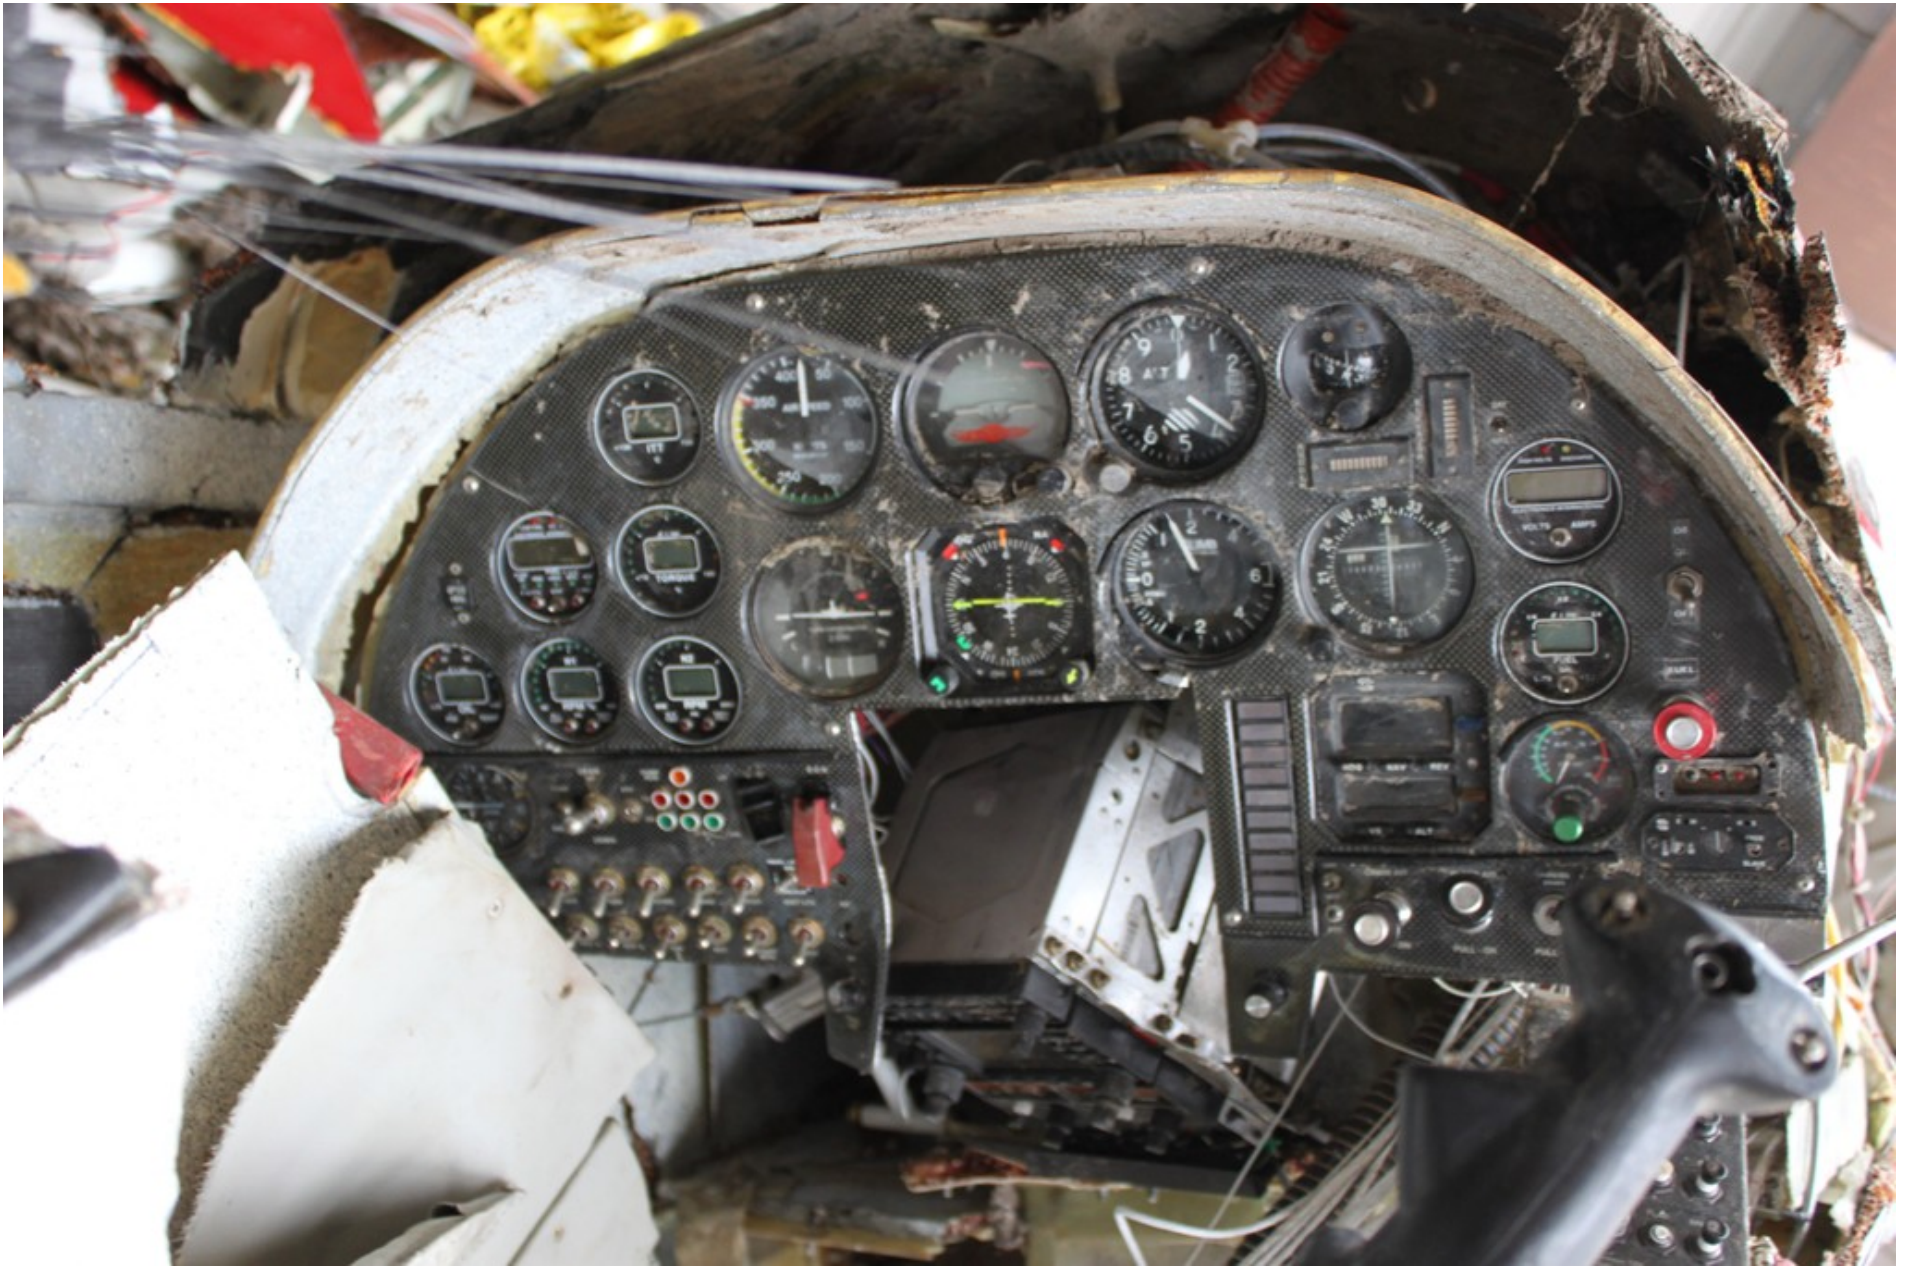
Photo 11 - NTSB Digital Photograph. View of the Instrument Panel.
