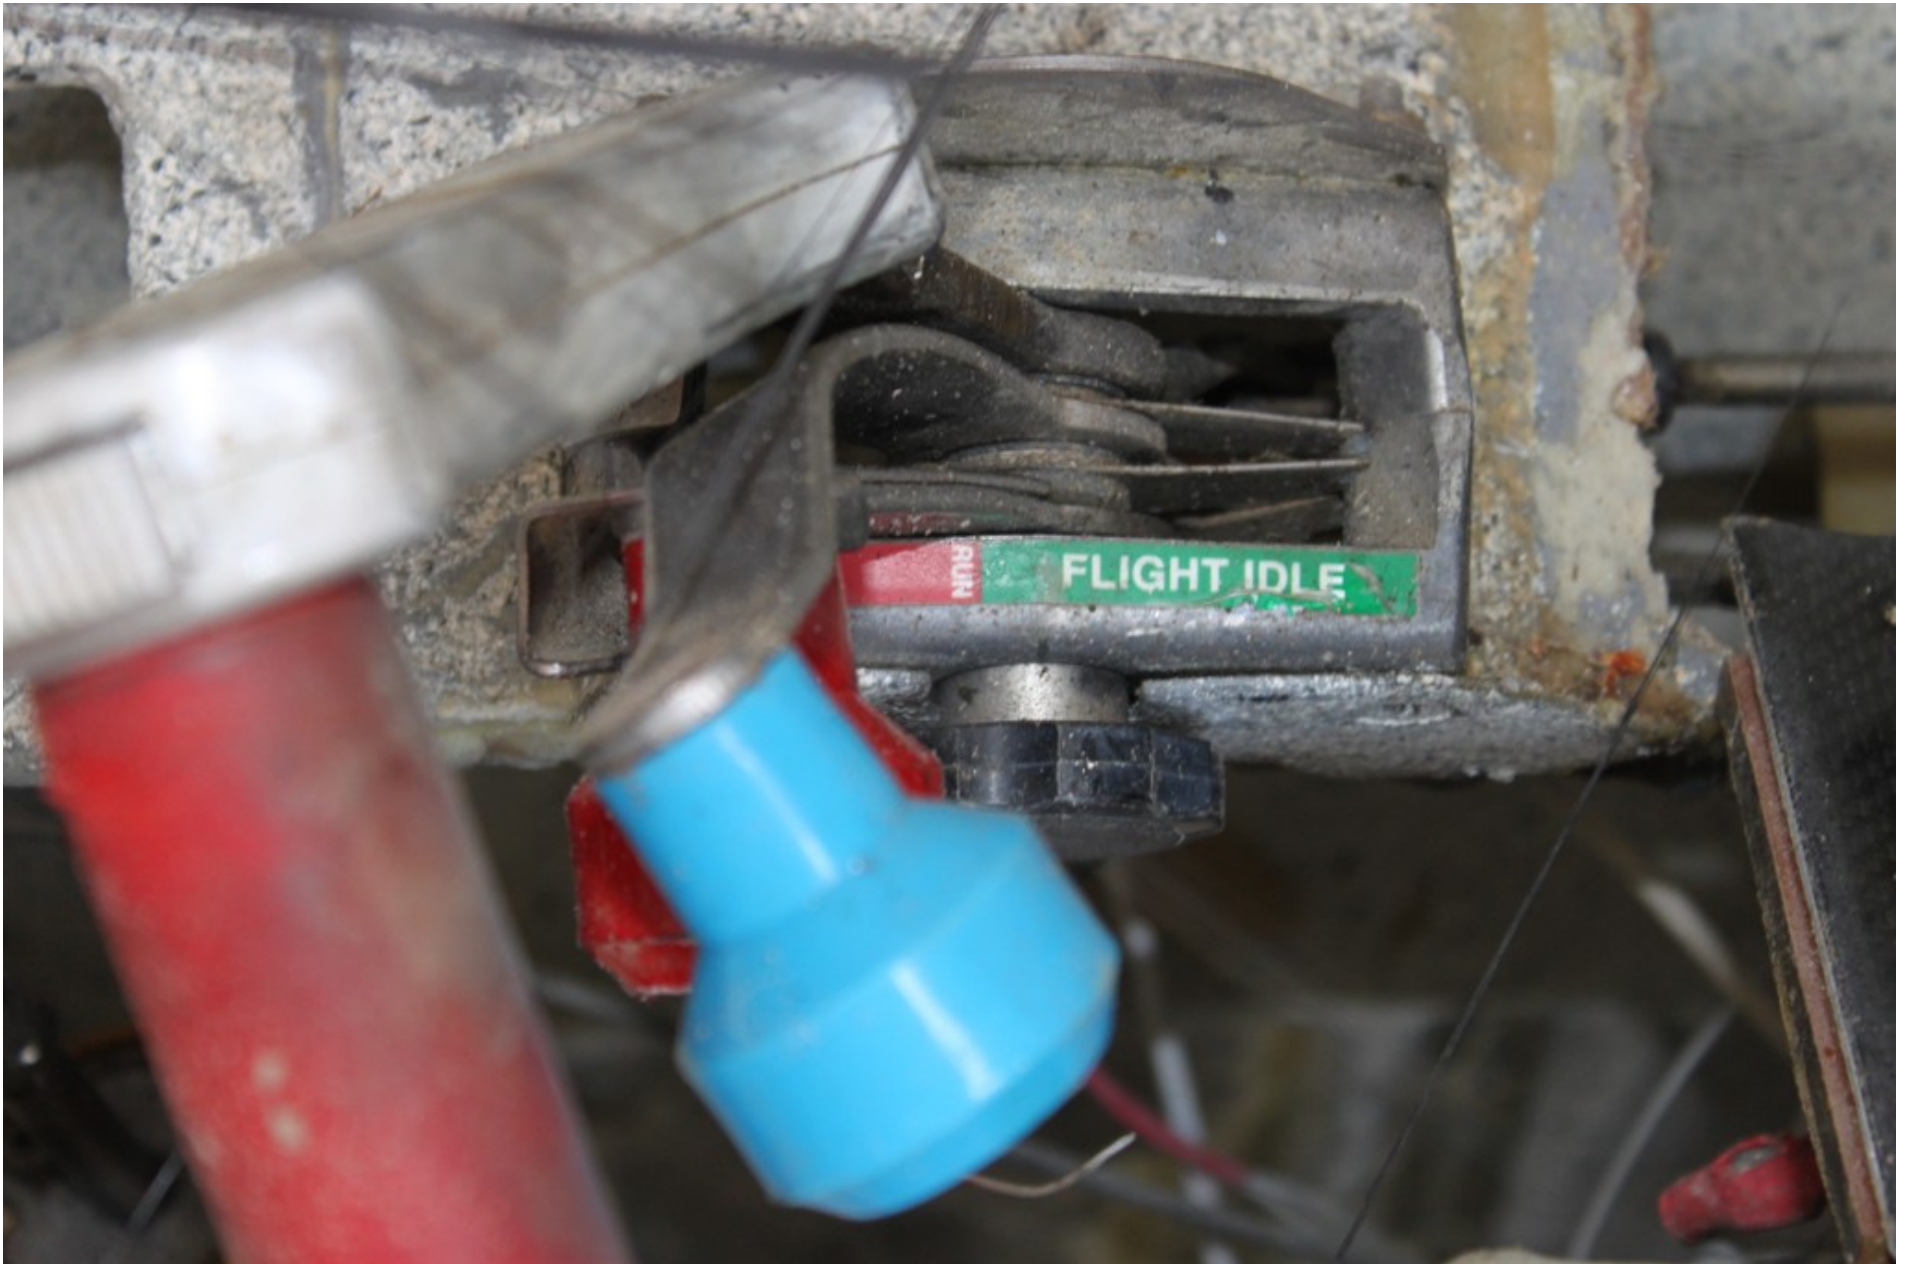
Photo 12 - NTSB Digital Photograph. View of the Throttle Quadrant.

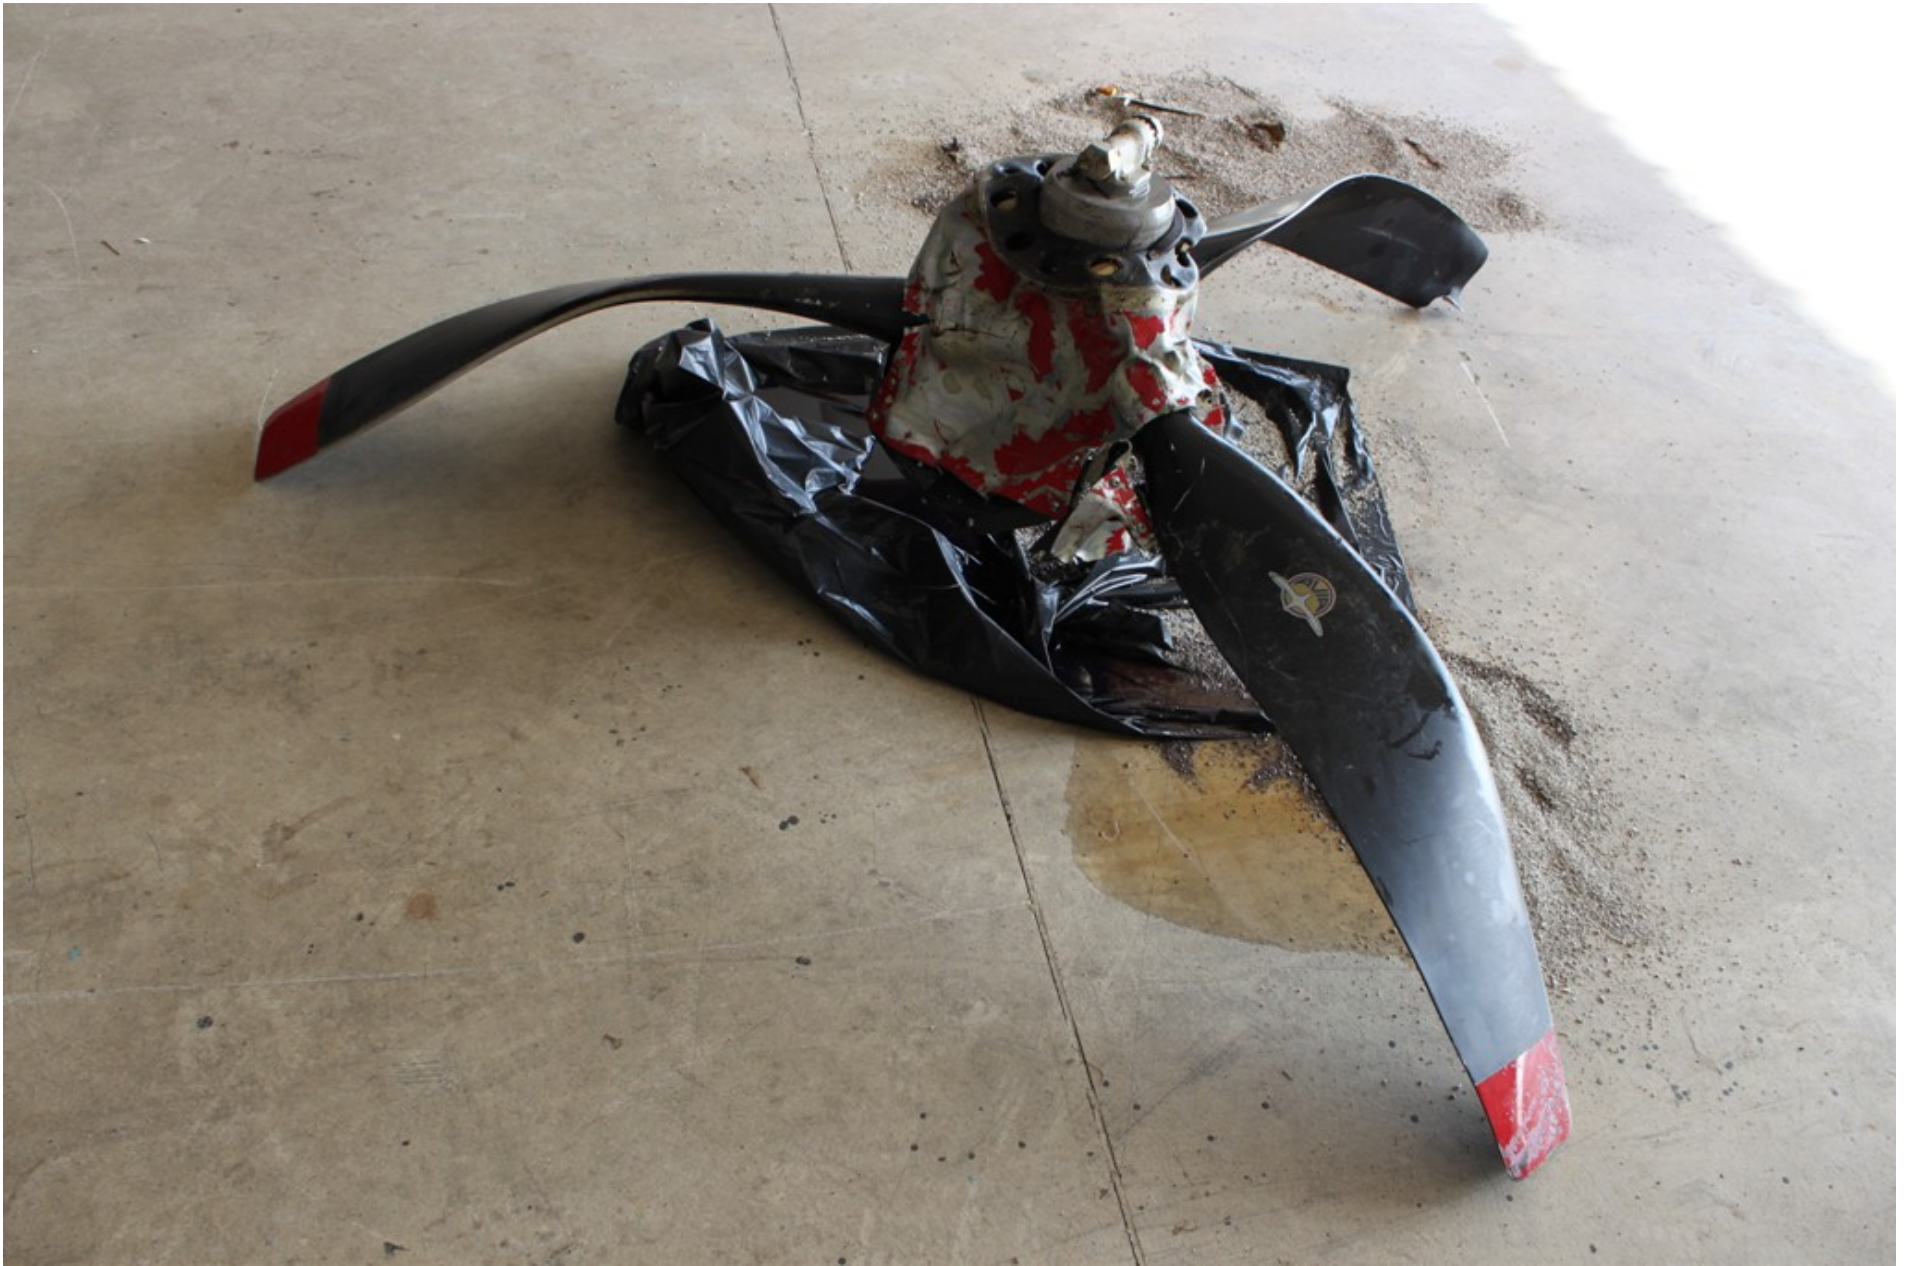
Photo 13 - NTSB Digital Photograph. View of the Separated Propeller.
