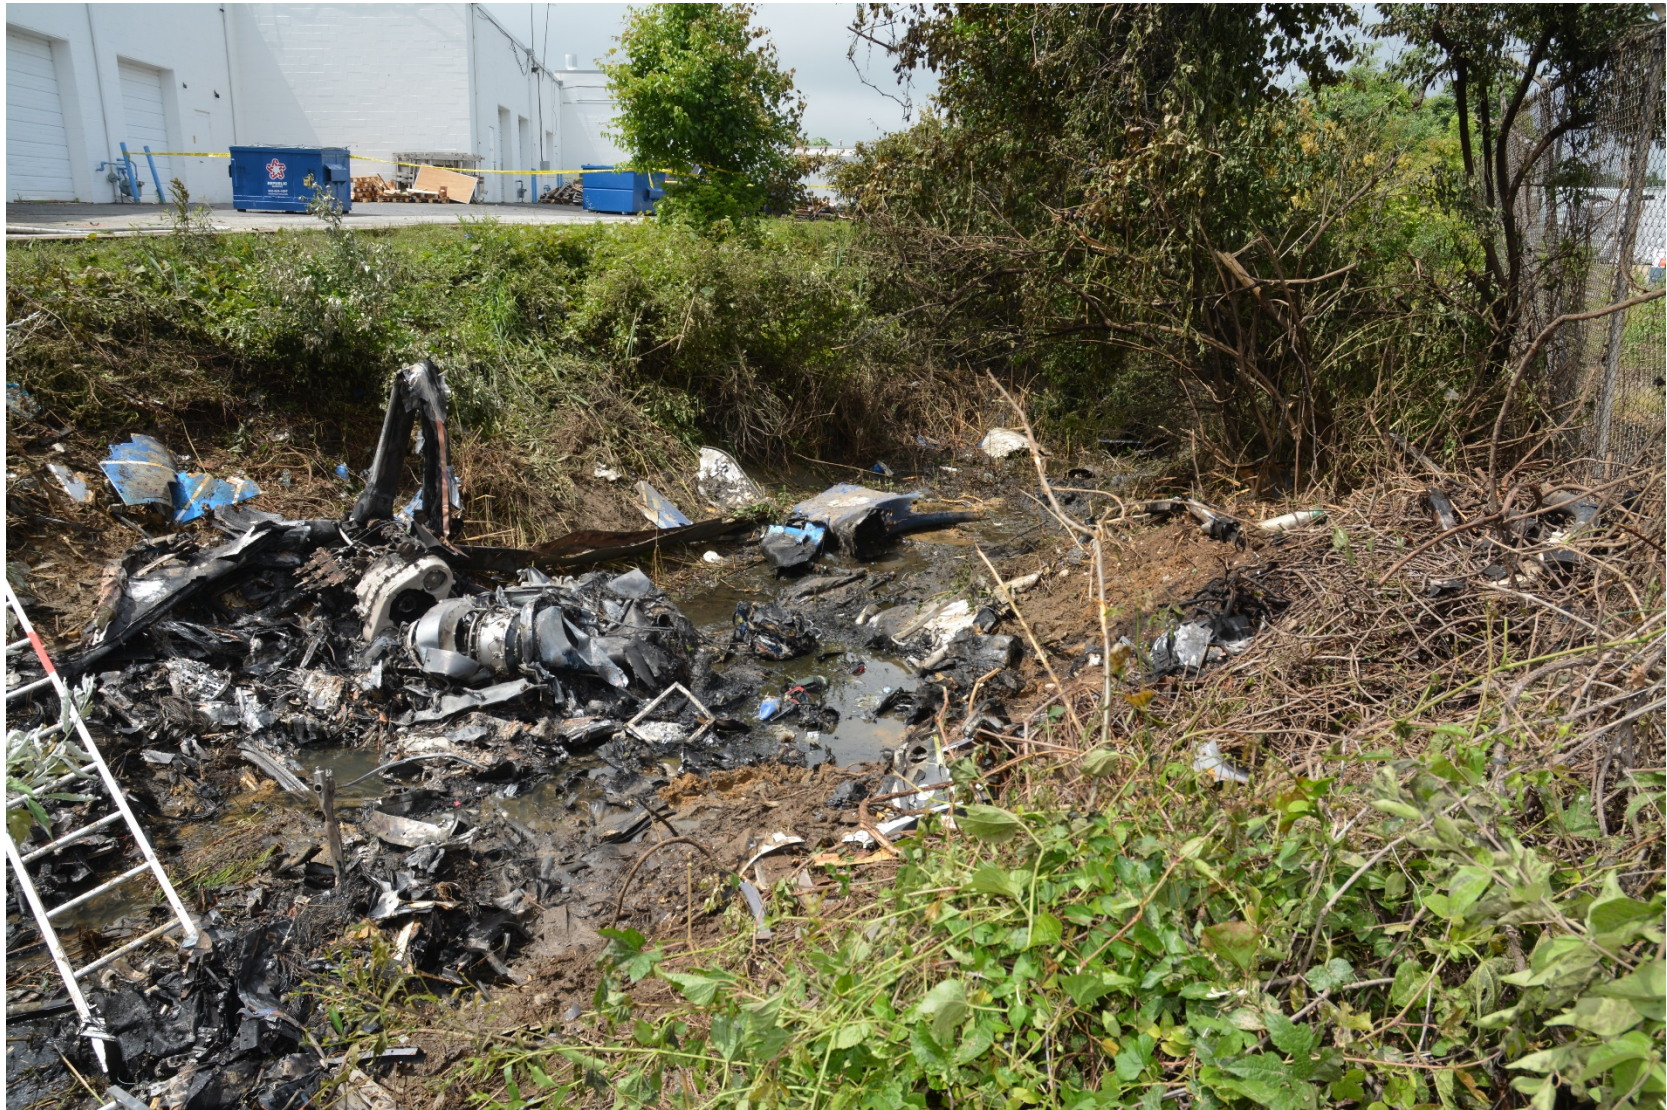
**Photo 1 –Overview of Main Wreckage (Courtesy of DSP)**

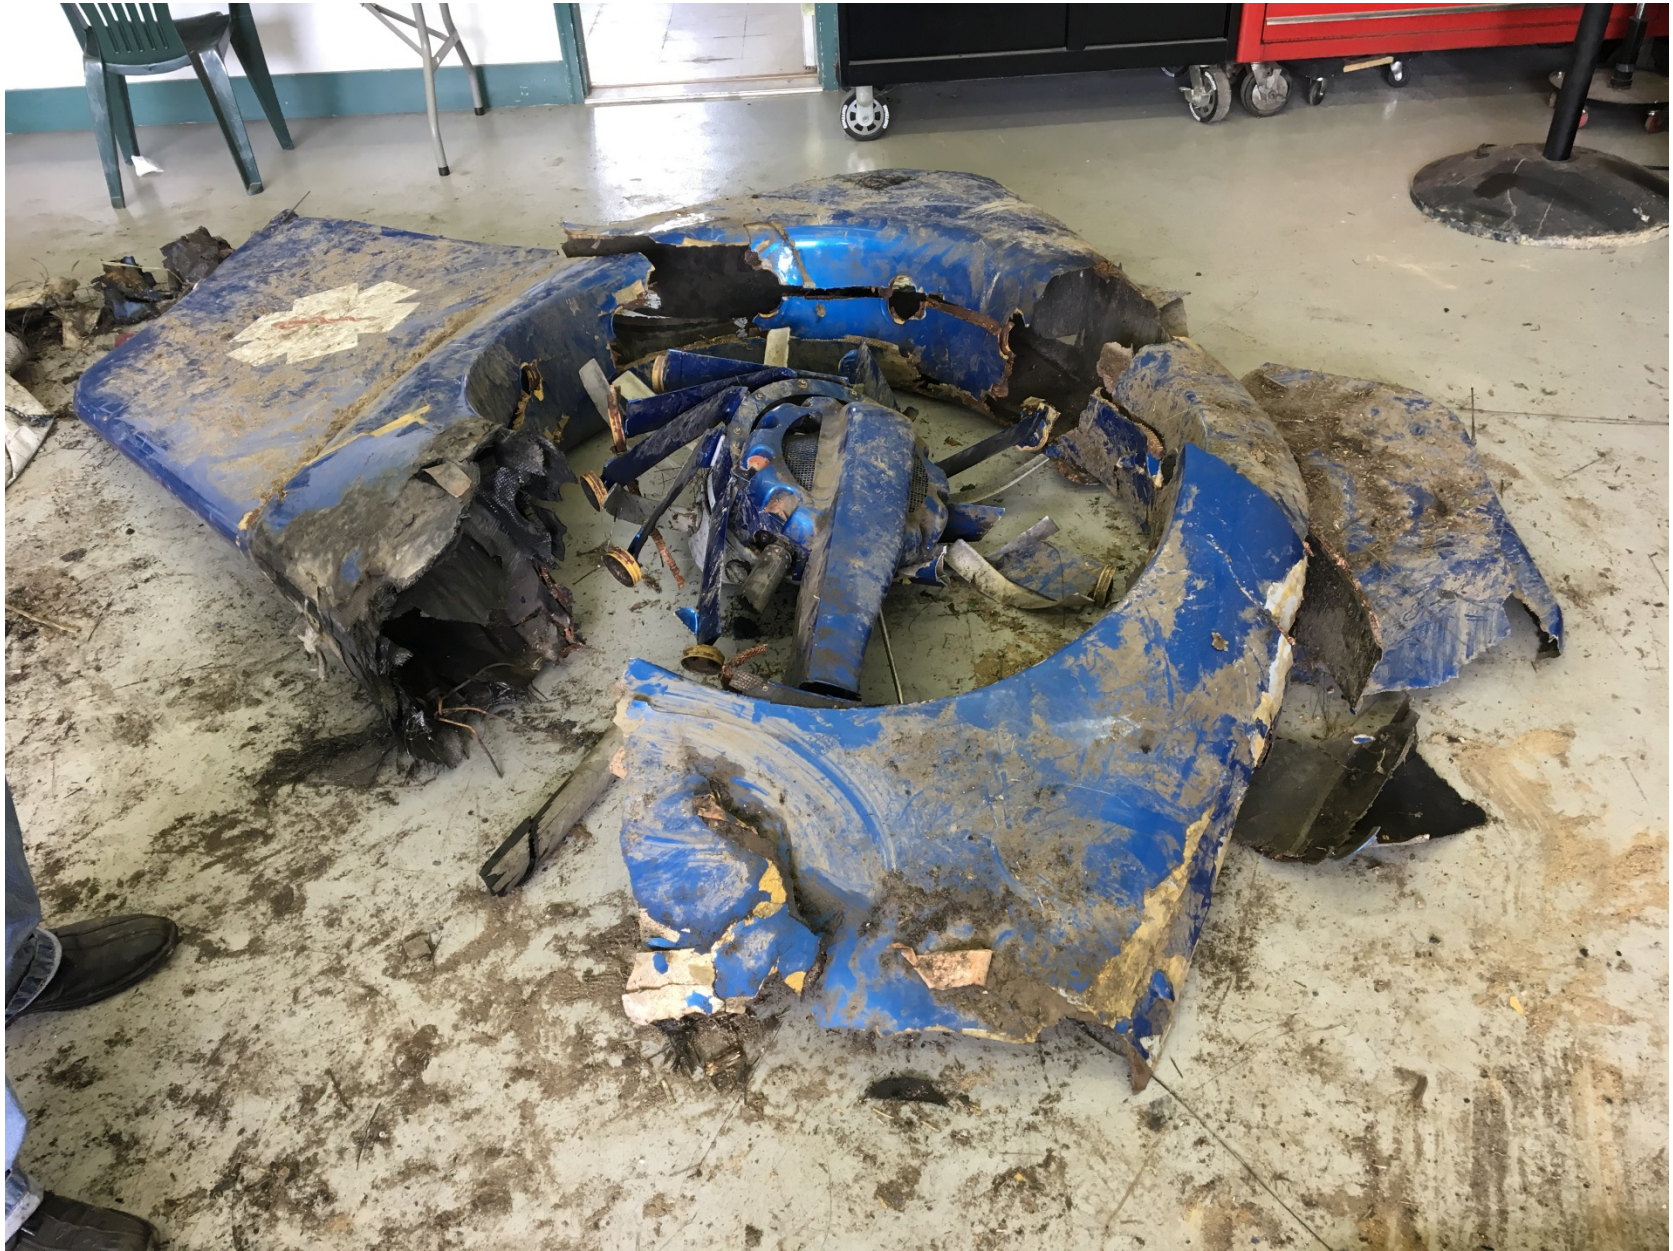
**Photo 2 – View of reconstructed fenestron**

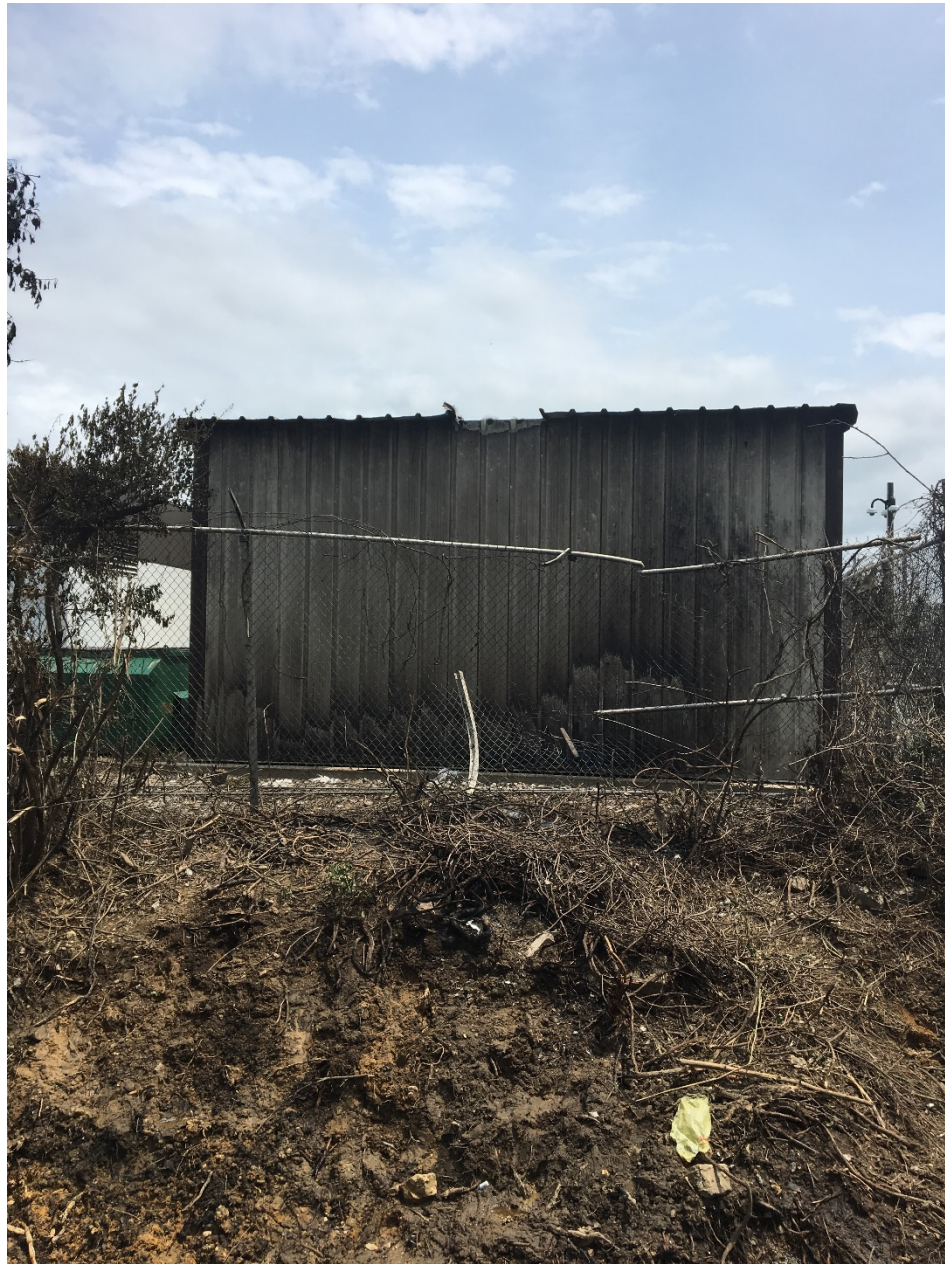
**Photo 3 – Fence with cut**

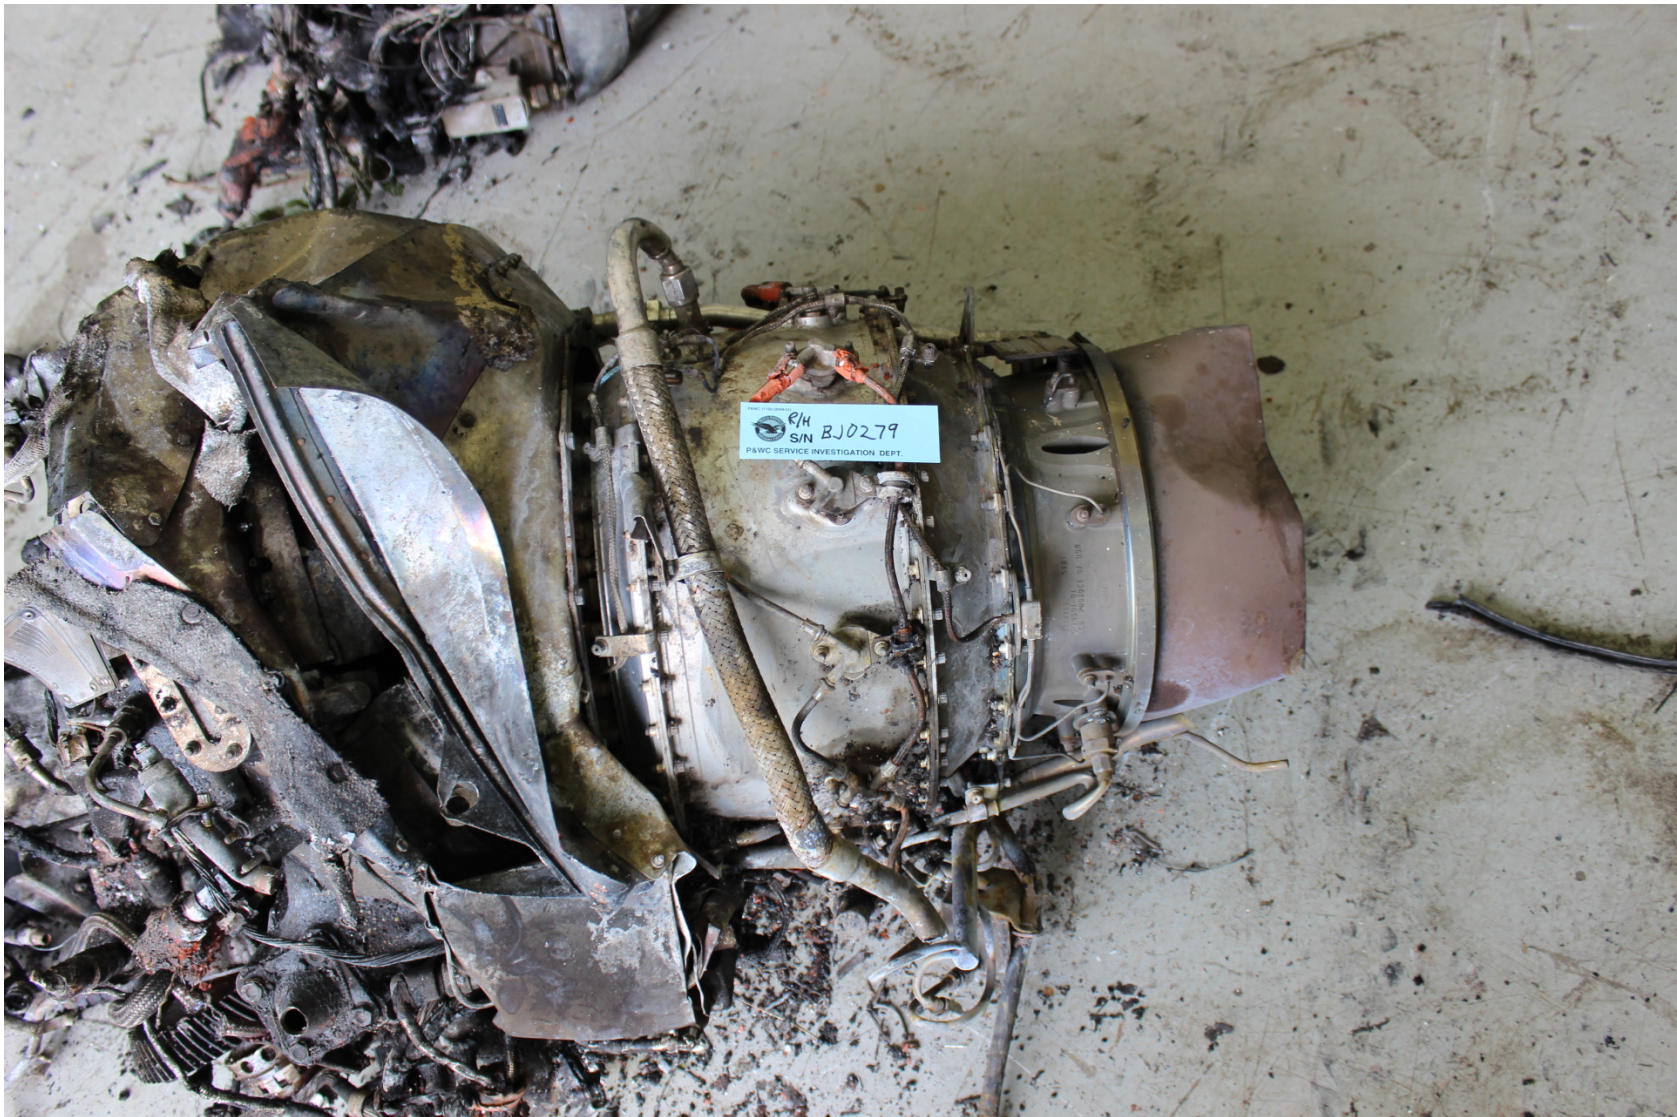
**Photo 4 – View of Right Engine (Courtesy of Pratt & Whitney Canada)**

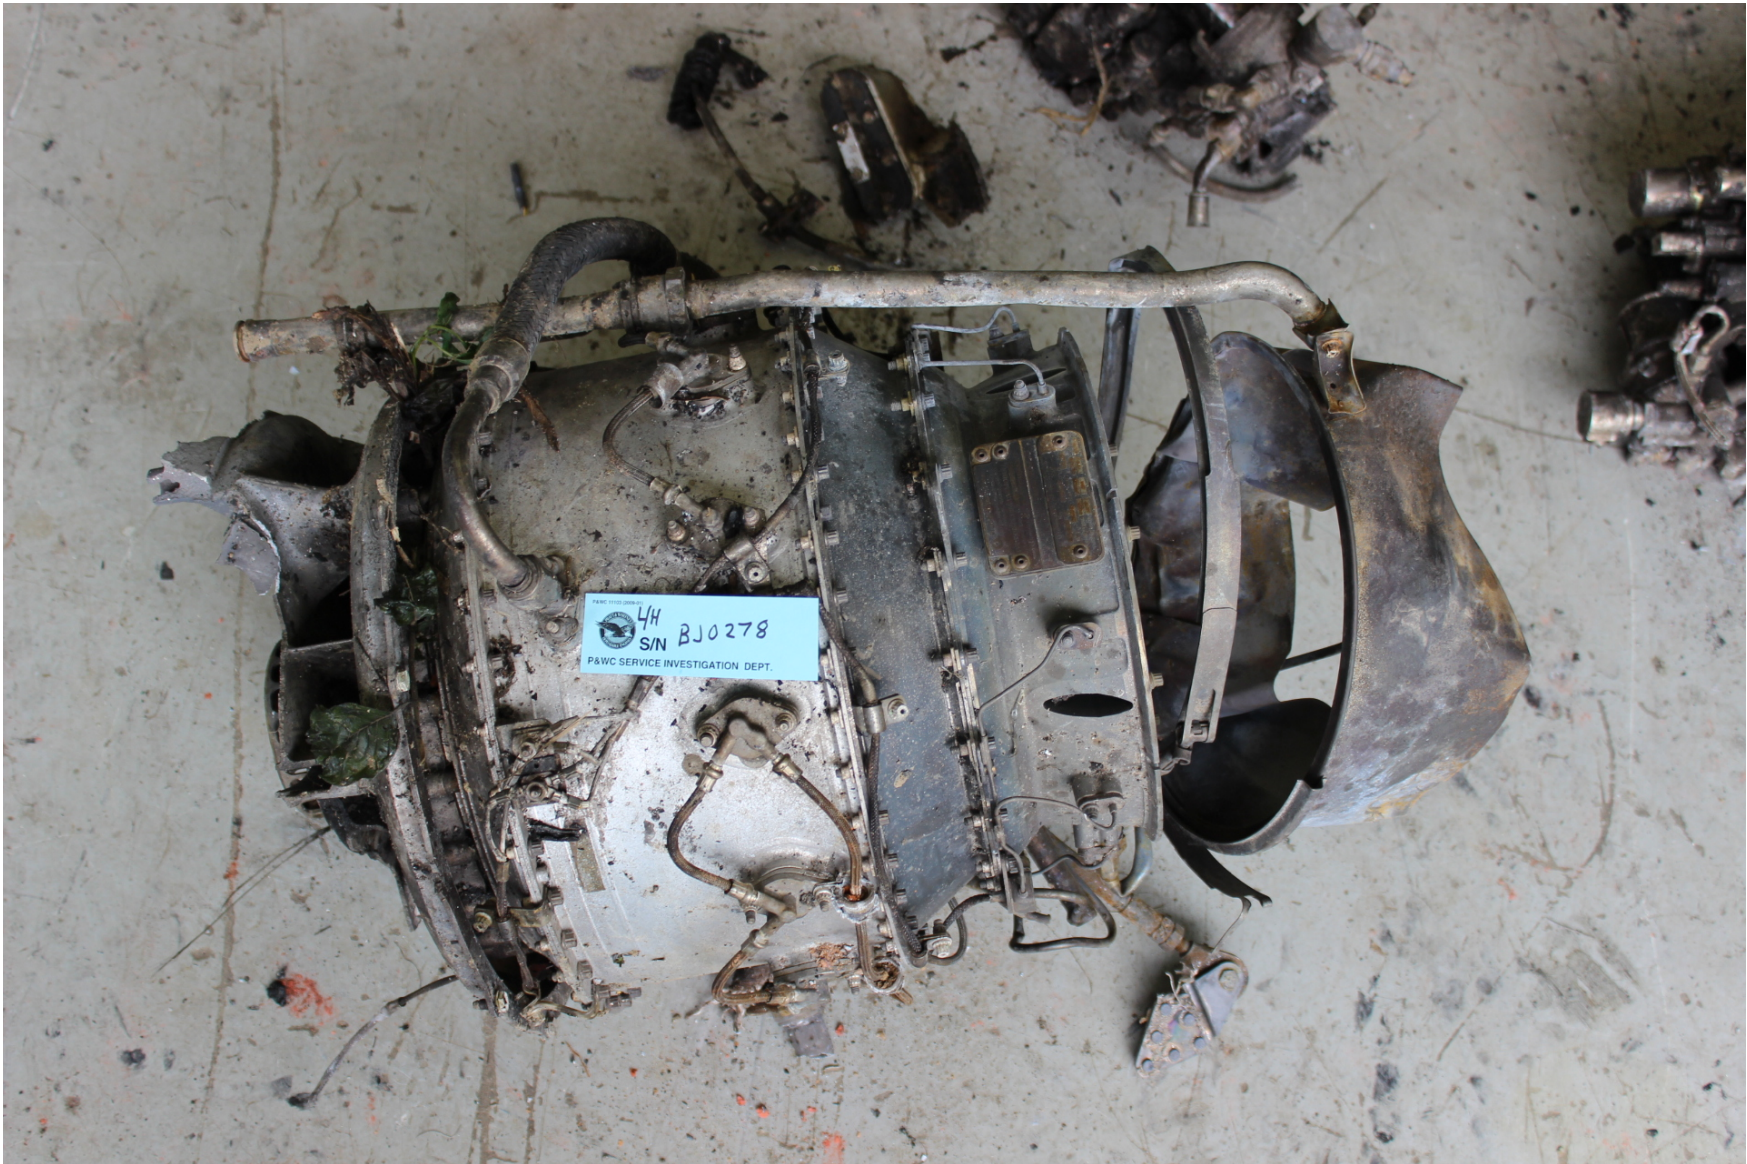
**Photo 5 – View of Left Engine (Courtesy of Pratt & Whitney Canada)**

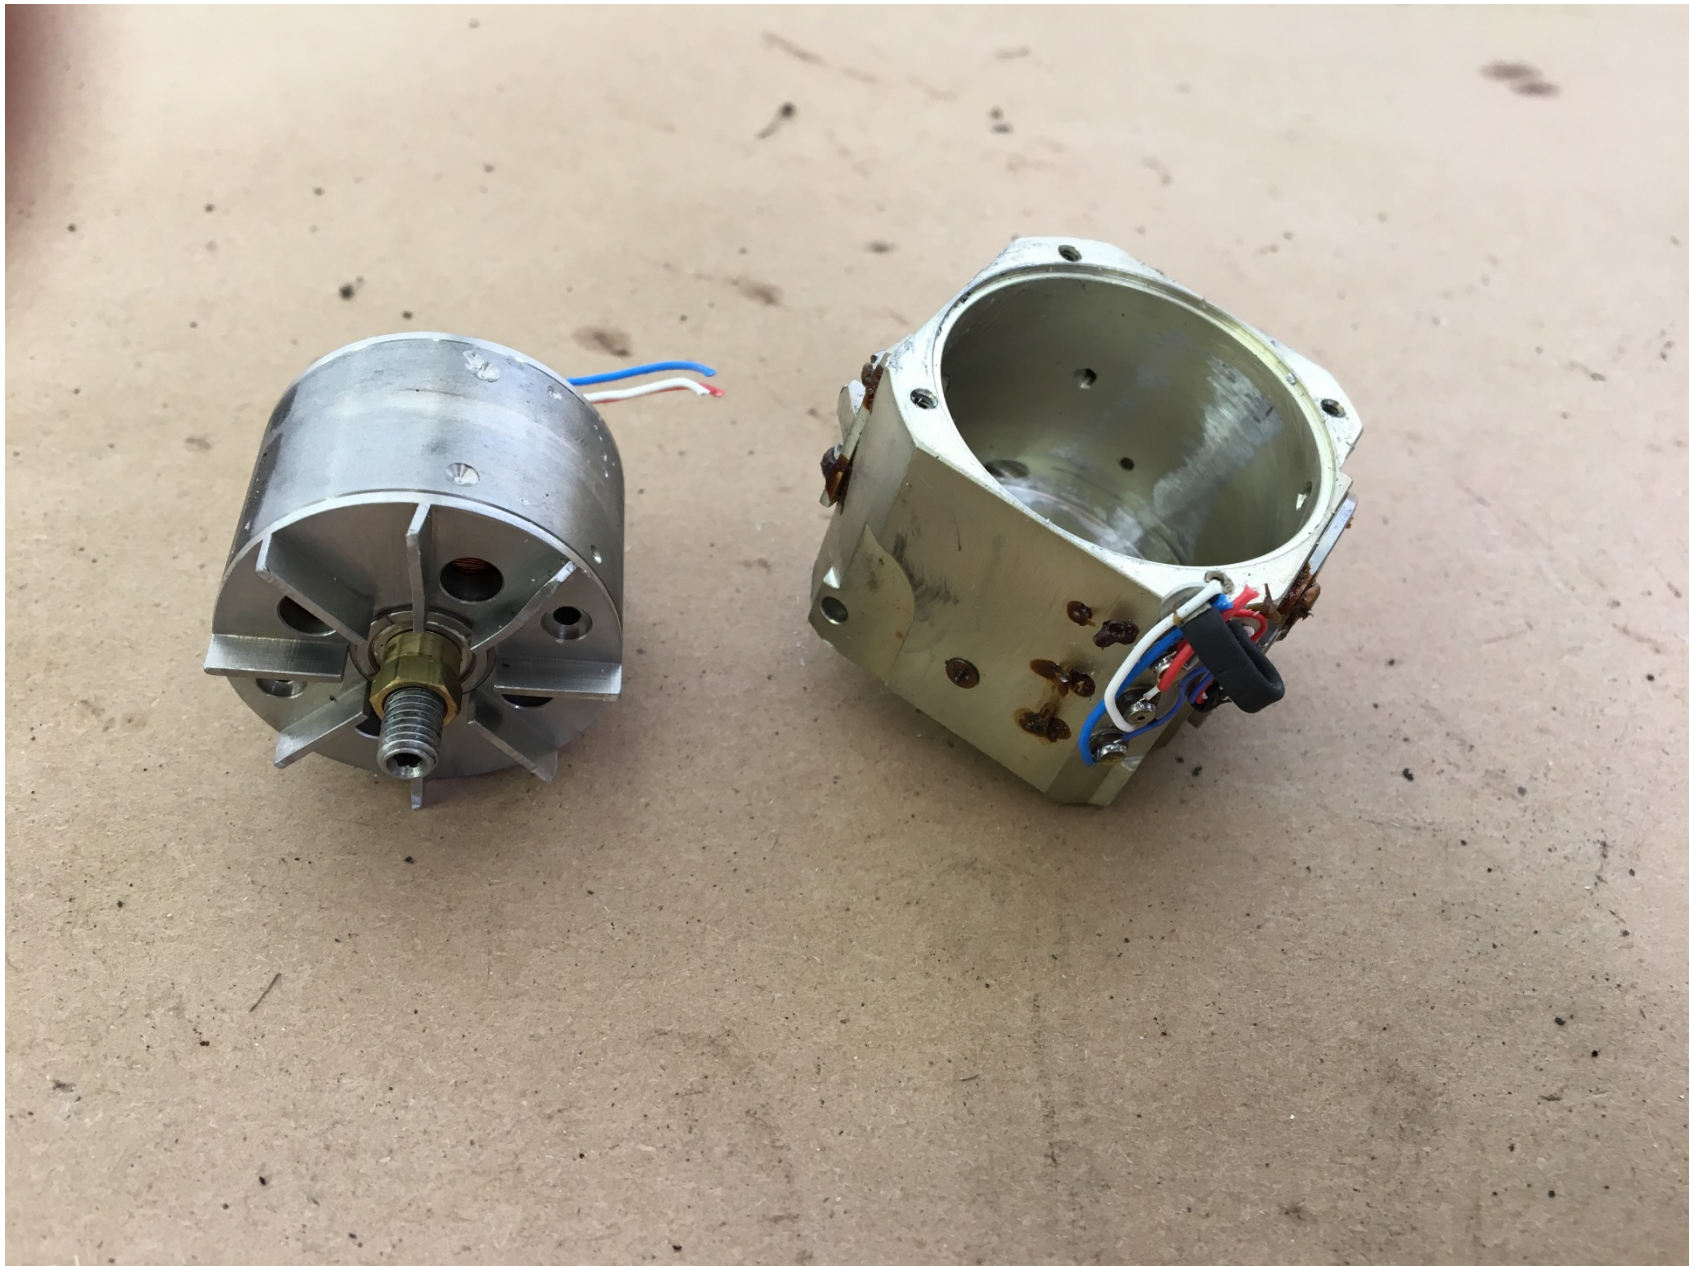
**Photo 6 – View of Attitude Gyro and Housing**
