NATIONAL TRANSPORTATION SAFETY BOARD

Office of Aviation Safety
Eastern Region

Photo Array

ERA19LA224

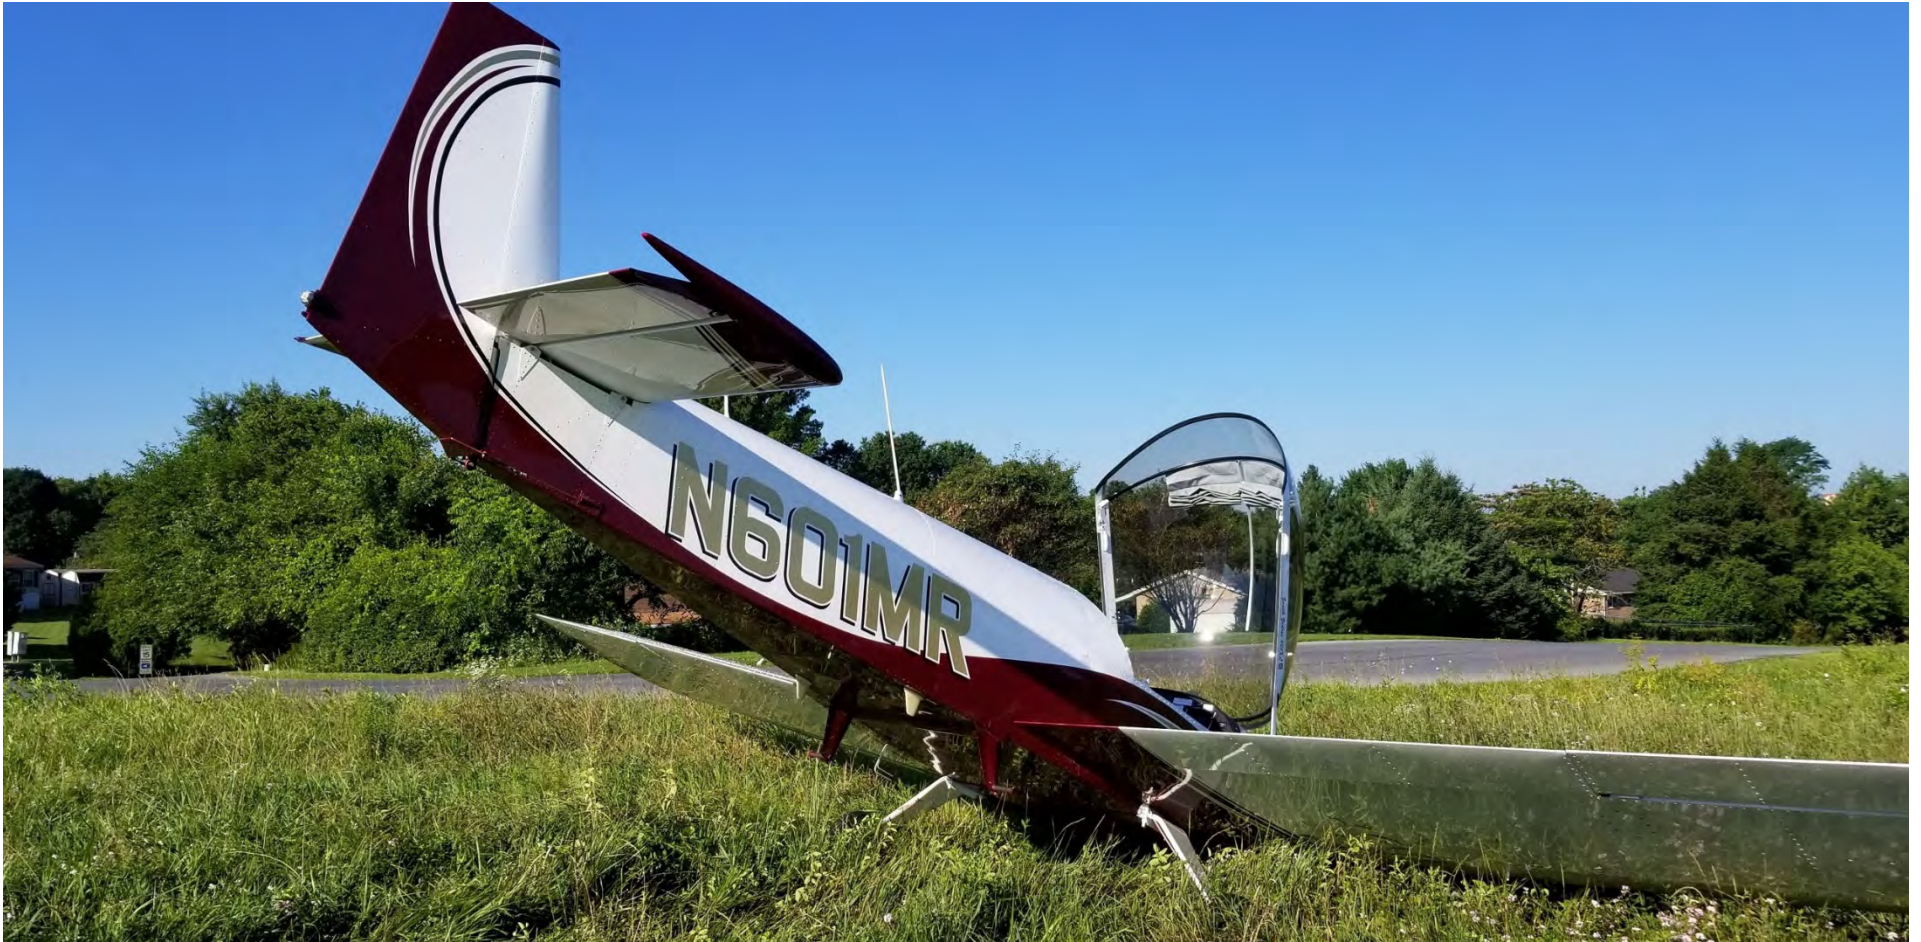
Photo 1 – View of Airplane from Right Side (Photo Courtesy of Pilot)

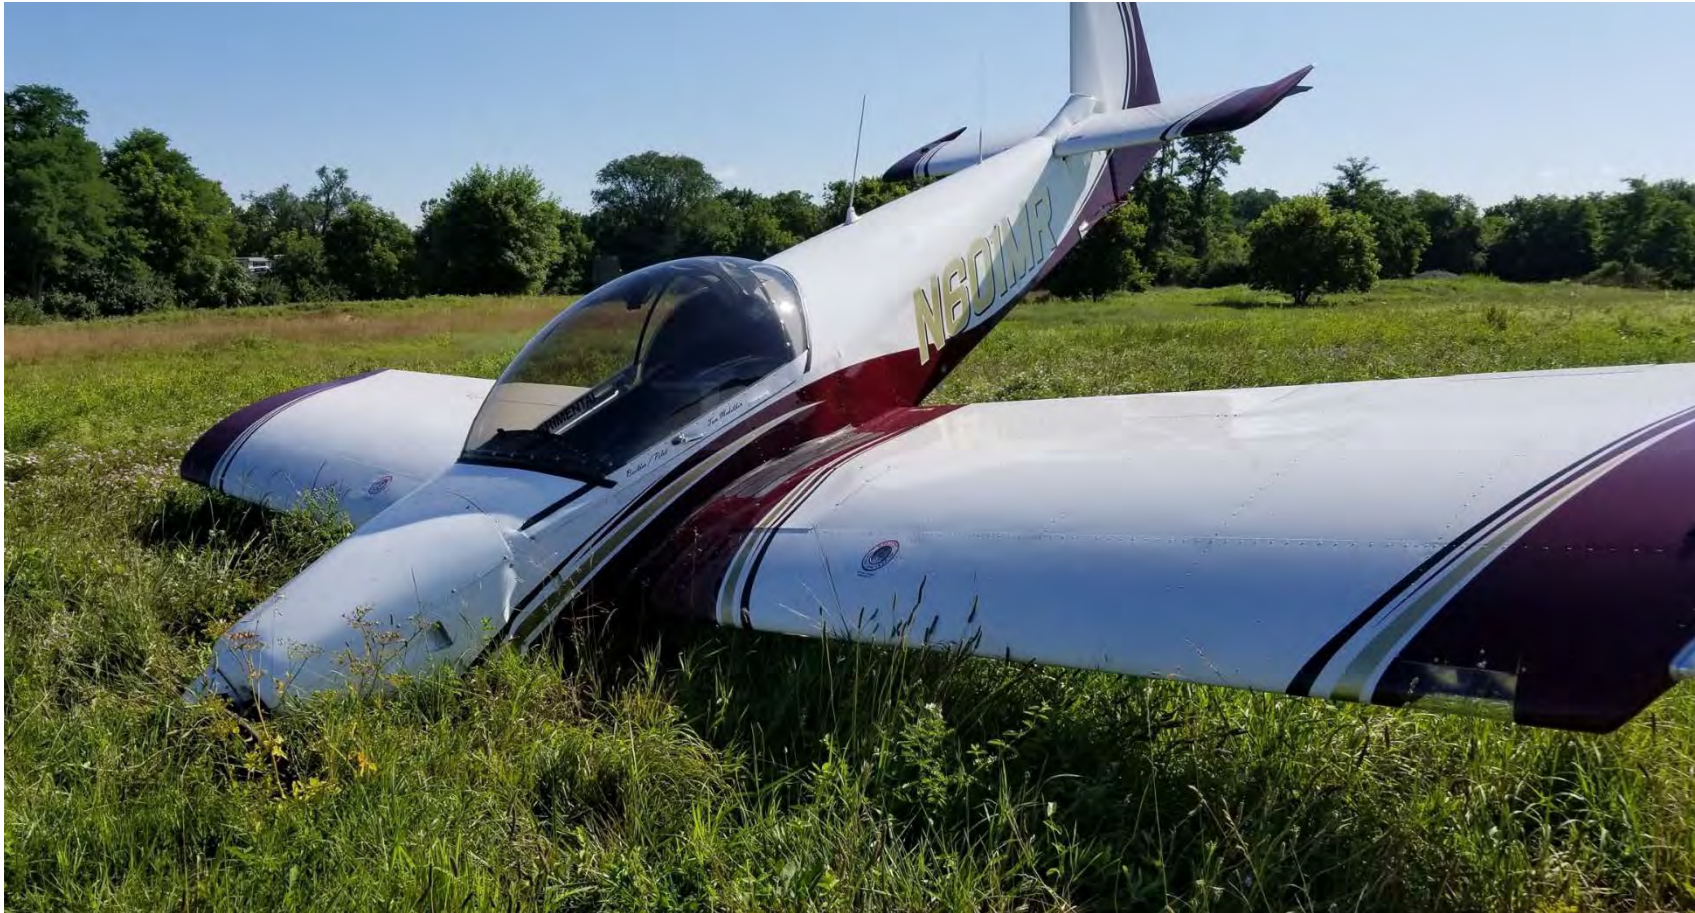
Photo 2 – View of Airplane from Left Side (Photo Courtesy of Pilot)

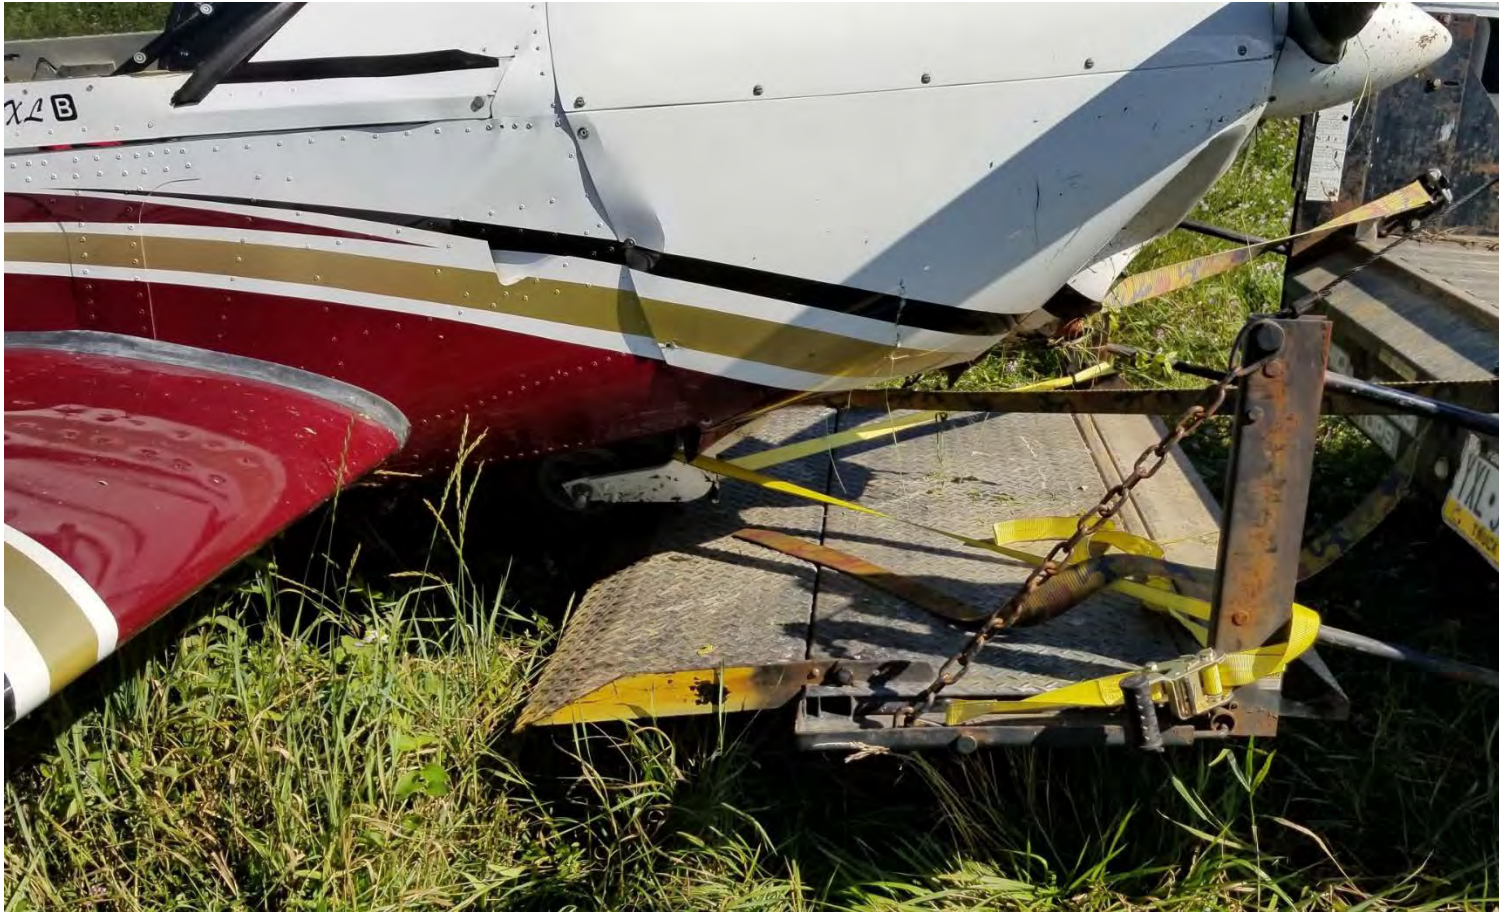
Photo 3 – Cowling Damage (Photo Courtesy of Pilot)

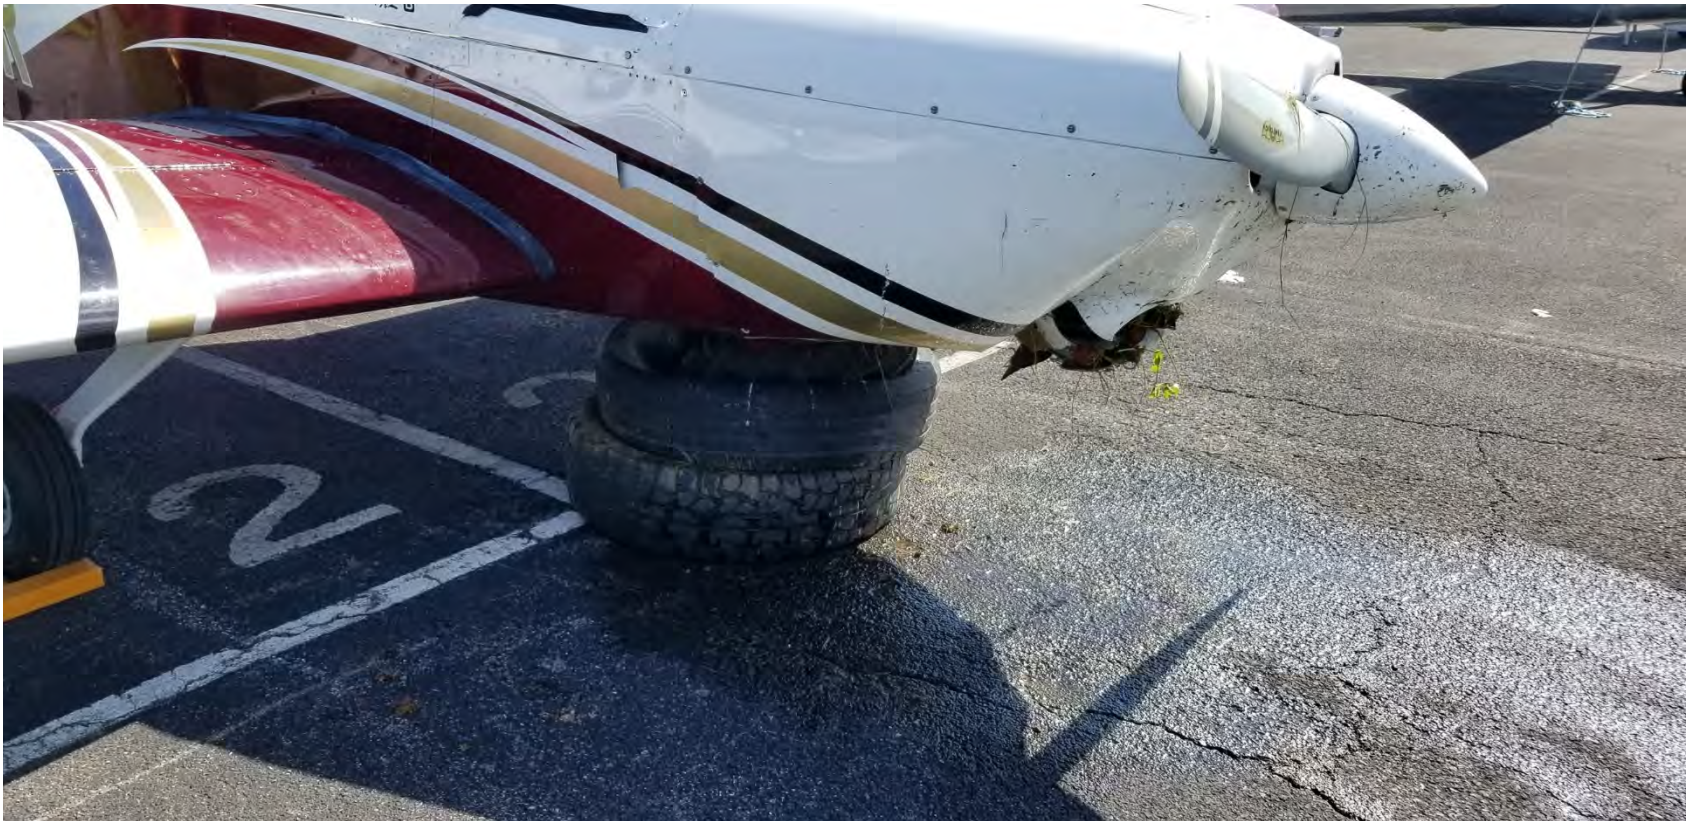
Photo 4 – View of Airplane Nose and Propeller (Photo Courtesy of Pilot)
