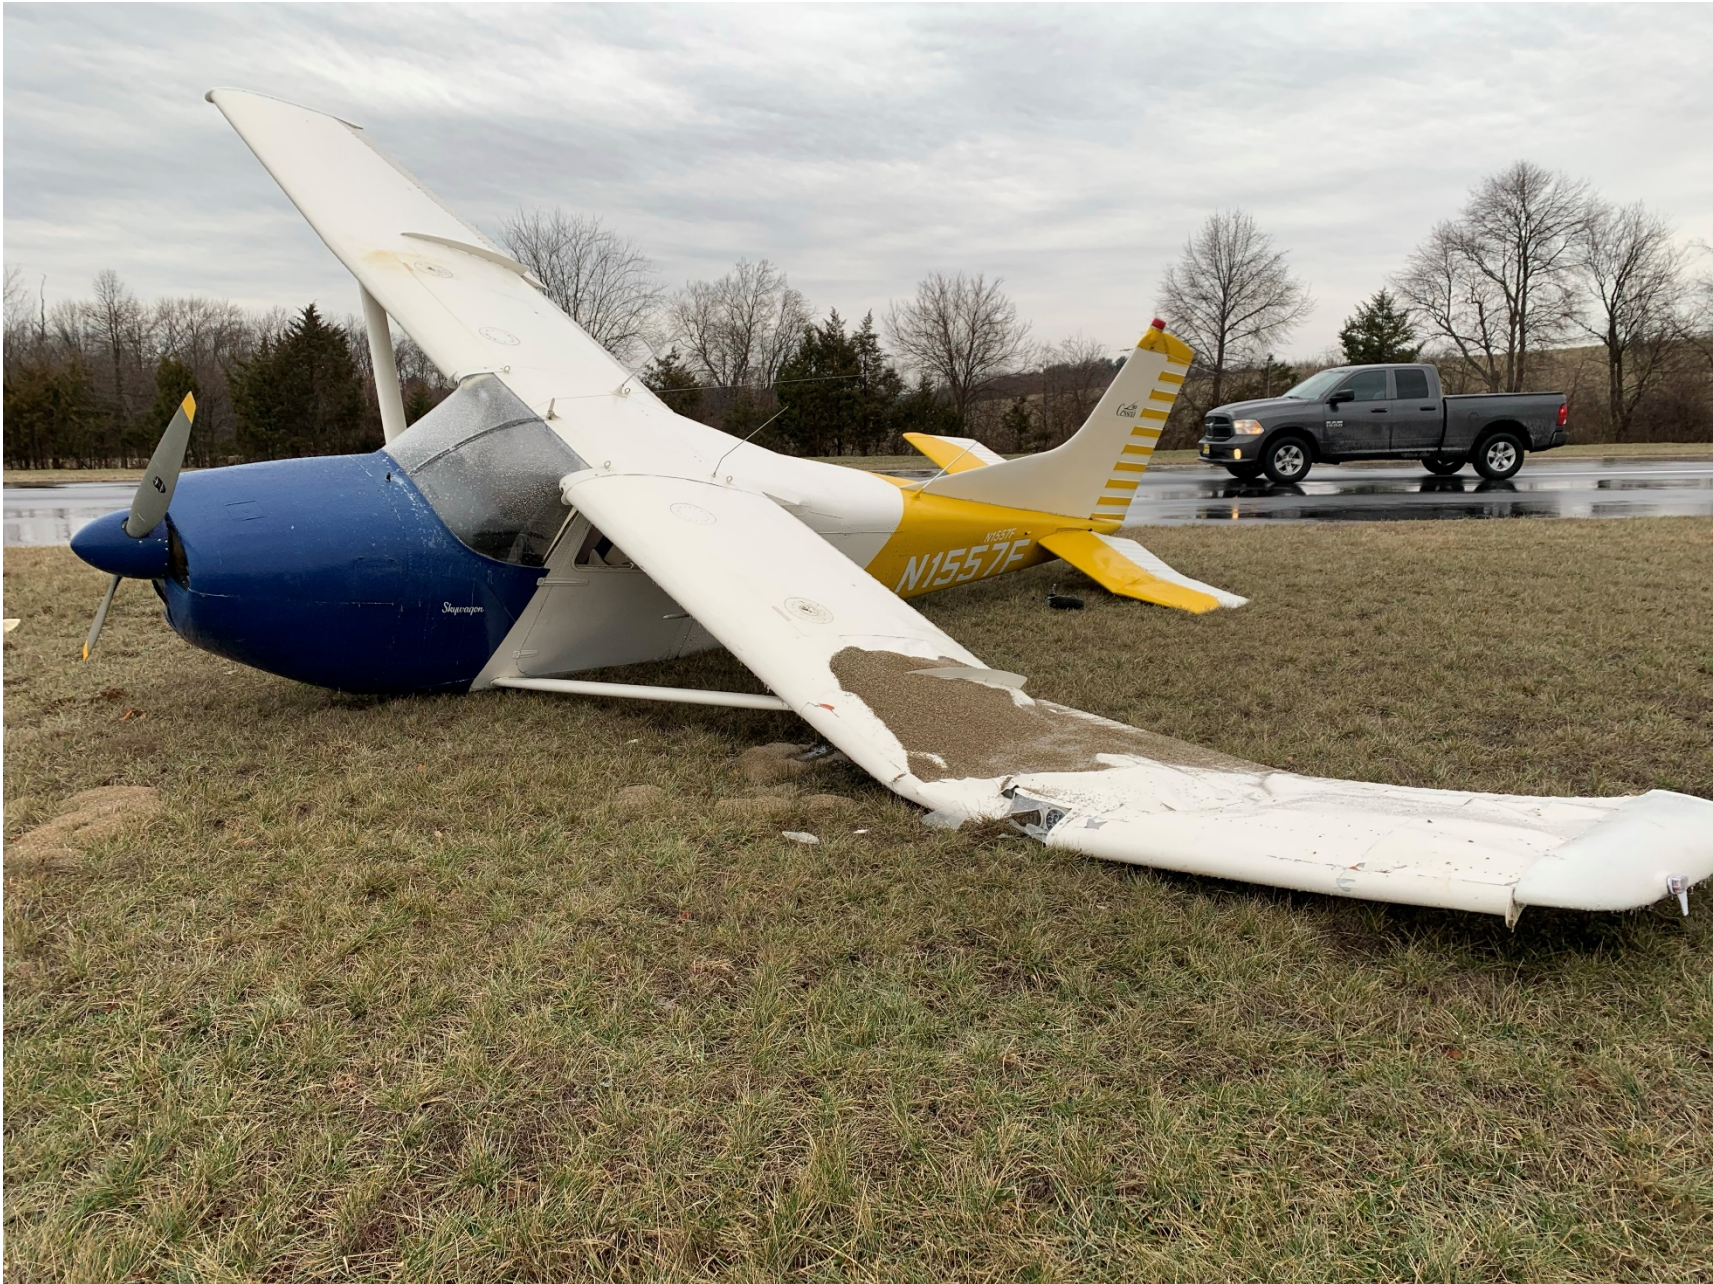
Photo 1 –View of airplane at rest (Courtesy of FAA)

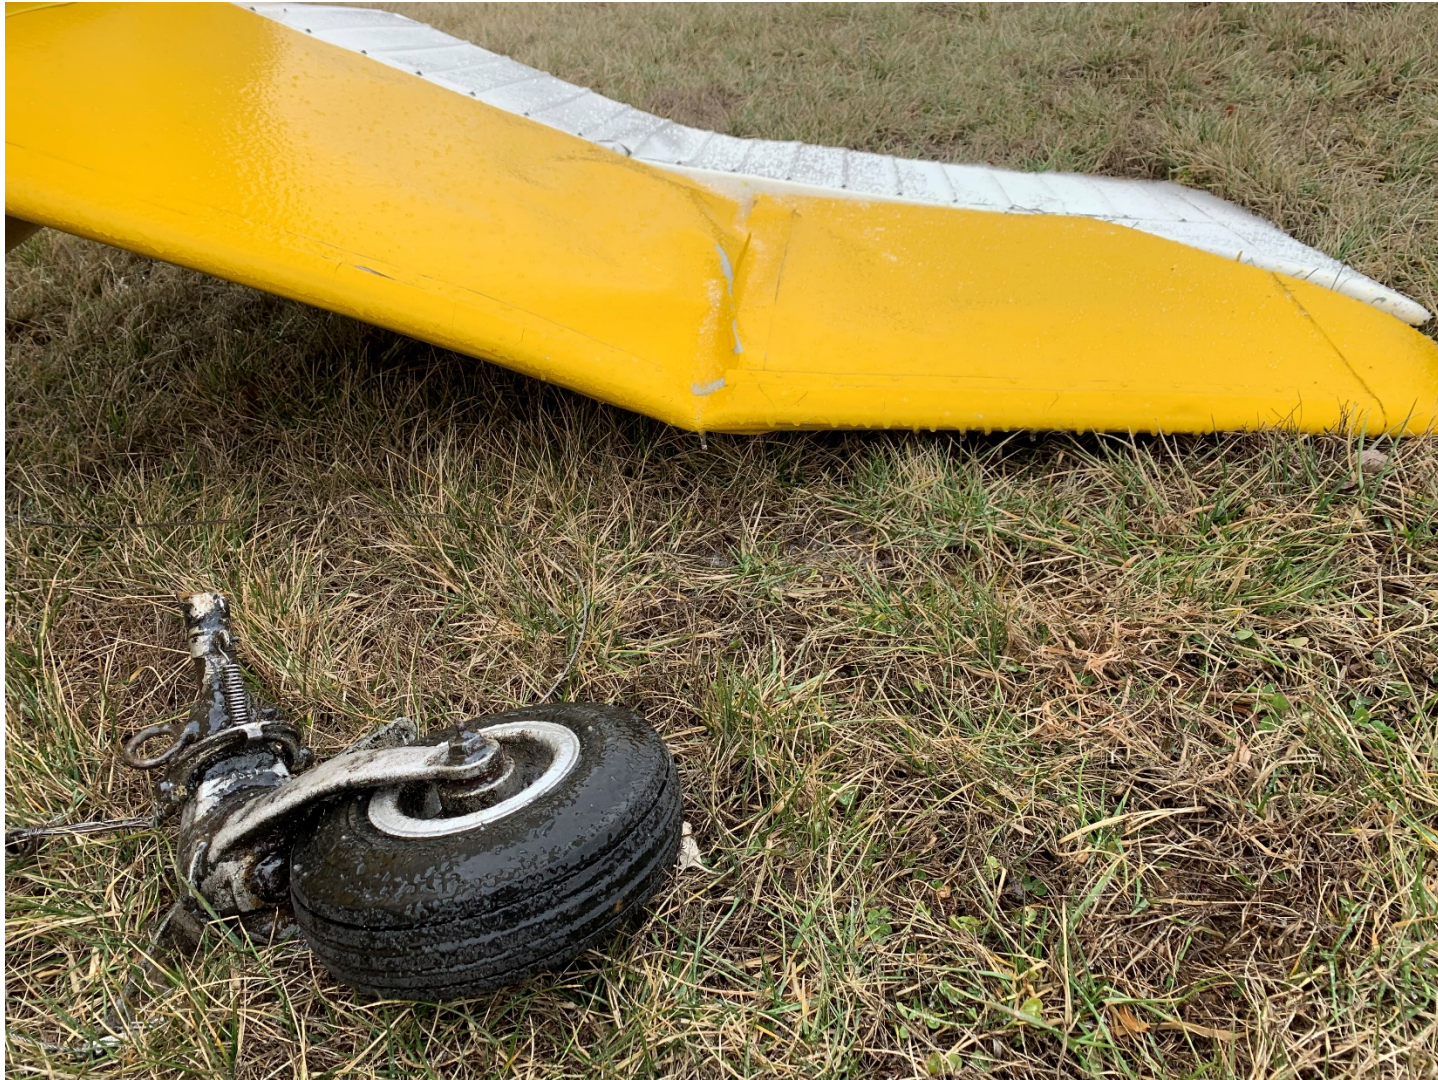
Photo 2 – View of tailwheel where it came to rest (Courtesy of FAA)

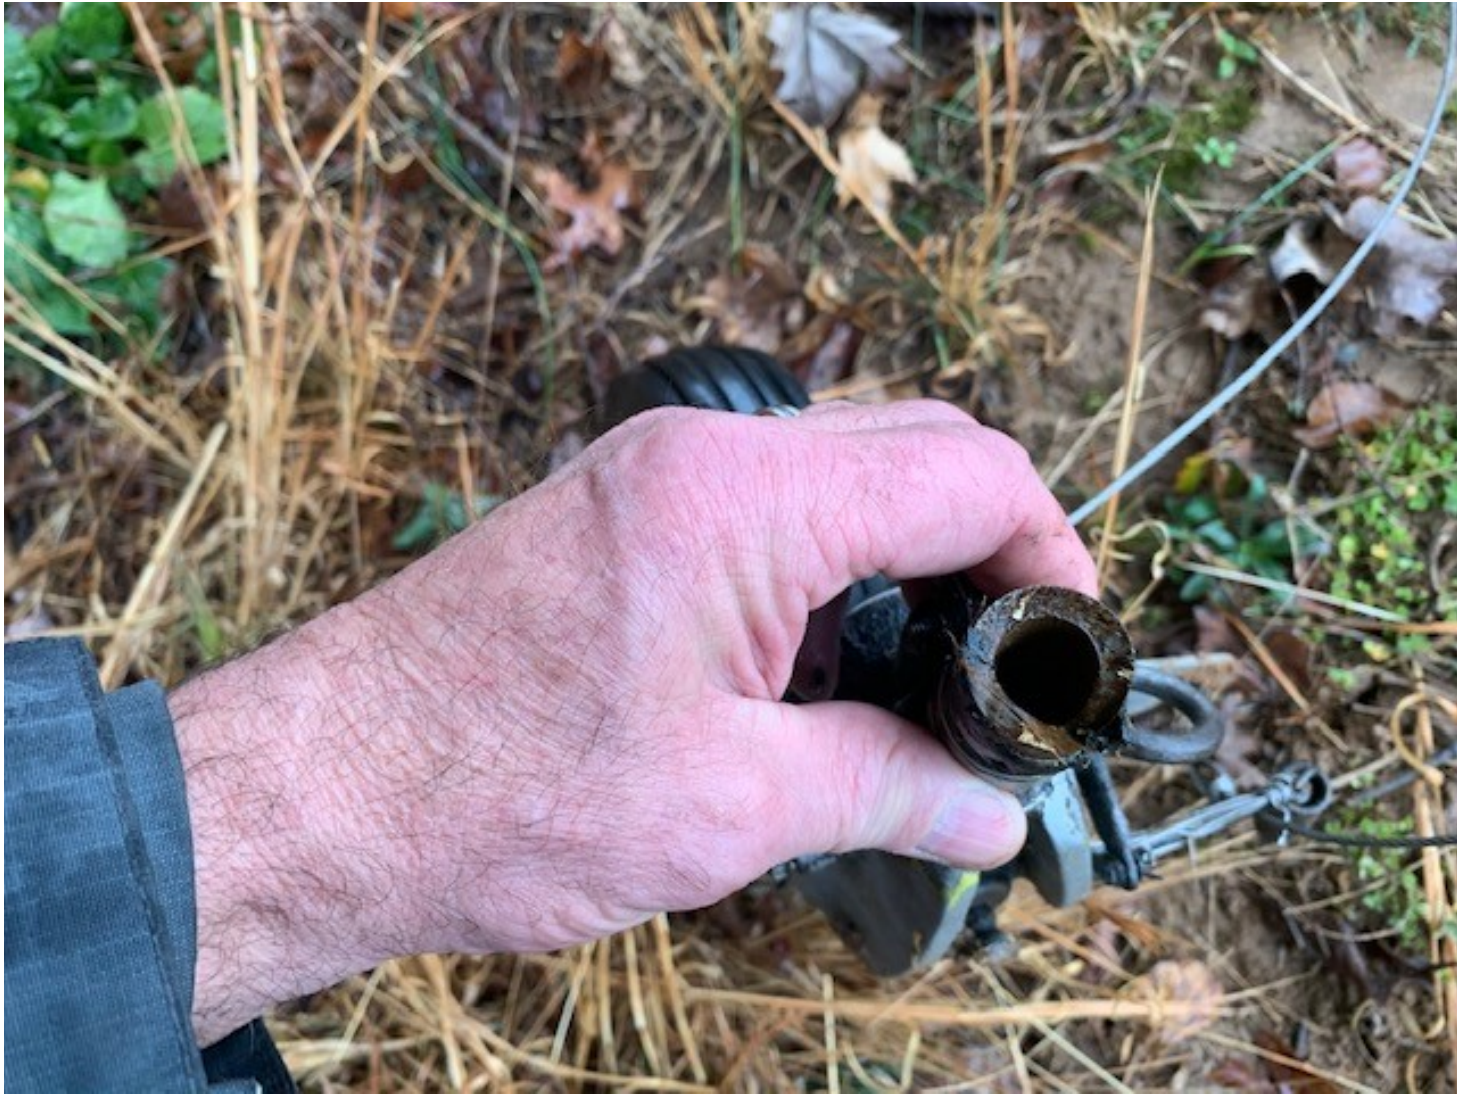
Photo 3 – View of fractured tailwheel attachment tube (Courtesy of Salvage Company)

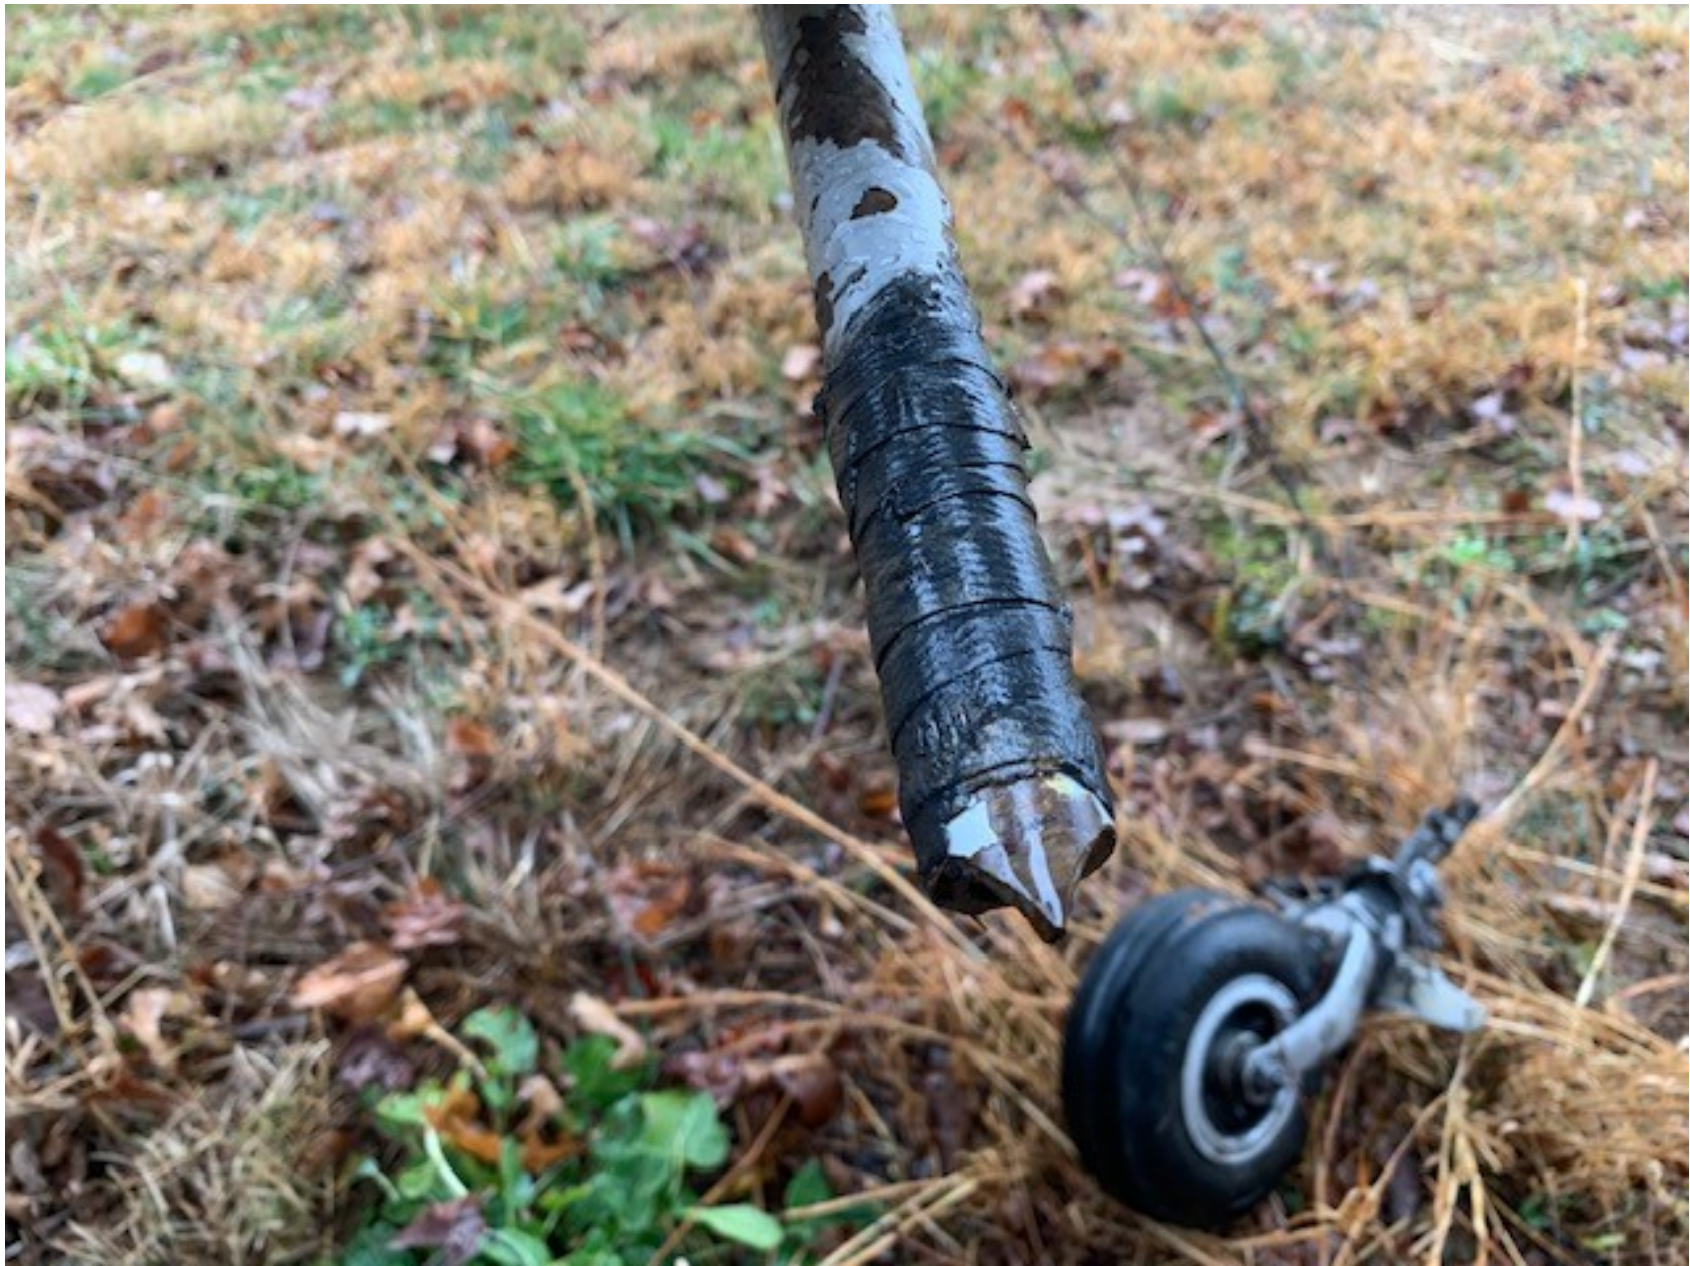
Photo 4 – Closer View of Broken Tailwheel Attach Tube (Courtesy of Salvage Company)
