Photo 1 – NTSB Drone Photograph. Google Earth Mosaic of the Accident Site.

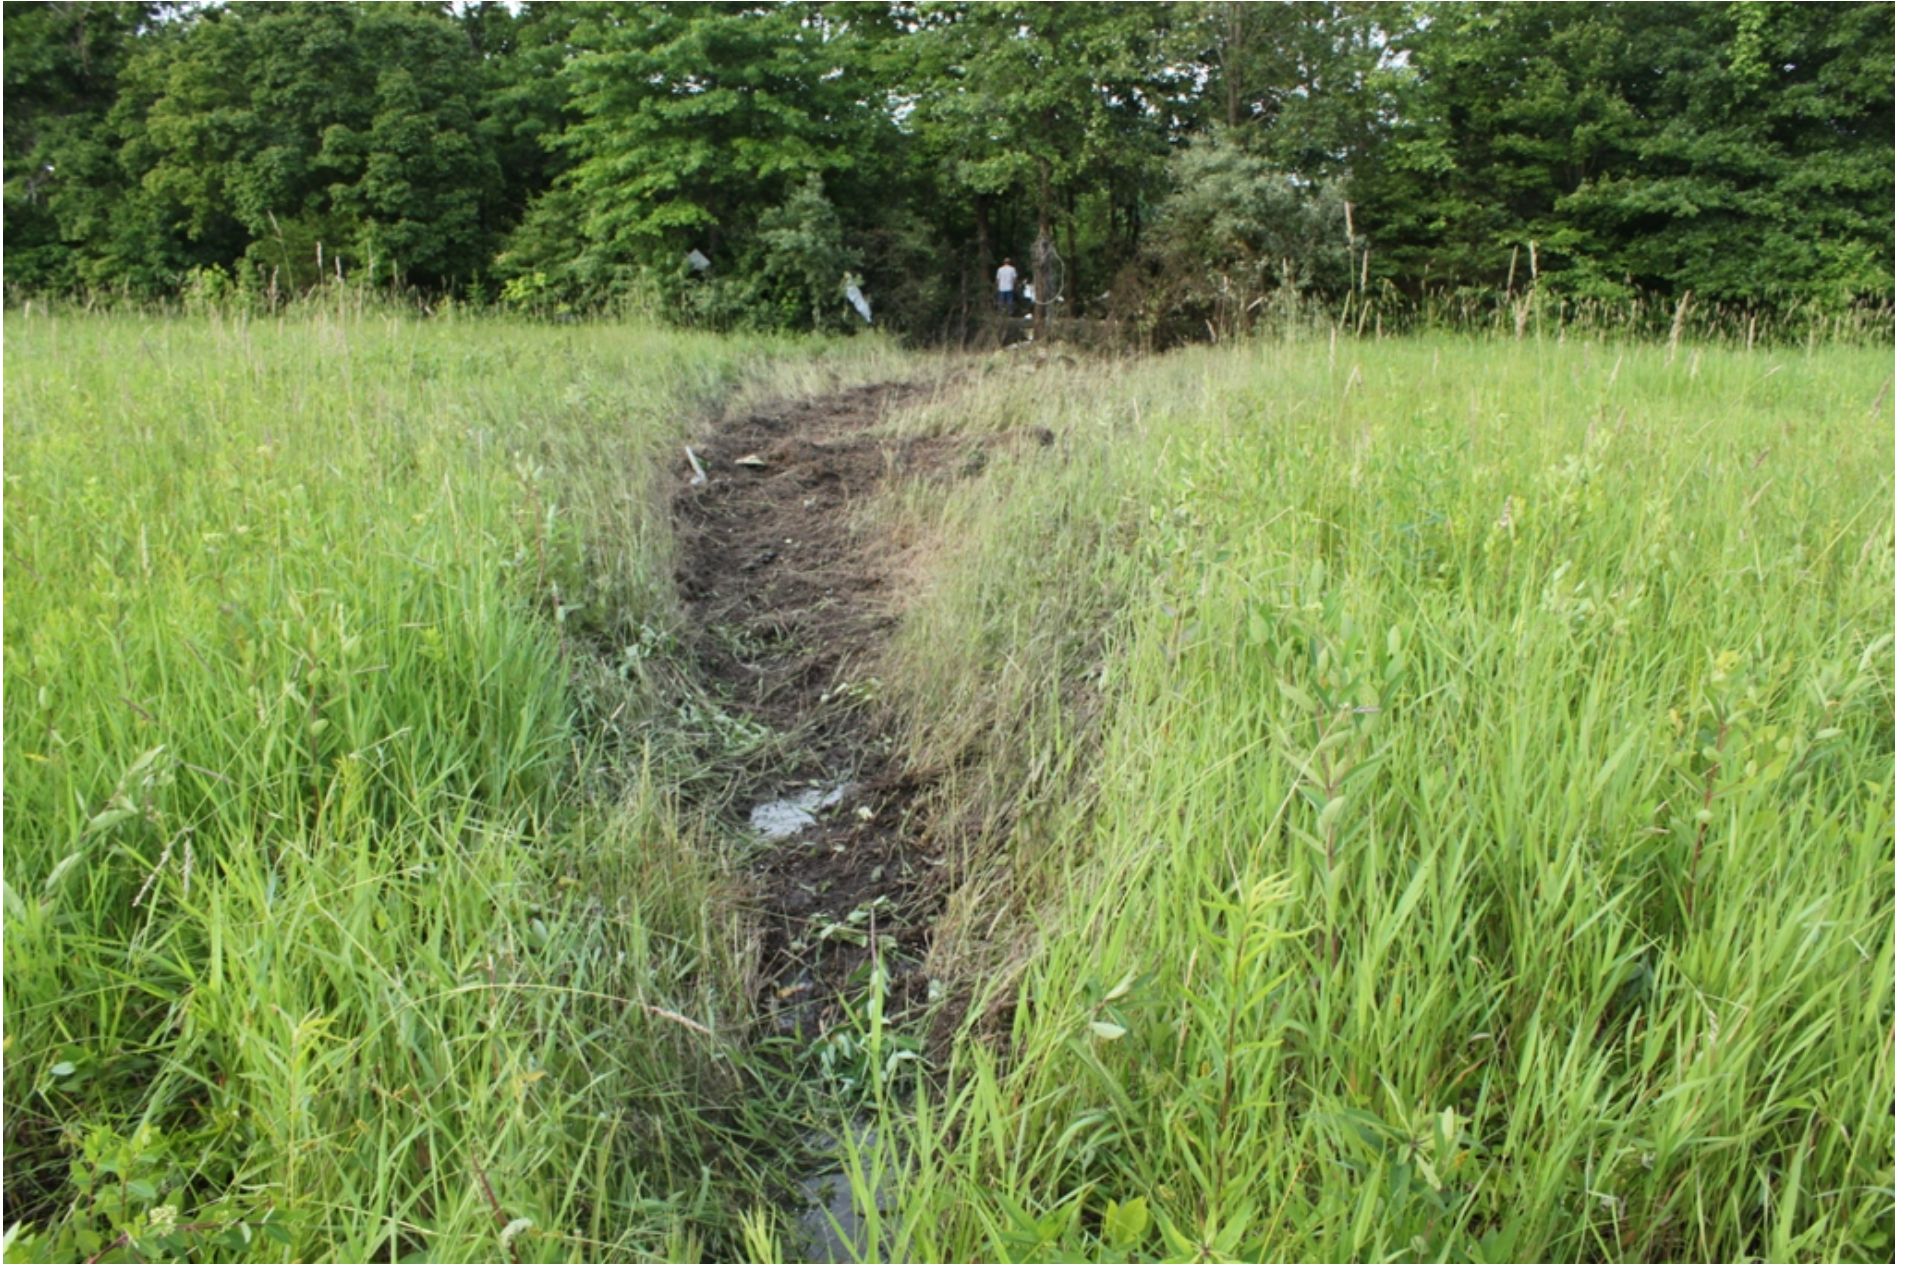
Photo 2 - NTSB Digital Photograph. View of the Initial Impact Ground Scar.

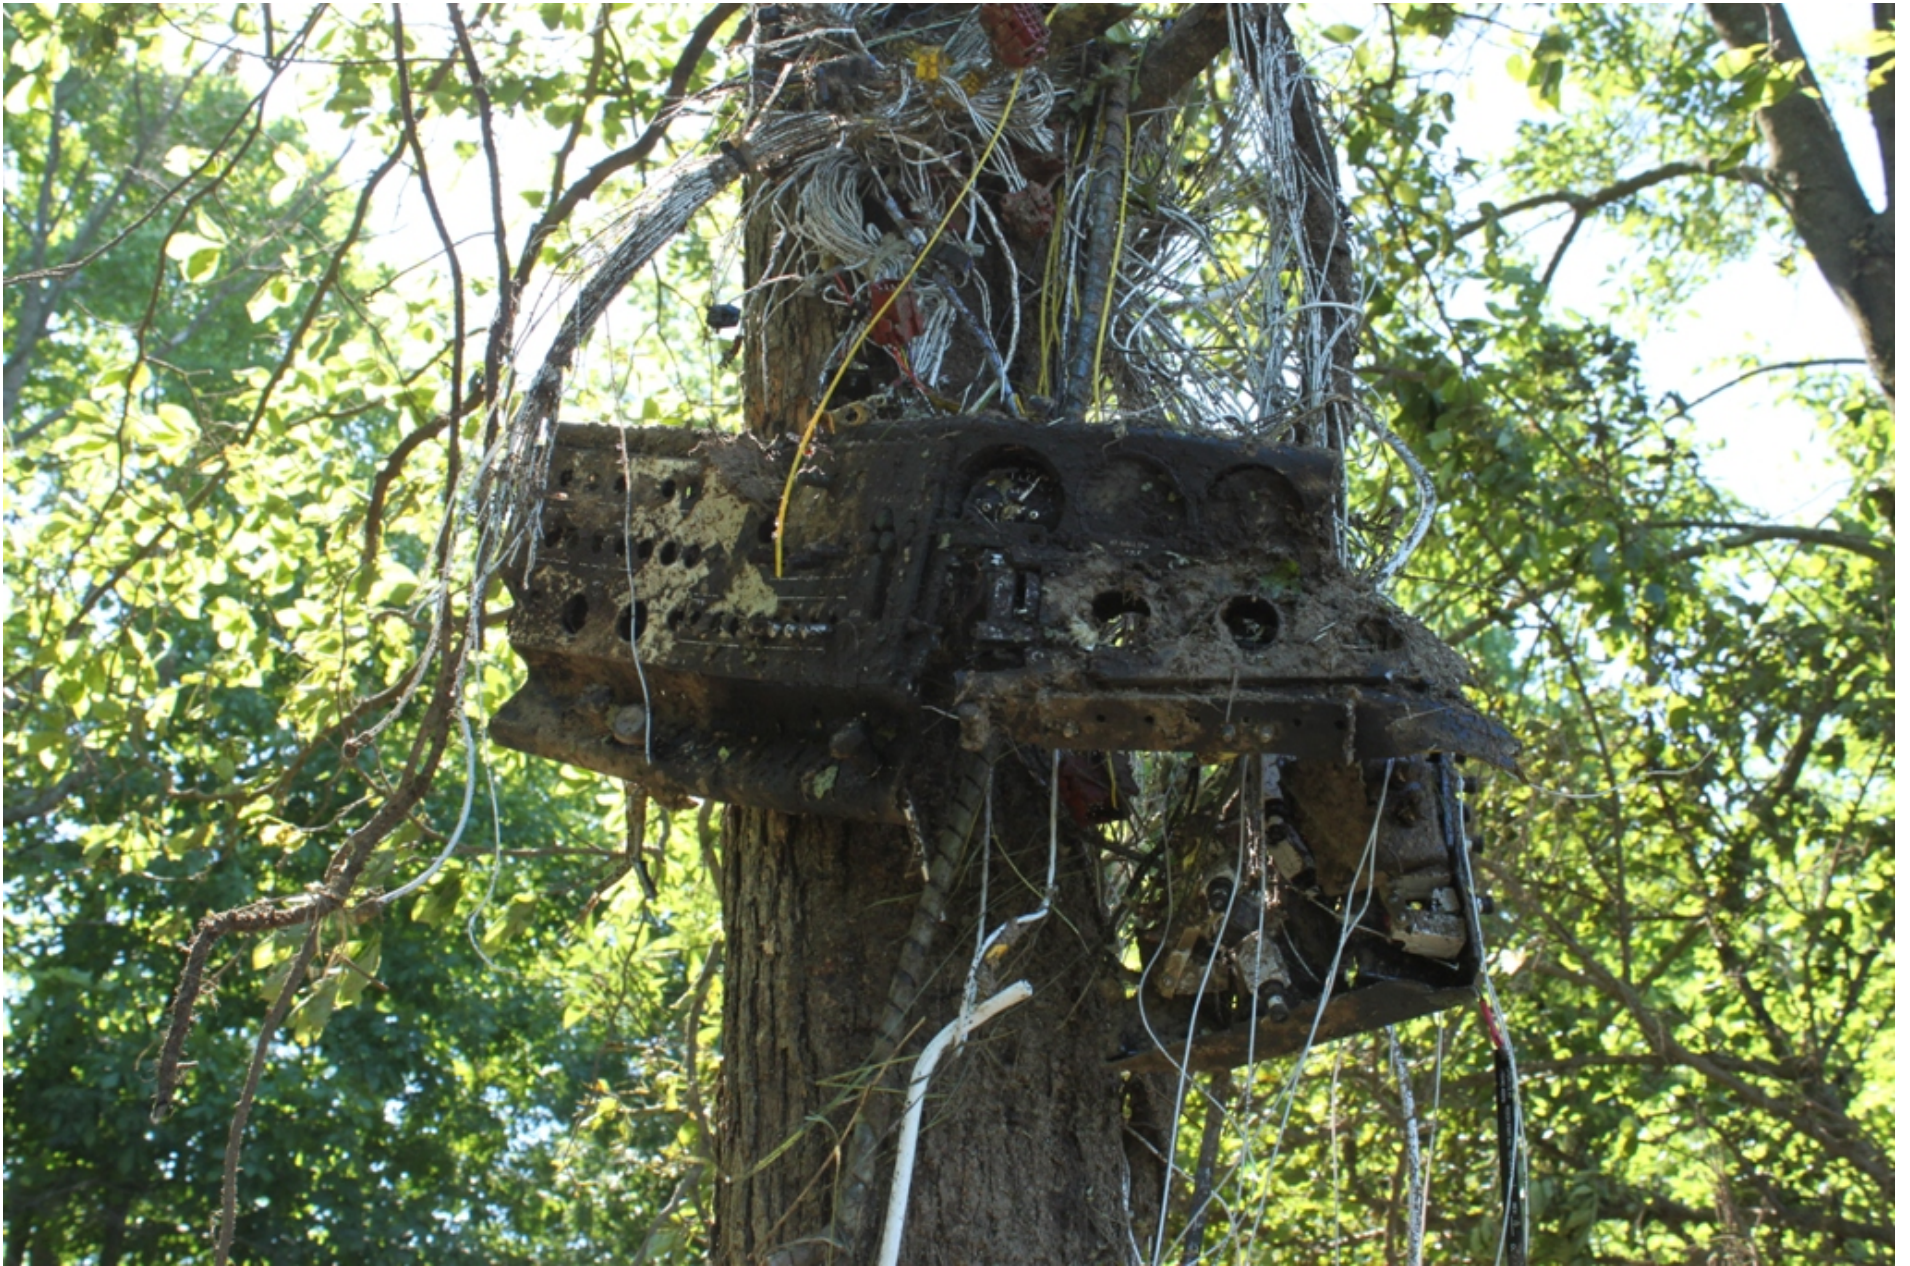
Photo 3 - NTSB Digital Photograph. View of a Portion of the Instrument Panel in a Tree.

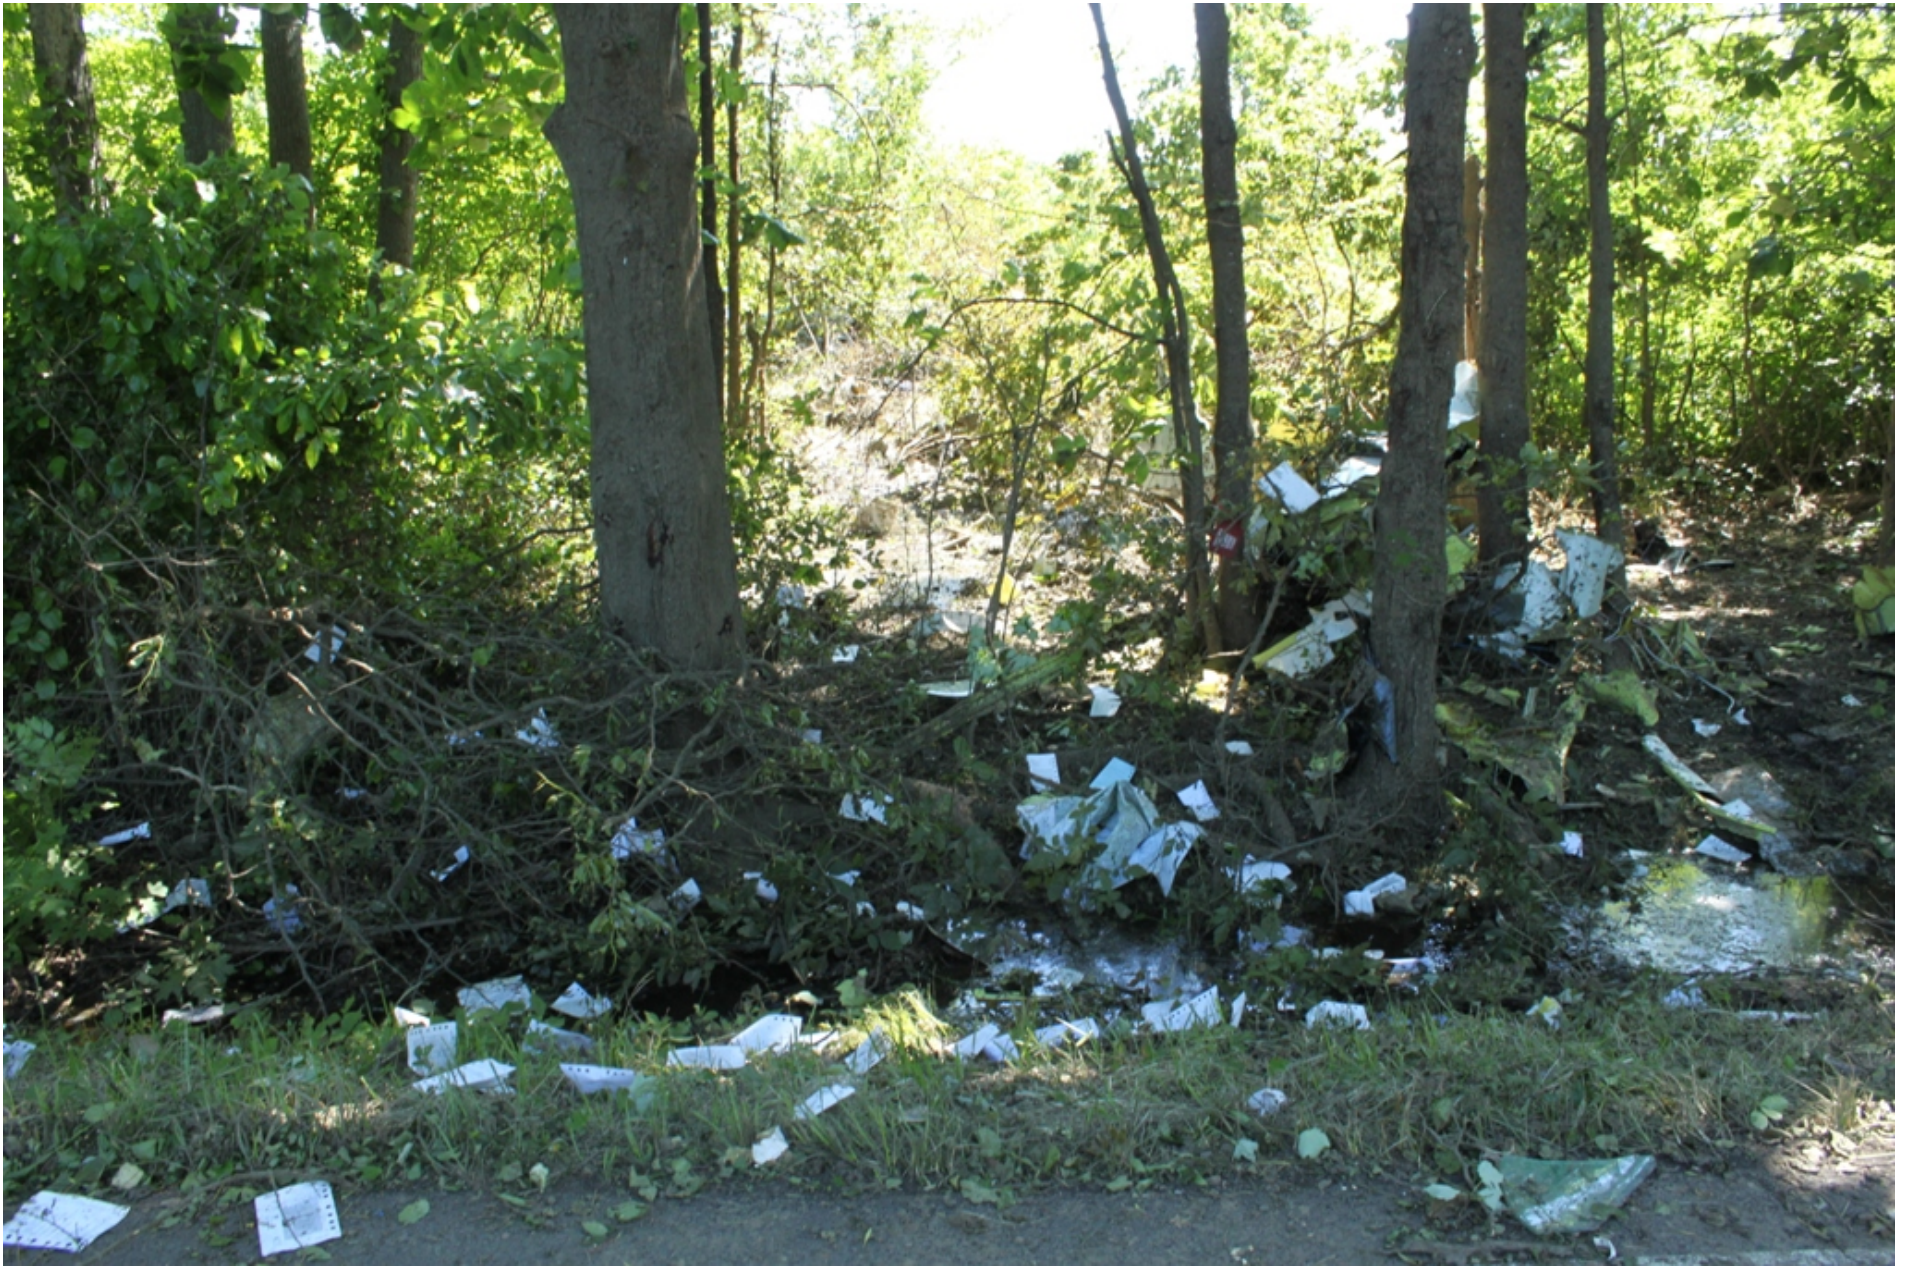
Photo 4 - NTSB Digital Photograph. View of Charts, Papers, and Wreckage located Adjacent to Road.

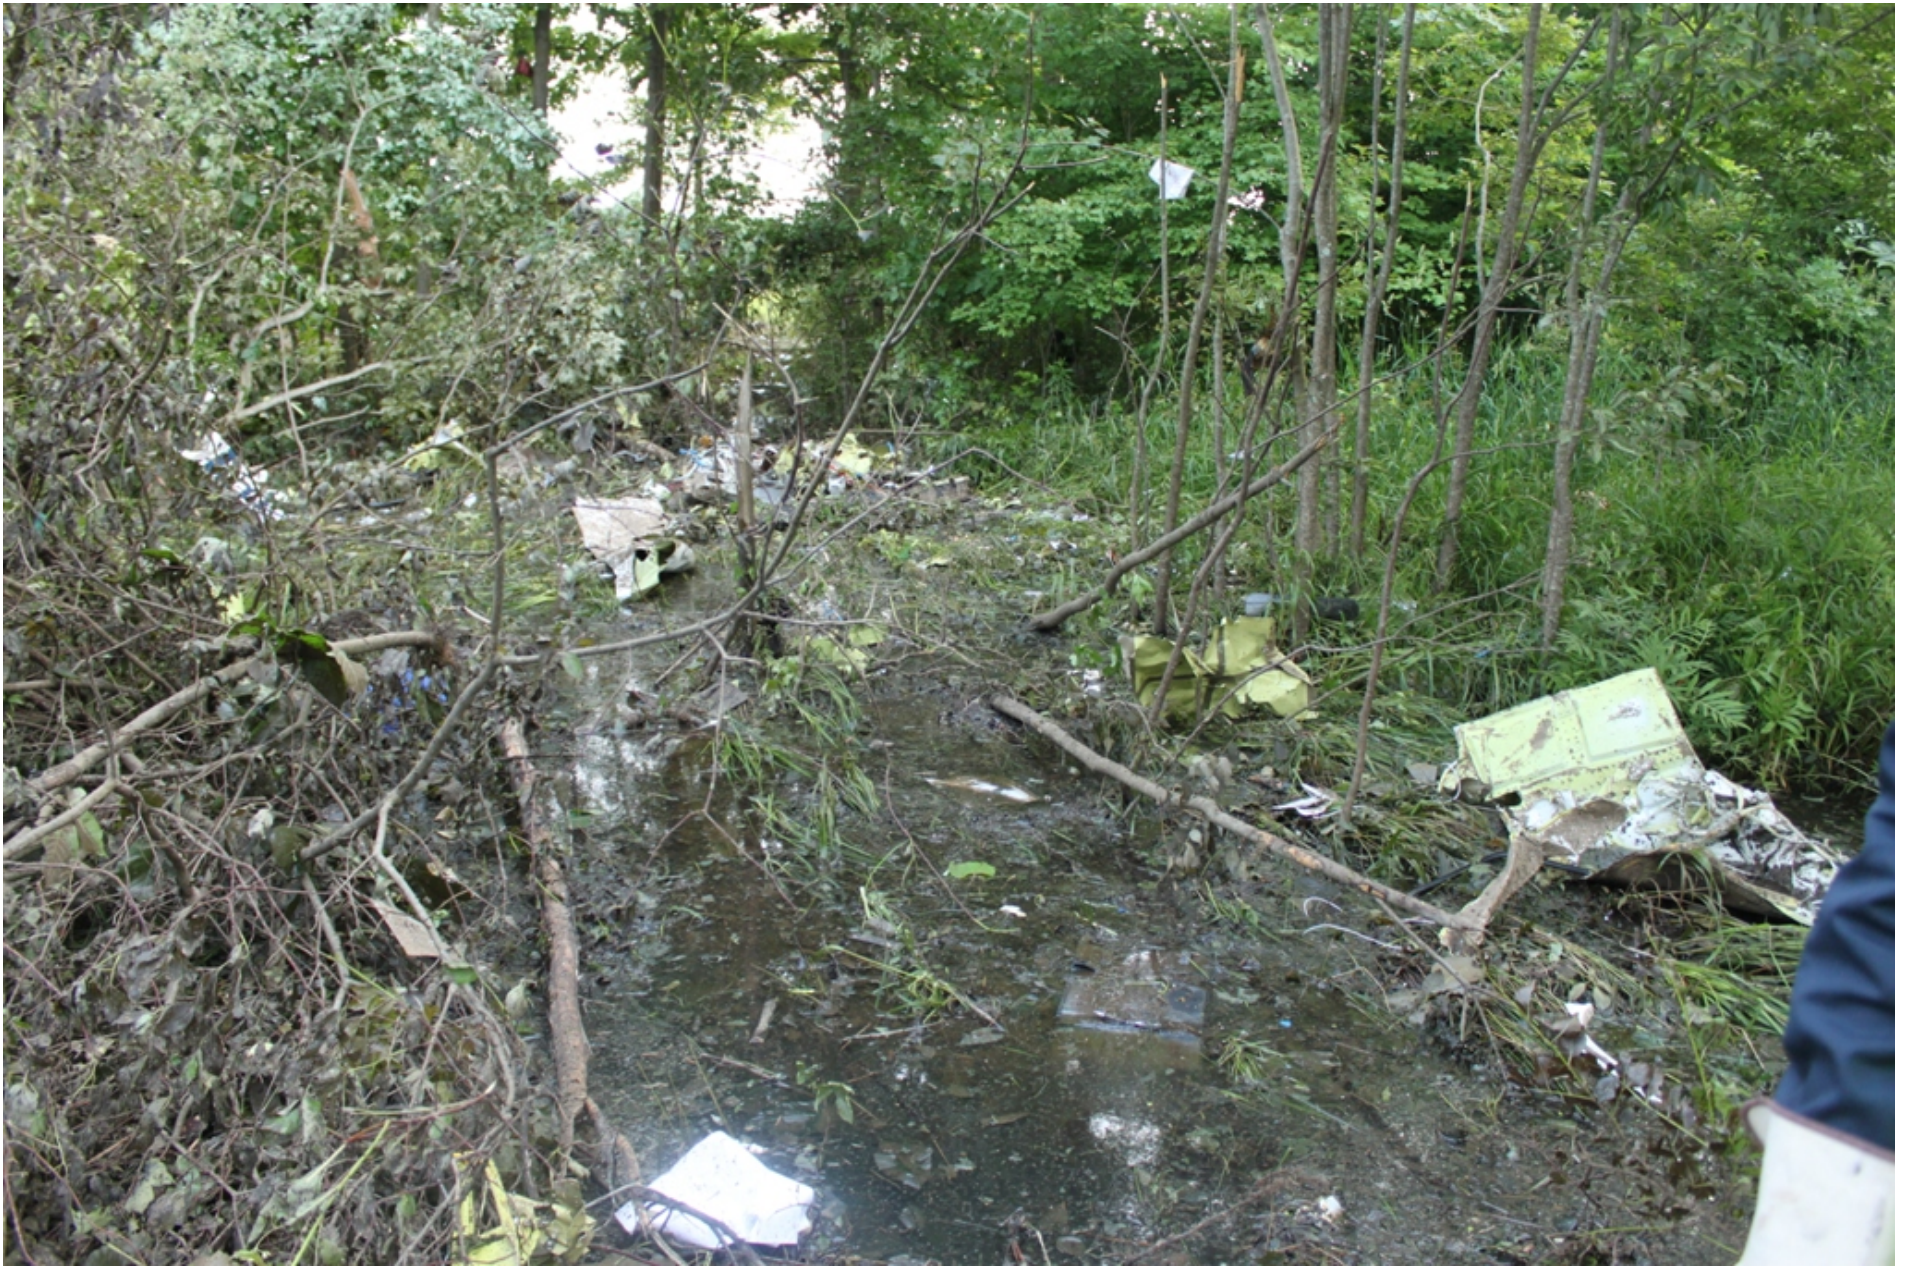
Photo 5 - NTSB Digital Photograph. View of Fragmented Wreckage at Accident Site.

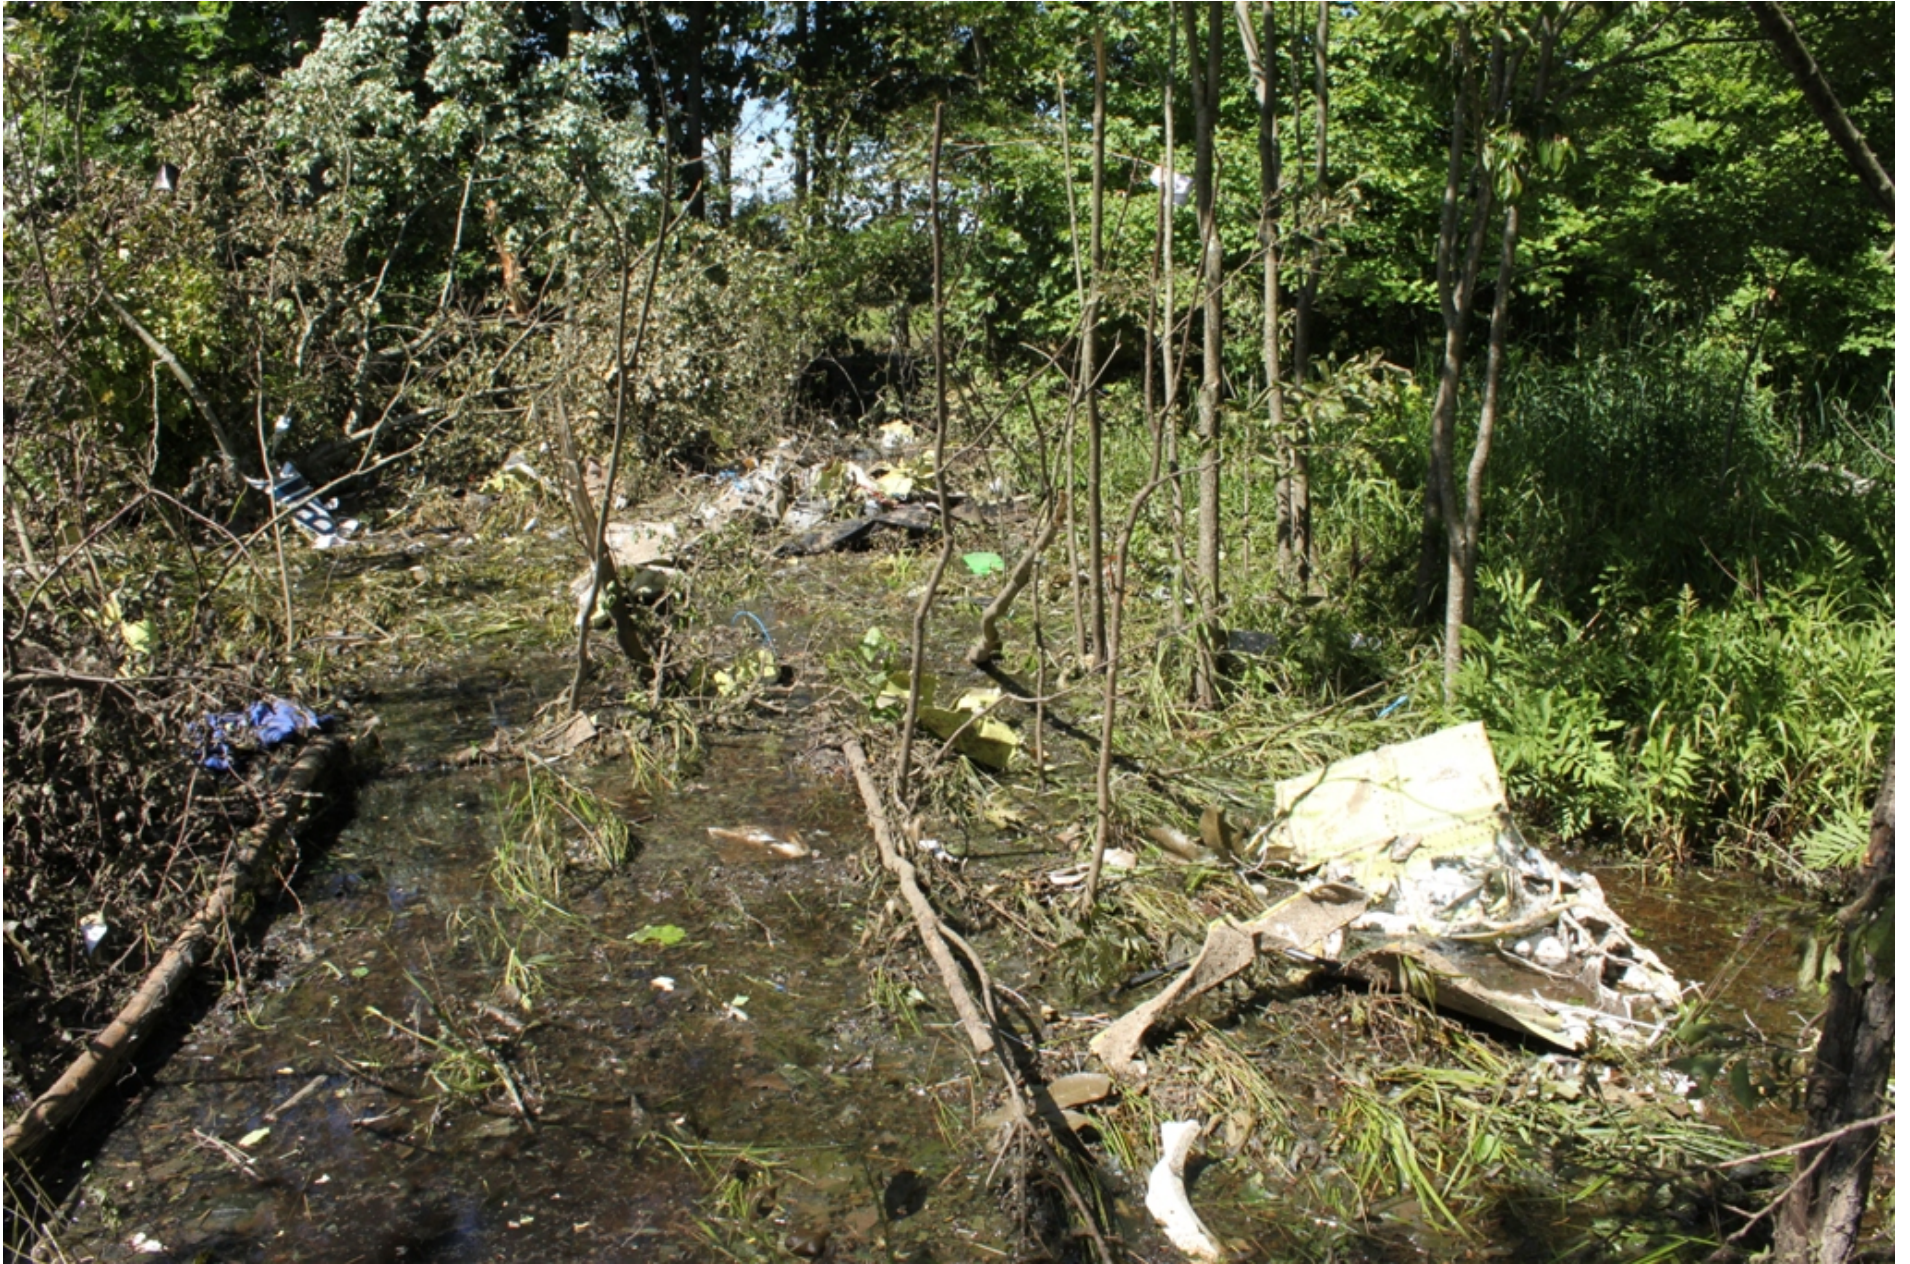
Photo 6 - NTSB Digital Photograph. Another View of Fragmented Wreckage at Accident Site.

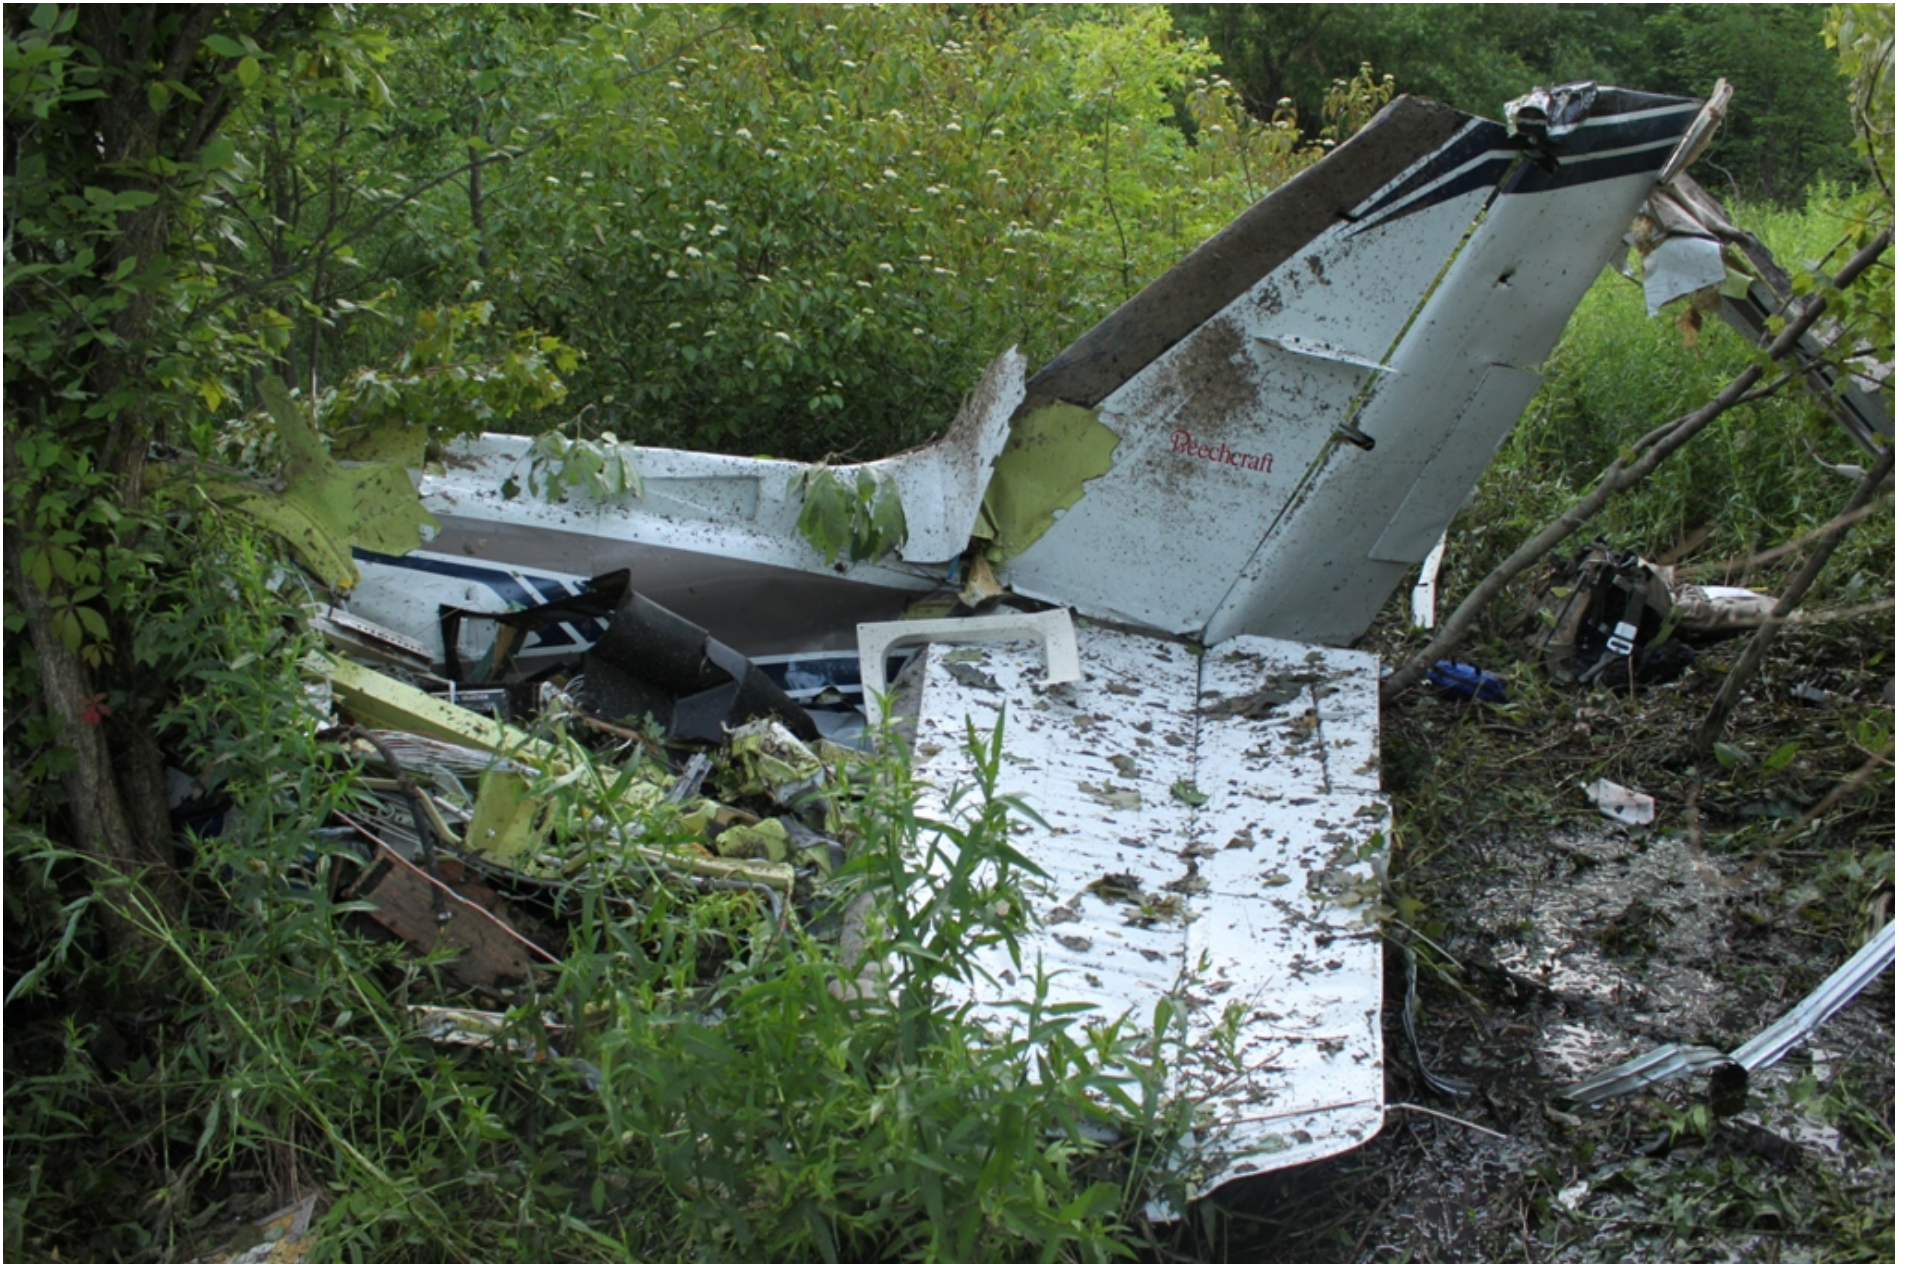
Photo 7 - NTSB Digital Photograph. Left Side View of Aft Empennage at the Accident Site.

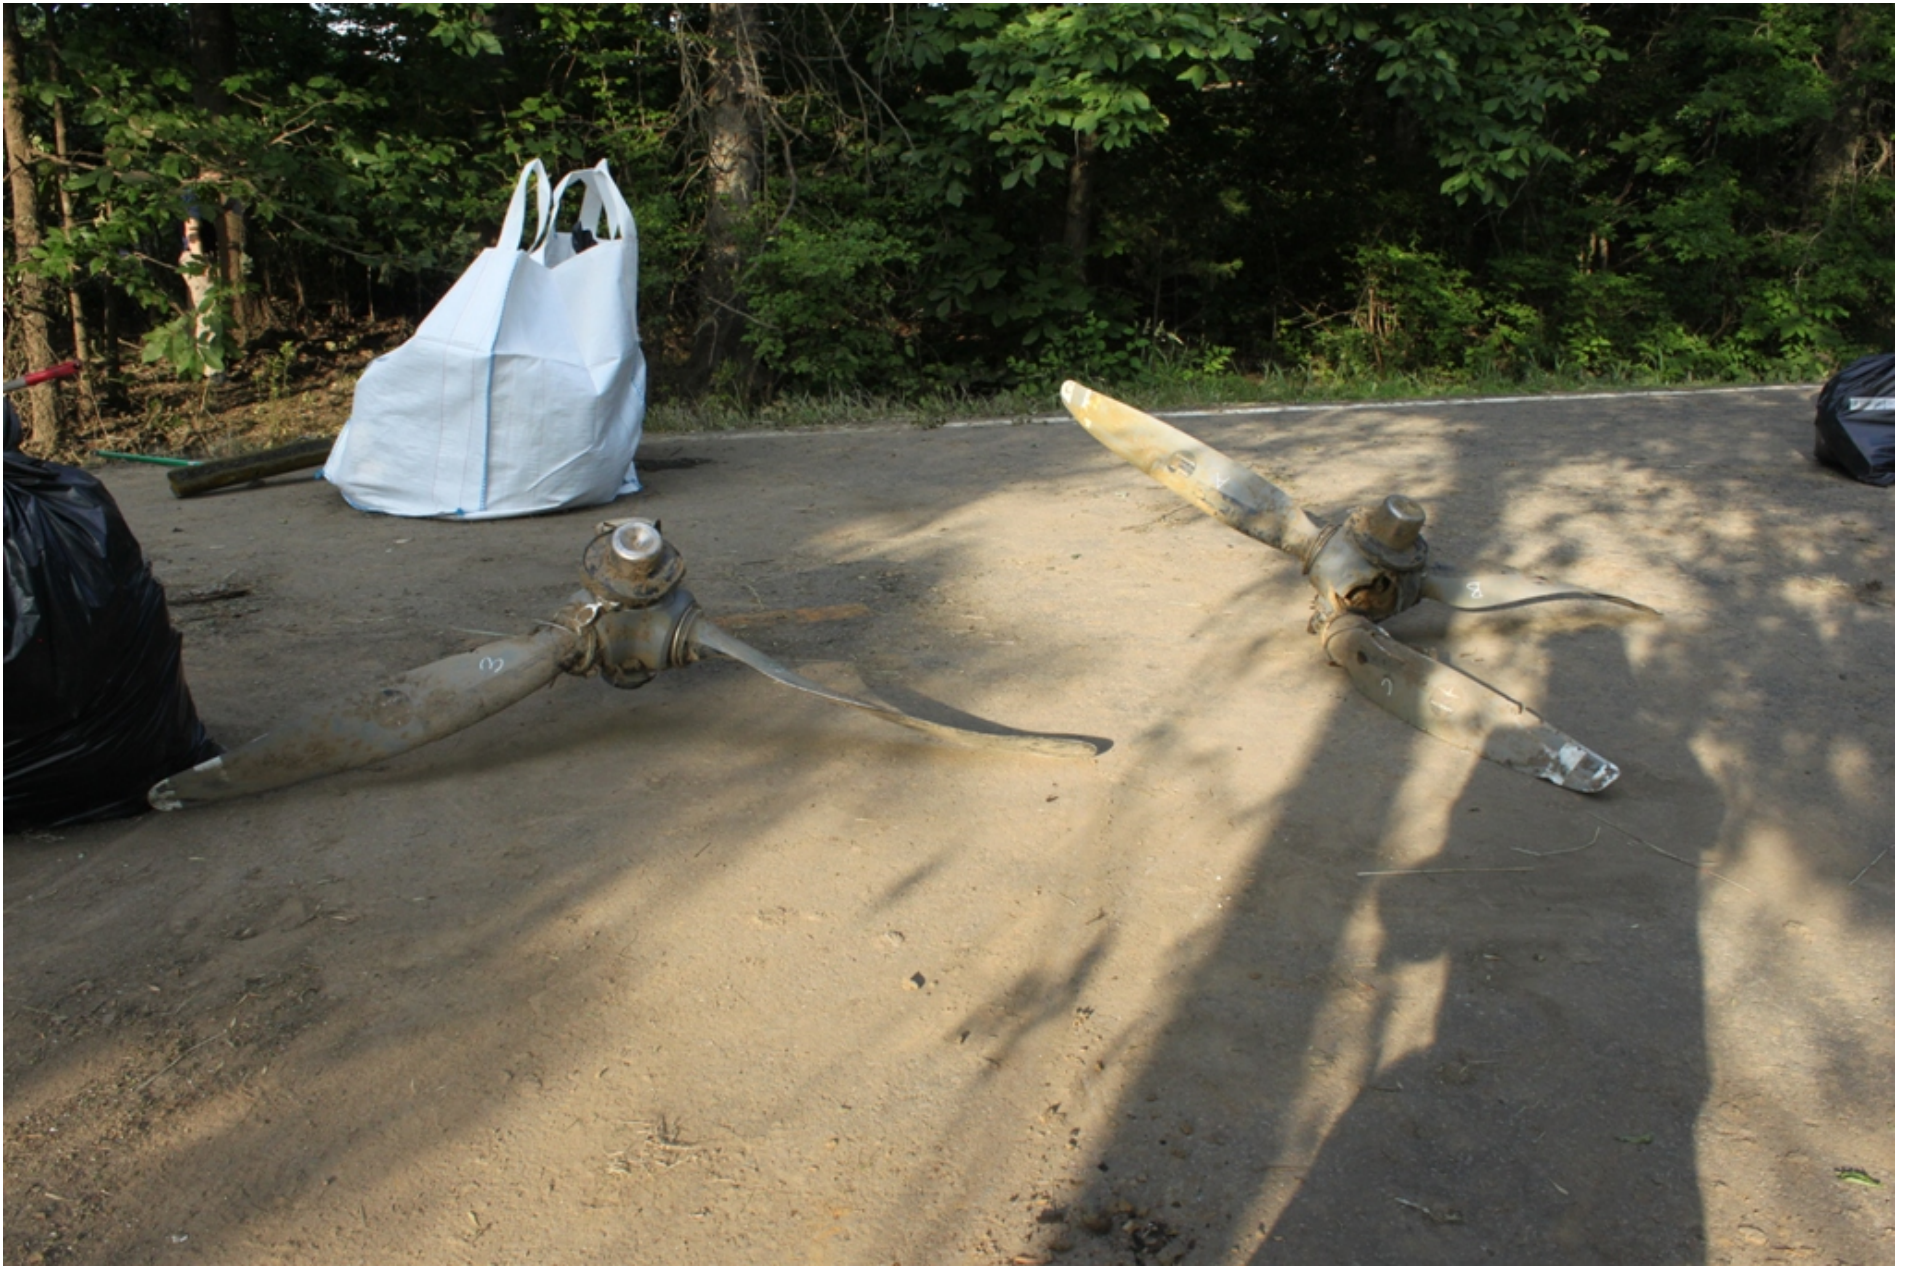
Photo 8 - NTSB Digital Photograph. View of Both Propellers at the Accident Site Following Recovery.

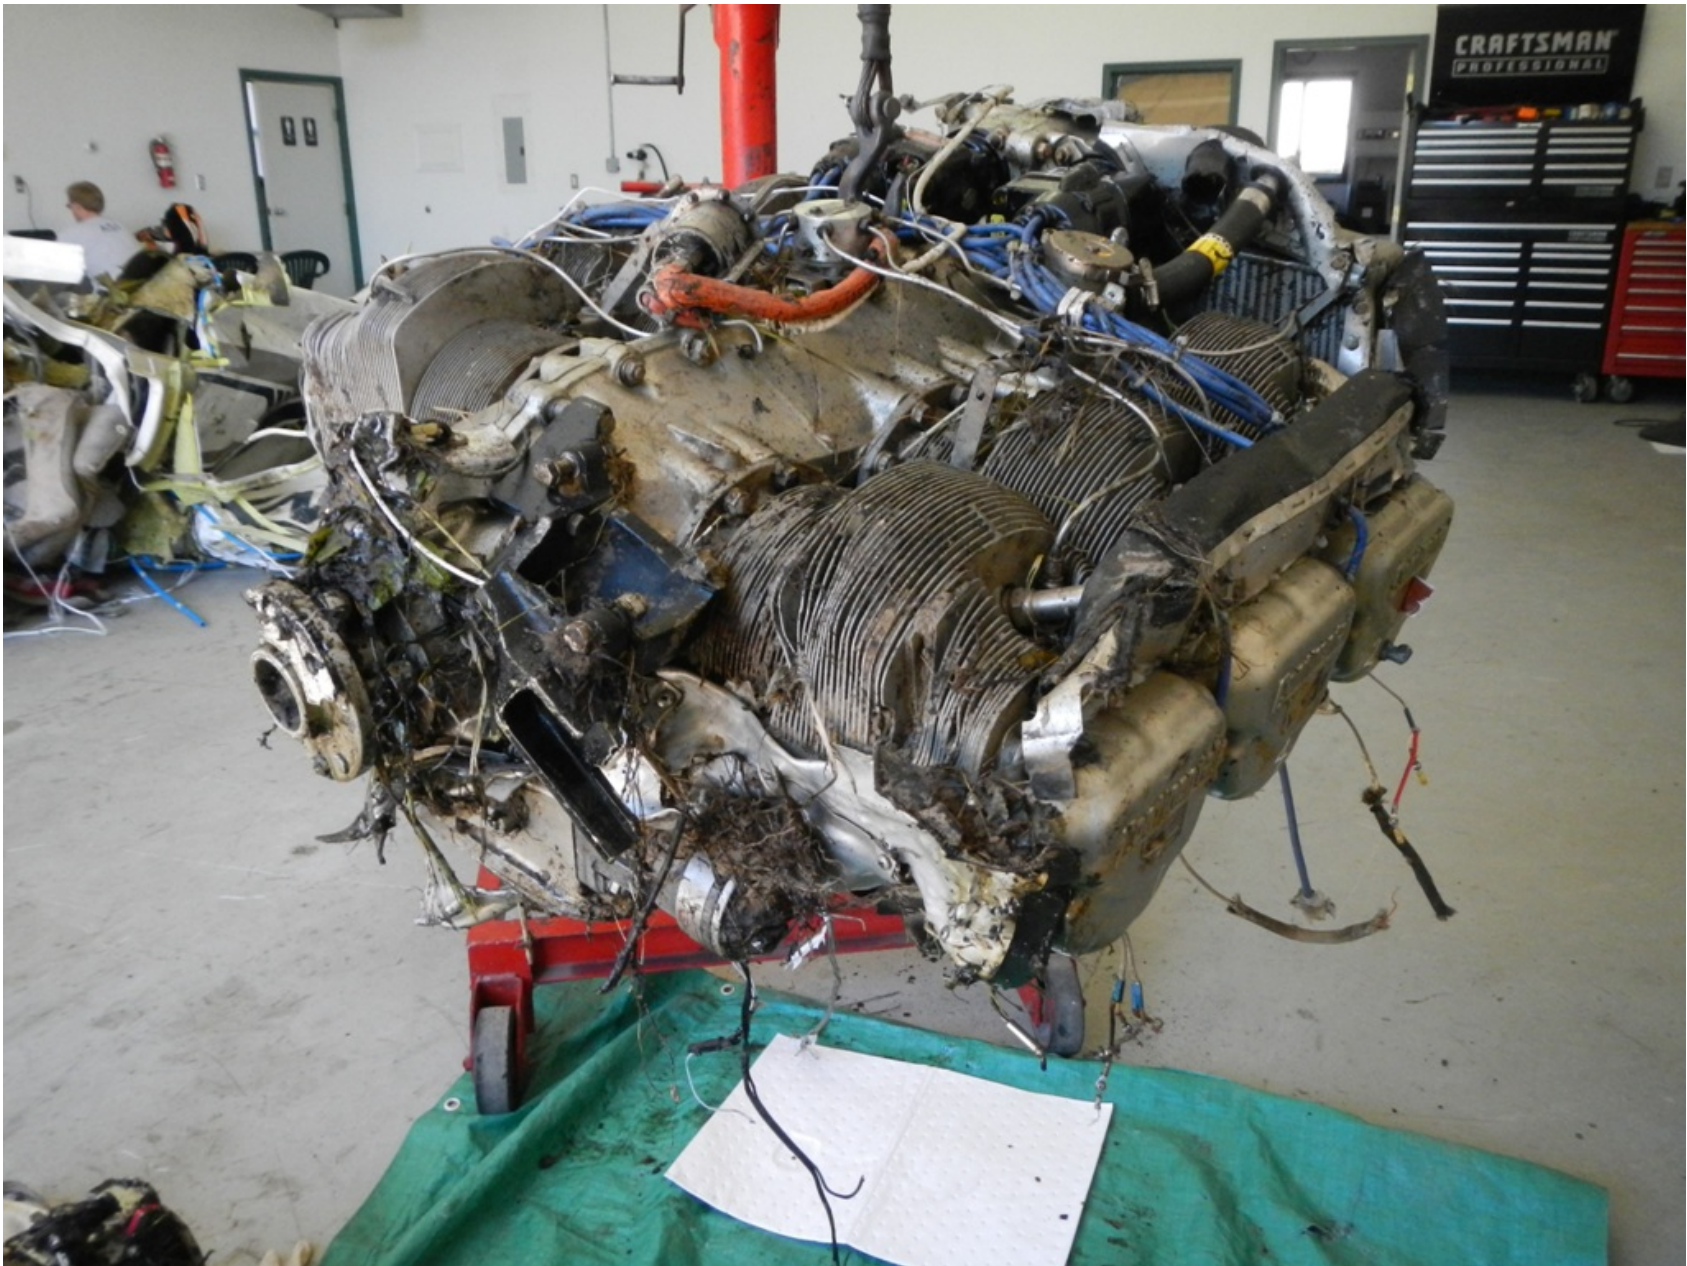
Photo 9 – Continental Aerospace Technologies Digital Photograph. View of the Left Engine Following Recovery.

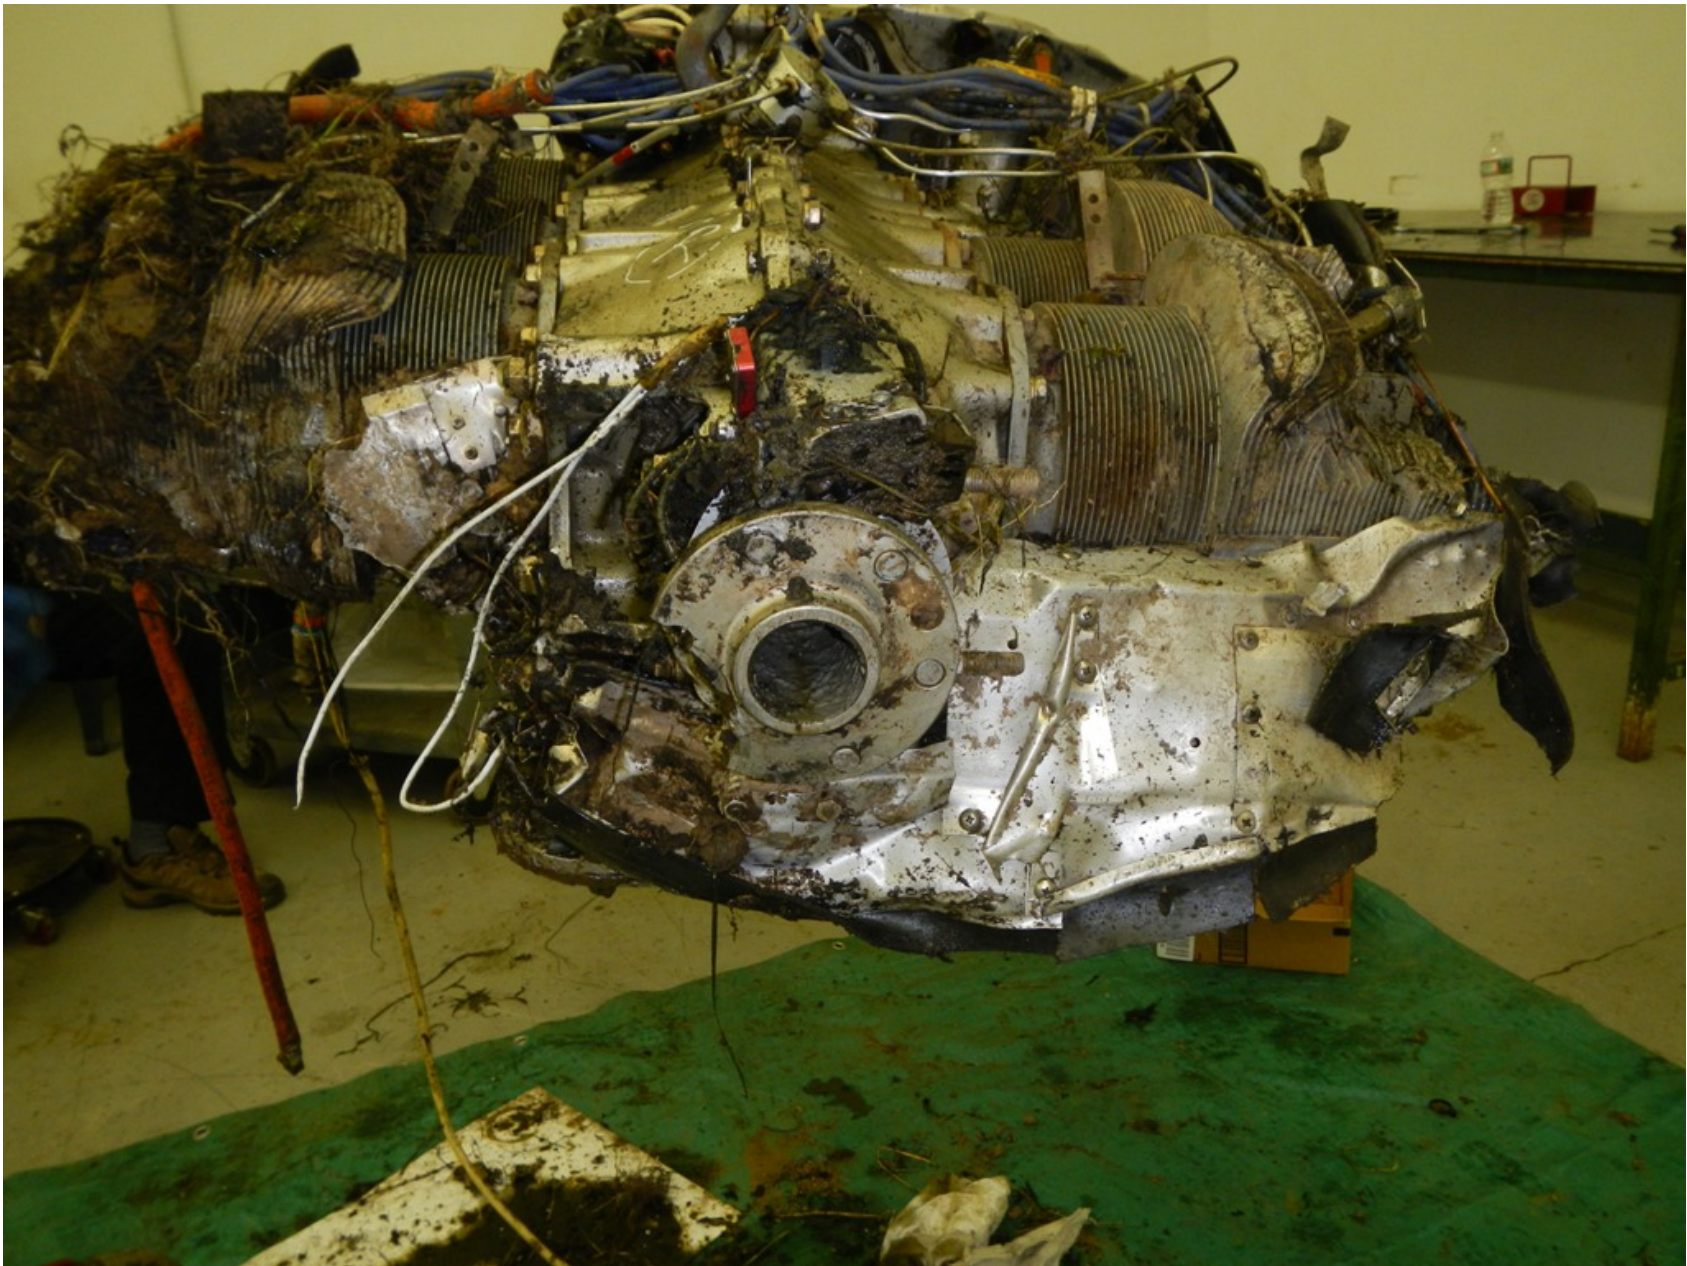
Photo 10 - Continental Aerospace Technologies Digital Photograph. View of the Right Engine Following Recovery
