Photo 1 – NTSB Drone Photograph. Google Earth Mosaic of the Accident Site.

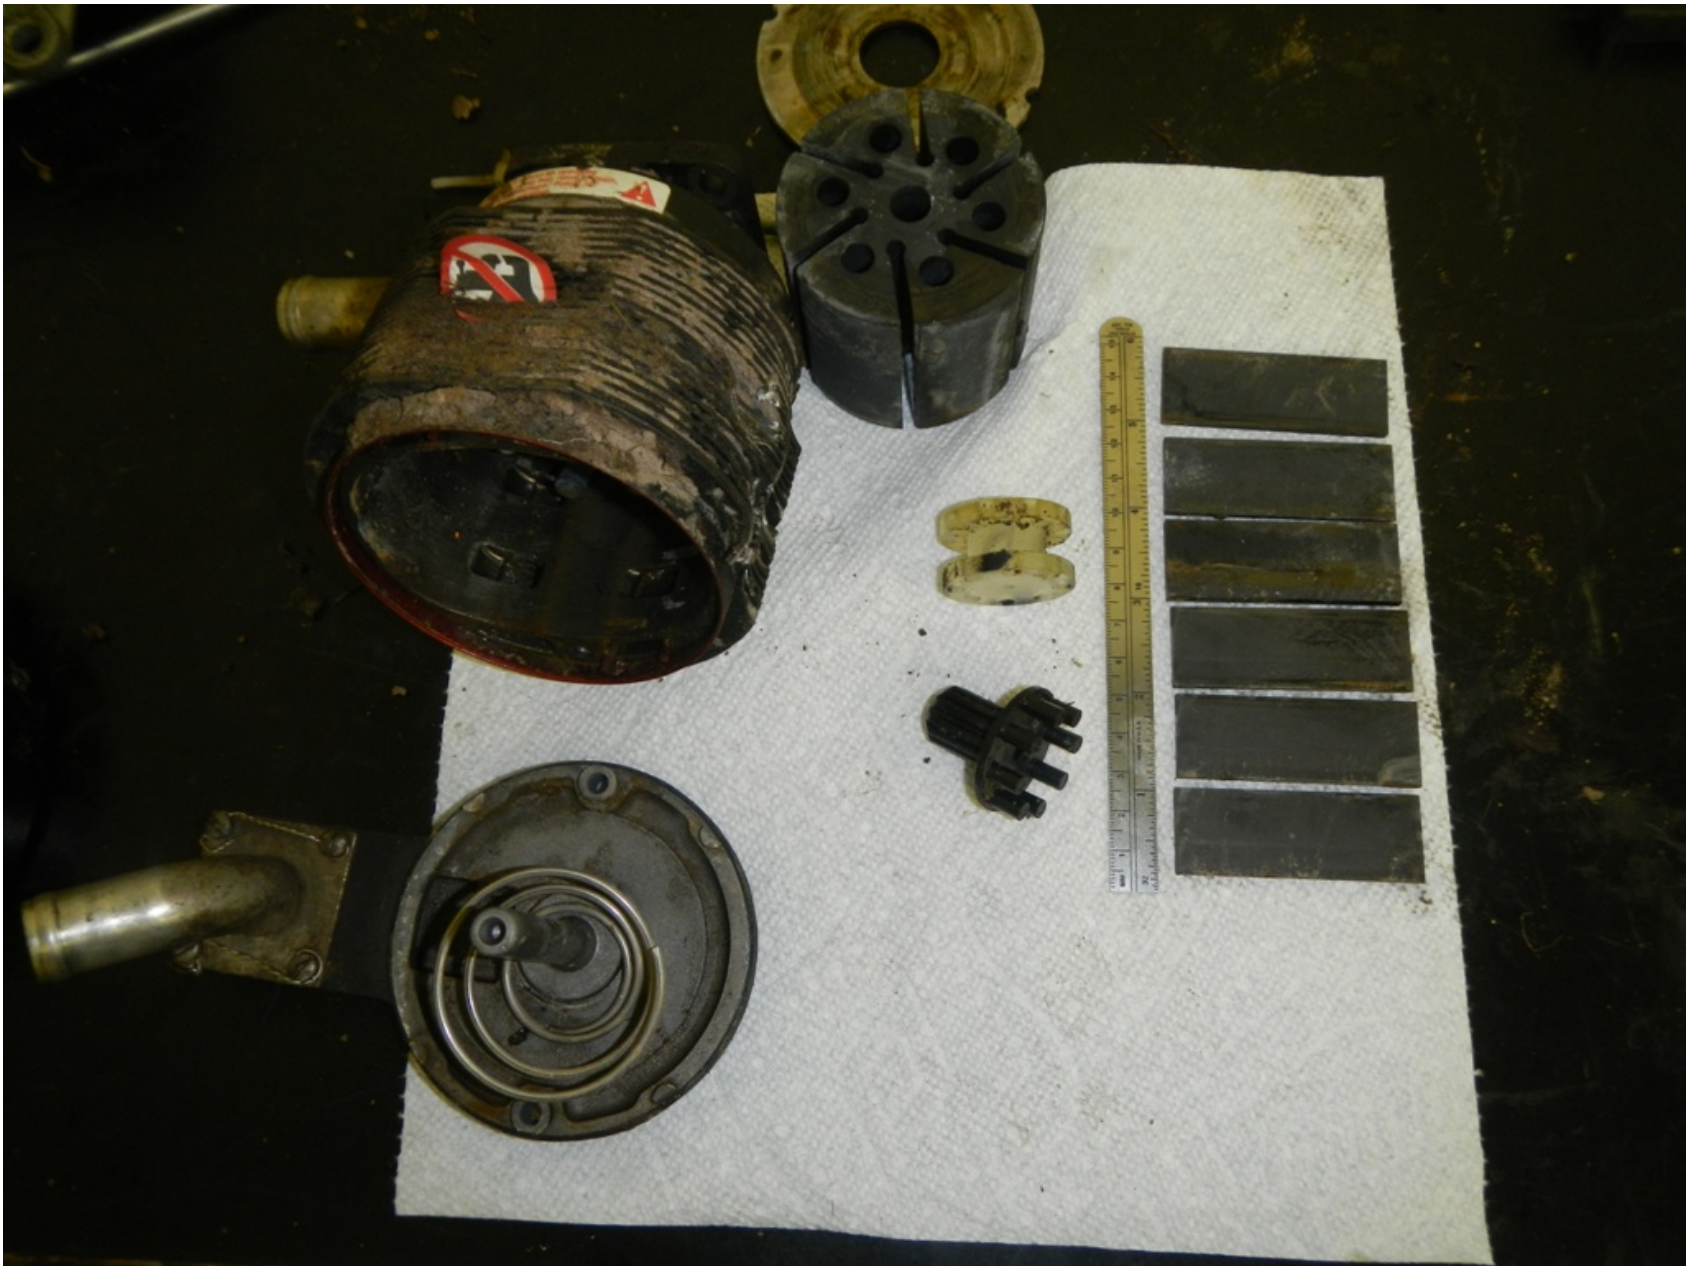
Photo 11 - Continental Aerospace Technologies Digital Photograph. View of the Right Engine-Driven Vacuum Pump Following Disassembly.
