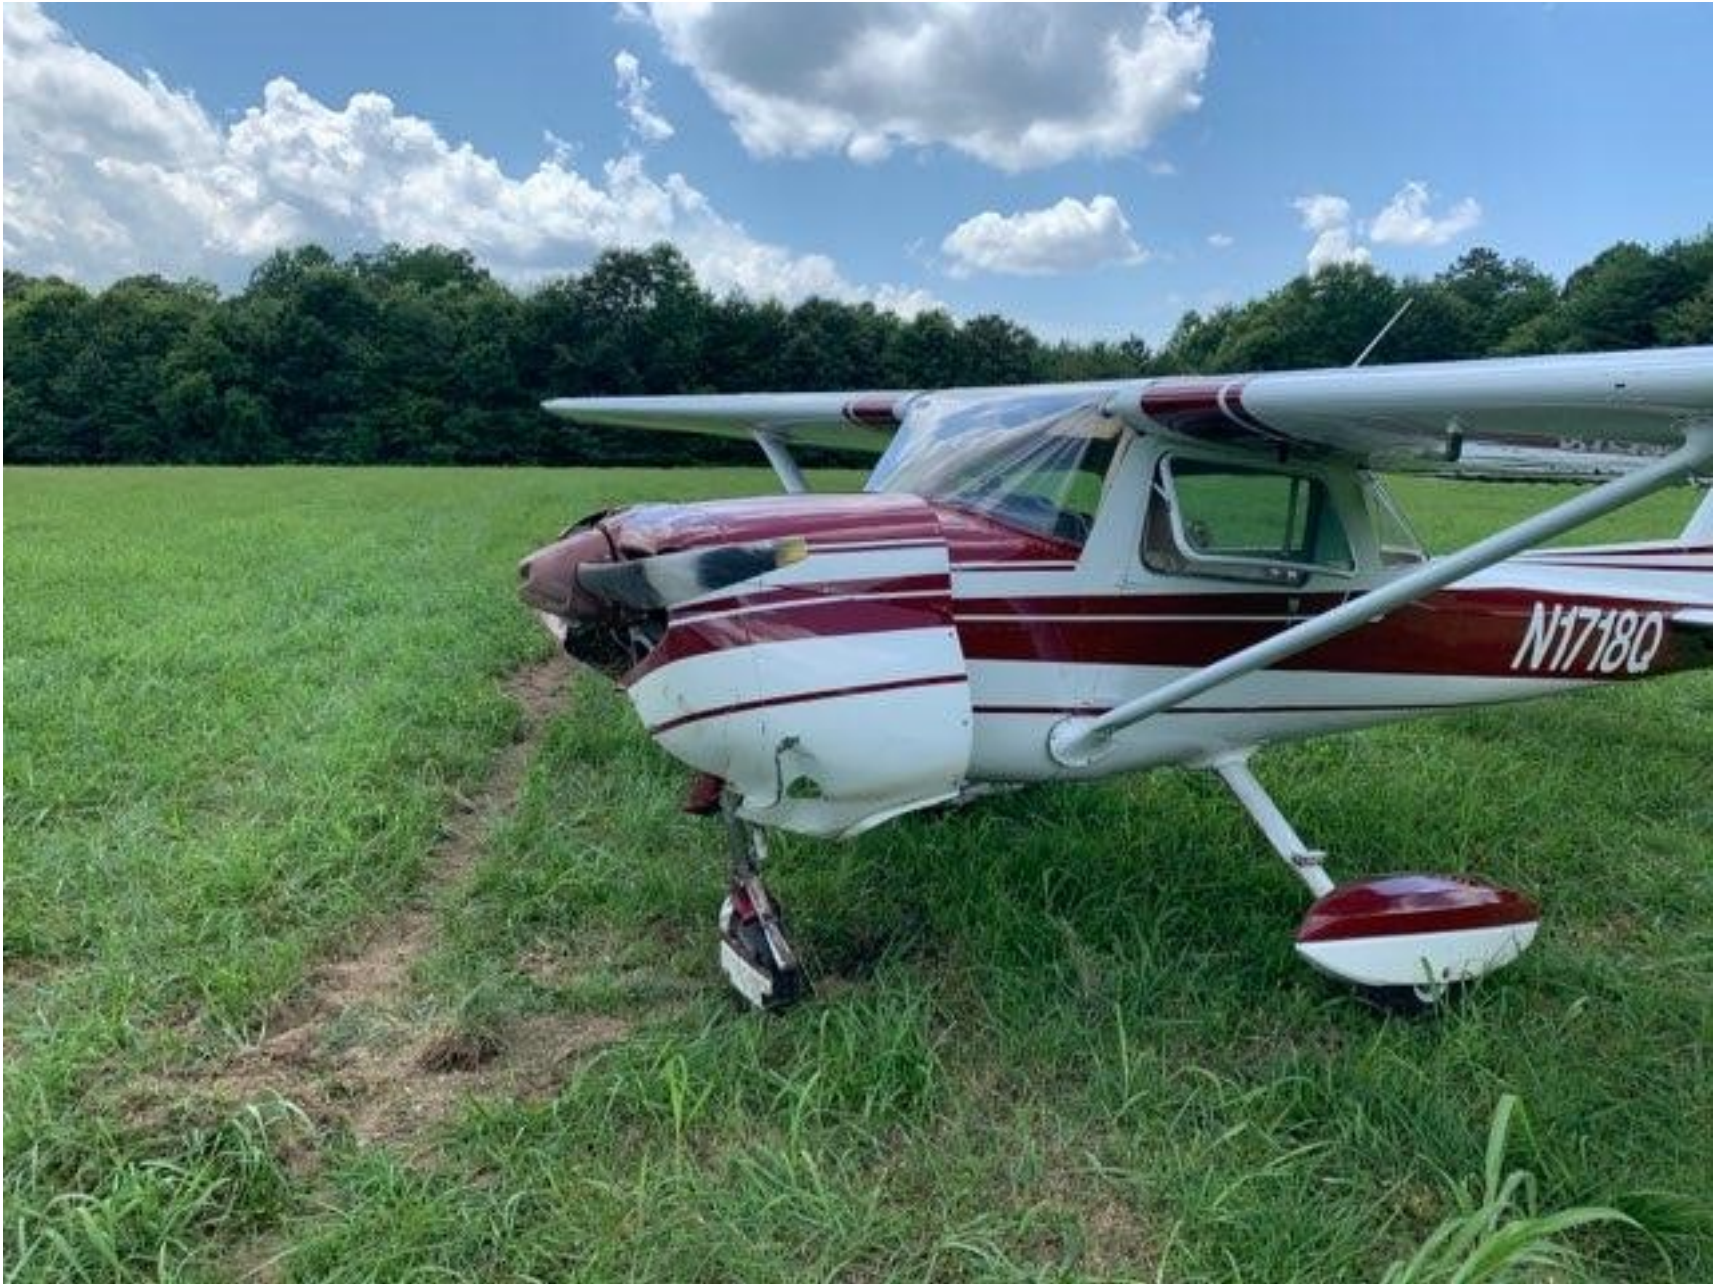
Photo 1 – View of airplane at rest (Courtesy of FAA)

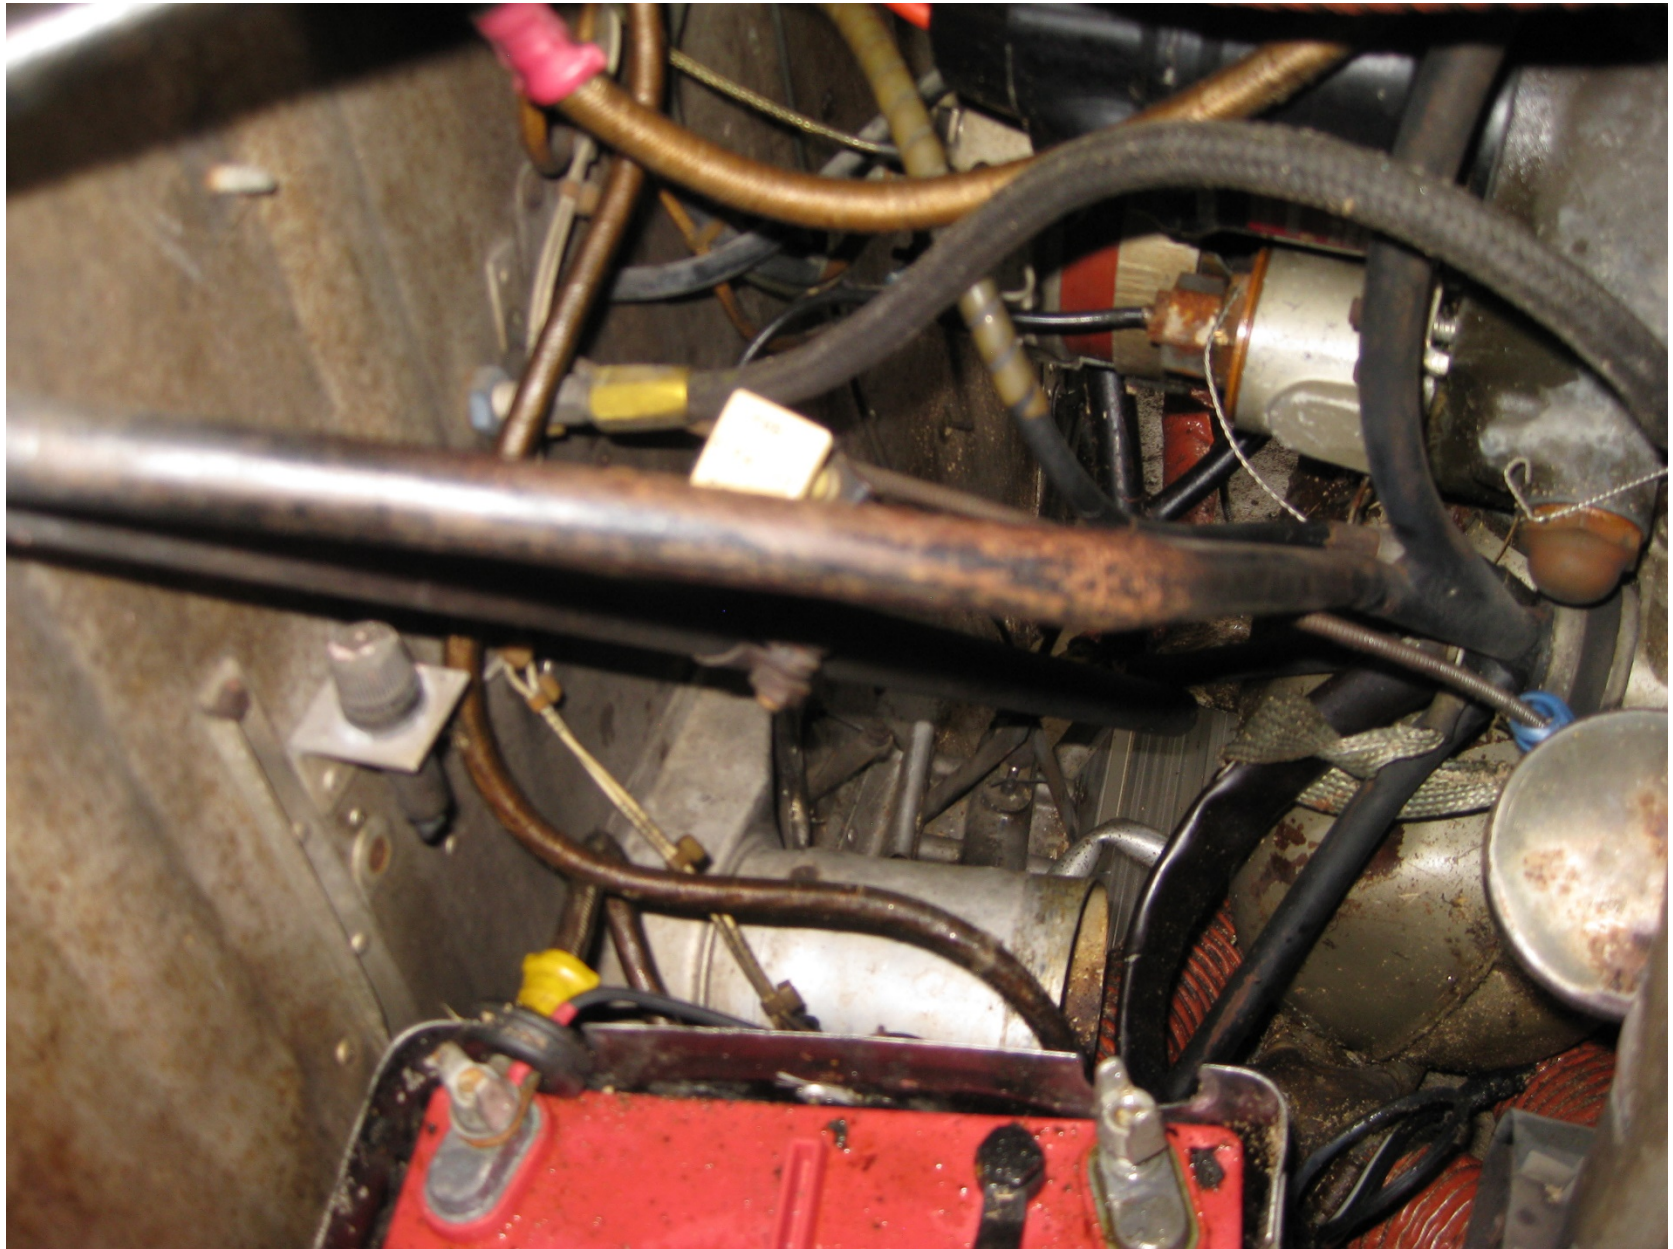
Photo 2 – View of Bent Engine Mount [the closest one] (Courtesy of FAA)

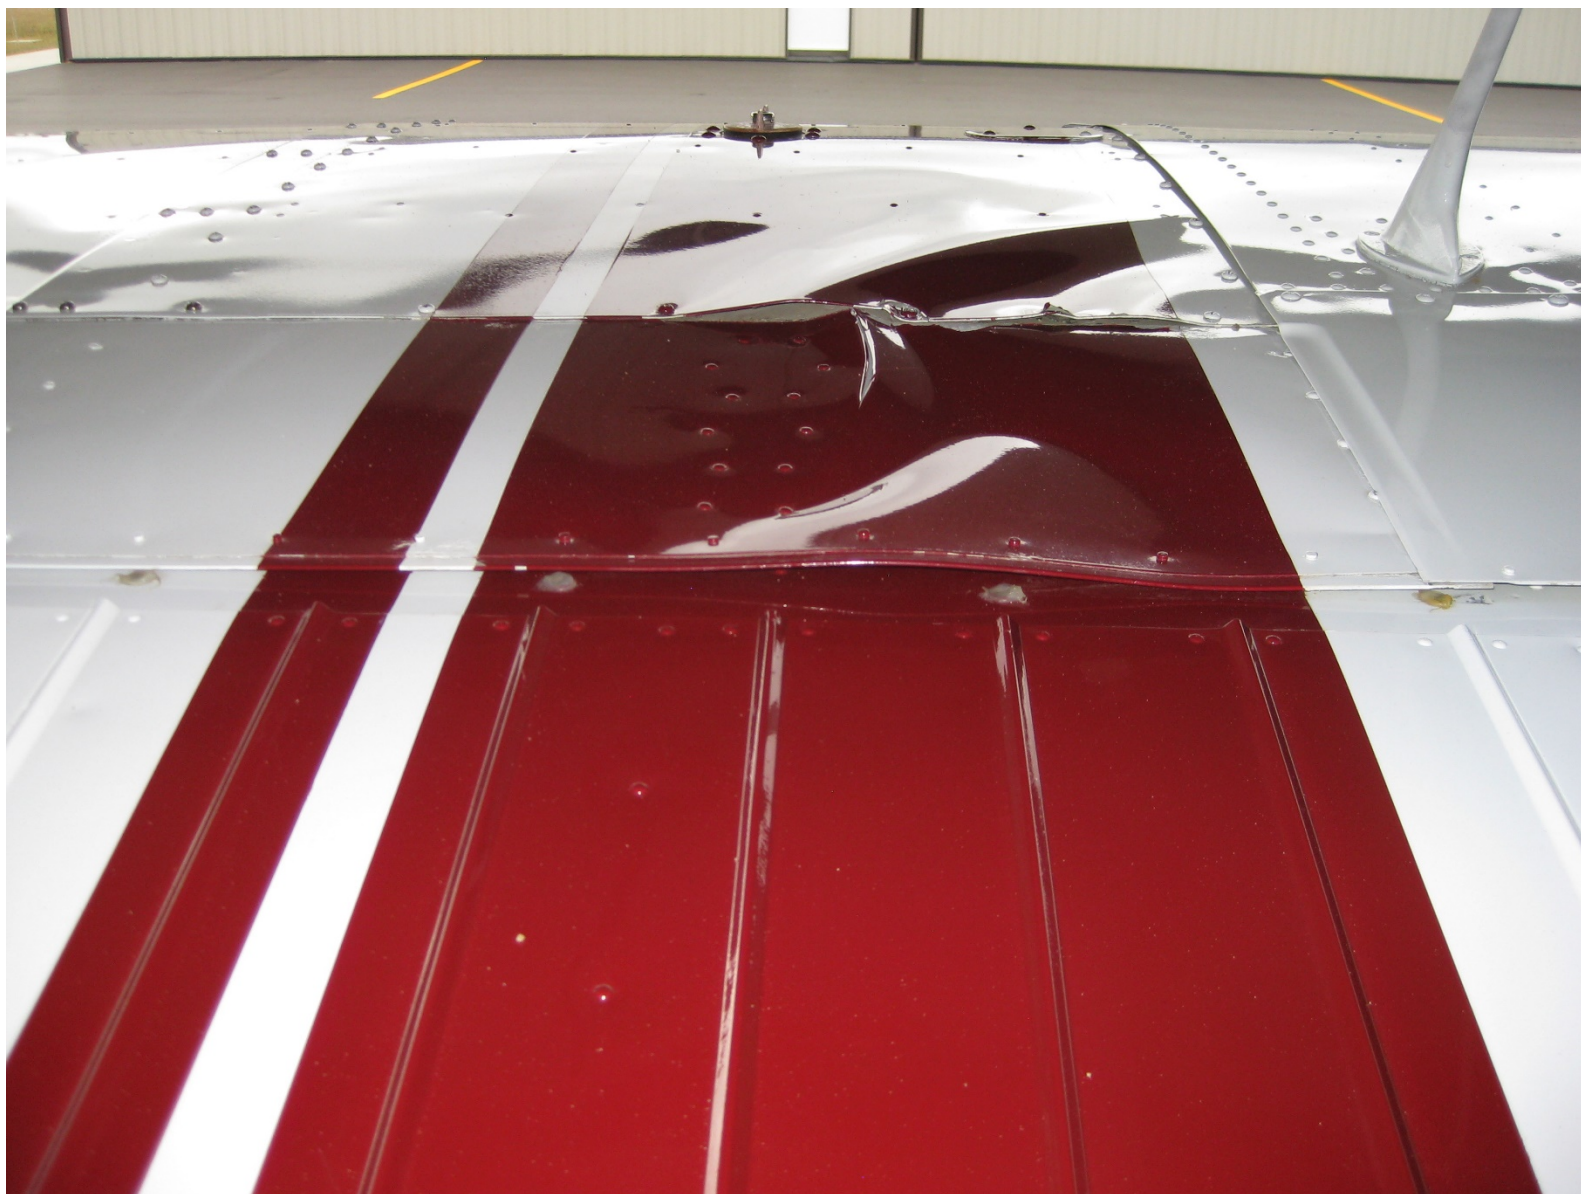
Photo 3 – View of Left Wing Damage (Courtesy of FAA)
