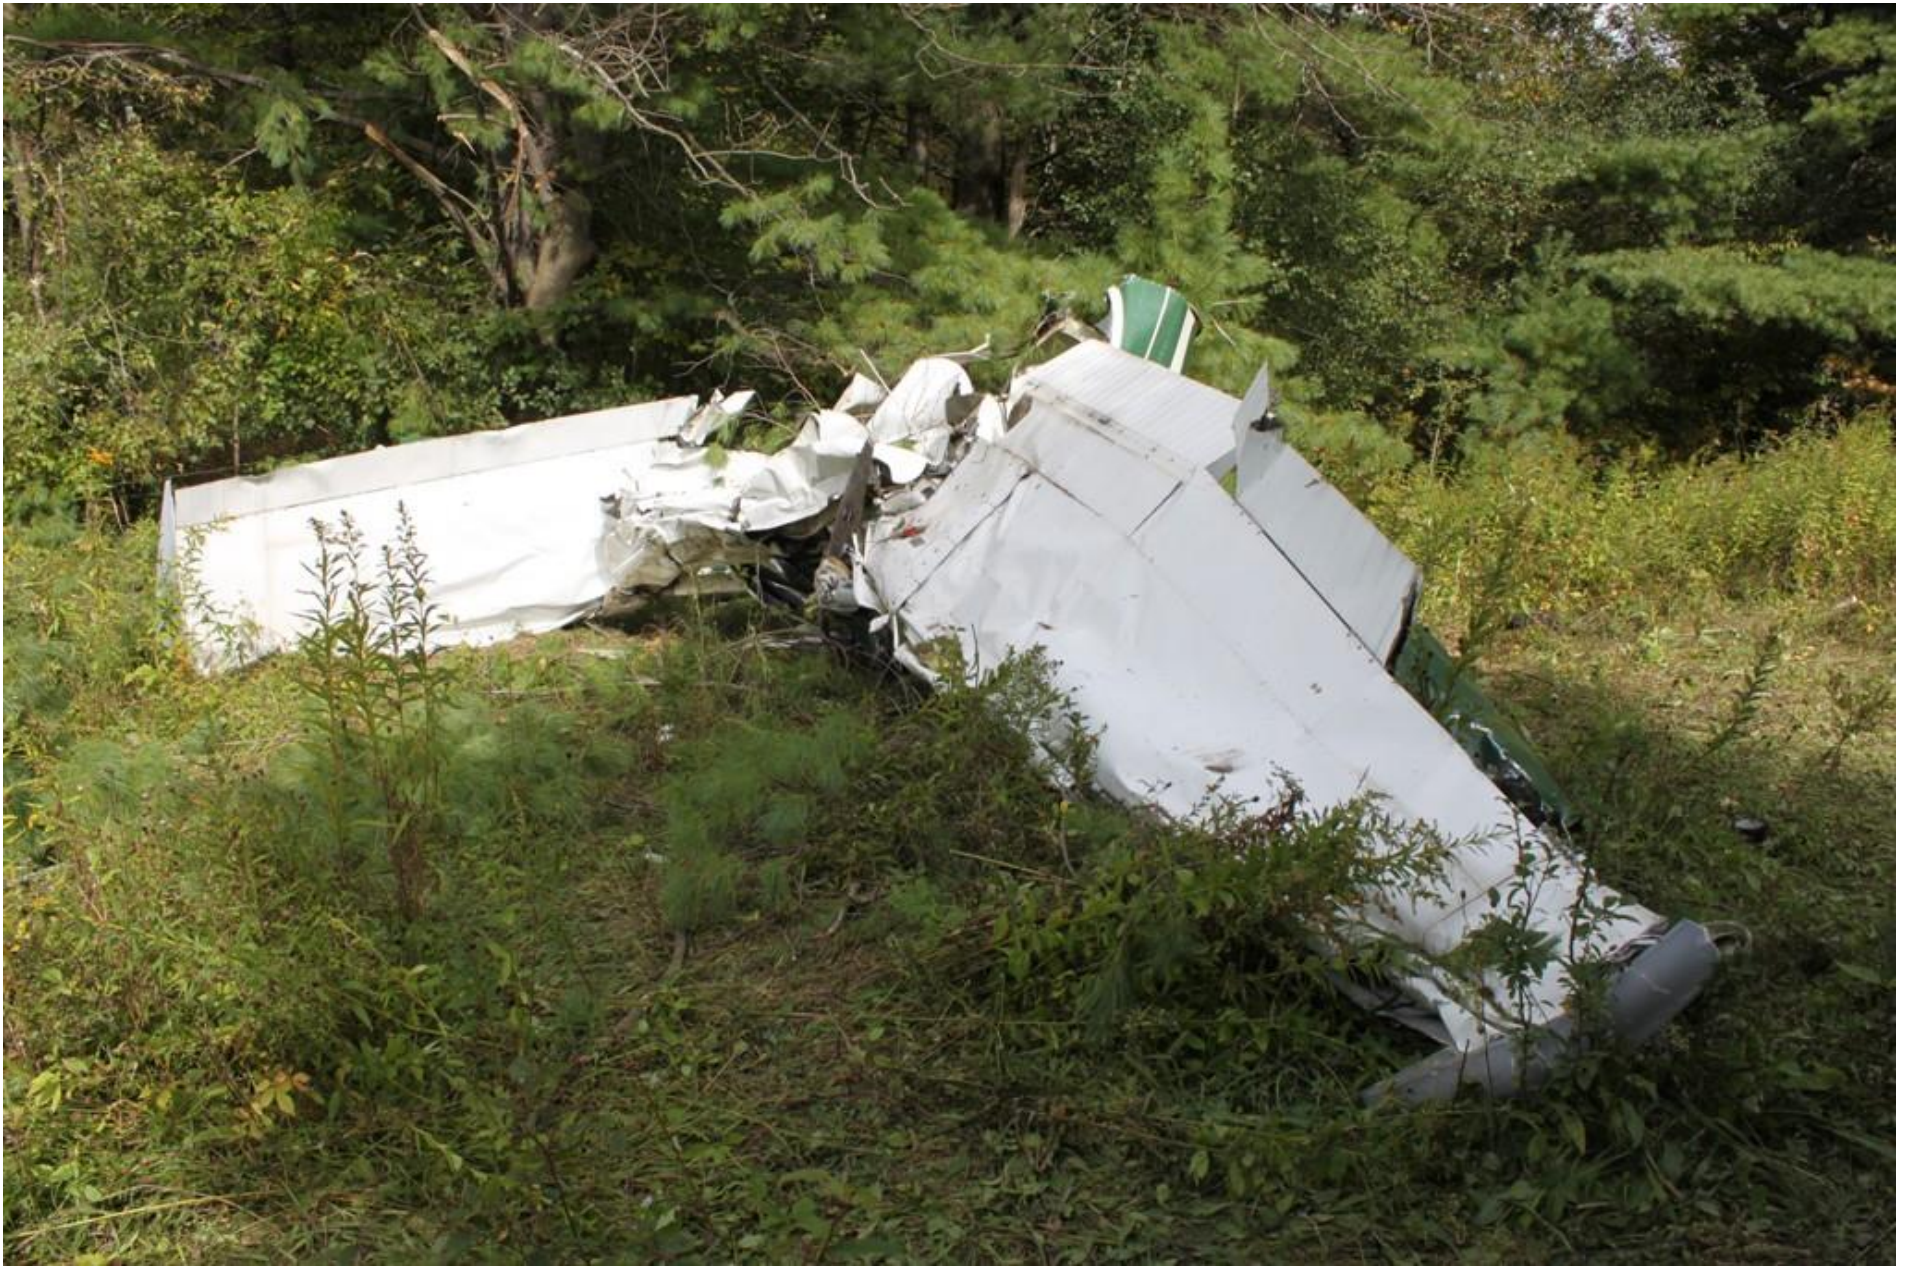
Photo 1 – NTSB Digital Photograph. Left Forward Quartering View of the Wreckage.

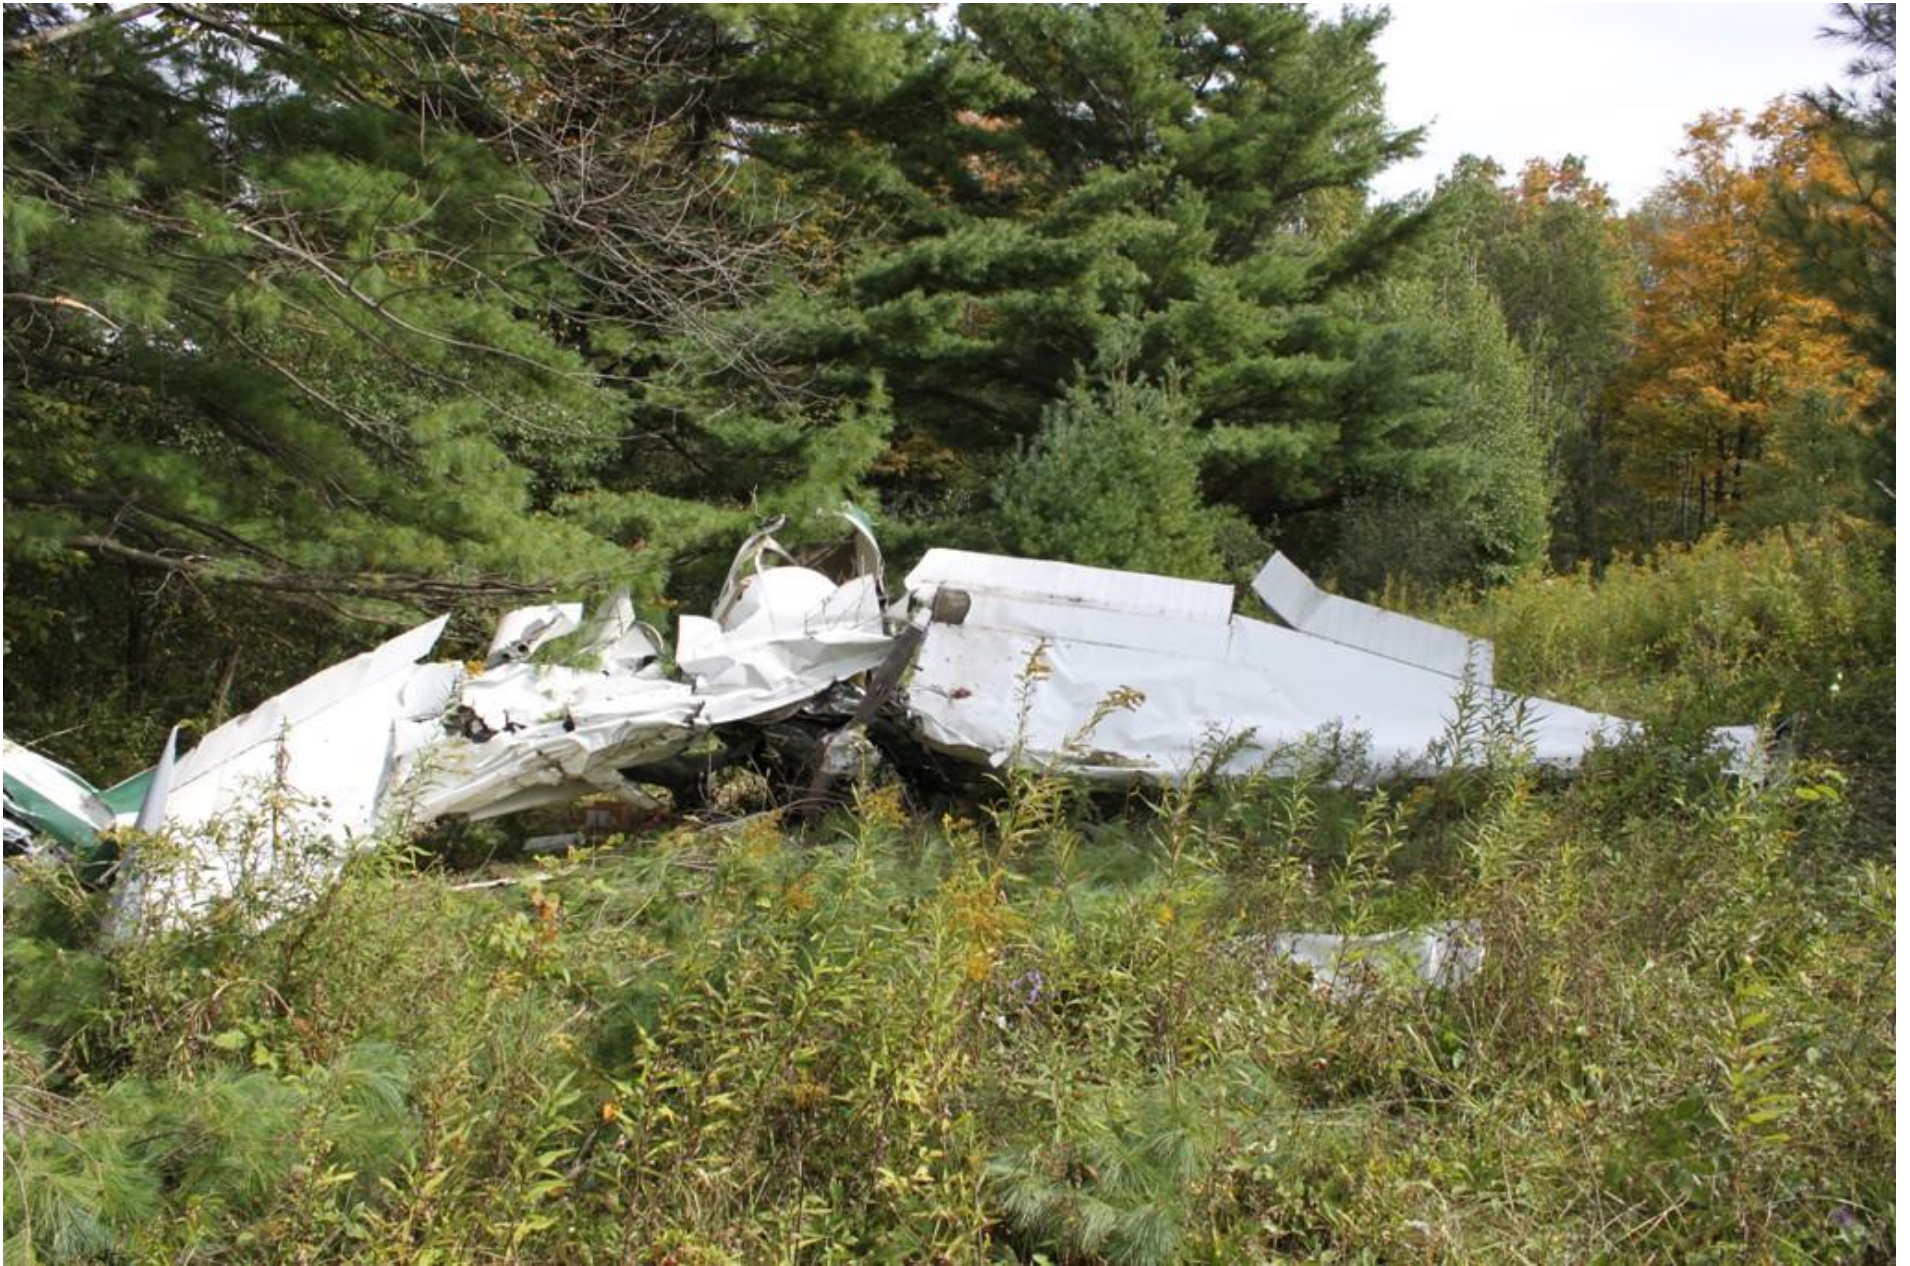
Photo 2 - NTSB Digital Photograph. Forward View of the Wreckage.

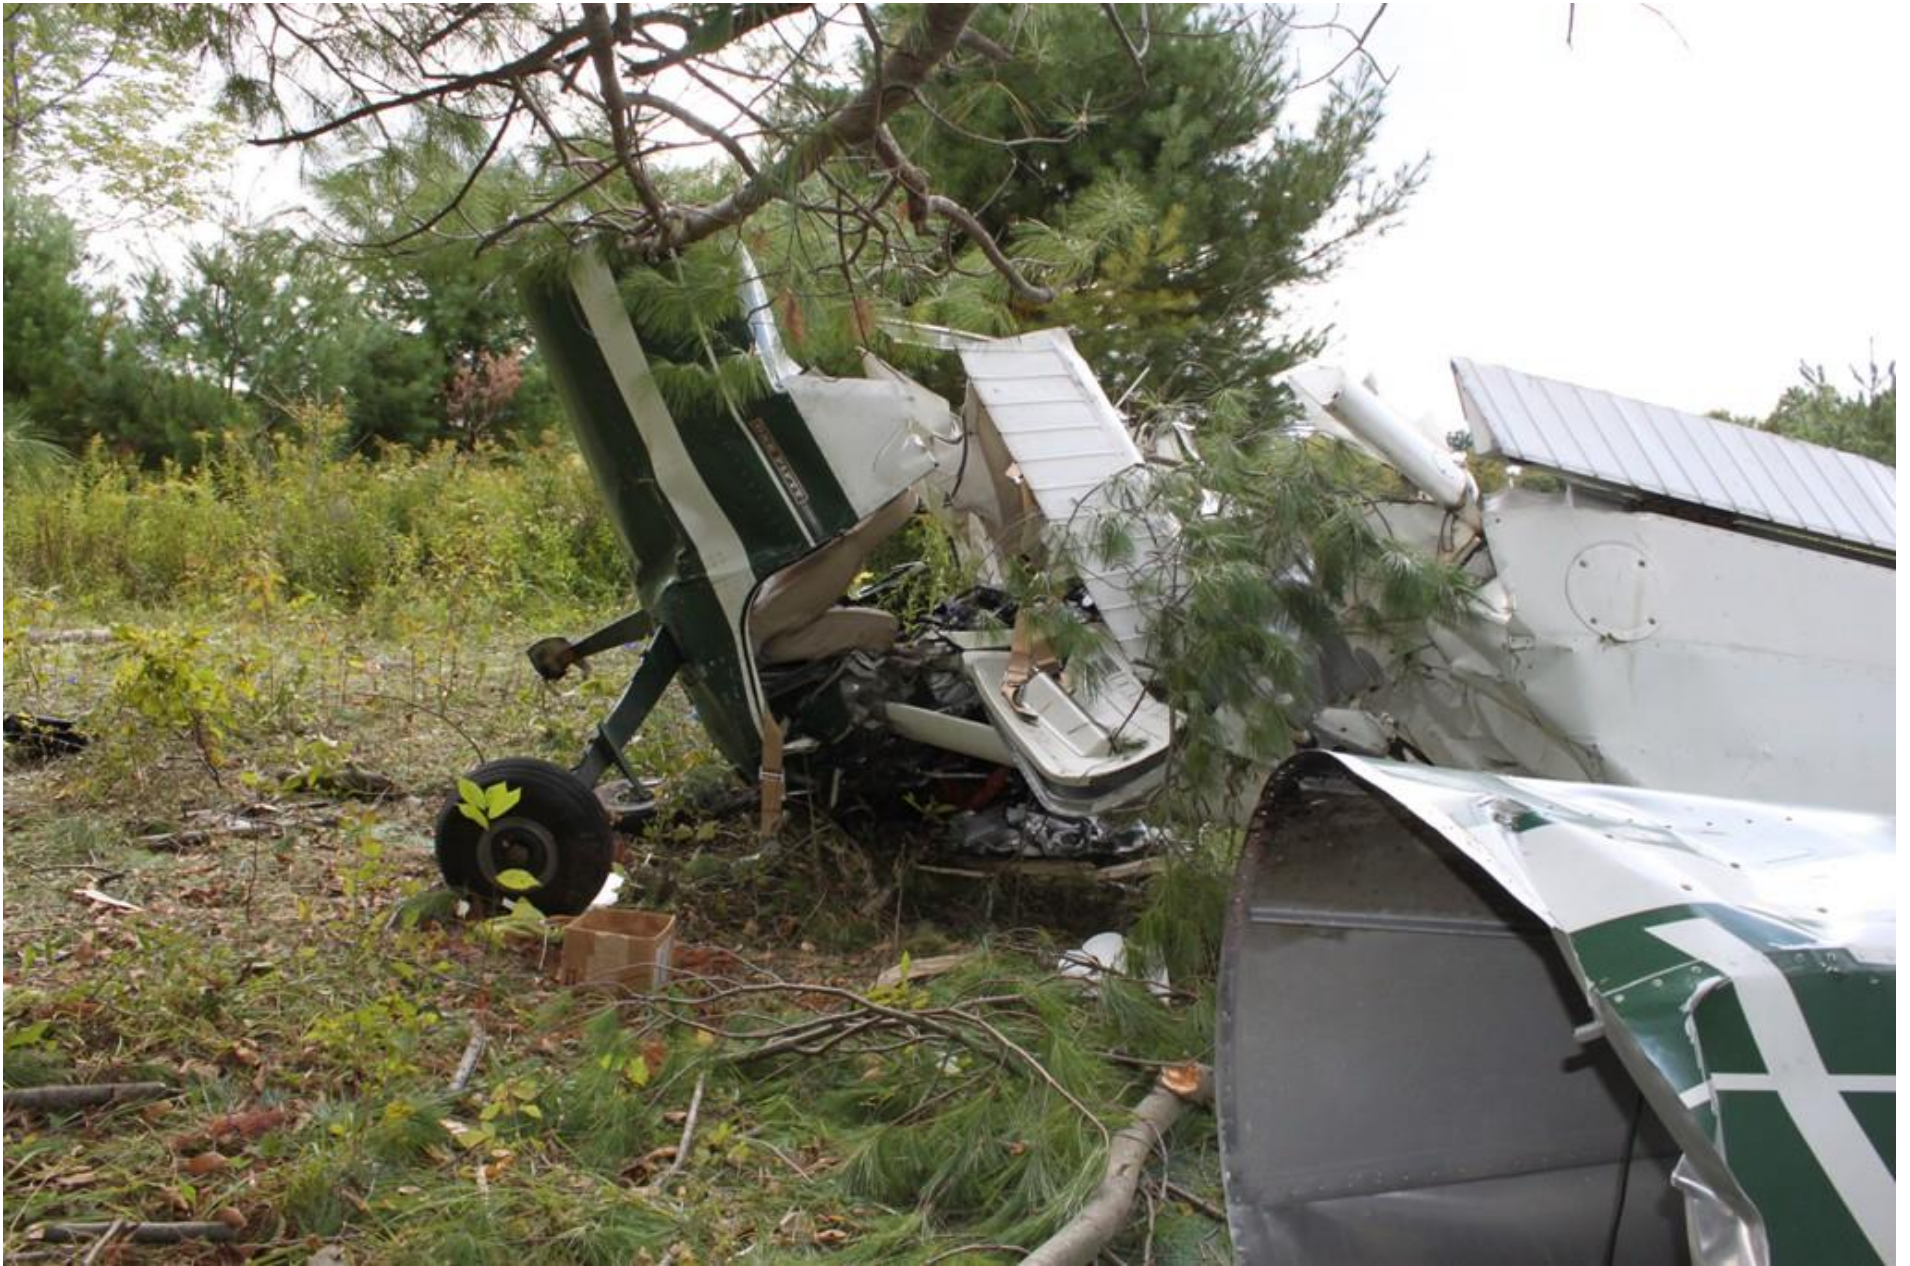
Photo 3 - NTSB Digital Photograph. Right Side View of the Wreckage.

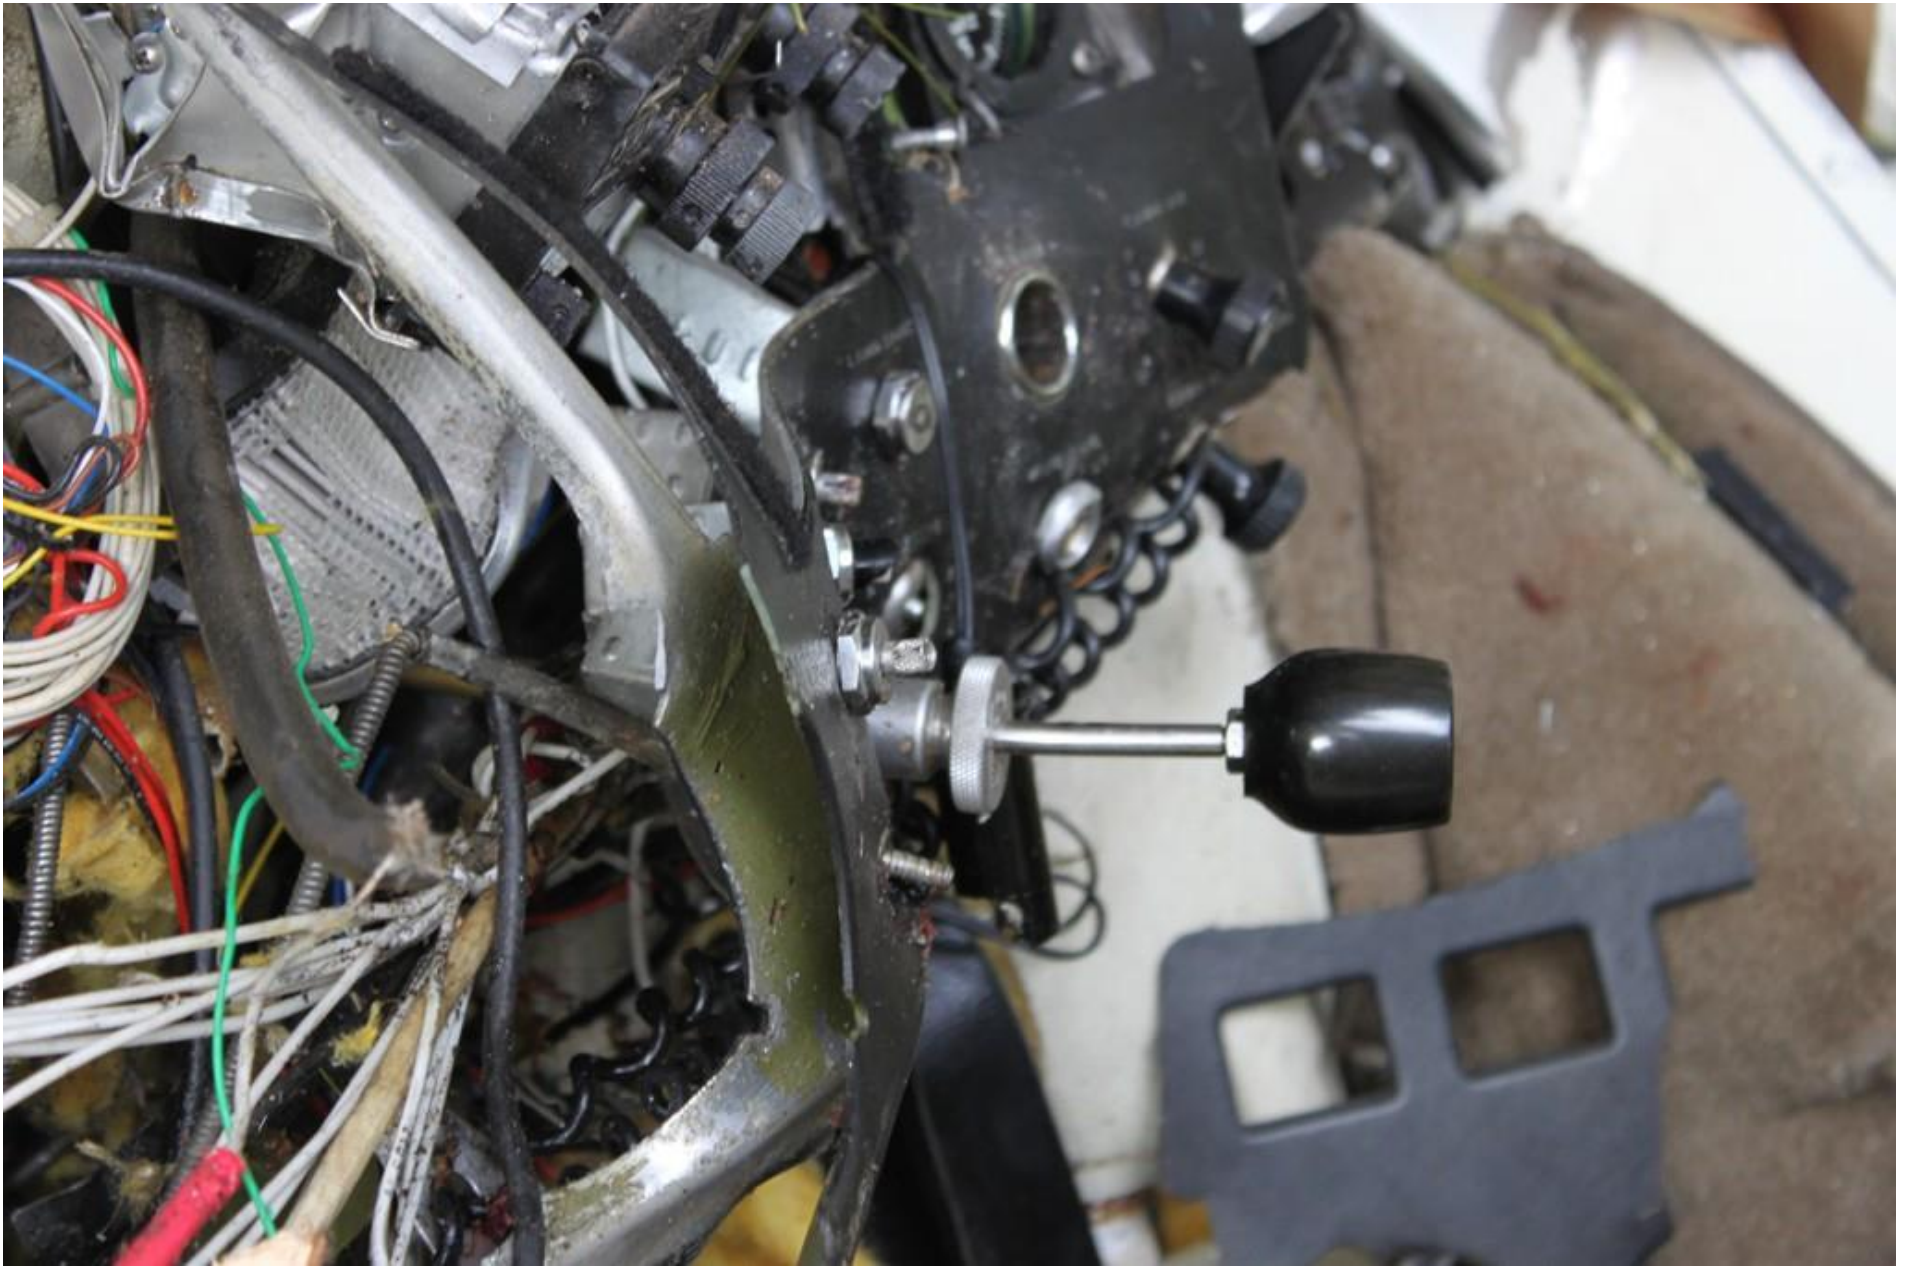
Photo 4 - NTSB Digital Photograph. View of the Throttle Control Extended 1.75 inches

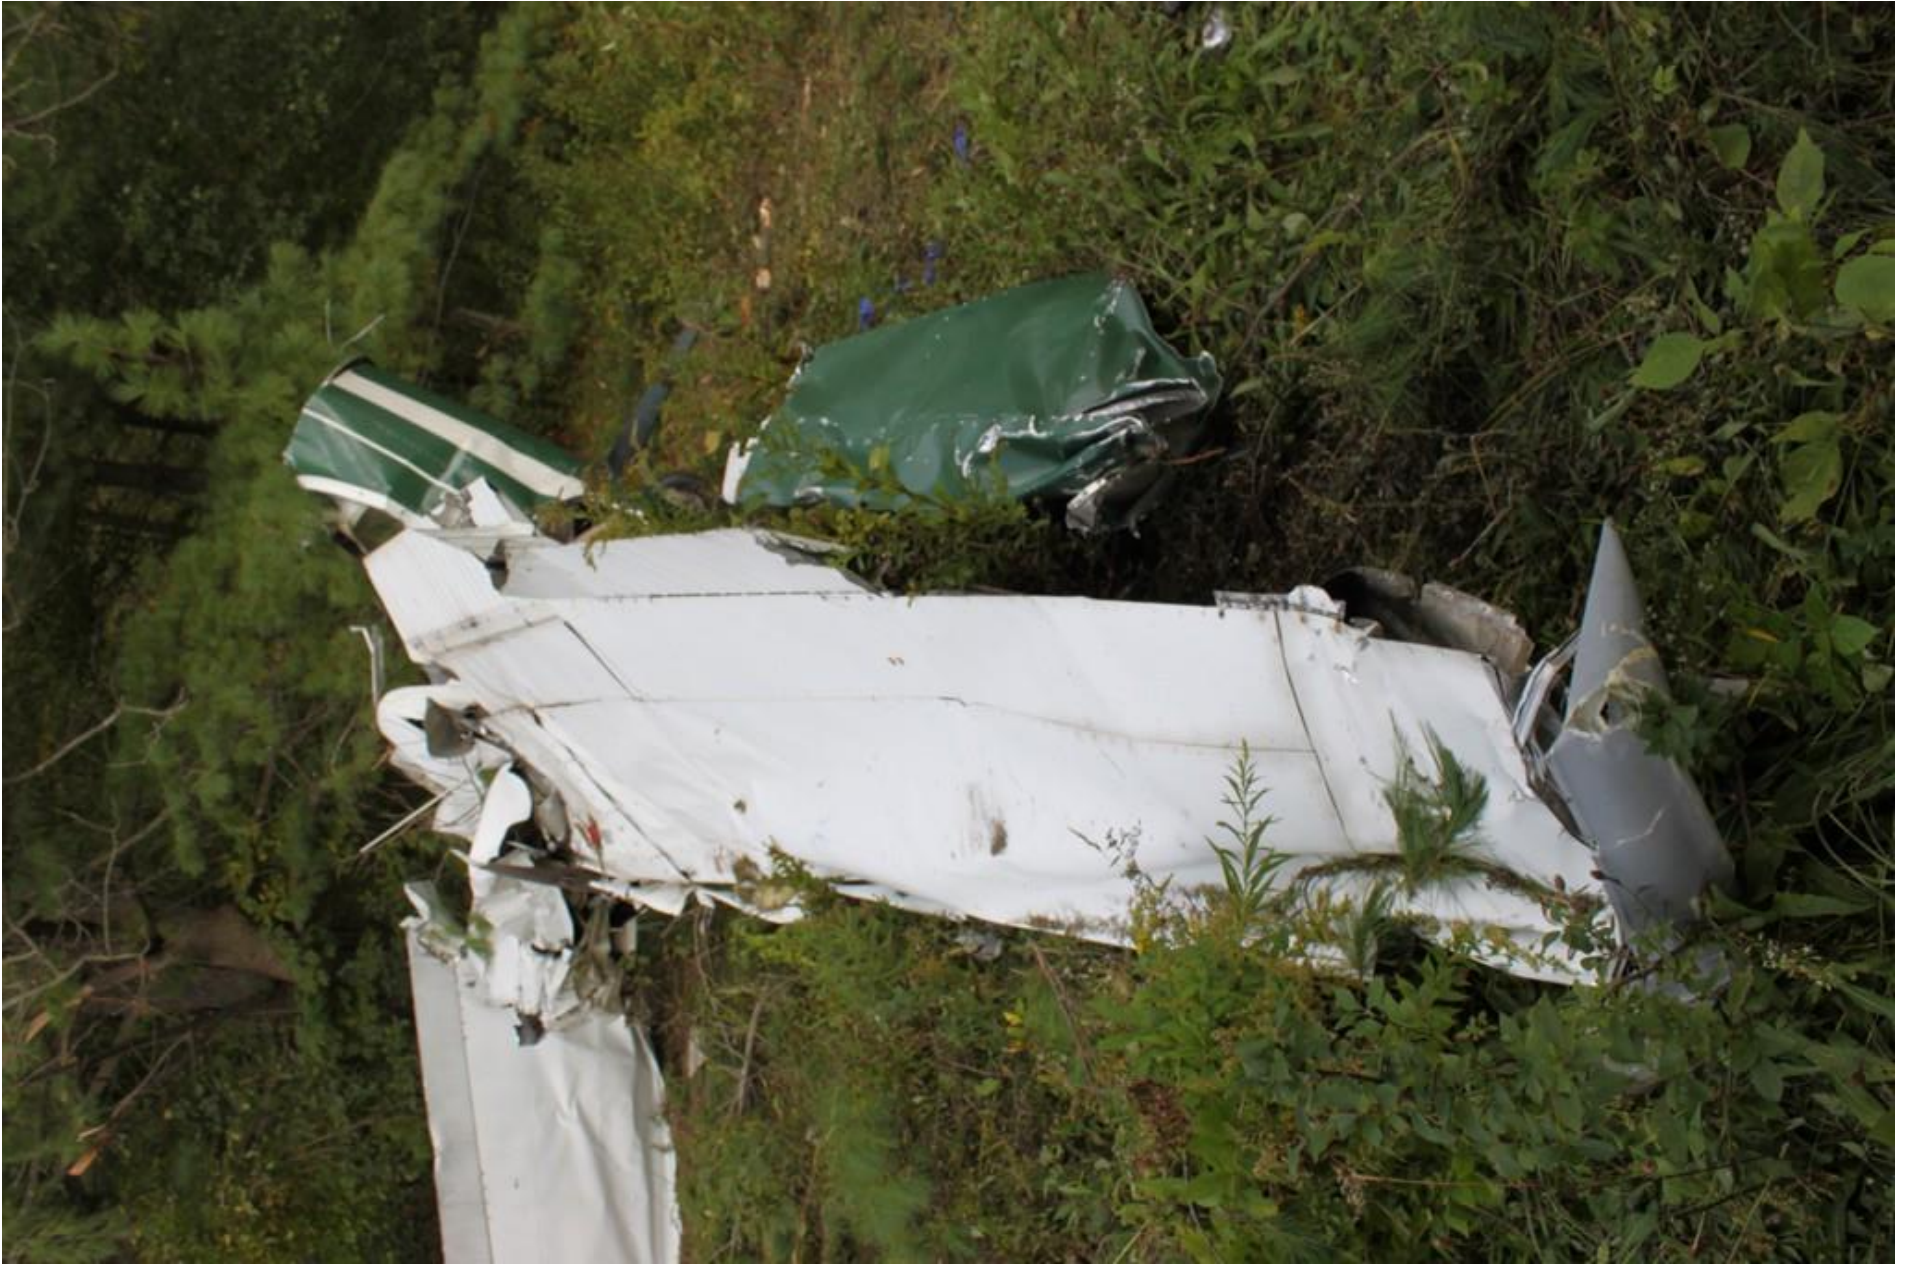
Photo 5 - NTSB Digital Photograph. View of the Left Wing

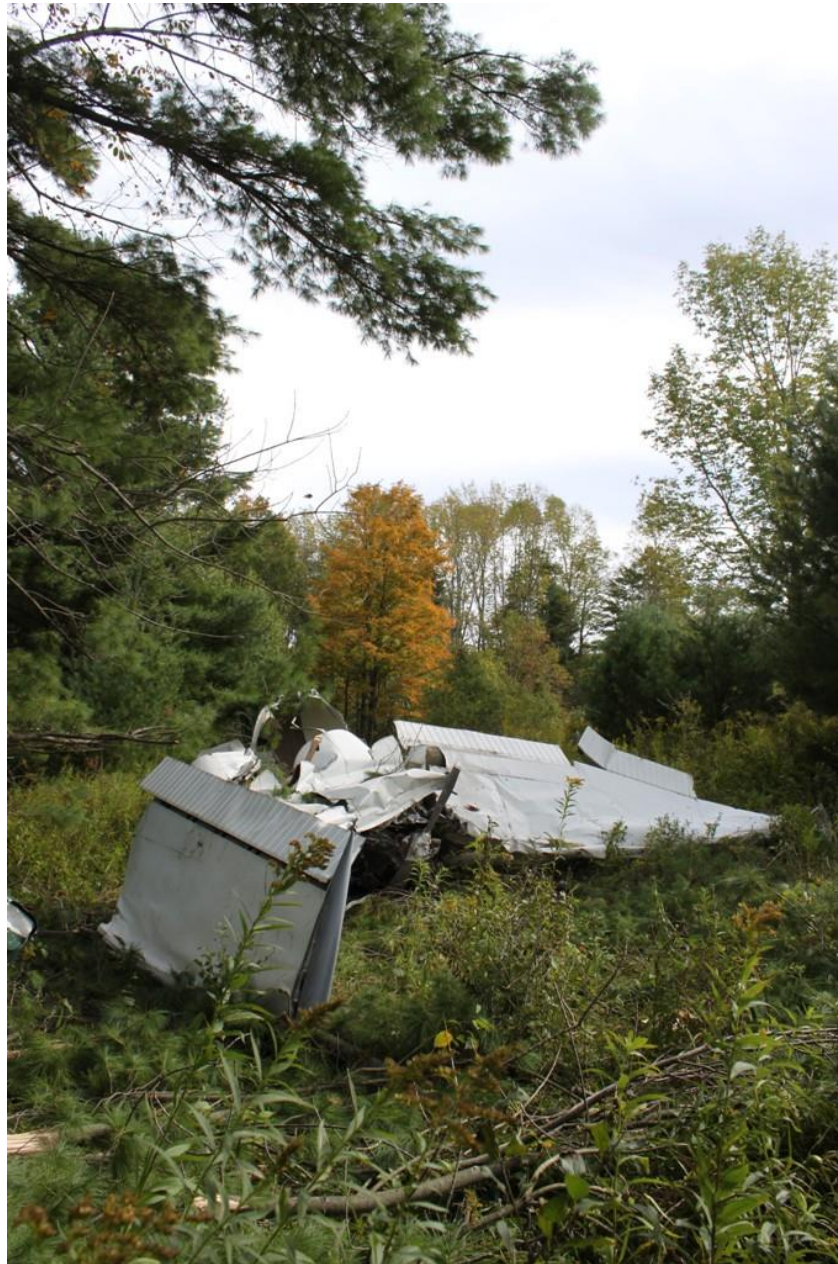
Photo 6 - NTSB Digital Photograph. Right Forward Quartering View of the Main Wreckage

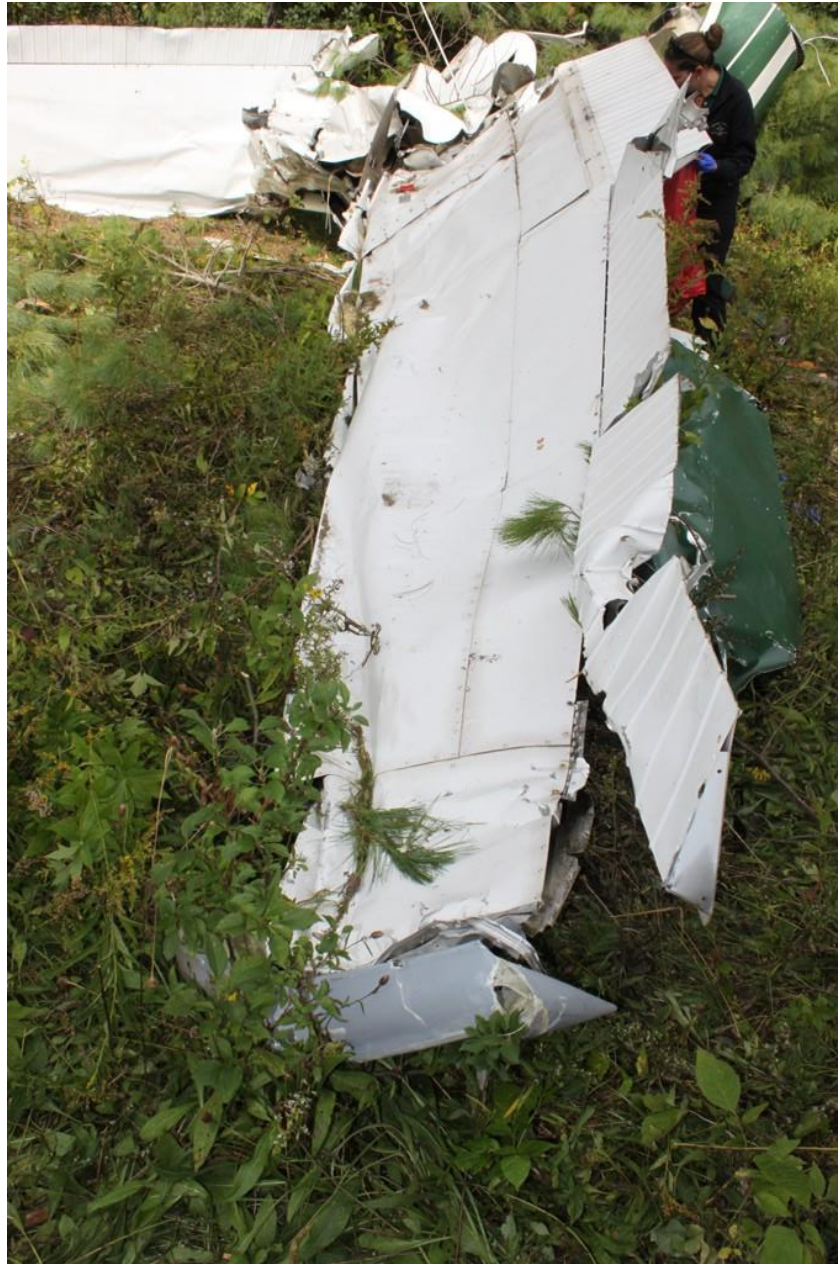
Photo 7 - NTSB Digital Photograph. Left Side View of the Left Wing

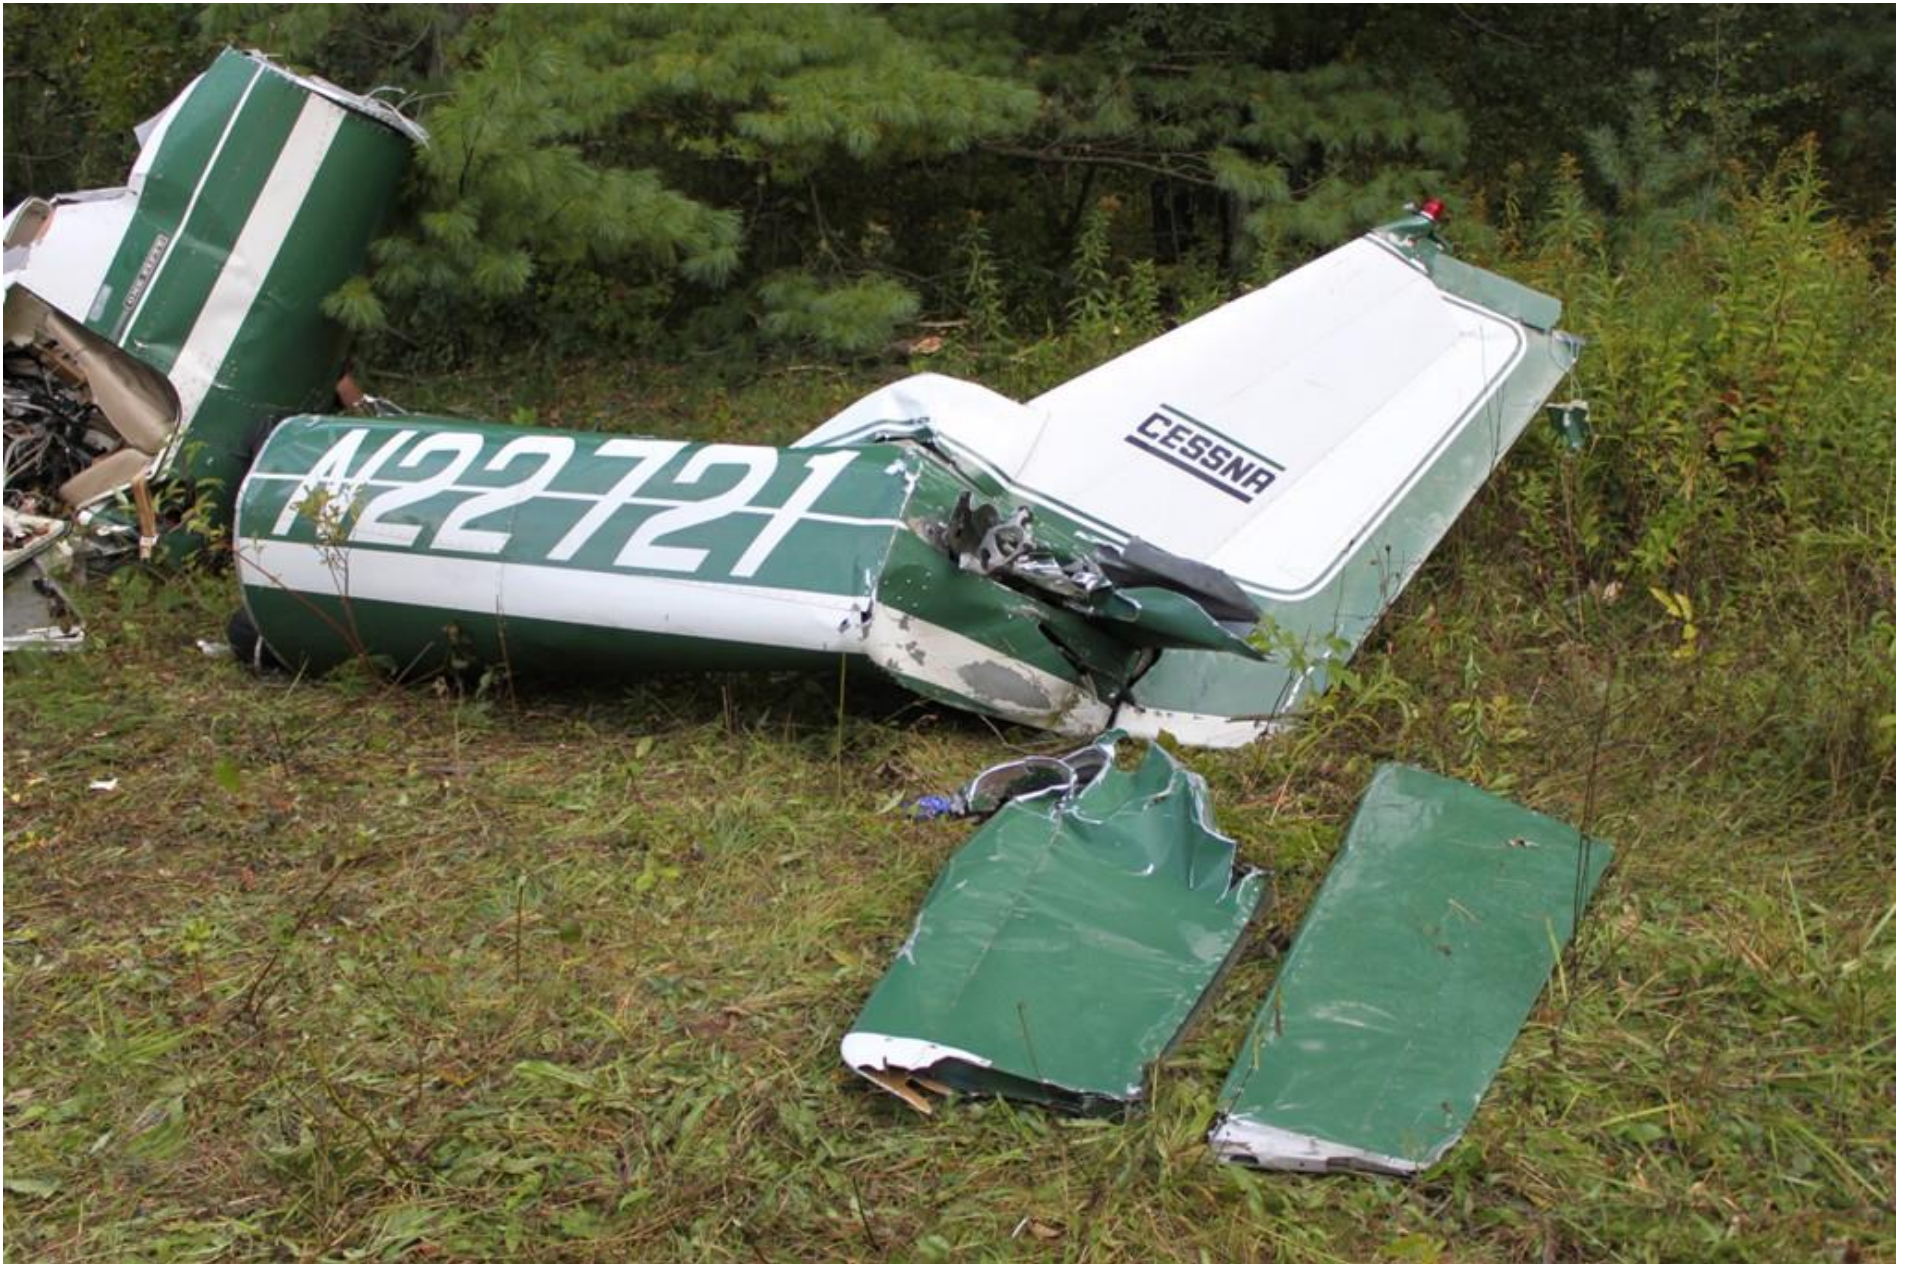
Photo 8 - NTSB Digital Photograph. Left Side View of the Empennage

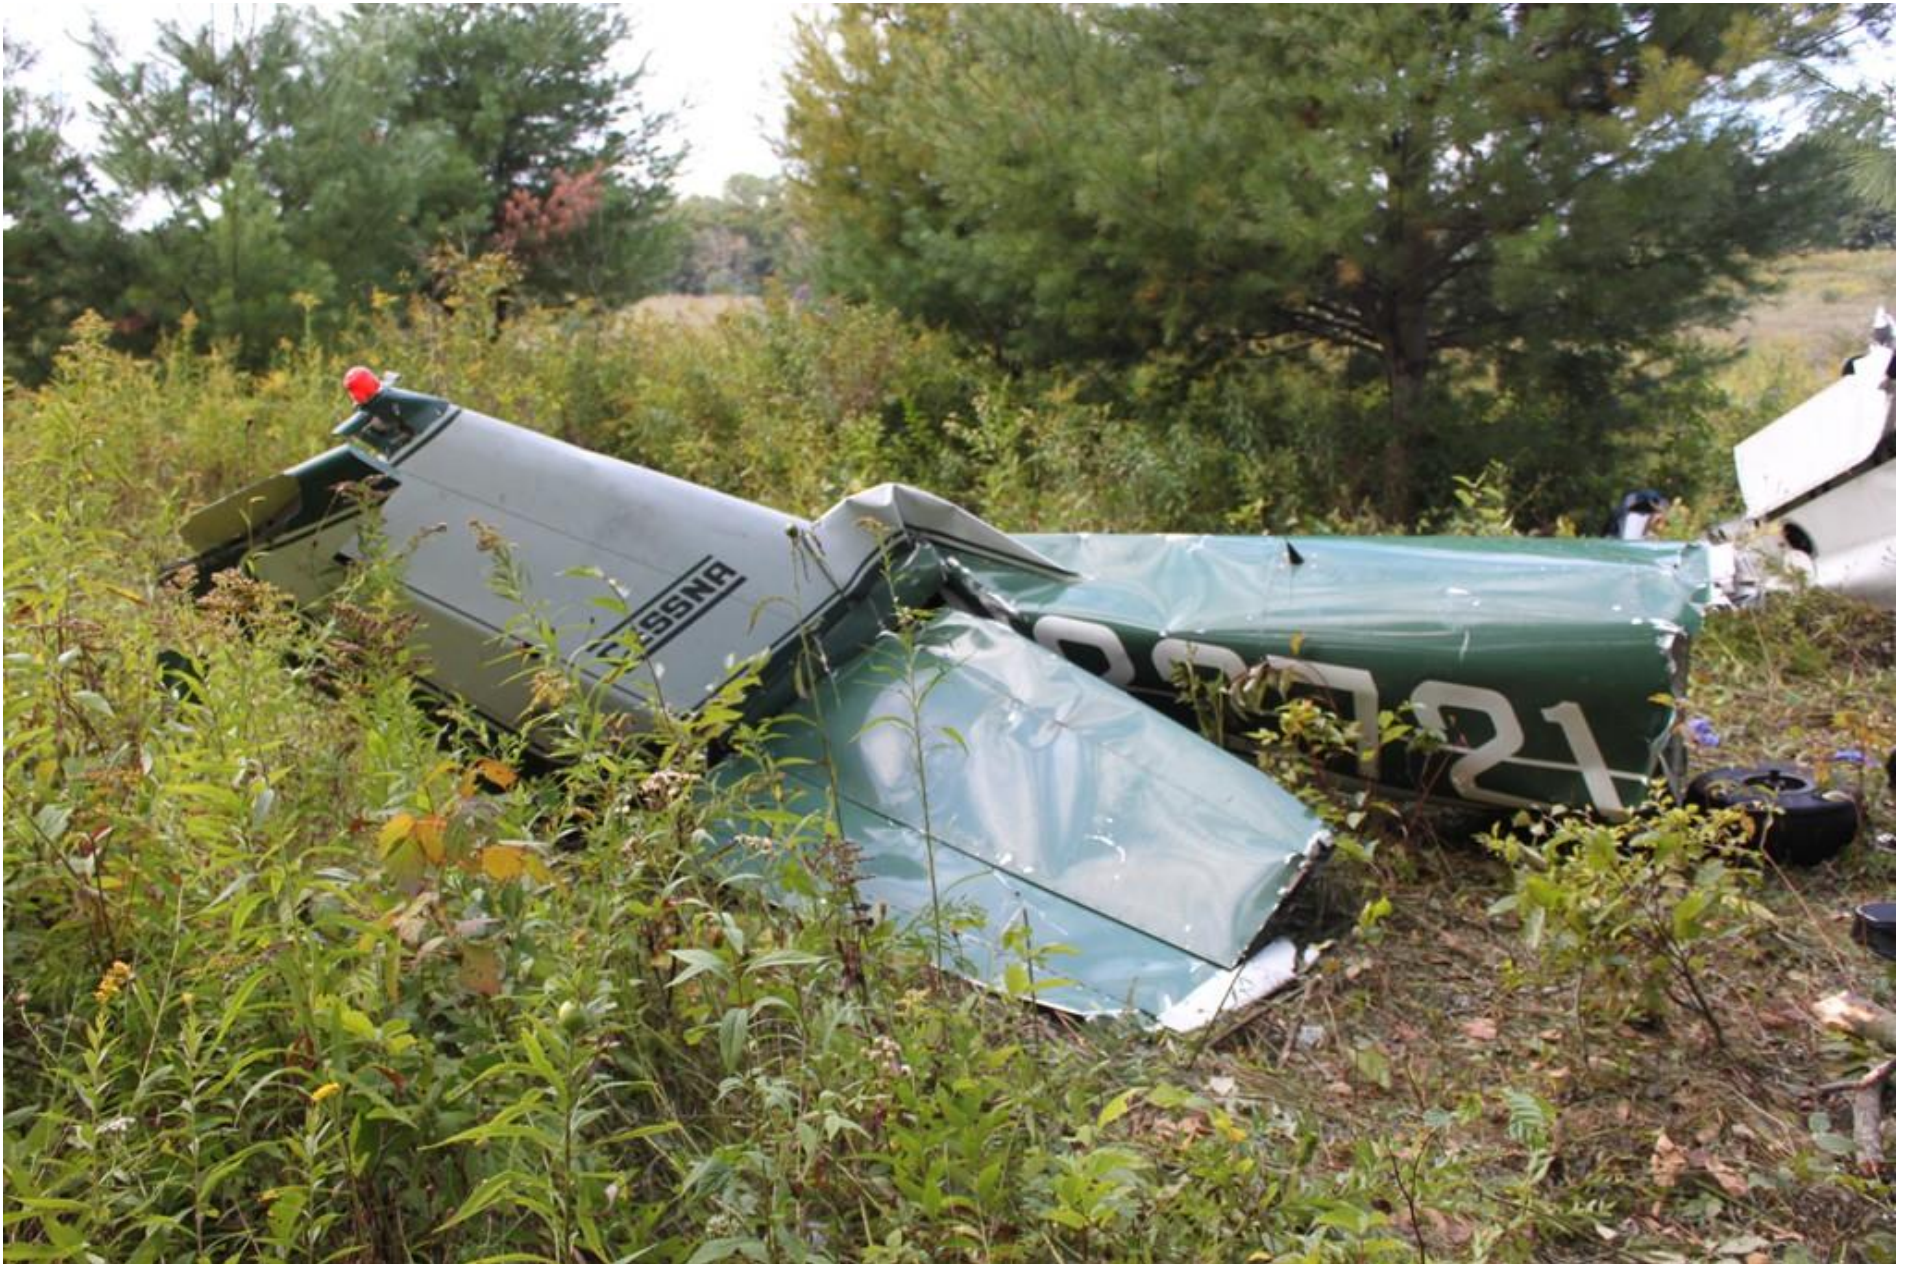
Photo 9 – NTSB Digital Photograph. Right Side View of the Empennage

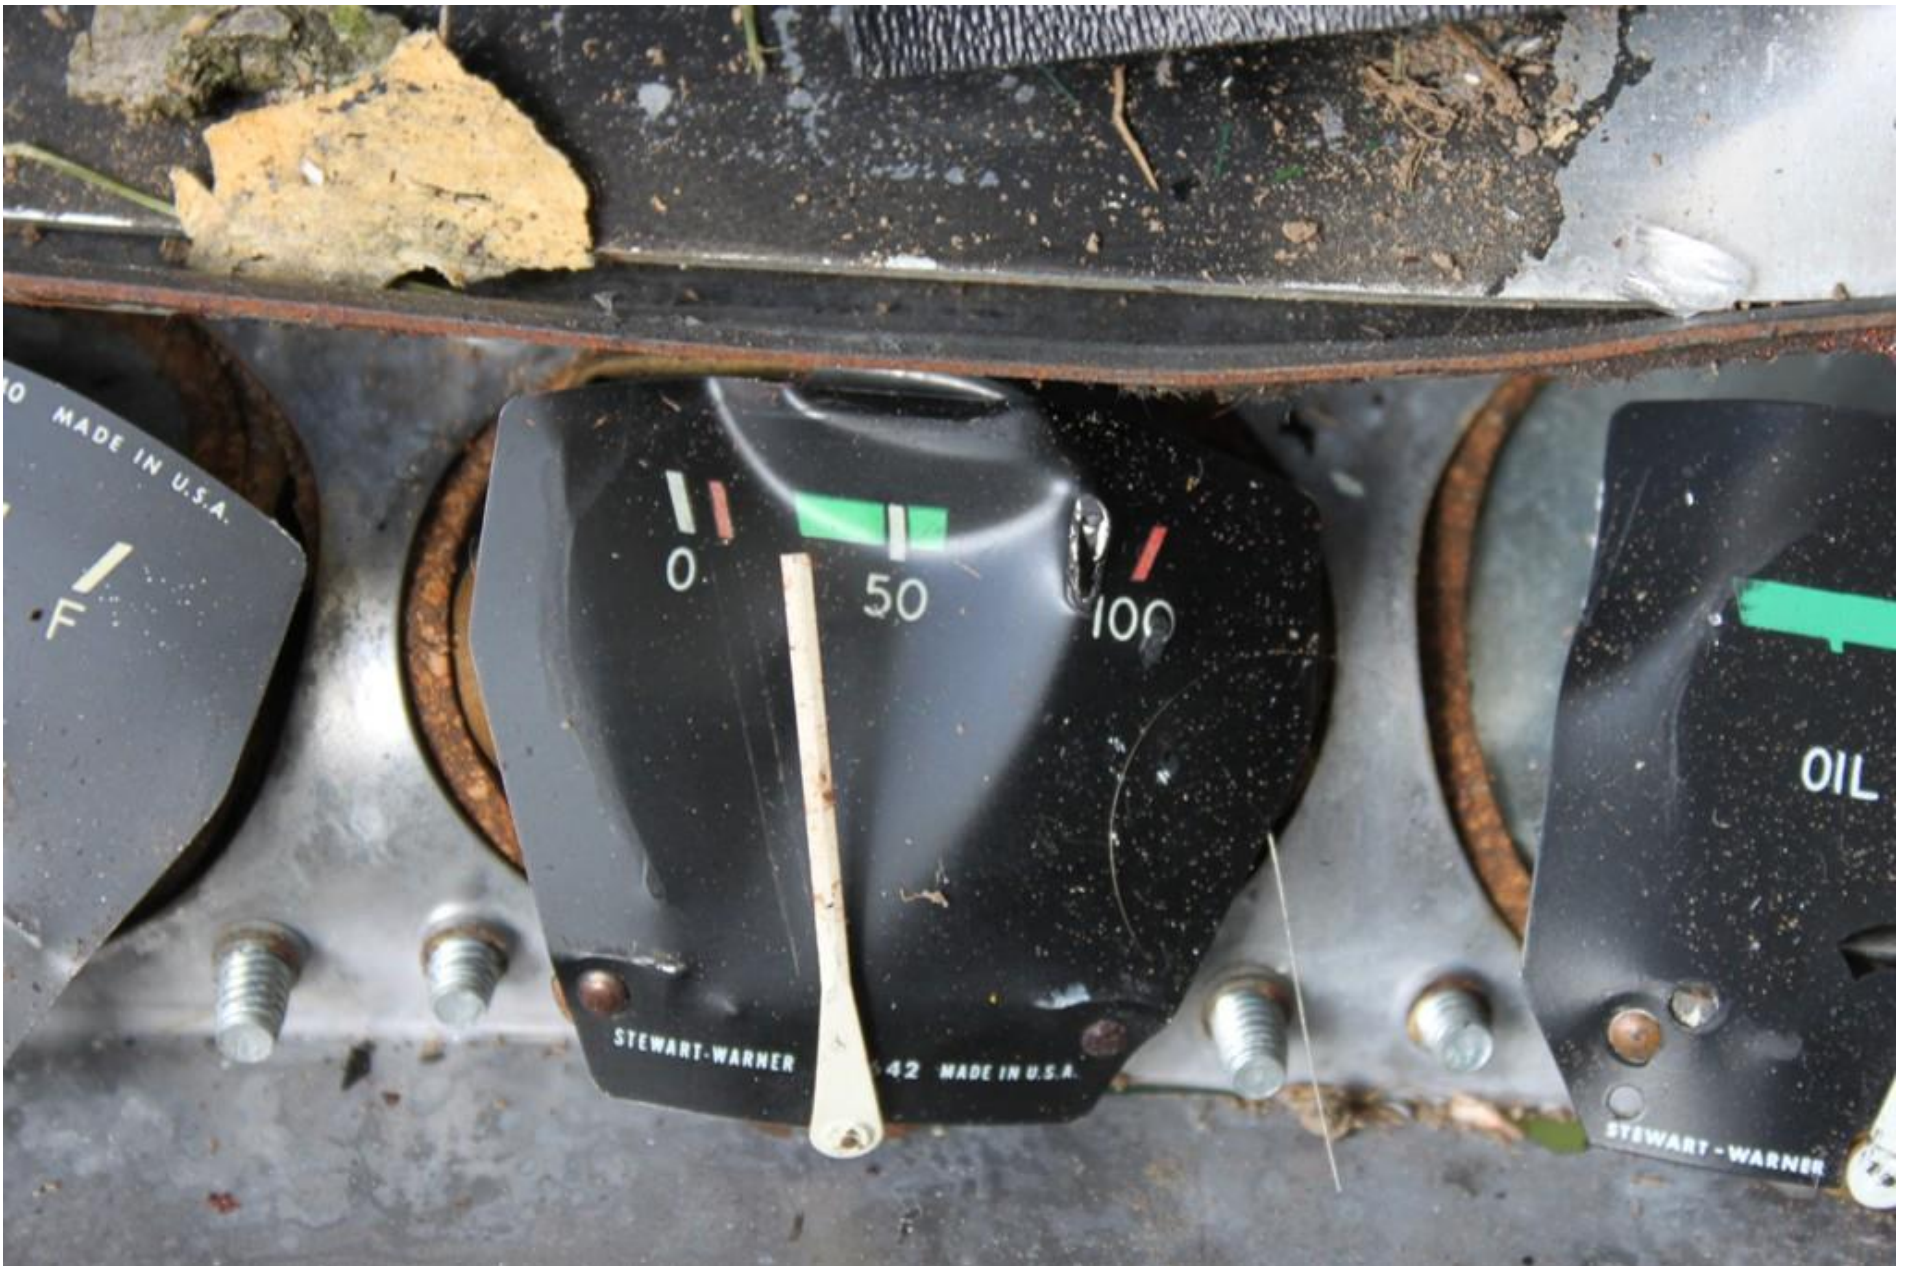
Photo 10 - NTSB Digital Photograph. View of the Oil Pressure Gauge
