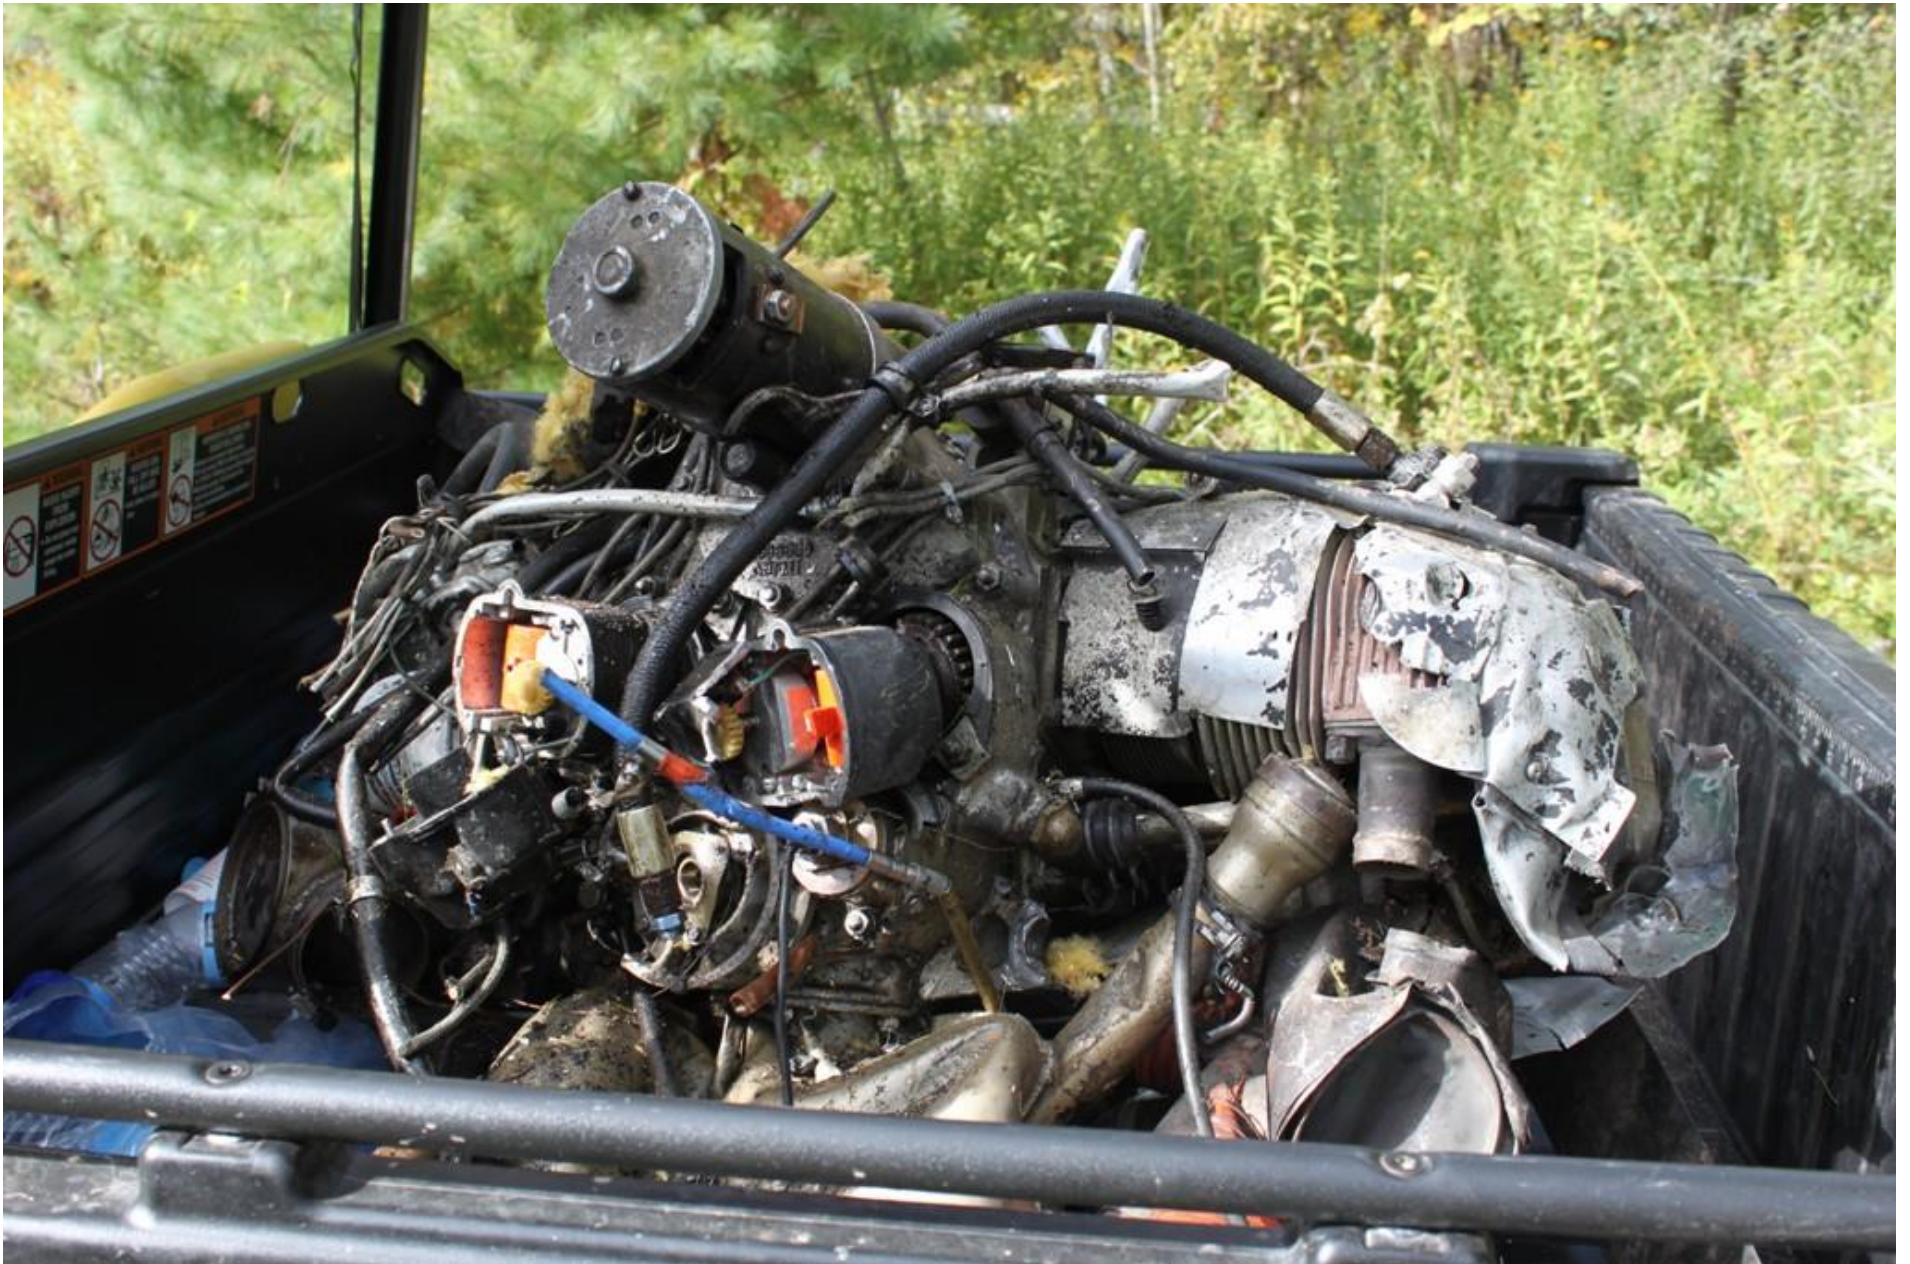
Photo 11 - NTSB Digital Photograph. View of the Aft Side of the Engine Assembly

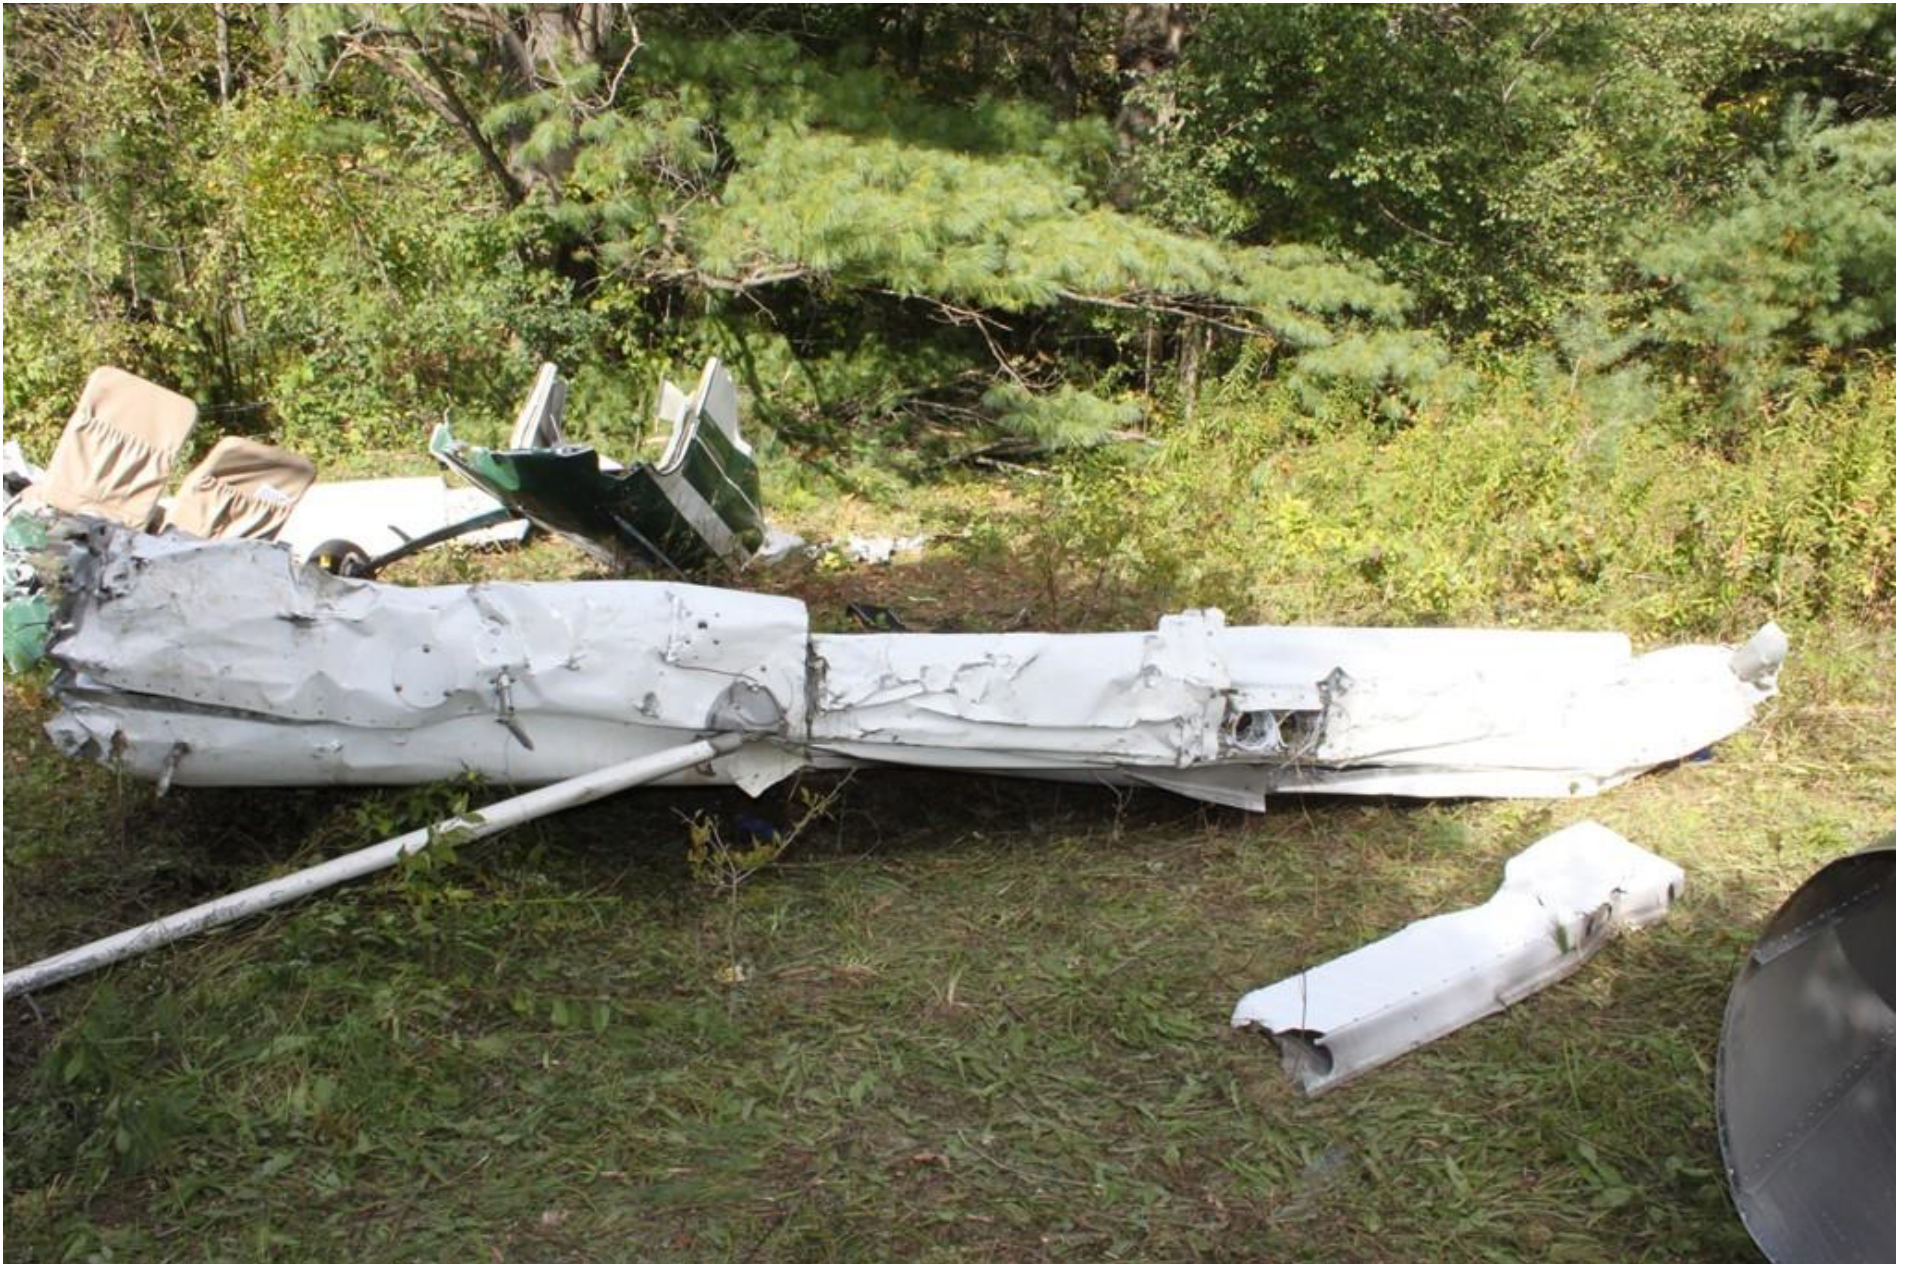
Photo 12 - NTSB Digital Photograph. Forward View of the Left Wing. Note the Full Span Leading Edge Crushing

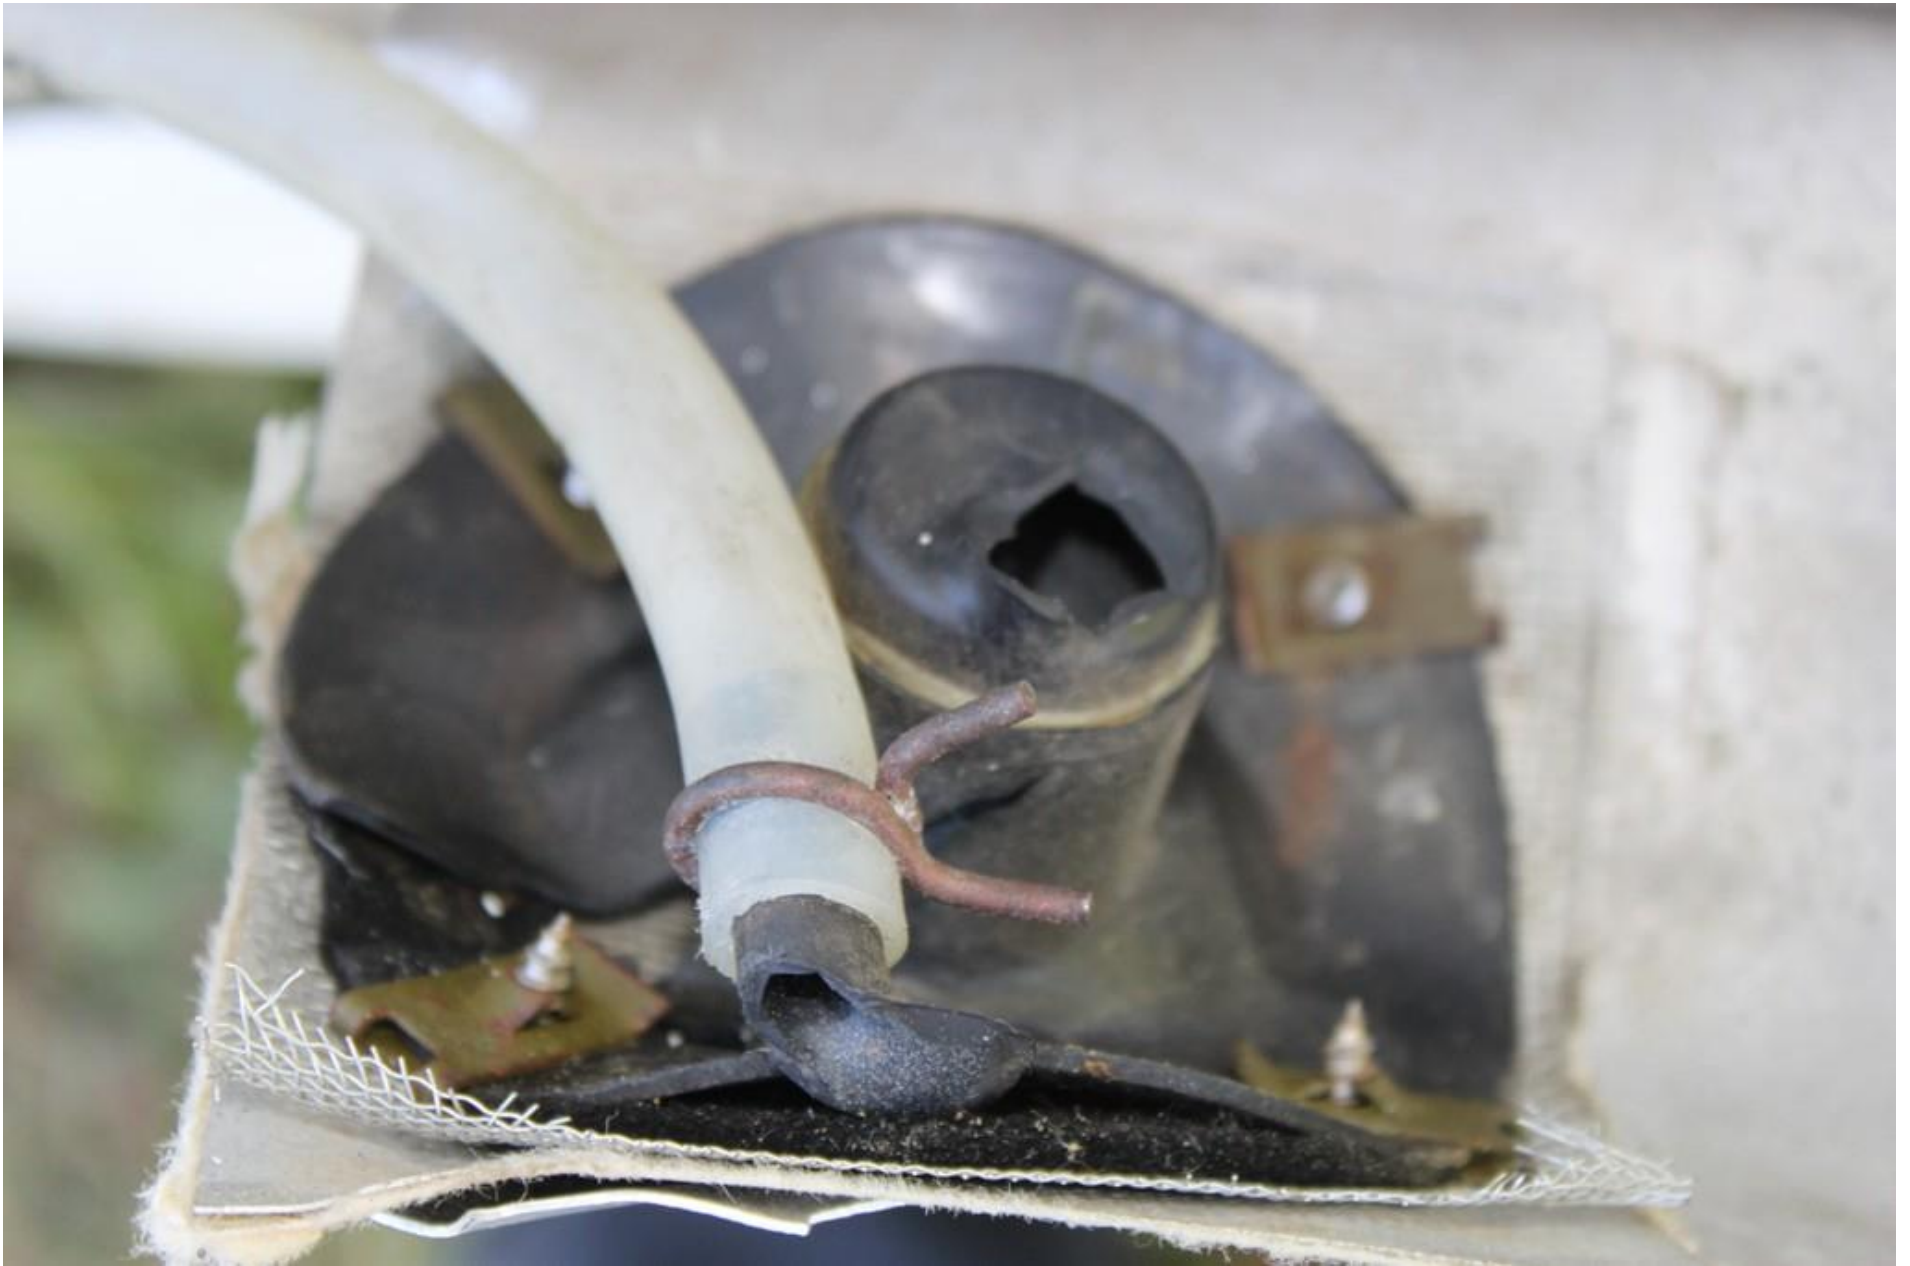
Photo 13 - NTSB Digital Photograph. View of the Stall Warning Horn Housing

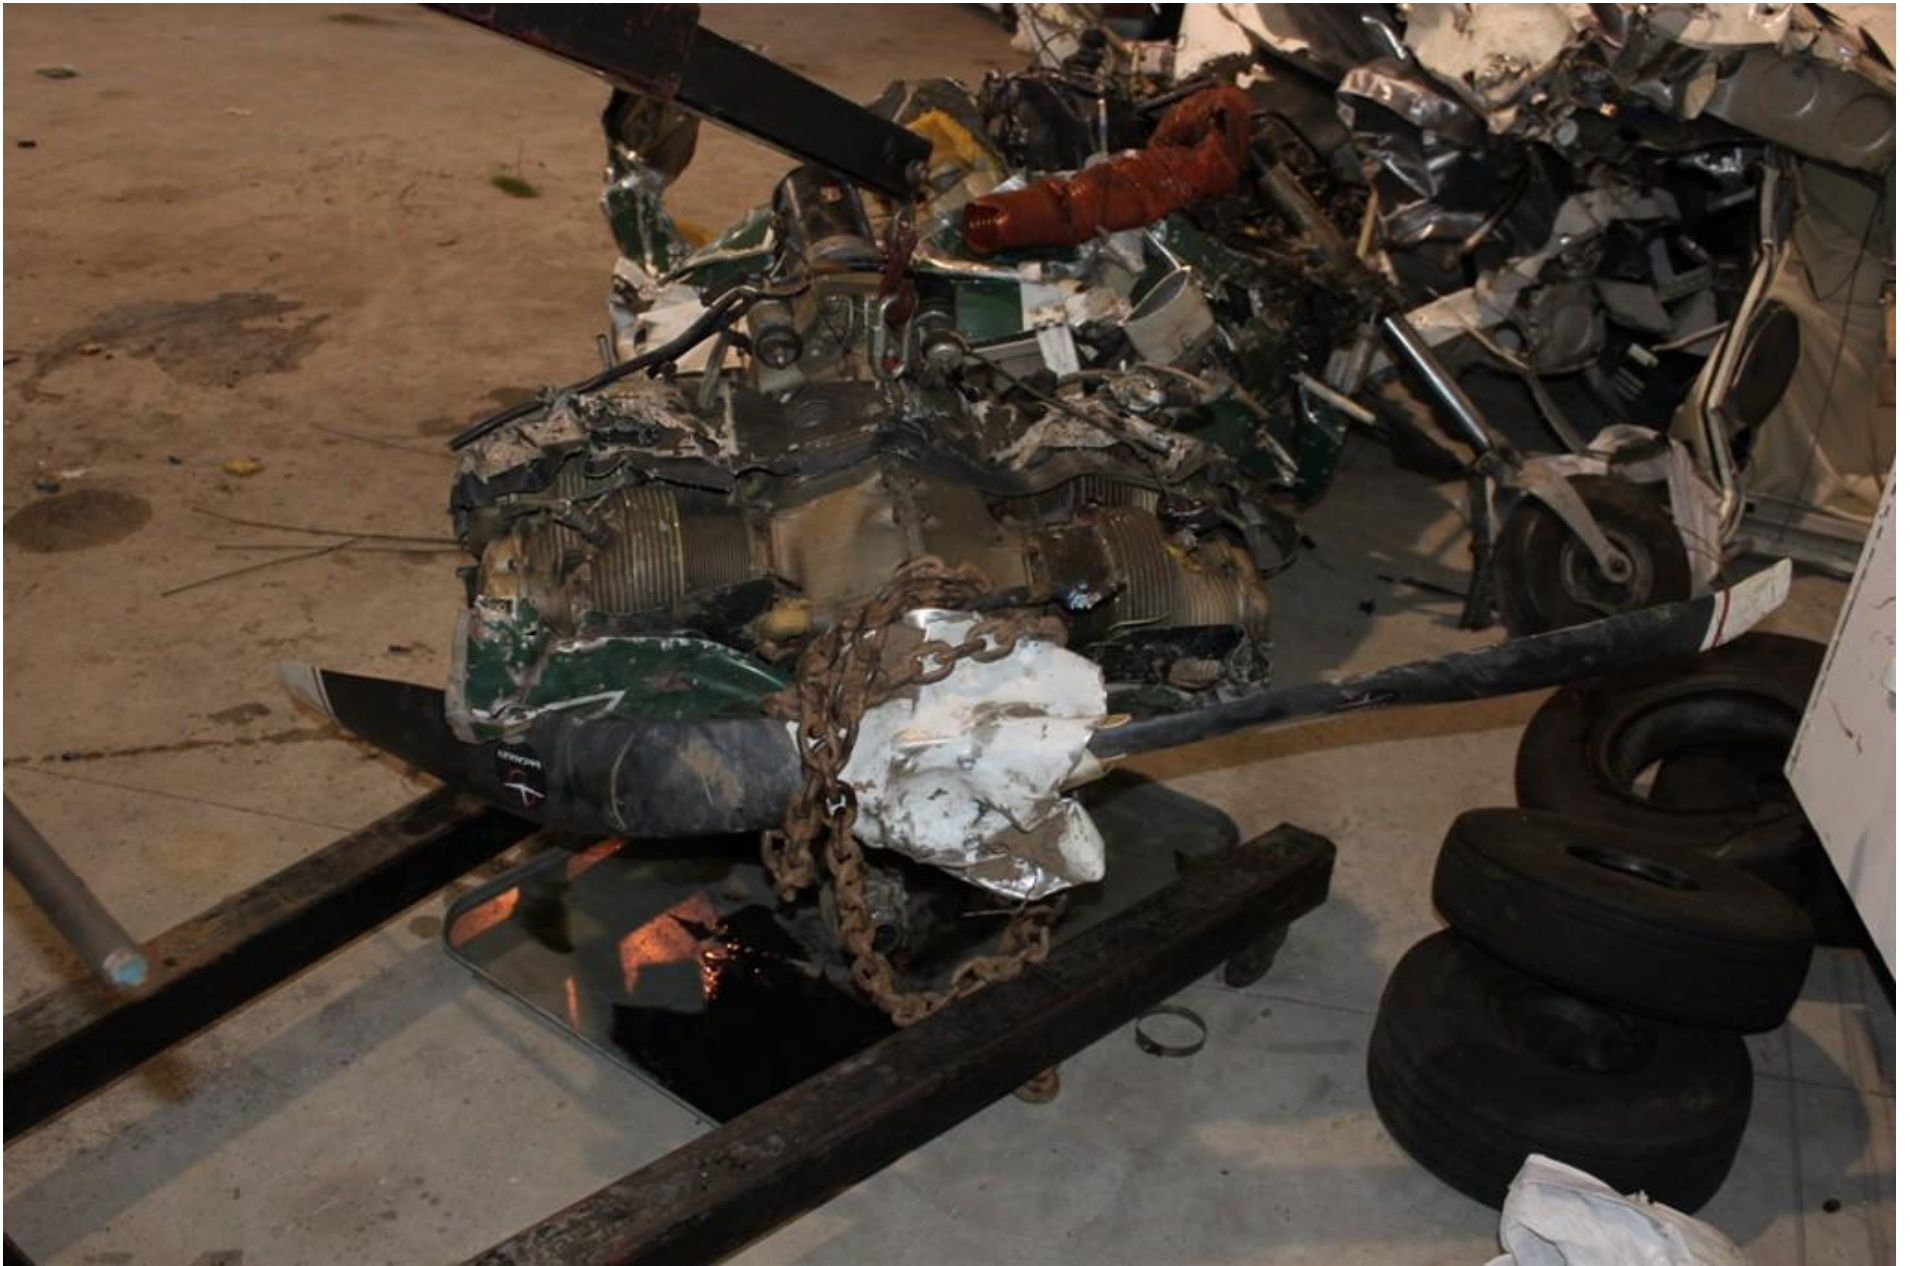
Photo 14 - NTSB Digital Photograph. Forward View of the Engine Assembly with Attached Propeller

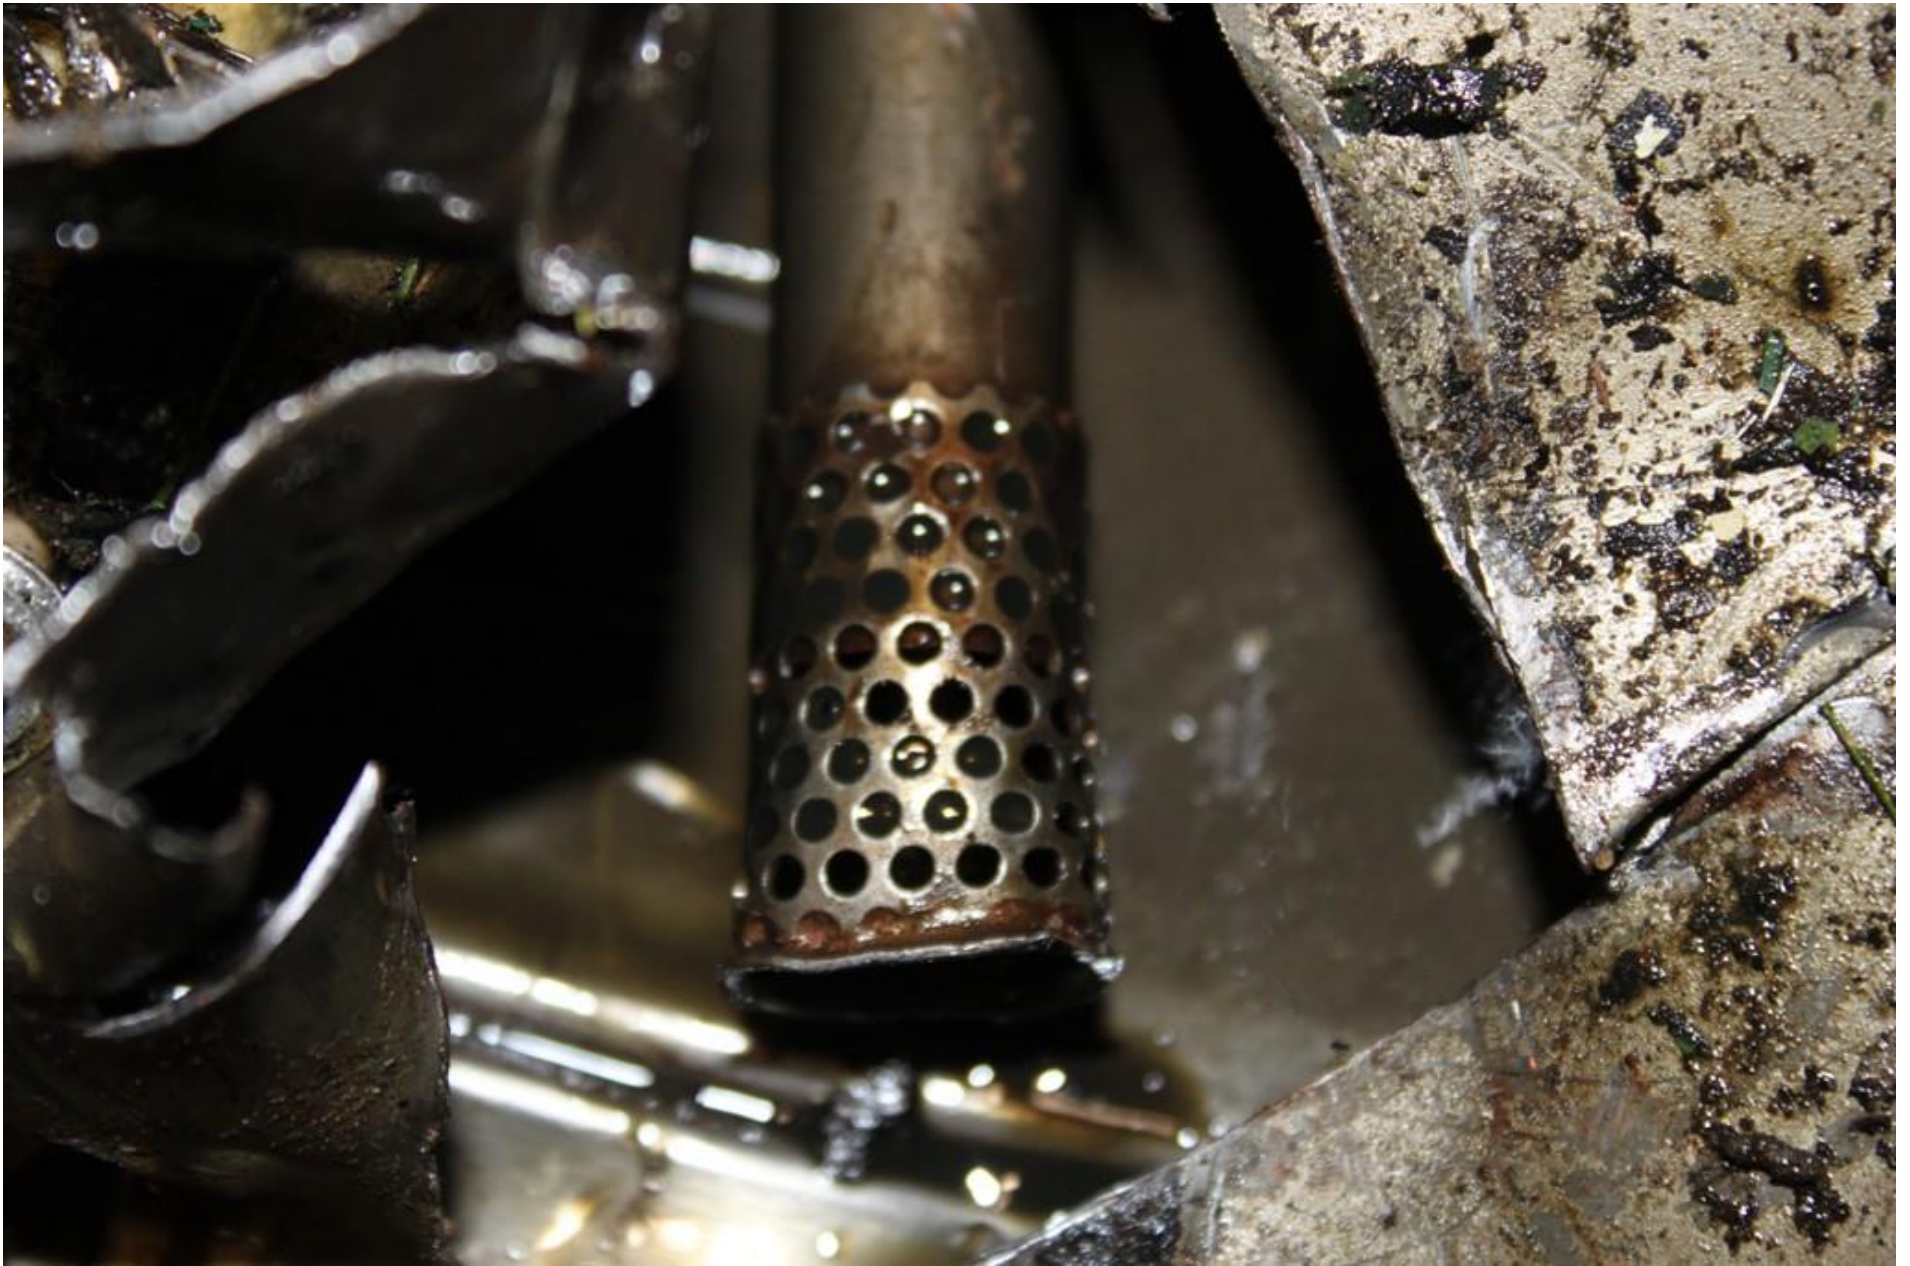
Photo 15 - NTSB Digital Photograph. View of the Oil Pickup Screen

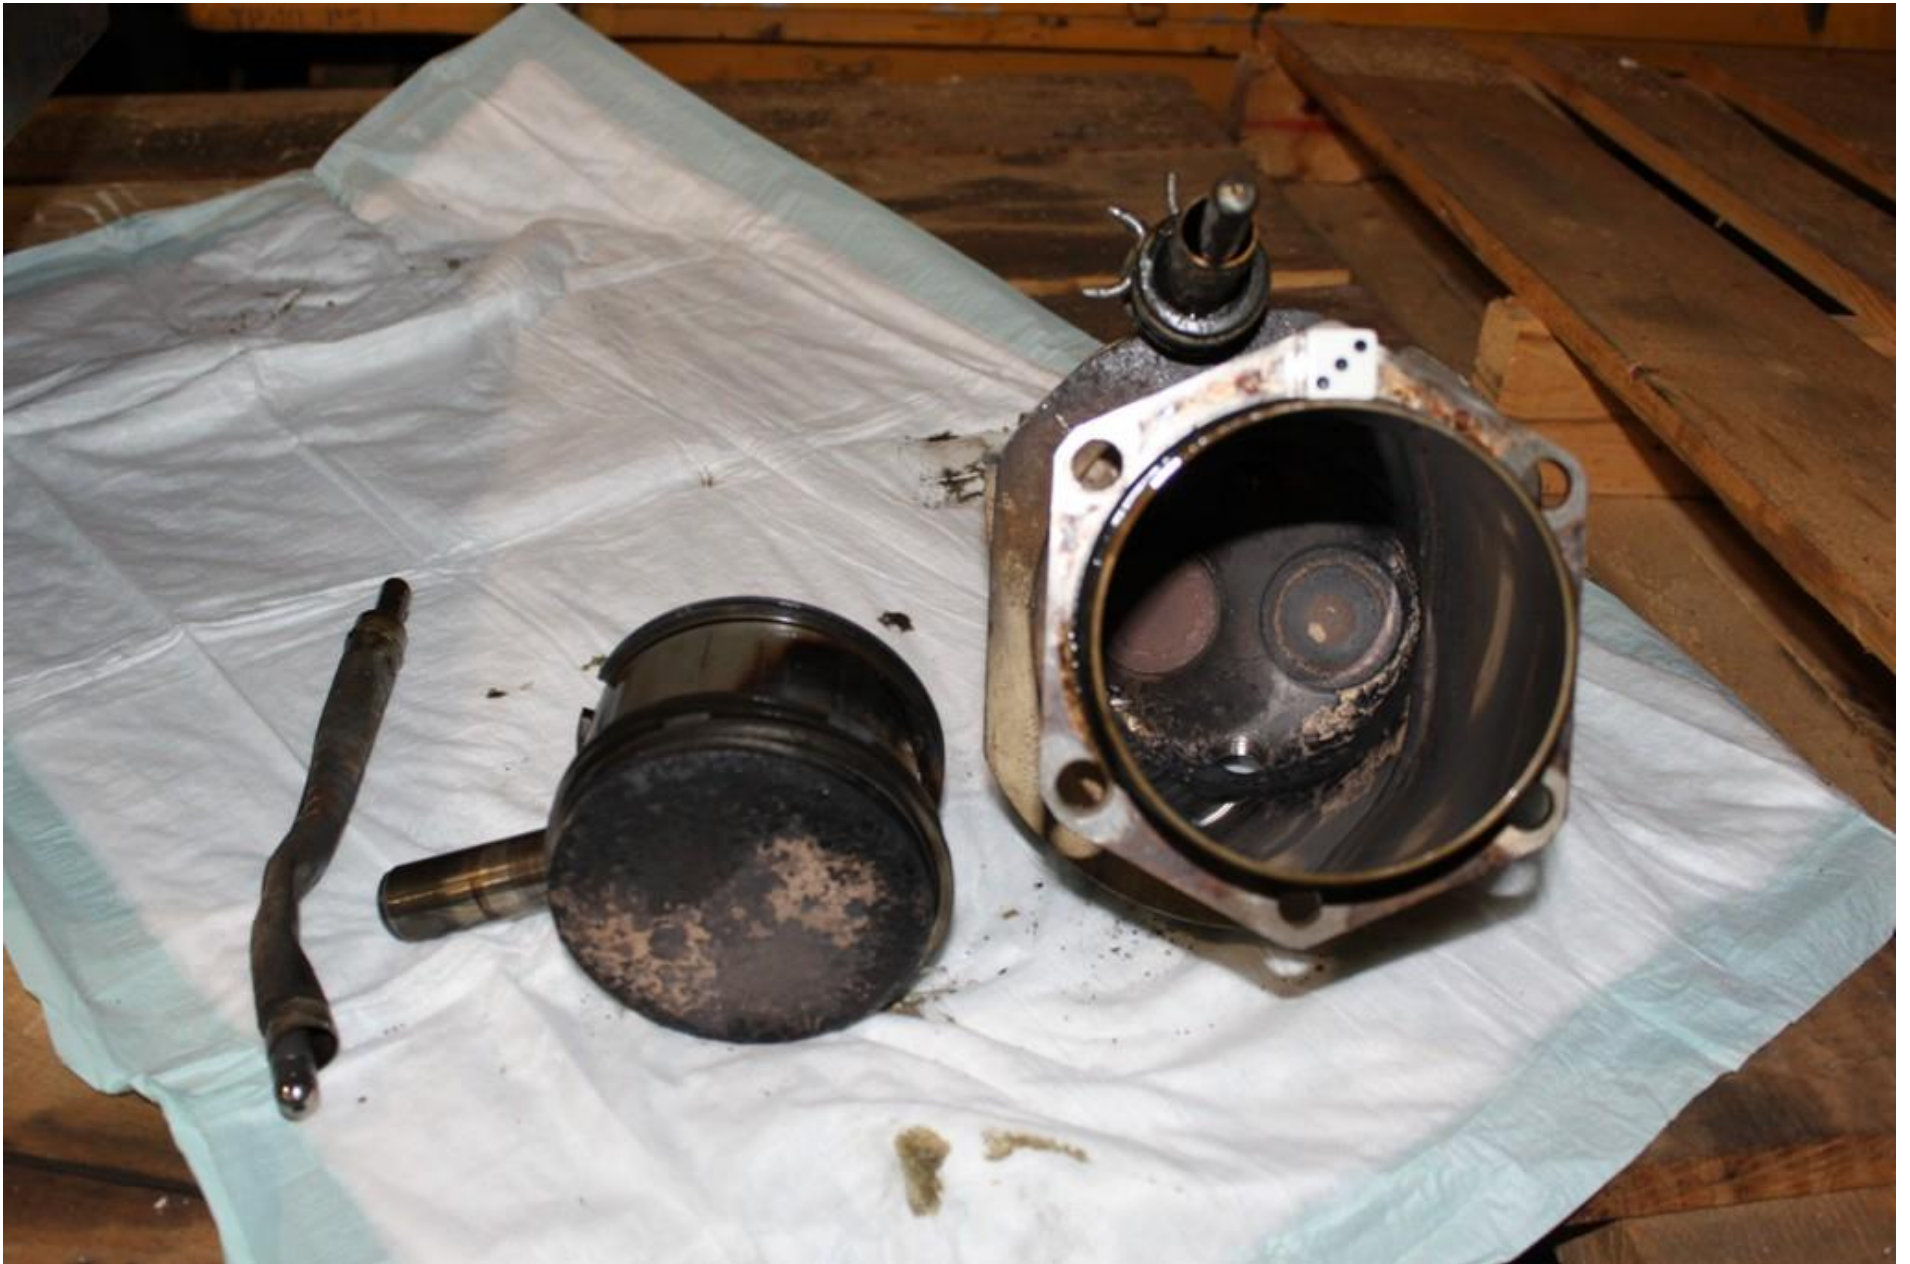
Photo 16 - NTSB Digital Photograph. View of the No. 3 Cylinder and Piston

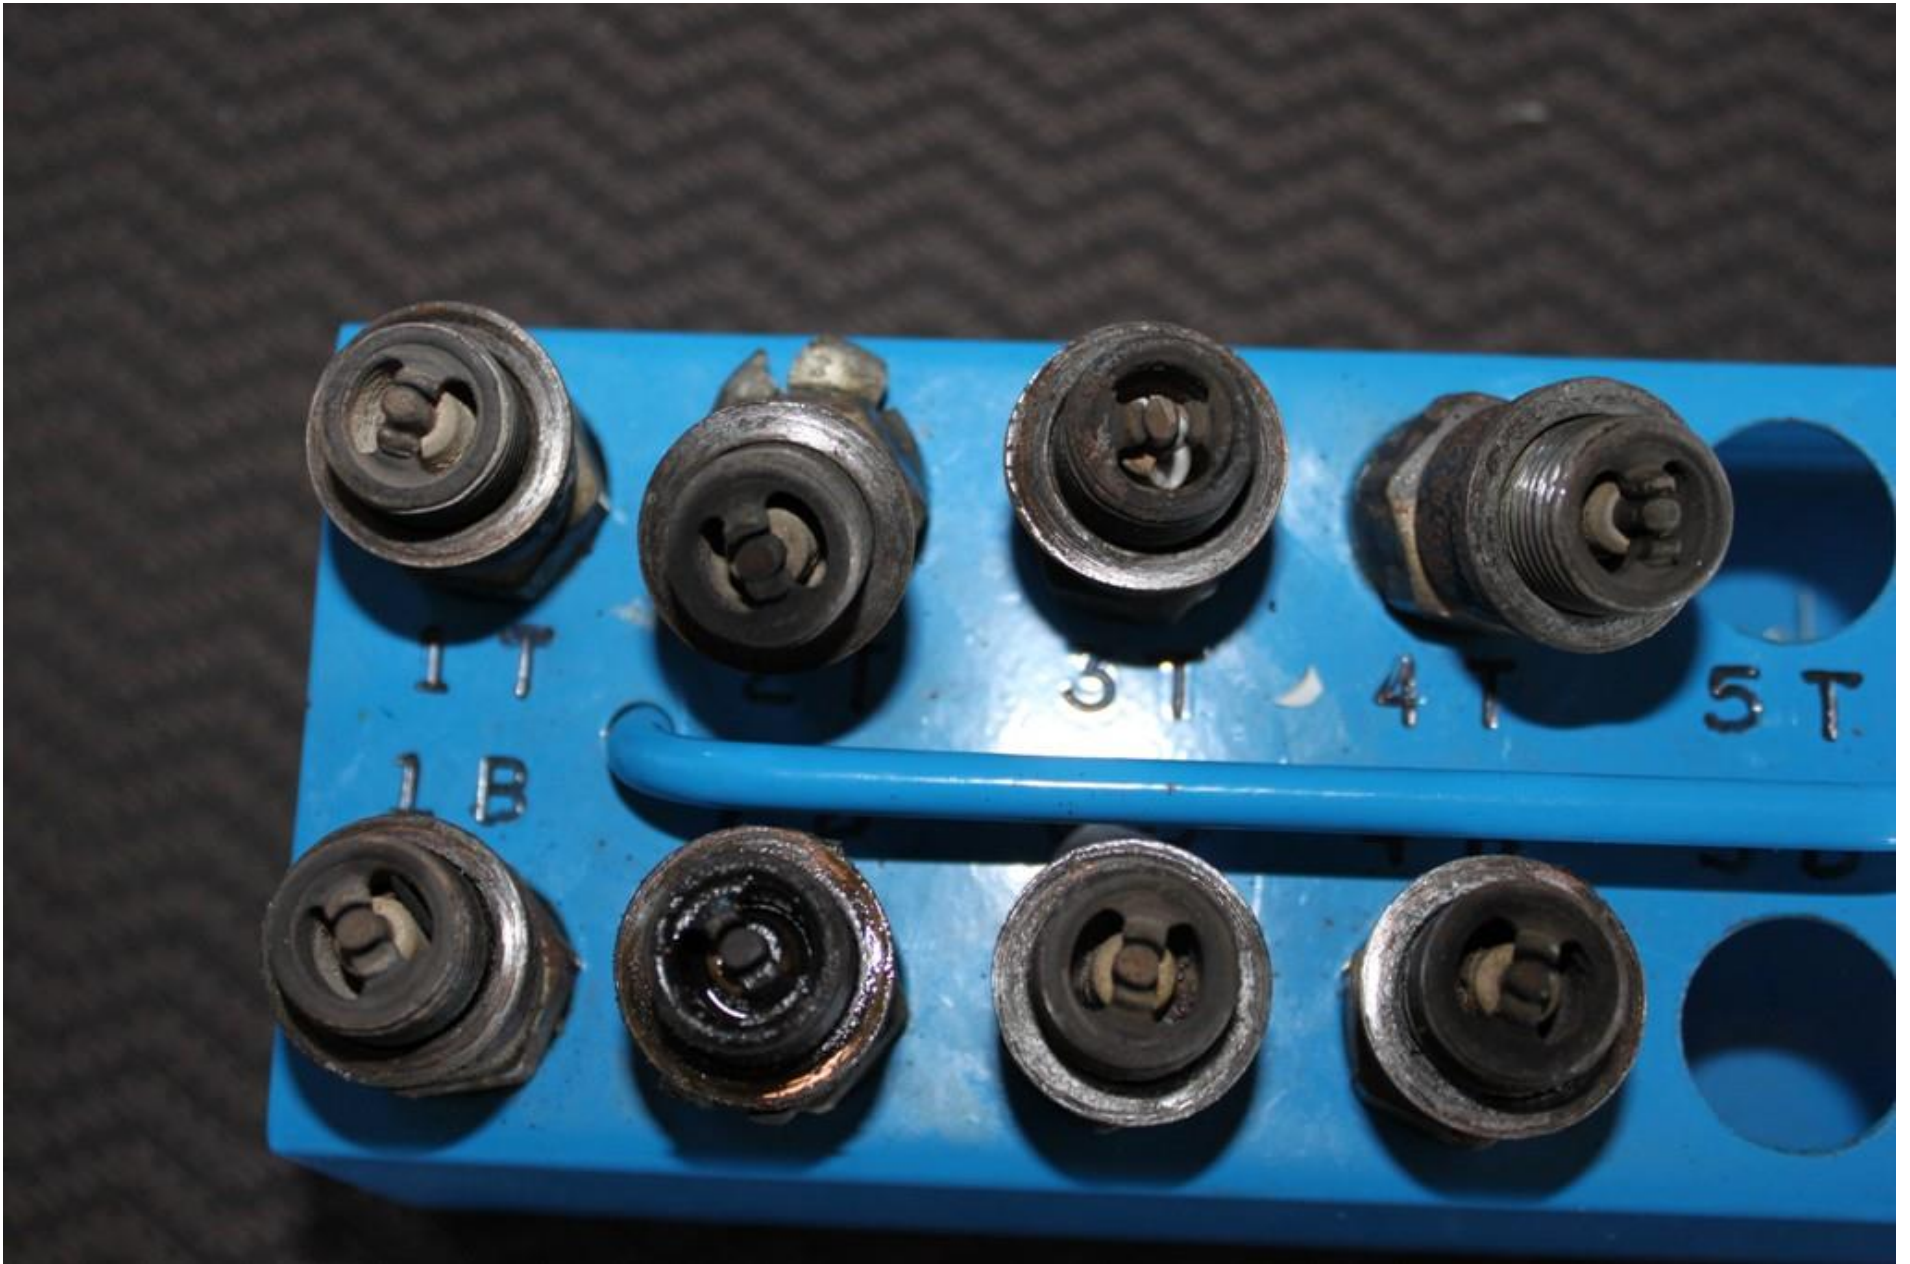
Photo 17 - NTSB Digital Photograph. View of the Upper and Lower Spark Plugs

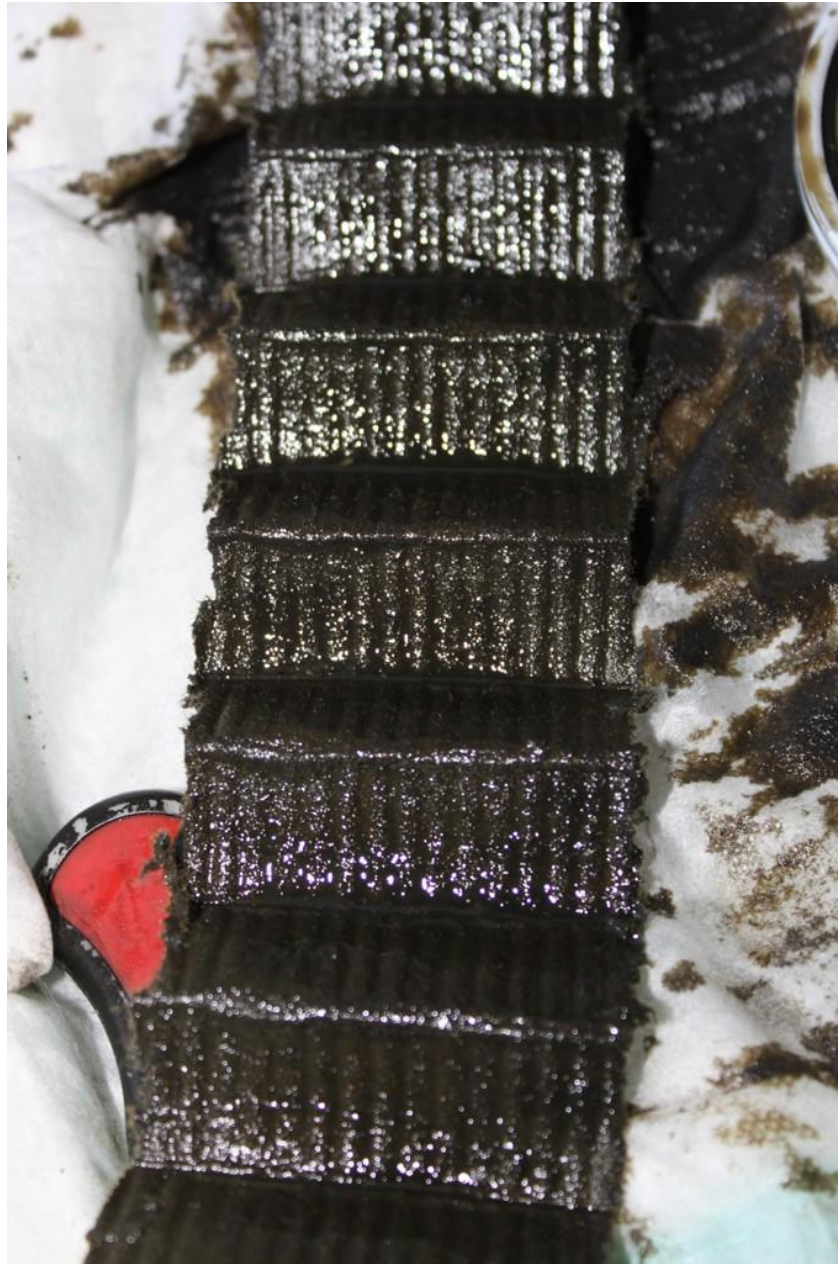
Photo 18 - NTSB Digital Photograph. View of the Oil Filter Element

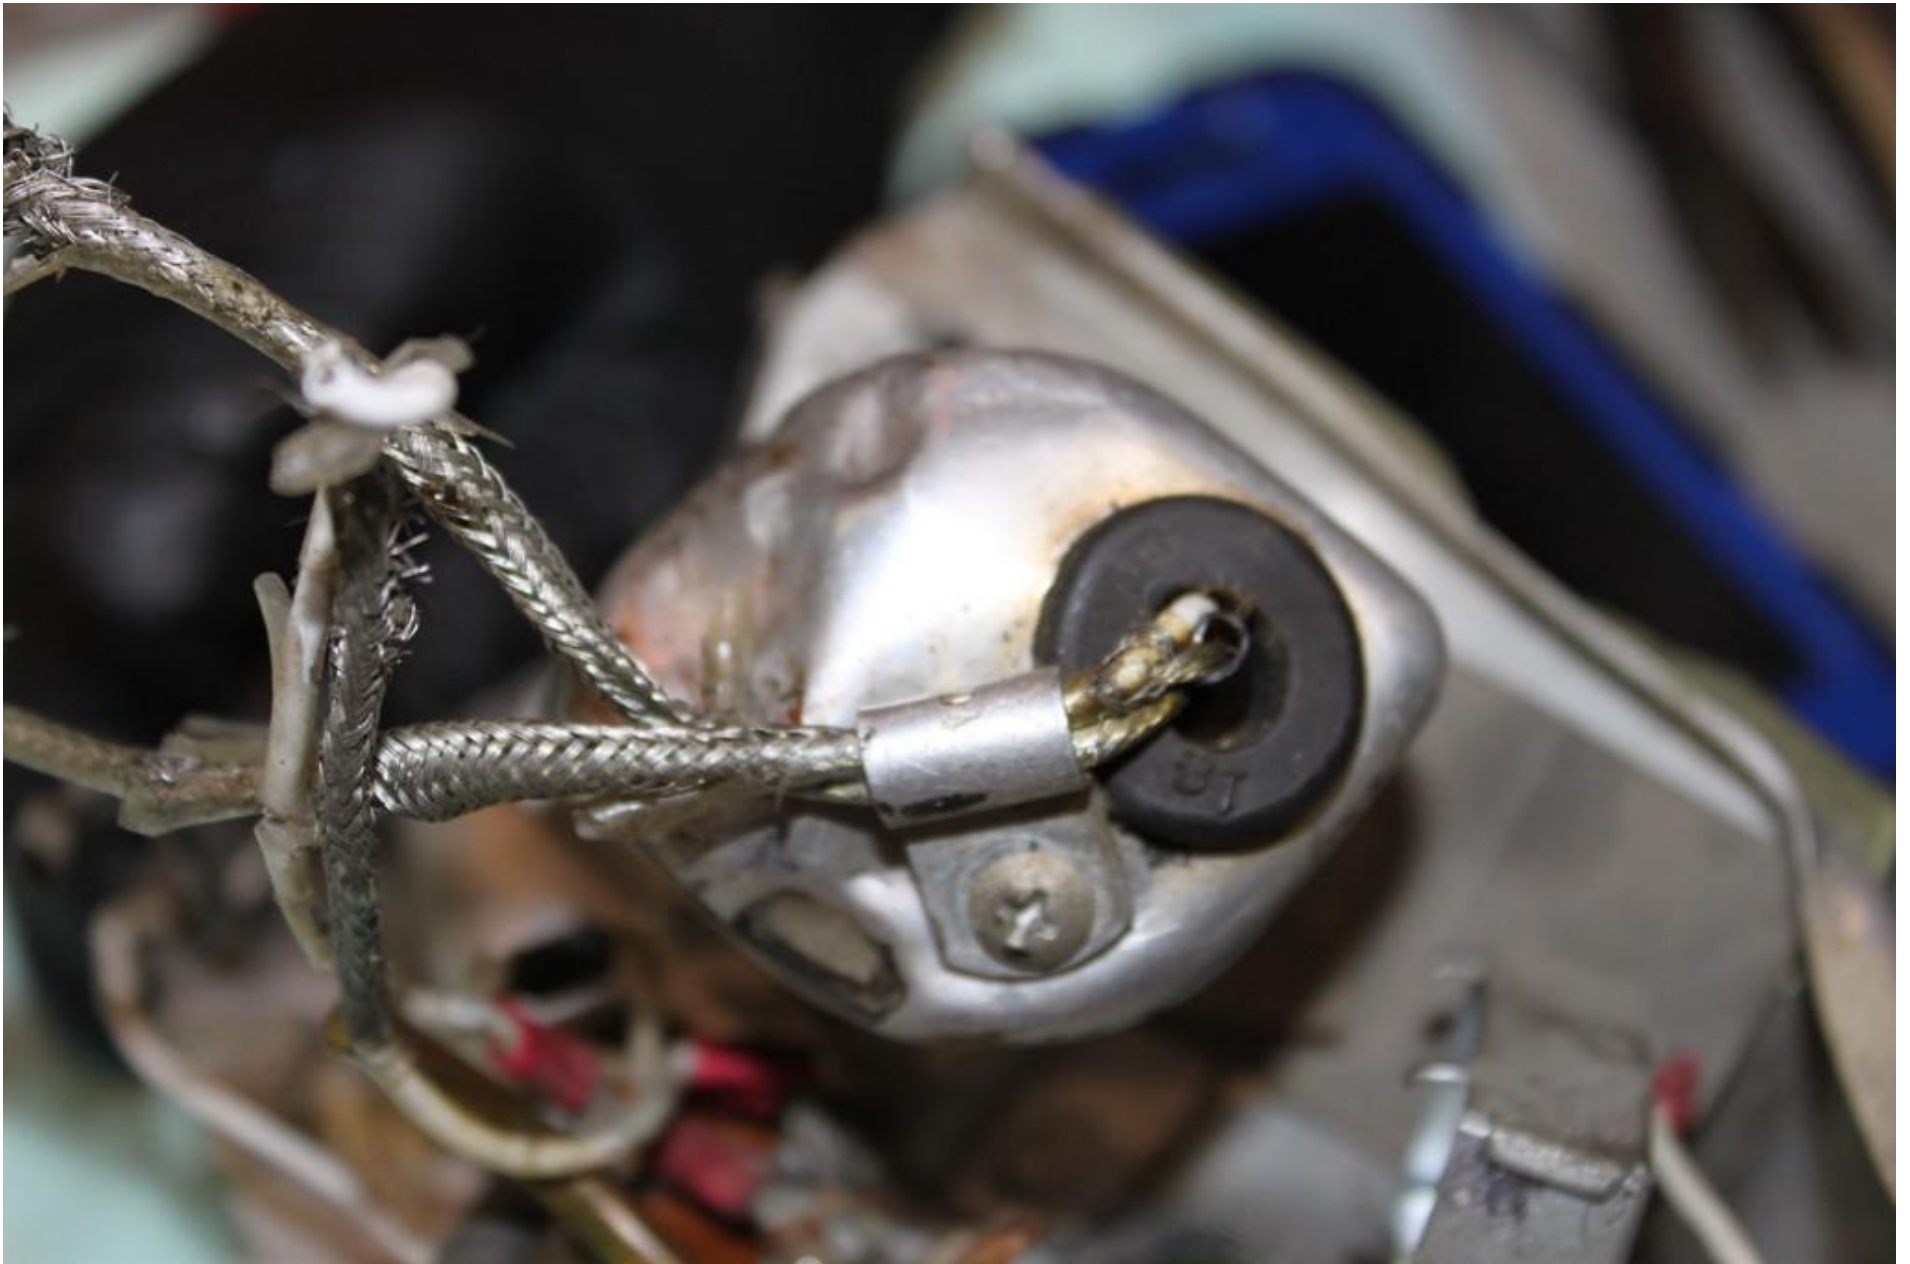
Photo 19 - NTSB Digital Photograph. View of the Aft Portion of the Ignition Switch. Note the Impact Damage to the Rear Cover

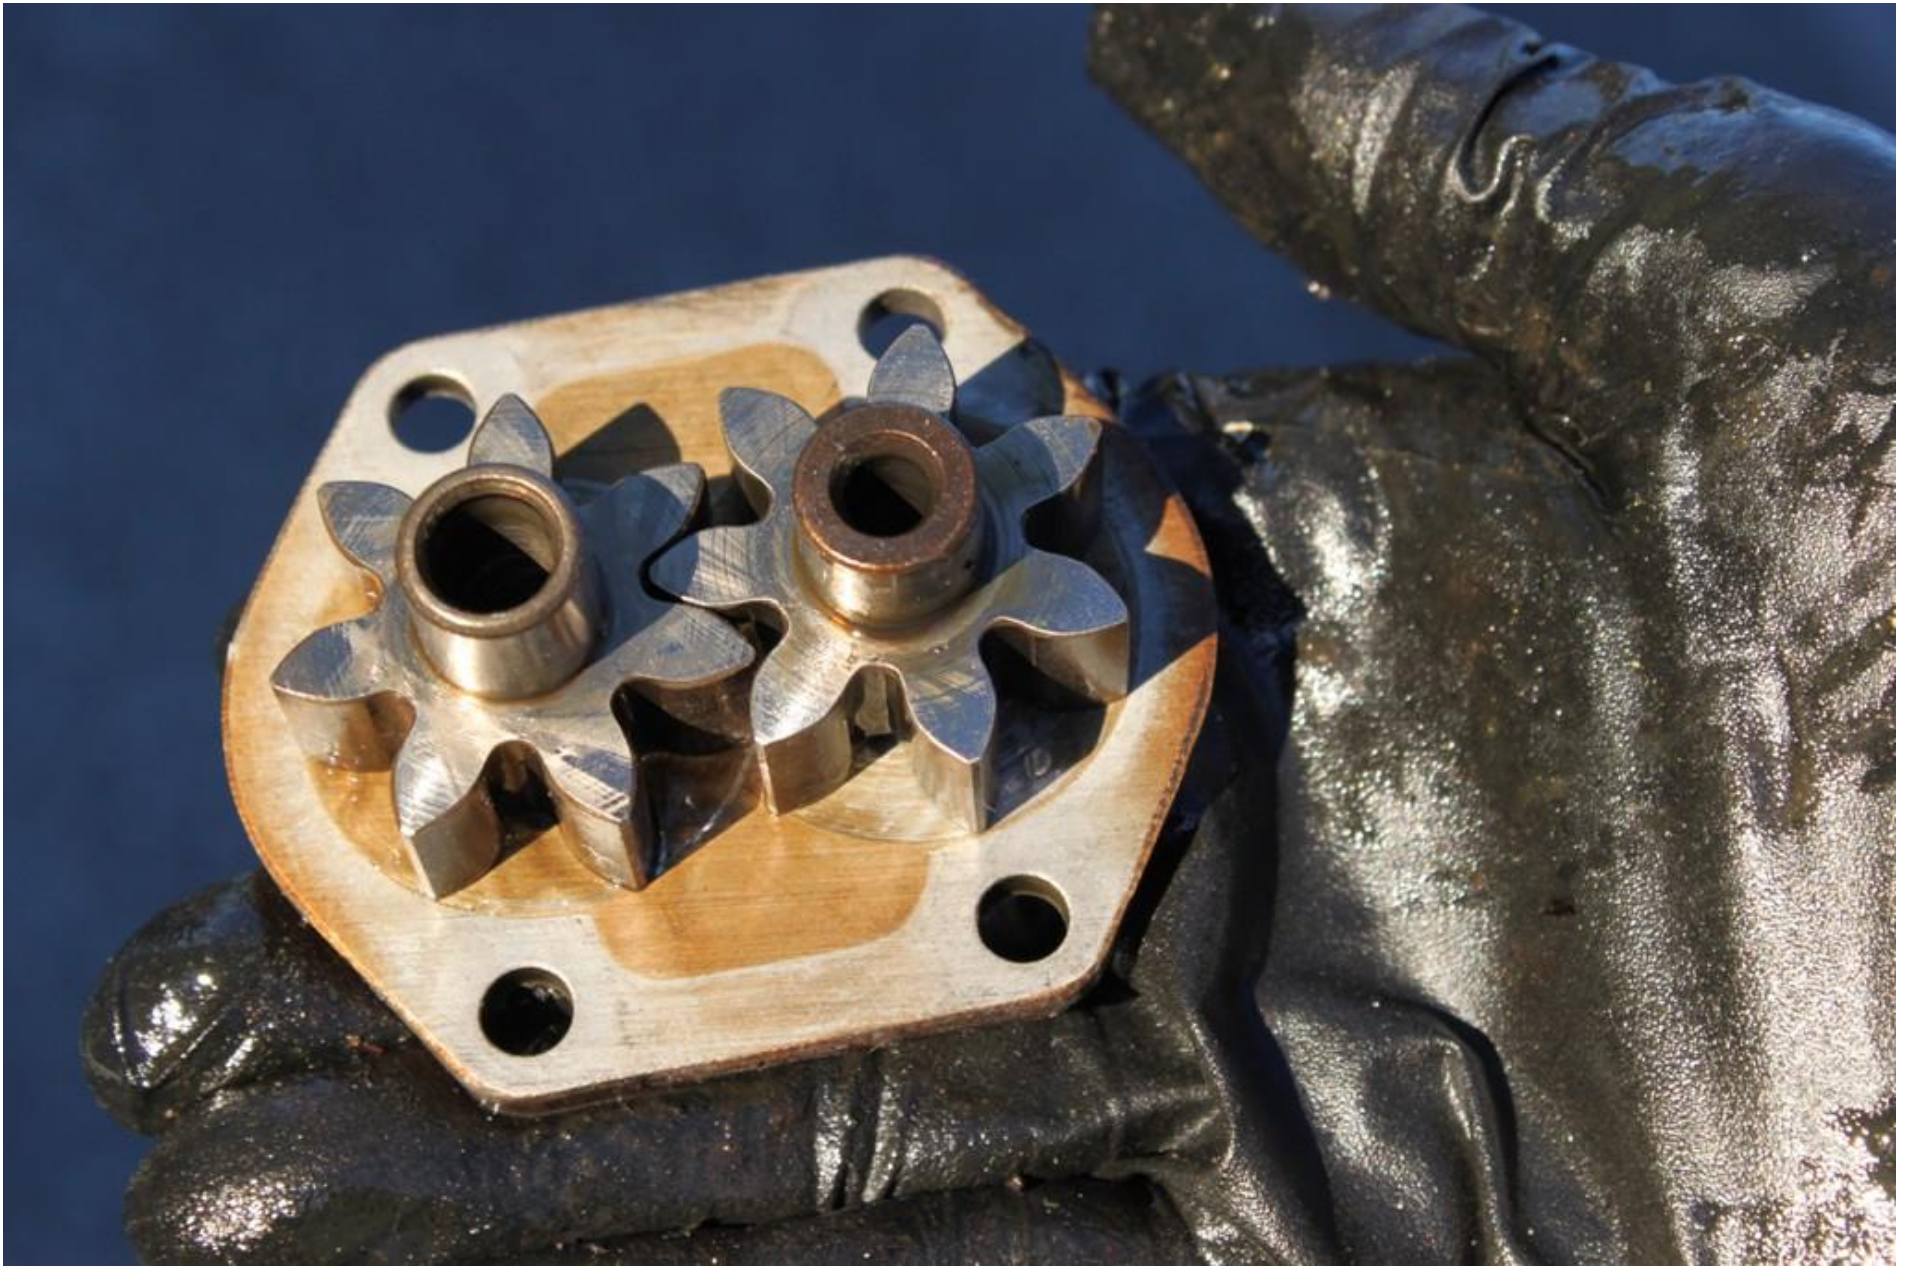
Photo 20 - NTSB Digital Photograph. View of the Oil Pump Gears
