CEN15FA331

Air Tractor 602

N6007N

NTSB ON-SCENE FIELD NOTES

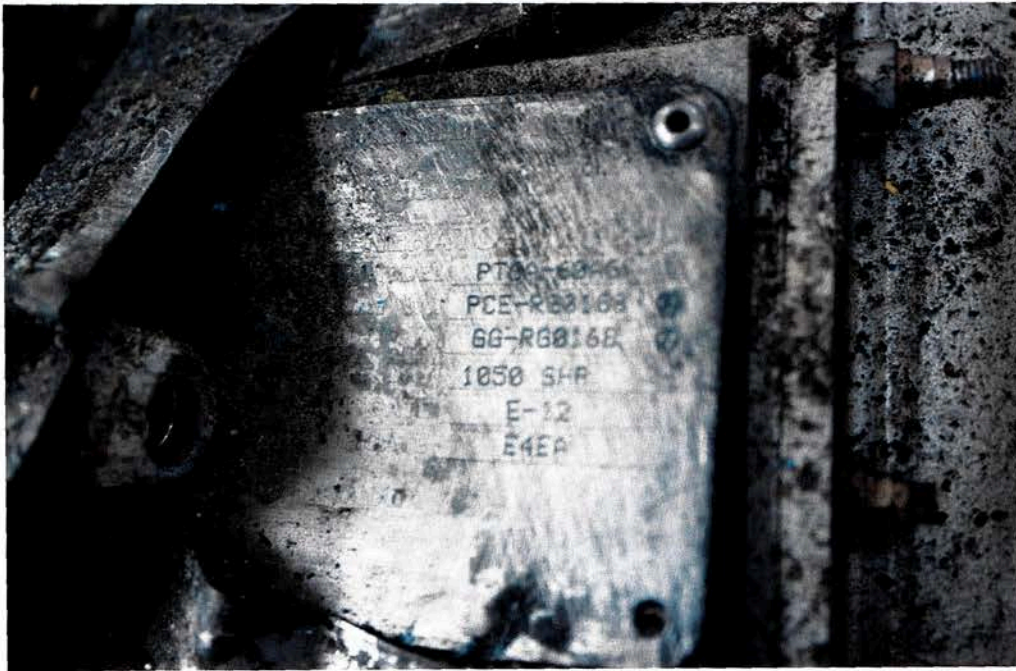
Photo No. 1

The engine was a Pratt & Whitney Canada PT6A-60AG model, serial number PCE- RG0168 (Ref. Photo No. 1).

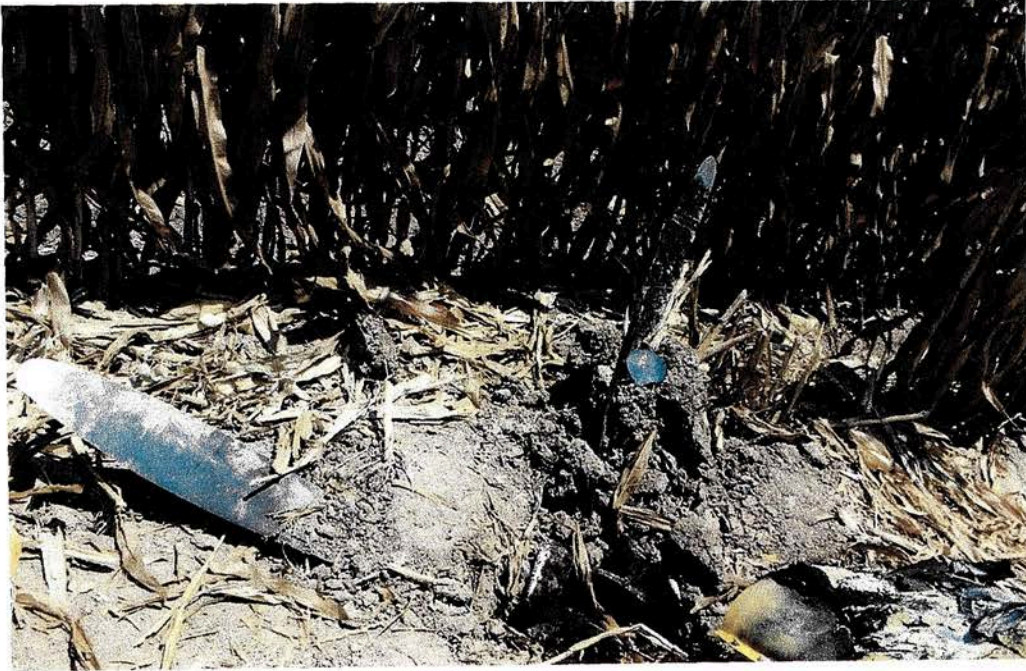
Photo No. 2

The propeller assembly had separated from the engine at the propeller shaft flange (Ref. Photo No. 2). The accessory gearbox and inlet case had separated from the gas generator case during impact with the terrain (Ref. Photo No. 3). Most of the propeller governor had separated from its respective mounting pad on the front reduction gearbox housing. The fuel pump, fuel control, fuel/oil heater, and the external scavenge oil pumps were separated from their respective mounting positions on the accessory gearbox housing.

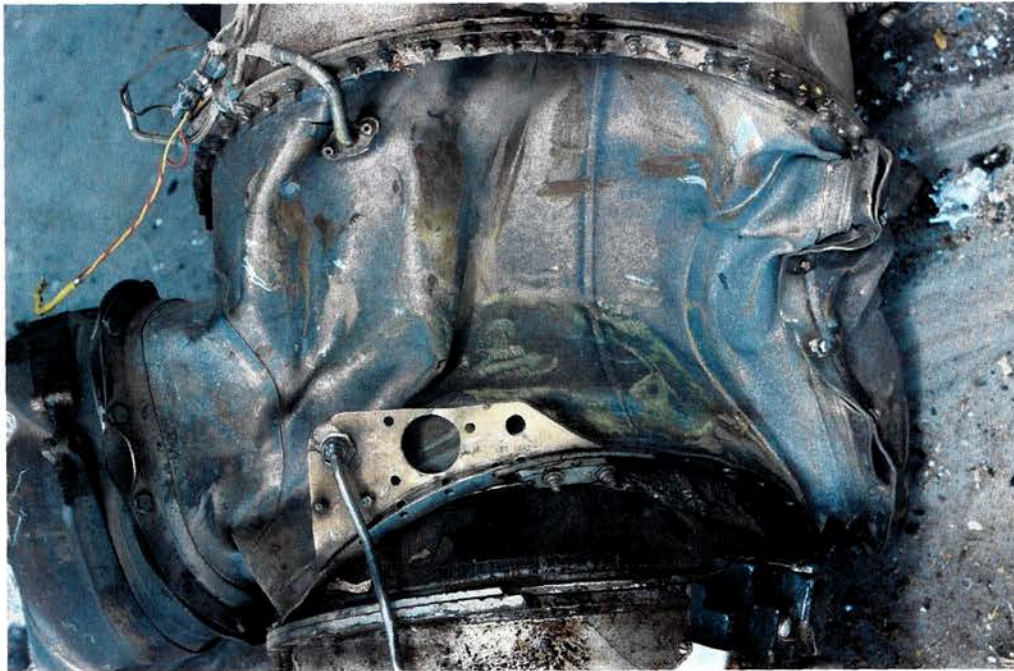
Photo No. 4

The exhaust duct displayed compressional bending due to contact/impact with the terrain (Ref. Photo No. 4). The exhaust stacks were bent and distorted. The gas generator case displayed bending and distortion on the lower right hand side (Ref. Photo No. 5).

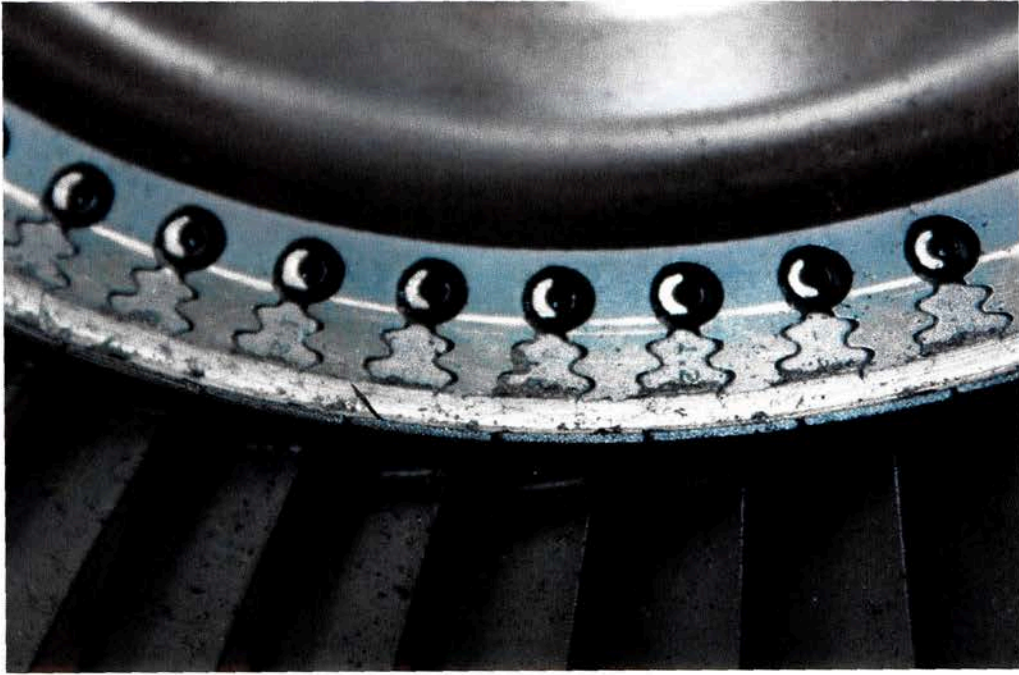
The engine was separated adjacent to the "C" flange to expose the hot section components. The downstream and upstream faces of the compressor turbine disc and blades exhibited rotational scoring from contact with its respective adjacent static components (Ref. Photo No. 6 & 7). The 1st stage power turbine vane and baffle exhibited rubs on both sides from contact with the power turbine and compressor turbine discs and blades. The 1st stage power turbine disc and blades exhibited rotational scoring on the upstream face (Ref. Photo No. 8). The 1st stage power turbine blades were all displaced forward in the disc (Ref. Photo No. 8).

Photo No. 6 (downstream side)

The bending of the compressor blades opposite the direction of rotation and the rotational scoring on the compressor turbine disc/blades, and the rotational scoring on the 1st stage power turbine disc/blades indicates that the engine was producing power at impact. The power range that the engine was operating at during impact could not be determined.

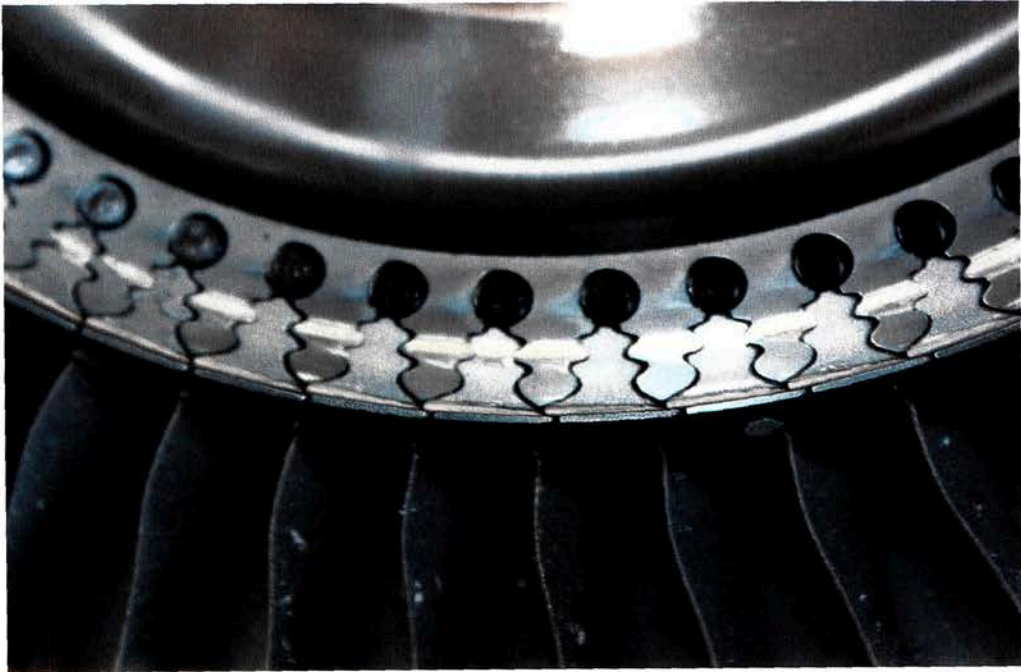
Photo No. 7 (upstream side)

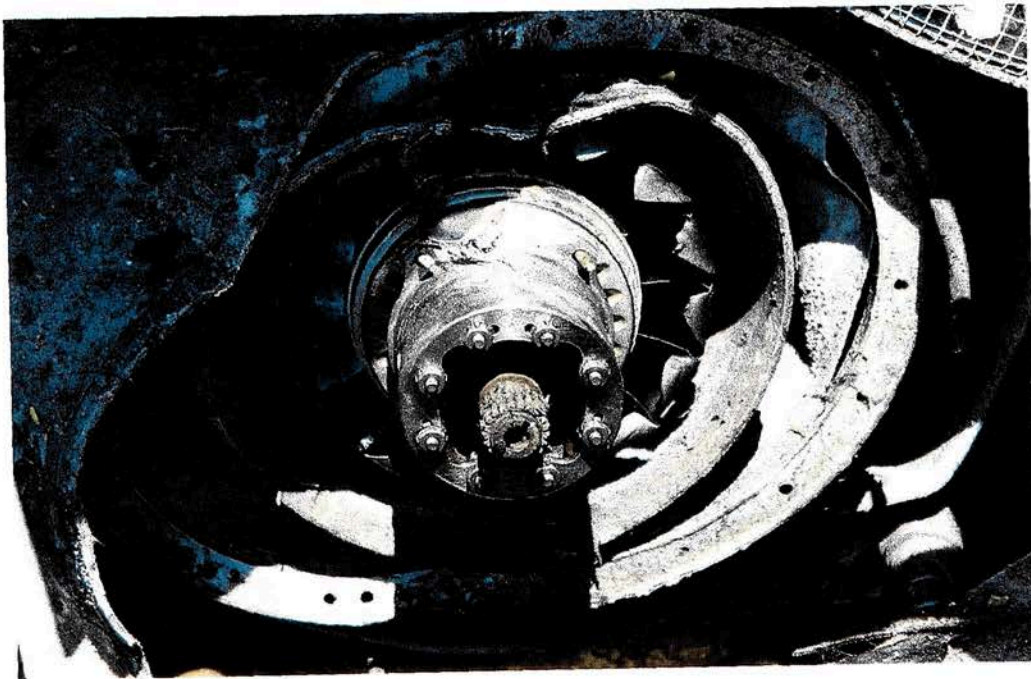
Photo No. 9

The 1st stage compressor blades were all bent opposite of the direction of rotation. (Ref. Photo No. 9).

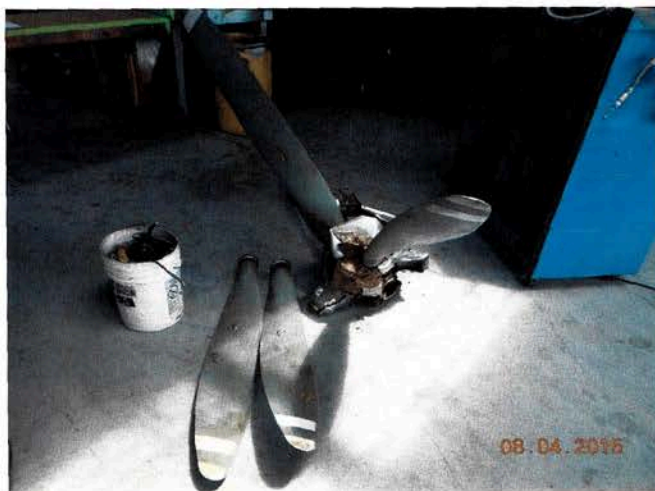
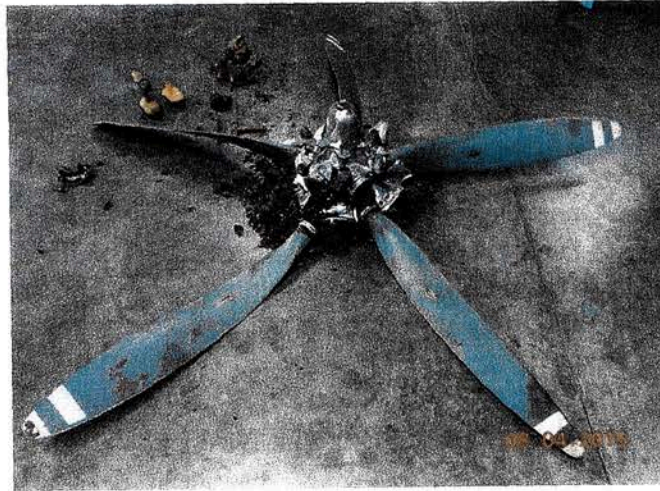
The propeller fractured off the engine mounting flange during impact. The propeller was relocated from the crash scene to Dawson's in the condition shown in Photos 10 and 11. The spinner dome was deformed around the hub, counterweights and blade clamps giving some blade angle information.

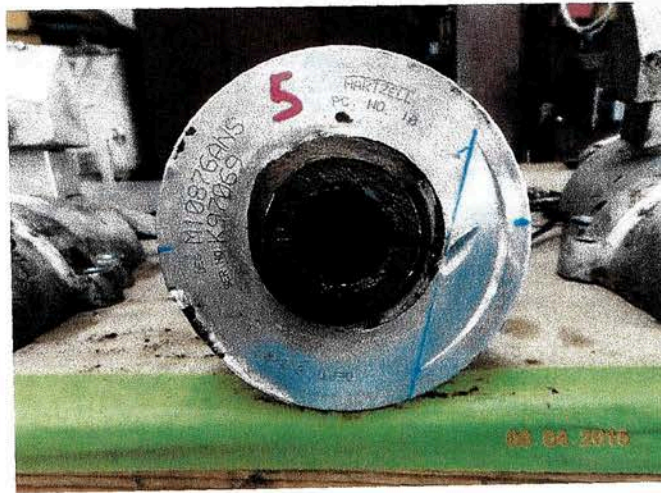
Photo No. 12

The spinner fragments, remaining blades, clamps and propeller piston were removed to examine the propeller. The blades 1 and 5 fractured the pilot tube and separated from the blade clamps and hub. Blade 2 fractured the pilot tube but was retained by the blade clamp. Blades 1, 2, and 5 showed blade butt impact marks indicating impact forces in the lead-to-trail direction (see Photo No. 12). Blades 3 and 4 remained attached to the hub and did not display any blade butt impact marks.

Blade angle impact marks indicated the propeller was operating in the normal blade angle range at impact. There were no discrepancies noted that would prevent or degrade normal propeller operation prior to impact. All damage was consistent with high impact forces.

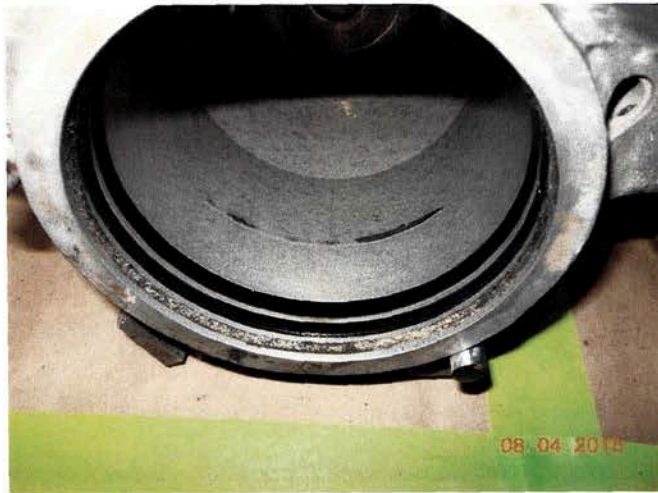
Photo No. 13

The piston showed internal impact marks providing some blade angle information (see Photo No. 13)

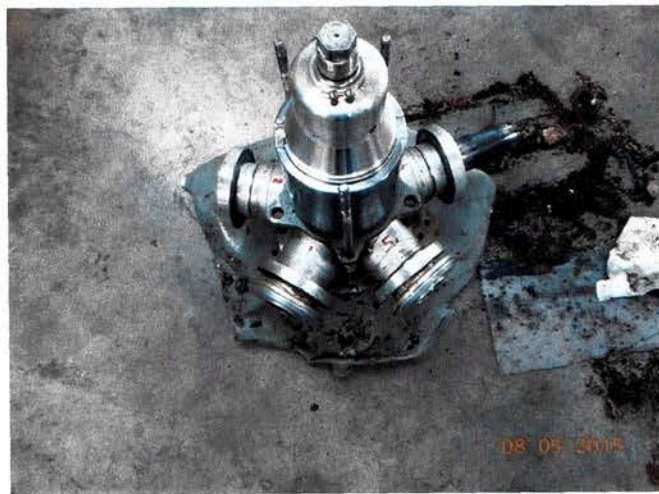
Photo No. 14

The cylinder, feathering spring assembly were intact with no apparent damage (Photo No. 14).

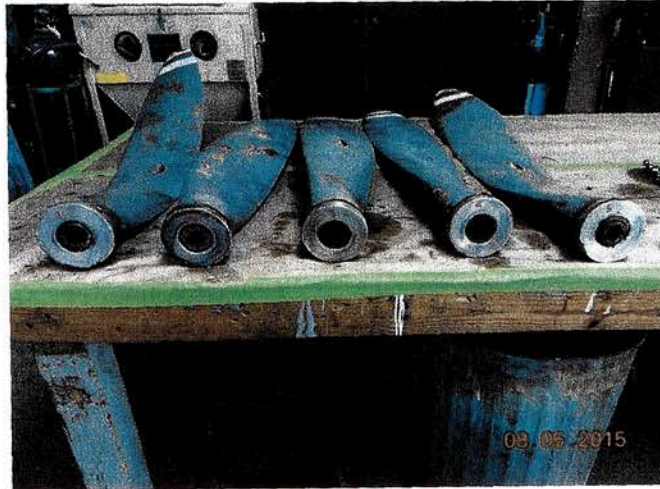
Photo No. 15

Blades 1 and 5 displayed bending in the forward direction. Blades 2 and 3 showed bending in the aft direction. Blade 4 did not have visually noticeable bending or twisting (Photo No. 15)
