**Investigator-In-Charge
FACTUAL REPORT**

**August 27, 2016, Rupture of a DOT-105 Rail Tank Car
and Subsequent Chlorine Release**

New Martinsville, West Virginia

DCA16SH002

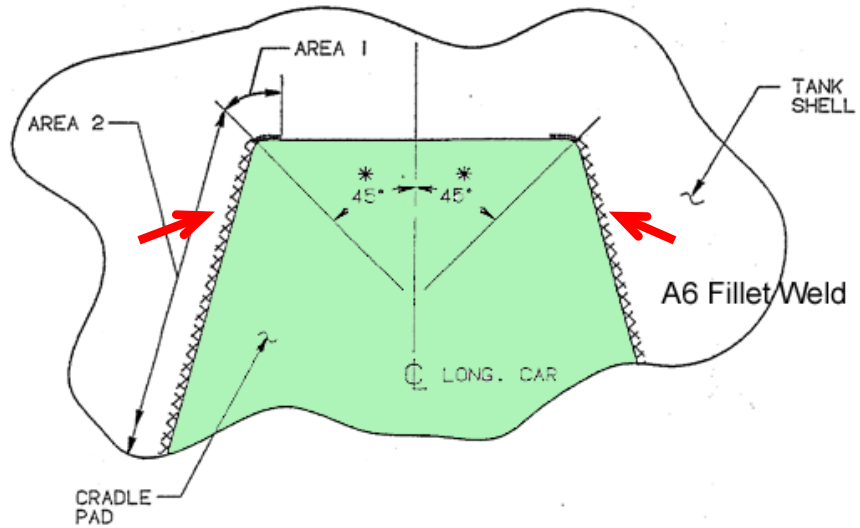
Figure 5. Diagram of Cradle Pad and Weld Repair Instructions from ACF Maintenance Bulletin TC-200. Red arrows added to denote the A6 fillet welds.

- AREA 1
- A. GRIND OR ARC-GOUGE AND GRIND TO REMOVE BOTH CRACKED AND SOUND SOUND WELD METAL TO THE 45° LINE AS SHOWN.
 - B. GRIND CRADLE PAD AND TANK SHELL SMOOTH, AND GRIND A SMOOTH TERMINATION ON THE WELD.
 - C. DYE CHECK TANK SHELL AND 1" OF THE REMAINING WELD.
 - D. REMOVE AN EQUAL AMOUNT OF WELD FROM ADJACENT CRADLE PAD CORNER AND DYE CHECK AREA.

AREA 2 REPAIR IN ACCORDANCE WITH M-1002, APPENDIX R&W.

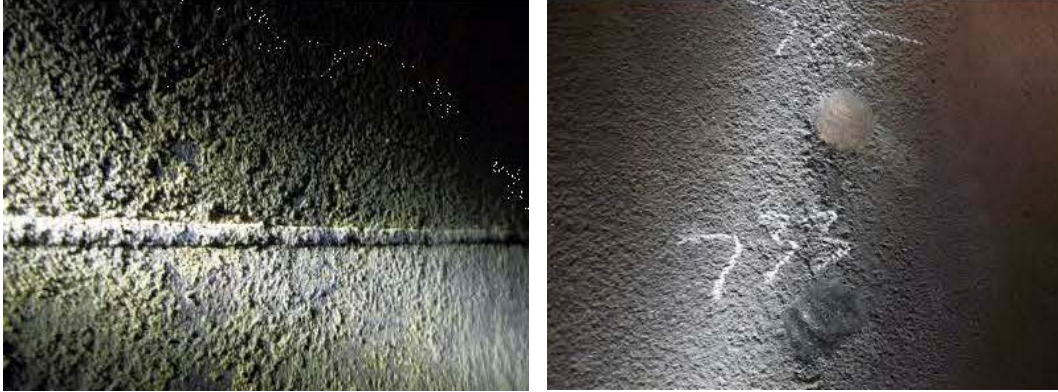
The visual inspection found evidence of corrosion damage to the shell and manway nozzle flange (Figure 6). Inspectors mapped areas of metal loss between 2 feet each side of the bottom centerline using ultrasonic thickness tests (UTT). The inspector found corrosion spots in the bottom of the tank in each of the five tank rings that resulted in shell thickness below Axiall's designated minimum for AXLX1702 of 0.7438 inch. The area of the tank where the crack occurred in Ring #4 had a measured thickness as low as 0.709 inch at one location. The inspector did not note any shell buckling in the area inboard of the A-end cradle pad. The inspector completed a structural integrity defect record and reported that the tank failed inspection.

Figure 6: AXLX1702 internal corrosion and ultrasonic thickness measurement locations in Ring 2, Rescar inspection March 21, 2016.

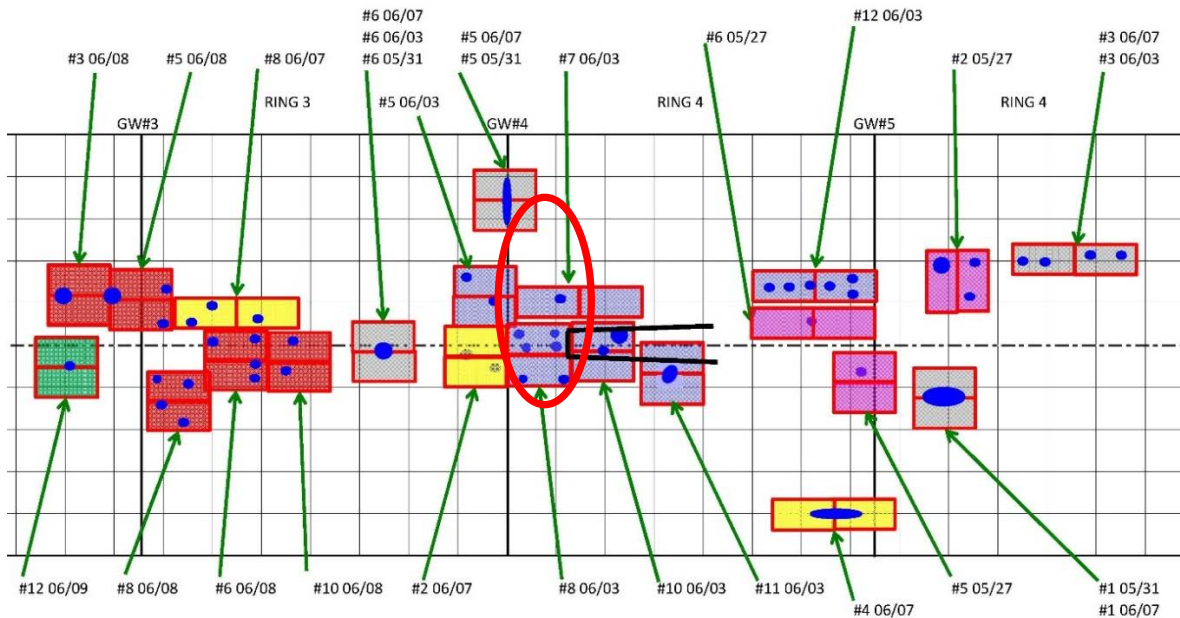
Figure 7: Rescar post weld heat treatment map for AXLX1702. Area of the shell crack is circled in red nearest heating elements 7 and 8.

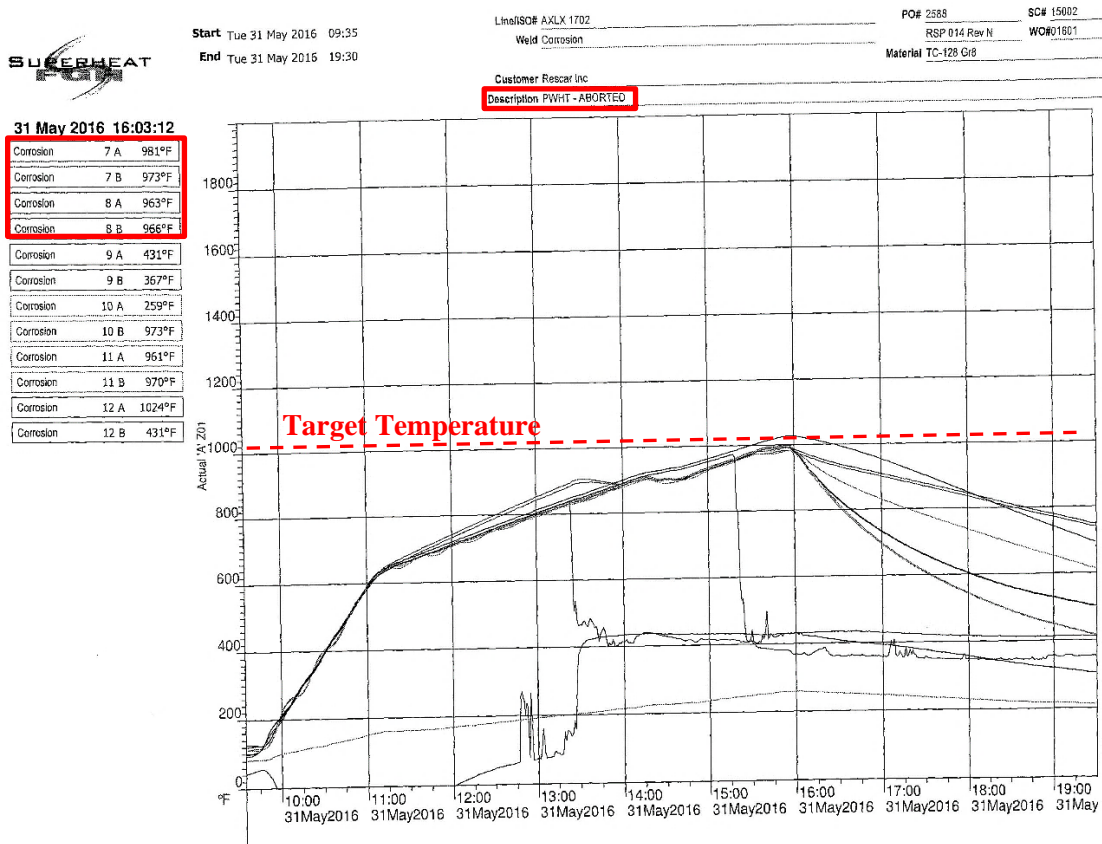
Superheat can abort heat treatment cycles if communication is lost with thermocouples or heating pads do not reach or maintain the target temperature. Superheat records indicate that the area of the tank car where the shell crack occurred received LPWHT as part of a 6-circuit run on May 31, 2016, but the run was aborted (see elements 7 and 8 in Figure 8). Superheat records indicate that LPWHT was successfully completed on this same area of the tank on June 3, 2016 (Figure 9).

Figure 8: Aborted post-weld heat treatment run, Superheat chart of May 31, 2016. Channels 7 and 8 are highlighted in the red box. The chart traces show thermocouple temperatures that failed to reach the target temperature of 1012 ± 12 °F (indicated by the dashed line) for 3 hours.

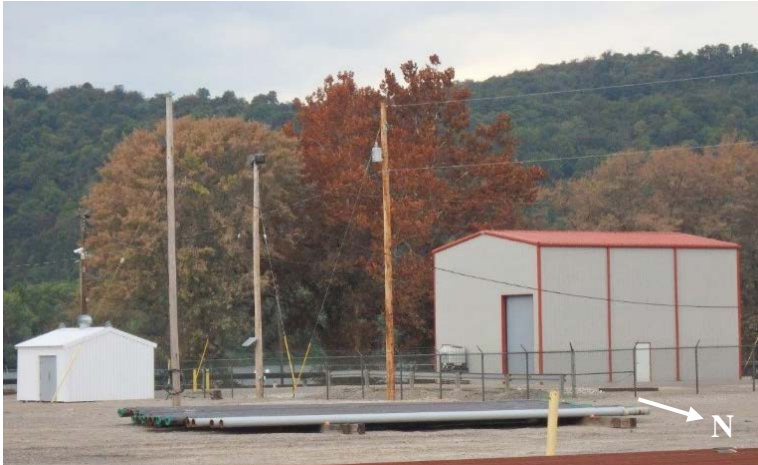
On August 31, 2016, NTSB investigators observed evidence of vegetation damage near Axiall's perimeter about 4,000 feet south of the incident location (Figure 11), and in a forest about 2 miles south of Axiall, east of West Virginia Route 2.

Figure 11: Damaged (brown) vegetation near Axiall Corporation south perimeter, August 31, 2016.

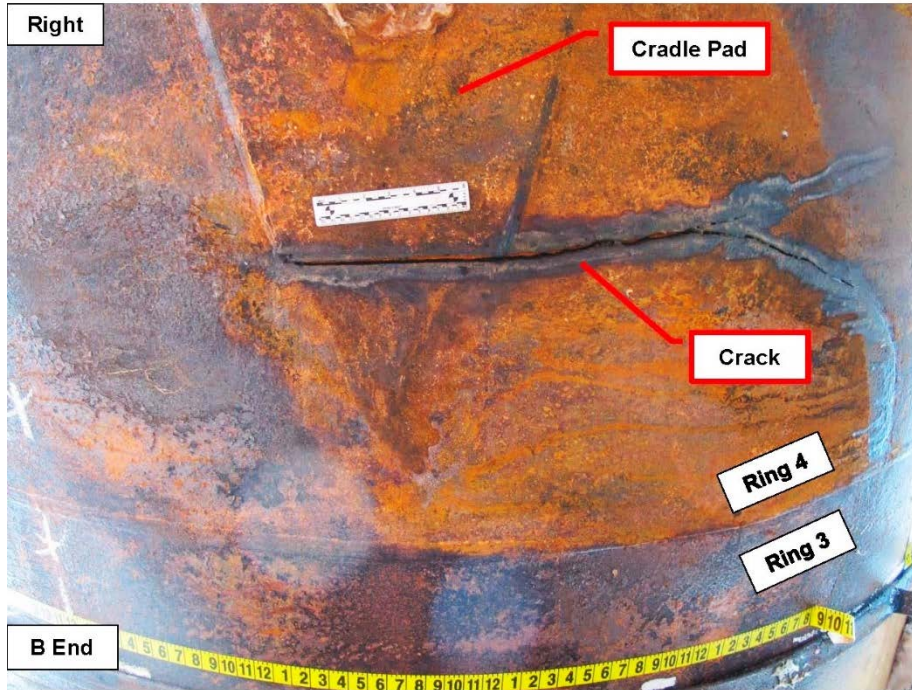
circumferentially across the bottom of the tank. The crack ended near the right corner of the cradle pad and showed local yielding of the tank material.⁶⁶ To the left, the crack ran partially up the side of the tank and split into two legs. One leg continued circumferentially about 13 inches before arresting and the other leg turned horizontally toward the B end. This leg terminated at the girth weld between the 4th and 3rd barrel section rings. The crack faces were gapped apart about 0.25 inch at the bottom of the tank. However, the only visible yielding deformation was at the right end of the crack.

Figure 14: Exterior surface of tank car AXLX1702 showing a circumferential crack inboard of the cradle pad, September 1, 2016.

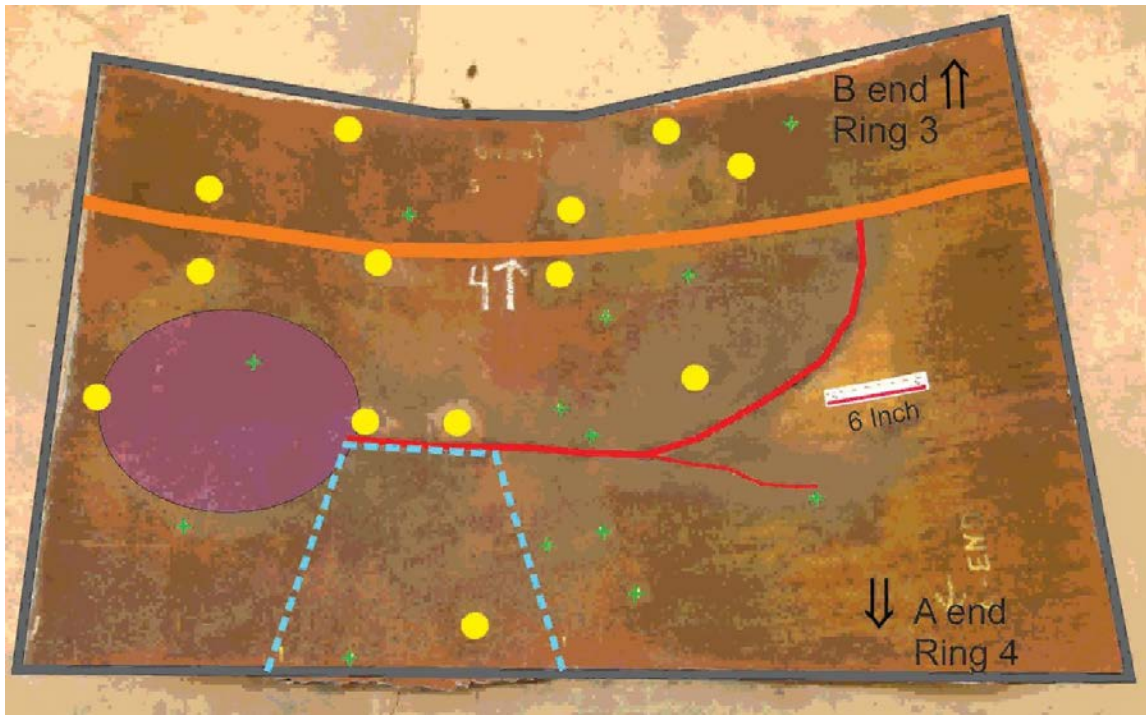
The shell material in Ring #4 was buckled between the crack at the cradle pad plate and the ring 3 to 4 girth weld joint. In the approximate 11-inch distance, the interior surface was deformed downward approximately ½ inch. The circumferential extent of the deformation was not established.

Figure 16. Annotated interior surface of the tank shell section showing the shell crack (red line), corrosion weld repairs (yellow circles), inboard cradle pad termination on exterior/opposite surface (dashed blue line), girth weld between ring 3 and ring 4 (orange line). The purple oval on the left indicates the area with visible interior surface scaling. Ground spots are identified with a green + mark.

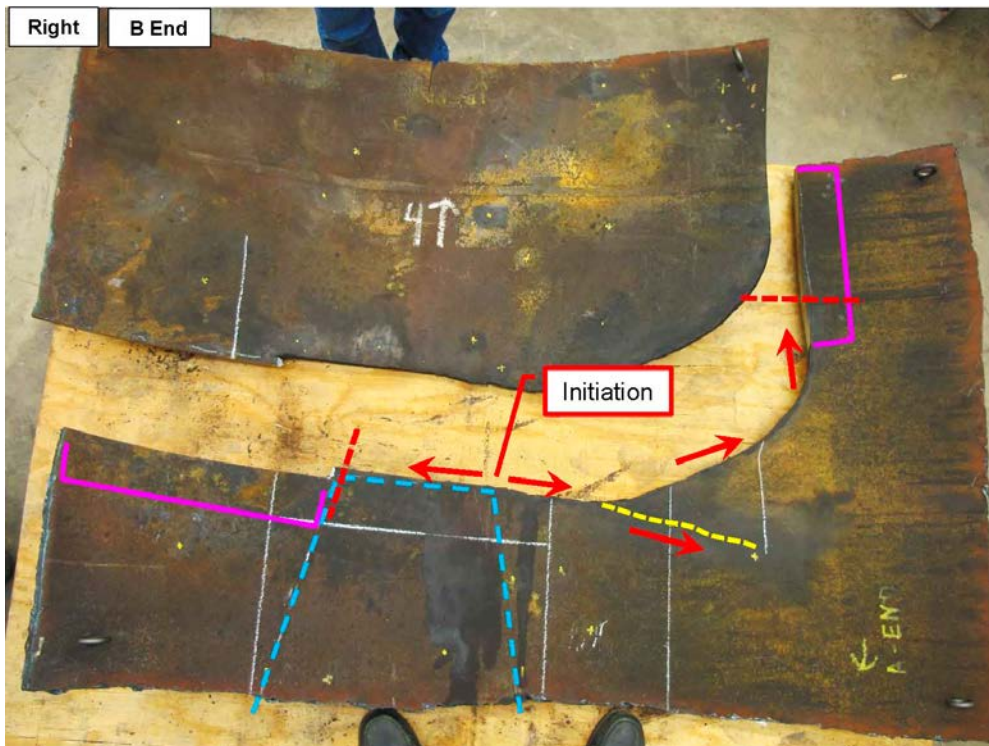
When the crack was opened, NTSB investigators found that the crack was consistent with brittle fracture propagation for the entire length. Chevron markings on the crack faces demonstrated that the crack initiated near the toe of the left-hand repair weld bead.

Propagation was circumferentially away from the left weld (see Figure 17). Progression to the right side arrested near the right cradle pad repair weld, but did not intersect the weld or its apparent heat affected zone. The left crack propagation continued to propagate circumferentially before splitting into two legs with the longer portion turning toward the B end of the car and arresting in the fusion weld connecting rings 3 and 4. The shorter leg of the crack continued for a distance and arrested in the middle of the plate.

Figure 17: Opened crack with saw cuts indicated by purple brackets, crack propagation is indicated by red arrows, the dashed blue line indicates location of cradle pad on opposite side of the shell.

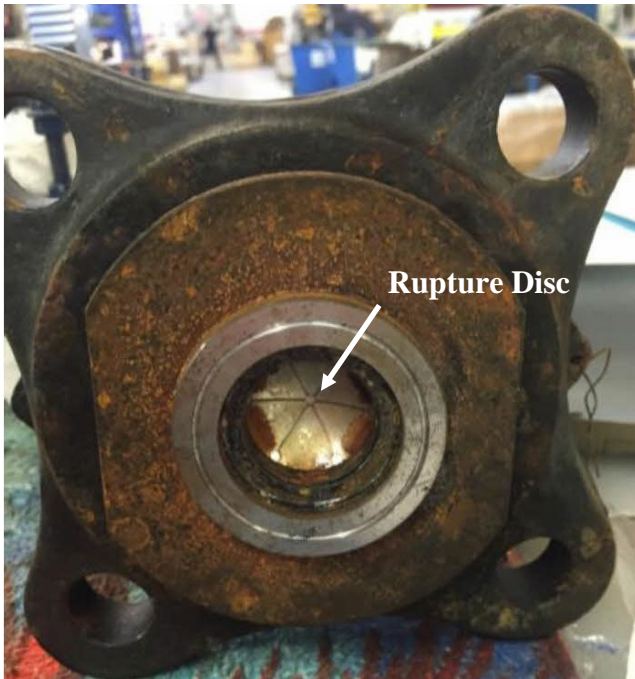
Figure 18. Bottom view of the pressure relief device removed from AXLX1702 for examination, showing the intact rupture disc. Midland Manufacturing photograph, September 8, 2016.

The rupture disc assembly was subjected to an initial pressure test of about 50 percent of its rated burst pressure of 375 psig. The pressure test found no evidence of leakage, indicating that the rupture disc had not been compromised. The rupture disc burst pressure was then measured to be 410 psig. The Midland engineer reported that acceptable burst pressure limit was 319 to 375 psig, and therefore the disc failed the pressure test.⁷⁴

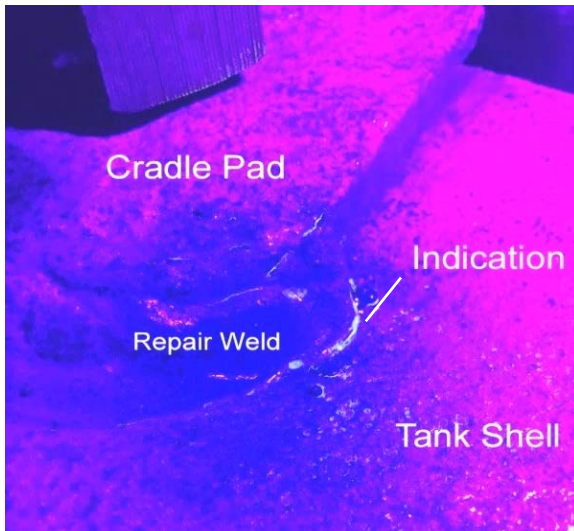
Using wet particles, the original manufacturer's weld showed a tank side toe linear indication along most of its length. The repair weld showed a ¼ to ½ inch crack-like indication in the tank material at the inboard toe of the weld (Figure 19).

Figure 18: Wet magnetic particle examination at termination of right B end cradle pad (A6) fillet weld, with indication at toe of the weld, November 9, 2016.

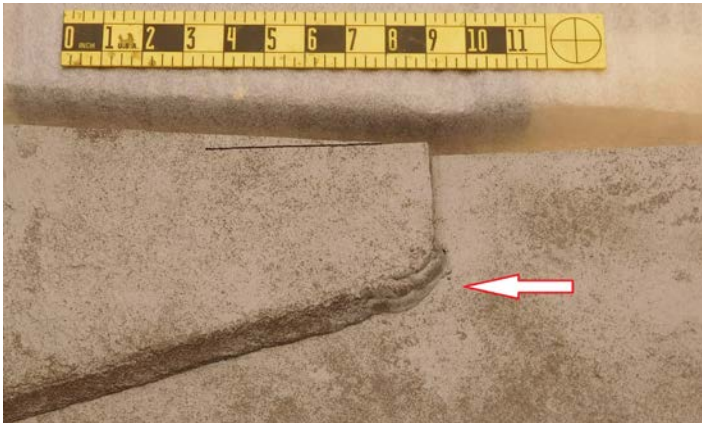
The existing surface of the tank was too rough to reliably couple the ultrasonic beam, therefore an area inboard of the repaired fillet weld termination was abrasively ground smooth, leaving approximately 1-inch band of unground surface remaining adjacent to the weld. Tests were limited to the repair weld (Figure 20). Using a 60-degree angle beam probe, scanning was performed in both the first and second leg of the ultrasonic beam. An indication was observed in the second leg of the beam, about 0.750 inch in length and about 0.100 inch in depth. The indication was determined to be an undercut at the toe of the fillet weld to tank shell. This indication was in the same location as the previously noted magnetic particle test crack-like indication.

Figure 19: AXLX1702 B-end stub sill weld termination ultrasonic testing scan area, November 9, 2016.
