REPORT NO. F16108-R-01

EVALUATION OF FUEL PUMP BOLTS - CARNIVAL LIBERTY

FOWLER RODRIGUEZ

OCTOBER 12, 2016

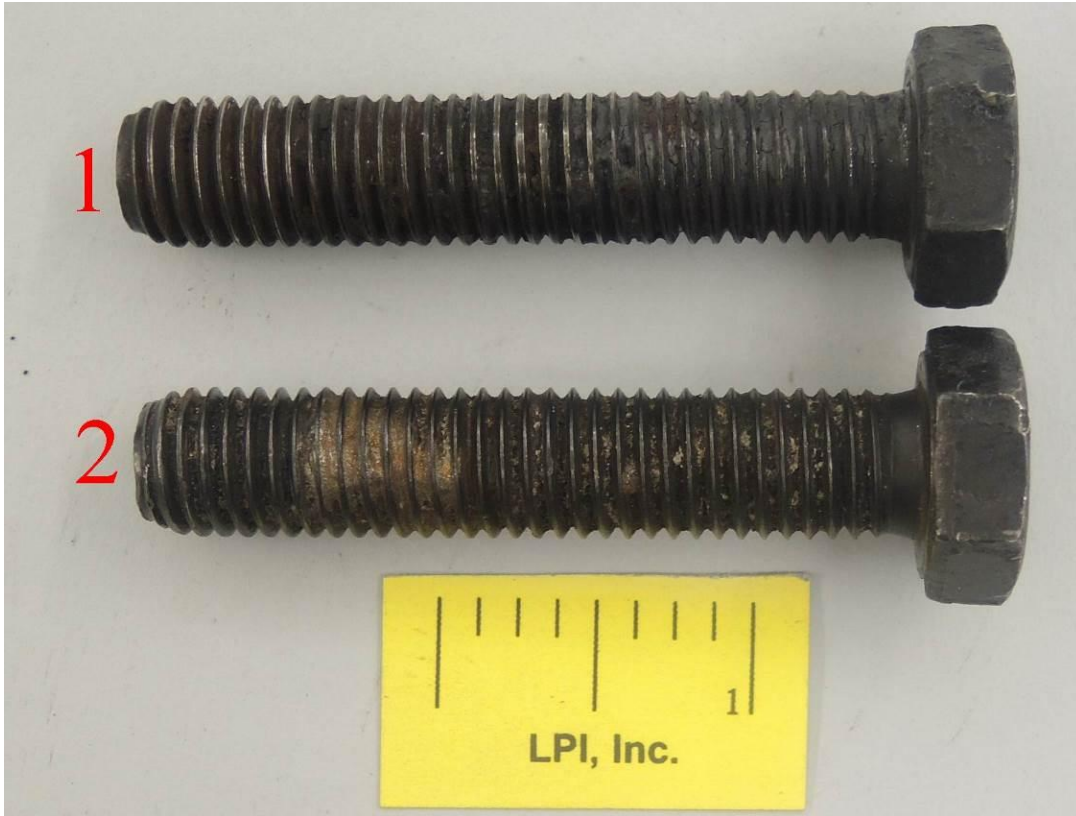
The submitted bolts are shown in Figs. 1 and 2 in the as-received condition. The two bolts initially submitted, shown in Fig. 1, were arbitrarily marked 1 and 2 by LPI. The two bolts provided by NTSB/USCG, shown in Fig. 2 had been marked "Separated" and "Attached" and were identified by LPI as bolt

The bolts were covered with black oxide and exhibited debris in the bolt threads. The debris was collected for further analysis, shown in Fig. 5, and all four bolts were cleaned. Magnified visual examination of the bolt threads did not reveal any signs of cracking or spalling of the black surface oxide layer due to excessive bolt torquing. In addition, thread pitch measurements and utilization of a thread gage did not reveal any permanent stretch of the bolt shank. Liquid fluorescent magnet particle inspection and dye penetrant inspection performed did not reveal any cracks in the thread roots or at the bolt head radii.

Fig. 1 Initially submitted bolts 1 and 2 as-received.

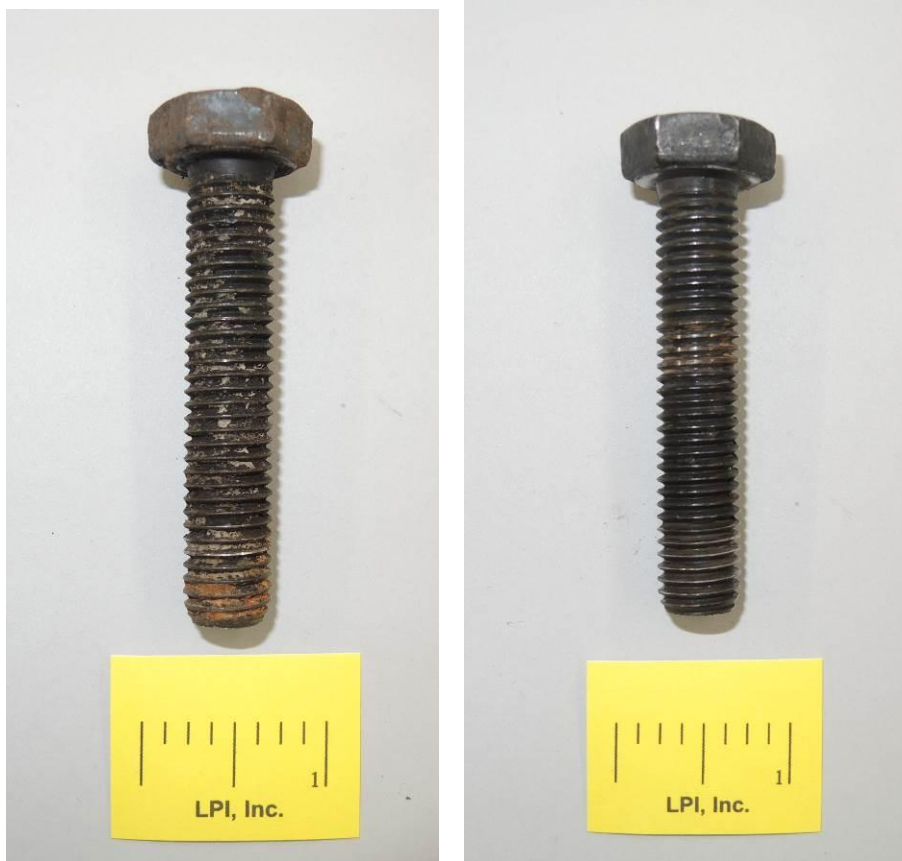
3 (“Seperated”) and bolt 4 (“Attached”). The submitted Petri dishes are shown in Fig. 3 in the as-received condition.

Fig. 2 Bolt 3(left) and bolt 4 (right) as-received.

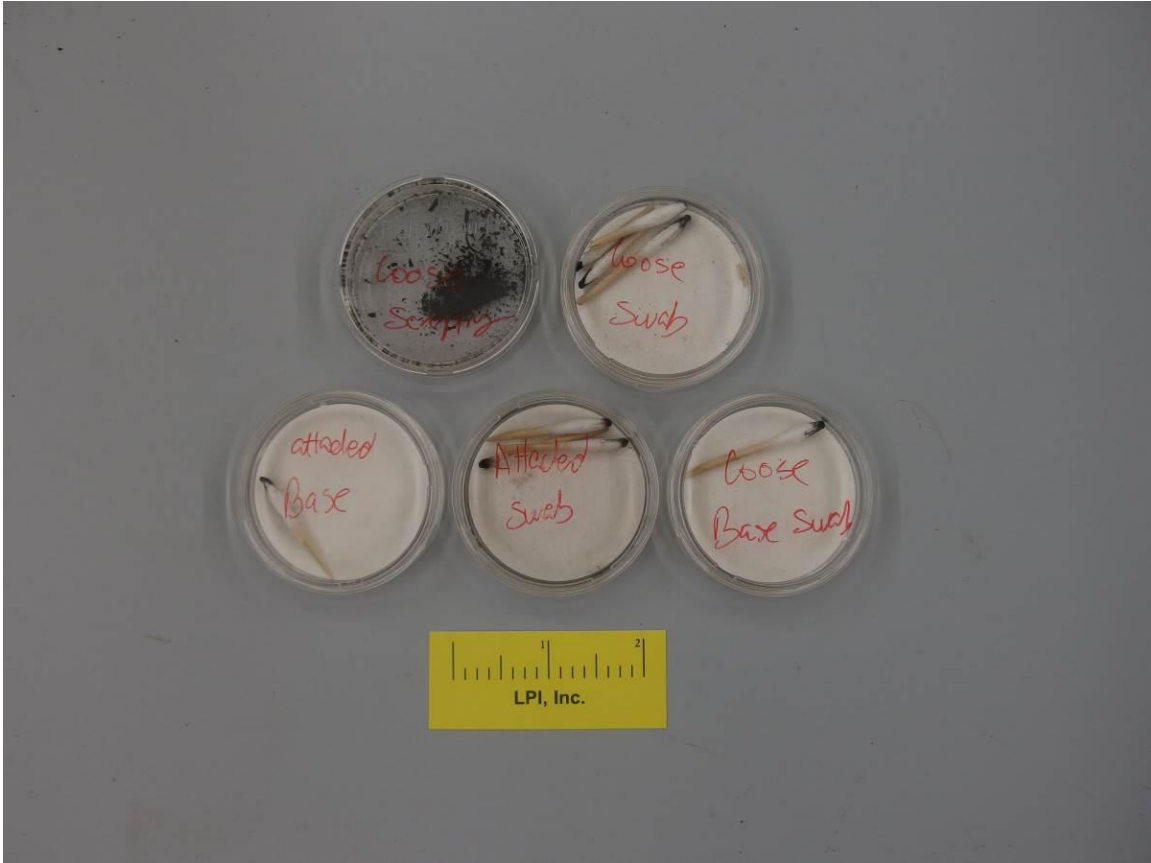
Fig. 3 Submitted Petri dishes as-received.

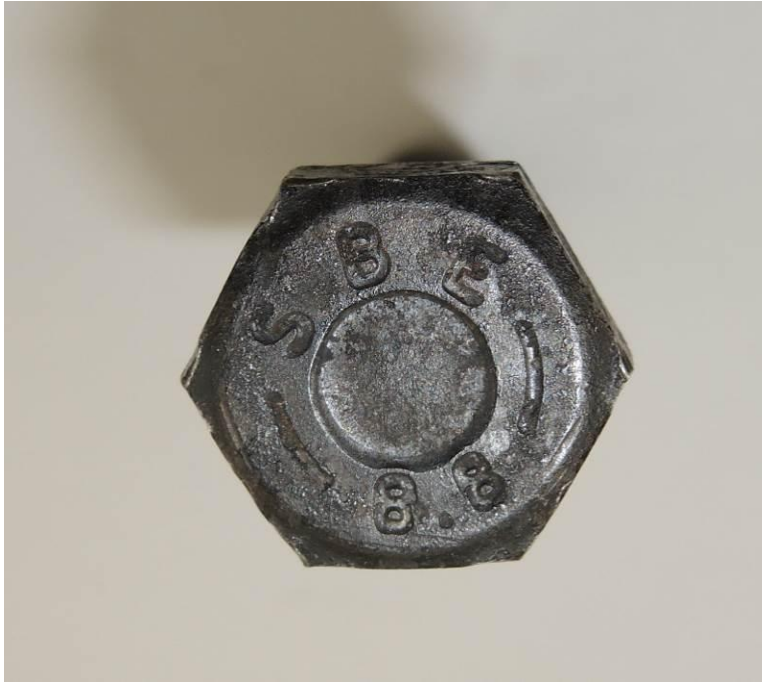
All four bolts exhibited identical bolt head markings (SBE 8.8) identifying them as ISO 898-1 Grade 8.8 metric bolts, as shown in Fig. 4. The bolts measured approximately 2.67 in. overall length x 0.46 in. (11.7mm) outer thread diameter. The thread pitch was determined, utilizing a thread pitch gage, to be 1.75 mm, thus the subject bolts were nominal M12 coarse thread bolts.

Fig. 4 Bolt head markings.

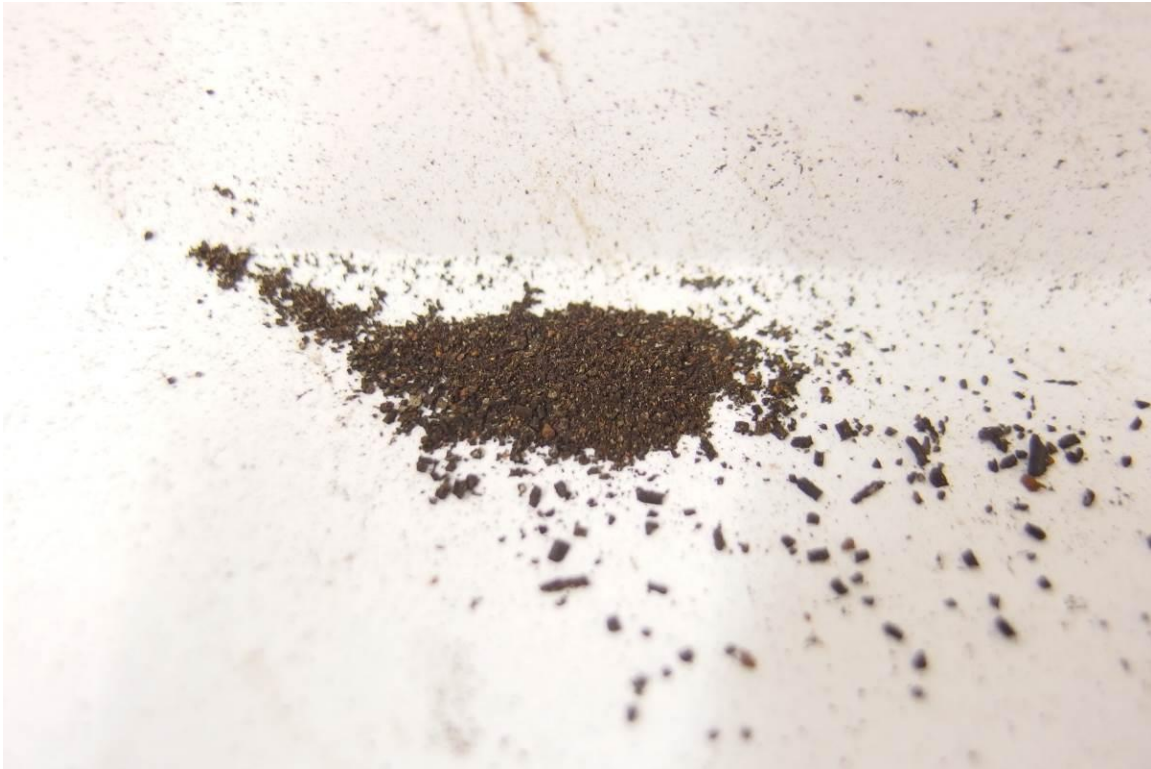
Examination of the bolt thread debris for the presence of any thread locking adhesives was performed by Analyze, Inc. The Analyze report, given in the attachment, revealed that no cyanoacrylate was present in the examined debris. The cyanoacrylate family is a sub-class of adhesives typically associated with Loctite thread locking products.

Fig. 5 Debris collected from the thread shank of bolt 3.

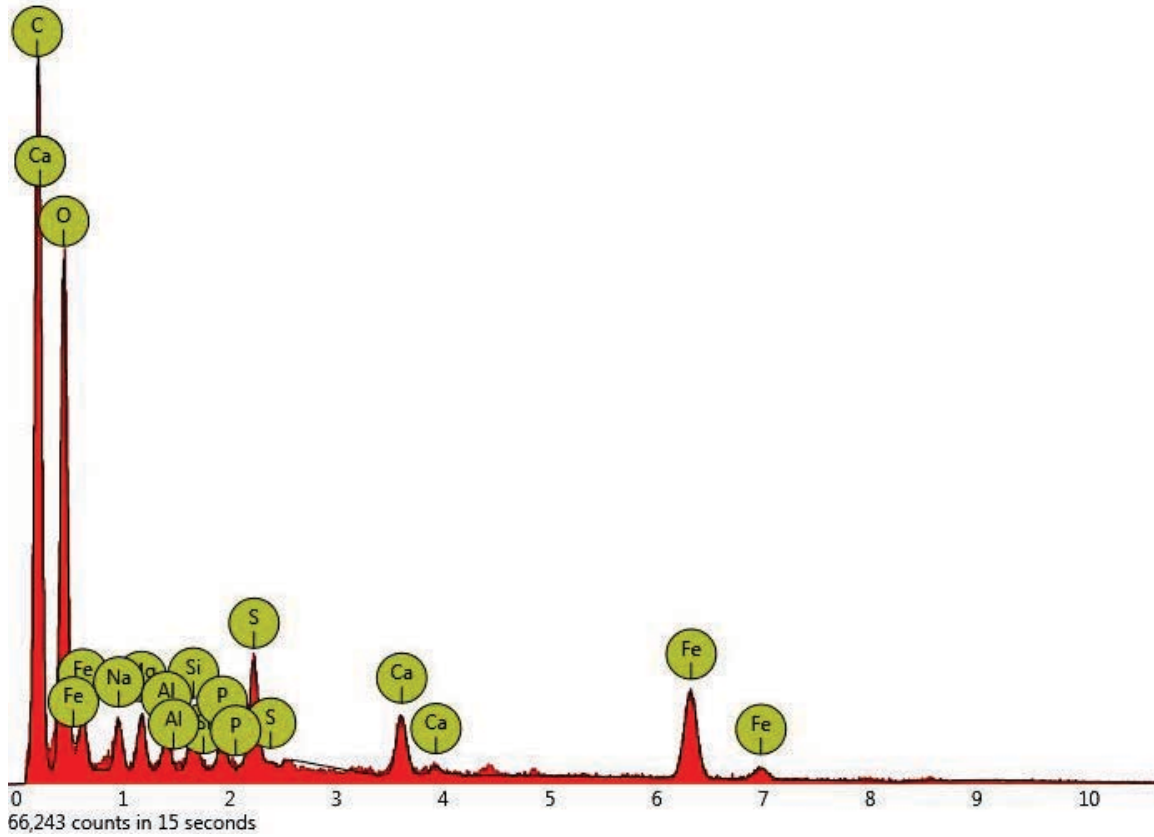
In addition, Energy Dispersive X-Ray Spectroscopy (EDS) was performed on the debris collected from the bolt 3. The acquired spectrum, shown in Fig. 6, revealed that no copper was present in the collected debris, indicating that anti-seize product Loctite LB 8008 C5-A had not been used during bolt installation.

Examination of debris removed from the threaded shank of bolt 3 revealed the absence of cyanoacrylate containing thread locking adhesives. Further, from the absence of copper in the debris it was apparent that an anti-seize product known as Loctite LB 8008 C5-A had not been present on the bolt.

Fig. 6 EDS spectrum of debris removed from bolt 3.
