Report Issued: October 31, 1996

Report #: 413.62-96.34

Laboratory Test Report

SUBJECT: LEAK IN GAS LINE DFM-3, BETWEEN SANTA CRUZ AND DAVENPORT

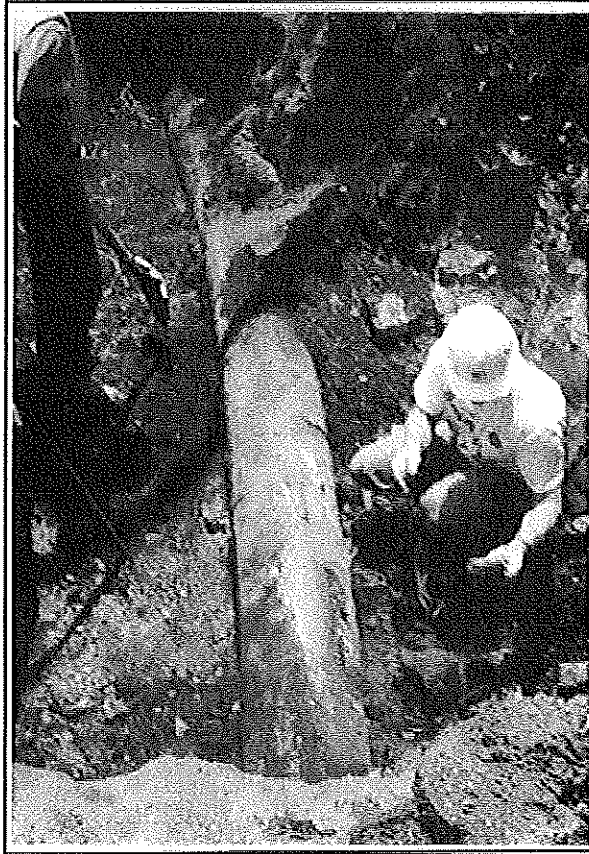
In June of 1996 a leak was discovered during a walk-down of the DFM-3 gas line, between Santa Cruz and Davenport (installation year 1957). The leak was located in a section of pipe where the line had been field bent to transit down an embankment (Figure 1). After excavation, the TES Welding and Inspection Services Unit performed visual, wall thickness and x-ray inspection of an eight foot section. No evidence of pitting or other wall loss due to corrosion was found. Wet fluorescent magnetic particle examination found a linear indication that ran longitudinally along the pipe and encompassed all six leak sites (Figures 2 and 3). It was recommended to remove the entire spool piece. The section that had been inspected was sent to the TES Metallurgy Lab for evaluation.

Figure 1 (left). DFM-3 pipe while being excavated. Note bend in pipe necessary to transit down embankment.

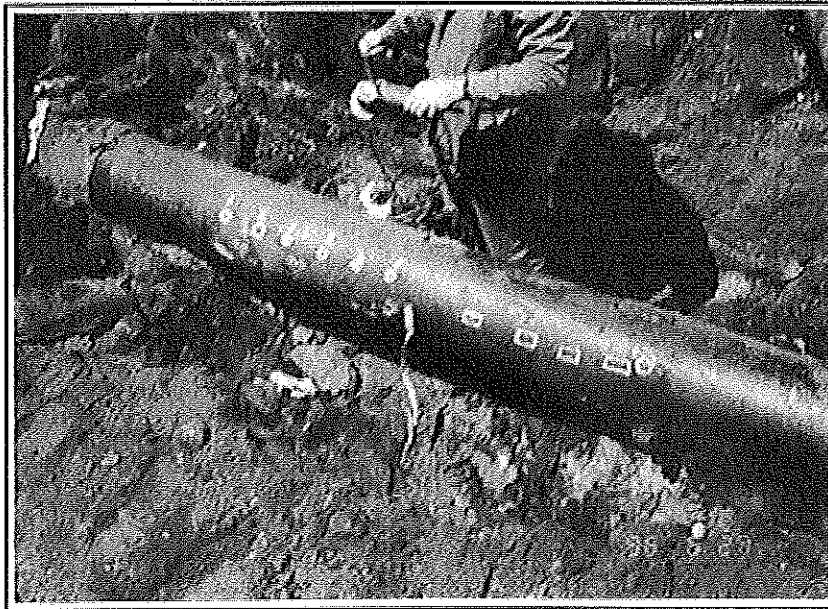
Figure 2 (bottom). Pipe during inspection. White round circles indicate leaks. Note their linear arrangement along the longitudinal axis of the pipe.
