Lancair Owners and Builders Organization Factual Report in the case of:

NTSB Identification: CEN17LA009. Accident occurred Saturday, October 01, 2016 near Iola, Kansas.

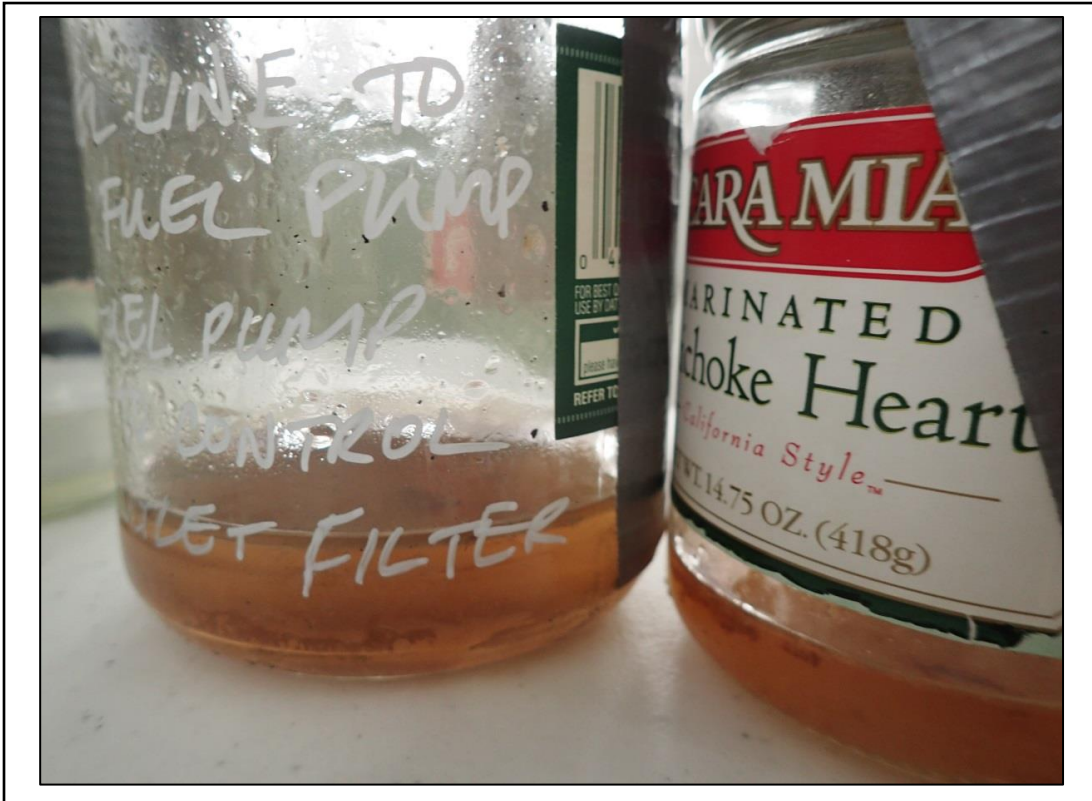
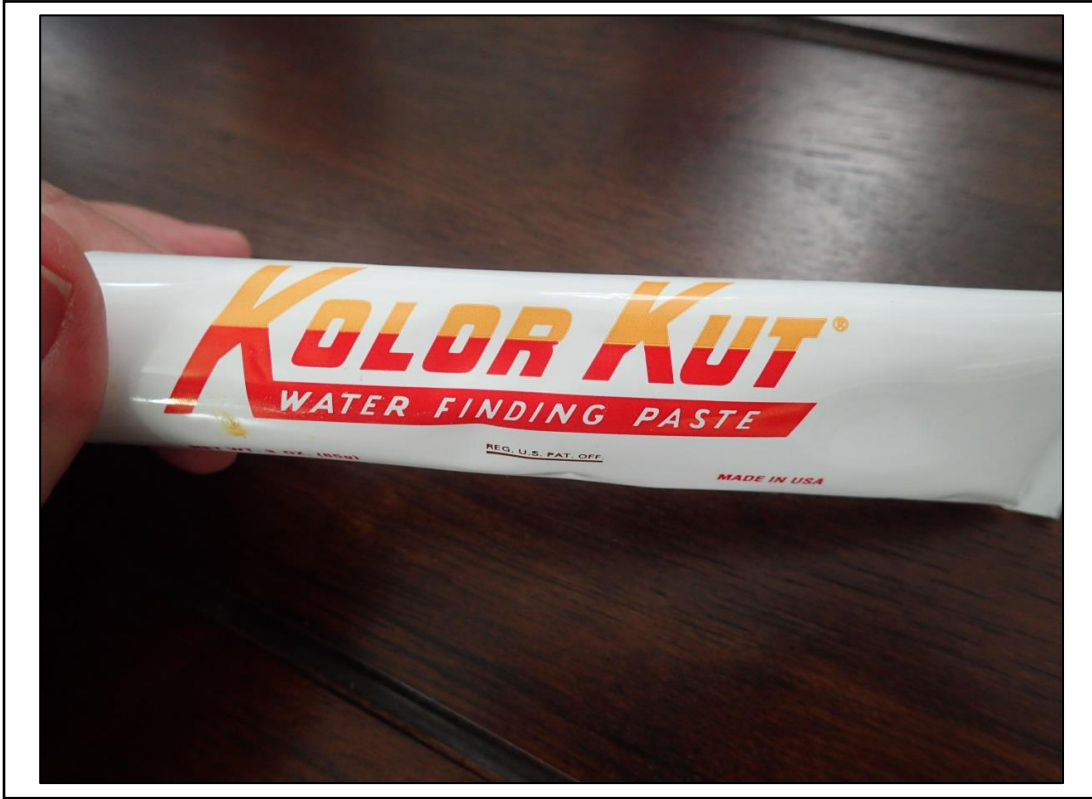
19. The firewall mounted electric fuel boost pump was not located with the wreckage.
20. The firewall mounted Parker 1J18-4 sn 2BH11 fuel filter/ gascolator was found separate from the airframe. It contained a small amount of liquid. The filter was opened and disassembled revealing the four filtration wafers. Each wafer had a whitish in color contaminant adhering to the wafer. The liquids were drained into glass jars and stored by this author pending further disposition.

21. The fuel control was removed from the engine and its fuel filter was opened revealing more liquid contaminants. The liquids were drained into glass jars and stored by this author pending further disposition.

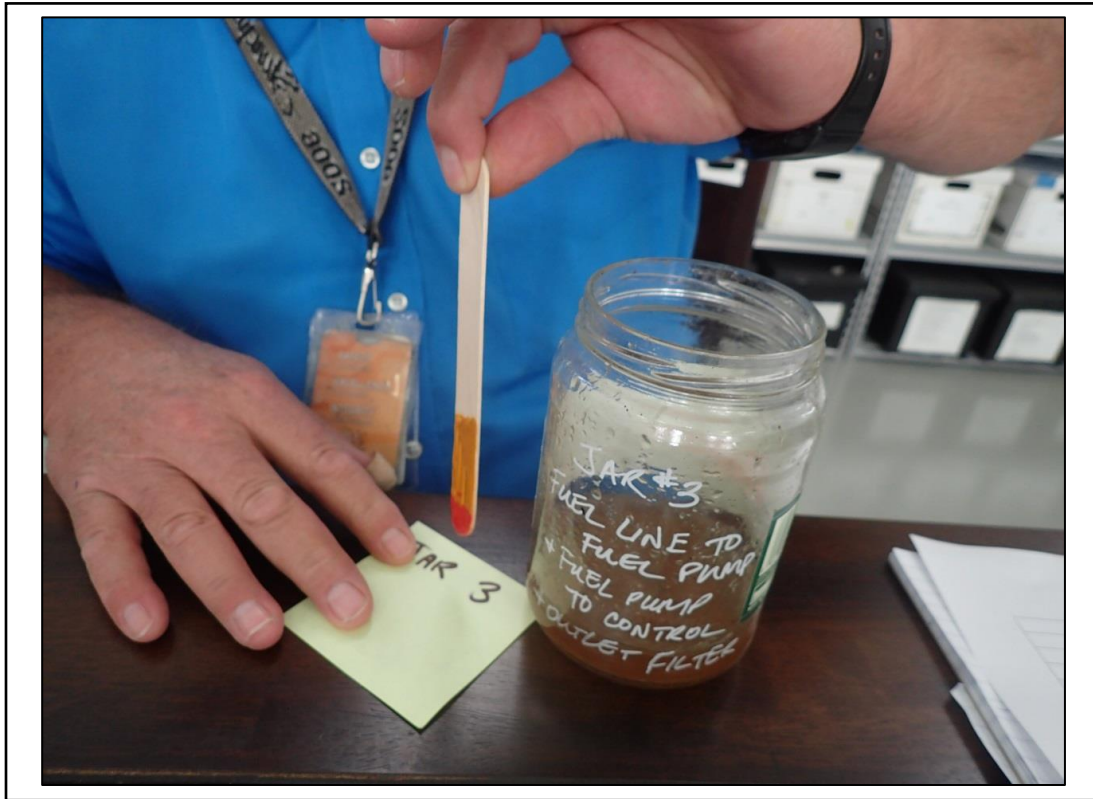
22. On June 17, 2017, inspectors from the St. Louis FSDO met at my office and performed a test for water using a Kolor Kut water finding paste test on the subject samples from the fuel control and fuel filter. All samples tested positive for water contamination.

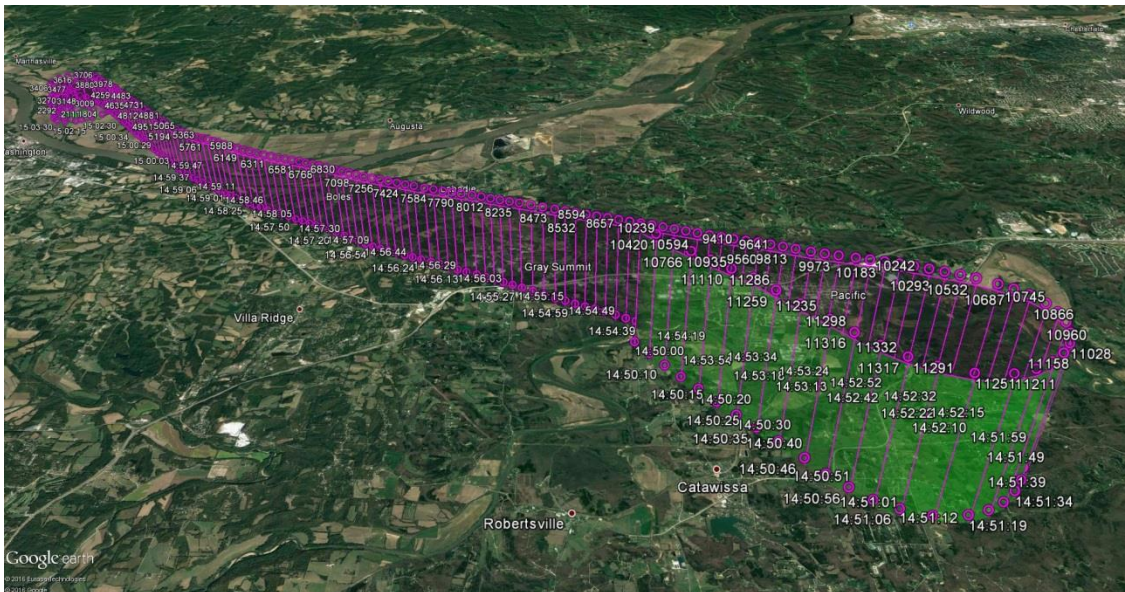
1. An exemplar Lancair Evolution was flown by this author to replicate the glide portion of the accident flight. The test demonstrated that if the aircraft was flown at best glide airspeed of 110 KIAS and with landing gear and flaps UP with the propeller feathered per the POH that the aircraft would arrive over the airport at approximately 3500' AGL achieving a glide ratio of approximately 18:1. The flight test also demonstrated that if the propeller was not feathered, and the aircraft was flown with the landing gear and flaps UP at best glide speed of 110 KIAS with a glide ratio of 13.5:1, the airport was also within glide range.
