Report Issued: October 31, 1996

Report #: 413.62-96.34

Laboratory Test Report

SUBJECT: LEAK IN GAS LINE DFM-3, BETWEEN SANTA CRUZ AND DAVENPORT

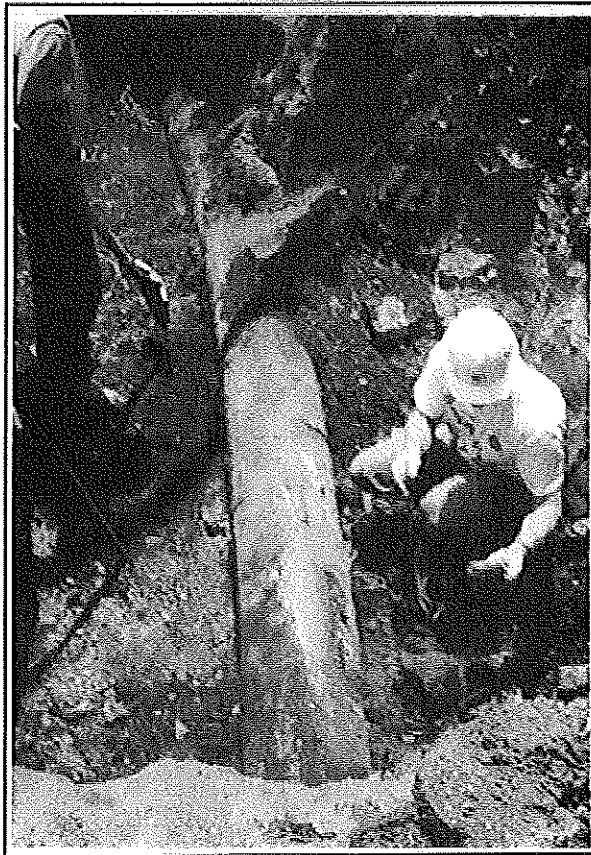
In June of 1996 a leak was discovered during a walk-down of the DFM-3 gas line, between Santa Cruz and Davenport (installation year 1957). The leak was located in a section of pipe where the line had been field bent to transit down an embankment (Figure 1). After excavation, the TES Welding and Inspection Services Unit performed visual, wall thickness and x-ray inspection of an eight foot section. No evidence of pitting or other wall loss due to corrosion was found. Wet fluorescent magnetic particle examination found a linear indication that ran longitudinally along the pipe and encompassed all six leak sites (Figures 2 and 3). It was recommended to remove the entire spool piece. The section that had been inspected was sent to the TES Metallurgy Lab for evaluation.

Figure 1 (left). DFM-3 pipe while being excavated. Note bend in pipe necessary to transit down embankment.

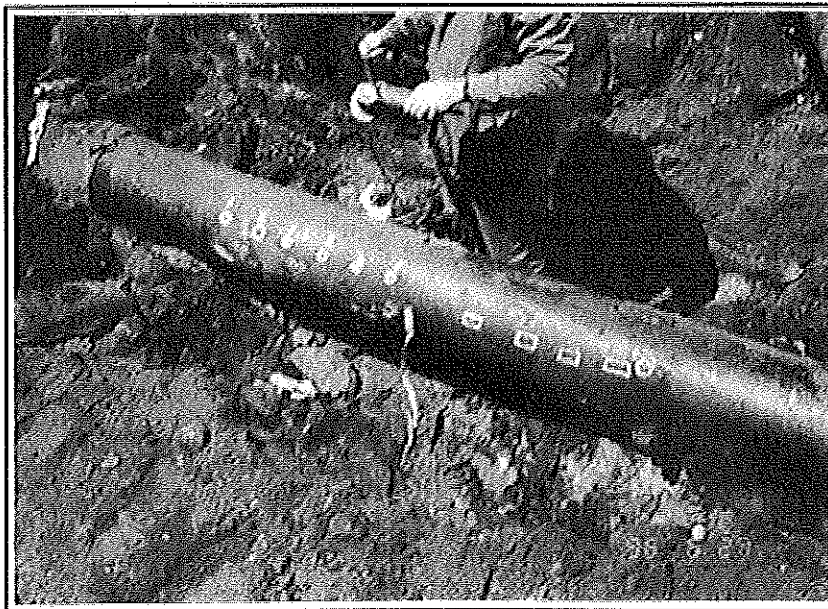
Figure 2 (bottom). Pipe during inspection. White round circles indicate leaks. Note their linear arrangement along the longitudinal axis of the pipe.

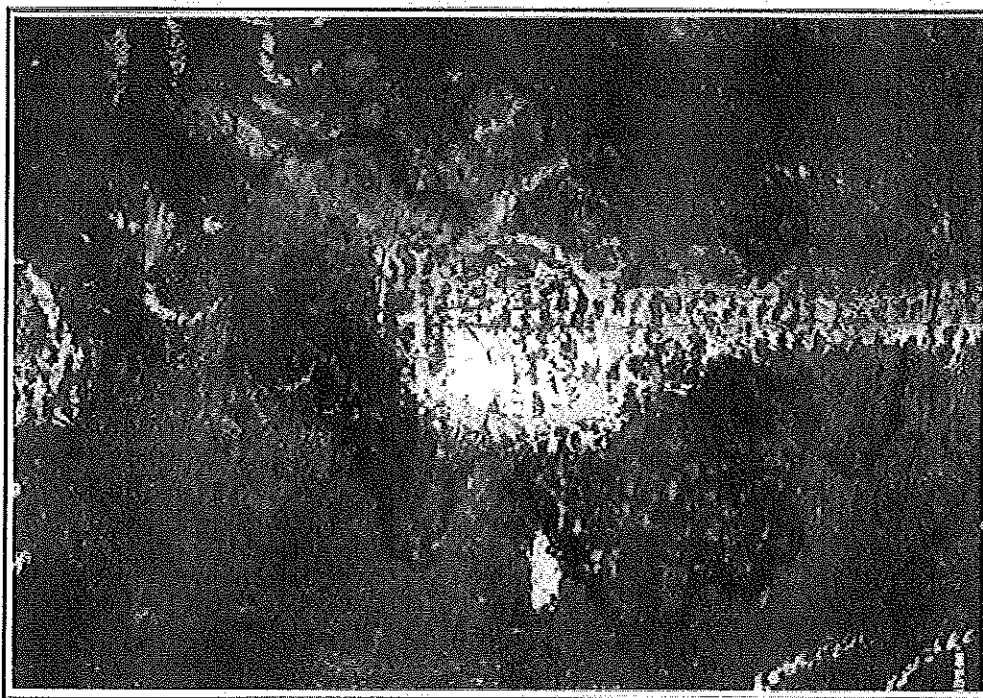
Three cross-section were taken through the linear indication in order to characterize the leak. It was discovered that the leaks are associated with the longitudinal weld of the pipe. The pipe was formed by forge welding, a method where a sheet is formed into a pipe and the longitudinal edges, each with a single bevel, are forge-welded together. The pipe is then usually cold or hot expanded to its final diameter and the weld is not evident anymore. Although no through-wall leak was seen in the cross-sections, several areas with lack of bonding were noted along the forge weld (Figures 4 and 5). It is likely that these are scale or oxide inclusions that were not expelled from the weld during manufacturing.

Figure 3. Close-up of linear indication. It runs left to right, about midway through the picture.

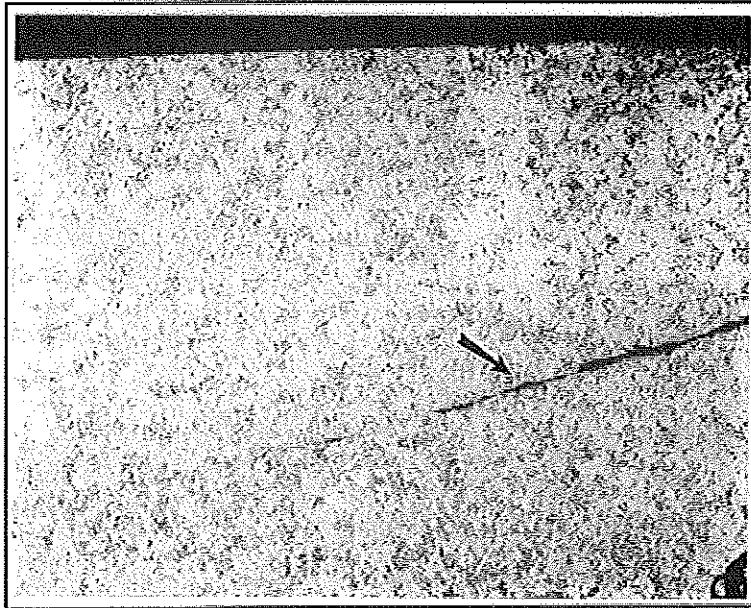
- The pipe meets the tensile specifications for API 5L Grade X42.
- It was forge welded (not seamless).
- The leaks occurred along the weld. Metallographic cross-sections showed that there were areas of disbonding due to scale or oxide inclusions. This is a common defect in forge welds.
- Because no evidence of corrosion was found, it is possible that the leaks were created when the pipe was field bent.

Figure 4. Metallographic cross-section through defect area. Arrow points towards linear defect along forge weld. This delamination is most likely due to scale on the bevel surface.

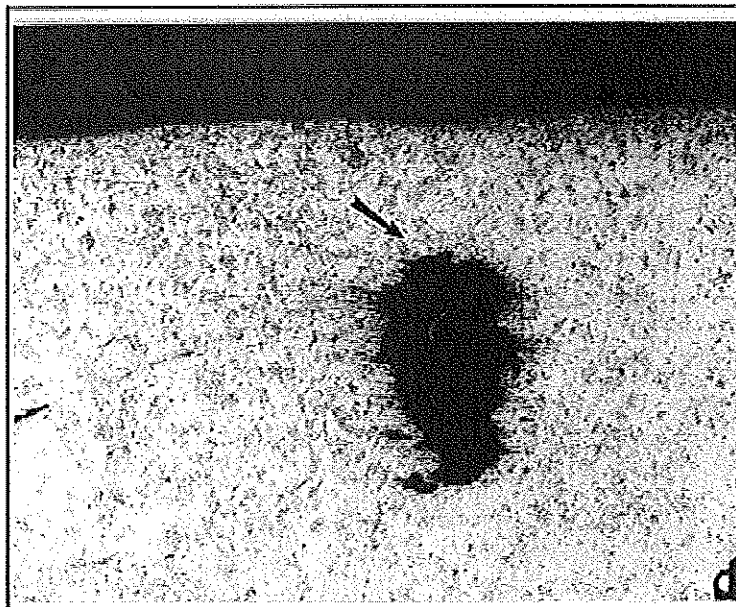
Figure 5. Another defect seen on the forge weld. this is most likely due to a slag inclusion. Index marks on the outside of the picture indicate location of forge weld (both pictures 15X, nital etch).
