Continental Motors

ENGINE FIELD INSPECTION REPORT

ENGINE MODEL	IO470D (15)
ENGINE SERIAL NUMBER	105176
AIRCRAFT MAKE & MODEL	Cessna 310F
AIRCRAFT SERIAL NUMBER	310-0070
AIRCRAFT REGISTRATION	N6770X
CMI FILE NUMBER	15-562

EXAMINATION		ACCIDENT DATA	
DATE	5-7-2016	NTSB ACCIDENT #	CEN16FA172
FACILITY	Pulaski Technical College-A&P School	NTSB INVESTIGATOR	Todd Fox
ADDRESS	[REDACTED] North Little Rock, AR North Little Rock Municipal Airport	FAA INVESTIGATOR	Brian Love
		ACCIDENT DATE	5-5-2016
		ACCIDENT LOCATION	North Little Rock Municipal (ORK)

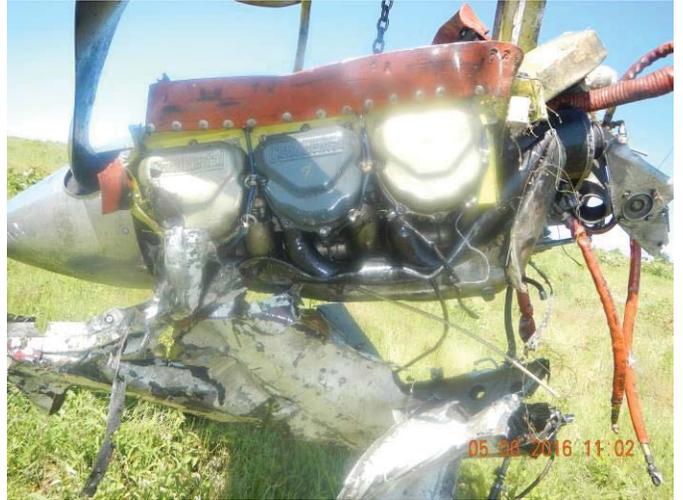
EXHAUST SYSTEM

The exhaust risers and collector were crushed upward due to impact forces

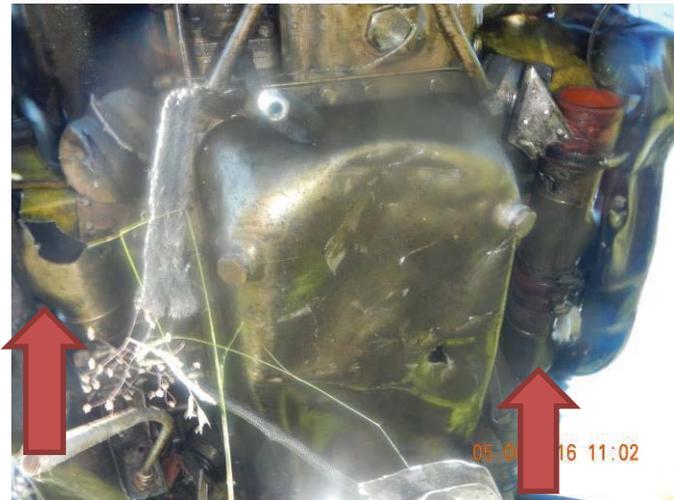
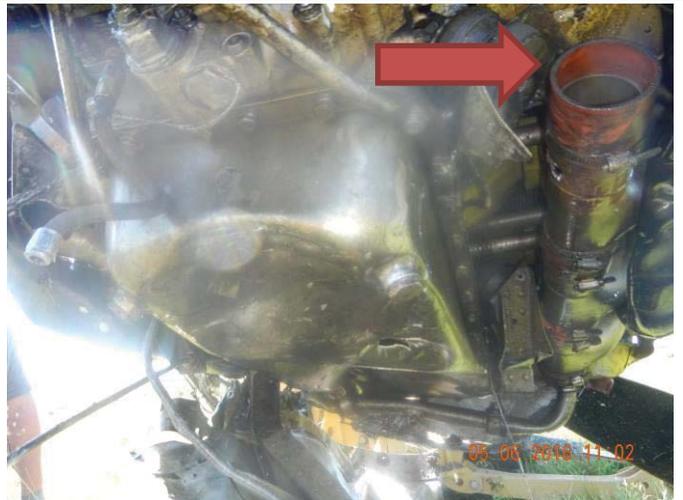
INDUCTION SYSTEM

Red arrows indicate broken and missing induction system components

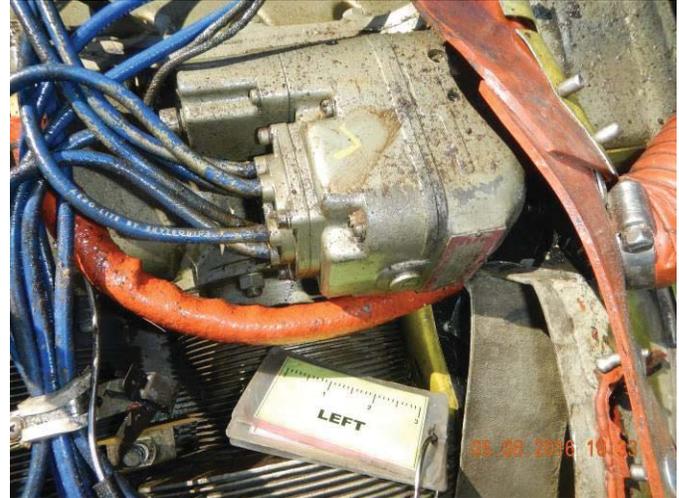
LEFT MAGNETO

Condition: The left magneto remained attached and intact. The magneto was removed from the engine, bench tested and found to be functional

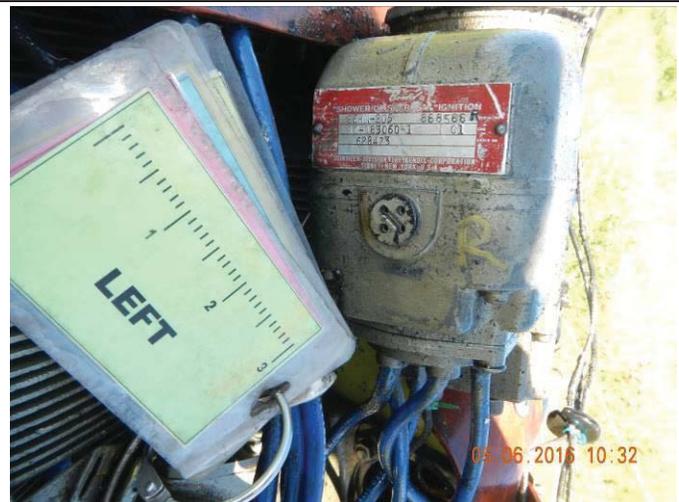
RIGHT MAGNETO

Condition: The right magneto separated from its mount but remained attached to the ignition harness. The magneto was removed from the engine and bench tested. The magneto was found to be functional.

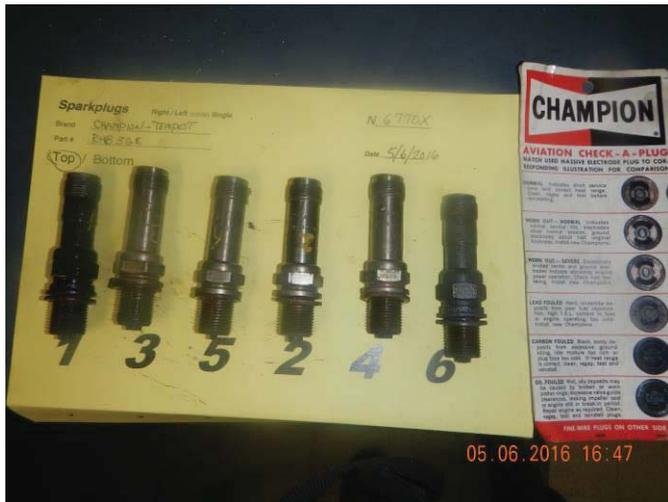
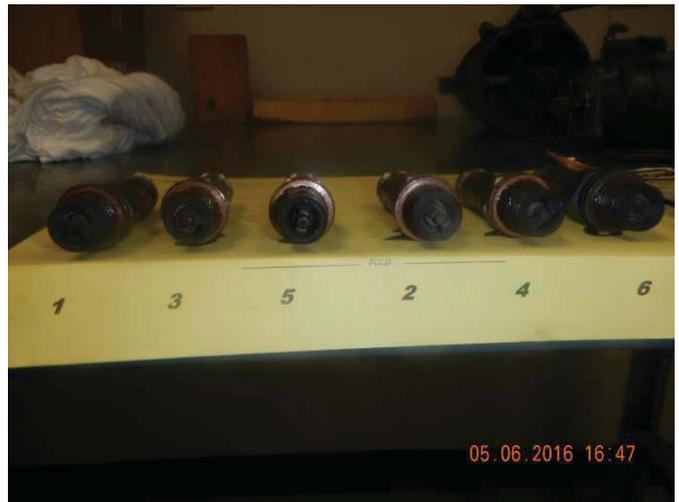
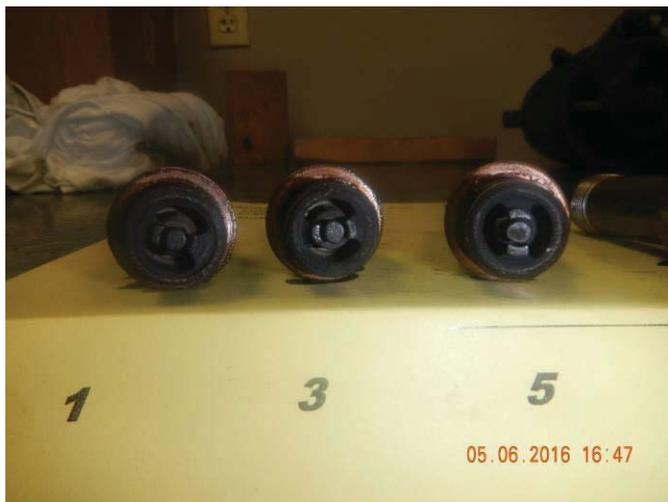
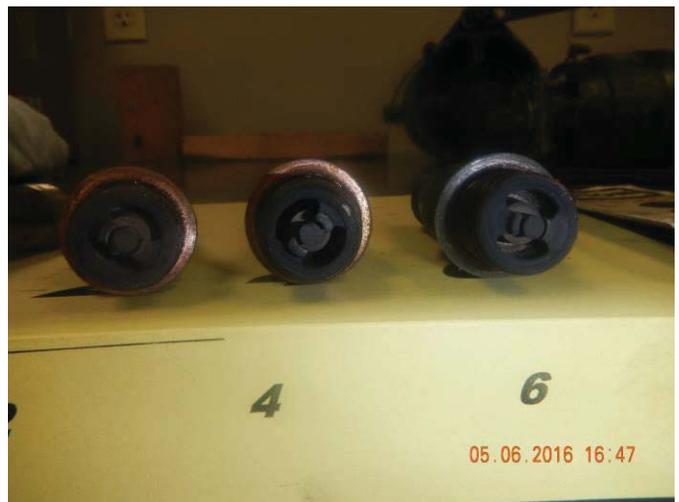
SPARK PLUGS	Manufacturer: Mixture of Champion and Tempest brand	P/N: RHB32E - Champion P/N URHB32E - Tempest	
Condition:	Normal to worn-out normal, according to a Champion Check A Plug chart. All sparkplugs were dark in color.

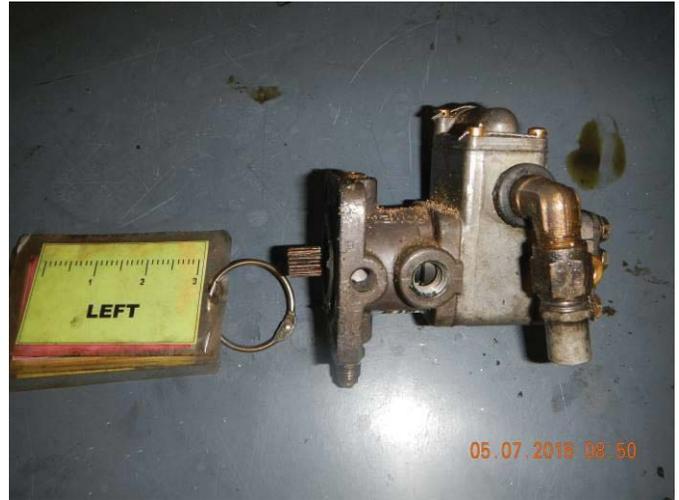
FUEL PUMP

The fuel pump rotated smoothly when manually rotated. Fuel was present in the fuel hoses and the drive gear was intact

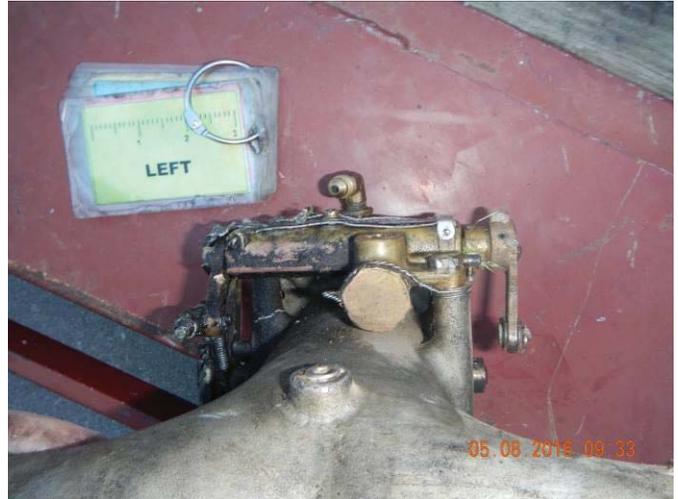
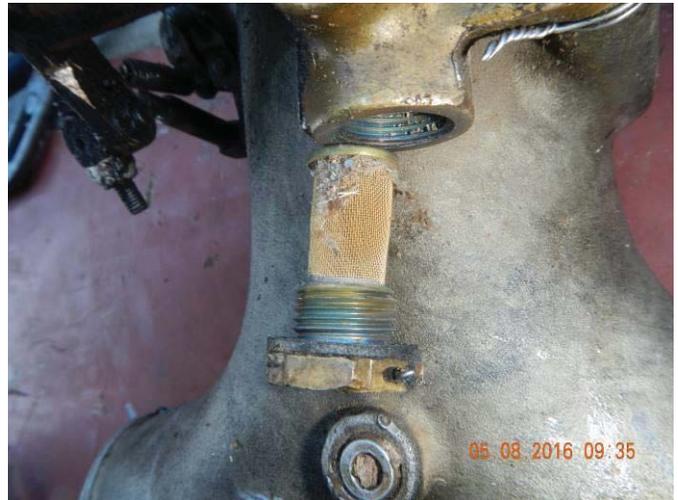
THROTTLE BODY METERING UNIT

The fuel screen was removed and a small amount of lint-like contaminate was present. The throttle plate was frozen in the wide open position.

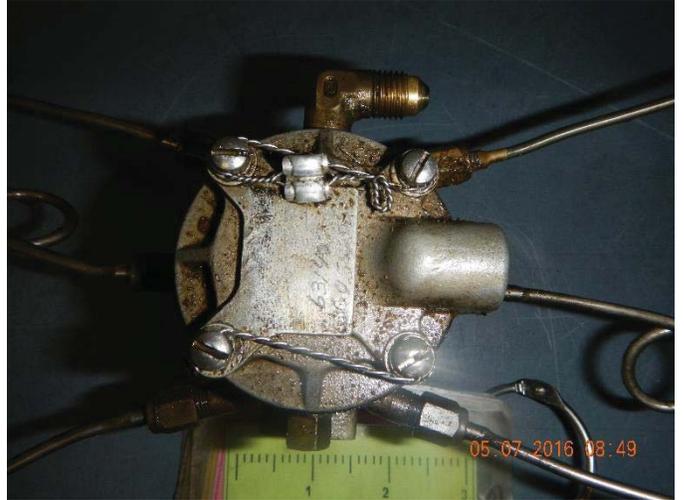
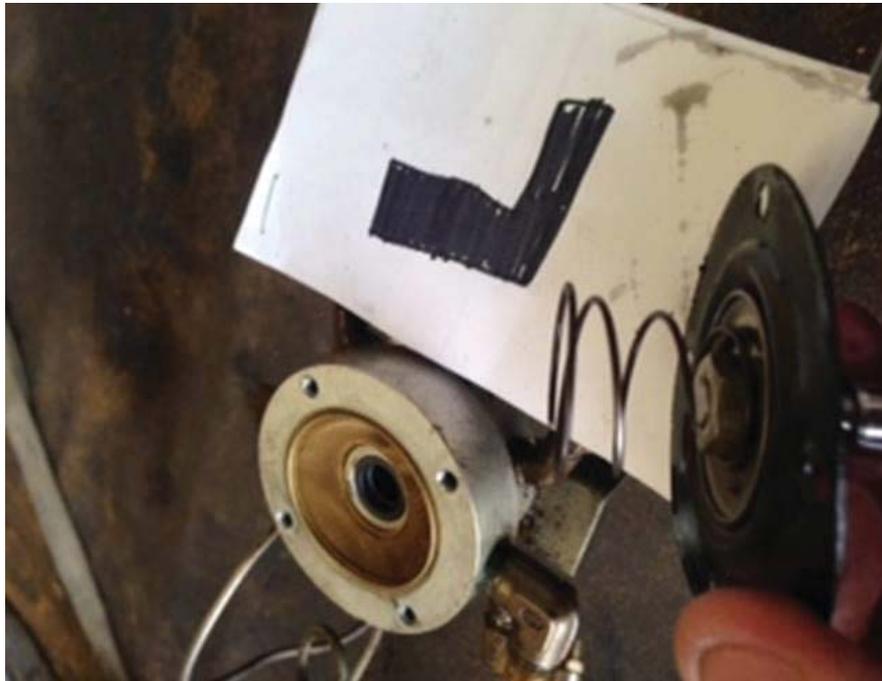
FUEL MANIFOLD VALVE	Manufacturer: TCM Overhauled in the field	P/N: 631427	S/N: 6057208
Condition:	The manifold contained uncontaminated fuel. All components were intact and the fuel screen was uncontaminated.

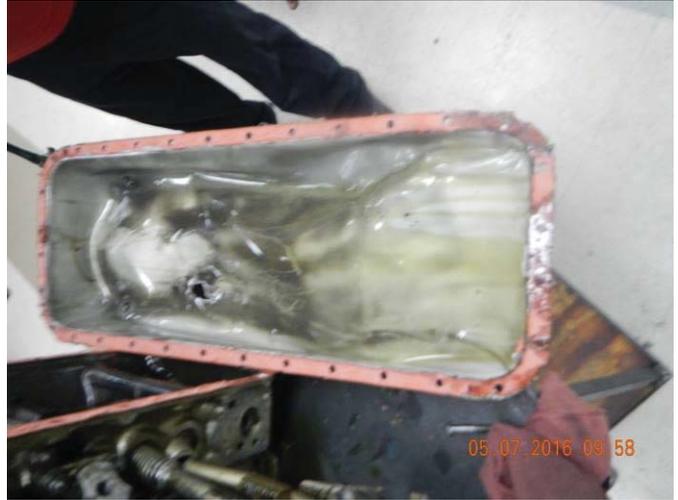
OIL SUMP

Both left and right exhaust components exhibited impact damage. Both left and right induction tubes and elbows remained intact with the exception of the left and right rear wye pipes which separated. The forward induction balance tube was impact damaged. The engine oil sump was damaged due to contact with the ground.

Condition: The oil sump received impact damage

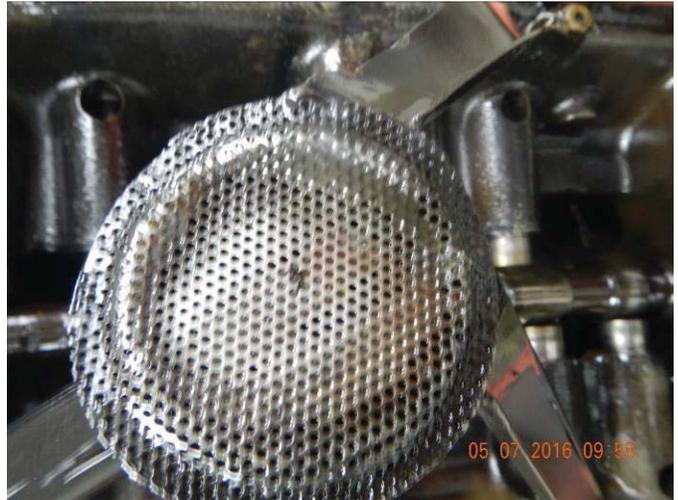
**OIL PICK-UP
TUBE &
SCREEN**

Condition: The screen was intact and contained only a small amount of contaminant

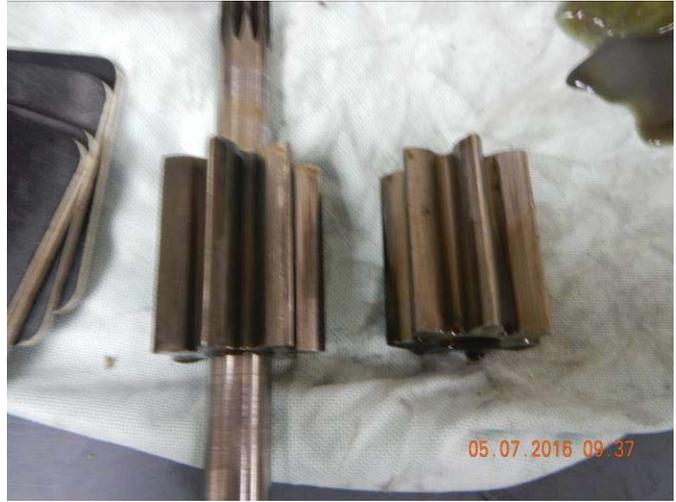
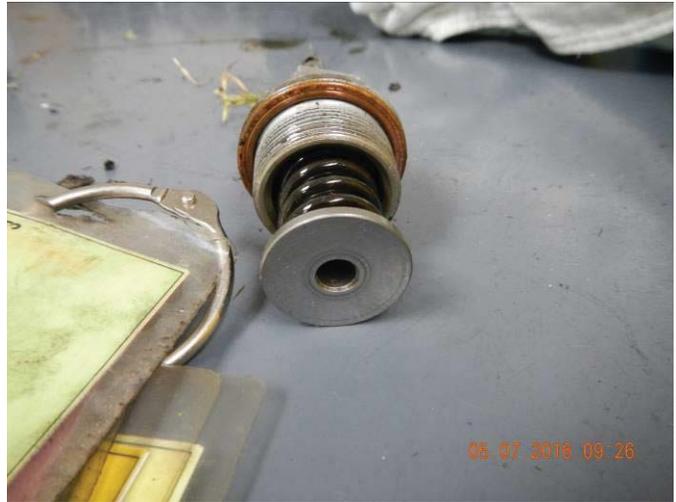
OIL PUMP

The oil pump was disassembled and showed no evidence of hard particle passage

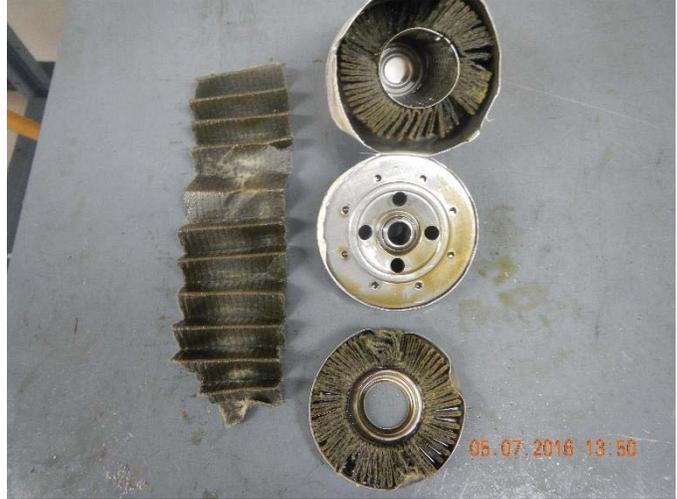
OIL FILTER	Manufacturer: Tempest	P/N: AA48110-2
Condition:	The outer shell was impact damaged. The filter was opened and inspected for contaminants. Only a small amount of contaminant consistent with carbon was noted. No metal was found.

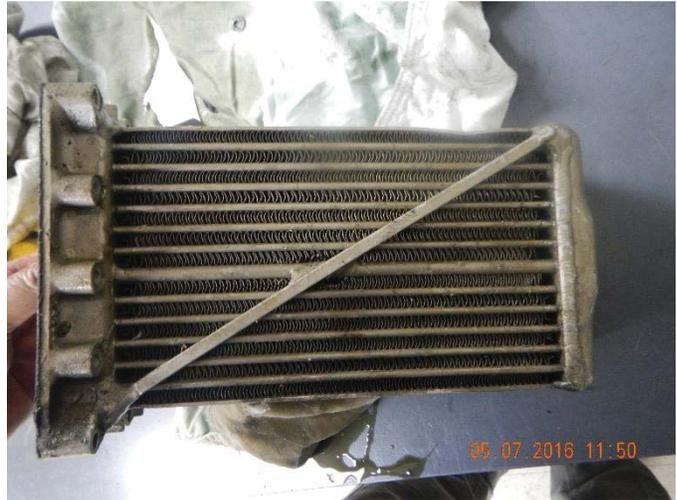
OIL COOLER	Manufacturer: Undetermined	P/N: Undetermined	S/N: Undetermined
Condition:	The oil cooler did not display impact damage. The data tag was missing.

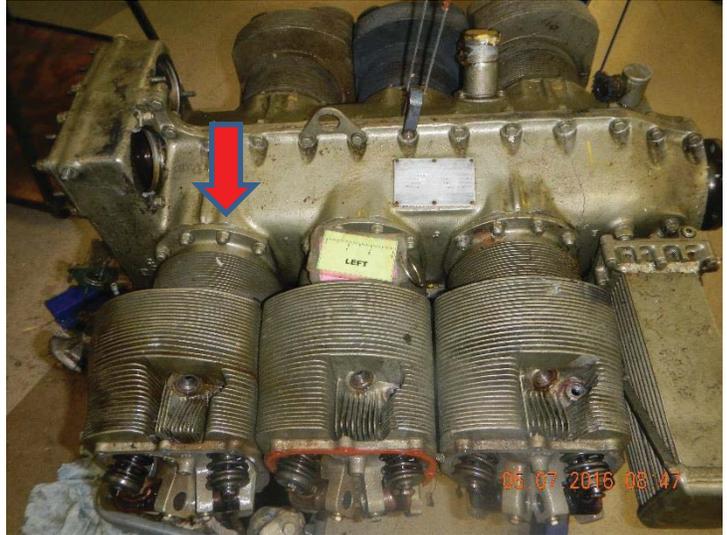
CYLINDER #1	P/N: 186072	S/N: Undetermined	Head Date: Undetermined
Work Orders:	Undetermined		
Condition:	No damage was noted. Red arrow points to cylinder 1

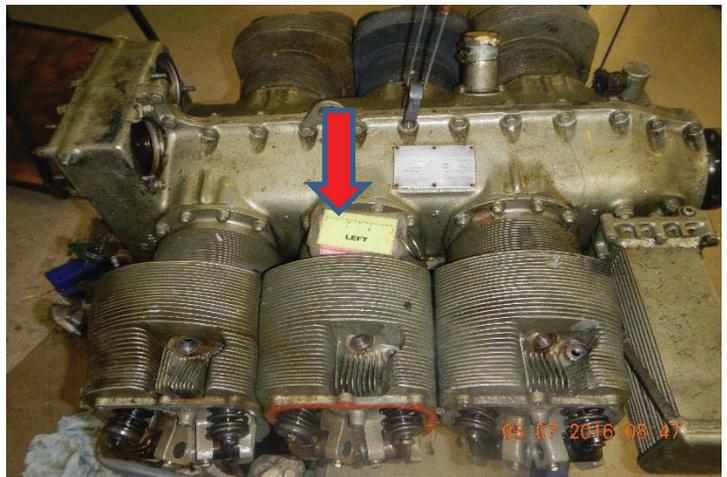
NOTE: The log book entry above indicates that the number 3 cylinder was removed and repaired. The post-accident inspection of this engine reveals that the number 4 cylinder appeared to have had fresh gray paint applied and the number 3 cylinder did not appear to have been removed or installed recently. One of the #4 cylinder base attachment nuts was not an approved part.

CYLINDER #3	P/N: Undetermined	S/N: Undetermined	Head Date: Undetermined
Work Orders:	Undetermined		
Condition:	No damage was noted. Red arrow points to cylinder 3. This cylinder does not appear to have been recently installed.

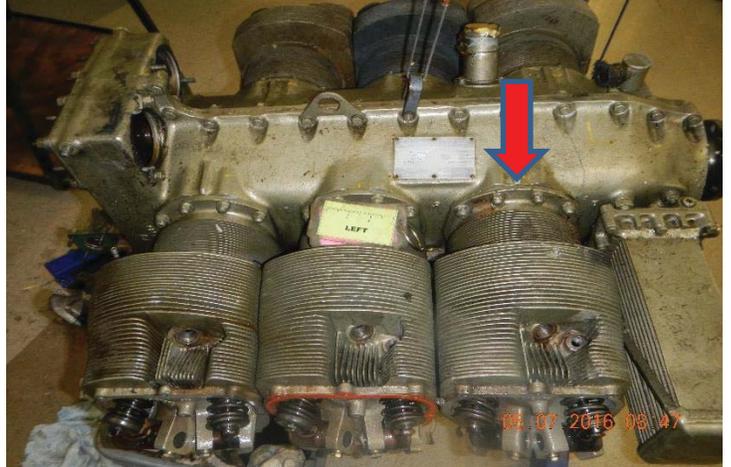
CYLINDER #5	P/N: 649166	S/N: Undetermined	Head Date: 10-91
Work Orders:	Undetermined		
Condition:	Minor damage to the cooling fins was evident. The red arrow points to cylinder 5

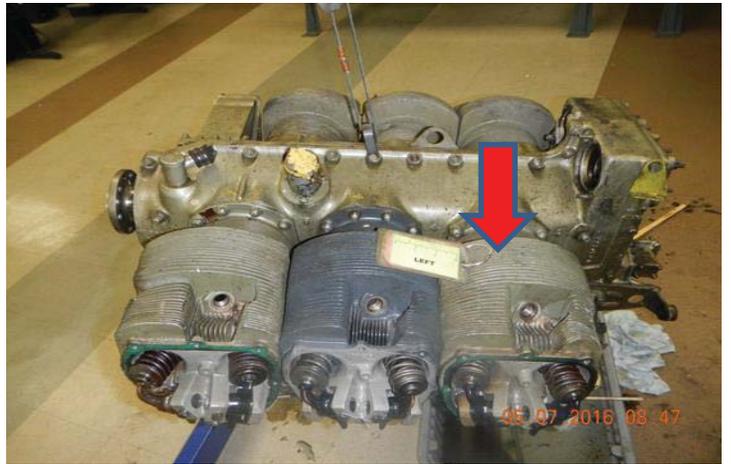
CYLINDER #2	P/N: 538288	S/N: Undetermined	Head Date: Undetermined
Work Orders:	J9590-4		
Condition:	No damage was noted. Red arrow points to cylinder 2

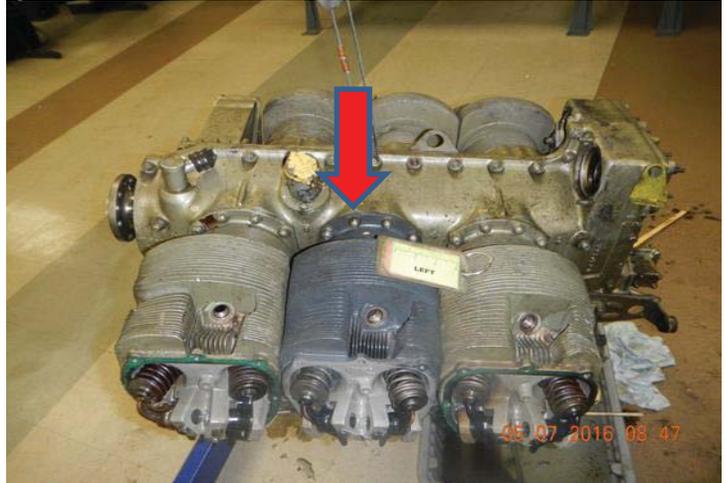
CYLINDER #4	P/N: Undetermined	S/N: 1140S6A	Head Date: Undetermined
Work Orders:	C1561		
Condition:	No damage was evident. This cylinder appears to have been freshly painted and installed recently. One lower deck stud nut was unapproved hardware.

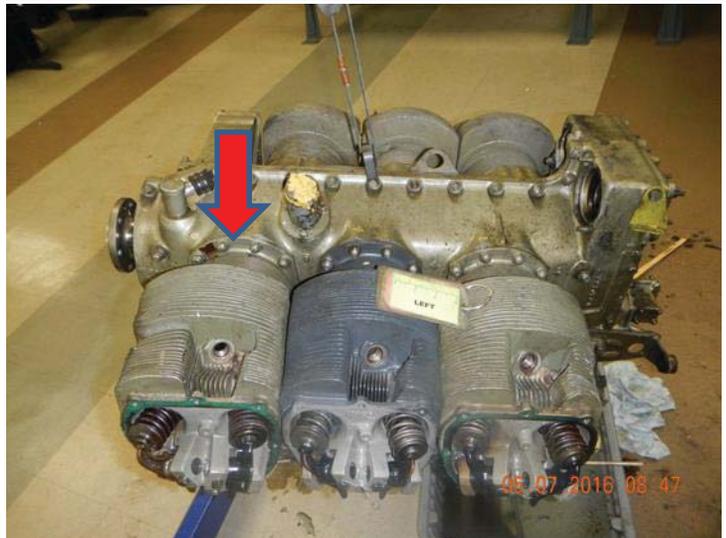
Cylinder # 6 rocker box cover was damaged and small section of the rocker box separated. All other rocker box covers remained intact and attached to its prospective cylinder. Forward cooling fins were impact damaged.

CYLINDER #6	P/N: Undetermined	S/N: Undetermined	Head Date: 10-94
Work Orders:	Undetermined-unreadable.		
Condition:	Minor impact damage was evident to cooling fins on the front of cylinder. Red arrow points to cylinder 6.

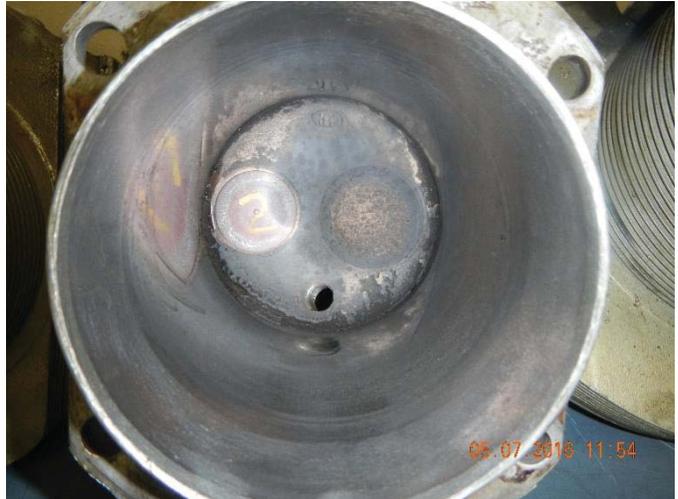
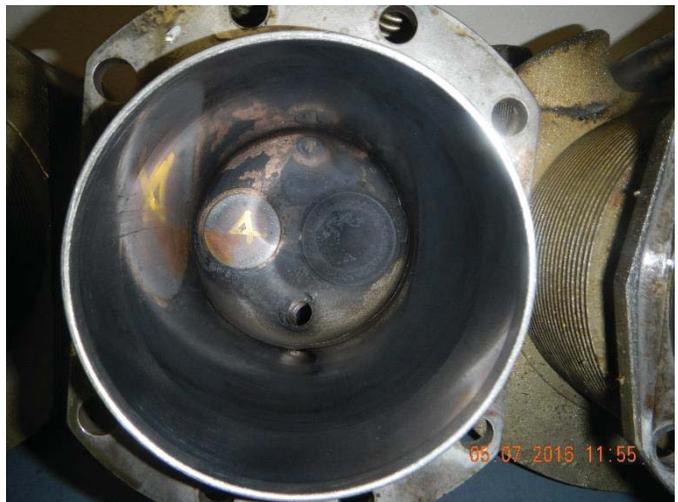
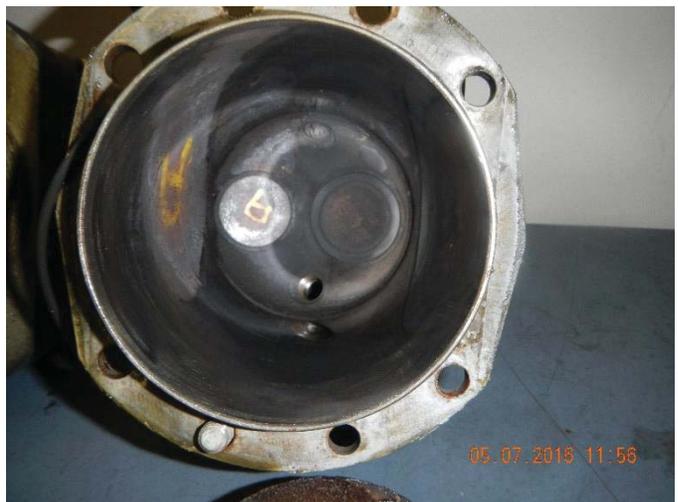
VALVES

All valves were intact and exhibited normal combustion signatures

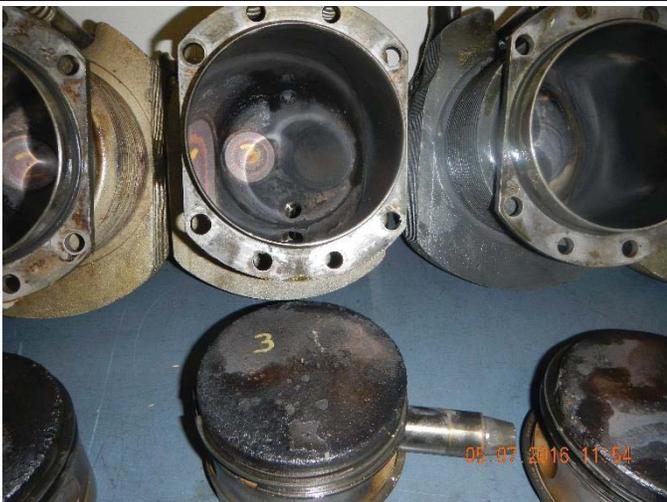
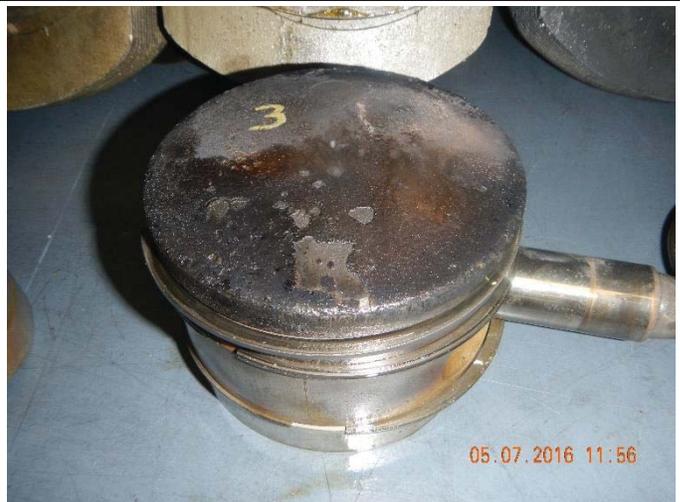
**#3 PISTON,
RINGS AND PIN**

The piston, piston rings and piston pin displayed normal combustion signatures and wear patterns.

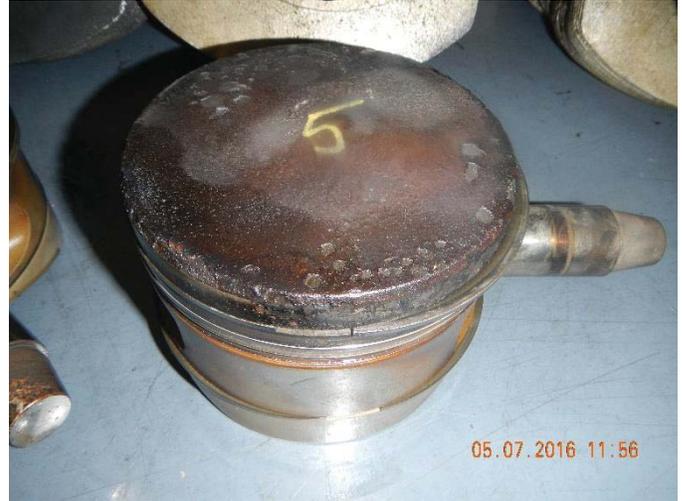
**#5 PISTON,
RINGS AND PIN**

The piston, piston rings and piston pin displayed normal combustion signatures and wear patterns.

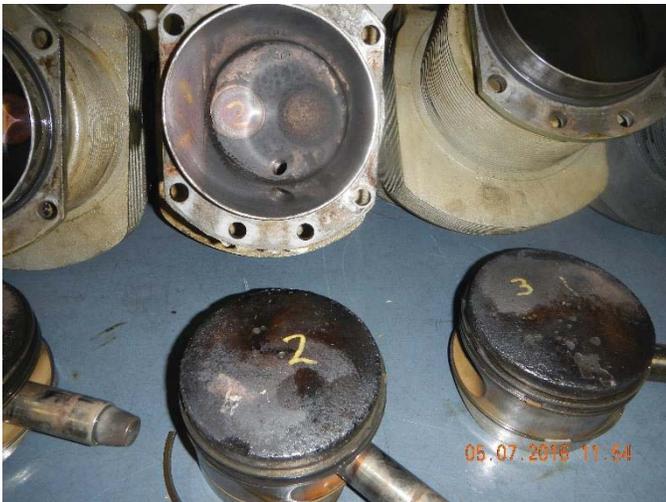
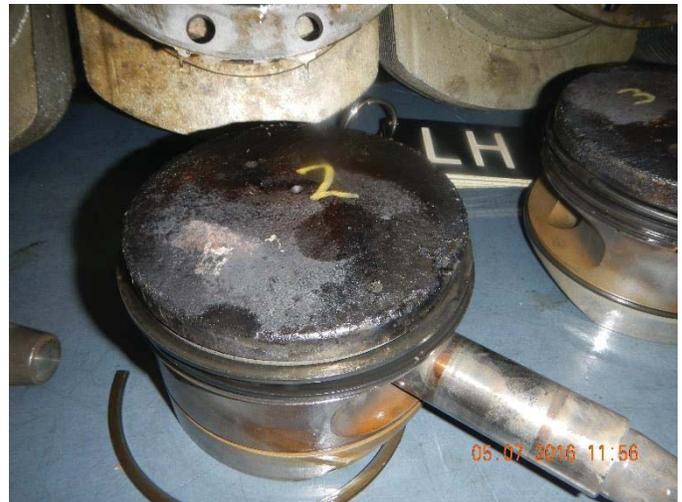
**#2 PISTON,
RINGS AND PIN**

The piston, piston rings and piston pin displayed normal combustion signatures and wear patterns.

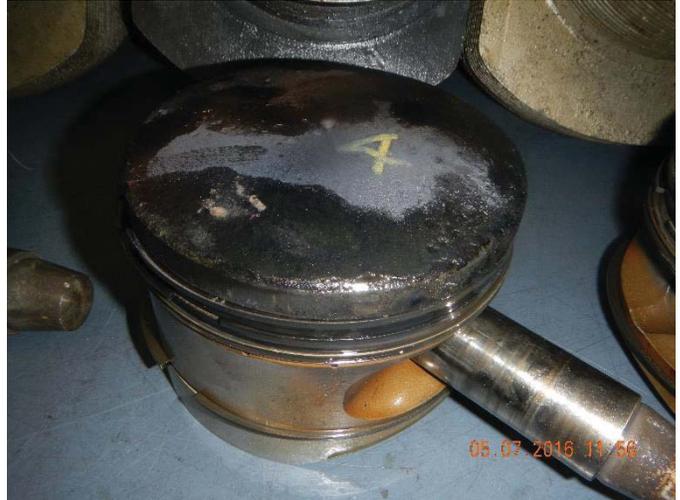
**#4 PISTON,
RINGS AND PIN**

The piston, piston rings and piston pin displayed normal combustion signatures and wear patterns.

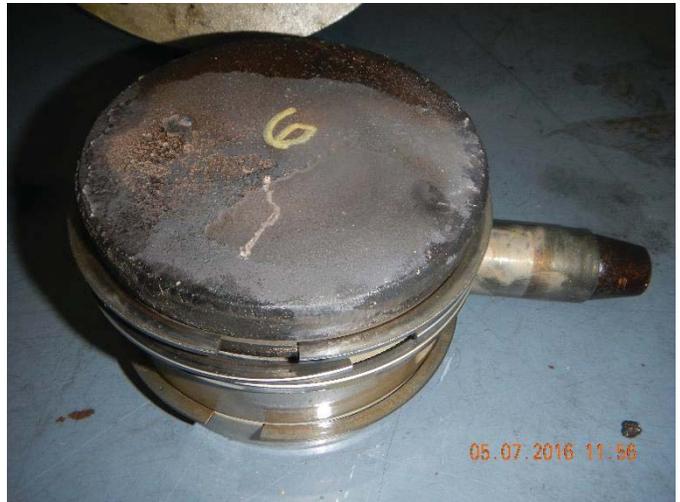
**#6 PISTON,
RINGS AND PIN**

The piston, piston rings and piston pin displayed normal combustion signatures and wear patterns.

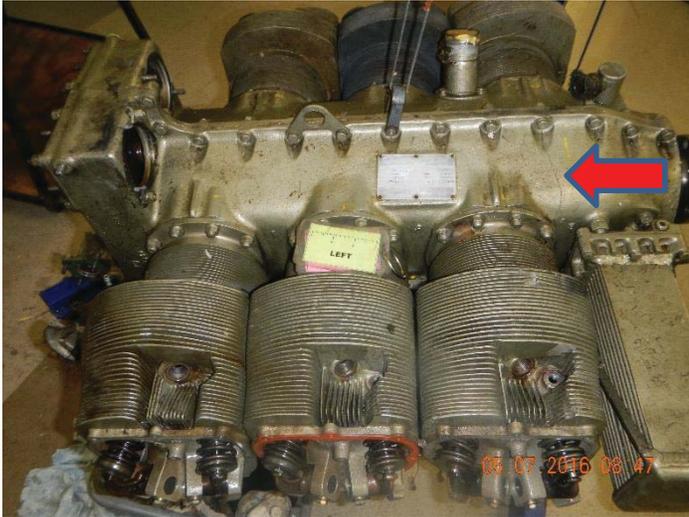
CRANKCASE

Condition: The crankcase was intact but with a crack on the right half (1-3-5 side) beginning at the top parting line and extending down to the mounting pad for cylinder # 5. A crack on the left crankcase half (2-4-6 side) extended from the top parting line to mounting pad for cylinder # 6. The red arrows point to the cracks.

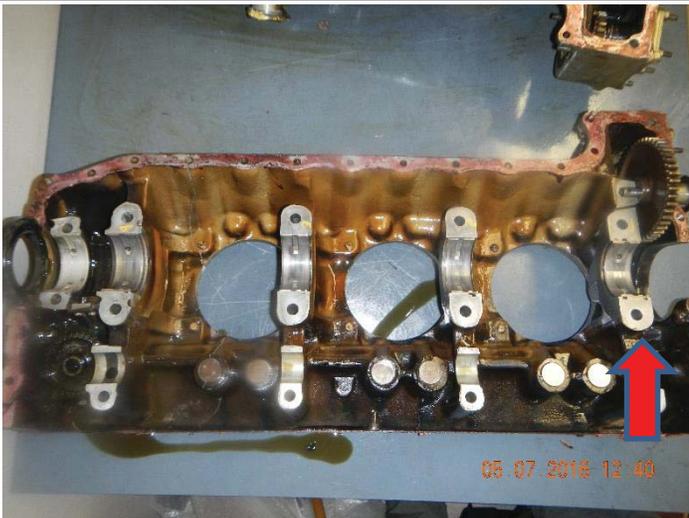
#1 MAIN BEARINGS

Condition: The main bearings exhibited normal wear signatures. Red arrow points to # 1 main bearing.

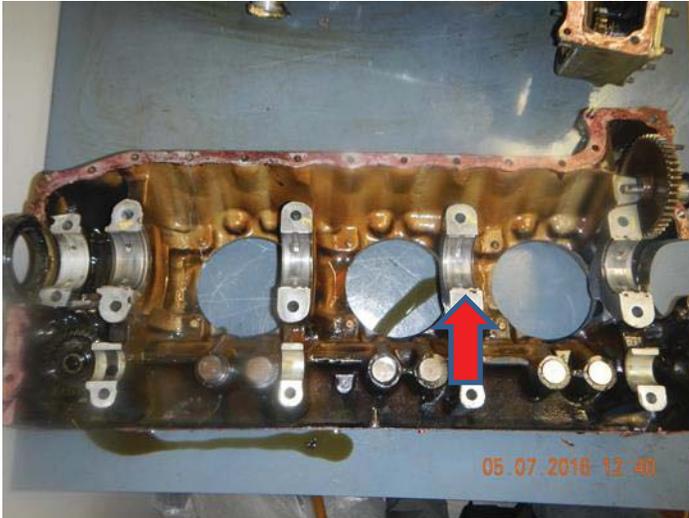
#2 MAIN BEARINGS

The main bearings exhibited normal wear signatures. Red arrow points to # 2 main bearing.

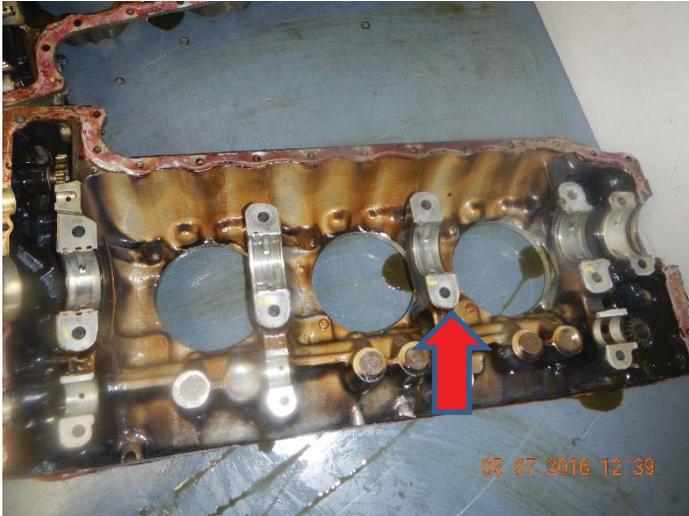
#3 MAIN BEARINGS

The main bearings exhibited normal wear signatures. Red arrow points to # 3 main bearing.

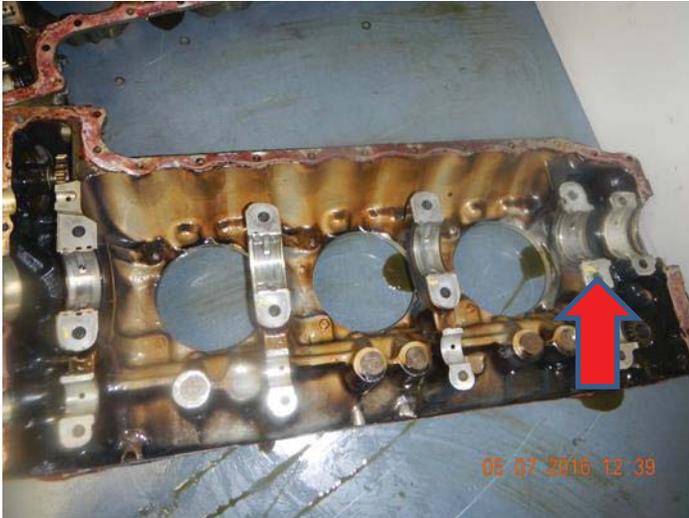
#4 MAIN BEARINGS	P/N: SA630464-MO10	Date Code: 10-00
-------------------------	--------------------	------------------

Condition: The main bearings exhibited normal wear signatures. Red arrow points to # 4 main bearing.

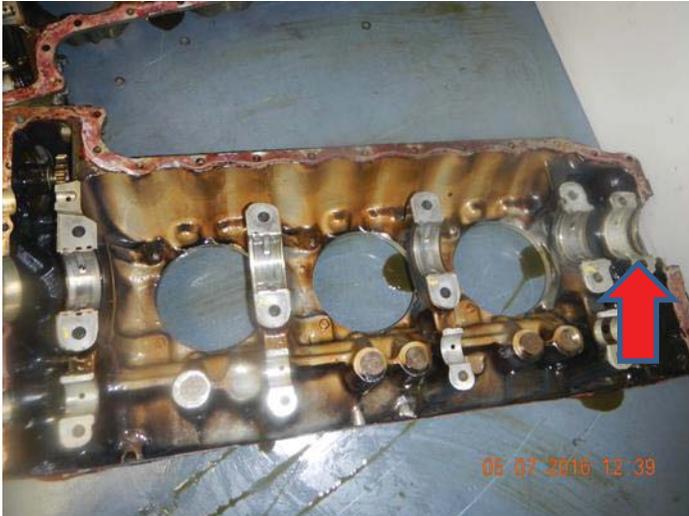
#5 MAIN BEARINGS	P/N: SA530386-MO10	Date Code: 2-03
-------------------------	--------------------	-----------------

Condition: The main bearings exhibited normal wear signatures. Red arrow indicates main bearing # 5.

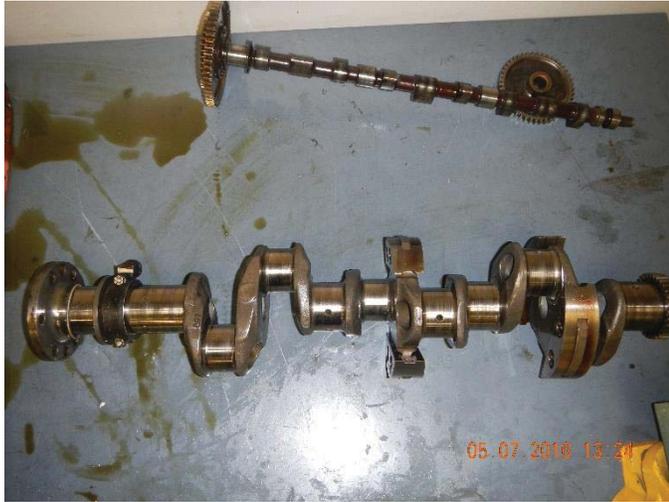
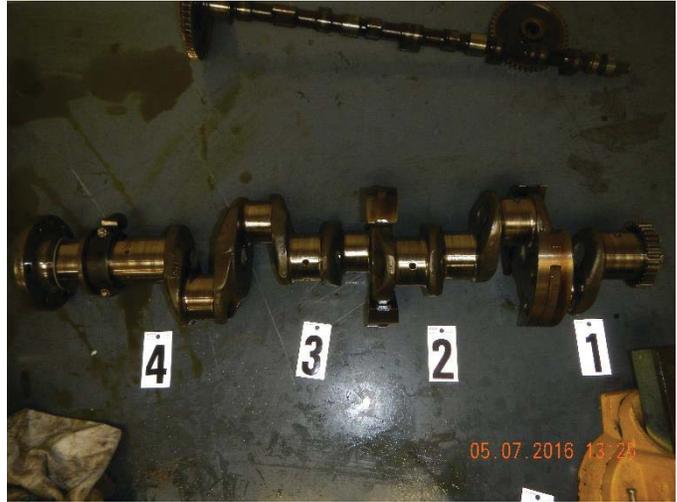
Condition: The crankshaft appeared to be undamaged.

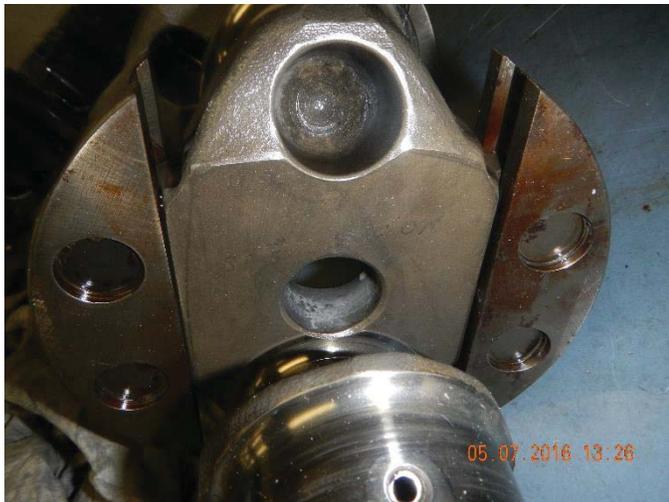
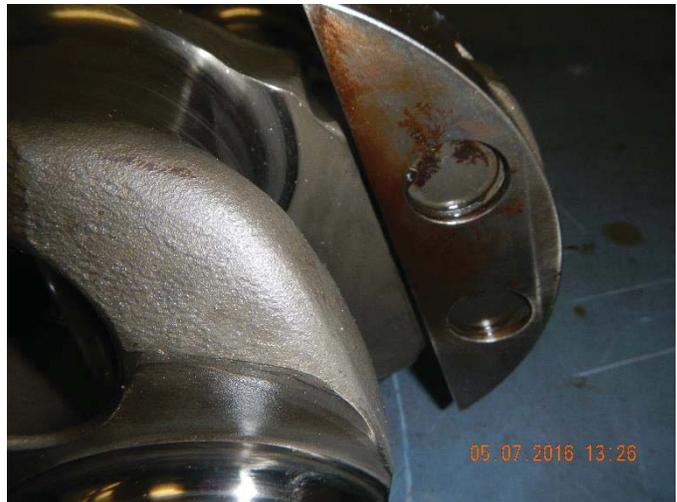
Condition: Counter weights were intact and moved freely on pins

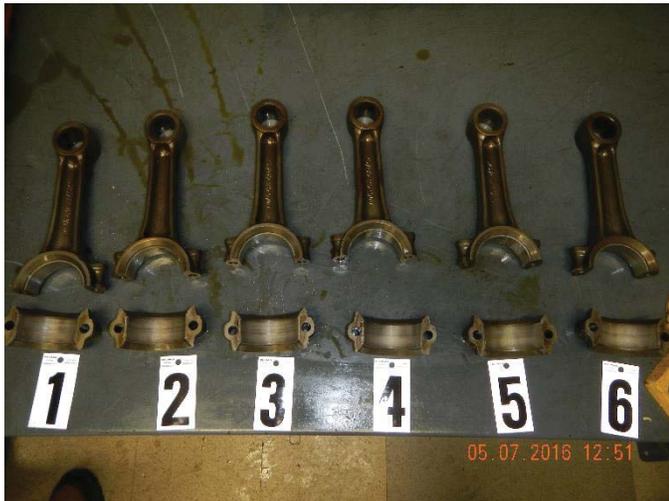
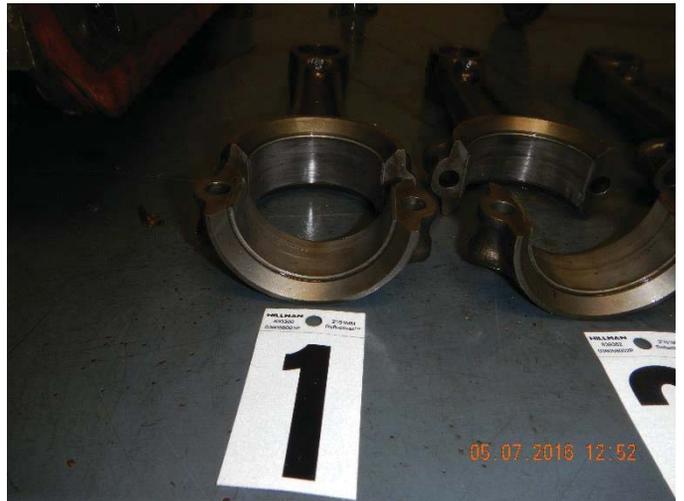
#1 CONNECTING ROD	P/N:655910	Forging or Serial Number: 40742
Condition:	Normal wear appearance	
#1 CONNECTING ROD BEARING	P/N: SA630826-MO10	
Condition:	Normal wear exhibited

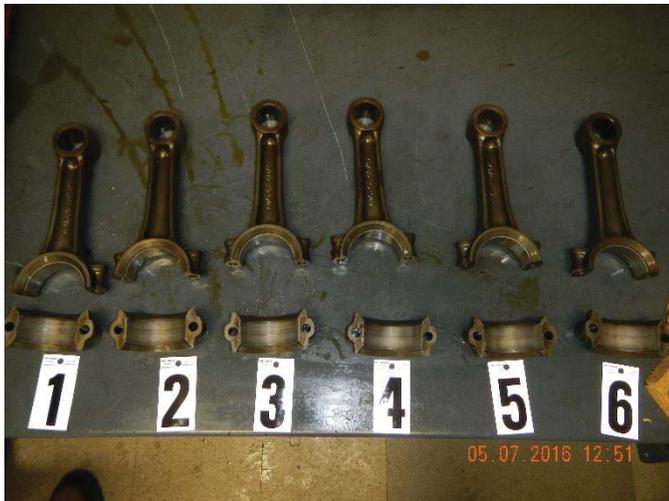
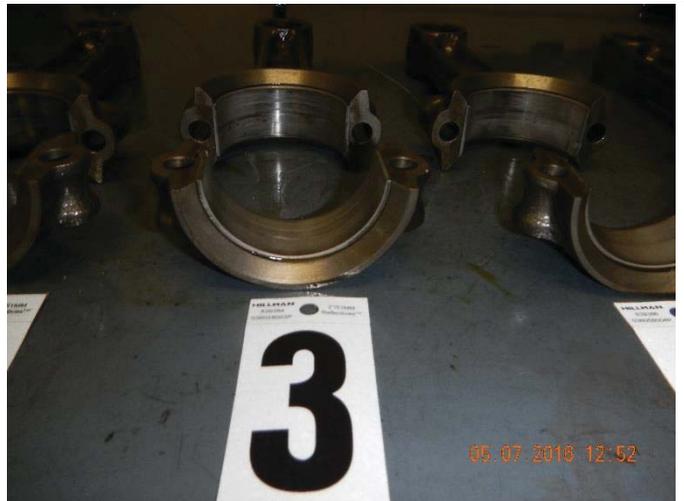
#3 CONNECTING ROD	P/N: 655910	Forging or Serial Number: 40742
Condition:	Normal wear appearance	
#3 CONNECTING ROD BEARING	P/N: SA630826-MO10	
Condition:	Normal wear exhibited

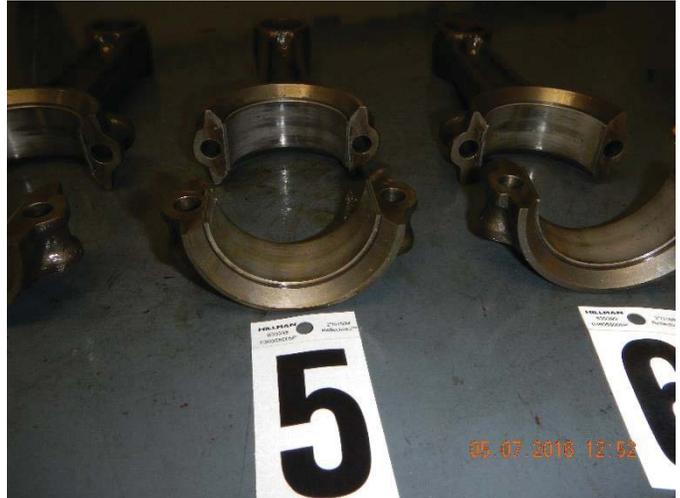
#5 CONNECTING ROD	P/N: 655910	Forging or Serial Number: 40742
Condition:	Normal wear appearance	
#5 CONNECTING ROD BEARING	P/N: SA630826-MO10	
Condition:	Normal wear exhibited

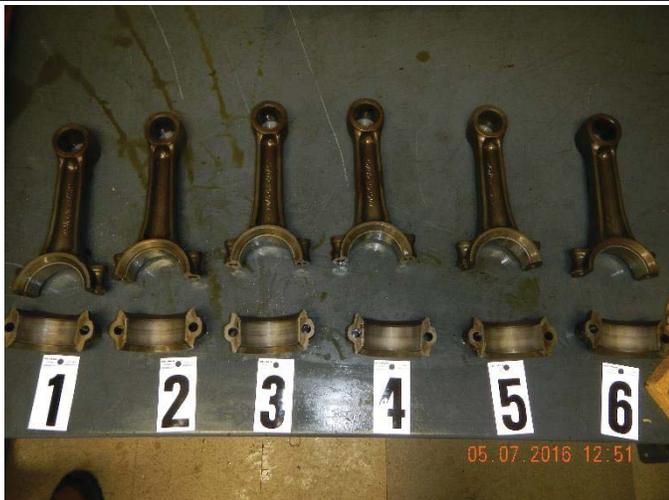
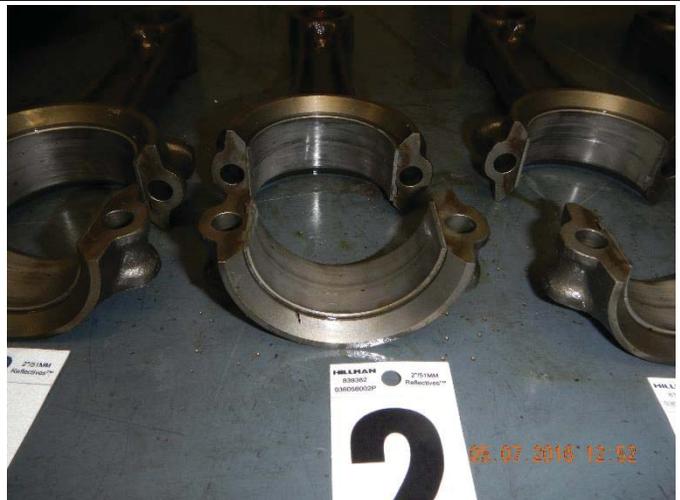
#2 CONNECTING ROD	P/N: 655910	Forging or Serial Number: 40742
Condition:	Normal wear appearance	
#2 CONNECTING ROD BEARING	P/N: SA630826-MO10	
Condition:	Normal wear exhibited

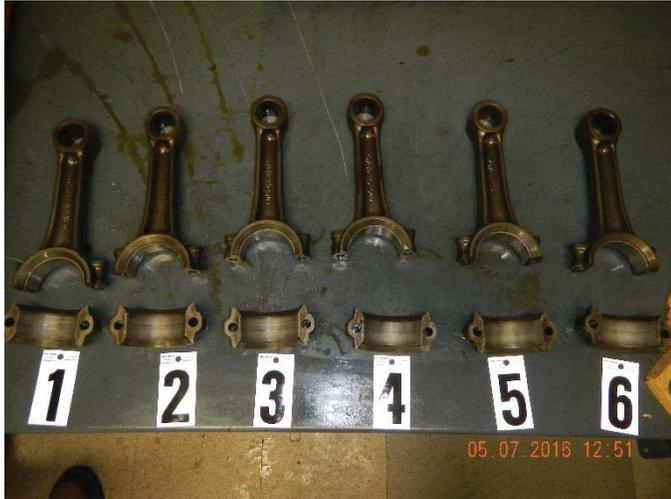
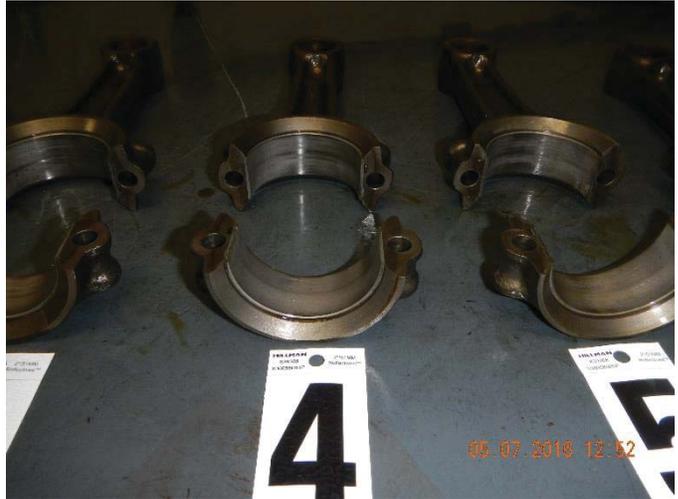
#4 CONNECTING ROD	P/N: 655910	Forging or Serial Number: 40742
Condition:	Normal wear appearance	
#4 CONNECTING ROD BEARING	P/N: SA630826-MO10	
Condition:	Normal wear exhibited

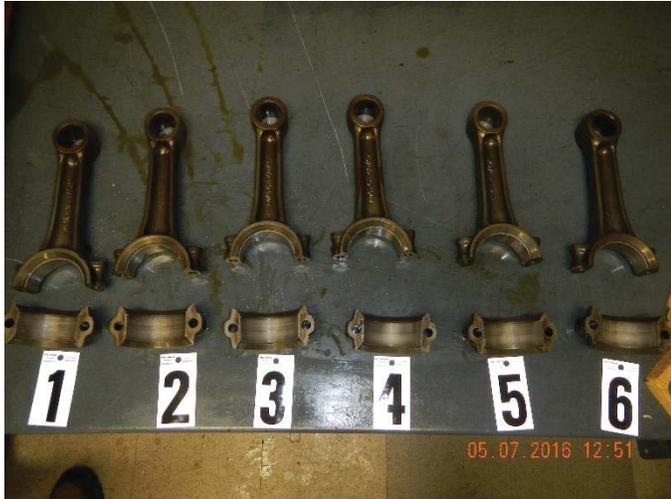
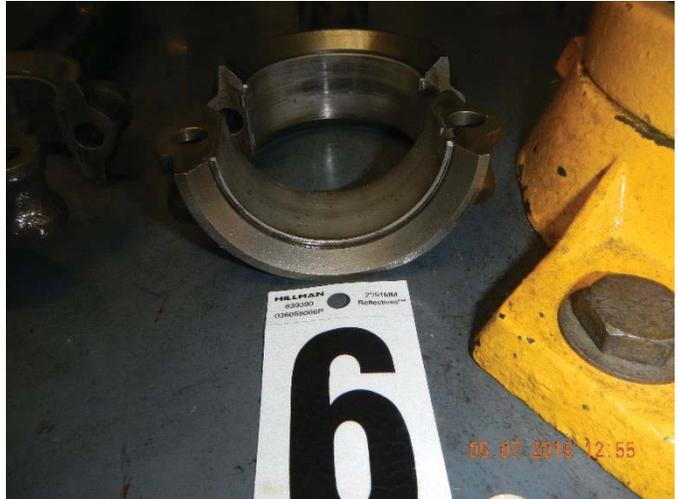
#6 CONNECTING ROD	P/N: 655910	Forging or Serial Number: 40742
Condition:	Normal wear appearance	
#6 CONNECTING ROD BEARING	P/N: SA630826-MO10	
Condition:	Normal wear exhibited

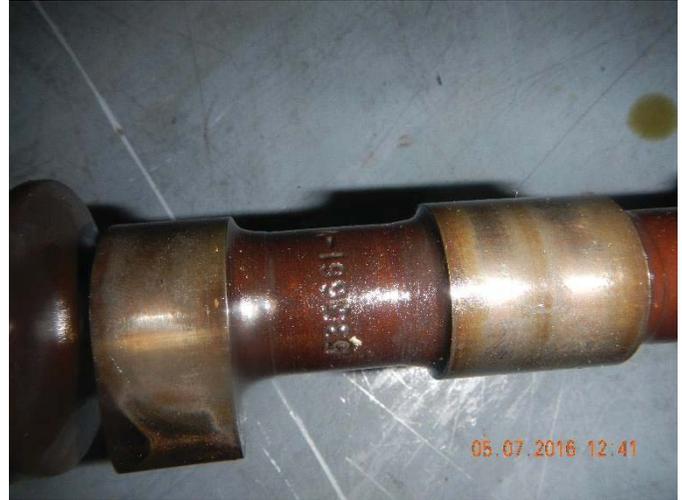
CAMSHAFT	P/N: 535661-V	S/N: Undetermined
Condition:	The cam exhibited normal wear patterns

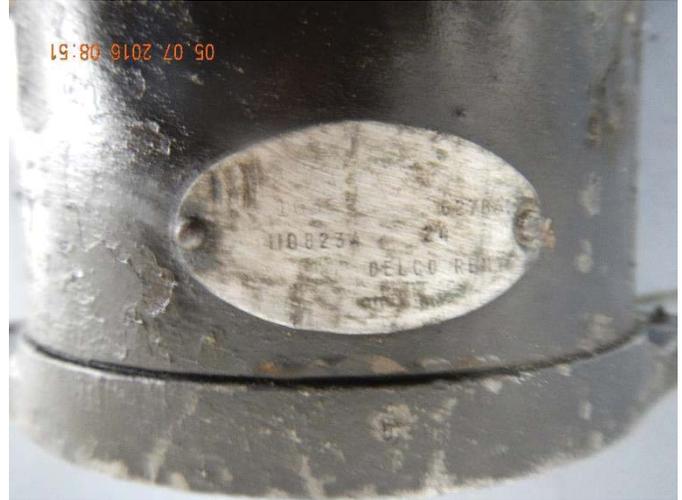
STARTER	Manufacturer: Delco-Remy	P/N: 627861	S/N: 1188234
Condition:	The starter motor was removed and visually inspected. No damage was noted
