Continental Motors

ENGINE FIELD INSPECTION REPORT

ENGINE MODEL	IO470D (15)
ENGINE SERIAL NUMBER	105176
AIRCRAFT MAKE & MODEL	Cessna 310F
AIRCRAFT SERIAL NUMBER	310-0070
AIRCRAFT REGISTRATION	N6770X
CMI FILE NUMBER	15-562

EXAMINATION		ACCIDENT DATA	
DATE	5-7-2016	NTSB ACCIDENT #	CEN16FA172
FACILITY	Pulaski Technical College-A&P School	NTSB INVESTIGATOR	Todd Fox
ADDRESS	[REDACTED] North Little Rock, AR North Little Rock Municipal Airport	FAA INVESTIGATOR	Brian Love
		ACCIDENT DATE	5-5-2016
		ACCIDENT LOCATION	North Little Rock Municipal (ORK)

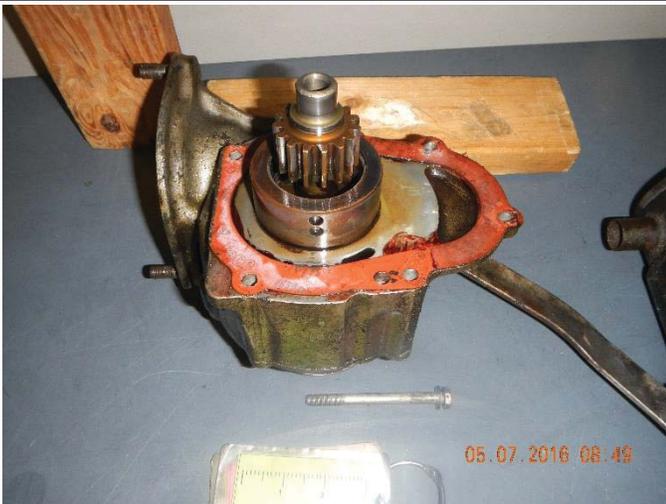
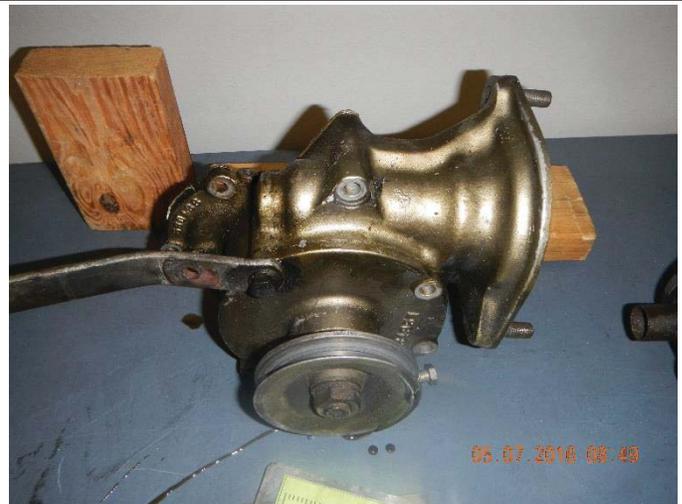
Condition:	The starter adapter was removed and visually inspected. The shaft rotated smoothly when the gear was rotated manually
------------	---

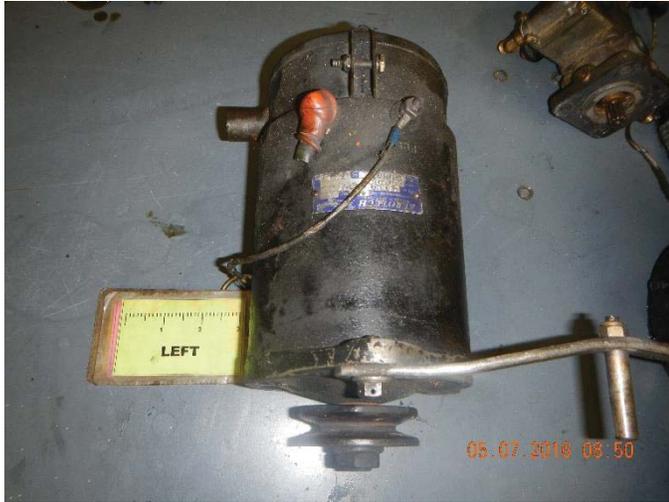
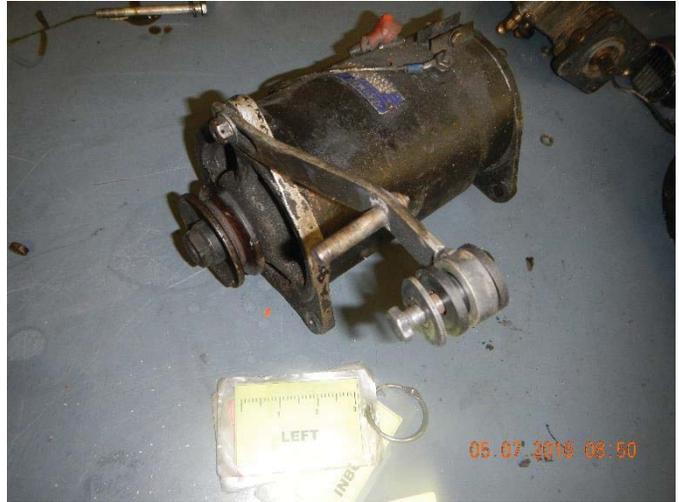
GEN	Manufacturer: Delco-Remy – Overhauled by AeroTech	P/N: 1105053	S/N: A10907
Condition:	The generator separated but was recovered. The drive pulley received impact damage.

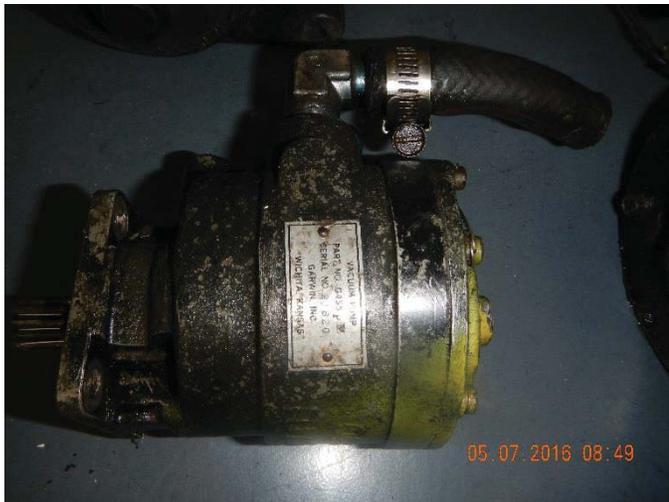
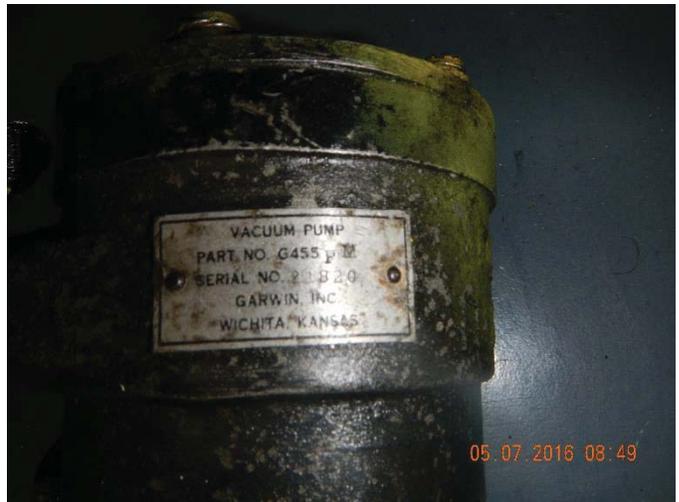
VACUUM PUMP	Manufacturer: Garwin	P/N: G455P	S/N: 30820
Condition:	The vacuum pump was removed and inspected. The pump produced suction at the inlet fitting when the pump was rotated manually

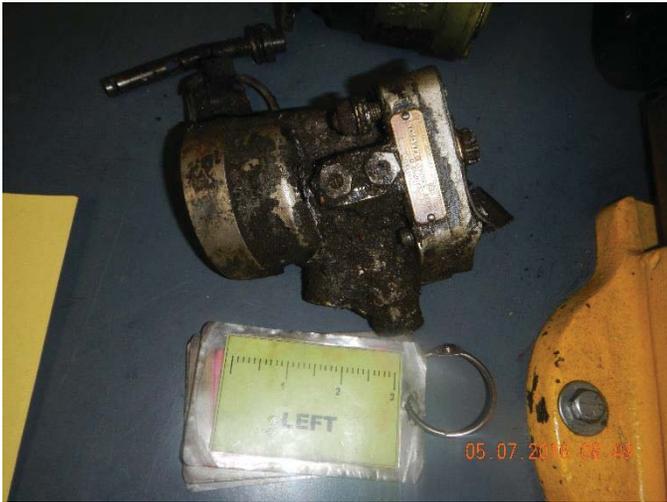
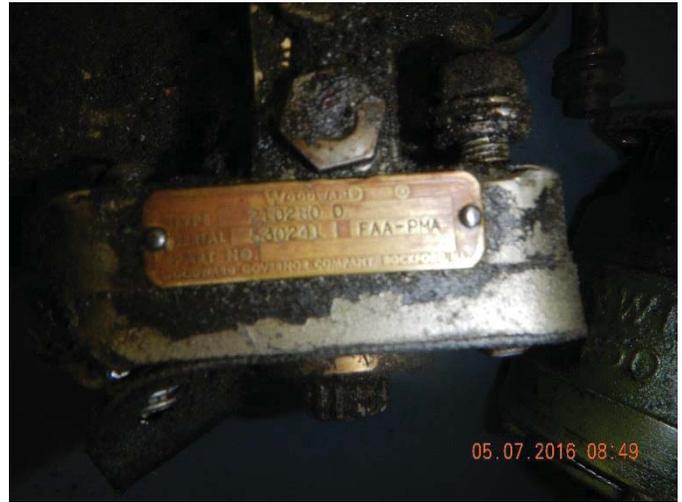
PROPELLER GOVERNOR	Manufacturer: Woodward	P/N: Undetermined	S/N: 530241
Condition:	The propeller governor separated from the engine due to impact but was recovered.

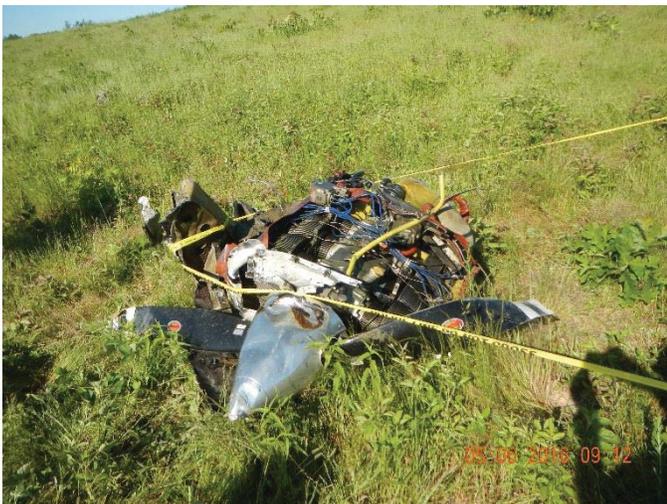
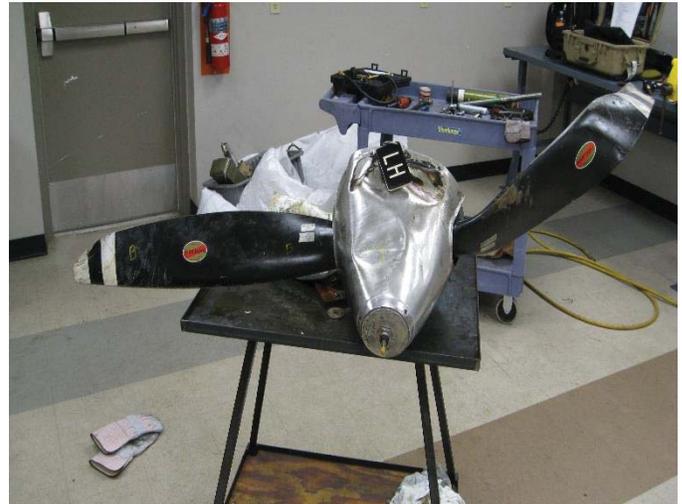
PROPELLER	Manufacturer: Hartzell	M/N: HC-C2YF-2CUFC8468-3	S/N: AN7313B
Blade 1 S/N:	I95963		
Blade 2 S/N:	J95964		
Condition:	Blade A exhibited a forward bend on the tip trailing edge only. Blade B exhibited a rearward twisting bend approximately 70-80 degrees beginning approximately 7 inches from blade root.
