Date of Accident: May 5, 2016

NTSB File No.: CEN16FA172

Aircraft: Cessna 310F

Propeller Teardown Report

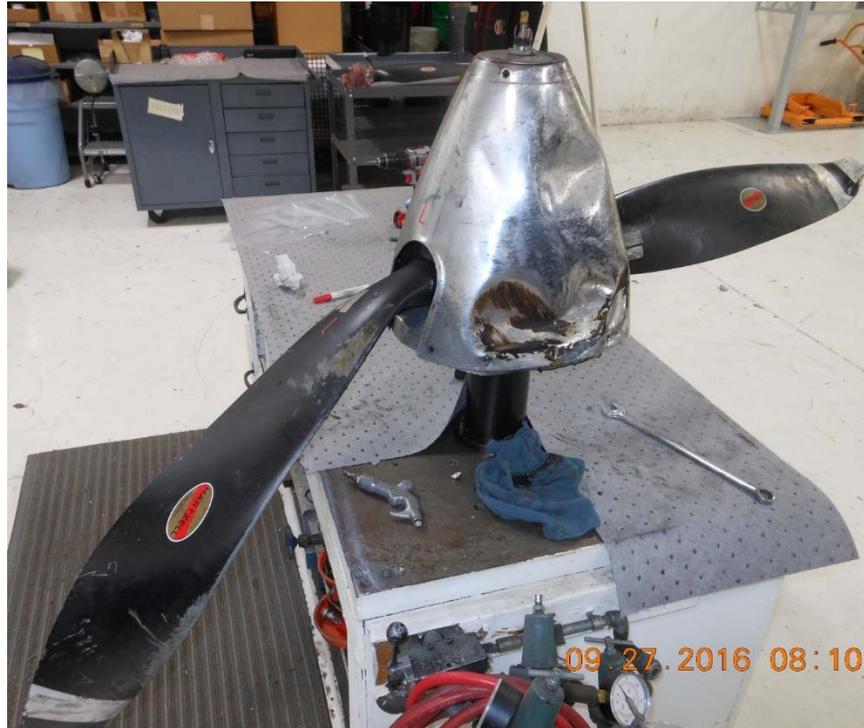
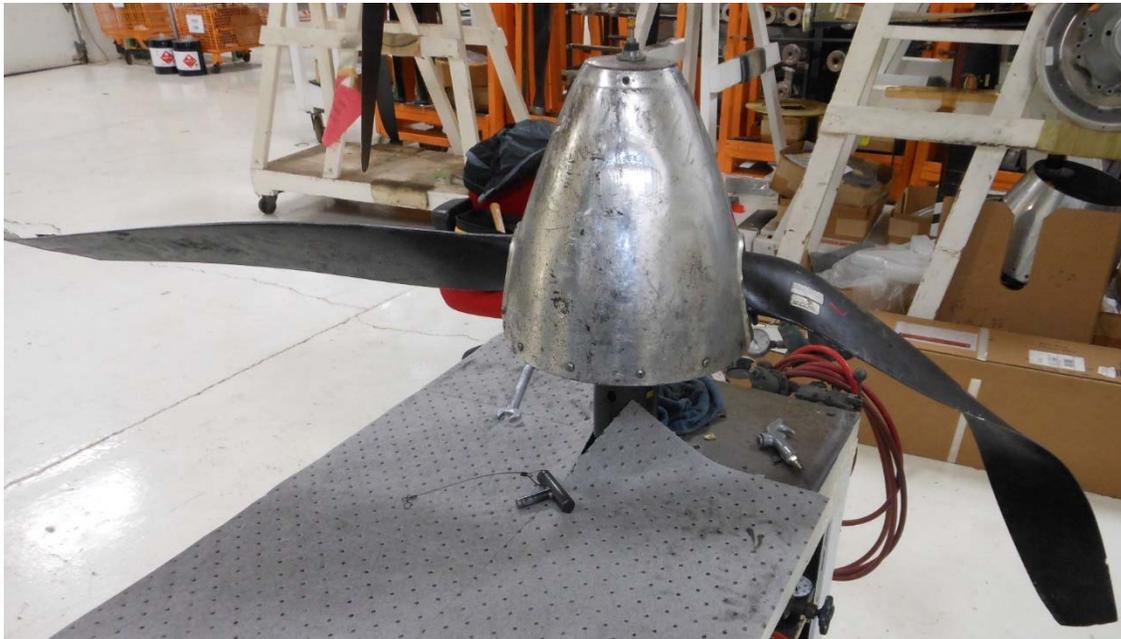
As Received Condition: The propeller was received in the condition shown in Photos #1 and #2. The spinner dome was crushed and scored predominantly on one side. One blade was bent aft, the other had some forward bending damage near the tip. Both blades appeared to be at or near a start lock position. The low pitch stop/air valve assembly appeared intact and there was an approximate 10 psig residual aircharge. The blades could not be rotated by hand or air pressure.

Photo #1 – Left propeller as-received

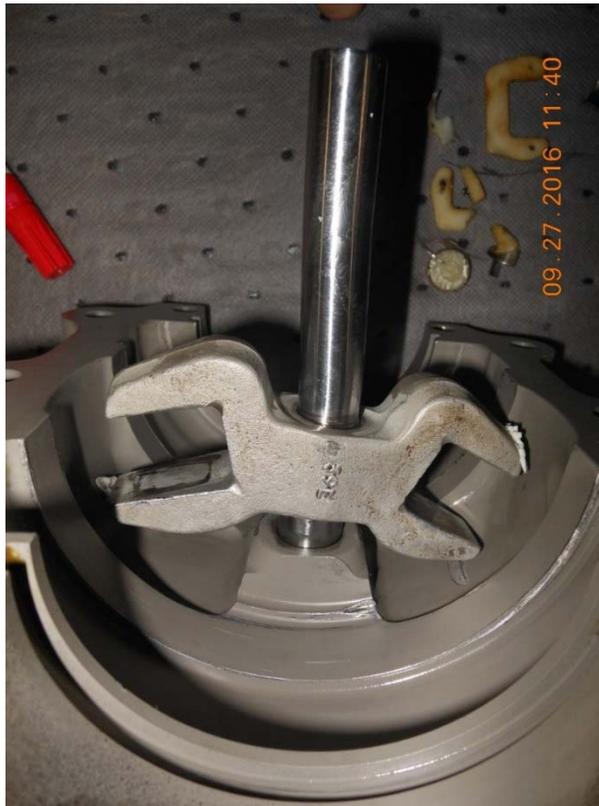
Photo #3 – Left

Pitch Change Rod: The pitch change rod was intact but bent on either side of the fork (see Photo #3). This bend prevented removal of the fork, and also the rod from the hub assembly without cutting. Therefore, the rod with the piston and fork attached remained in the forward hub half.

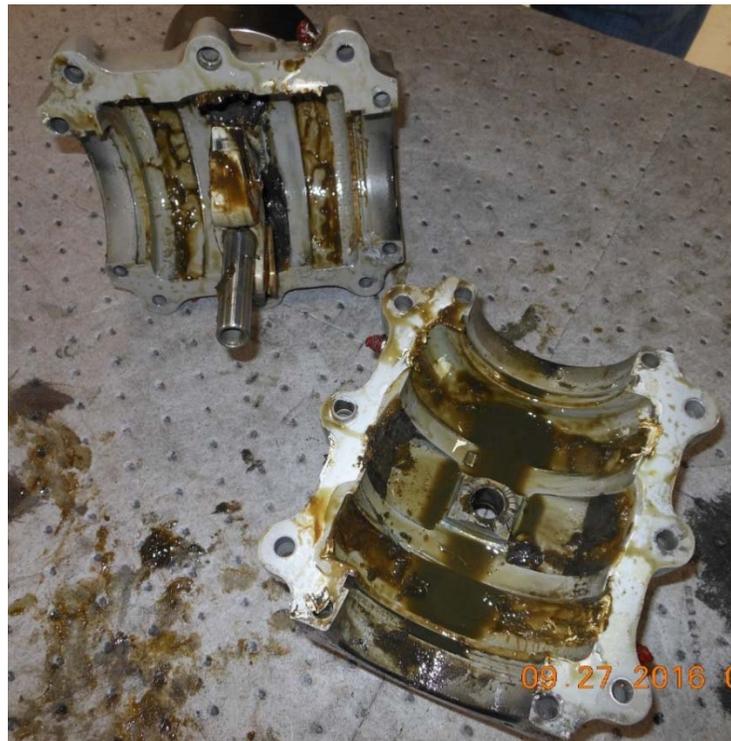
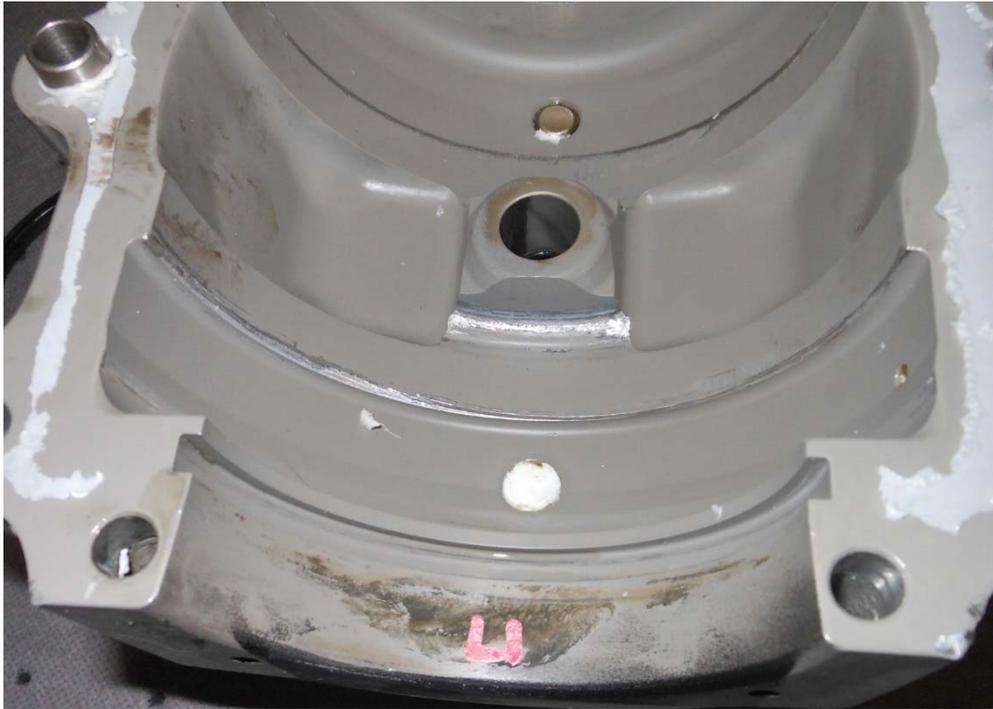
Hub Assembly: The external surfaces of the hub appeared undamaged. When opened, there was a mild to moderate amount of grease in the hub cavity indicating overservicing (Photo #4). There was also engine oil in the hub cavity suggesting the propeller had oil pressure from the governor and not feathered at time of impact. There was a fork impact mark on the forward hub half. There was preload plate shelf damage in both blade sockets (Photo #5). There was also black paint overspray on the L2 blade arm.

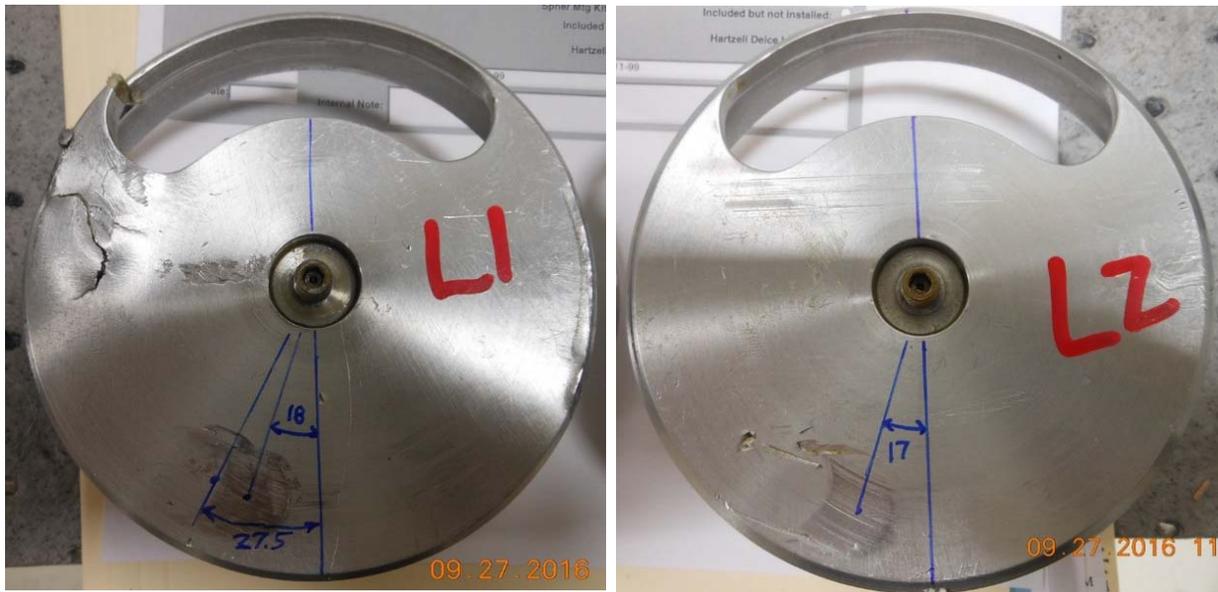
Photo #6 – Left

Preload Plates: See Photo #6

L1 preload plate had impact/rub marks at 18° and 27.5° from the hub splint line which are approximately equal to blade angles of 30° and 20.5° respectively. The L1 preload plate was fractured on the forward/low pitch side due to the blade rotating towards low pitch. The aft corner of the preload plate was deformed and the lip sheared due to impact forces in the aft direction.

L2 preload plate had a rub mark that was 17° from the hub split line approximately equal to a blade angle of 21° . The forward and aft lips had deformation damage or partially sheared due to impact forces.

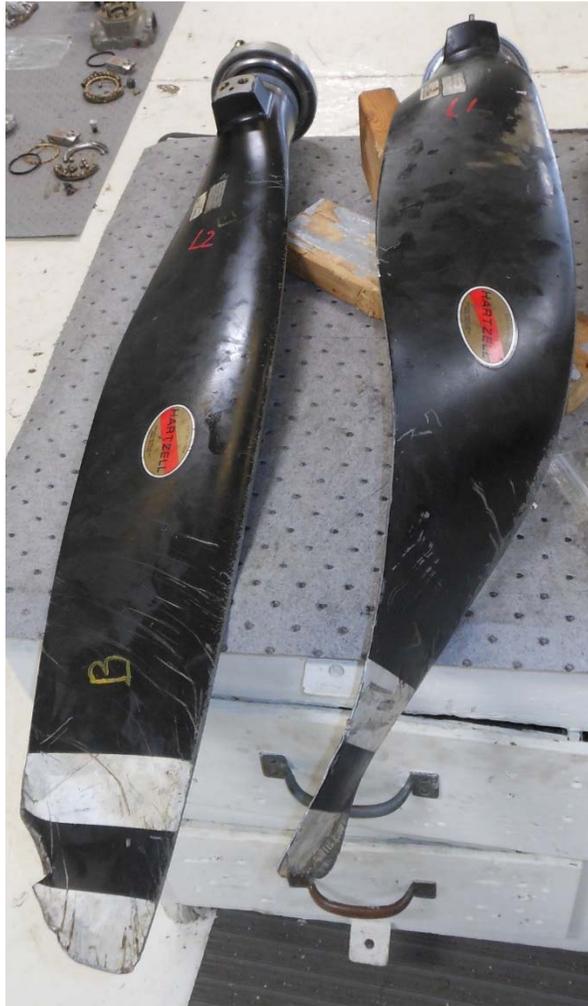
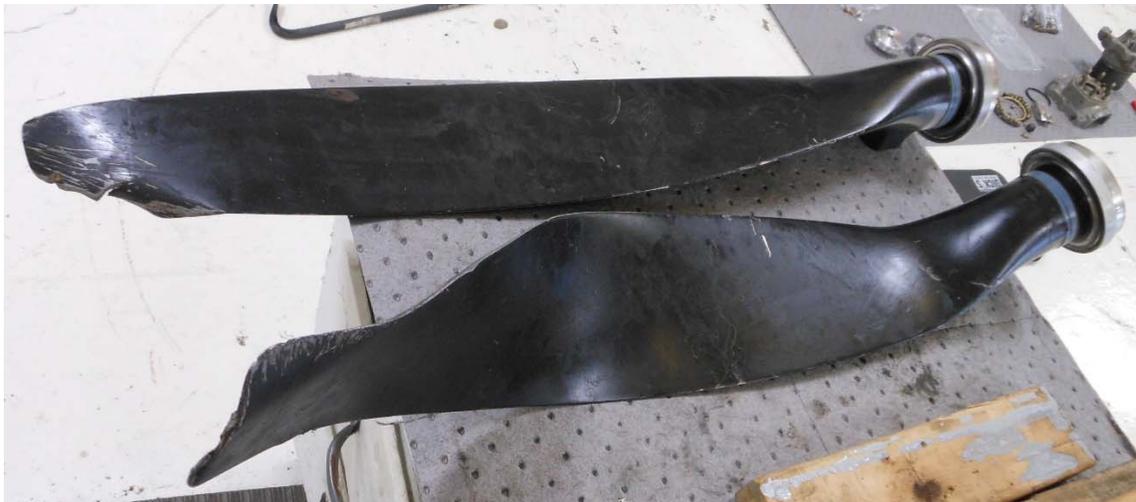
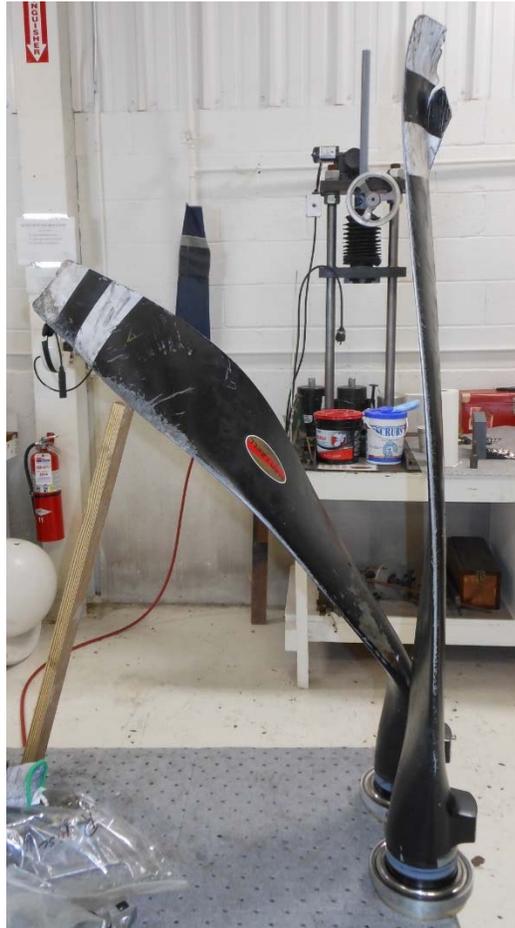
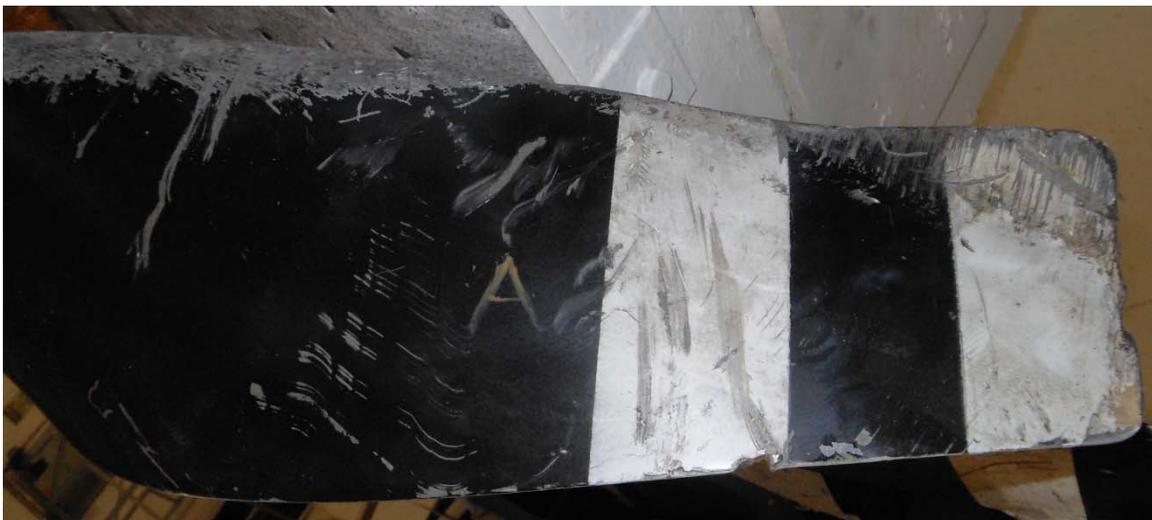
The left propeller blade damage included aft bending and limited chordwise/rotational marks on one blade only, suggesting one blade hit while rotating but rotation stopped quickly. The internal impact marks on the preload plates and hub, as well as the presence of oil in the hub cavity indicated the propeller was not in the feathered position (oil pressure had not been dumped) and that impact forces were in the aft direction with the blades in flat pitch.

Propeller Blade Properties: See Photos #7 through #10

Camber side	Chordwise/rotational scoring near tip, some sooting near shank
Face side	Chordwise/rotational scoring near tip
Bend	Aft
Twist	Leading edge down
Lead edge damage	Nicks and dents
Trail edge damage	Gouge 4" from tip
Knob condition	Knob was fractured off, knob block fractured into multiple pieces. Knob post had impact mark from preload plate. Although this propeller was overhauled in 2007, the knobs did not appear to be shot peened.
Counterweight	Intact and undamaged, was removed to gain access to hub clamping bolts
Blade bearings	Hub side bearing race fractured with ball impression marks
Butt/shank impact marks	There were crescent-shaped, circumferential impression/scoring marks on the face side of the blade butt.
De-Ice boot	NA

Camber side	Spanwise scraping near tip, chordwise scrapes 10-12" from tip
Face side	Spanwise scraping near tip
Bend	Aft
Twist	Not remarkable
Lead edge damage	Appeared to be normal erosion
Trail edge damage	Tearing, feathering/fracture at tip
Knob condition	Not remarkable
Counterweight	Intact and undamaged, was removed to gain access to hub clamping bolts
Blade bearings	Not remarkable
Butt/shank impact marks	Not remarkable
De-Ice boot	NA

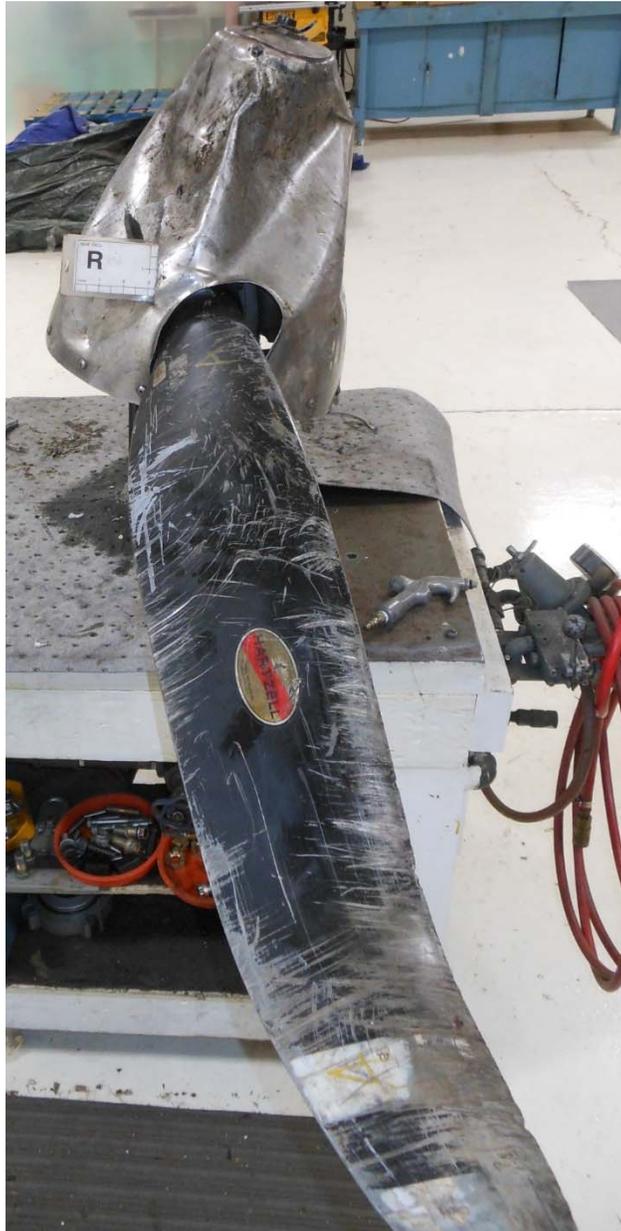
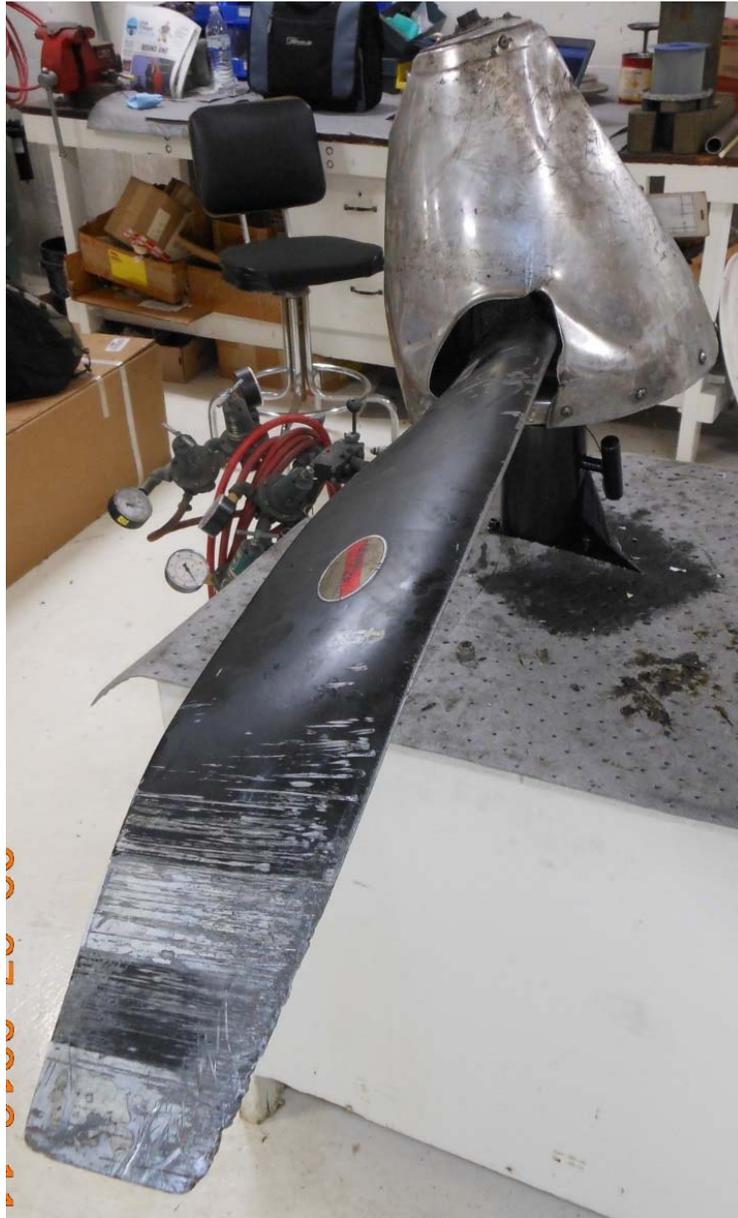
As Received Condition: The propeller was received in the condition shown in Photos #11 and #12. The blades appeared in the start lock position. Both blades had prominent leading edge gouging and chordwise/rotational scoring on the camber sides. One blade displayed S-bending and the other was bent aft. The spinner was crushed and bent leaning to one side. A counterweight had punctured through the spinner dome. The air valve was fractured off the low pitch stop assembly.

Photo #11 – Right propeller as-received

Photo #12 – Right propeller as-received

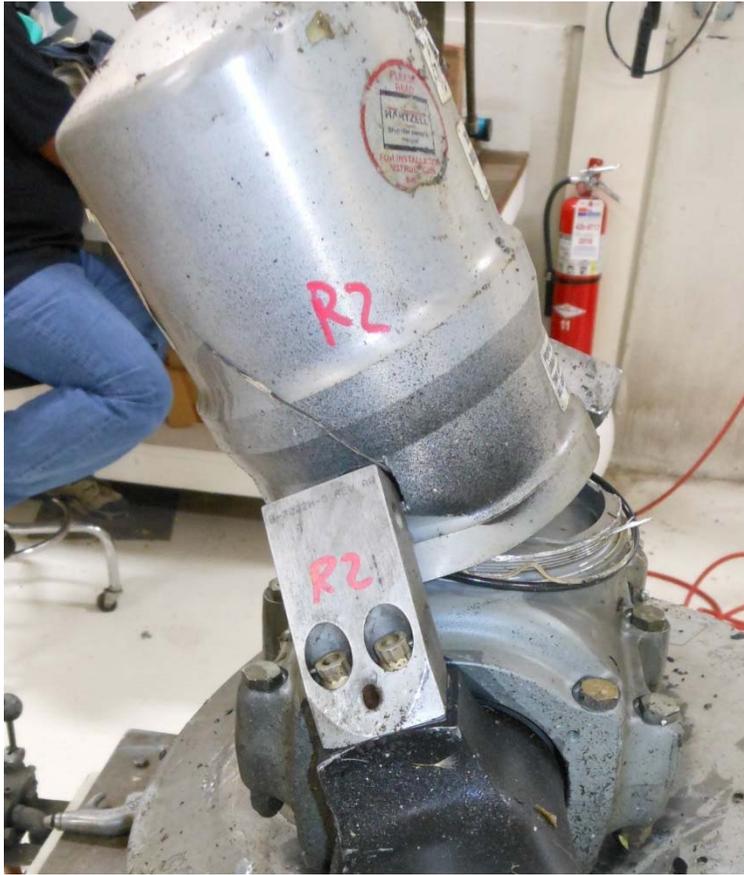
Photo #13 – Right

Cylinder: The cylinder had fractured from the hub mounting threads and was bent over to one side of the hub (see Photo #13). It was punctured by the R2 counterweight.

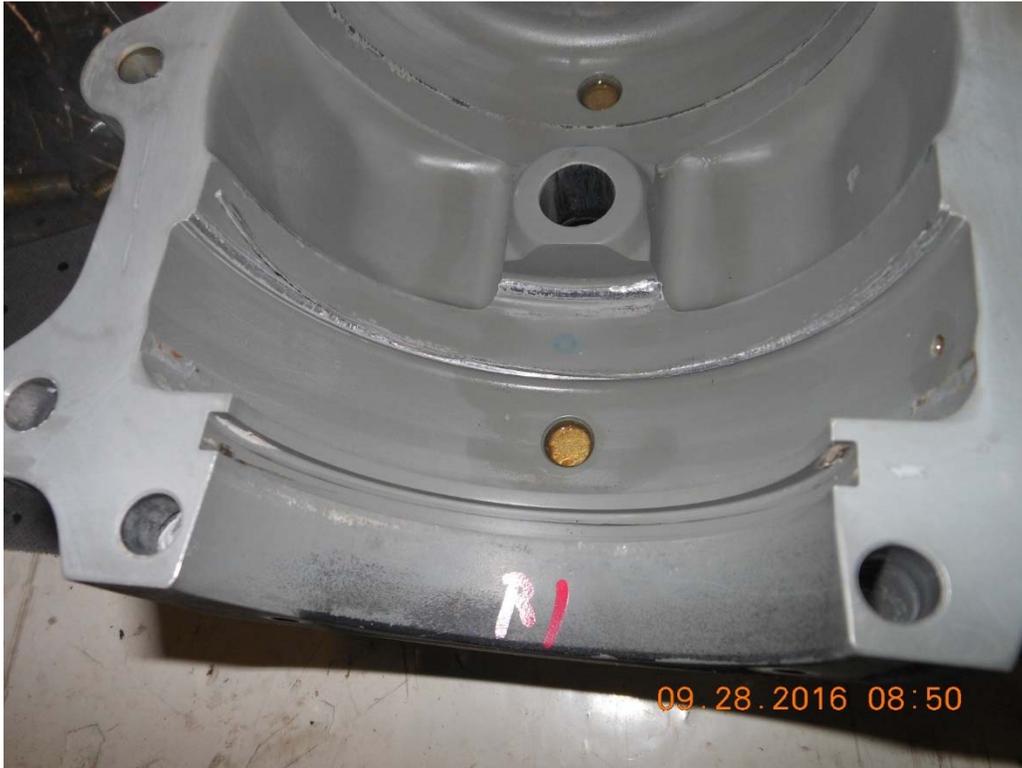
Photo #15 – Right

Hub Assembly: The external surfaces of the hub appeared undamaged other than the cylinder mounting boss threads. The aft hub half was removed first due to the pitch change rod and cylinder damage initially preventing removal of the hydraulic unit from the front hub half. When opened, there was a mild to moderate amount of grease in the hub cavity indicating overservicing (see Photo #14). There were fork impact marks on the forward hub half. There was preload plate shelf damage in both blade sockets (Photo #15). The forward pitch change rod boss was cracked.

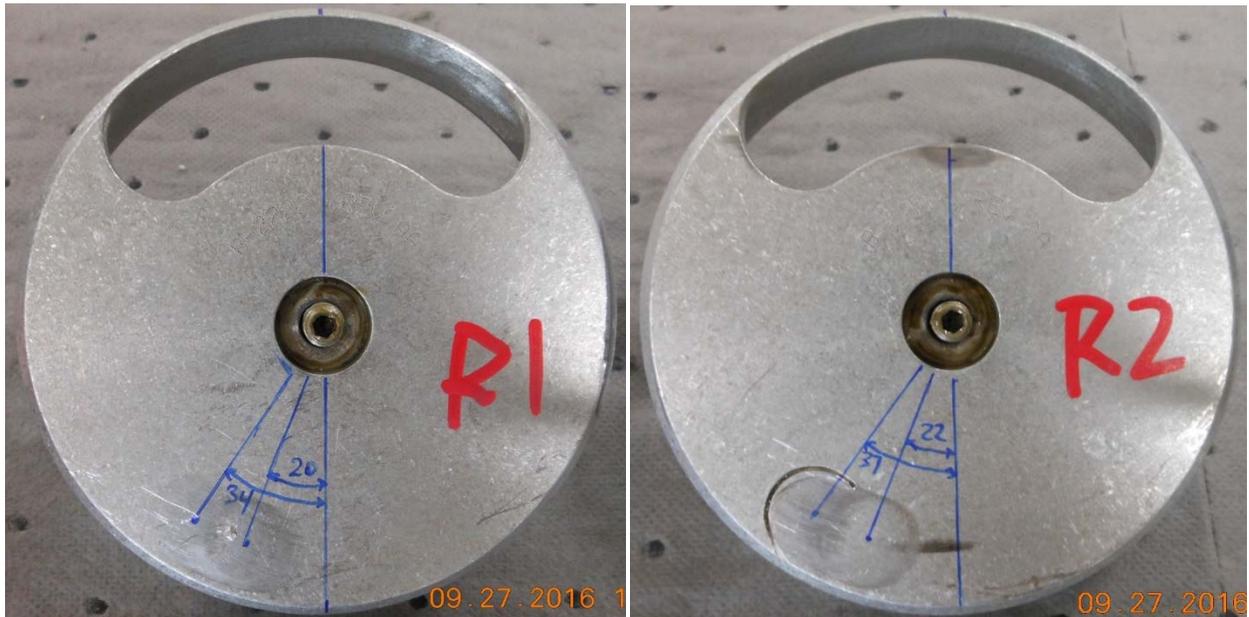
Photo #16 – Right

Preload Plates: (see Photo #16)

R1 preload plate had bumper rub marks at between $34-20^\circ$ from the hub splint line which are approximately equal to blade angles of $14-28^\circ$ respectively. The aft corner of the preload plate was deformed and the lip sheared due to impact forces in the aft direction.

R2 preload plate had bumper rub marks at between $37-22^\circ$ from the hub splint line which are approximately equal to blade angles of $11-26^\circ$ respectively. There was a deep circular impression of the knob block bumper skirt at the 37° mark. The aft/trail edge lip sheared due to impact forces in the aft/opposing rotation direction.

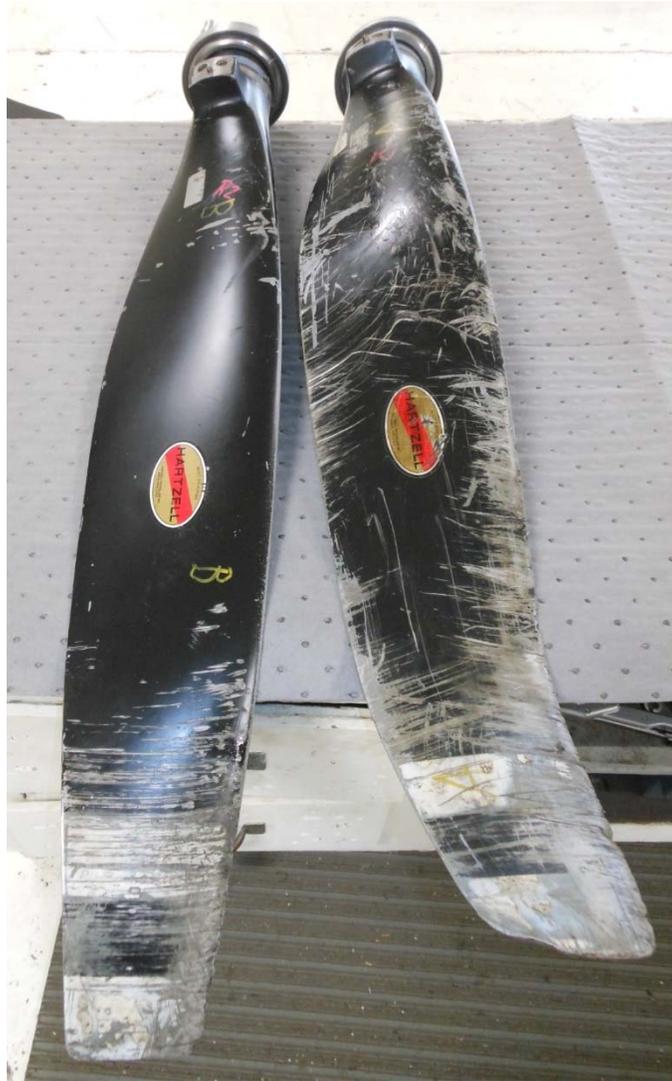
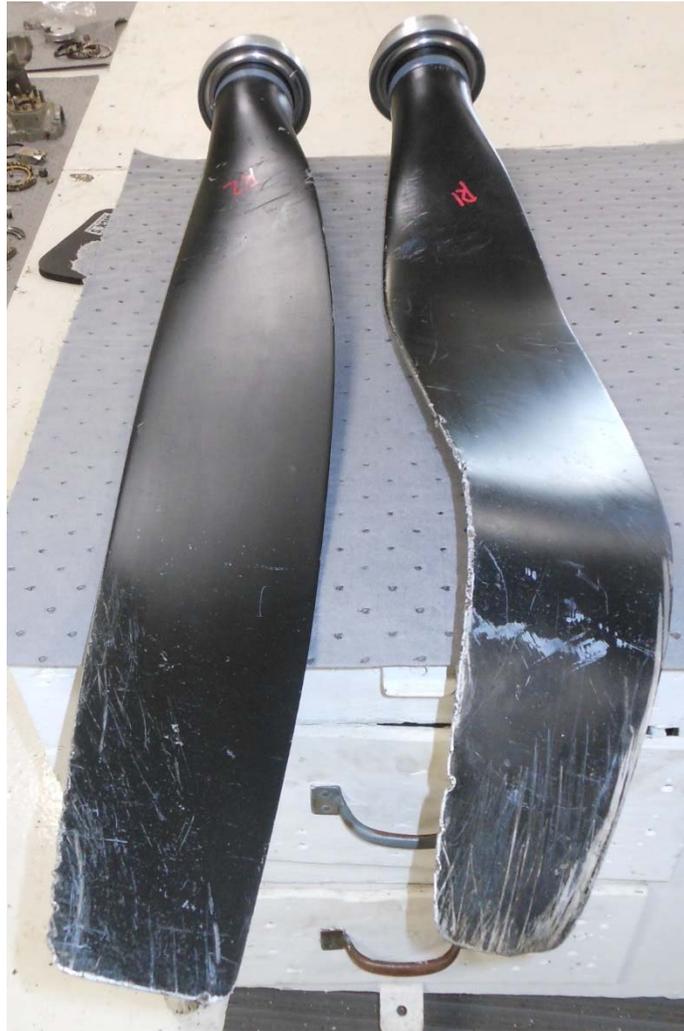
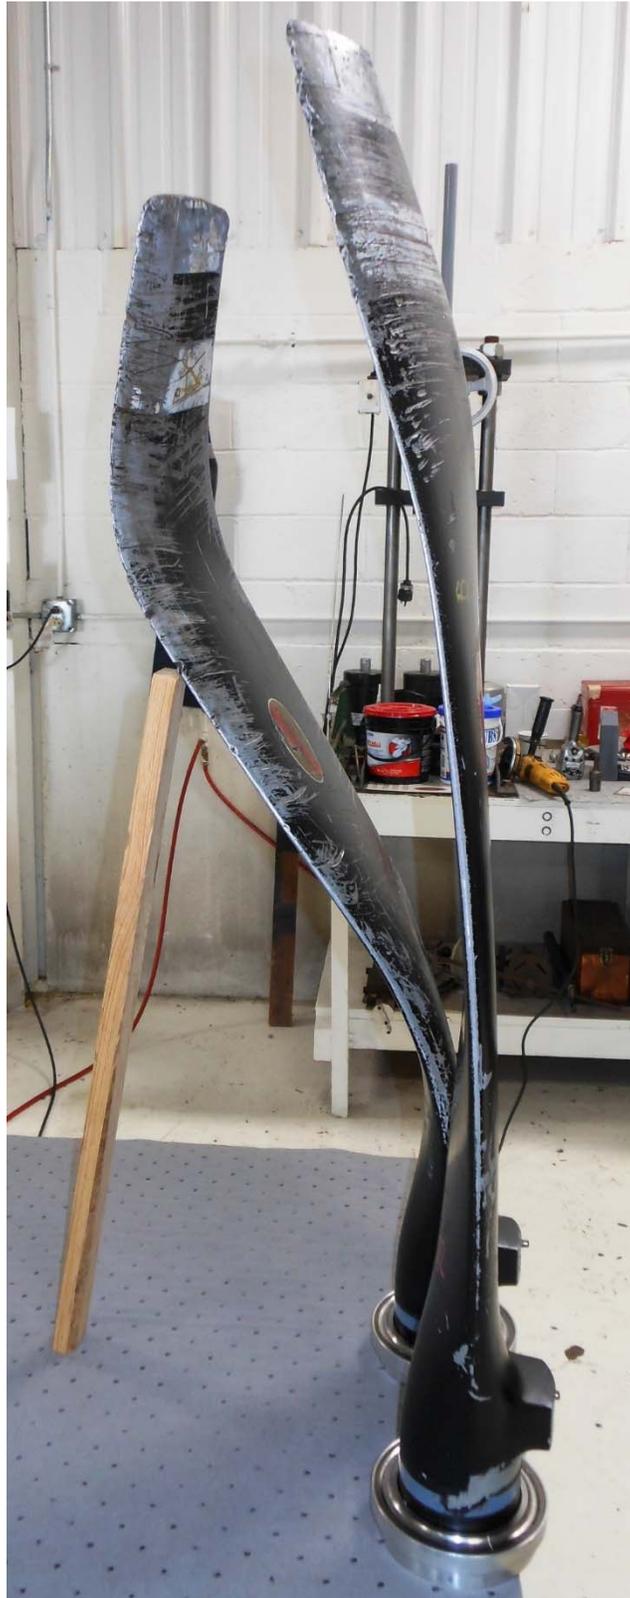
The right propeller blade damage included prominent chordwise/rotational scoring and leading edge gouging indicating the propeller was rotating under power at time of impact. The internal impact marks on the preload plates, pitch change knobs and hub suggested the blades were forcibly rotated towards low pitch.

Propeller Blade Properties: (See Photos #17 through #19)

Camber side	Chordwise/rotational scoring and gouging.
Face side	Spanwise scoring near tip
Bend	S-bend; tip forward, mid blade aft
Twist	Leading edge up
Lead edge damage	Gouging, nicks and dents
Trail edge damage	Nicks near tip
Knob condition	Bent opposite low pitch. The knob block bumper skirt was fractured and the bumper smashed. There was a preload plate slot impact mark on low pitch side.
Counterweight	Intact and undamaged, was removed to gain access to hub clamping bolts
Blade bearings	Intact
Butt/shank impact marks	Crescent shaped material discoloration on the face side edge
De-Ice boot	NA

Camber side	Chordwise/rotational scoring
Face side	Not remarkable
Bend	Aft
Twist	Leading edge down
Lead edge damage	Gouging, nicks and dents
Trail edge damage	Not remarkable
Knob condition	Not remarkable, The knob block bumper skirt was fractured and the bumper smashed.
Counterweight	Intact and undamaged, was removed to gain access to hub clamping bolts
Blade bearings	Intact
Butt/shank impact marks	Crescent shaped material discoloration on the face side edge
De-Ice boot	NA

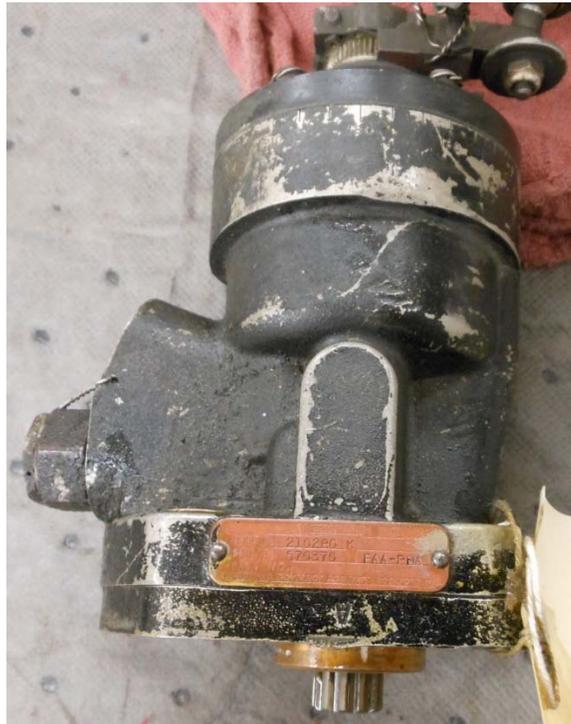
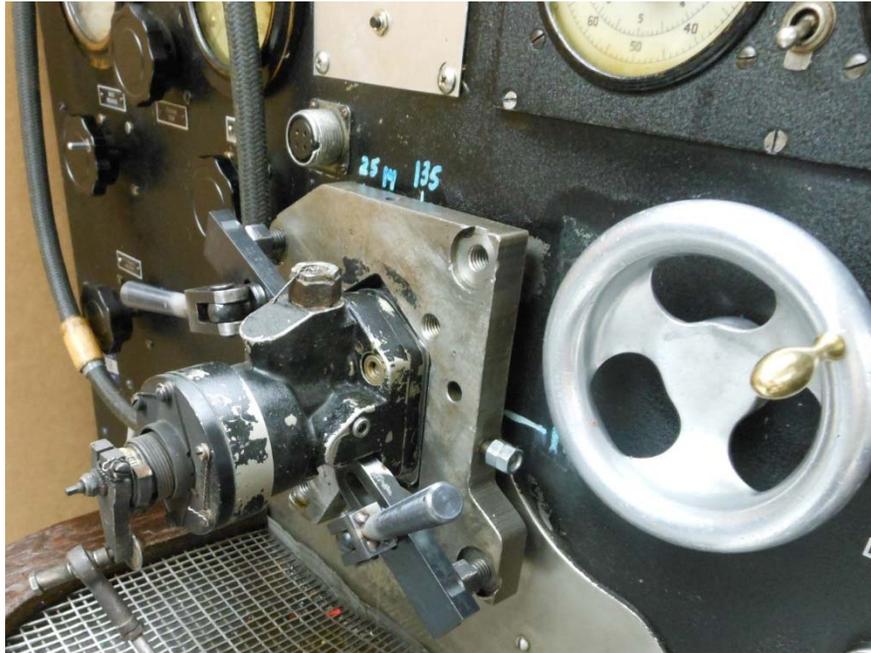
The right propeller governor P/N was 210280K, S/N 570370 and is pictured in Photo #20. The right propeller governor was intact and functionally tested on the test bench without any disassembly or adjustments (Photo #21). The following performance was recorded for the right propeller governor while operated on the test bench:

- 270 psi output pressure @ 900 RPM
- 280 psi output pressure @ 1550 RPM
- 295 psi output pressure @ 2070 RPM
- 305 psi output pressure (max relief setting) @ 2650 RPM
- The maximum RPM setting was determined to be 2745
- The minimum governor RPM setting was 2033
- The feather valve/dump was functional

Photo #20 – Right propeller governor as-received

Photo #21 – Right propeller governor mounted on test bench

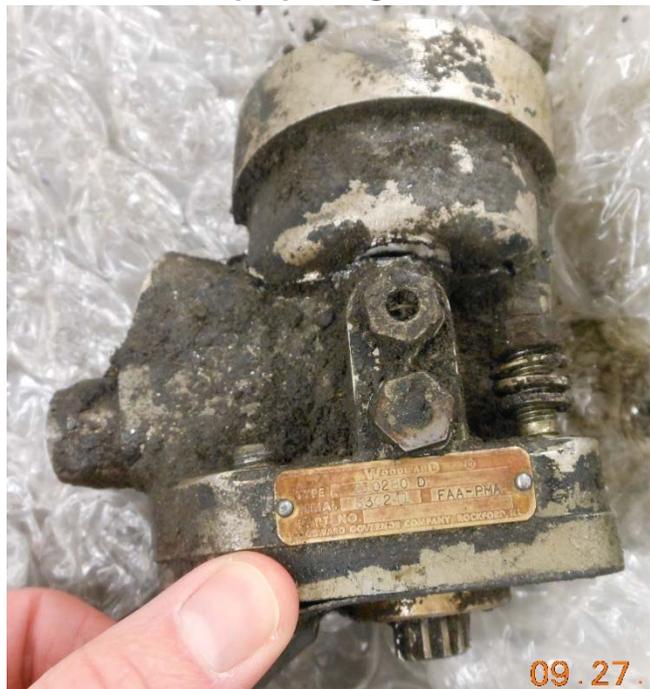
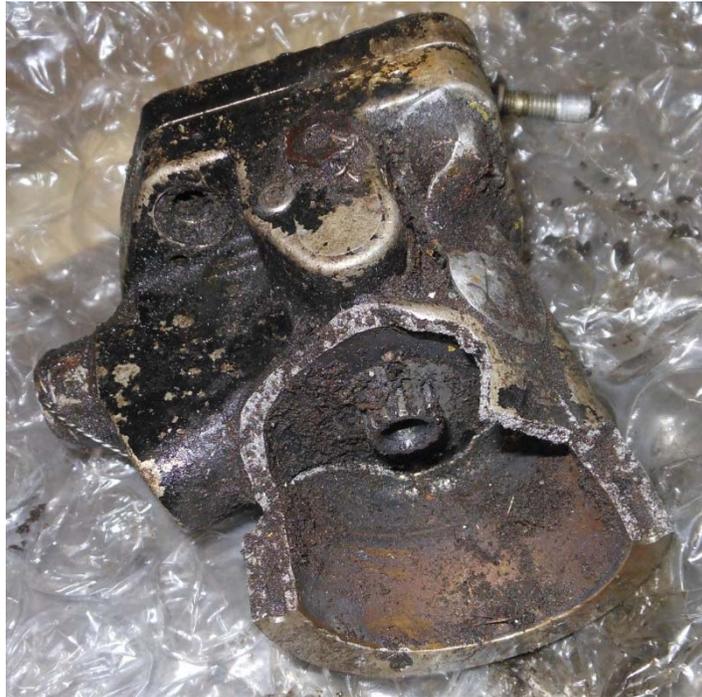
The left propeller governor P/N was 210280D, S/N 530241 and is pictured in Photos #22 and #23 as-received. The governor was found at the crash scene fractured from the engine and was packed with dirt. The inlet screen was partially pried from the base and was bent and packed with dirt. The governor body was fractured open and the control arm, spool valve and flyweight assembly were missing. The governor pump shaft was frozen and would not rotate when hand torque was applied. Photos #24 and #25 show the governor after it was cleaned in a solvent tank. No further disassembly or testing of the left propeller governor was conducted.

Photo #22 – Left propeller governor as-received

Photo #23 – Left propeller governor as-received
